Visual Site Inspection Report

Project Name	H-600 Pipeline Spread G	AFE	124300137	Spread	H-600 Pipeline Spread
Contractor	Precision			Report #	677
Inspector	Len Kruizenga			Date/Time	8/12/2019 7:22 AM
Permit #	TBD	Inspection Type	VA SWPP	Station Begin	11354+00
State	VA	Inspection Area	Full	Station End	11161+00
County	Giles	Ground	Dry	Temperature (°F)	90.00
Municipality	N/A	Weather	Sunny	Rain Gauge (in)	0.00
				Rain Accumulation Time (days)	3.00

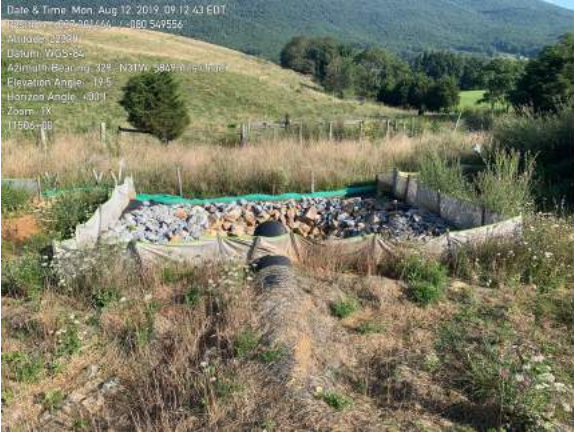
</div>		<div><p>Date & Time: Mon Aug 12, 2019 09:13:48 EDT Position: +037.321773 / -080.626776 Altitude: 2271ft Datum: WGS-84 Azimuth/Bearing: 421° S61W 428ft (True) Elevation Angle: -0.1° Horizon Angle: +00.5° Zoom: 1X 11502+00</p>

</div>			
GPS Location	see photo.	GPS Location	see photo		
Field Station#	11506+00	Field Station#	11502+00		
Pic 1 Desc.	Plunge pool in place.	Pic 2 Desc.	Conveyance channel with rock checks in place.		
<div><p>Date & Time: Mon Aug 12, 2019 09:26:21 EDT Position: +037.323694 / -080.433667 Altitude: 2105ft Datum: WGS-84 Azimuth/Bearing: 266° S86W 472ft (True) Elevation Angle: +04.2° Horizon Angle: +01.2° Zoom: 1X 11476+00</p>

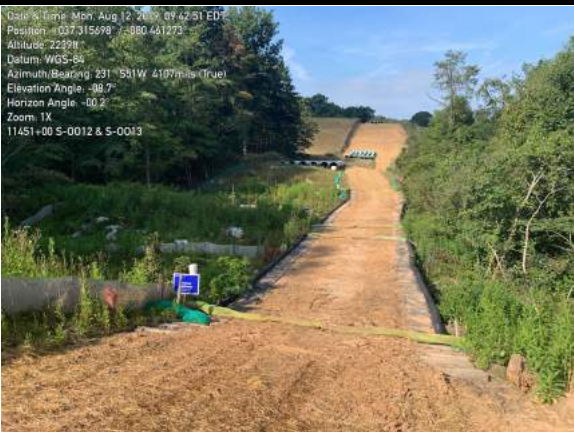
</div>			
GPS Location	see photo	GPS Location	see photo		
Field Station#	11451+00	Field Station#	11381+00		
Pic 5 Desc.	Sensitive resource buffer in place at stream.	Pic 6 Desc.	Triple barrier ECDs in place at off ROW karst.

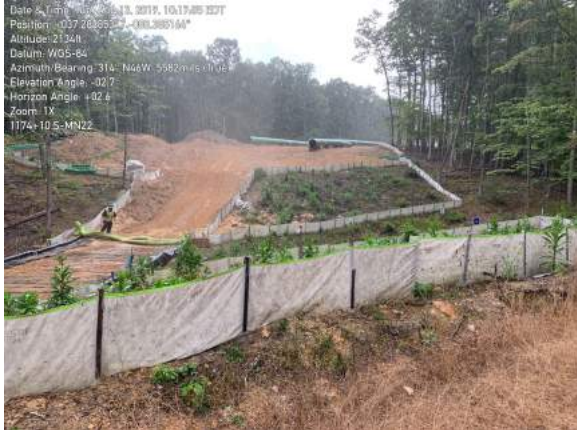
GPS Location	see photo	GPS Location	see photo		
Field Station#	11704+10	Field Station#	11712+00		
Pic 1 Desc.	Sensitive resource buffer in place at stream.	Pic 2 Desc.	Waterbar with sump pit and end treatment in place

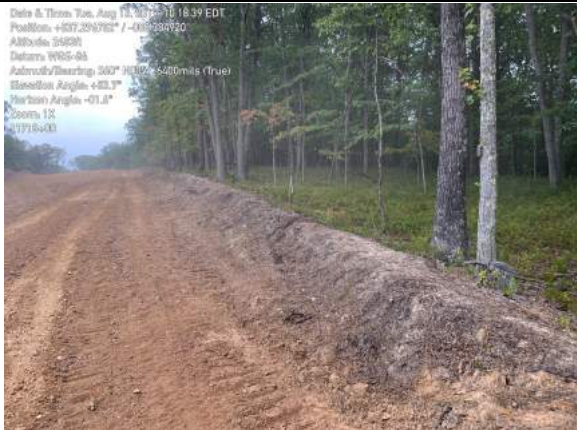
GPS Location	see photo	GPS Location	see photo		
Field Station#	11718+00	Field Station#	11715+00		
Pic 3 Desc.	Clean water diversion berm in place.	Pic 4 Desc.	Environmental crew installing waterbar due to storm

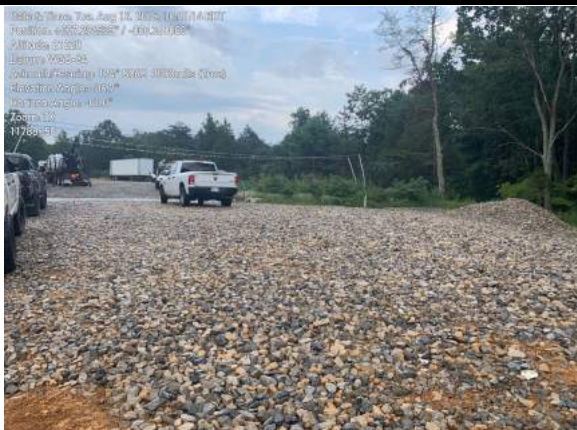
GPS Location	see photo	GPS Location	see photo		
Field Station#	11788+50	Field Station#	11670+00		
Pic 5 Desc.	RCE in place at Mount Tabor Road.	Pic 6 Desc.	Undermined priority one silt fence.

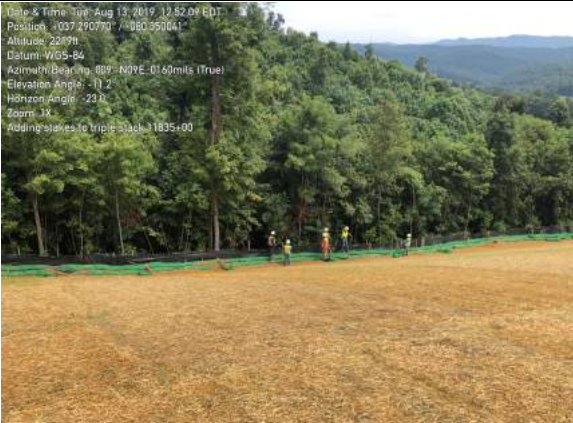
<p>Date & Time: Tue Aug 13, 2019, 13:14:57 EDT Position: +037.242280° / -080.36778° Altitude: 2239ft Datum: WGS-84 Azimuth/Bearing: 88° N99E 016mils (True) Elevation Angle: -11.2° Horizon Angle: -23.0° Zoom: 1X repairing temp water bars 11837+00</p>

GPS Location	5	GPS Location	6		
Field Station#	11835+00	Field Station#	11837+00		
Pic 5 Desc.	Staking triple stack CFS.	Pic 6 Desc.	Putting back temporary water bar.

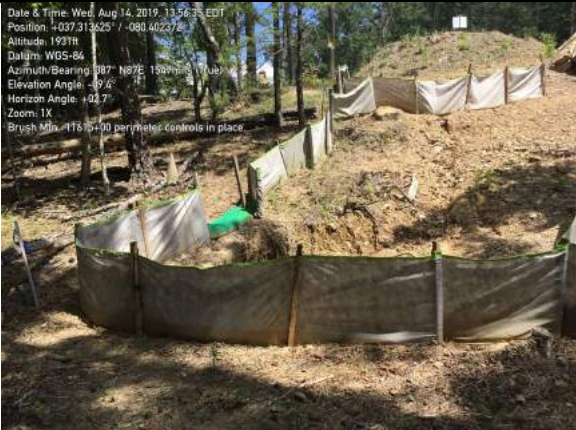
GPS Location	Location on photo		GPS Location	Location on photo	
Field Station#	11645+00		Field Station#	11615+00	
Pic 5 Desc.	ROW conditions are currently stable		Pic 6 Desc.	ECDs were checked and found acceptable

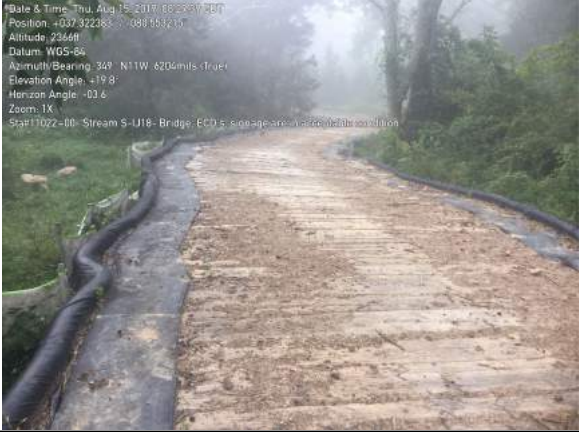
<p>Date & Time: Thu, Aug 15, 2019, 08:38:05 EDT Position: +037.322365 / -080.555109 Altitude: 2366ft Datum: WGS-84 Azimuth Bearing: 34° N11W 620mils (True) Elevation Angle: +19.8° Horizon Angle: -03.6° Zoom: 1X Stat: 11022+00- Stream S-IJ18- Bridge- ECD's, signage, bridge, good</p>

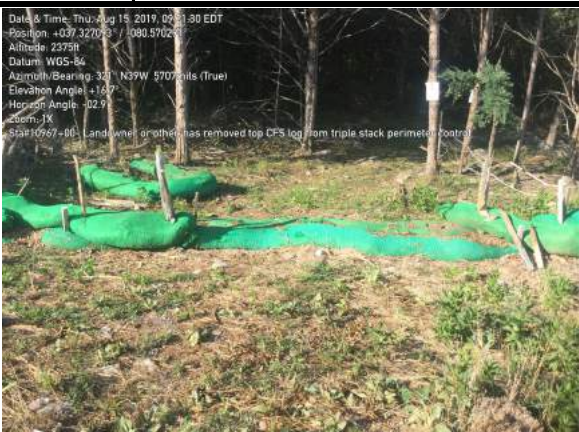
<p>Date & Time: Thu, Aug 15, 2019, 09:29:44 EDT Position: +037.327037 / -080.570267 Altitude: 2397ft Datum: WGS-84 Azimuth Bearing: 321° N39W 5707mils (True) Elevation Angle: +16.7° Horizon Angle: -02.9° Zoom: 1X Stat: 10969+00- Landowner: Grother has removed top CFS log from triple stack perimeter controls</p>
