# Visual Site Inspection Report

<b>Project Name</b>	H-600 Pipeline Spread G	<b>AFE</b>	124300137	<b>Spread</b>	H-600 Pipeline Spread
<b>Contractor</b>	Precision			<b>Report #</b>	1031
<b>Inspector</b>	Len Kruizenga			<b>Date/Time</b>	8/19/2019 8:36 AM
<b>Permit #</b>	TBD	<b>Inspection Type</b>	VA SWPP	<b>Station Begin</b>	11857+00
<b>State</b>	VA	<b>Inspection Area</b>	Full	<b>Station End</b>	12001+00
<b>County</b>	Montgomery	<b>Ground</b>	Damp	<b>Temperature (°F)</b>	90.00
<b>Municipality</b>	N/A	<b>Weather</b>	Sunny	<b>Rain Gauge (in)</b>	0.30
				<b>Rain Accumulation Time (days)</b>	3.00

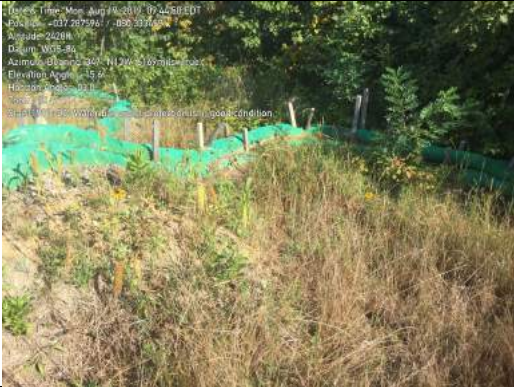
<p>Date &amp; Time: Mon, Aug 19, 2019, 07:42:58 EDT Position: +017.287961 / +080.33358 Altitude: 2269 ft Datum: WGS-84 Azimuth/Bearing: 320° N12W, 5831mils (True) Elevation Angle: +25.4° Horizon Angle: -02.4° Zoom: 2X Star#11901+00: CFS checks where 266.03 crosses the row are in acceptable condition.</p>

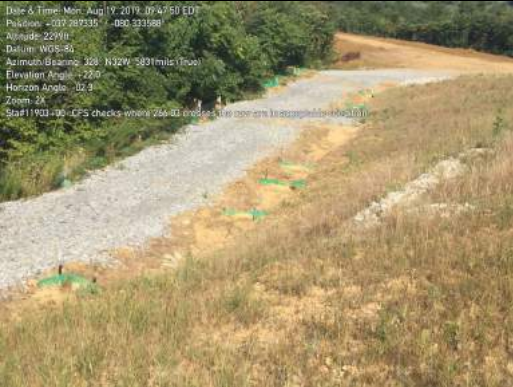
<p>Date &amp; Time: Mon, Aug 19, 2019, 07:47:50 EDT Position: +017.287335 / +080.33358 Altitude: 2291 ft Datum: WGS-84 Azimuth/Bearing: 320° N12W, 5831mils (True) Elevation Angle: +22.0° Horizon Angle: -02.4° Zoom: 2X Star#11903+00: CFS checks where 266.03 crosses the row are in acceptable condition.</p>			
<b>GPS Location</b>	See photo GPS	<b>GPS Location</b>	See photo GPS		
<b>Field Station#</b>	11901+00	<b>Field Station#</b>	11903+00		
<b>Pic 1 Desc.</b>	Water bar outlet protection is in acceptable condition.	<b>Pic 2 Desc.</b>	CFS checks along 266.03 where access road crosses the row are in acceptable condition.

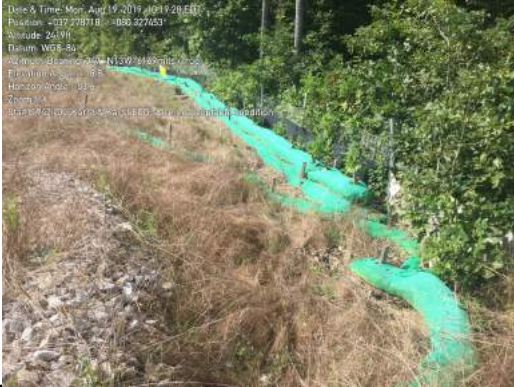
<p>Date &amp; Time: Mon, Aug 19, 2019, 09:19:20 EDT Position: +017.278718 / +080.327653 Altitude: 2619 ft Datum: WGS-84 Azimuth/Bearing: 320° N12W, 5831mils (True) Elevation Angle: +35.5° Horizon Angle: -02.5° Zoom: 2X Star#11942+00: Karst &amp; Karst ECD's are in acceptable condition.</p>

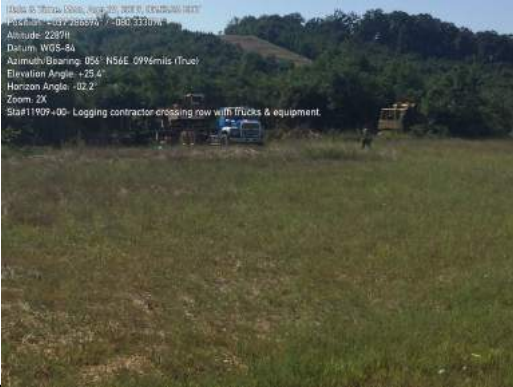
<p>Date &amp; Time: Mon, Aug 19, 2019, 09:19:20 EDT Position: +017.278718 / +080.327653 Altitude: 2287 ft Datum: WGS-84 Azimuth/Bearing: 85° N56E, 5996mils (True) Elevation Angle: +25.4° Horizon Angle: -02.2° Zoom: 2X Star#11909+00: Logging contractor crossing row with trucks &amp; equipment.</p>			
<b>GPS Location</b>	See photo GPS	<b>GPS Location</b>	See photo GPS		
<b>Field Station#</b>	11942+00	<b>Field Station#</b>	11909+00		
<b>Pic 3 Desc.</b>	Karst & Karst ECD's are in acceptable condition.	<b>Pic 4 Desc.</b>	Logging contractor crossing row with equipment & trucks, CFS perimeter controls have been pulled back..

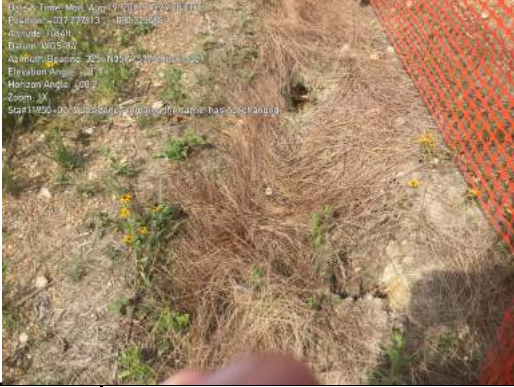
<p>Date &amp; Time: Mon, Aug 19, 2019, 09:40:43 EDT Position: +017.278279 / +080.322931 Altitude: 1524 ft Datum: WGS-84 Azimuth/Bearing: 320° N12W, 5831mils (True) Elevation Angle: +34.7° Horizon Angle: -02.2° Zoom: 2X Star#11950+00: Subsidence remains the same, has not changed.</p>

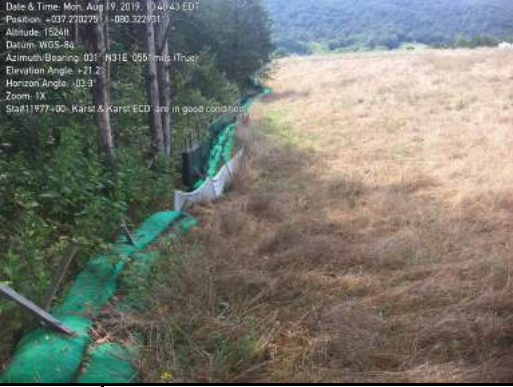
<p>Date &amp; Time: Mon, Aug 19, 2019, 09:40:43 EDT Position: +017.278279 / +080.322931 Altitude: 1524 ft Datum: WGS-84 Azimuth/Bearing: 031° N31E, 0581mils (True) Elevation Angle: +21.2° Horizon Angle: -03.3° Zoom: 1X Star#11977+00: Karst &amp; Karst ECD's are in good condition.</p>			
<b>GPS Location</b>	See photo GPS	<b>GPS Location</b>	See photo GPS		
<b>Field Station#</b>	11950+00	<b>Field Station#</b>	11977+00		
<b>Pic 5 Desc.</b>	Subsidence remains the same, has not changed from previous inspection.	<b>Pic 6 Desc.</b>	Karst & Karst ECD's are in acceptable condition.

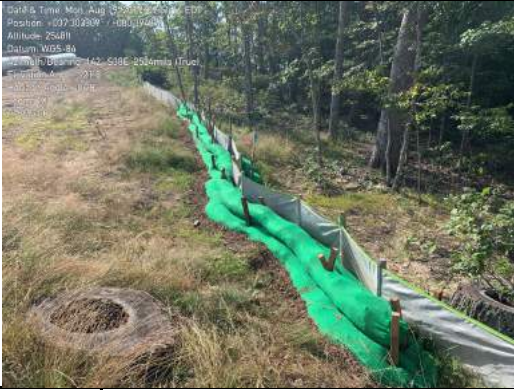
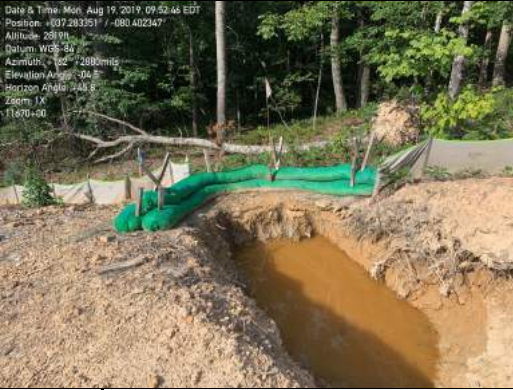
<b>GPS Location</b>	See photo for GPS location.		<b>GPS Location</b>	See photo for GPS location.	
<b>Field Station#</b>	11669+00		<b>Field Station#</b>	11670+00	
<b>Pic 1 Desc.</b>	ECDs upgraded to triple stack compost filter sock and priority one silt fence.		<b>Pic 2 Desc.</b>	Triple stack compost filter sock in place with sump pit.

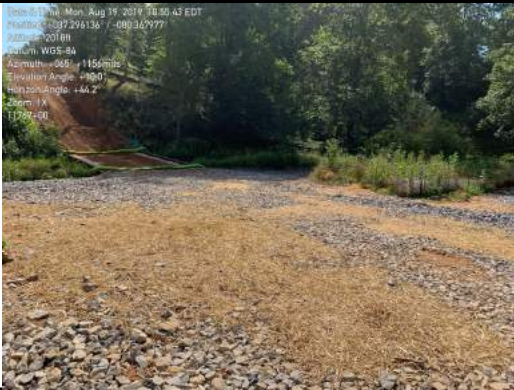
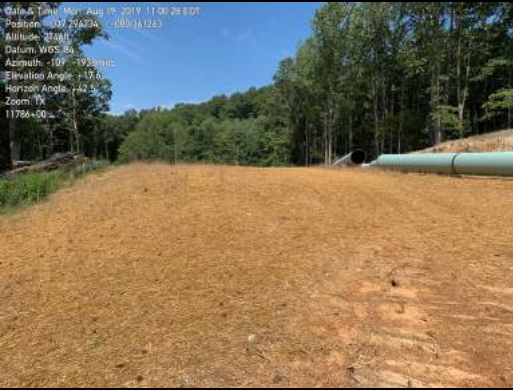
<b>Pic 5 Desc.</b>	RCE in place at main line valve 26.		<b>Pic 6 Desc.</b>	ROW has been temporarily stabilized with seed and mulch.

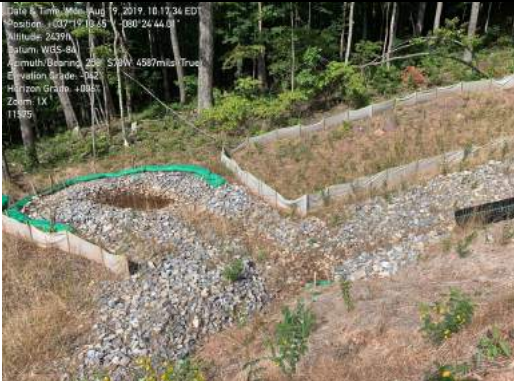
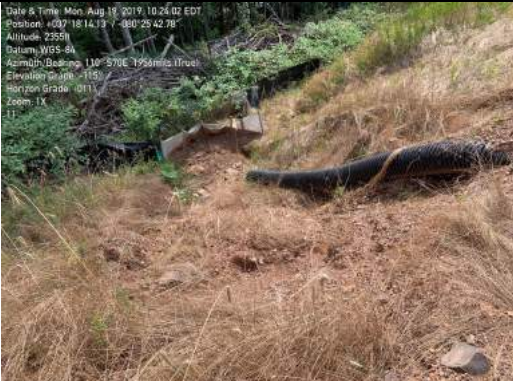
<b>GPS Location</b>	See picture above for GPS coordinates		<b>GPS Location</b>	See picture above for GPS coordinates	
<b>Field Station#</b>	11575+00		<b>Field Station#</b>	11579+00	
<b>Pic 3 Desc.</b>	ECD's and row conditions for S- PP22		<b>Pic 4 Desc.</b>	Sump full from sediment

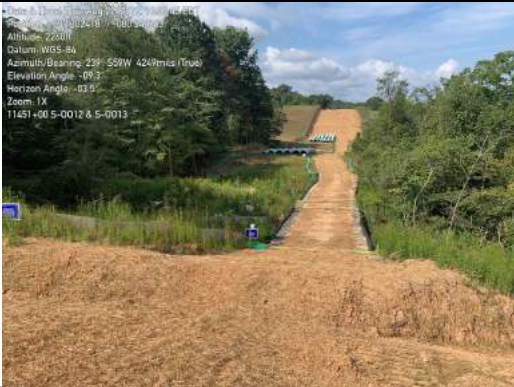
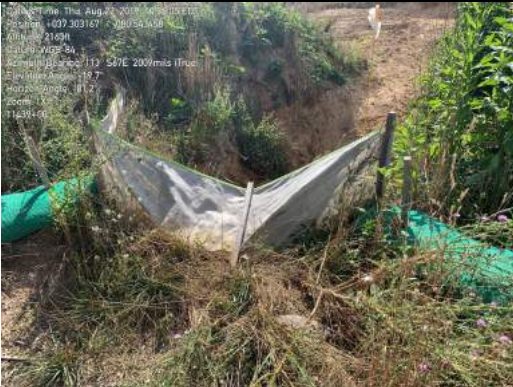
<b>GPS Location</b>	See photo for GPS location.		<b>GPS Location</b>	See photo for GPS location.	
<b>Field Station#</b>	11451+00		<b>Field Station#</b>	11439+00	
<b>Pic 3 Desc.</b>	Sensitive resource buffer in place at streams S-0013 & S-0012.		<b>Pic 4 Desc.</b>	Broken priority one silt fence stake at end treatment.

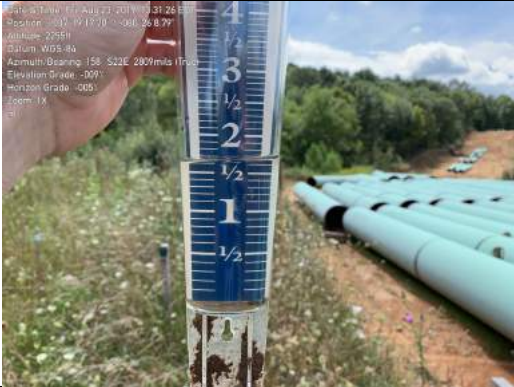
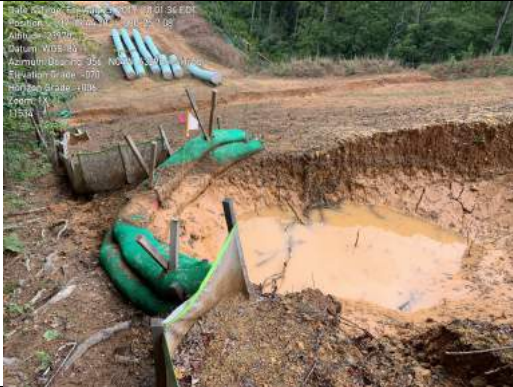
<b>GPS Location</b>	See picture above for GPS coordinates		<b>GPS Location</b>	See picture above for GPS coordinates	
<b>Field Station#</b>	2+56		<b>Field Station#</b>	11534+00	
<b>Pic 1 Desc.</b>	1.6" of rain recorded @ Steel Acres		<b>Pic 2 Desc.</b>	End treatment showing sediment buildup

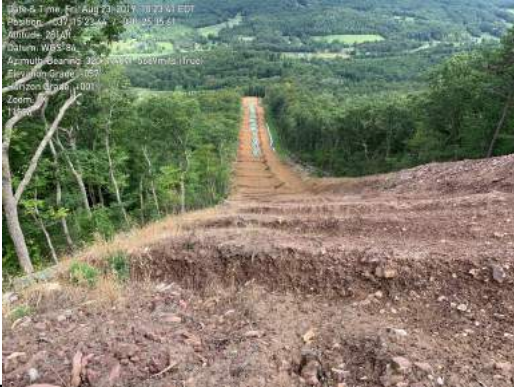
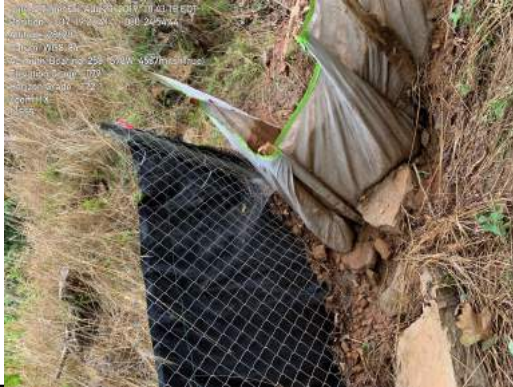
<b>GPS Location</b>	See picture above for GPS coordinates		<b>GPS Location</b>	See picture above for GPS coordinates	
<b>Field Station#</b>	11553+00		<b>Field Station#</b>	11555+00	
<b>Pic 3 Desc.</b>	ECD's and row conditions		<b>Pic 4 Desc.</b>	End treatment undermined @ 11555+00

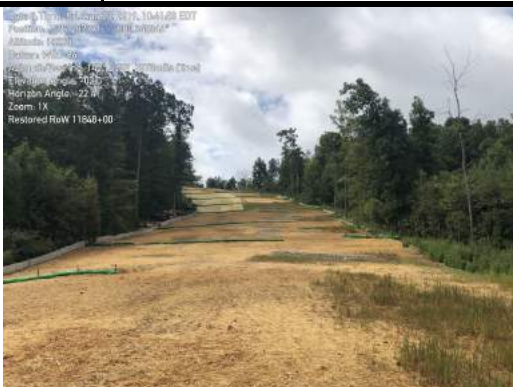
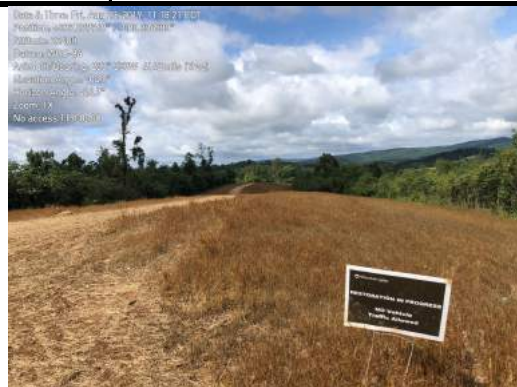
GPS Location	5	GPS Location	6		
Field Station#	11848+00	Field Station#	11900+00		
Pic 5 Desc.	Section of restored RoW.	Pic 6 Desc.	No traffic signs at beginning of restored area.
