## Visual Site Inspection Report

<b>Project Name</b>	H-600 Pipeline Spread G	<b>AFE</b>	124300137	<b>Spread</b>	H-600 Pipeline Spread
<b>Contractor</b>	Precision			<b>Report #</b>	1373
<b>Inspector</b>	Len Kruizenga			<b>Date/Time</b>	8/26/2019 8:39 AM
<b>Permit #</b>	TBD	<b>Inspection Type</b>	VA SWPP	<b>Station Begin</b>	12005+00
<b>State</b>	VA	<b>Inspection Area</b>	Full	<b>Station End</b>	12005+00
<b>County</b>	Giles	<b>Ground</b>	Dry	<b>Temperature (°F)</b>	70.00
<b>Municipality</b>	N/A	<b>Weather</b>	Cloudy	<b>Rain Gauge (in)</b>	0.10
				<b>Rain Accumulation Time (days)</b>	3.00

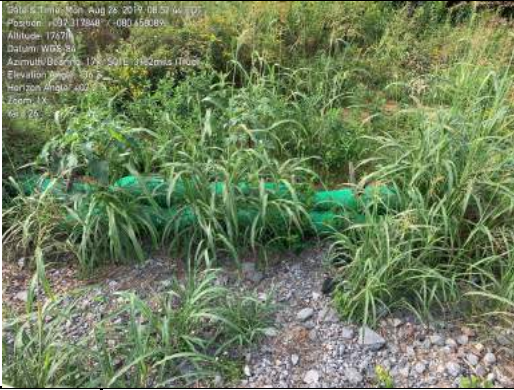
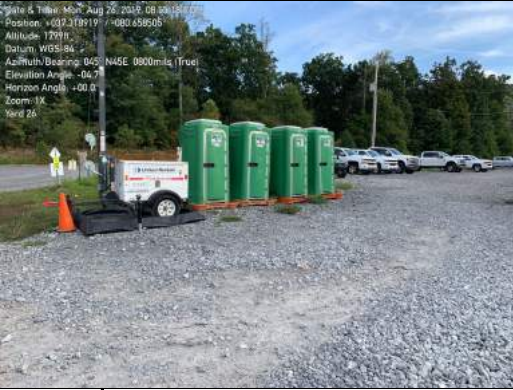
<b>GPS Location</b>	See photo for GPS location.		<b>GPS Location</b>	See photo for GPS location.	
<b>Field Station#</b>	12005+00		<b>Field Station#</b>	12005+00	
<b>Pic 1 Desc.</b>	Triple stack compost filter sock in place at yard 26.		<b>Pic 2 Desc.</b>	Light plant and ports potties at lay down yard 26 in secondary containment.

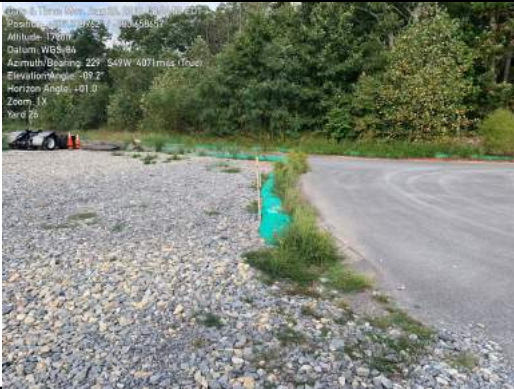
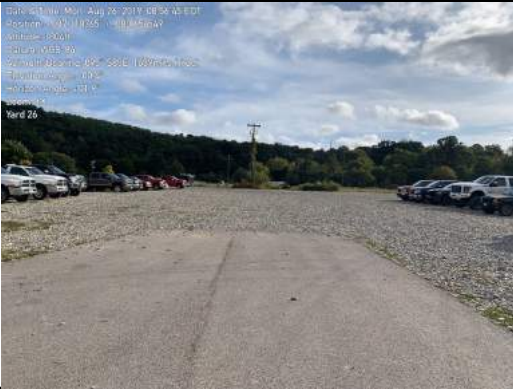
<b>GPS Location</b>	See photo for GPS location.		<b>GPS Location</b>	See photo for GPS location.	
<b>Field Station#</b>	12005+00		<b>Field Station#</b>	12005+00	
<b>Pic 3 Desc.</b>	18 inch compost filter sock in place.		<b>Pic 4 Desc.</b>	RCE in place at yard 26.

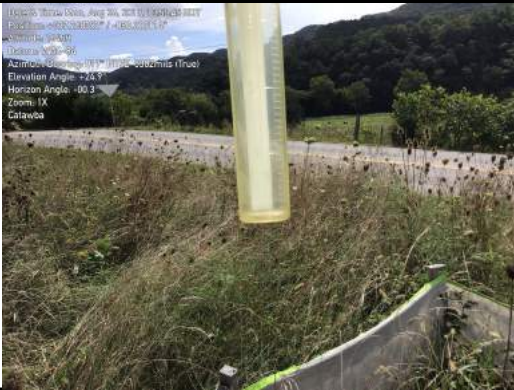
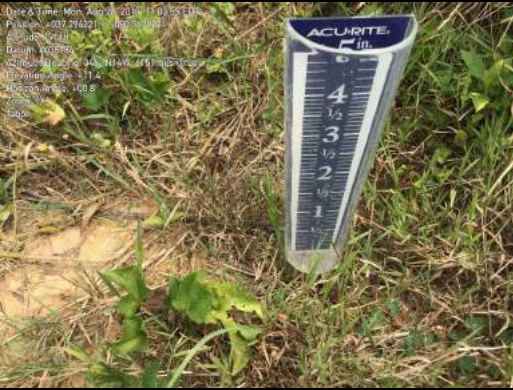
<b>GPS Location</b>	See photo for GPS location.		<b>GPS Location</b>	See photo for GPS location.	
<b>Field Station#</b>	11990+00		<b>Field Station#</b>	11767+00	
<b>Pic 5 Desc.</b>	Rain gauge at Catawba Road reads 0.1 inches.		<b>Pic 6 Desc.</b>	Rain gauge at Mount Tabor Road reads 0.0.

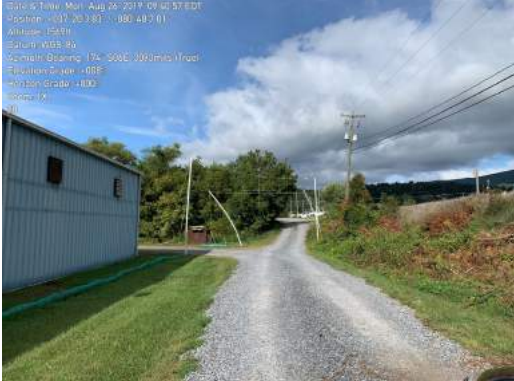
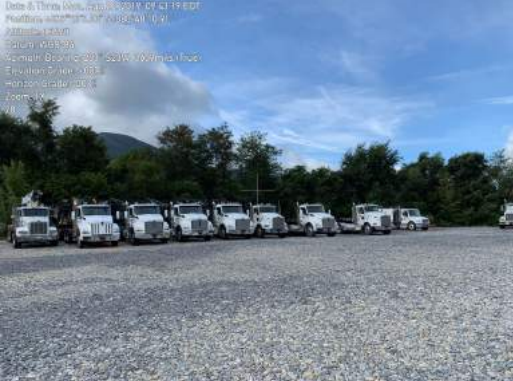
<b>GPS Location</b>	See picture above for GPS coordinates		<b>GPS Location</b>	See picture above for GPS coordinates	
<b>Field Station#</b>	+28		<b>Field Station#</b>	+28	
<b>Pic 1 Desc.</b>	ECD's and row conditions		<b>Pic 2 Desc.</b>	ECD's and row conditions

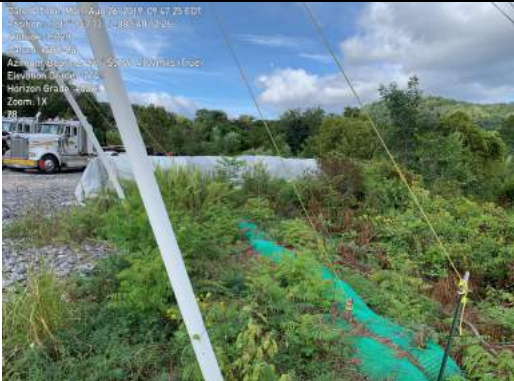
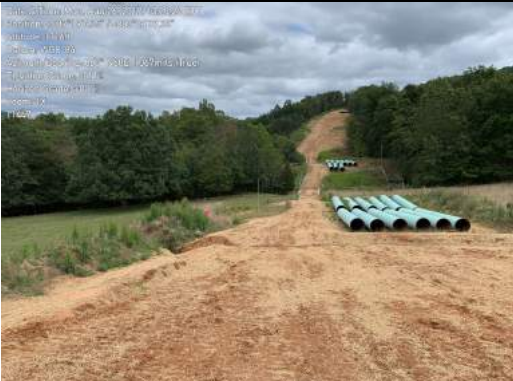
<b>GPS Location</b>	See picture above for GPS coordinates		<b>GPS Location</b>	See picture above for GPS coordinates	
<b>Field Station#</b>	+28		<b>Field Station#</b>	11447+00	
<b>Pic 3 Desc.</b>	ECD's and row conditions		<b>Pic 4 Desc.</b>	ECD's and row conditions

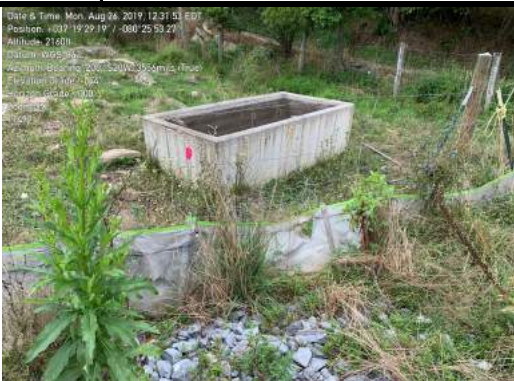
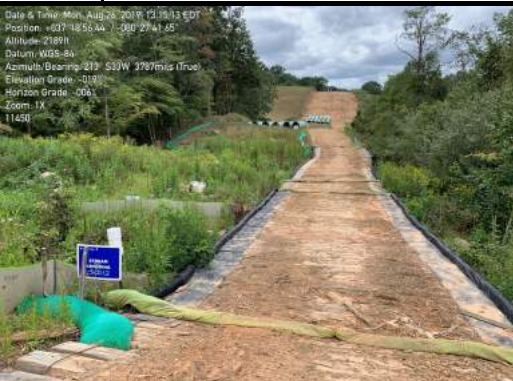
<b>GPS Location</b>	See picture above for GPS coordinates		<b>GPS Location</b>	See picture above for GPS coordinates	
<b>Field Station#</b>	11492+00		<b>Field Station#</b>	11450+00	
<b>Pic 5 Desc.</b>	Damaged P1		<b>Pic 6 Desc.</b>	ECD's and row conditions

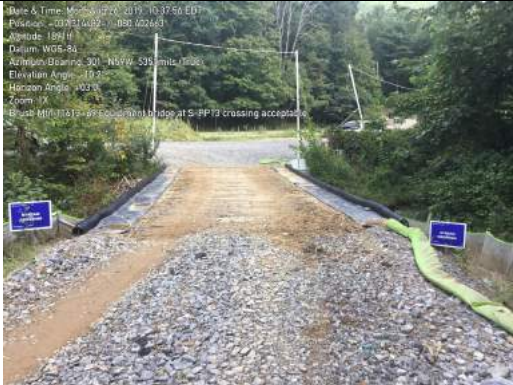
GPS Location	On photo		GPS Location	On photo	
Field Station#	11613+69		Field Station#	11614+20	
Pic 1 Desc.	The equipment bridge at the S-RR13 crossing is in good condition.		Pic 2 Desc.	The equipment bridge at the S-RR14 crossing is in good condition with well vegetated buffers.

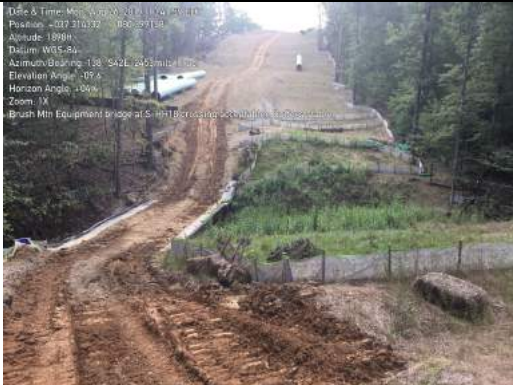
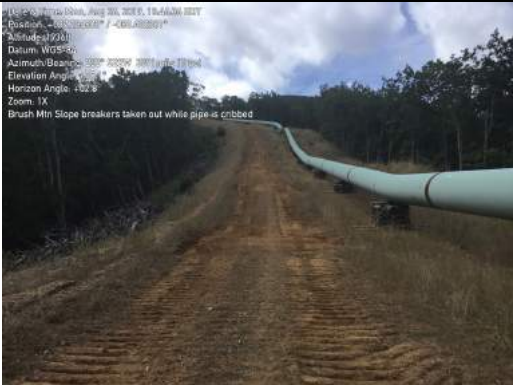
GPS Location	On photo		GPS Location	On photo	
Field Station#	11626+04		Field Station#	11656+00	
Pic 3 Desc.	S-HH18 crossing buffers well vegetated. Travel lane currently disturbed while area is active.		Pic 4 Desc.	Travel lane disturbed during re-setting of pipe.

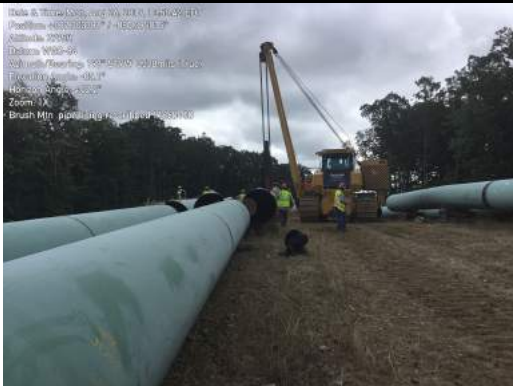
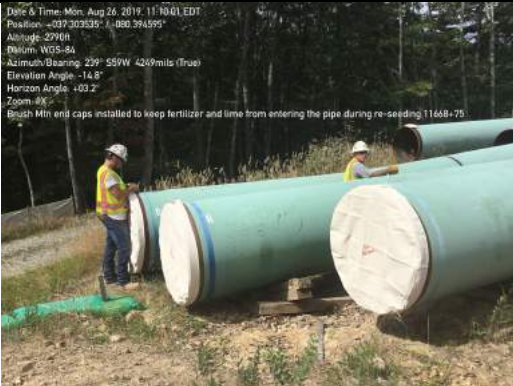
GPS Location	On photo		GPS Location	On photo	
Field Station#	11668+00		Field Station#	11668+75	
Pic 5 Desc.	Pipe cribbing being repaired or replaced as needed.		Pic 6 Desc.	End caps being installed to prevent soil amendments and animals from entering pipe.

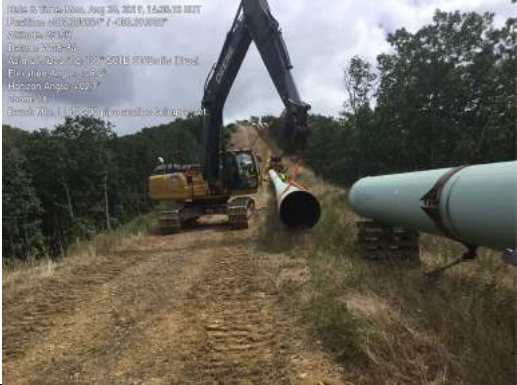
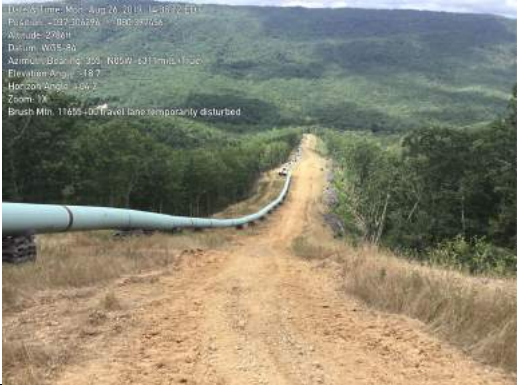
<b>GPS Location</b>	On photo	<b>GPS Location</b>	On photo		
<b>Field Station#</b>	11659+00	<b>Field Station#</b>	11655+00		
<b>Pic 7 Desc.</b>	Pipe being re-set on cribbing.	<b>Pic 8 Desc.</b>	Travel lane disturbed from activity. Will be stabilized and hydro seeded once work is completed.		
Insert image here		Insert image here			
<b>GPS Location</b>		<b>GPS Location</b>			
<b>Field Station#</b>		<b>Field Station#</b>			
<b>Pic 9 Desc.</b>		<b>Pic 10 Desc.</b>			
Insert image here		Insert image here			
<b>GPS Location</b>		<b>GPS Location</b>			
<b>Field Station#</b>		<b>Field Station#</b>			
<b>Pic 11 Desc.</b>		<b>Pic 12 Desc.</b>

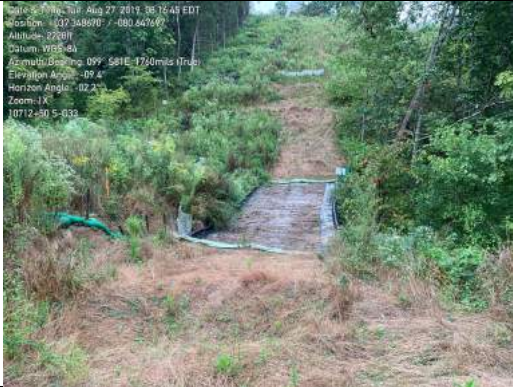
<b>GPS Location</b>	See photo for GPS location.		<b>GPS Location</b>	See photo for GPS location.	
<b>Field Station#</b>	12005+00		<b>Field Station#</b>	10712+50	
<b>Pic 1 Desc.</b>	Sock checks in place along access road 241.04 in bar ditch.		<b>Pic 2 Desc.</b>	Sensitive resource buffer in place at stream S-G33.

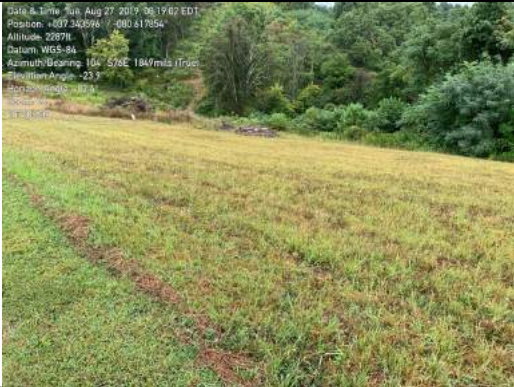
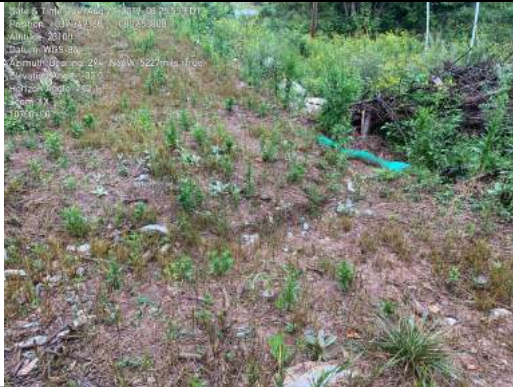
<b>GPS Location</b>	See photo for GPS location.		<b>GPS Location</b>	See photo for GPS location.	
<b>Field Station#</b>	10710+00		<b>Field Station#</b>	10700+00	
<b>Pic 3 Desc.</b>	ROW has is stabilized with natural vegetation.		<b>Pic 4 Desc.</b>	Waterbar in place across travel lane with CFS as end treatment.

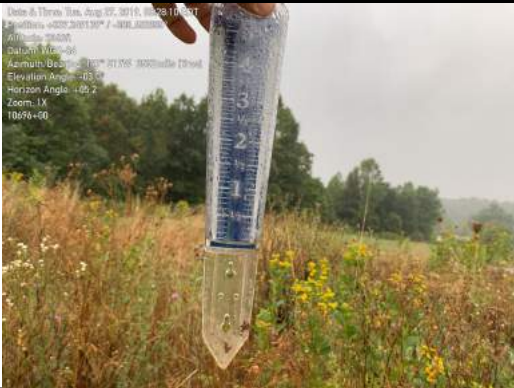
<b>Pic 5 Desc.</b>	0.1 inches of rain fall at Buffalo Anklets Road.		<b>Pic 6 Desc.</b>	RCE in place Old Stoney Road.

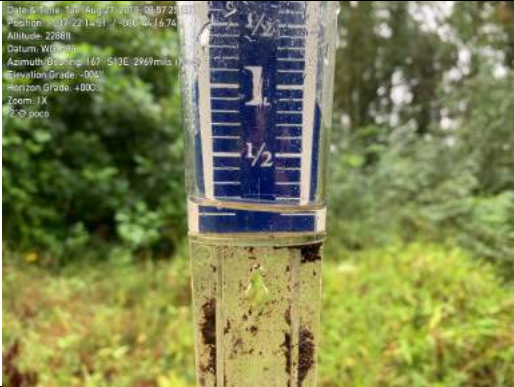
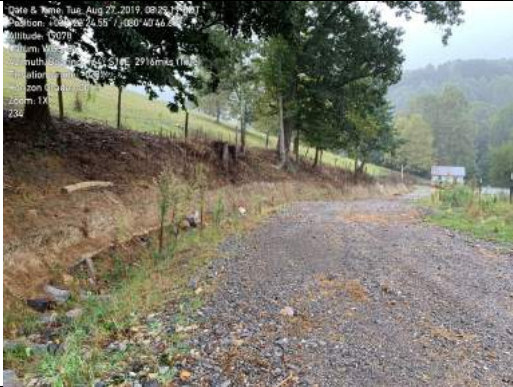
<b>GPS Location</b>	See picture above for GPS coordinates		<b>GPS Location</b>	See picture above for GPS coordinates	
<b>Field Station#</b>	+1		<b>Field Station#</b>	2+34	
<b>Pic 1 Desc.</b>	.2" of rain recorded @ Pocahontas		<b>Pic 2 Desc.</b>	ECD's and row conditions @ AR 234

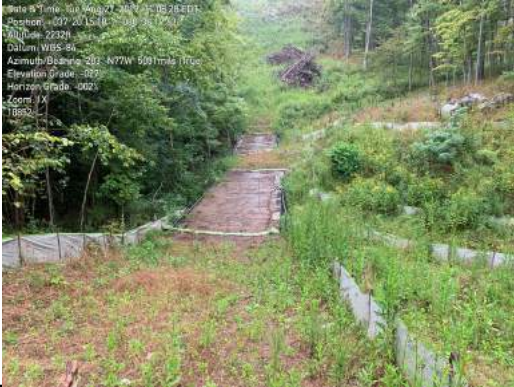
<b>GPS Location</b>	See picture above for GPS coordinates		<b>GPS Location</b>	See picture above for GPS coordinates	
<b>Field Station#</b>	10852+00		<b>Field Station#</b>	10854+00	
<b>Pic 3 Desc.</b>	ECD's and row conditions @ SA33 & SA34		<b>Pic 4 Desc.</b>	ECD's and row conditions

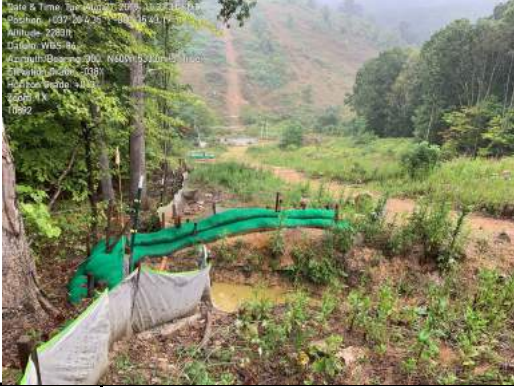
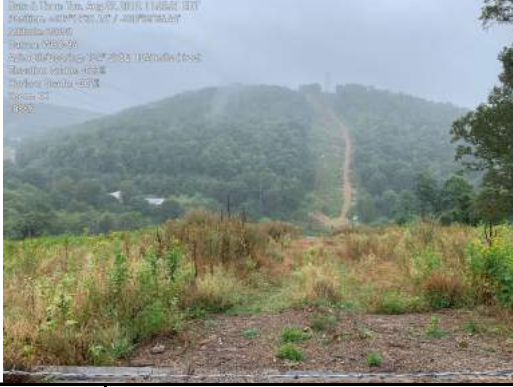
<b>GPS Location</b>	See picture above for GPS coordinates		<b>GPS Location</b>	See picture above for GPS coordinates	
<b>Field Station#</b>	10892+00		<b>Field Station#</b>	10869+00	
<b>Pic 5 Desc.</b>	ECD's and row conditions		<b>Pic 6 Desc.</b>	ECD's and row conditions

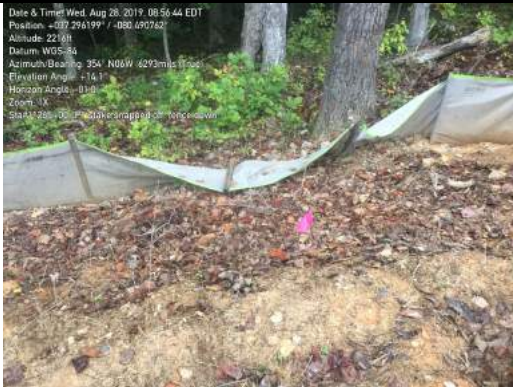
<p>Date &amp; Time: Wed, Aug 28, 2019, 08:56:44 EDT Position: -087.296199° / -080.490762° Altitude: 221m Datum: WGS-84 Azimuth/Bearing: 354° N06W 6293mils (True) Elevation Angle: +14.1° Horizon Angle: -11.8° Zoom: 1x Start: 11265+00 - P1 perimeter controls are down</p>

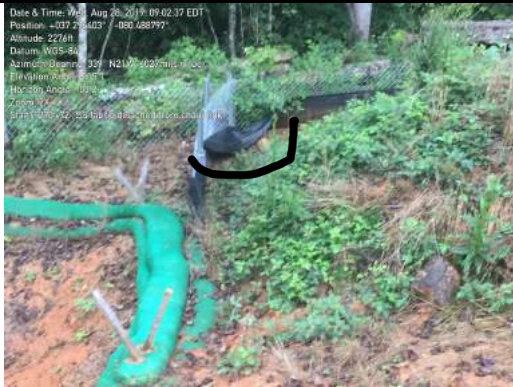
<p>Date &amp; Time: Wed, Aug 28, 2019, 09:02:37 EDT Position: -087.2972403° / -080.498799° Altitude: 227m Datum: WGS-84 Azimuth/Bearing: 337° N21W 6027mils (True) Elevation Angle: +14.1° Horizon Angle: -11.8° Zoom: 1x Start: 11270+72 - SSF fabric detached from chain link</p>			
<b>GPS Location</b>	See photo GPS	<b>GPS Location</b>	See photo GPS		
<b>Field Station#</b>	11265+00	<b>Field Station#</b>	11270+72		
<b>Pic 1 Desc.</b>	P1 perimeter controls are down, stake snapped off.	<b>Pic 2 Desc.</b>	SSF fabric detached from chain link.

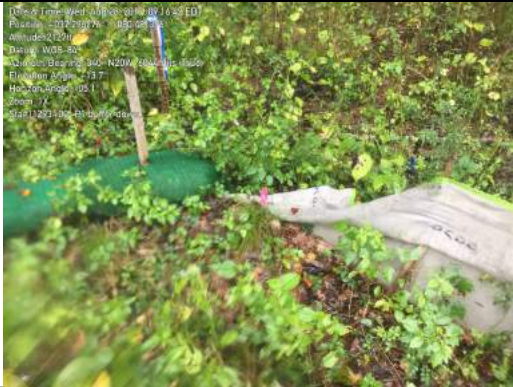
<p>Date &amp; Time: Wed, Aug 28, 2019, 09:14:59 EDT Position: -089.299776° / -88.500000° Altitude: 220m Datum: WGS-84 Azimuth/Bearing: 360° N20W 6040mils (True) Elevation Angle: +13.7° Horizon Angle: -12.1° Zoom: 1x Start: 11293+00 - P1 perimeter controls are down</p>

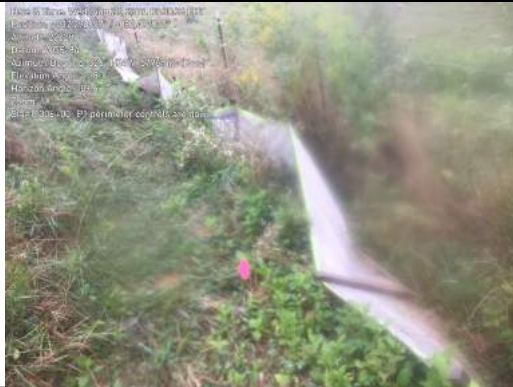
<p>Date &amp; Time: Wed, Aug 28, 2019, 09:36:10 EDT Position: -089.300000° / -88.500000° Altitude: 220m Datum: WGS-84 Azimuth/Bearing: 360° N00W 6040mils (True) Elevation Angle: +13.7° Horizon Angle: -12.1° Zoom: 1x Start: 11306+00 - P1 perimeter controls are down</p>			
<b>GPS Location</b>	See photo GPS	<b>GPS Location</b>	See photo GPS		
<b>Field Station#</b>	11293+00	<b>Field Station#</b>	11306+00		
<b>Pic 3 Desc.</b>	P1 down in stream buffer.	<b>Pic 4 Desc.</b>	P1 perimeter controls are are down

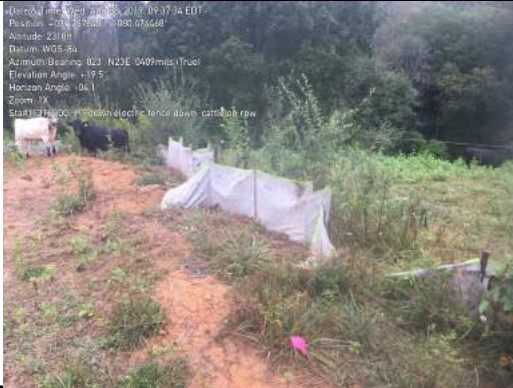
<p>Date &amp; Time: Wed, Aug 28, 2019, 09:37:34 EDT Position: -089.300000° / -88.49668° Altitude: 231m Datum: WGS-84 Azimuth/Bearing: 823° N23E 0409mils (True) Elevation Angle: +19.5° Horizon Angle: -18.1° Zoom: 1x Start: 11316+00 - P1 perimeter controls are down, electric fence down, cattle on row</p>

<b>GPS Location</b>	See photo GPS	<b>GPS Location</b>	See photo GPS		
<b>Field Station#</b>	11316+00	<b>Field Station#</b>	11323+50		
<b>Pic 5 Desc.</b>	P1 perimeter controls are down, electric fence down, cattle on row.	<b>Pic 6 Desc.</b>	Slope drain inlet filter rock is full of sediment.

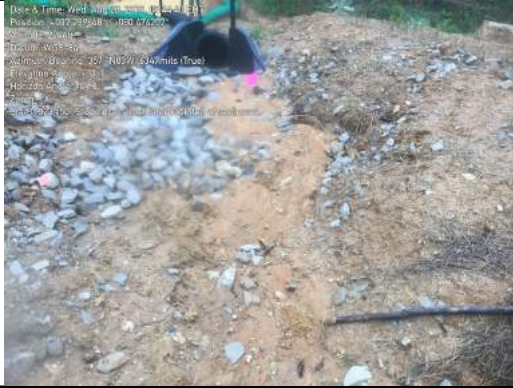
<p>Date &amp; Time: Wed, Aug 28, 2019, 09:47:00 EDT Position: -087.299348° / -88.497200° Altitude: 231m Datum: WGS-84 Azimuth/Bearing: 327° N03W 634mils (True) Elevation Angle: +19.5° Horizon Angle: -18.1° Zoom: 1x Start: 11323+50 - Slope drain inlet filter rock is full of sediment</p>

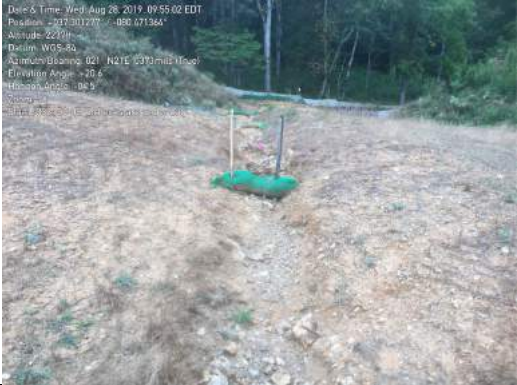
<p><small>Date &amp; Time: Wed, Aug 28, 2019, 07:55:02 EDT Position: +337.301270° / -090.071364° Altitude: 2229ft Datum: WGS-84 Azimuth/Bearing: 021° N21E 0301-mils (True) Elevation Angle: +20.6° Horizon Angle: -06.9° Pitch: 18° Roll: 11332+50 - P1 down at stream bridge entrance</small></p>		  <p><small>Date &amp; Time: Wed, Aug 28, 2019, 08:00:04 EDT Position: +337.301370° / -090.067533° Altitude: 2229ft Datum: WGS-84 Azimuth/Bearing: 021° N21E 0301-mils (True) Elevation Angle: +20.6° Horizon Angle: -06.9° Pitch: 18° Roll: 11352+00 - Remove sediment build up on CFS.</small></p>			
<b>GPS Location</b>	See photo GPS	<b>GPS Location</b>	See photo GPS		
<b>Field Station#</b>	11332+50	<b>Field Station#</b>	11352+00		
<b>Pic 7 Desc.</b>	CFS checks under cut in water bar flow line into sump.	<b>Pic 8 Desc.</b>	Remove sediment build up on CFS.

<p><small>Date &amp; Time: Wed, Aug 28, 2019, 10:16:41 EDT Position: +337.305537° / -090.062481° Altitude: 1720ft Datum: WGS-84 Azimuth/Bearing: 010° N10E 0178-mils (True) Elevation Angle: +09.2° Horizon Angle: -04.4° Pitch: 18° Roll: 11352+60 - P1 down at stream bridge entrance</small></p>

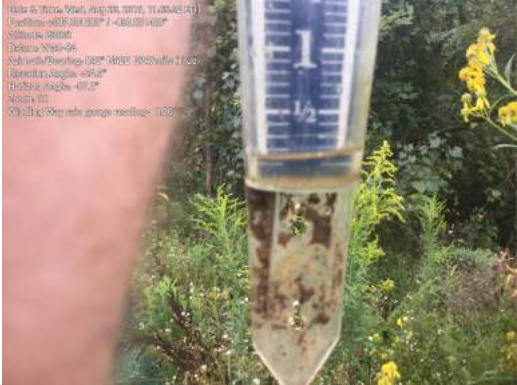
<p><small>Date &amp; Time: Wed, Aug 28, 2019, 11:00:04 EDT Position: +337.301370° / -090.067533° Altitude: 2229ft Datum: WGS-84 Azimuth/Bearing: 021° N21E 0301-mils (True) Elevation Angle: +20.6° Horizon Angle: -06.9° Pitch: 18° Roll: 11227+00 - Winding Way rain gauge reading- 0.20"</small></p>			
<b>GPS Location</b>	See photo GPS	<b>GPS Location</b>	See photo GPS		
<b>Field Station#</b>	11352+60	<b>Field Station#</b>	11227+00		
<b>Pic 9 Desc.</b>	P1 down at stream bridge entrance.	<b>Pic 10 Desc.</b>	Winding Way rain gauge reading- 0.20"		
Insert image here		Insert image here			
<b>GPS Location</b>		<b>GPS Location</b>

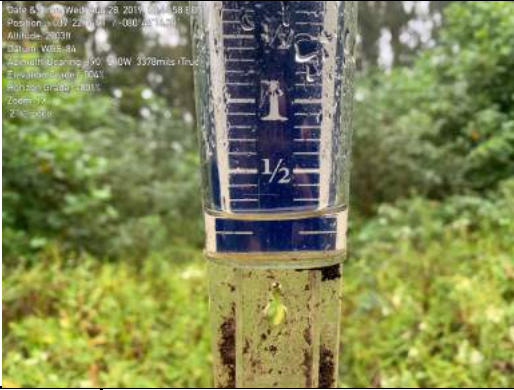
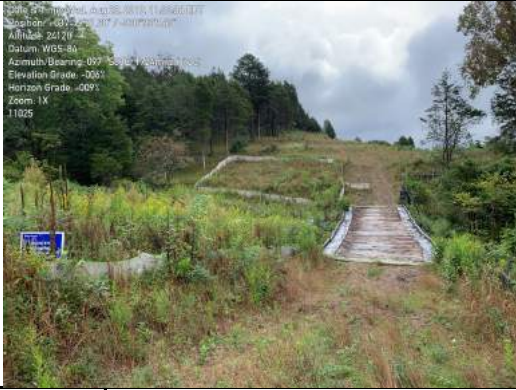
<b>GPS Location</b>	See picture above for GPS coordinates		<b>GPS Location</b>	See picture above for GPS coordinates	
<b>Field Station#</b>	+1		<b>Field Station#</b>	11025+00	
<b>Pic 1 Desc.</b>	.2" of rain recorded @ Pocahontas		<b>Pic 2 Desc.</b>	ECD's and row conditions @ SIJ18

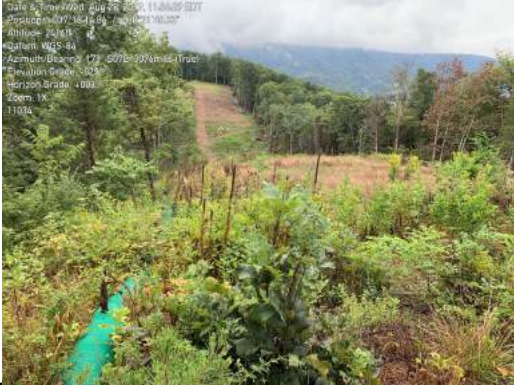
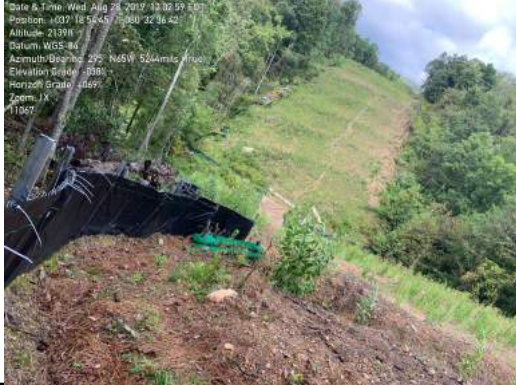
<b>GPS Location</b>	See picture above for GPS coordinates		<b>GPS Location</b>	See picture above for GPS coordinates	
<b>Field Station#</b>	11034+00		<b>Field Station#</b>	11067+00	
<b>Pic 3 Desc.</b>	ECD's and row conditions		<b>Pic 4 Desc.</b>	ECD's and row conditions

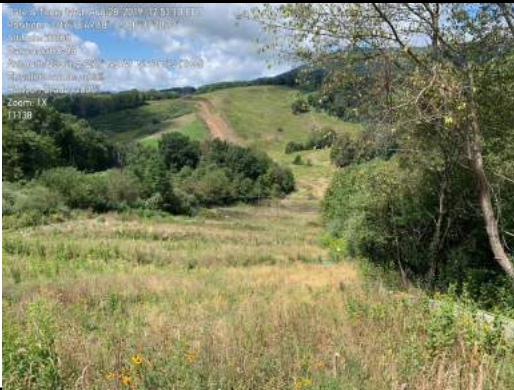
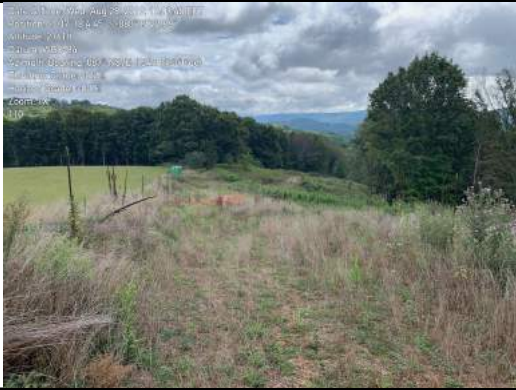
<b>GPS Location</b>	See picture above for GPS coordinates		<b>GPS Location</b>	See picture above for GPS coordinates	
<b>Field Station#</b>	11138+00		<b>Field Station#</b>	11073+00	
<b>Pic 5 Desc.</b>	ECD's and row conditions		<b>Pic 6 Desc.</b>	ECD's and row conditions

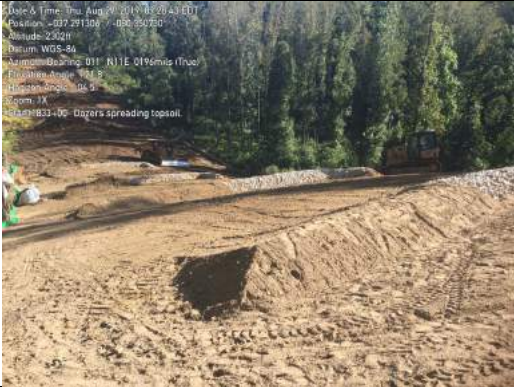
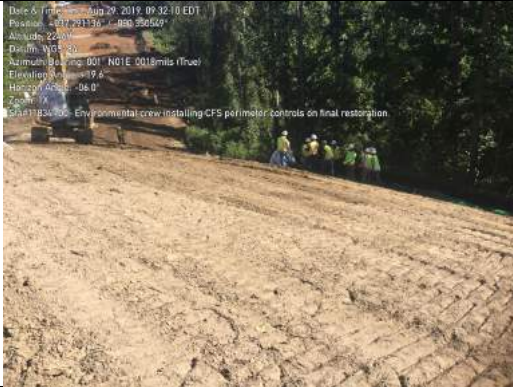
<b>GPS Location</b>	See photo GPS	<b>GPS Location</b>	See photo GPS		
<b>Field Station#</b>	11833+00	<b>Field Station#</b>	11834+00		
<b>Pic 1 Desc.</b>	Dozers spreading topsoil	<b>Pic 2 Desc.</b>	Environmental crew installing CFS perimeter controls.

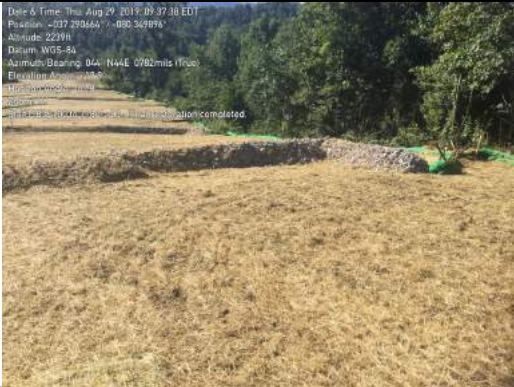
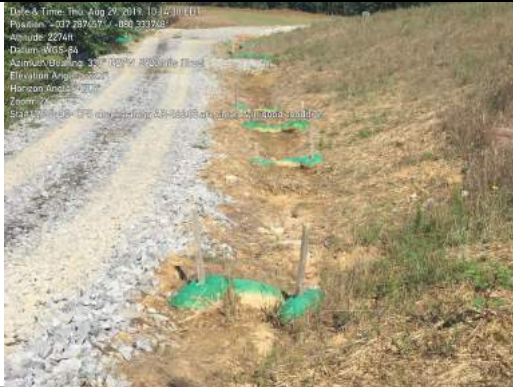
<b>GPS Location</b>	See photo GPS	<b>GPS Location</b>	See photo GPS		
<b>Field Station#</b>	11836+00	<b>Field Station#</b>	11900+00		
<b>Pic 3 Desc.</b>	Sta#11836+00 to 11841+00- Final restoration completed.	<b>Pic 4 Desc.</b>	CFS checks along AR-266.03 are clean & in good condition.

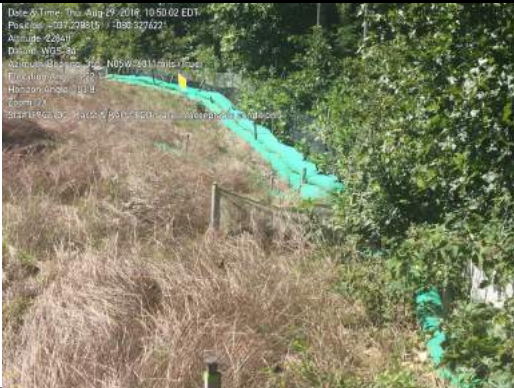
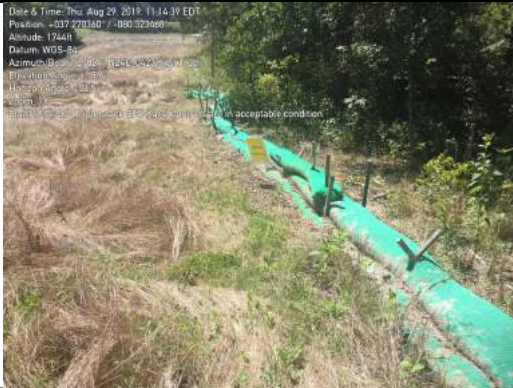
<b>GPS Location</b>	See photo GPS	<b>GPS Location</b>	See photo		
<b>Field Station#</b>	11942+00	<b>Field Station#</b>	11975+00		
<b>Pic 5 Desc.</b>	Karst and Karst ECD's are in acceptable condition.	<b>Pic 6 Desc.</b>	Triple stack CFS perimeter controls in Karst area are in acceptable condition.

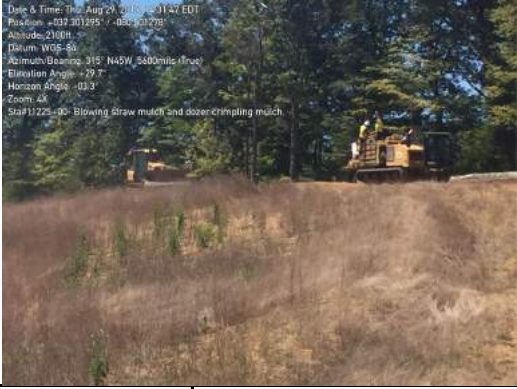
<p>Insert image here</p>			
<b>GPS Location</b>	See photo GPS	<b>GPS Location</b>			
<b>Field Station#</b>	11225+00	<b>Field Station#</b>			
<b>Pic 7 Desc.</b>	Marooka blowing mulch, dozer crimping mulch.	<b>Pic 8 Desc.</b>			
<p>Insert image here</p>		<p>Insert image here</p>			
<b>GPS Location</b>		<b>GPS Location</b>			
<b>Field Station#</b>		<b>Field Station#</b>			
<b>Pic 9 Desc.</b>		<b>Pic 10 Desc.</b>			
<p>Insert image here</p>		<p>Insert image here</p>			
<b>GPS Location</b>		<b>GPS Location</b>			
<b>Field Station#</b>		<b>Field Station#</b>			
<b>Pic 11 Desc.</b>		<b>Pic 12 Desc.</b>

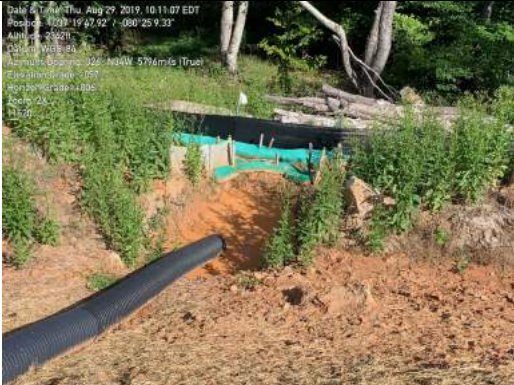
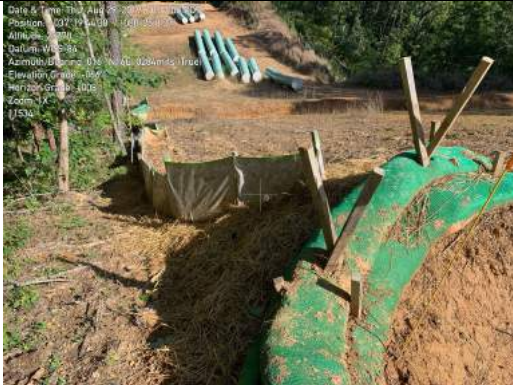
<b>GPS Location</b>	See picture above for GPS coordinates		<b>GPS Location</b>	See picture above for GPS coordinates	
<b>Field Station#</b>	11520+00		<b>Field Station#</b>	11534+00	
<b>Pic 1 Desc.</b>	ECD's and row conditions		<b>Pic 2 Desc.</b>	End treatment stabilized

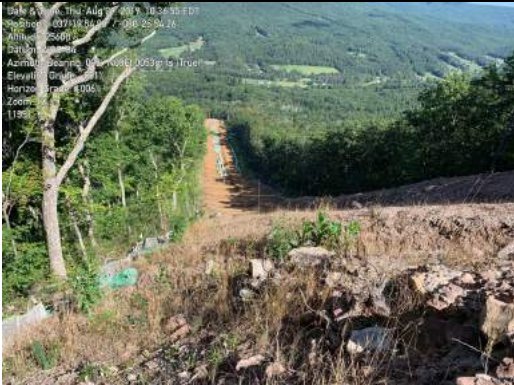
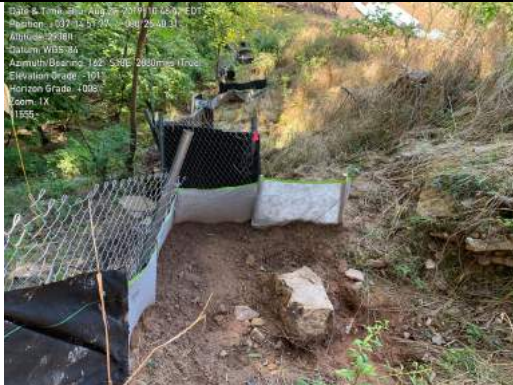
<b>GPS Location</b>	See picture above for GPS coordinates		<b>GPS Location</b>	See picture above for GPS coordinates	
<b>Field Station#</b>	11551+00		<b>Field Station#</b>	11555+00	
<b>Pic 3 Desc.</b>	ECD's and row conditions		<b>Pic 4 Desc.</b>	P1SF end treatment repaired

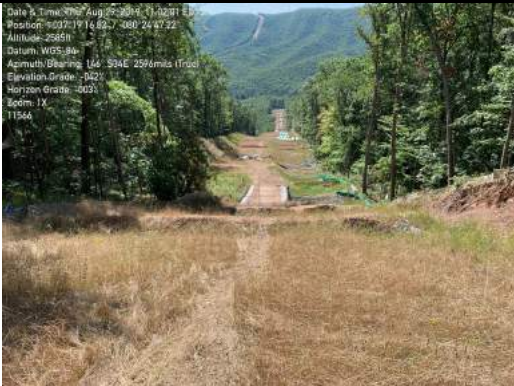
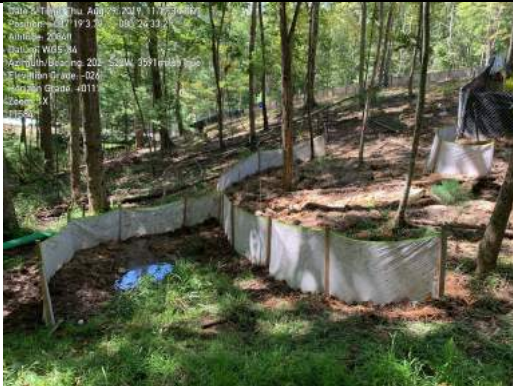
<b>GPS Location</b>	See picture above for GPS coordinates		<b>GPS Location</b>	See picture above for GPS coordinates	
<b>Field Station#</b>	11566+00		<b>Field Station#</b>	11584+00	
<b>Pic 5 Desc.</b>	ECD's and row conditions		<b>Pic 6 Desc.</b>	Crews repaired P1SF

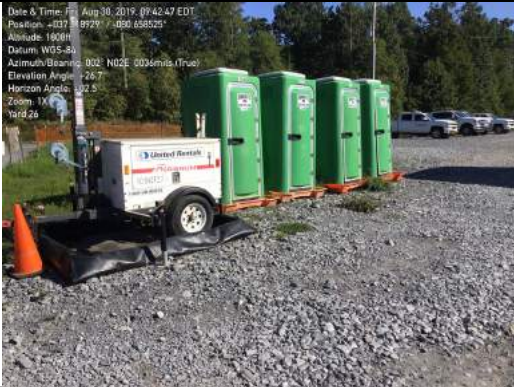
<b>GPS Location</b>	See photo for GPS location.		<b>GPS Location</b>	See photo for GPS location.	
<b>Field Station#</b>	12005+00		<b>Field Station#</b>	12005+00	
<b>Pic 3 Desc.</b>	Secondary containment in place under light plant and porta potties.		<b>Pic 4 Desc.</b>	Secondary containment in place under fuel cell.
