COMPLAINT INSPECTION REPORT

Project Name:	Mountain Valley Pipeline	Inspector:	Marshall Willis
Inspection Date:	Monday, October 28, 2019	Project Contact:	Brian Clauto
Spread H: Montgomery County	STA 12175+00 – 12200+00 ATWS 703, ATWS 704A, ATWS 1446 & ATWS 1375 MVP-MN-275/274	Weather (Wet/Dry/Rain):	Wet

FIELD INSPECTION PHOTO LOG

Project Name: Mountain Valley Pipeline

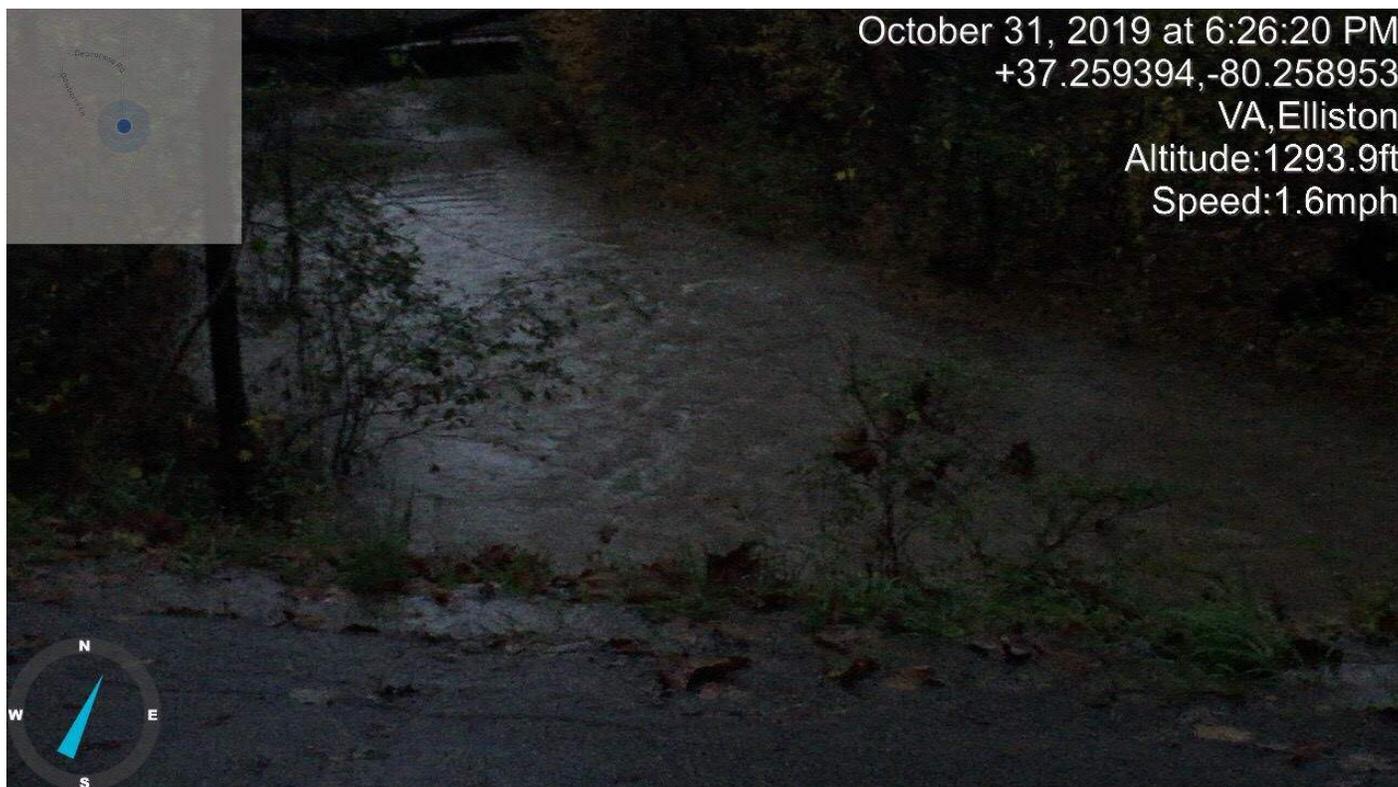
Upstream of MVP ROW is, as always, running?relatively clear even after more than an inch of rain fell:

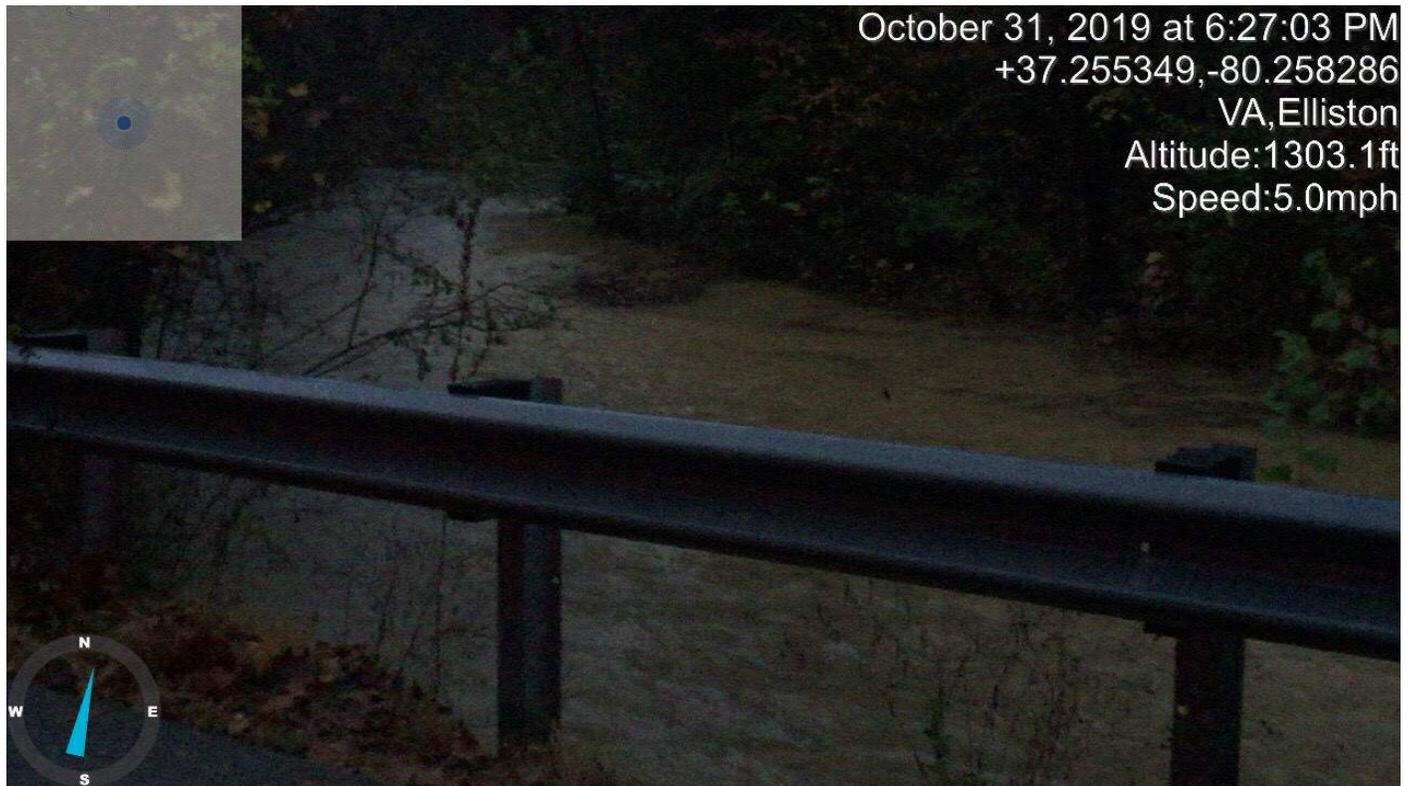
It is difficult to see here but sediment laden water is emptying in Bradshaw creek from an inaccessible UNT. Never in my years of living and traveling Bradshaw have I seen sediment entering the creek here until MVP began construction. DEQ claims the Railroad is to blame. If this is the case then I'd ask why their violations have not been corrected?

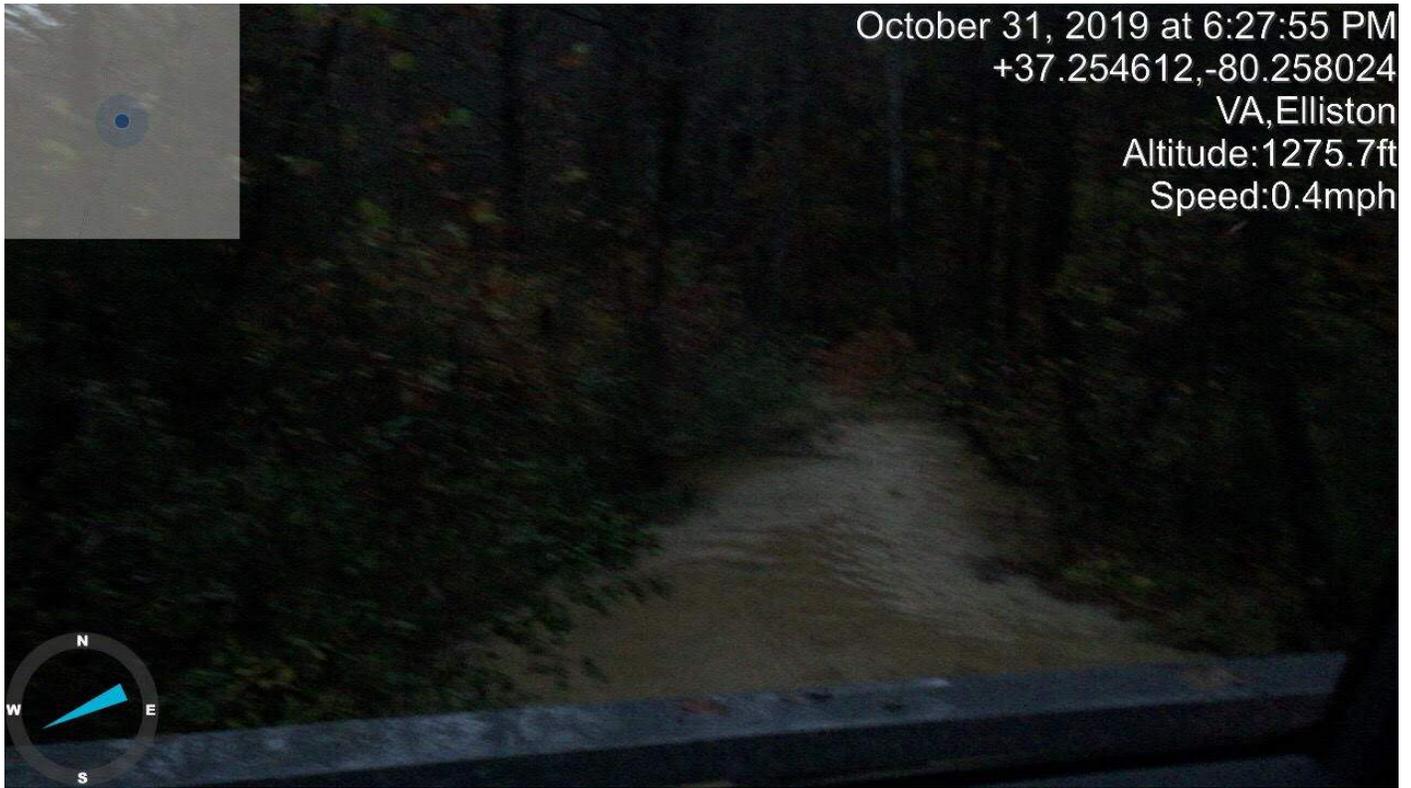
Bradshaw downstream from above image:

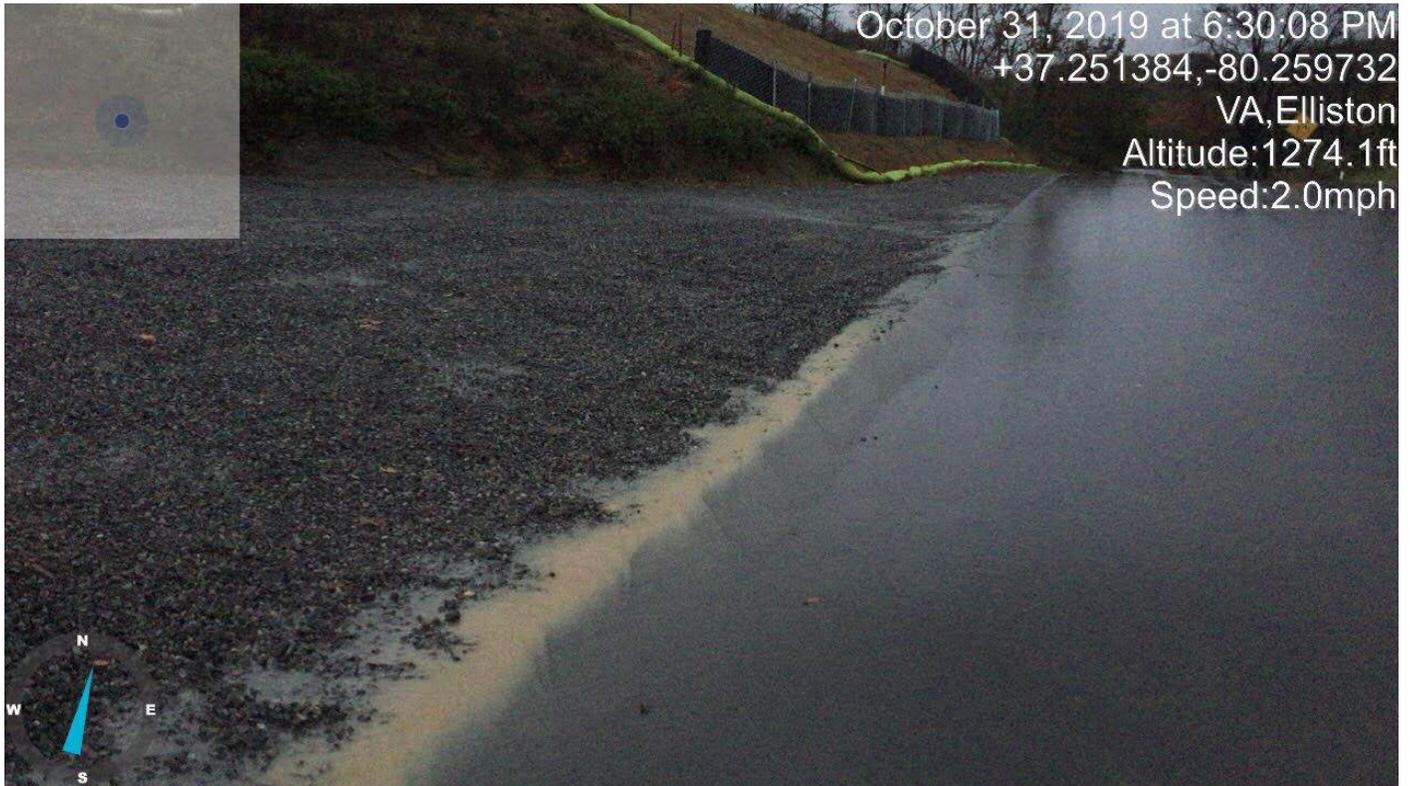
Sediment laden water from MVP ROW:

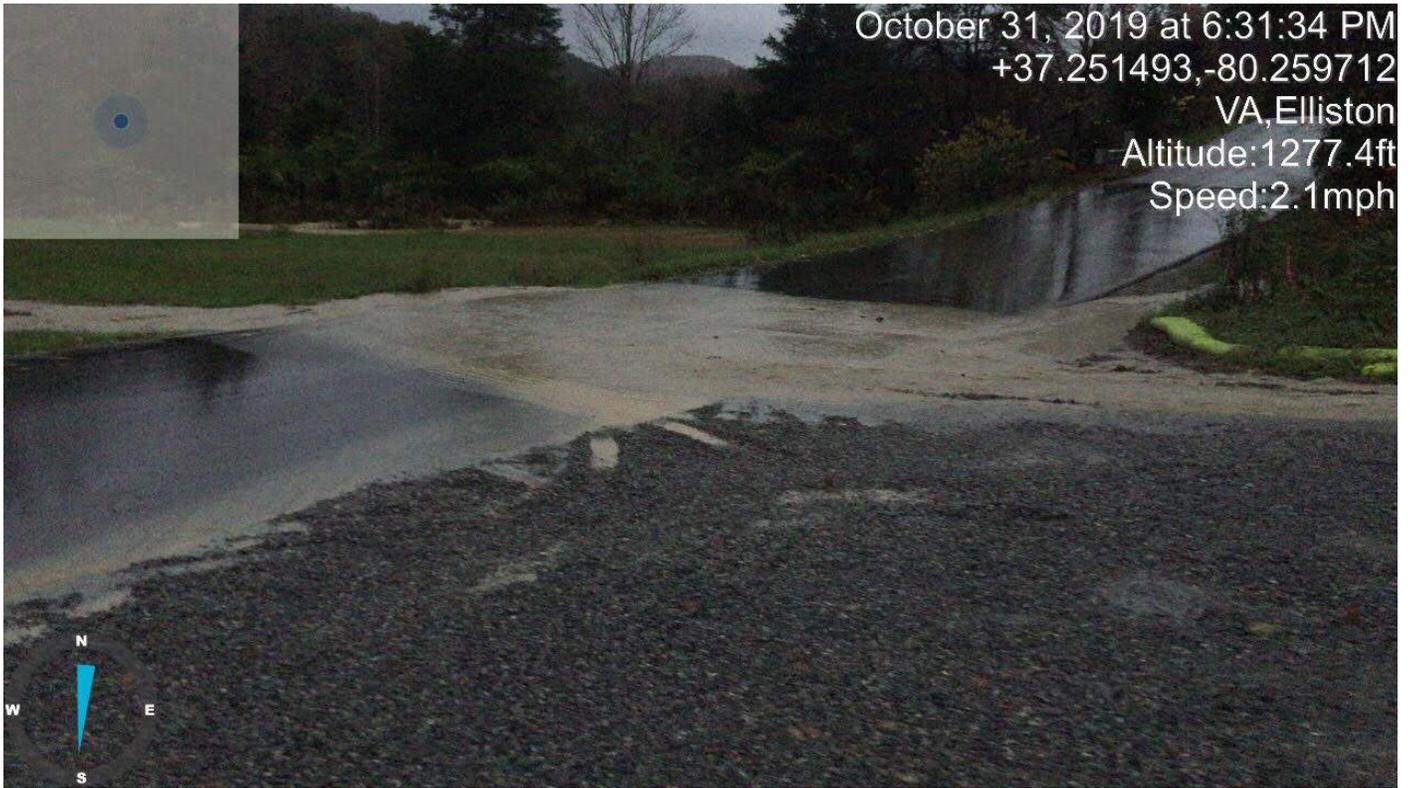
Sediment laden water from MVP access road and an UNT that MVP crosses between Bradshaw and Flatwoods:

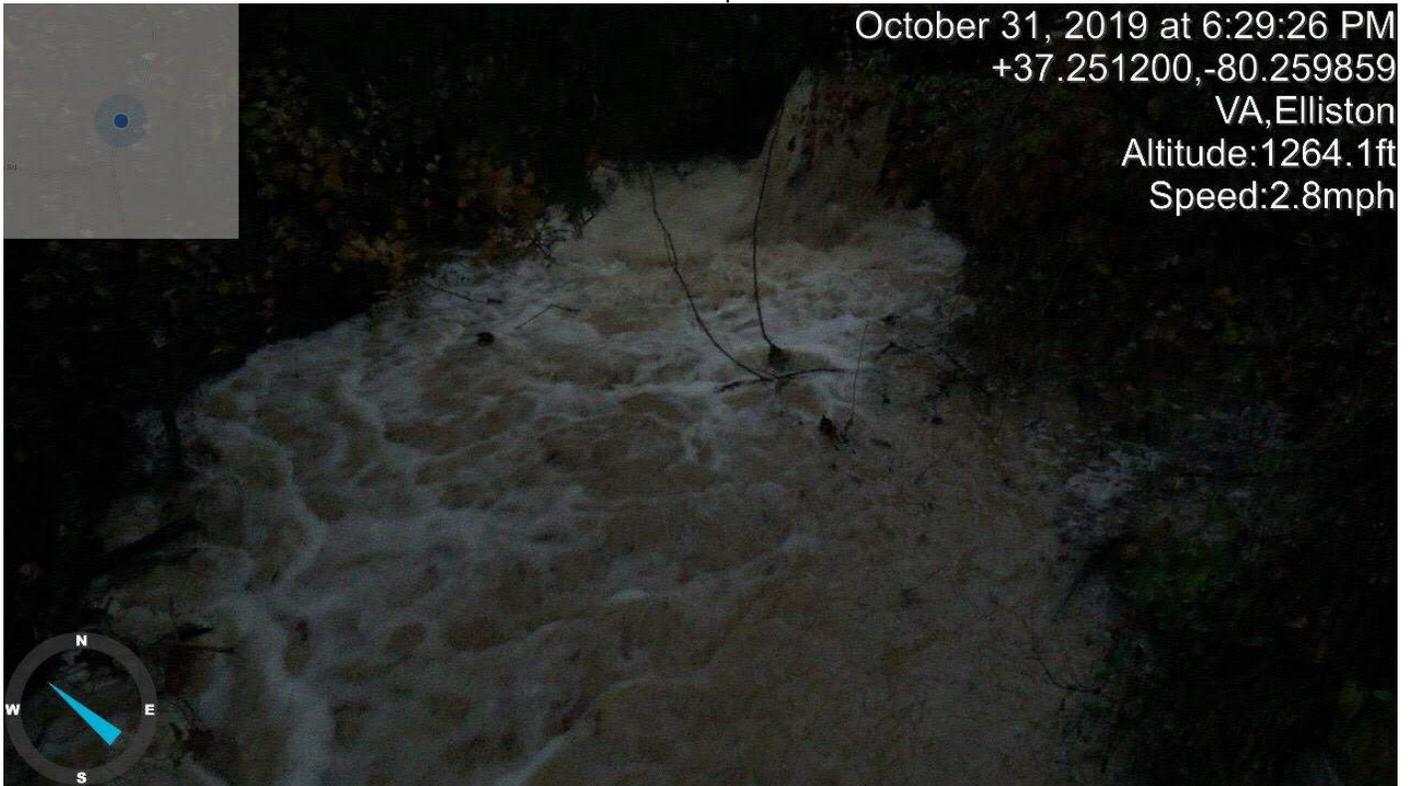
Sediment laden water from an UNT that MVP crosses. This empties into Bradshaw creek:

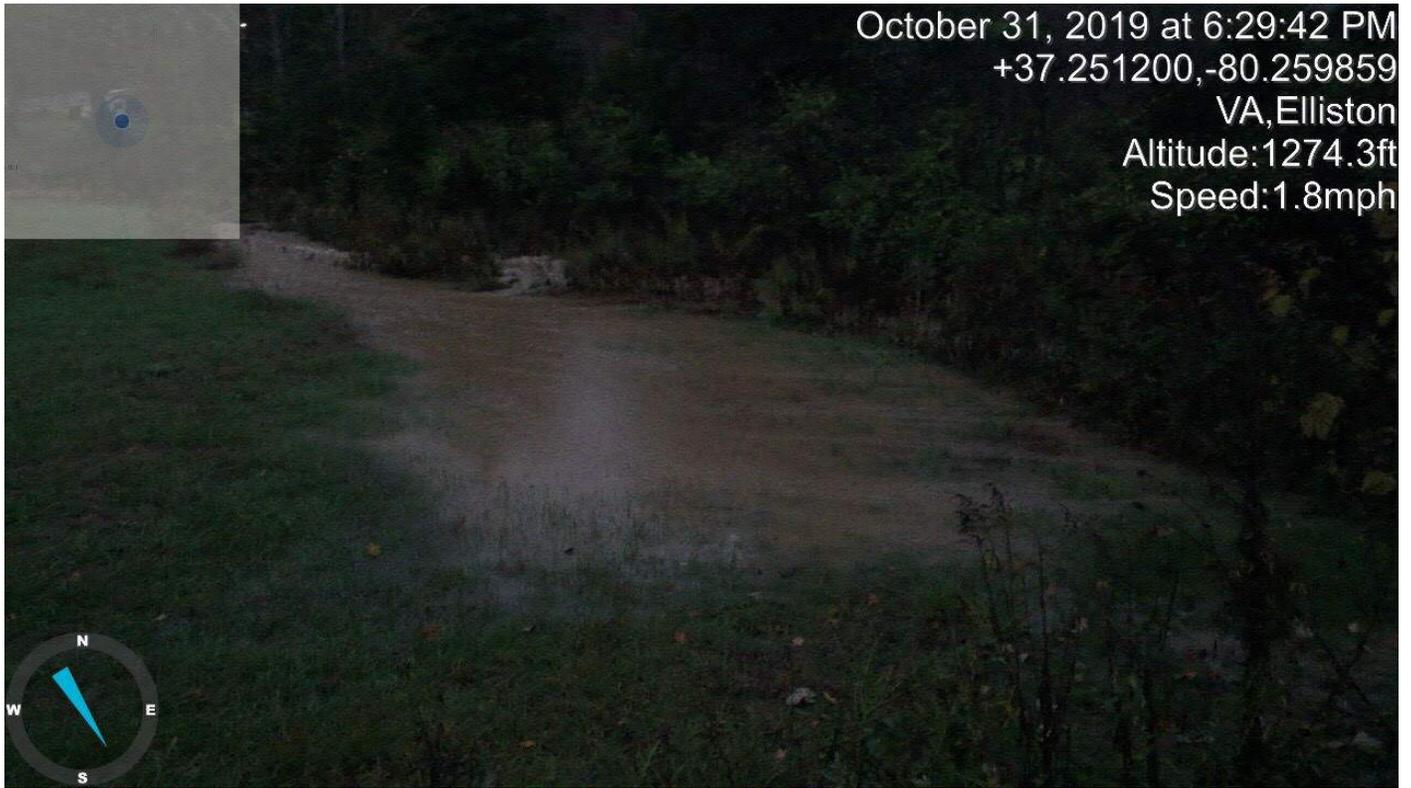
The same UNT across Bradshaw rd flooding a field:

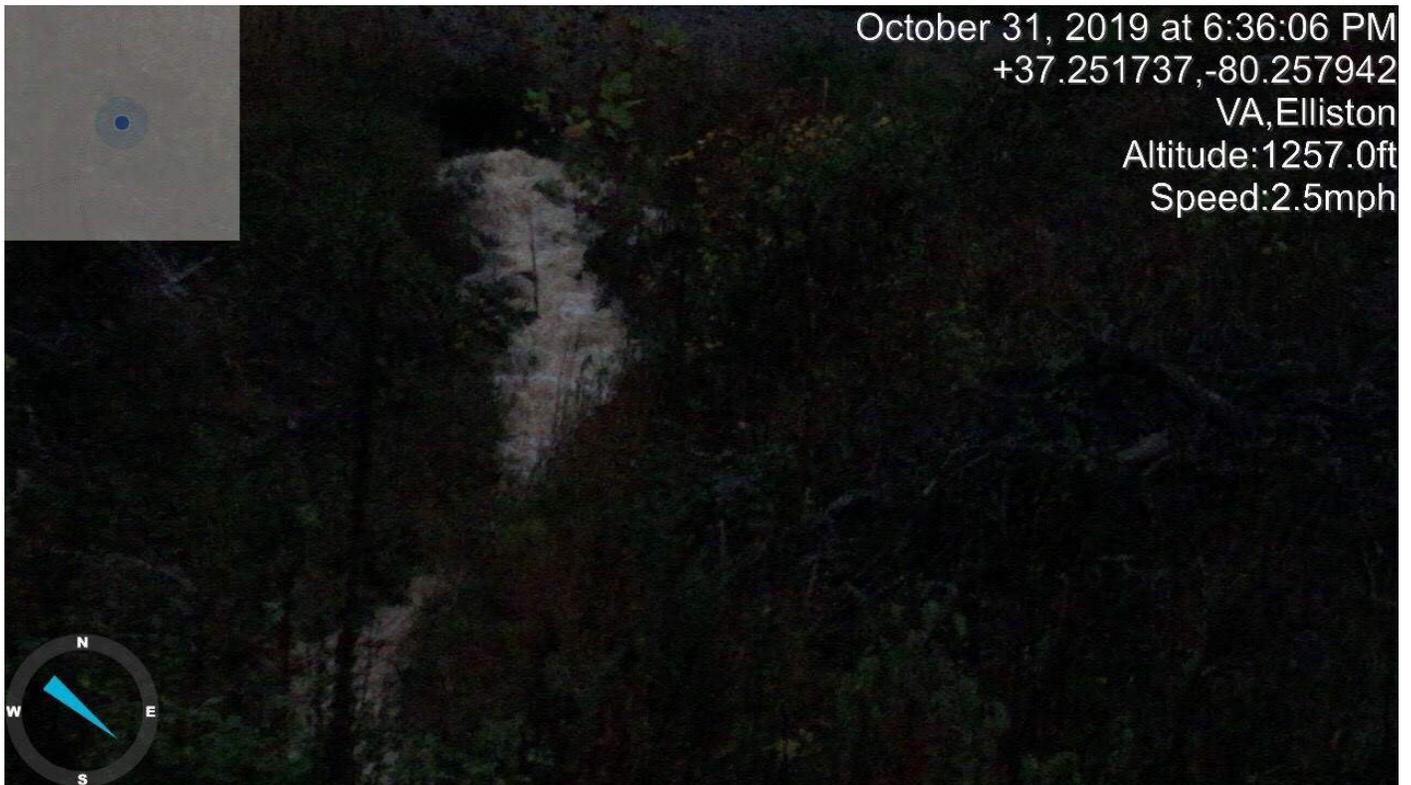
Sediment laden water running from a culvert opposite side of the RR tracks from the MVP ROW. This UNT also empties into Bradshaw Creek:

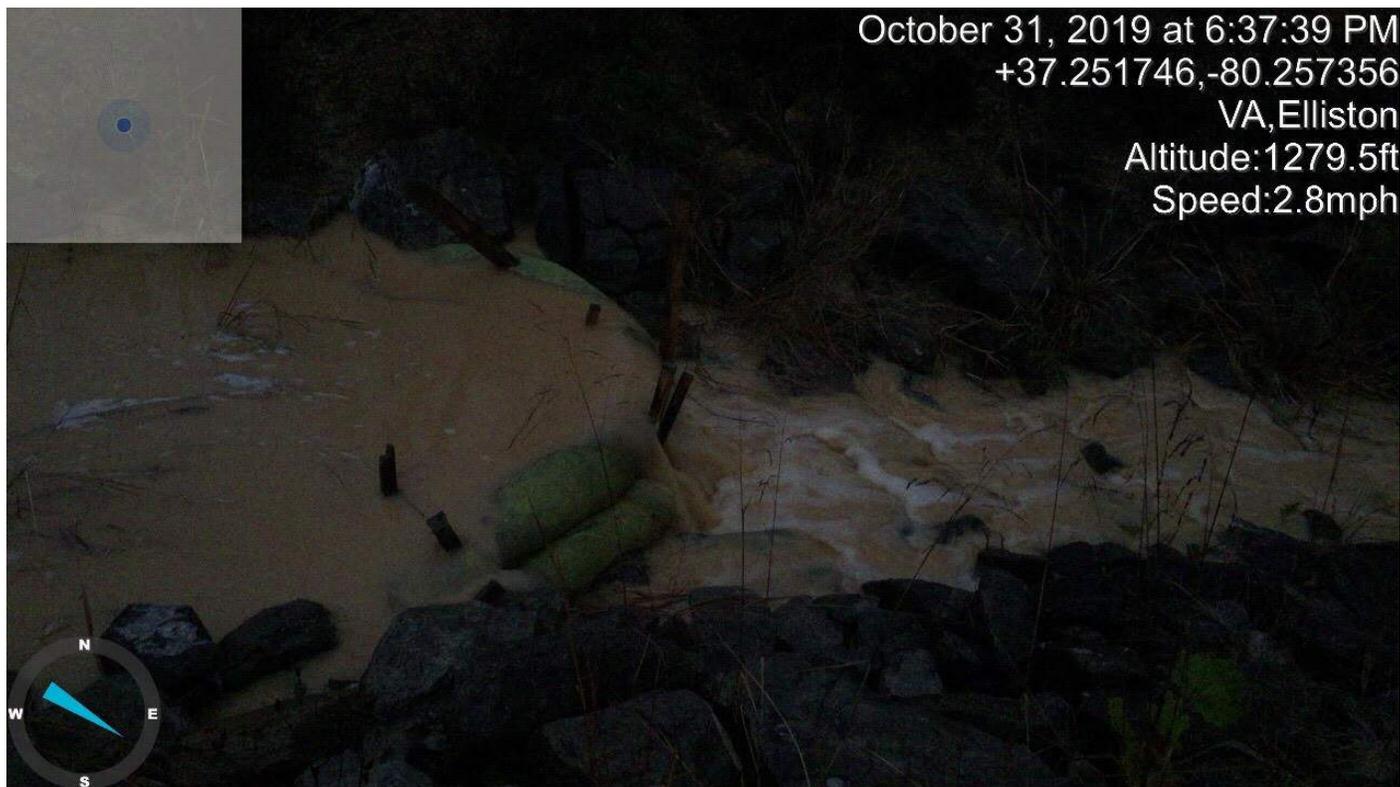
Obvious SE control failures below the steep slope MVP ROW ascends. This section has been reported multiple times:

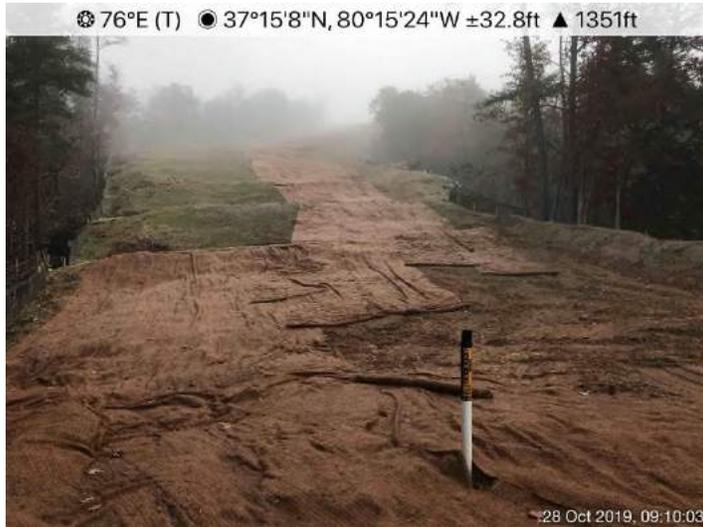
Fig. 1: STA 12201+00 – Controls in place and functioning. Area stabilized with erosion fabric and seed.

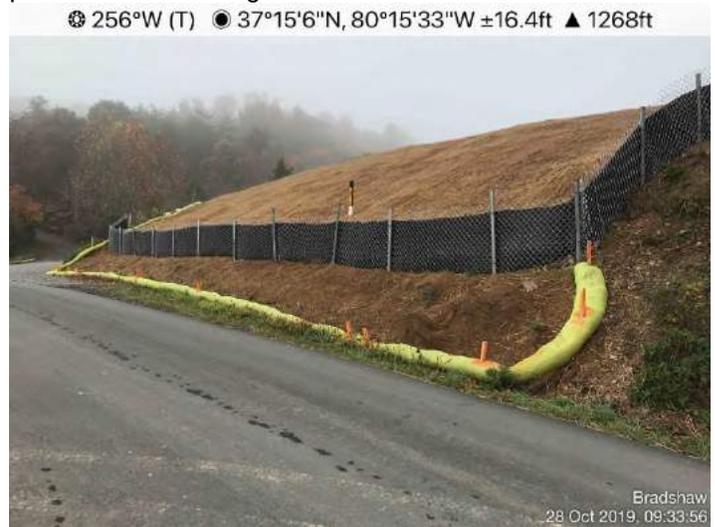
Fig. 2: STA 12190+75 – Bradshaw Road crossing. No evidence of sediment discharge from ROW. Controls in place and functioning.

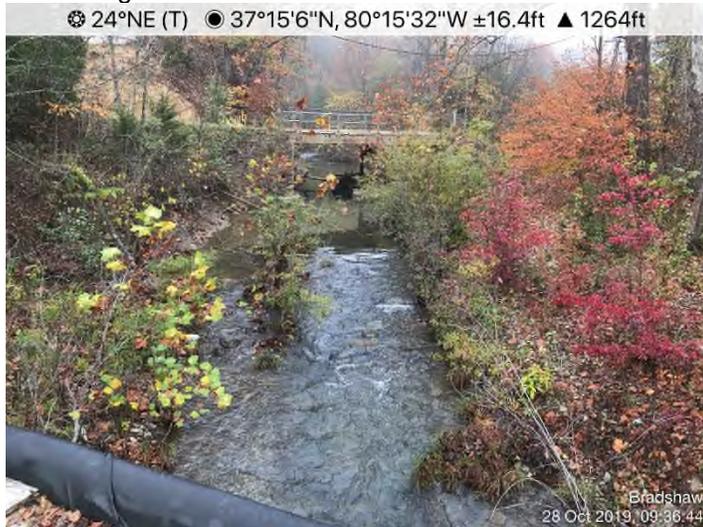
Fig. 3: Stream S-C21 – Looking upstream at Bradshaw Creek crossing towards Bradshaw Road. No evidence of sediment discharge from ROW. Controls in place and functioning.

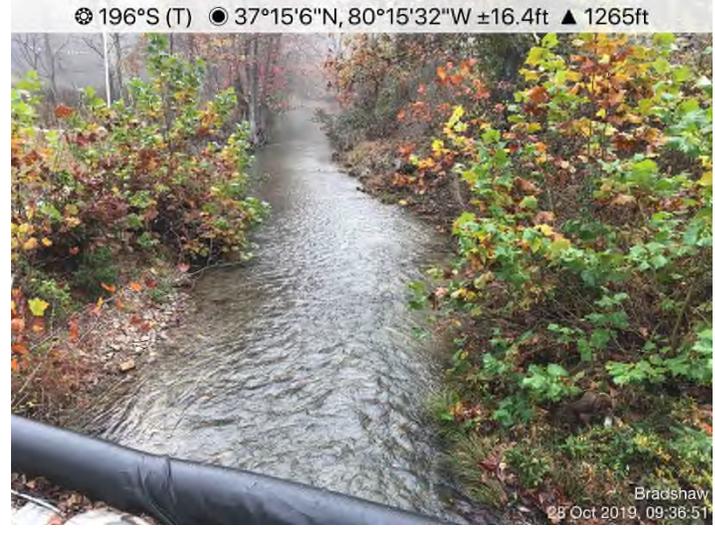
Fig. 4: Stream S-C21 – Looking downstream at Bradshaw Creek crossing. No evidence of sediment discharge from ROW. Controls in place and functioning.

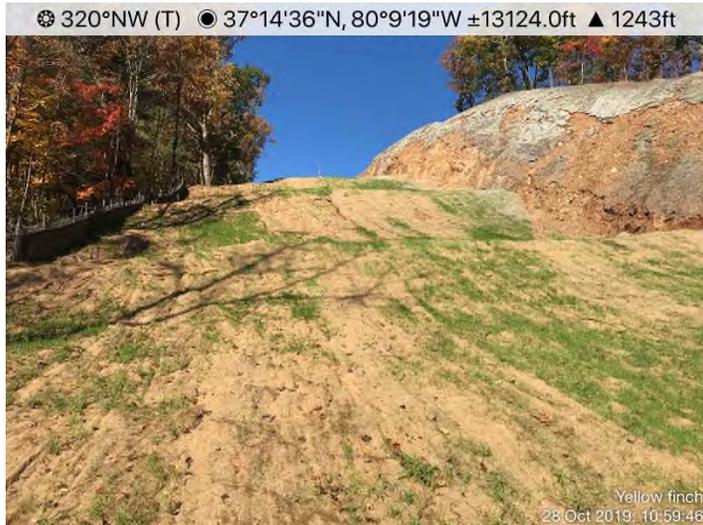
Fig. 1: **STA 12544+00** – Area stabilized with erosion matting. Controls in place and functioning at the time of inspection.

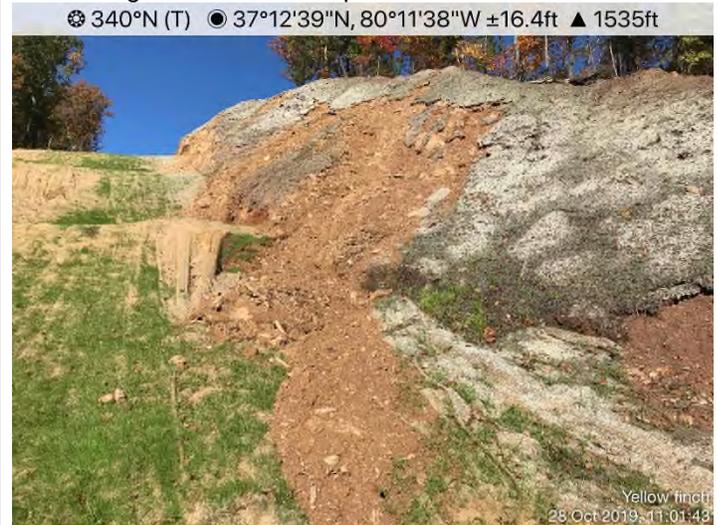
Fig. 2: **STA 12543+00** – Stockpile slipping onto ROW. Item identified by MVP on 10/20/2019. Repair extended due to wet ROW conditions. Controls in place and functioning at the time of inspection.

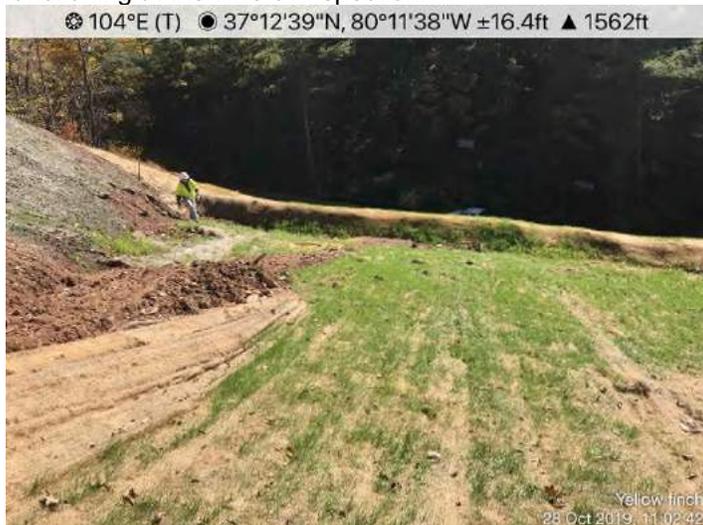
Fig. 3: **STA 12541+00** – Stockpile slipping onto ROW. Item identified by MVP on 10/20/2019. Repair extended due to wet ROW conditions. Controls in place and functioning at the time of inspection.

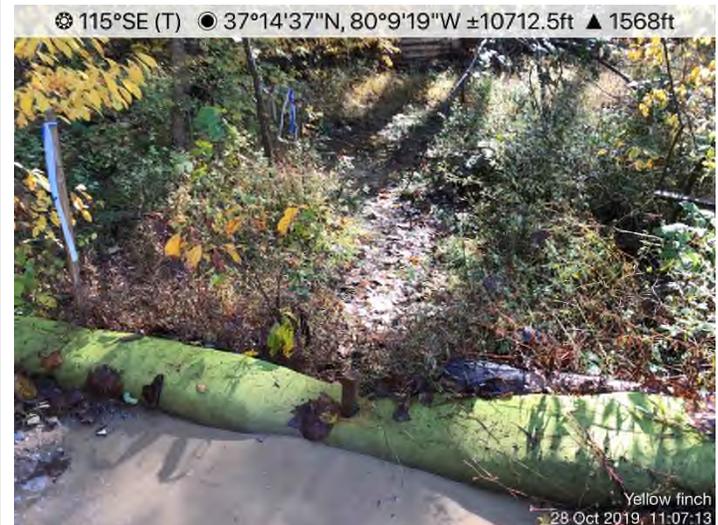
Fig. 4: **MVP-MN-278.01** – Yellow Finch Lane. CFS installed correctly and functioning properly at the time of inspection.

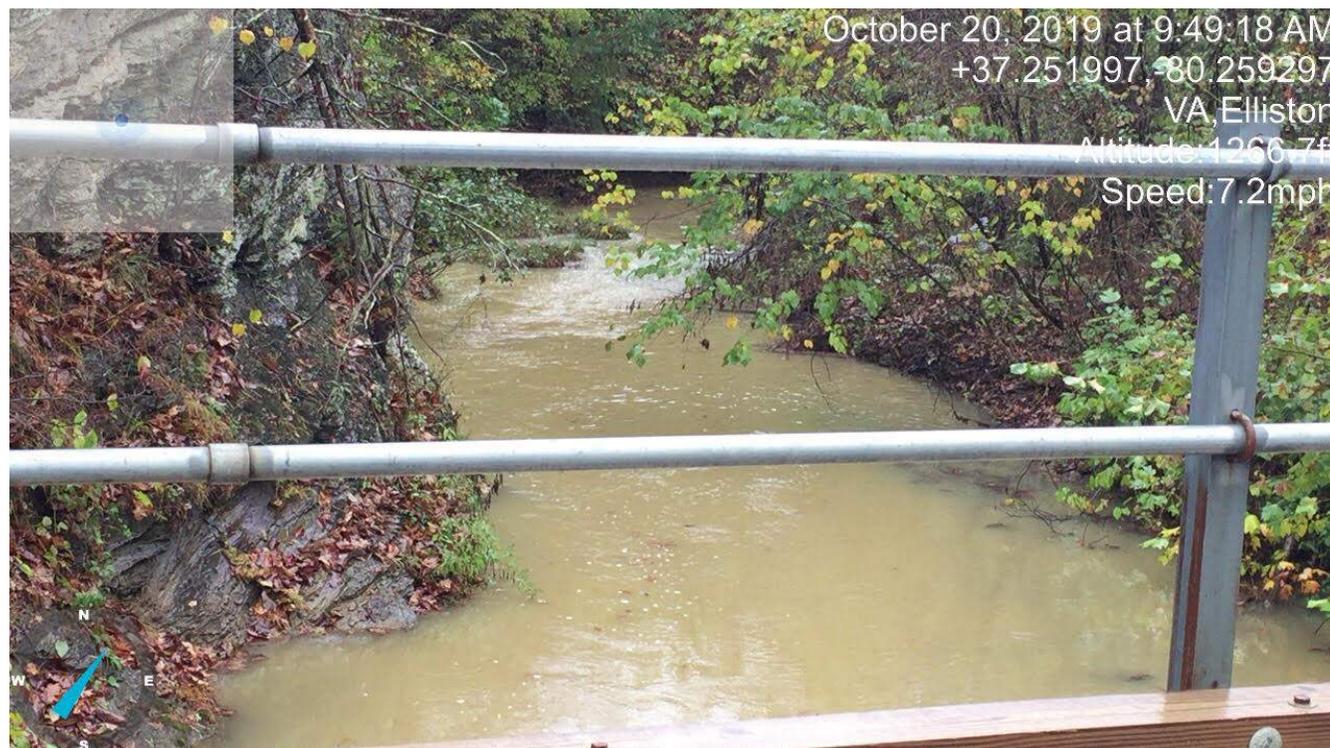
1. Bradshaw Creek at the bridge nearest the ROW.

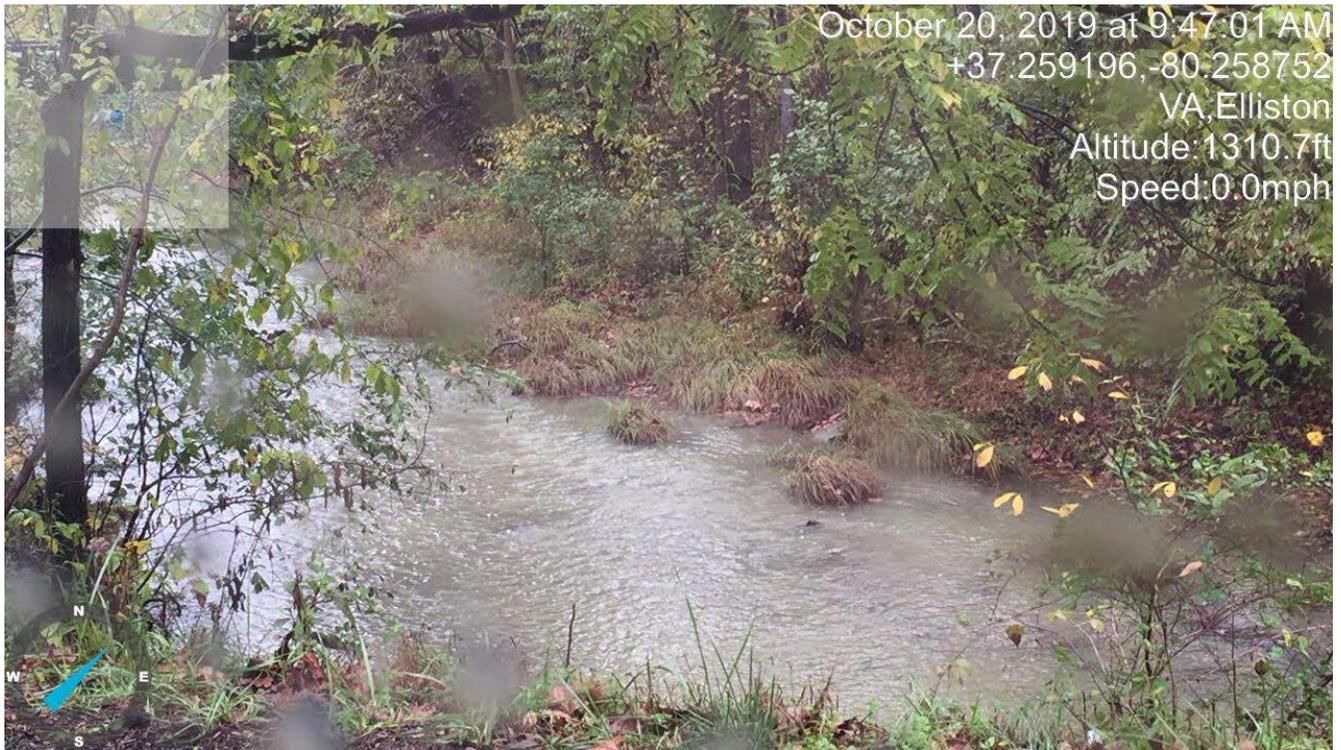
2. Bradshaw upstream of the ROW and any areas of drainage off the ROW on the slopes above Bradshaw.

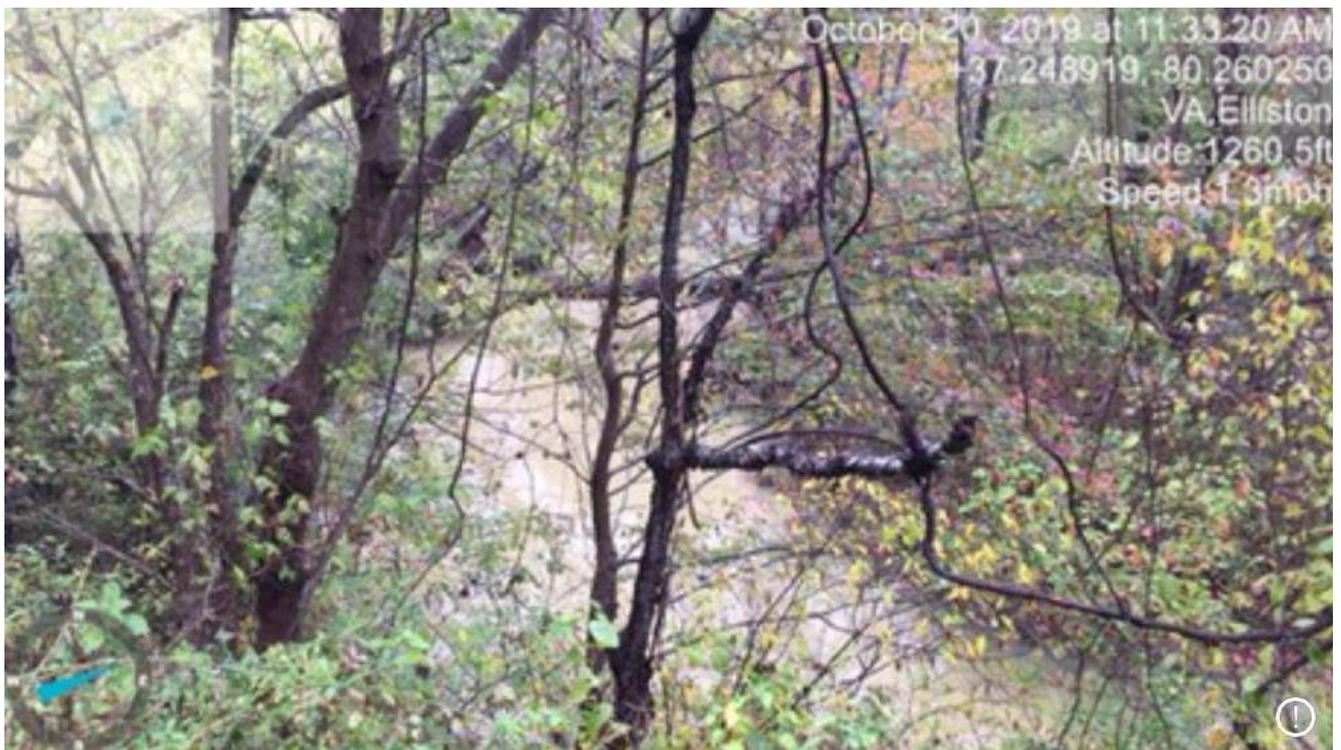
2a. Bradshaw downstream from ROW.

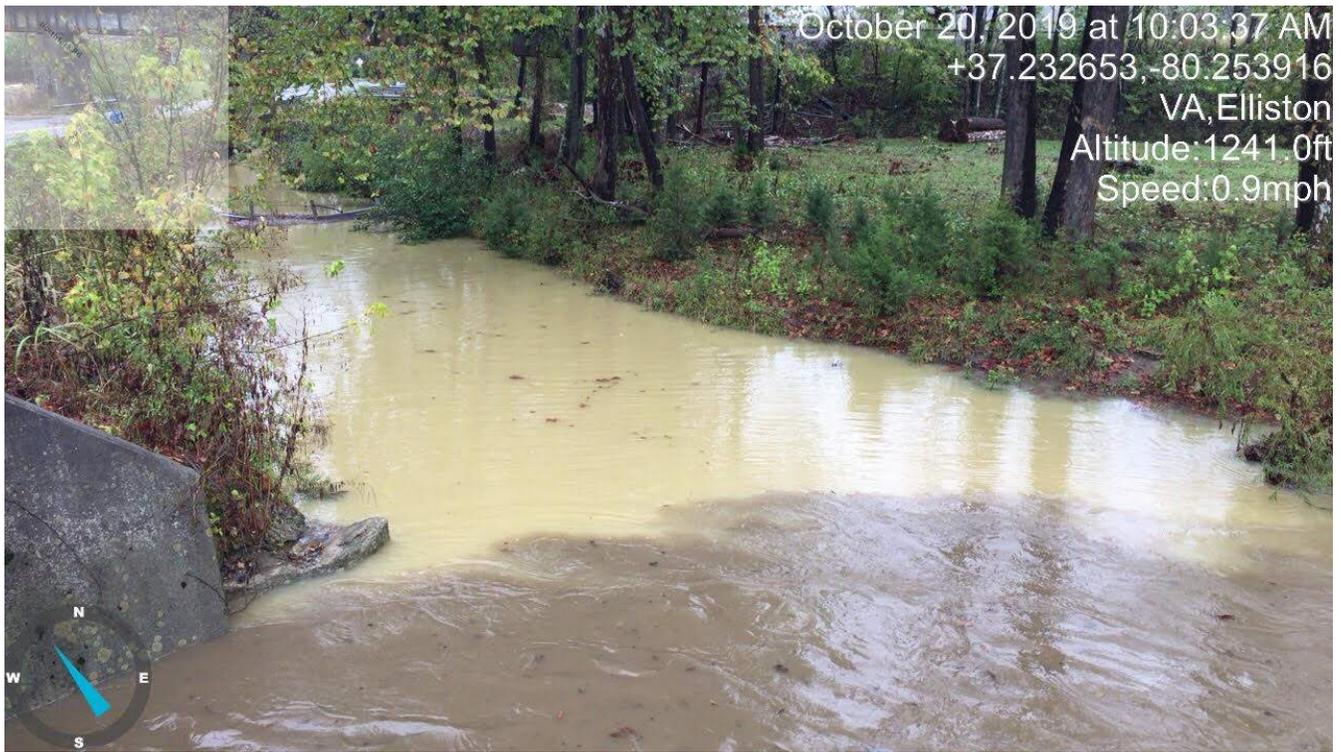
3. Confluence of Bradshaw and North Fork. Bradshaw is the one with more turbidity.

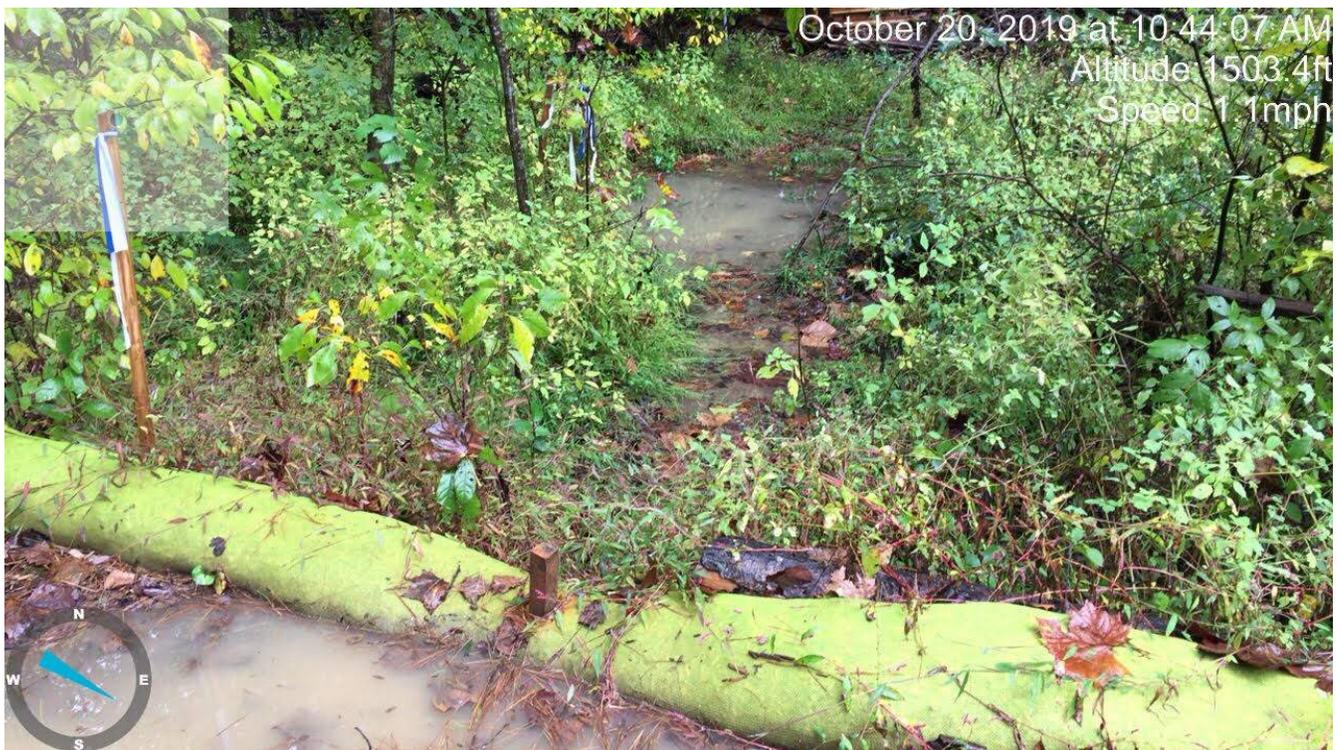
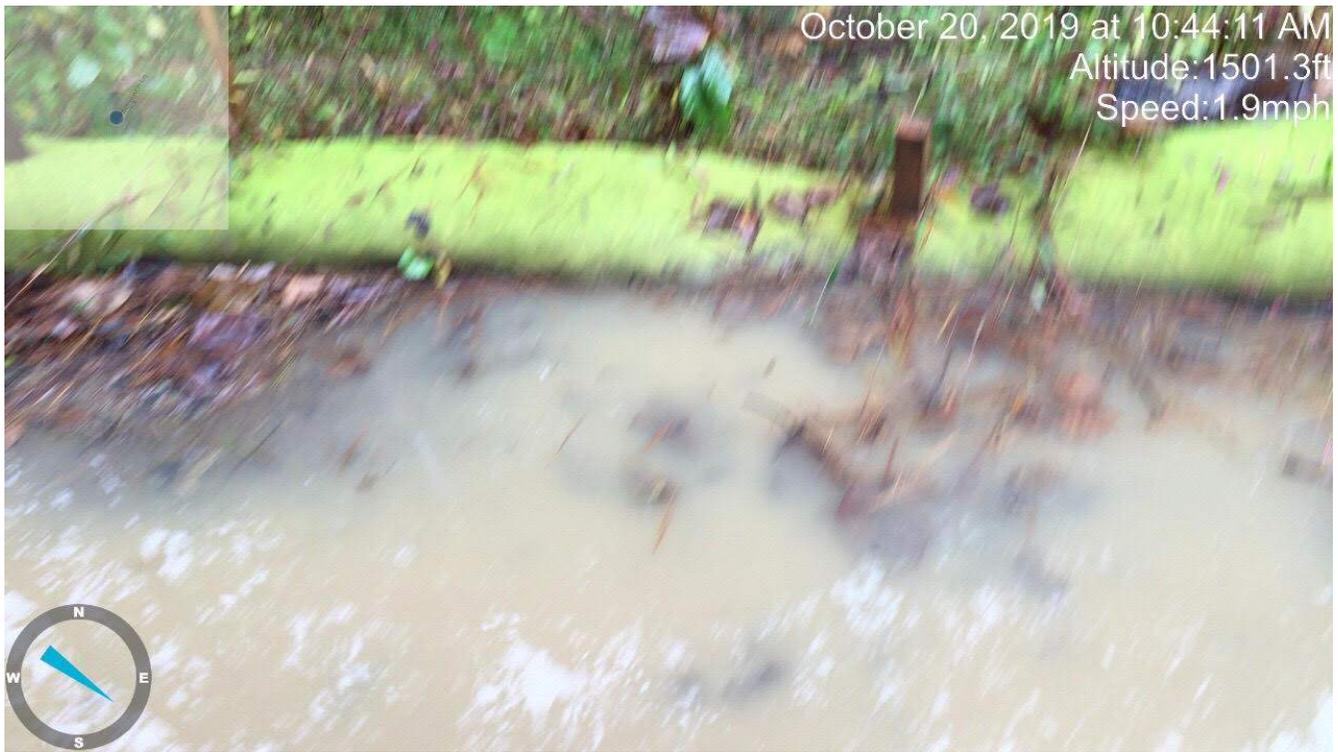
4. Sediment into UNT at Yellow Finch Rd

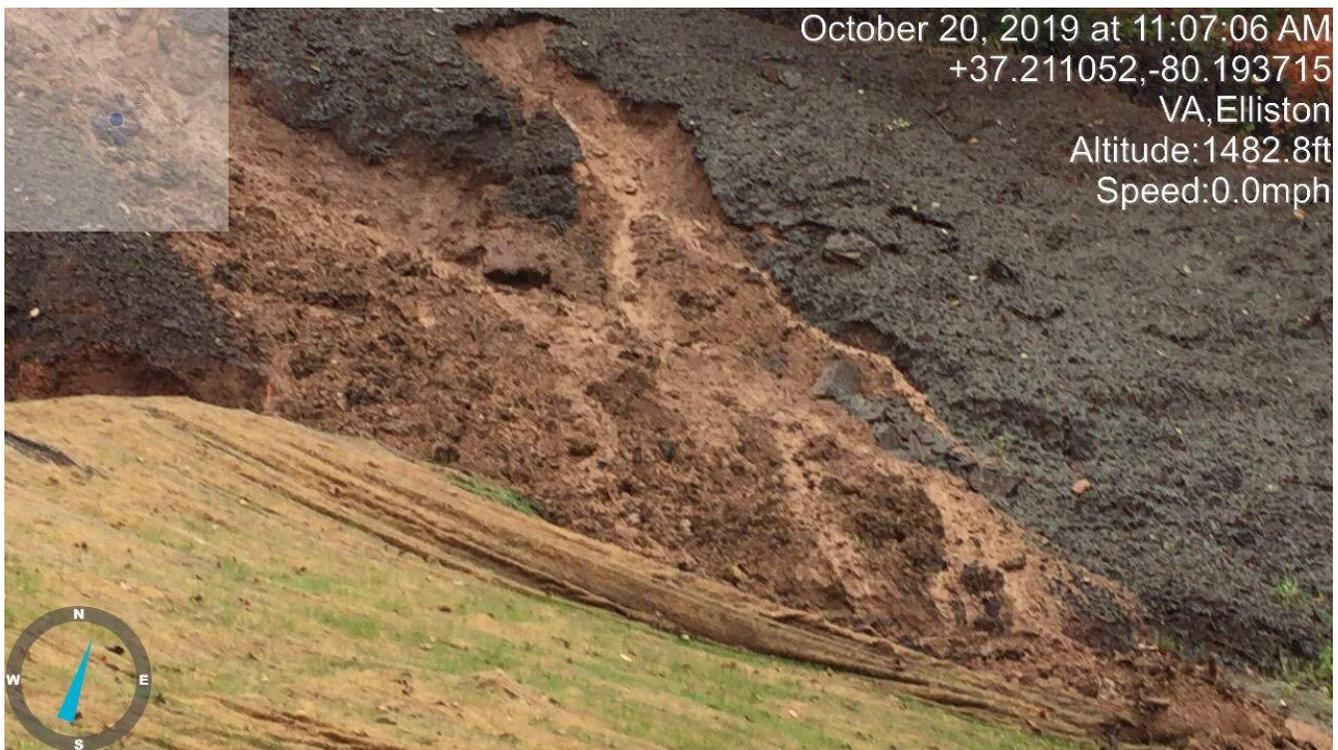
CIS of MN-278.01 to observe the spoil pile slip. Inspectors confirmed that the did appear to have evidence of erosion and the relocated material appeared to be caught by the downslope water bars. The sumps associated with these water bars appeared to have accumulated some sediment during the rain event from the sloughed off material however, they appeared to be less than half full. End treatments of the observed sumps appeared to be maintained and functional. Inspectors photographed the area and opened an action item to repair and re-stabilize the spoil pile between stations 12541+00 and 12543+00. ROW observations during the inspection of this area were between stations 12539+00 and 12544+00. Inspectors returned to MVP security vehicle and departed the area.

5. Soil slippage on ROW above Yellow Finch Rd
