Visual Site Inspection Report

Project Name	H-600 Pipeline Spread H	AFE	124300138	Spread	H-600 Pipeline Spread	
Contractor	Precision			Report #	4528	
Inspector	Pat Davis			Date/Time	10/10/2019 6:10 PM	
Permit #	TBD	Inspection Type	VA SWPP	Station Begin	+0	
State	VA	Inspection Area	Partial	Station End	+0	
County	Roanoke	Ground	Dry	Temperature (°F)	74.00	
Municipality	N/A	Weather	Sunny	Rain Gauge (in)	0.00	
				Rain Accumulation Time (days)	0.00

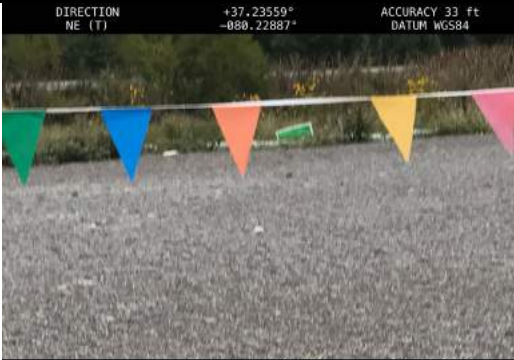
<p>DIRECTION NE (T) +37.23559° -880.22887° ACCURACY 33 ft DATUM WGS84</p> <p>MVP-PY-006_101019 Signage and flagging for feature 2019-10-10 07:40:24-04:00</p>

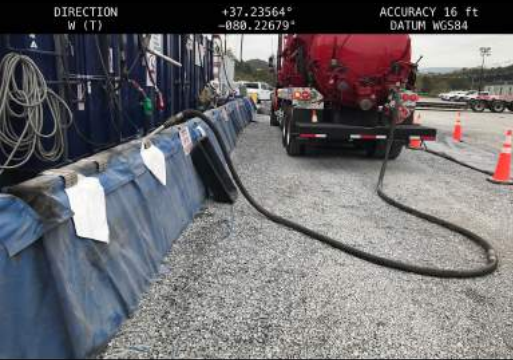
<p>DIRECTION W (T) +37.23564° -880.22679° ACCURACY 16 ft DATUM WGS84</p> <p>MVP-PY-006_101019 Blue Bulk Fuel containment stormwat... 2019-10-10 08:17:21-04:00</p>			
GPS Location	MVP-PY-006 See photo for gps data		GPS Location	MVP-PY-006 See photo for gps data	
Field Station#	+0		Field Station#	+0	
Pic 1 Desc.	Signage and flagging in place along off LOD feature. Looking NE.		Pic 2 Desc.	Blue Bulk Fuel tanks crew cleaning and pumping stormwater from containment. Looking W.

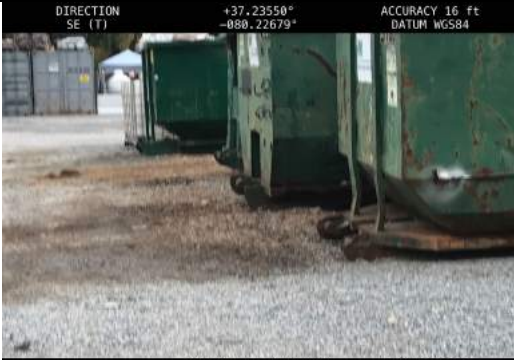
<p>DIRECTION SE (T) +37.23550° -880.22679° ACCURACY 16 ft DATUM WGS84</p> <p>MVP-PY-006_101019 No loose trash around dumpsters 2019-10-10 07:42:21-04:00</p>

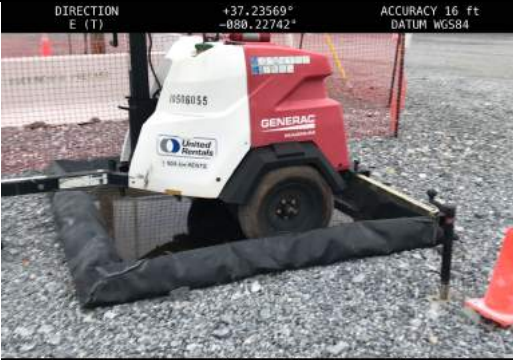
<p>DIRECTION E (T) +37.23569° -880.22742° ACCURACY 16 ft DATUM WGS84</p> <p>MVP-PY-006_101019 Condition of containment 2019-10-10 07:41:21-04:00</p>

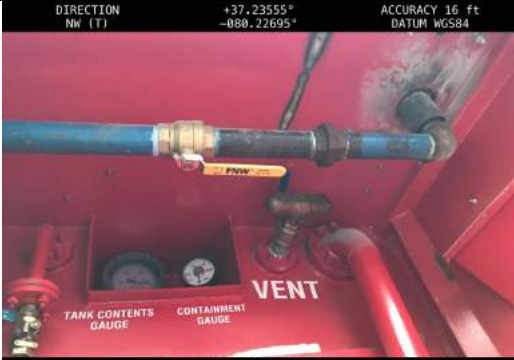
<p>DIRECTION NW (T) +37.23555° -880.22695° ACCURACY 16 ft DATUM WGS84</p> <p>MVP-PY-006_101019 Off Road Fuel unit no leaky fittings 2019-10-10 07:43:12-04:00</p>

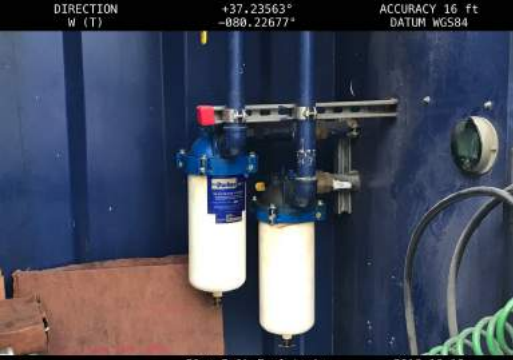
<p>DIRECTION W (T) +37.23563° -880.22677° ACCURACY 16 ft DATUM WGS84</p> <p>MVP-PY-006_101019 Blue Bulk Fuel tanks no leaky fittings 2019-10-10 07:46:20-04:00</p>			
GPS Location	MVP-PY-006 See photo for gps data		GPS Location	MVP-PY-006 See photo for gps data	
Field Station#	+0		Field Station#	+0	
Pic 5 Desc.	Off Road Fuel unit no leaky fittings. Looking NW.		Pic 6 Desc.	Blue Bulk Fuel tanks no leaky fittings. Looking W.

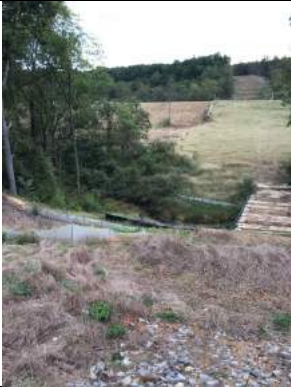
GPS Location	00000	GPS Location	0000		
Field Station#	13543+00	Field Station#	13543+00		
Pic 1 Desc.	Ecds in place at stream crossing, hill side stabilized		Pic 2 Desc.	Inspected equipment bridge and protection

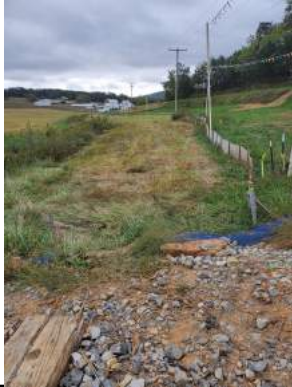
GPS Location	00000	GPS Location	0000		
Field Station#	13644+99	Field Station#	13497+89		
Pic 3 Desc.	Ag land with vegetation starting to come up		Pic 4 Desc.	Land owner drove over the CFS	
Insert image here			Insert image here		
GPS Location		GPS Location			
Field Station#		Field Station#			
Pic 5 Desc.			Pic 6 Desc.

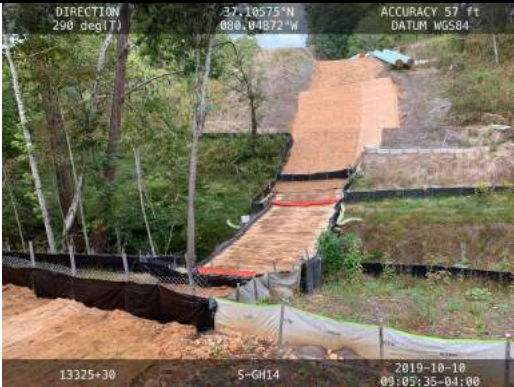
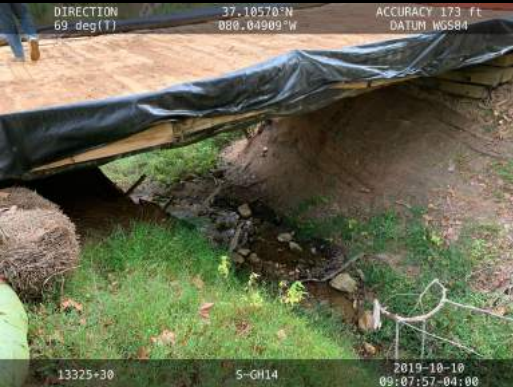
GPS Location	See photo for gps data.		GPS Location	See photo for gps data.	
Field Station#	13325+30		Field Station#	13325+30	
Pic 1 Desc.	Photo shows the bridge over stream S-GH14.		Pic 2 Desc.	Photo shows stream S-GH14.

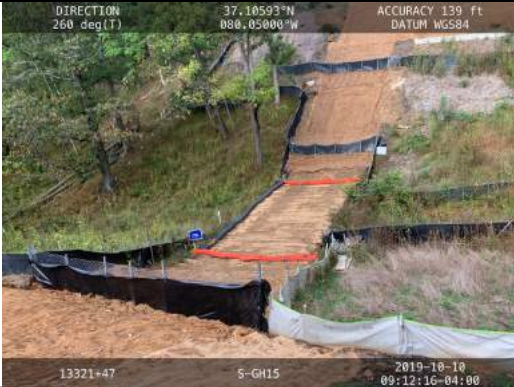
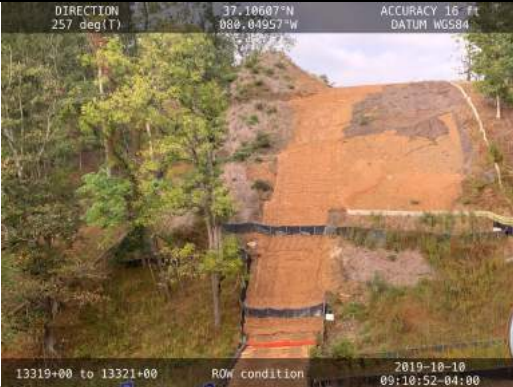
GPS Location	See photo for gps data.		GPS Location	See photo for gps data.	
Field Station#	13321+47		Field Station#	13319+00	
Pic 3 Desc.	Photo shows the bridge over stream S-GH15.		Pic 4 Desc.	Photo shows the ROW condition from about 13319+00 to 13321+00

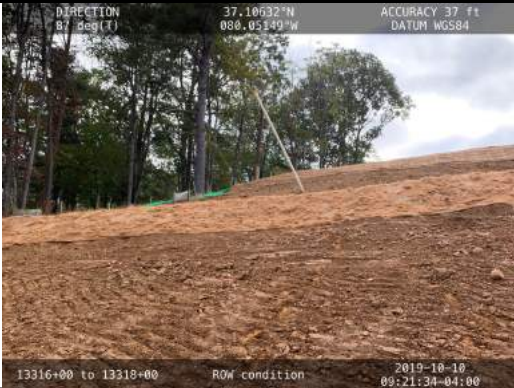
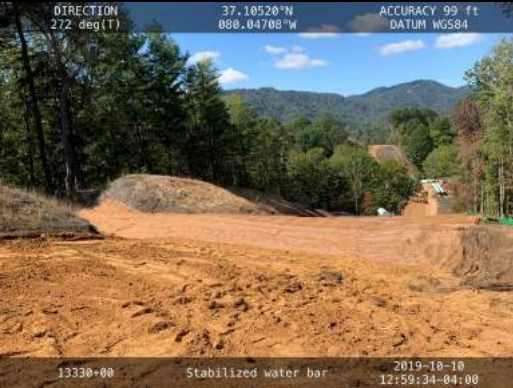
GPS Location	See photo for gps data.		GPS Location	See photo for gps data.	
Field Station#	13317+00		Field Station#	13330+00	
Pic 5 Desc.	Photo shows the ROW condition from about 13316+00 to 13318+00.		Pic 6 Desc.	Photo shows the reworked and stabilized water bar 13330+00.

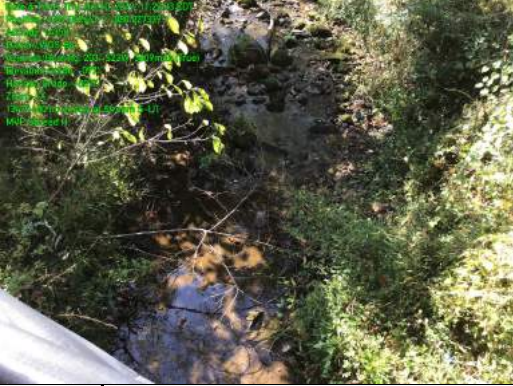
<p> Date & Time: Thu, 10/10/2019 3:04 PM Position: 32.0210000° N / -90.0210000° W Altitude: 1000 ft Datum: WGS84 Address: 13413+00 S-RR11 Elevation: 1000 ft Horizontal Scale: 1000 ft Vertical Scale: 1000 ft 13413+00 S-RR11 MVP Project II </p>			
GPS Location	See pic for GPS location		GPS Location	See pic for GPS location	
Field Station#	13415+36		Field Station#	13413+00	
Pic 1 Desc.	No impacts observed at Stream crossing S-IJ3		Pic 2 Desc.	No issues or impacts observed near stream S-IJ1.

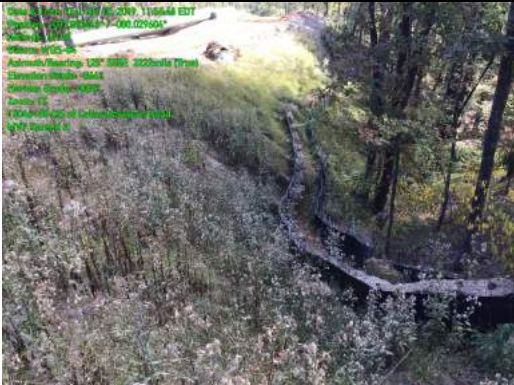
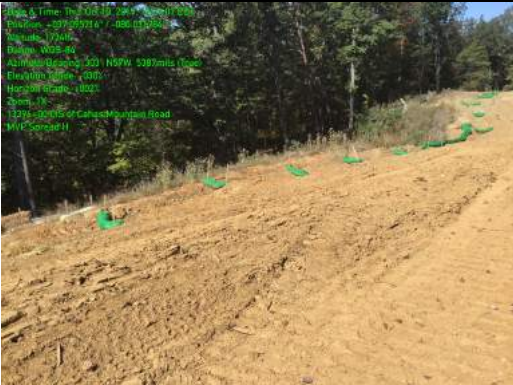
GPS Location	See pic for GPS location		GPS Location	See pic for GPS location	
Field Station#	13406+00		Field Station#	13396+00	
Pic 3 Desc.	No ECD deficiencies or maintenance issues found in the area on the CIS of Cahas Mountain Road.		Pic 4 Desc.	Haybale checks replaced with CFS.

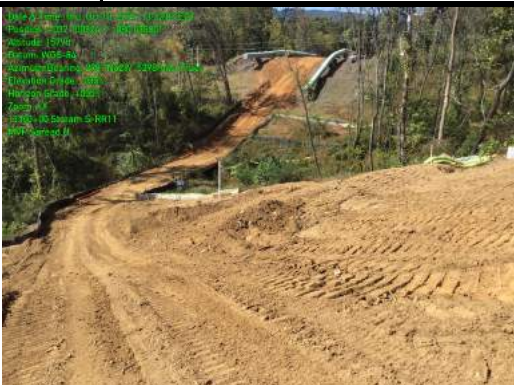
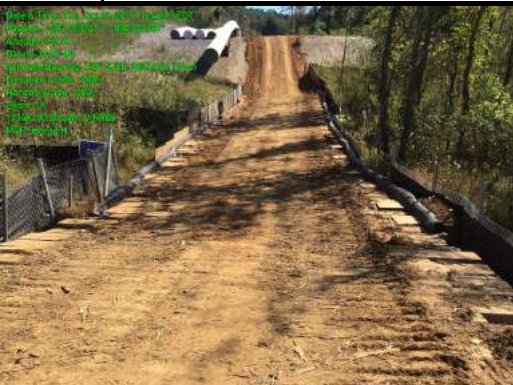
Pic 5 Desc.	No issues or impacts observed near stream S-RR11		Pic 6 Desc.	No issues or impacts observed near stream S-RR08.

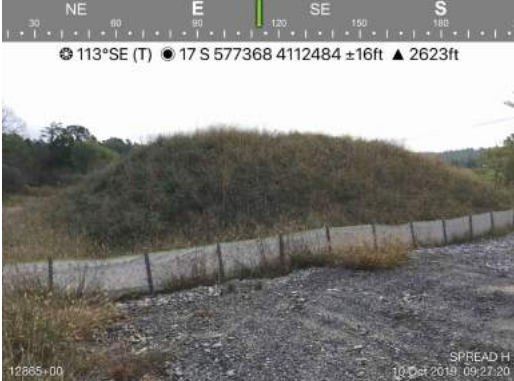
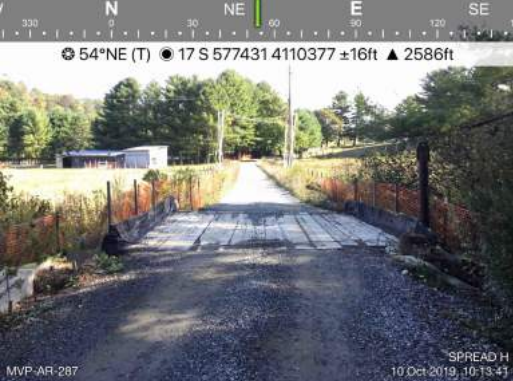
GPS Location	See Photo Above		GPS Location	See Photo Above	
Field Station#	12865+00		Field Station#	2+87	
Pic 1 Desc.	Stockpile stabilized with P1SF in good condition		Pic 2 Desc.	MVP-AR-287 timber matting at S-Z16 crossing

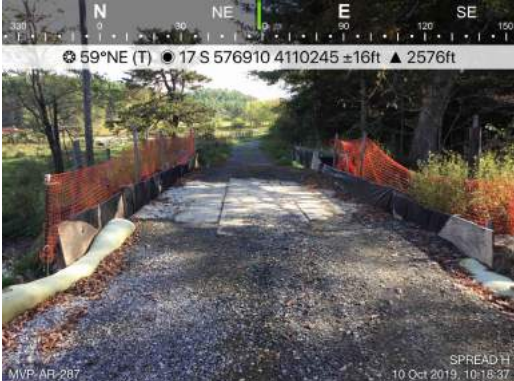
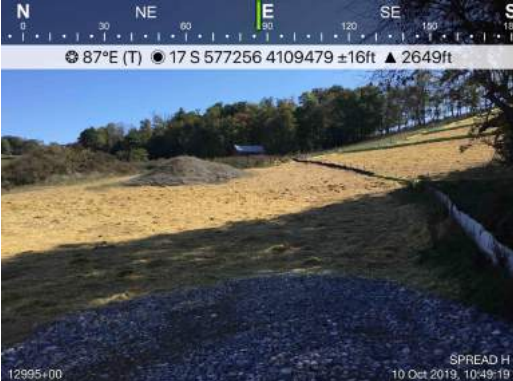
GPS Location	See Photo Above		GPS Location	See Photo Above	
Field Station#	2+87		Field Station#	12995+00	
Pic 3 Desc.	MVP-AR-287 timber matting at S-Z17 crossing		Pic 4 Desc.	Temp stabilization with P1SF in good condition

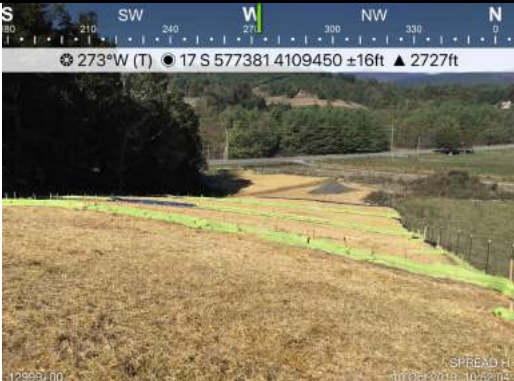
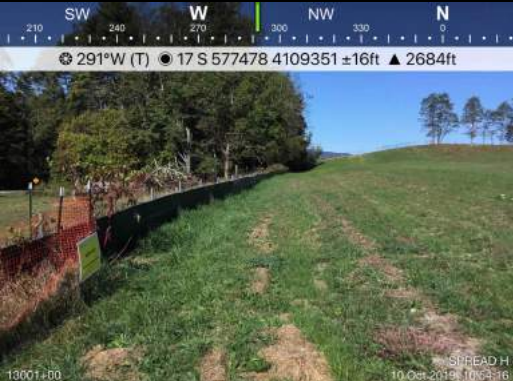
GPS Location	See Photo Above		GPS Location	See Photo Above	
Field Station#	12999+00		Field Station#	13001+00	
Pic 5 Desc.	Slope temporary stabilized with CFS Waterbars in place		Pic 6 Desc.	SSF along ROW CIS of a Blue Ridge Parkway

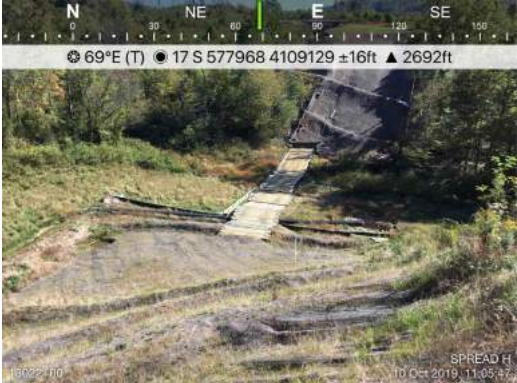
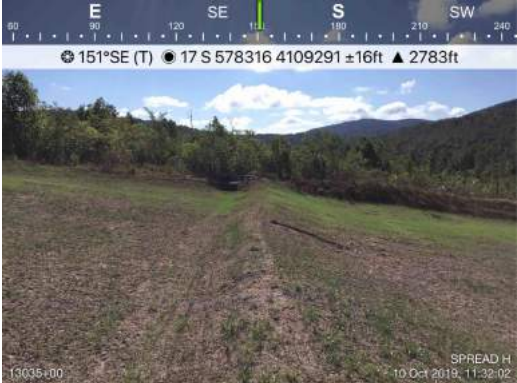
GPS Location	See Photo Above		GPS Location	See Photo Above	
Field Station#	13022+00		Field Station#	13035+00	
Pic 7 Desc.	CWD Pipe and Berm CIS of S-G24 with slope temporarily stabilized		Pic 8 Desc.	Waterbar with stabilization taking in areas GAS of MVP-AR-289

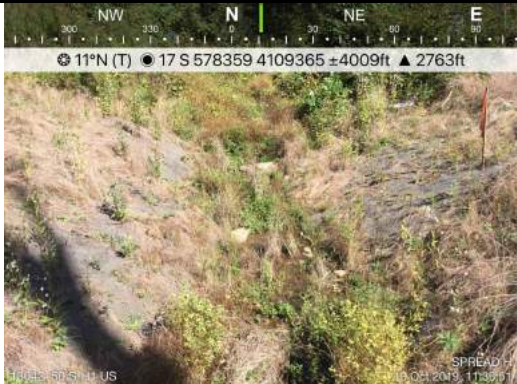
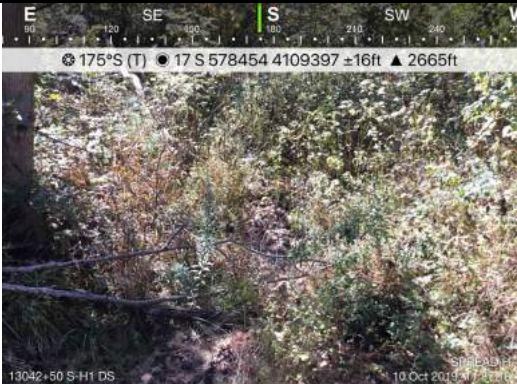
GPS Location	See Photo Above		GPS Location	See Photo Above	
Field Station#	13042+50		Field Station#	13042+50	
Pic 9 Desc.	S-H1 upstream		Pic 10 Desc.	S-H1 downstream

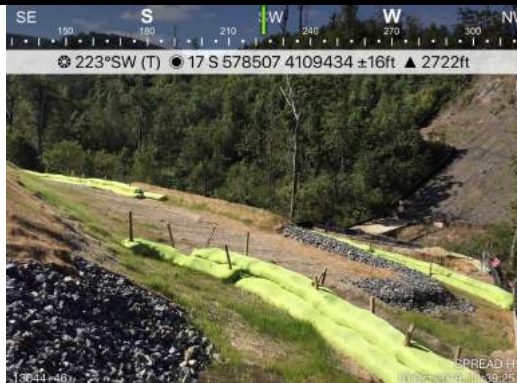
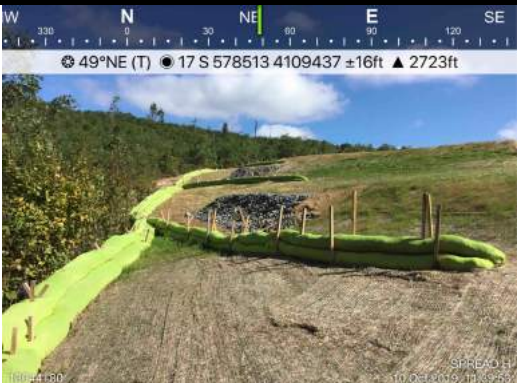
GPS Location	See Photo Above		GPS Location	See Photo Above	
Field Station#	13044+48		Field Station#	13044+80	
Pic 11 Desc.	Permanent waterbars on GAS slope of S-H1		Pic 12 Desc.	CFS triple stack and permanent waterbars in good condition

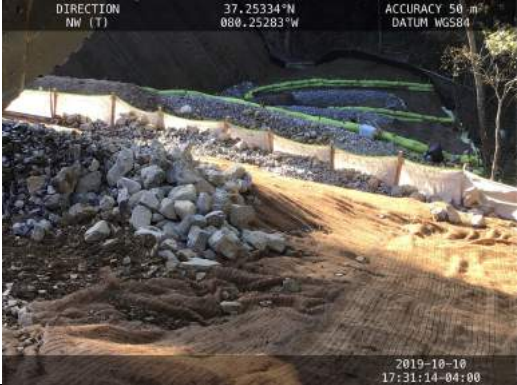
Insert image here			
GPS Location	See photo		GPS Location		
Field Station#	12112+00		Field Station#		
Pic 13 Desc.	P1 silt fence was used to catch rock as it cascaded off the back of the rock weir being built in this location.		Pic 14 Desc.		
Insert image here			Insert image here		
GPS Location			GPS Location		
Field Station#			Field Station#		
Pic 15 Desc.			Pic 16 Desc.		
Insert image here			Insert image here		
GPS Location			GPS Location		
Field Station#			Field Station#		
Pic 17 Desc.			Pic 18 Desc.

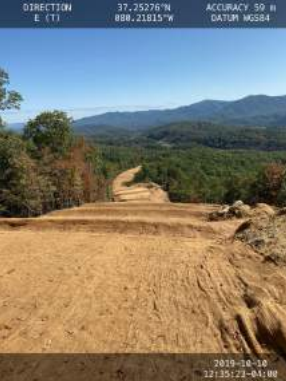
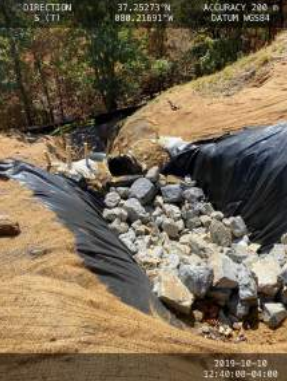
GPS Location	See picture for GPS data		GPS Location	See picture for GPS data	
Field Station#	12320+00		Field Station#	12341+00	
Pic 1 Desc.	Stabilized ROW.		Pic 2 Desc.	Inlet protection for fill slope drain.

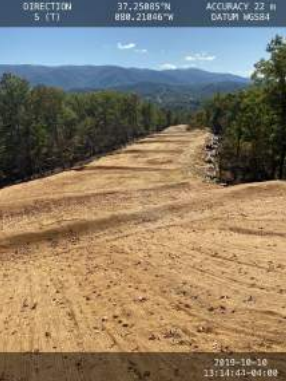
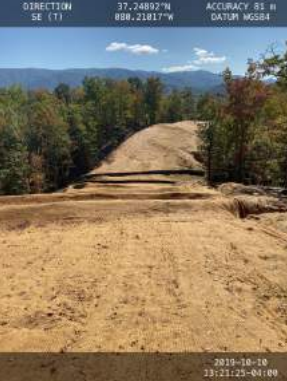
GPS Location	See picture for GPS data		GPS Location	See picture for GPS data	
Field Station#	12350+50		Field Station#	12361+02	
Pic 3 Desc.	Stabilized ROW.		Pic 4 Desc.	Stabilized ROW with landowner road crossing.

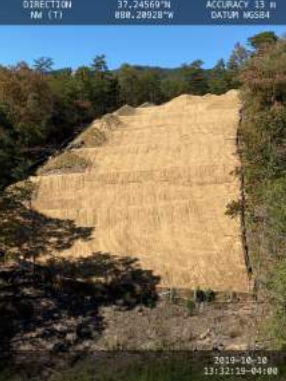
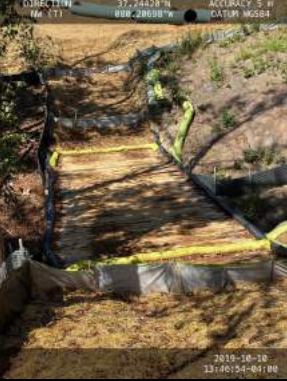
GPS Location	See picture for GPS data		GPS Location	See picture for GPS data	
Field Station#	12370+50		Field Station#	12380+04	
Pic 5 Desc.	Stabilized Hillside CIS of I-81		Pic 6 Desc.	Bridge crossing S-NN19

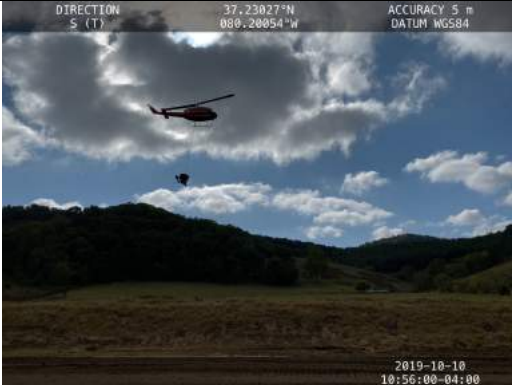
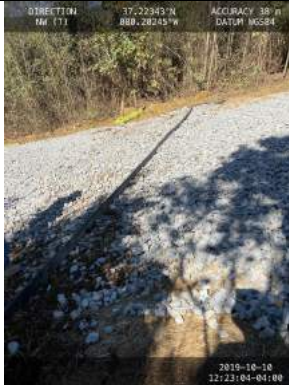
GPS Location	See picture for GPS data.		GPS Location	See picture for GPS data	
Field Station#	12455+37		Field Station#	12482+67	
Pic 1 Desc.	Helicopter with the hopper for stabilization.		Pic 2 Desc.	Water deflected crossing the access road.

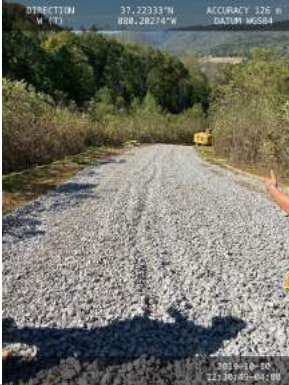
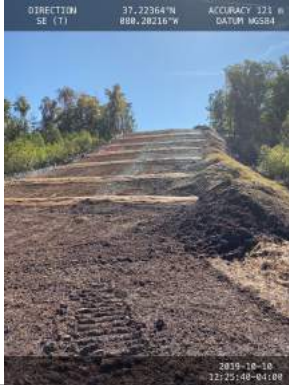
GPS Location	See picture for GPS data		GPS Location	See picture for GPS data	
Field Station#	12482+67		Field Station#	12484+00	
Pic 3 Desc.	Crew adding rock to the access road.		Pic 4 Desc.	Hillside with the start of flextera being applied.

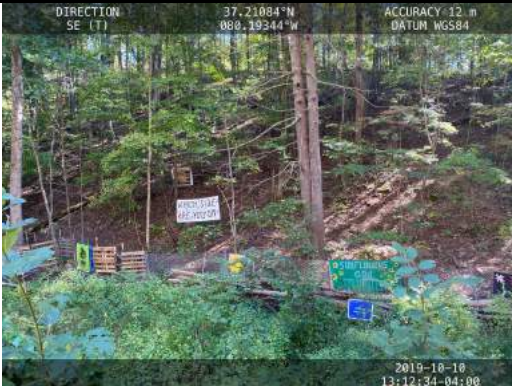
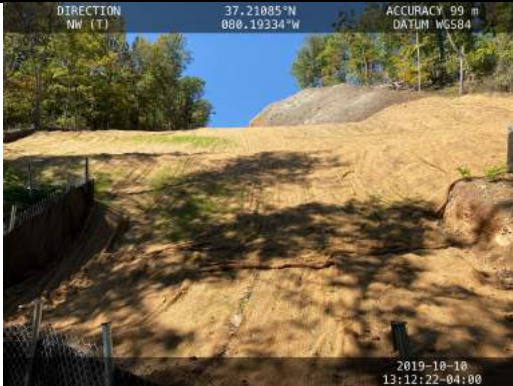
GPS Location	See picture for GPS data		GPS Location	See picture for GPS data	
Field Station#	12543+56		Field Station#	12542+00	
Pic 5 Desc.	Barrier wall built by opposition with SSF materials and pallets.		Pic 6 Desc.	Stabilized hillside with vegetation beginning to grow.
