# Visual Site Inspection Report

<b>Project Name</b>	H-600 Pipeline Spread G	<b>AFE</b>	124300137	<b>Spread</b>	H-600 Pipeline Spread
<b>Contractor</b>	Precision			<b>Report #</b>	4668
<b>Inspector</b>	Chris Burns			<b>Date/Time</b>	10/14/2019 6:59 AM
<b>Permit #</b>	TBD	<b>Inspection Type</b>	VA SWPP	<b>Station Begin</b>	11255+00
<b>State</b>	VA	<b>Inspection Area</b>	Partial	<b>Station End</b>	11354+00
<b>County</b>	Giles	<b>Ground</b>	Wet	<b>Temperature (°F)</b>	71.00
<b>Municipality</b>	N/A	<b>Weather</b>	Sunny	<b>Rain Gauge (in)</b>	0.00
				<b>Rain Accumulation Time (days)</b>	3.00

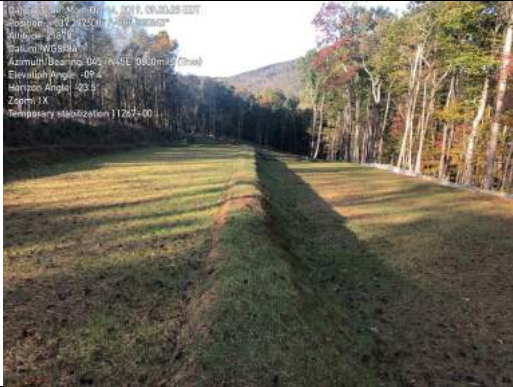
<b>GPS Location</b>	1	<b>GPS Location</b>	2		
<b>Field Station#</b>	11258+25	<b>Field Station#</b>	11267+00		
<b>Pic 1 Desc.</b>	Temporary stabilization.	<b>Pic 2 Desc.</b>	Temporary stabilization.

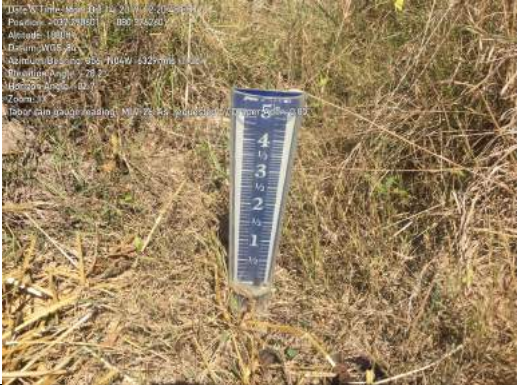
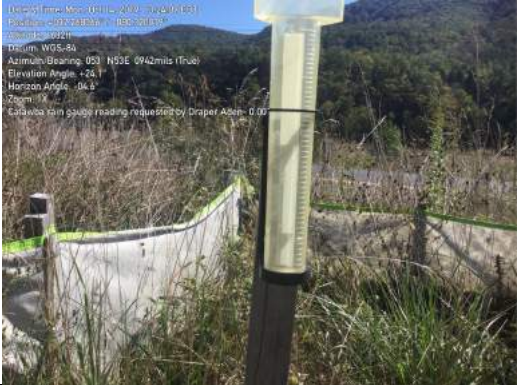
<b>GPS Location</b>	See photo GPS	<b>GPS Location</b>	See photo GPS		
<b>Field Station#</b>	11767+00	<b>Field Station#</b>	11989+00		
<b>Pic 7 Desc.</b>	Rain gauge readings requested by Draper Aden - Tabor- 0.00"	<b>Pic 8 Desc.</b>	Catawba rain gauge reading requested by Draper Aden- 0.00"		
Insert image here		Insert image here			
<b>GPS Location</b>		<b>GPS Location</b>			
<b>Field Station#</b>		<b>Field Station#</b>			
<b>Pic 9 Desc.</b>		<b>Pic 10 Desc.</b>			
Insert image here		Insert image here			
<b>GPS Location</b>		<b>GPS Location</b>			
<b>Field Station#</b>		<b>Field Station#</b>			
<b>Pic 11 Desc.</b>		<b>Pic 12 Desc.</b>

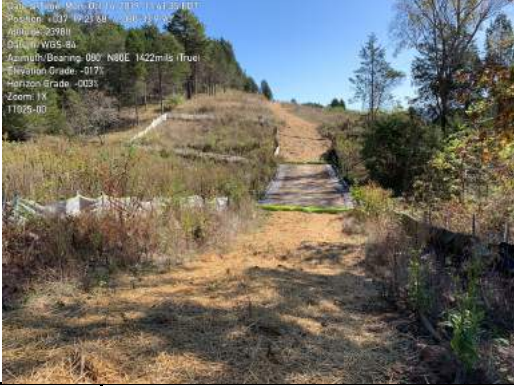
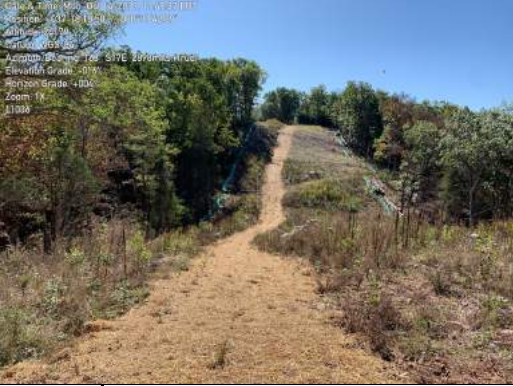
<b>GPS Location</b>	See picture above for GPS coordinates		<b>GPS Location</b>	See picture above for GPS coordinates	
<b>Field Station#</b>	11025+00		<b>Field Station#</b>	11032+00	
<b>Pic 1 Desc.</b>	ECD's and row conditions		<b>Pic 2 Desc.</b>	ECD's and row conditions

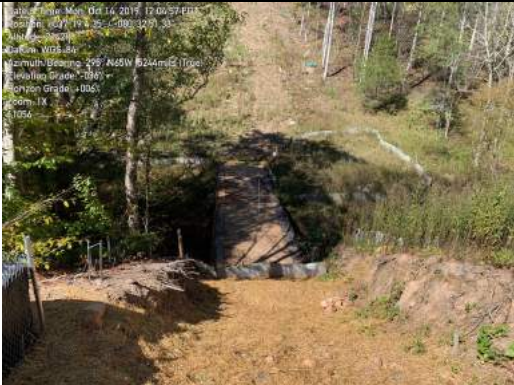
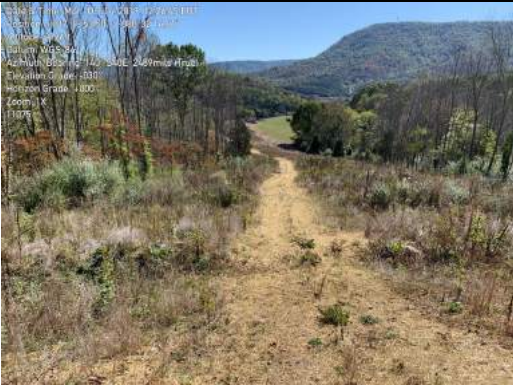
<b>GPS Location</b>	See picture above for GPS coordinates		<b>GPS Location</b>	See picture above for GPS coordinates	
<b>Field Station#</b>	11056+00		<b>Field Station#</b>	1107+50	
<b>Pic 3 Desc.</b>	ECD's and row conditions		<b>Pic 4 Desc.</b>	ECD's and row conditions

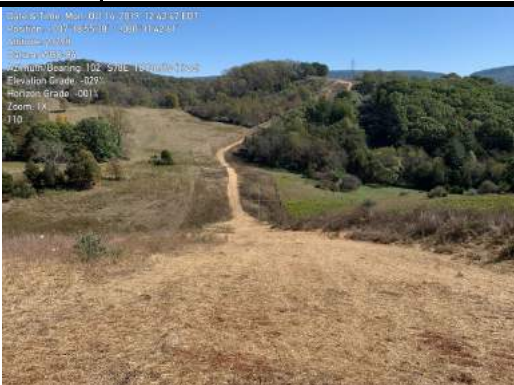
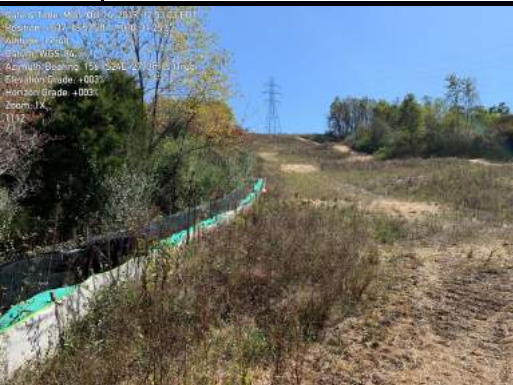
<b>GPS Location</b>	See picture above for GPS coordinates		<b>GPS Location</b>	See picture above for GPS coordinates	
<b>Field Station#</b>	11120+00		<b>Field Station#</b>	11130+00	
<b>Pic 5 Desc.</b>	ECD's and row conditions		<b>Pic 6 Desc.</b>	ECD's and row conditions

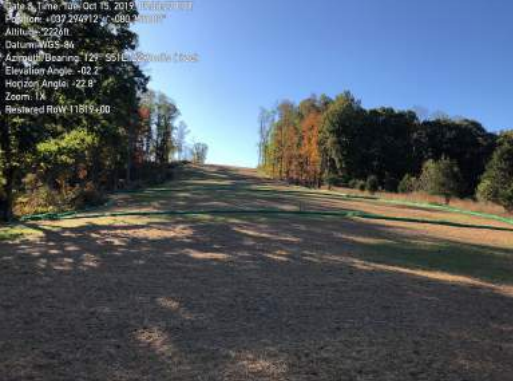
<b>GPS Location</b>	1	<b>GPS Location</b>	2		
<b>Field Station#</b>	11795+00	<b>Field Station#</b>	11819+00		
<b>Pic 1 Desc.</b>	Restored RoW.	<b>Pic 2 Desc.</b>	Restored RoW.		
<p>Date &amp; Time: Tue, Oct 15, 2019 08:04 EDT  Position: 4037.266139° / -88.15074°  Altitude: 2180 ft  Datum: WGS-84  Azimuth/Bearing: 201° 201E 109mils (True)  Elevation Angle: -65.2°  Horizon Angle: -65.2°  Zoom: 1X  Restored RoW: 11838+00</p>

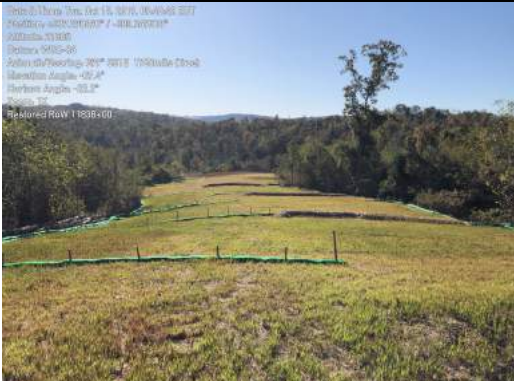
<b>GPS Location</b>	3	<b>GPS Location</b>	4		
<b>Field Station#</b>	11838+00	<b>Field Station#</b>	11863+65		
<b>Pic 3 Desc.</b>	Restored RoW.	<b>Pic 4 Desc.</b>	P-KL2.		
<p>Date &amp; Time: Tue, Oct 15, 2019 18:16 EDT  Position: 4037.267753° / -88.139113°  Altitude: 2180 ft  Datum: WGS-84  Azimuth/Bearing: 071° N71E 1242mils (True)  Elevation Angle: -65.1°  Horizon Angle: -72.1°  Zoom: 1X  Restored RoW: 11886+00</p>

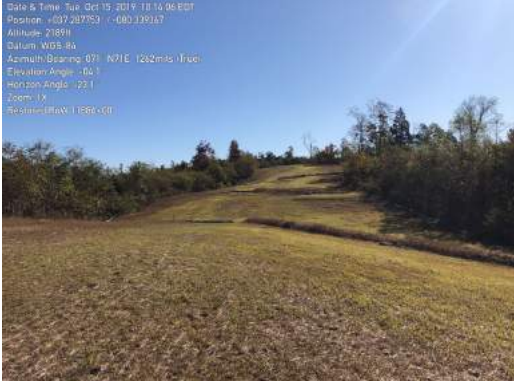
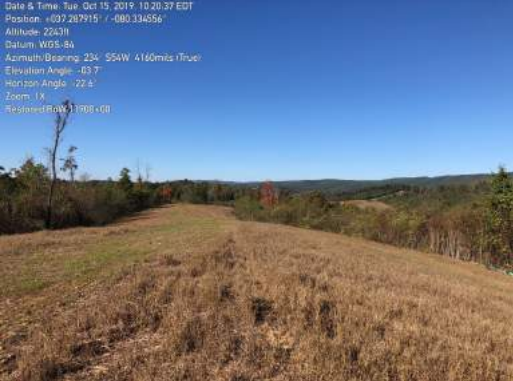
<b>GPS Location</b>	5	<b>GPS Location</b>	6		
<b>Field Station#</b>	11886+00	<b>Field Station#</b>	11900+00		
<b>Pic 5 Desc.</b>	Restored RoW.	<b>Pic 6 Desc.</b>	Restored RoW.

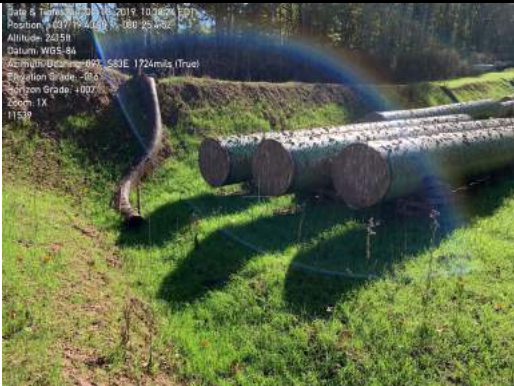
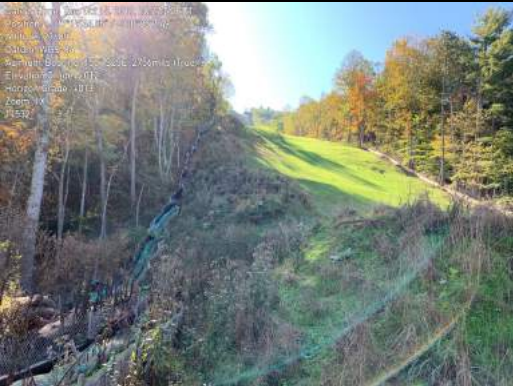
<b>Pic 5 Desc.</b>	ECD's and row conditions		<b>Pic 6 Desc.</b>	ECD's and row conditions

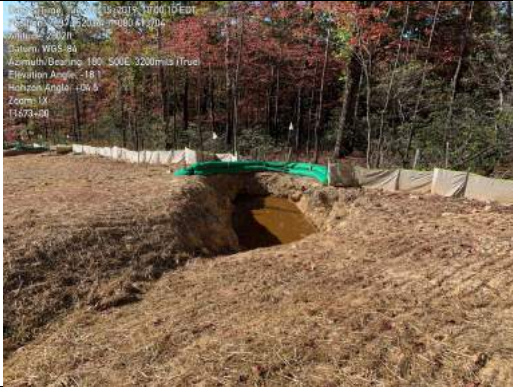
<b>GPS Location</b>		See photo for GPS location.		<b>GPS Location</b>	
<b>Field Station#</b>		1167+00		<b>Field Station#</b>	
<b>Pic 1 Desc.</b>		ROW has been stabilized with seed and mulch. Minor vegetation growth present.		<b>Pic 2 Desc.</b>

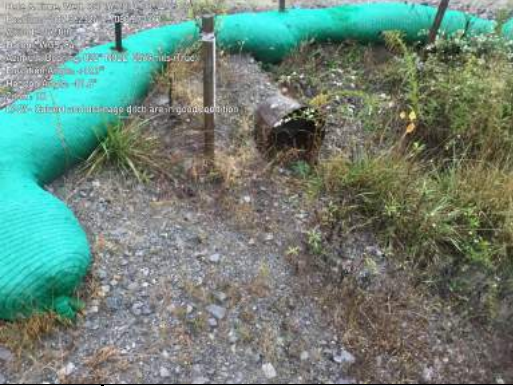
<p>Date &amp; Time: Wed, Oct 16, 2019, 08:21:28 EDT Position: +489.391488° / -488.794345° Altitude: 1887ft Datum: WGS-84 Azimuth/Bearing: 339° 53'57" 4871mils (true) Elevation Angle: +15.0° Horizon Angle: -0.0° Zoom: IX LY29- Culvert and drainage ditch are in acceptable condition.</p>			
<b>GPS Location</b>	See photo GPS		<b>GPS Location</b>	See photo GPS	
<b>Field Station#</b>	12005+00		<b>Field Station#</b>	12005+00	
<b>Pic 1 Desc.</b>	Arnold's seeding materials storage.		<b>Pic 2 Desc.</b>	LY29- Culvert and drainage ditch are in acceptable condition.

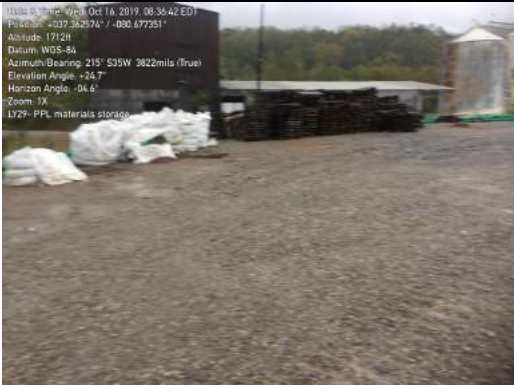
<p>Date &amp; Time: Wed, Oct 16, 2019, 08:35:42 EDT Position: +489.382974° / -488.677351° Altitude: 1712ft Datum: WGS-84 Azimuth/Bearing: 215° 53'57" 3822mils (true) Elevation Angle: +24.7° Horizon Angle: -04.6° Zoom: IX LY29- PPL materials storage.</p>		  <p>Date &amp; Time: Wed, Oct 16, 2019, 08:35:42 EDT Position: +489.382974° / -488.677351° Altitude: 1709ft Datum: WGS-84 Azimuth/Bearing: 300° 00'00" 3822mils (true) Elevation Angle: +23.3° Horizon Angle: -04.7° Zoom: IX LY29- Rock surface of the yard is maintained in acceptable condition.</p>			
<b>GPS Location</b>	See photo GPS		<b>GPS Location</b>	See	
<b>Field Station#</b>	12005+00		<b>Field Station#</b>	12005+00	
<b>Pic 3 Desc.</b>	LY29- PPL Materials storage		<b>Pic 4 Desc.</b>	LY29- Rock surface of the yard is maintained in acceptable condition.

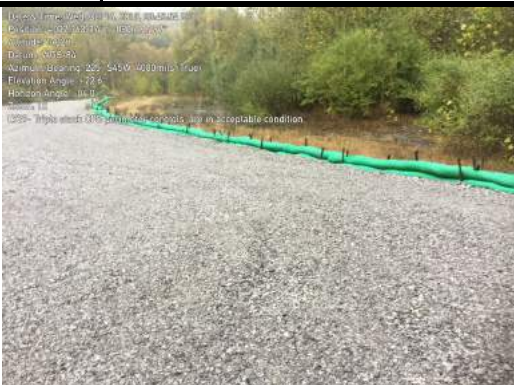
<p>Date &amp; Time: Wed, Oct 16, 2019, 08:52:27 EDT Position: +489.382974° / -488.677351° Altitude: 1816ft Datum: WGS-84 Azimuth/Bearing: 202° 54'50" 3591mils (true) Elevation Angle: +22.5° Horizon Angle: -02.1° Zoom: IX LY29- Triple stack CFS perimeter controls are in acceptable condition.</p>

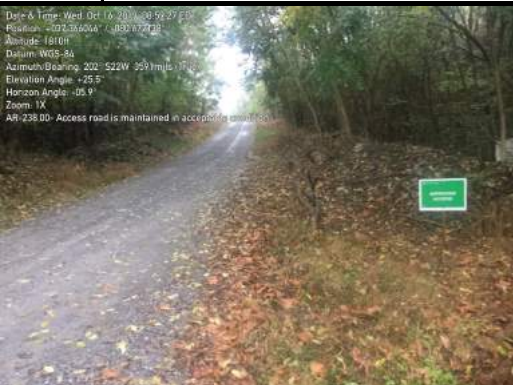
<p>Date &amp; Time: Wed, Oct 16, 2019, 08:52:27 EDT Position: +489.382974° / -488.677351° Altitude: 1816ft Datum: WGS-84 Azimuth/Bearing: 202° 52'22" 3591mils (true) Elevation Angle: +25.5° Horizon Angle: -05.9° Zoom: IX AR- 238.00- Access road is maintained in acceptable condition.</p>

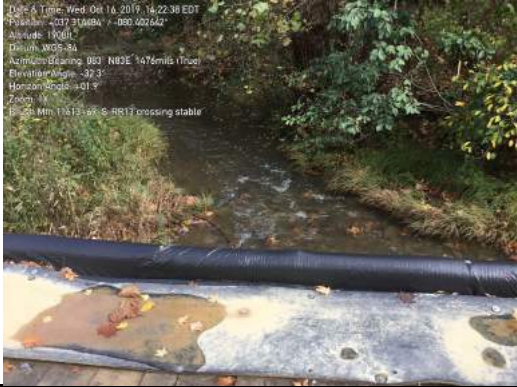
<p>Date &amp; Time: Wed, Oct 16, 2019, 14:22:38 EDT Position: -037 314694N / -080 02242W Altitude: 1906ft Datum: WGS-84 Azimuth/Bearing: 003° N03E 1676mils (True) Elevation Angle: -32.3° Horizon Angle: +01.5° Zoom: 1X Brush Mtn 11613+69 S-RR13 crossing stable</p>			
<b>GPS Location</b>	On photo	<b>GPS Location</b>	On photo		
<b>Field Station#</b>	11614+20	<b>Field Station#</b>	11613+69		
<b>Pic 7 Desc.</b>	S-RR14 crossing stable. Bridge in good condition. Controls in place.	<b>Pic 8 Desc.</b>	S-RR13 crossing stable. Bridge in good condition. Controls in place.

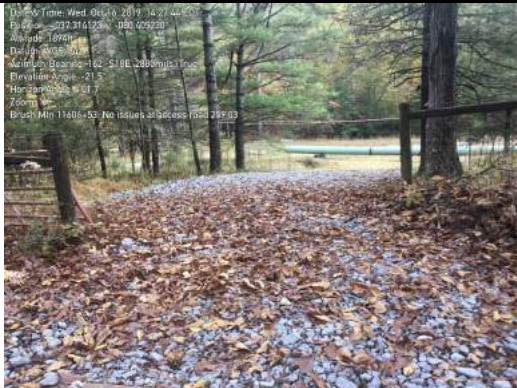
<p>Date &amp; Time: Wed, Oct 16, 2019, 14:27:44 EDT Position: -037 314135N / -080 02523W Altitude: 1899ft Datum: WGS-84 Azimuth/Bearing: 162° S10E 2880mils (True) Elevation Angle: -21.5° Horizon Angle: +01.7° Zoom: 1X Brush Mtn 11606+53 No features at access road 259.03</p>

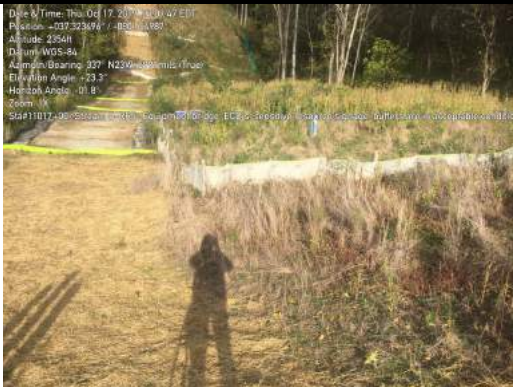
<p>Date &amp; Time: Thu, Oct 17, 2019, 00:00:57 EDT Position: -037.323694 / -83.031180 Altitude: 2564 ft Datum: WGS-84 Azimuth/Bearing: 337° N33W 6347mils (True) Elevation Angle: +23.3° Horizon Angle: -01.8° Zoom: IX Stream S-RR5- Equipment bridge, ECD's, buffers, sensitive resource signage and signage are in acceptable condition.</p>

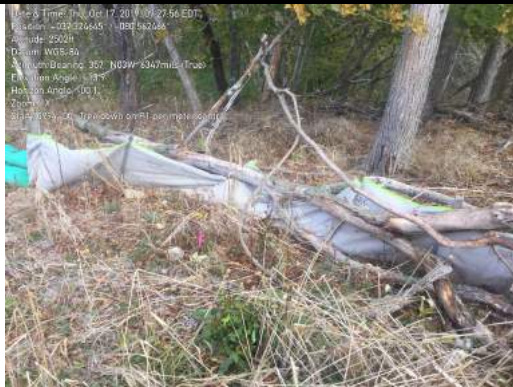
<p>Date &amp; Time: Thu, Oct 17, 2019, 00:27:56 EDT Position: -037.322645 / -83.032266 Altitude: 2502 ft Datum: WGS-84 Azimuth/Bearing: 307° N02W 6347mils (True) Elevation Angle: +31° Horizon Angle: -00.1° Zoom: IX A tree fell on P1 perimeter controls, the contractor cut up the tree and replaced the silt fence.</p>			
<b>GPS Location</b>	See photo GPS	<b>GPS Location</b>	See photo GPS		
<b>Field Station#</b>	11017+00	<b>Field Station#</b>	10994+00		
<b>Pic 3 Desc.</b>	Stream S-RR5- Equipment bridge, buffers, sensitive resource signage & ECD's are in acceptable condition.	<b>Pic 4 Desc.</b>	A tree fell on P1 perimeter controls, the contractor cut up the tree and replaced the silt fence.

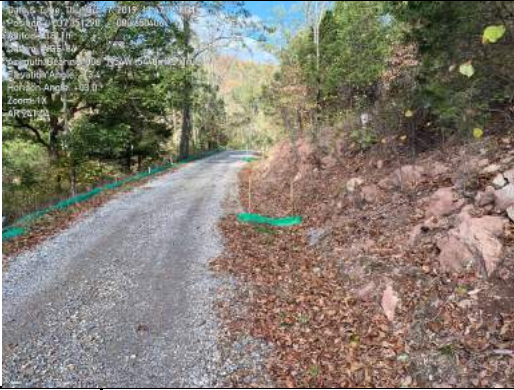
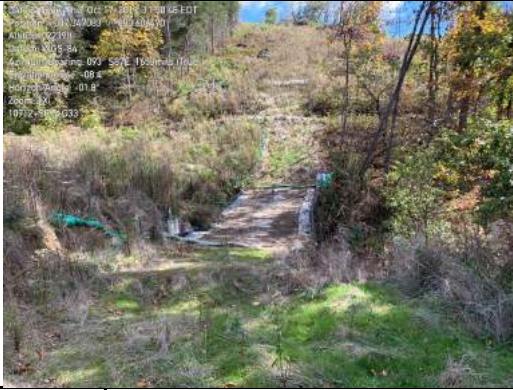
<b>GPS Location</b>	See photo for GPS location.		<b>GPS Location</b>	See photo for GPS location.	
<b>Field Station#</b>	12005+00		<b>Field Station#</b>	10712+50	
<b>Pic 1 Desc.</b>	Sock checks in bar ditch along access road 241.01.		<b>Pic 2 Desc.</b>	Sensitive resource buffer in place at stream S-G33.

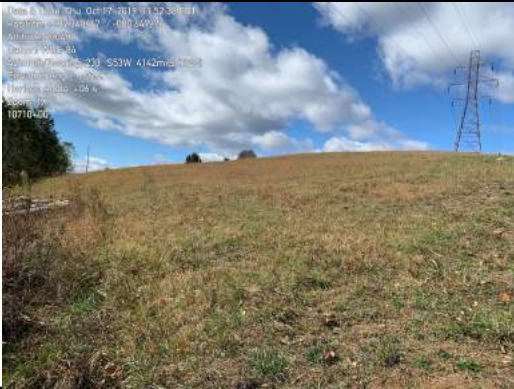
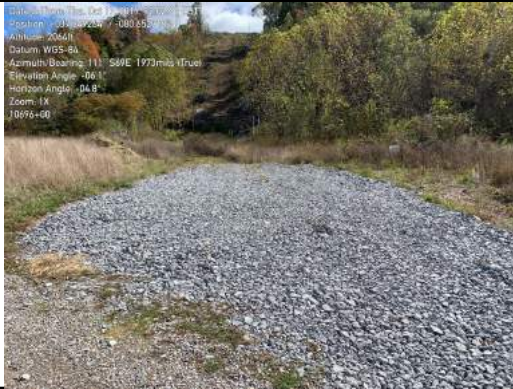
<b>GPS Location</b>	See photo for GPS location.		<b>GPS Location</b>	See photo for GPS location.	
<b>Field Station#</b>	10710+00		<b>Field Station#</b>	10696+00	
<b>Pic 3 Desc.</b>	ROW is stabilized with natural vegetation.		<b>Pic 4 Desc.</b>	RCE in place at buffalo anklets road to assist in the prevent of track out.

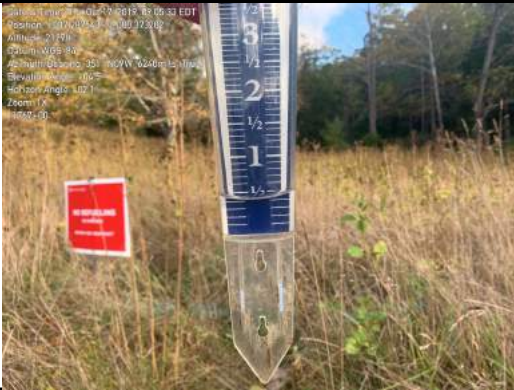
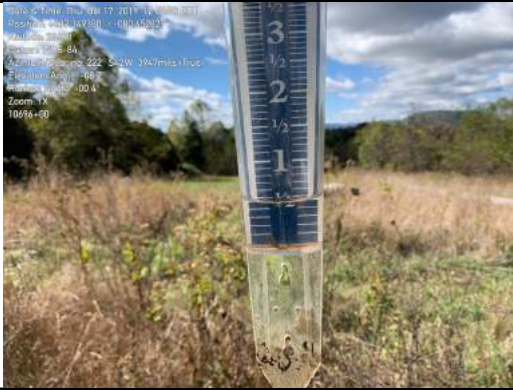
<b>Pic 5 Desc.</b>	Rain gauge at Mount Tabor Road read 0.5 inches.		<b>Pic 6 Desc.</b>	Rain gauge at Buffalo Anklets Road reads 0.5 inches.

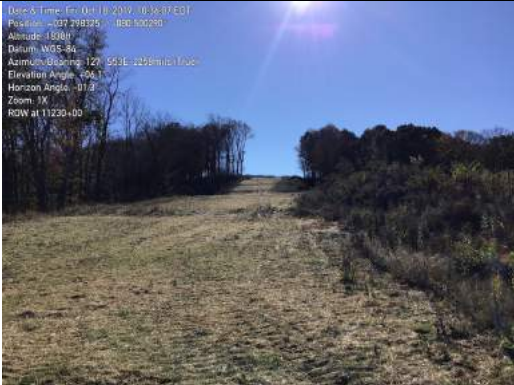
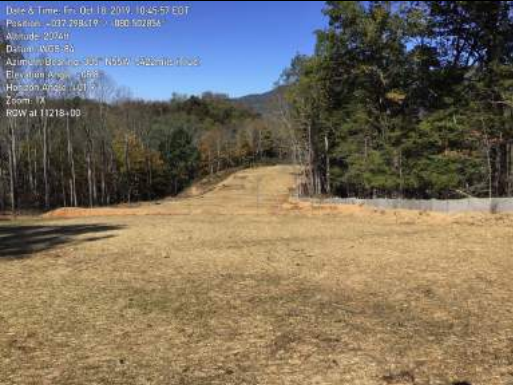
<b>GPS Location</b>	See photo		<b>GPS Location</b>	See photo	
<b>Field Station#</b>	11230+00		<b>Field Station#</b>	11218+00	
<b>Pic 1 Desc.</b>	Stabilized ROW, vegetation establishing		<b>Pic 2 Desc.</b>	Stabilized ROW, vegetation establishing

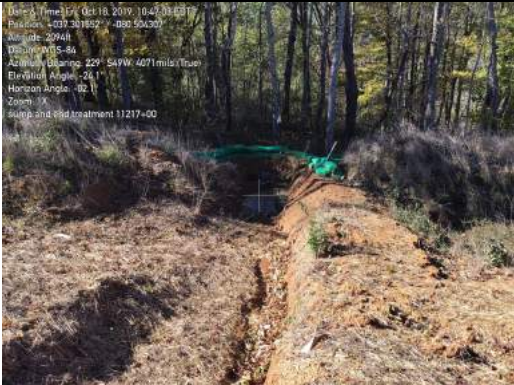
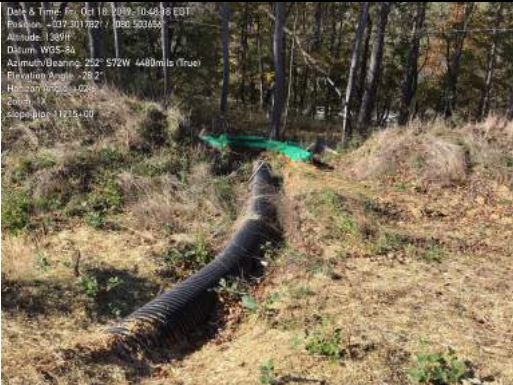
<b>GPS Location</b>	See photo		<b>GPS Location</b>	See photo	
<b>Field Station#</b>	11217+00		<b>Field Station#</b>	11215+00	
<b>Pic 3 Desc.</b>	Sump and end treatment.		<b>Pic 4 Desc.</b>	Slope pipe to sump at 11215+00

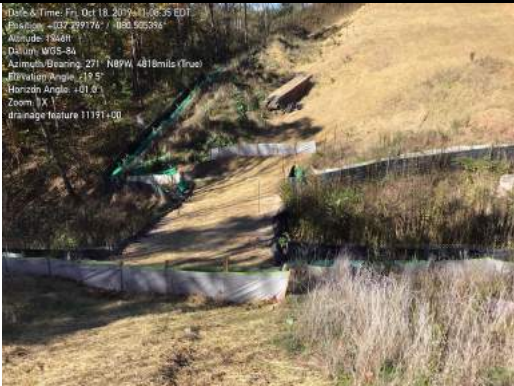
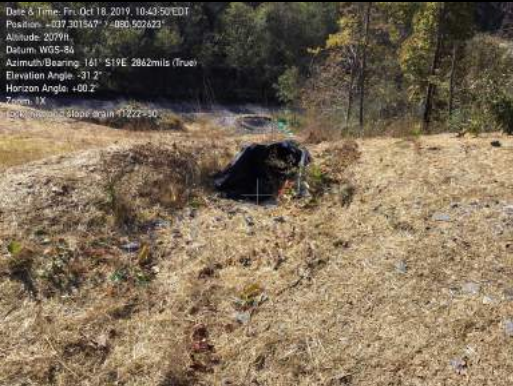
<b>GPS Location</b>	See photo		<b>GPS Location</b>	See photo	
<b>Field Station#</b>	11191+00		<b>Field Station#</b>	11222+50	
<b>Pic 5 Desc.</b>	Drainage feature, ECDs functional.		<b>Pic 6 Desc.</b>	Rock inlet into slope drain, no sediment build up.
