Visual Site Inspection Report

Project Name	H-600 Pipeline Spread G	AFE	124300137	Spread	H-600 Pipeline Spread
Contractor	Precision			Report #	4969
Inspector	Len Kruizenga			Date/Time	10/21/2019 7:03 AM
Permit #	TBD	Inspection Type	VA SWPP	Station Begin	11788+00
State	VA	Inspection Area	Full	Station End	12000+00
County	Giles	Ground	Muddy	Temperature (°F)	62.00
Municipality	N/A	Weather	Cloudy	Rain Gauge (in)	2.50
				Rain Accumulation Time (days)	1.00

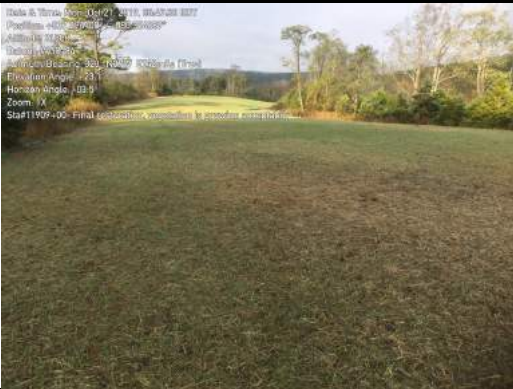
GPS Location	See photo GPS	GPS Location	See photo GPS		
Field Station#	11989+00	Field Station#	11809+00		
Pic 1 Desc.	Catawba rain gauge reading- 2.50"	Pic 2 Desc.	Final restoration vegetation growth is improving.

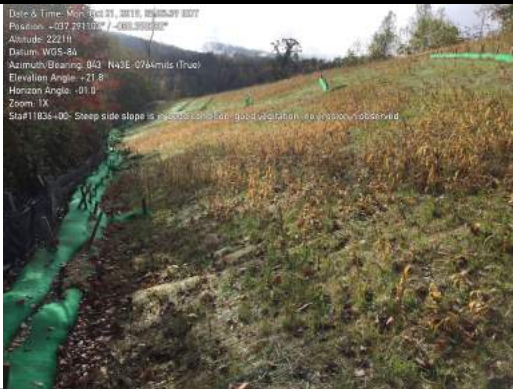
GPS Location	See photo GPS	GPS Location	See photo GPS		
Field Station#	11836+00	Field Station#	11872+00		
Pic 3 Desc.	Steep side slope is in good condition, vegetation improving.	Pic 4 Desc.	CFS controls damaged, fabric torn apart, assuming by bear.

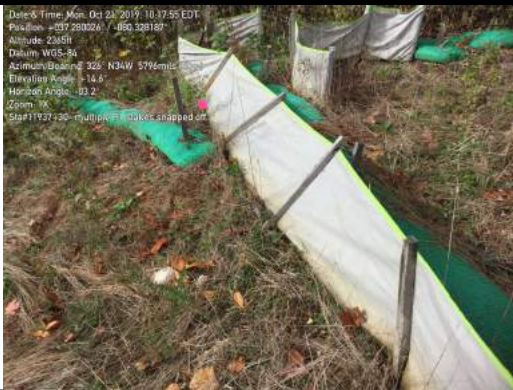
GPS Location	See photo GPS	GPS Location	See photo GPS		
Field Station#	11937+30	Field Station#	11977+00		
Pic 5 Desc.	P1 down, wooden stakes snapped off.	Pic 6 Desc.	Landowner damaged CFS perimeter controls.

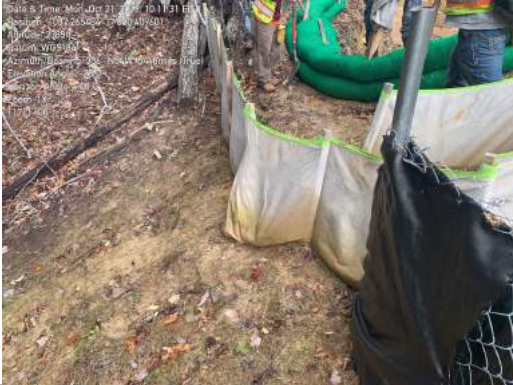
GPS Location	See photo for GPS location.		GPS Location	See photo for GPS location.	
Field Station#	11704+10		Field Station#	11711+00	
Pic 3 Desc.	Sensitive resource buffer in place at stream S-MN22.		Pic 4 Desc.	Priority one silt fence end treatment undermined.

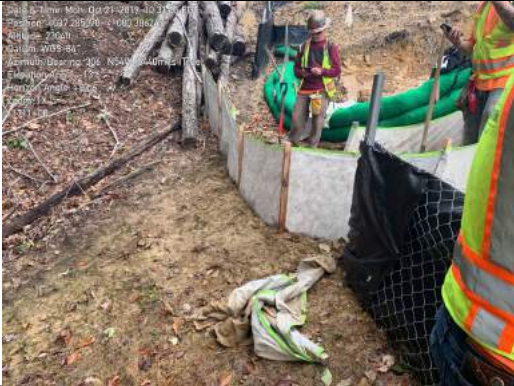
GPS Location	See photo for GPS location.		GPS Location	See photo for GPS location.	
Field Station#	11711+00		Field Station#	11767+00	
Pic 5 Desc.	Priority one silt fence end treatment replaced and retrenched.		Pic 6 Desc.	Rain gauge at Mount Tabor reads 2.4 inches.

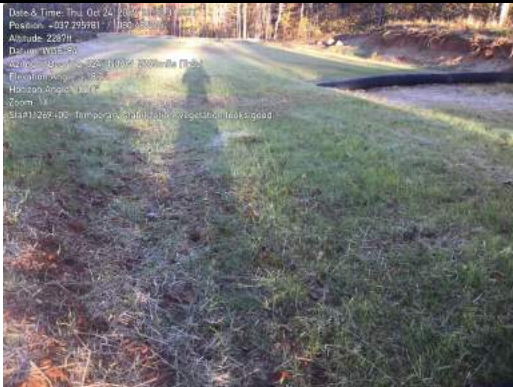
GPS Location	See photo GPS	GPS Location	See photo GPS		
Field Station#	11269+00	Field Station#	11282+00		
Pic 1 Desc.	Temporary stabilization vegetation looks good.	Pic 2 Desc.	Slope drain under cut, sump pit bank sloughed off, clean sump & install erosion blanket on banks.

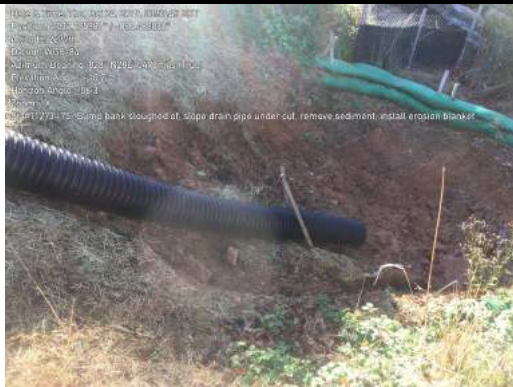
GPS Location	See photo GPS	GPS Location	See photo GPS		
Field Station#	11270+77	Field Station#	11273+75		
Pic 3 Desc.	Bank of sump pit have sloughed off into sump, remove sediment & install erosion blanket.	Pic 4 Desc.	Sump pit bank sloughed off, slope drain pipe under cut, remove sediment & install erosion blanket

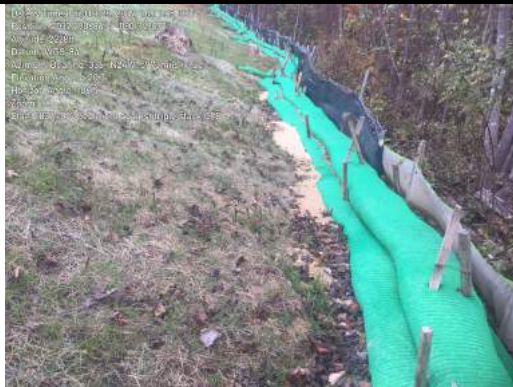
<p>Date & Time: Fri, Oct 25, 2019, 10:00:39 EDT Position: -037.291889° / -080.380927° Altitude: 2234ft Datum: WGS-84 Azimuth/Bearing: 036° N36E 0840mils (True) Elevation Angle: +26.8° Horizon Angle: -03.9° Zoom: 1X Sediment in front of CFS triple stack at the bottom of steep aide slope, no of row impact</p>

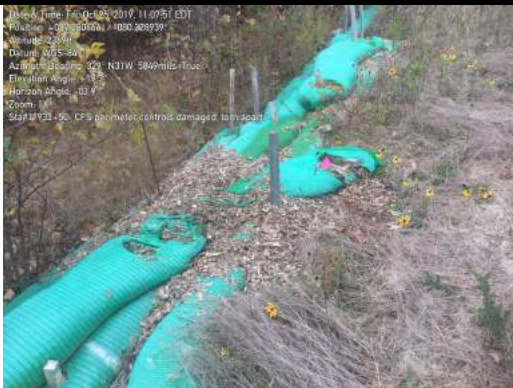
<p>Date & Time: Fri, Oct 25, 2019, 11:09:51 EDT Position: -037.300330° / -080.380927° Altitude: 2234ft Datum: WGS-84 Azimuth/Bearing: 323° N32W 3430mils (True) Elevation Angle: +19.0° Horizon Angle: -03.0° Zoom: 1X CFS perimeter controls damaged, torn apart</p>

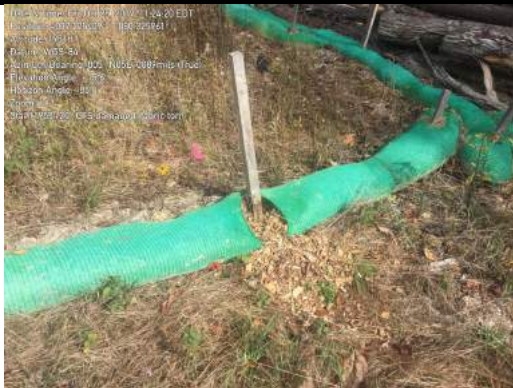
<p>Date & Time: Fri, Oct 25, 2019, 11:14:20 EDT Position: -037.300330° / -080.380927° Altitude: 2234ft Datum: WGS-84 Azimuth/Bearing: 002° N00E 0089mils (True) Elevation Angle: +19.0° Horizon Angle: -03.0° Zoom: 1X CFS damaged, fabric torn</p>			
GPS Location	See photo GPS		GPS Location	See photo GPS	
Field Station#	11933+50		Field Station#	11955+20	
Pic 5 Desc.	CFS perimeter controls are damaged, torn apart.		Pic 6 Desc.	CFS damaged, fabric torn.

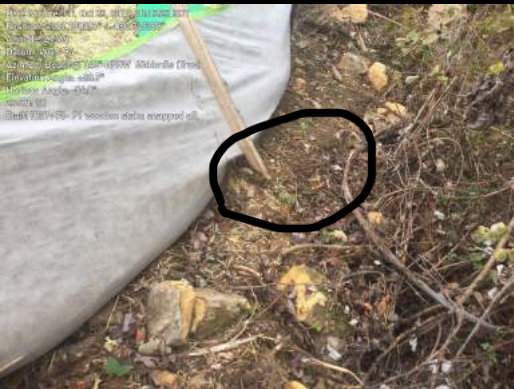
GPS Location		See photo GPS						GPS Location		See photo GPS	
Field Station#		11837+75						Field Station#		12001+00	
Pic 7 Desc.		P1 silt fence perimeter controls, wooden stake snapped off.						Pic 8 Desc.		Wetland ECD's at spread G & H spread break are in acceptable condition.	
Insert image here						Insert image here					
GPS Location								GPS Location			
Field Station#								Field Station#			
Pic 9 Desc.								Pic 10 Desc.			
Insert image here						Insert image here					
GPS Location								GPS Location			
Field Station#								Field Station#			
Pic 11 Desc.								Pic 12 Desc.
