## Visual Site Inspection Report

<b>Project Name</b>	H-600 Pipeline Spread G	<b>AFE</b>	124300137	<b>Spread</b>	H-600 Pipeline Spread G
<b>Contractor</b>	Precision			<b>Report #</b>	5251
<b>Inspector</b>	Len Kruizenga			<b>Date/Time</b>	10/28/2019 8:13 AM
<b>Permit #</b>	TBD	<b>Inspection Type</b>	VA SWPP	<b>Station Begin</b>	12005+00
<b>State</b>	VA	<b>Inspection Area</b>	Full	<b>Station End</b>	12005+00
<b>County</b>	Giles	<b>Ground</b>	Wet	<b>Temperature (°F)</b>	62.00
<b>Municipality</b>	N/A	<b>Weather</b>	Cloudy	<b>Rain Gauge (in)</b>	0.60
				<b>Rain Accumulation Time (days)</b>	2.00

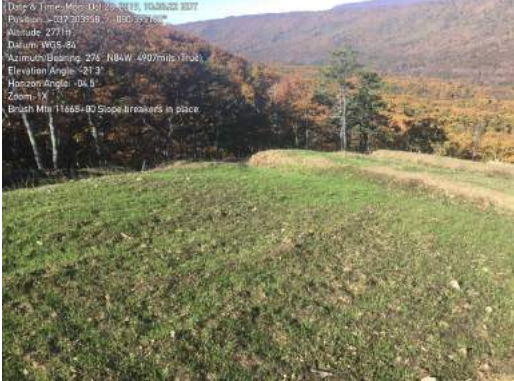
<p>Date &amp; Time: Mon, Oct 28, 2019, 1:16:22 EDT Position: +037.373940, -082.971632 Altitude: 2771 ft Datum: WGS-84 Azimuth/Bearing: 276° N84W 4907mils (true) Elevation Angle: -21.3° Horizon Angle: -06.5° Zoom: IX Brush Mtn 11665+00 Slope breakers in place</p>

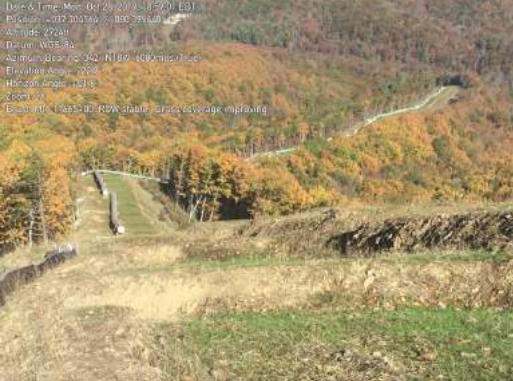
<p>Date &amp; Time: Mon, Oct 28, 2019, 1:16:20 EDT Position: +037.373940, -082.971632 Altitude: 2771 ft Datum: WGS-84 Azimuth/Bearing: 276° N84W 4907mils (true) Elevation Angle: -21.3° Horizon Angle: -06.5° Zoom: IX Brush Mtn 11665+00 ROW stable, grass coverage improving</p>			
<b>GPS Location</b>	On photo	<b>GPS Location</b>	On photo		
<b>Field Station#</b>	11668+00	<b>Field Station#</b>	11665+00		
<b>Pic 1 Desc.</b>	Slope breakers are in place.	<b>Pic 2 Desc.</b>	Slope breakers are in place and functional. Grasses are growing. ROW stable.

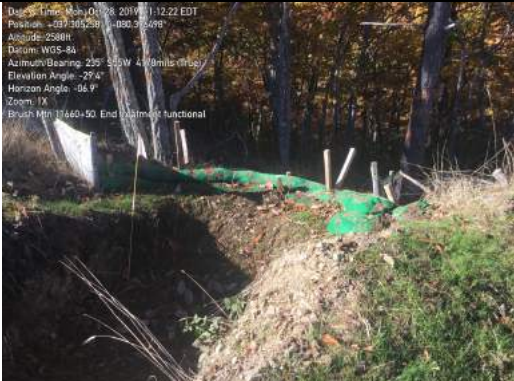
<p>Date &amp; Time: Mon, Oct 28, 2019, 11:12:22 EDT Position: +037.381220, -082.971632 Altitude: 2586 ft Datum: WGS-84 Azimuth/Bearing: 228° S55W 4770mils (true) Elevation Angle: -29.4° Horizon Angle: -06.9° Zoom: IX Brush Mtn 11660+50 End treatment functional</p>

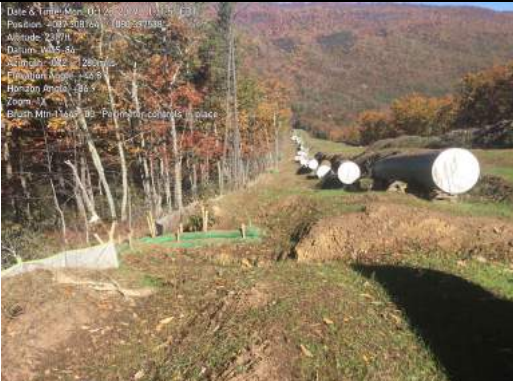
<p>Date &amp; Time: Mon, Oct 28, 2019, 11:11:43 EDT Position: +037.381660, -082.971632 Altitude: 2597 ft Datum: WGS-84 Azimuth/Bearing: 228° S55W 4770mils (true) Elevation Angle: -29.4° Horizon Angle: -06.9° Zoom: IX Brush Mtn 11649+00 Perimeter controls in place</p>			
<b>GPS Location</b>	On photo	<b>GPS Location</b>	On photo		
<b>Field Station#</b>	11660+50	<b>Field Station#</b>	11649+00		
<b>Pic 3 Desc.</b>	End treatments were found in place and functional	<b>Pic 4 Desc.</b>	Perimeter controls are in place and functioning

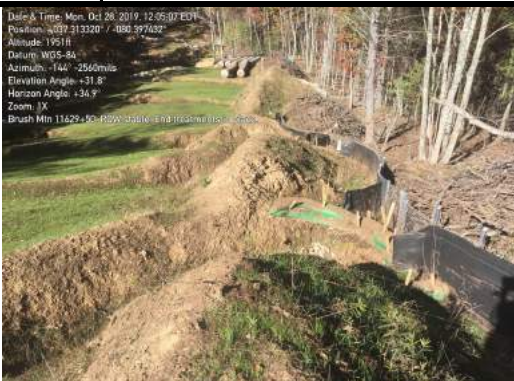
<p>Date &amp; Time: Mon, Oct 28, 2019, 12:05:07 EDT Position: +037.313220, -082.977632 Altitude: 1951 ft Datum: WGS-84 Azimuth/Bearing: 144° S56W 2560mils Elevation Angle: +31.8° Horizon Angle: +34.9° Zoom: IX Brush Mtn 11629+50 S-HH18 crossing is functional</p>

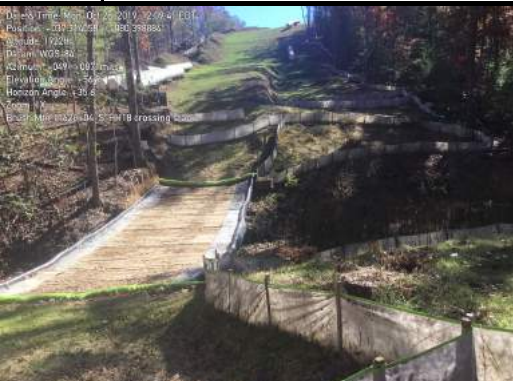
<p>Date &amp; Time: Mon, Oct 28, 2019, 12:04:41 EDT Position: +037.313220, -082.977632 Altitude: 1924 ft Datum: WGS-84 Azimuth/Bearing: 144° S56W 2560mils Elevation Angle: +31.8° Horizon Angle: +34.9° Zoom: IX Brush Mtn 11626+04 S-HH18 crossing is stable</p>

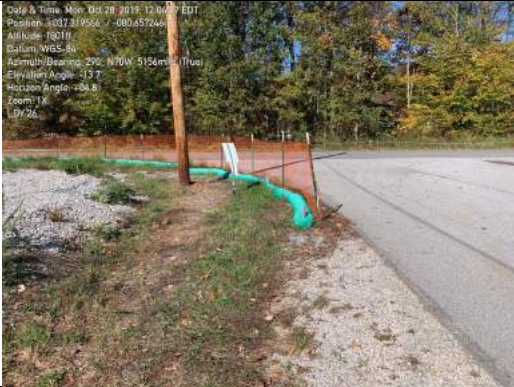
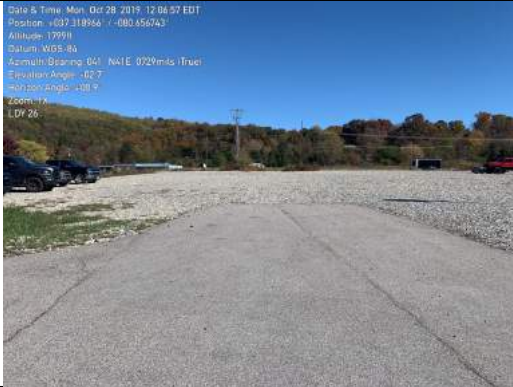
<b>GPS Location</b>	See photo for GPS location.		<b>GPS Location</b>	See photo for GPS location.	
<b>Field Station#</b>	12005+00		<b>Field Station#</b>	12005+00	
<b>Pic 1 Desc.</b>	18 inch compost filter sock in place.		<b>Pic 2 Desc.</b>	RCE in place at employee parking lot entrance to assist with track out prevention.

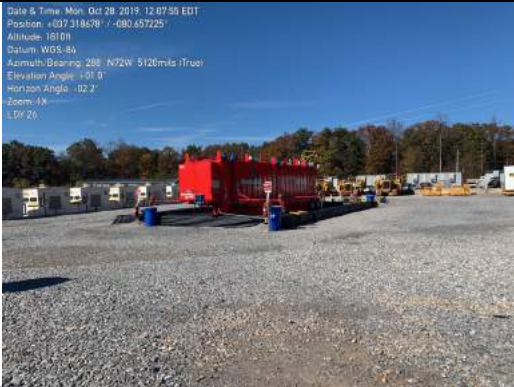
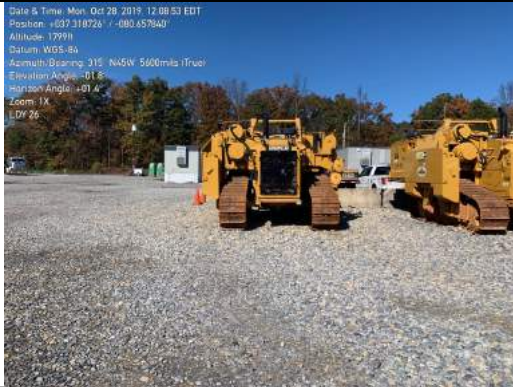
<b>GPS Location</b>	See photo for GPS location.		<b>GPS Location</b>	See photo for GPS location.	
<b>Field Station#</b>	12005+00		<b>Field Station#</b>	12005+00	
<b>Pic 3 Desc.</b>	Secondary containment in place under fuel cell.		<b>Pic 4 Desc.</b>	No leaks observed under staged equipment.

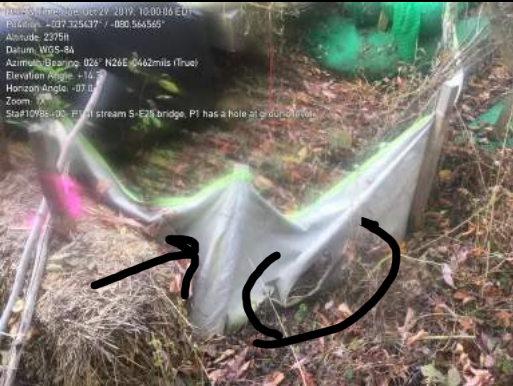
<p>Date &amp; Time: Tue Oct 29 2019 10:50:06 EDT Position: 43.07325437 / -83.054569 Altitude: 2275ft Datum: WGS-84 Azimuth/Bearing: 026° N26E 6462mils (True) Elevation Angle: +14.3° Horizon Angle: -07.0° Zoom: IX Sta#10986+00- P1 silt Stream S-E25 bridge, P1 has a hole at ground level.</p>

<b>GPS Location</b>	See photo GPS		<b>GPS Location</b>	See photo GPS	
<b>Field Station#</b>	10986+00		<b>Field Station#</b>	10986+00	
<b>Pic 5 Desc.</b>	Stream S-E24- Equipment bridge, ECD's, sensitive resource signage, buffers are in acceptable condition.		<b>Pic 6 Desc.</b>	Stream S-E25 P1 has hole in fabric at ground level.

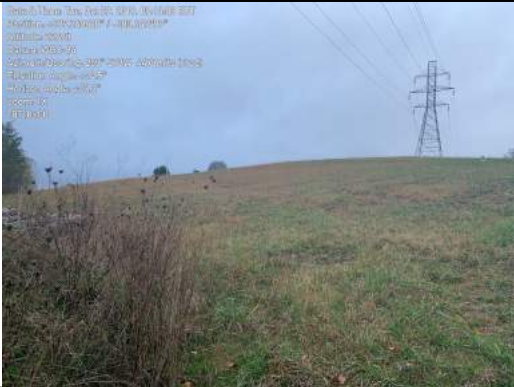
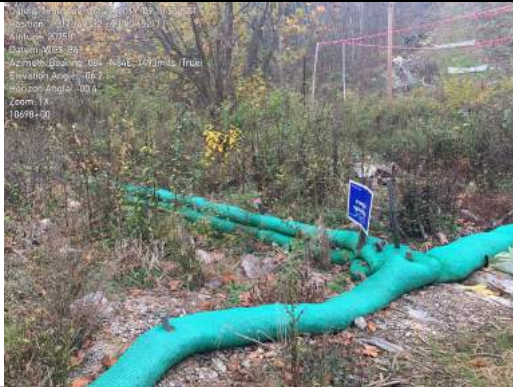
<b>GPS Location</b>	See photo for GPS location.		<b>GPS Location</b>	See photo for GPS location.	
<b>Field Station#</b>	10710+00		<b>Field Station#</b>	10698+00	
<b>Pic 3 Desc.</b>	ROW stabilized with natural vegetation.		<b>Pic 4 Desc.</b>	triple stack CFS in place at sensitive resource buffer for stream S-G32.

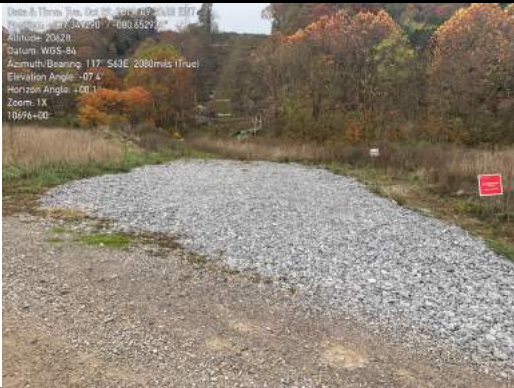
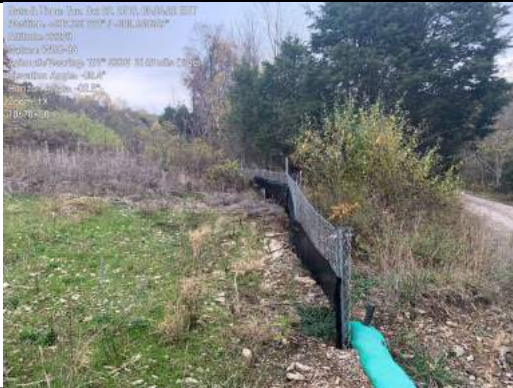
<b>GPS Location</b>	See photo for GPS location.		<b>GPS Location</b>	See photo for GPS location.	
<b>Field Station#</b>	10696+00		<b>Field Station#</b>	10670+00	
<b>Pic 5 Desc.</b>	RCE in place at Buffalo Anklets Road.		<b>Pic 6 Desc.</b>	Reinforced super silt fence in place along LOD.

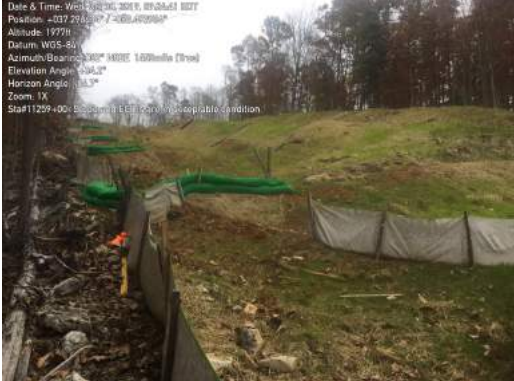
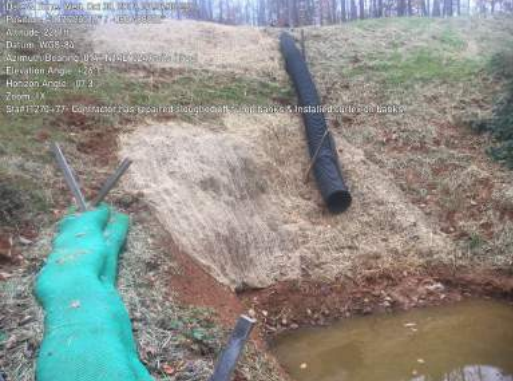
<b>GPS Location</b>	See photo GPS		<b>GPS Location</b>	See photo GPS	
<b>Field Station#</b>	11259+00		<b>Field Station#</b>	11270+77	
<b>Pic 1 Desc.</b>	Slope and ECD's are in acceptable condition.		<b>Pic 2 Desc.</b>	Contractor has cleaned sump repaired sloughed off banks & installed cur-lex on sump banks.

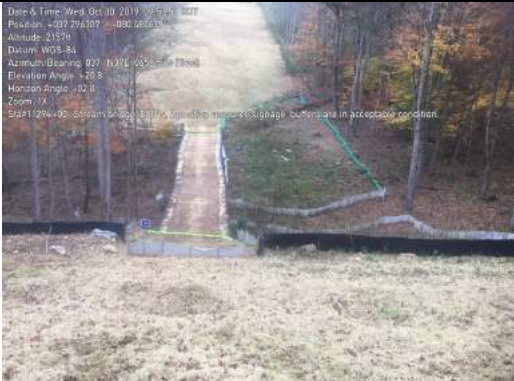
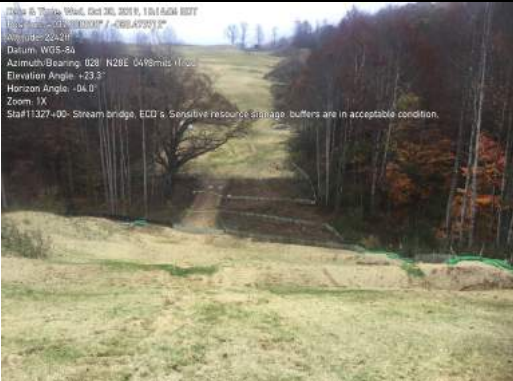
<b>GPS Location</b>	See photo GPS		<b>GPS Location</b>	See photo GPS	
<b>Field Station#</b>	11294+00		<b>Field Station#</b>	11327+00	
<b>Pic 3 Desc.</b>	Stream bridge, buffers, ECD's, sensitive resource signage are in acceptable condition.		<b>Pic 4 Desc.</b>	Stream ECD's bridge, buffers, sensitive resource signage are in acceptable condition.

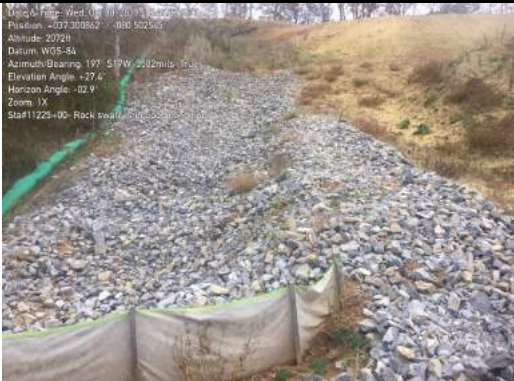
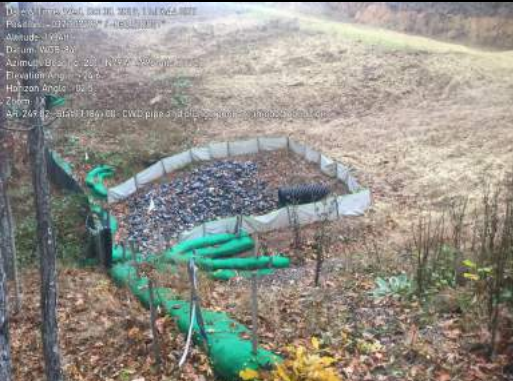
<b>Pic 5 Desc.</b>	Rock swale is in good condition.		<b>Pic 6 Desc.</b>	CWD pipe and plunge pool are in good condition.

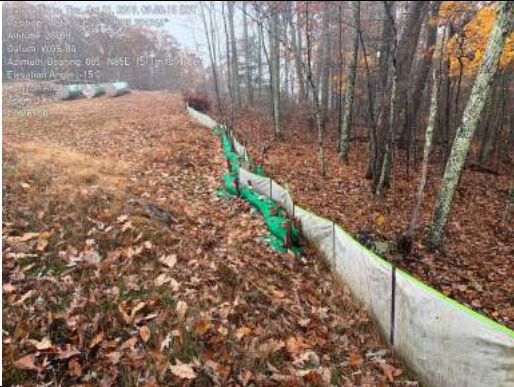
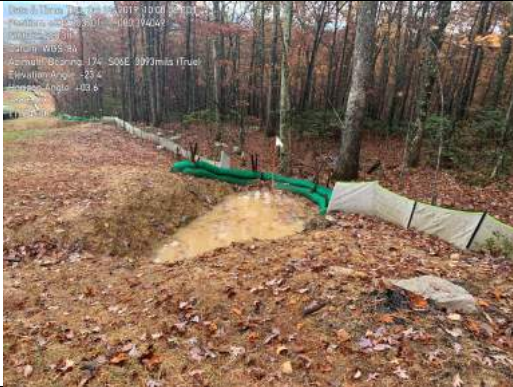
<b>GPS Location</b>	See photo for GPS location.		<b>GPS Location</b>	See photo for GPS location.	
<b>Field Station#</b>	11670+00		<b>Field Station#</b>	11674+00	
<b>Pic 1 Desc.</b>	Triple stack compost filter sock with priority one silt fence installed along LOD.		<b>Pic 2 Desc.</b>	Waterbar, sump pit, and triple stack compost filter sock end treatment in place.

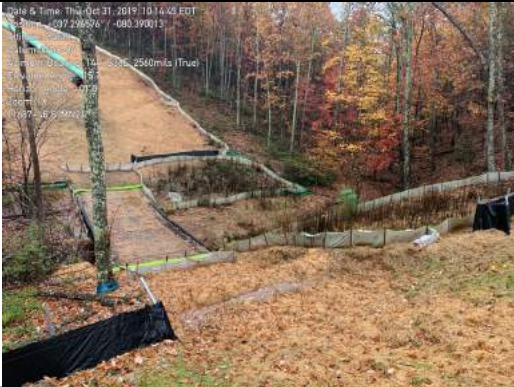
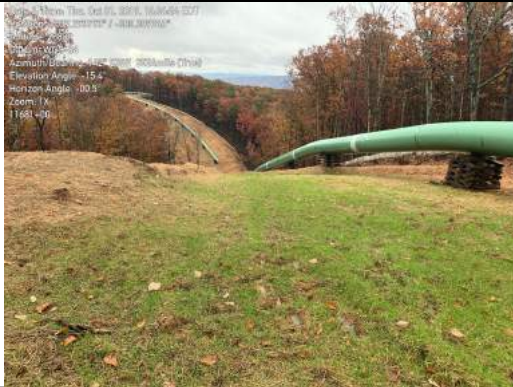
<b>GPS Location</b>	See photo for GPS location.		<b>GPS Location</b>	See photo for GPS location.	
<b>Field Station#</b>	11687+40		<b>Field Station#</b>	11681+00	
<b>Pic 3 Desc.</b>	Sensitive resource buffer in place at stream S-MN21.		<b>Pic 4 Desc.</b>	ROW stabilized with seed and mulch. Minor vegetation growth present.

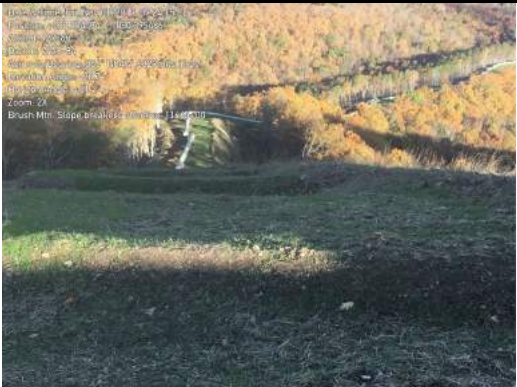
<p>Date &amp; Time: Nov 01, 2019 02:13 PM Position: 43.1310222 / -80.399107 Altitude: 2490 ft Datum: WGS84 Azimuth Bearing: 202.542W 354 mps True Elevation Angle: -16.0 Horizon Angle: -35.5 Zoom: 24 Brush Mtn. EOCs in place 11665+00</p>

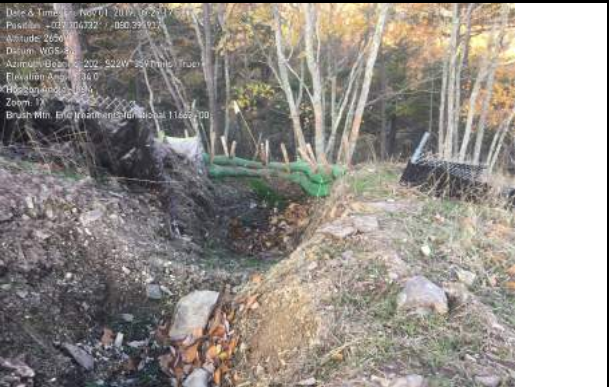
<p>Date &amp; Time: Nov 01, 2019 02:13 PM Position: 43.1310222 / -80.399107 Altitude: 2490 ft Datum: WGS84 Azimuth Bearing: 202.542W 354 mps True Elevation Angle: -16.0 Horizon Angle: -35.5 Zoom: 24 Brush Mtn. EOCs in place 11665+00</p>
GPS Location	On photo		GPS Location	On photo	
Field Station#	11665+00		Field Station#	11663+00	
Pic 1 Desc.	Slope breakers performing as designed		Pic 2 Desc.	Sumps and end treatments are working as designed

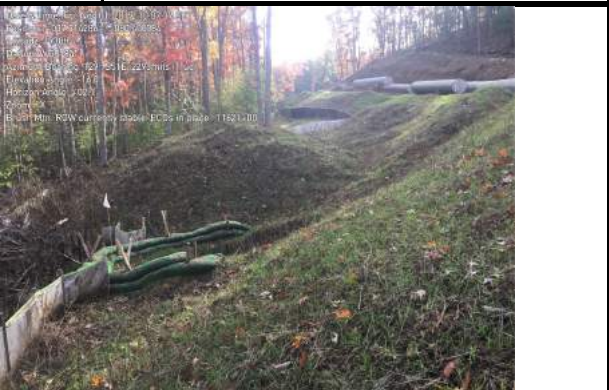
<p>Date &amp; Time: Nov 01, 2019 02:13 PM Position: 43.1310222 / -80.399107 Altitude: 2490 ft Datum: WGS84 Azimuth Bearing: 202.542W 354 mps True Elevation Angle: -16.0 Horizon Angle: -35.5 Zoom: 24 Brush Mtn. EOCs in place 11662+00</p>
GPS Location	On photo		GPS Location	On photo	
Field Station#	11628+00		Field Station#	11621+00	
Pic 5 Desc.	Perimeter controls are functional		Pic 6 Desc.	Perimeter controls are in place and functioning

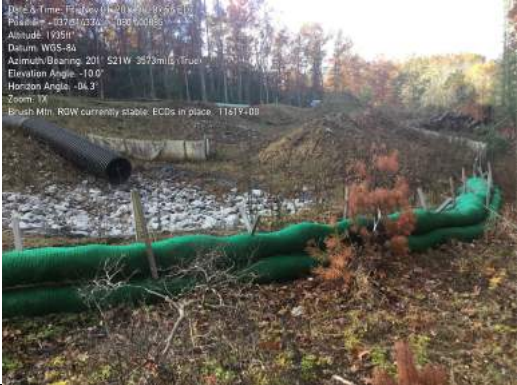
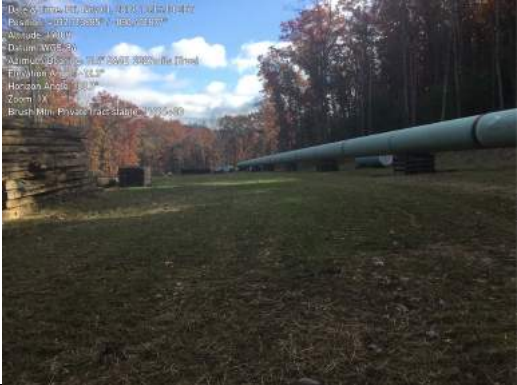
<b>GPS Location</b>	On photo	<b>GPS Location</b>	On photo		
<b>Field Station#</b>	11619+00	<b>Field Station#</b>	11616+00		
<b>Pic 7 Desc.</b>	Plunge pool and perimeter controls in good condition	<b>Pic 8 Desc.</b>	Grasses and straw mulch prevent movement of sediment on private tract

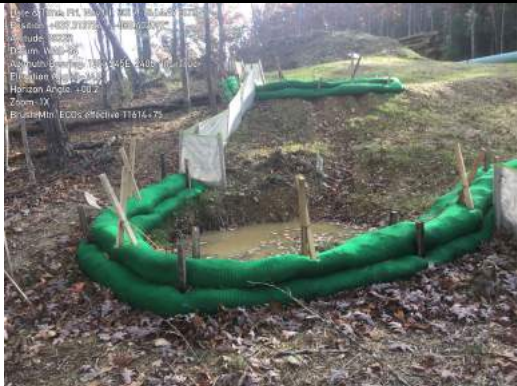
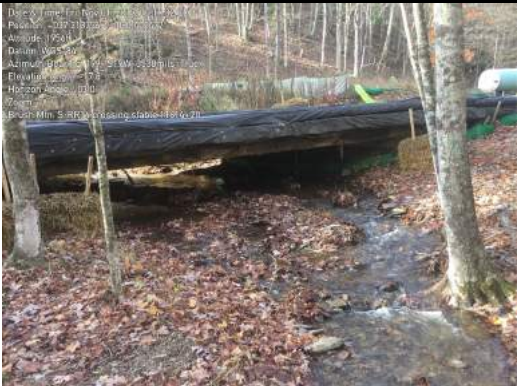
<b>GPS Location</b>	On photo	<b>GPS Location</b>	On photo		
<b>Field Station#</b>	11614+75	<b>Field Station#</b>	11614+20		
<b>Pic 9 Desc.</b>	Perimeter controls effective.	<b>Pic 10 Desc.</b>	No apparent impact at the S-RR14 crossing.

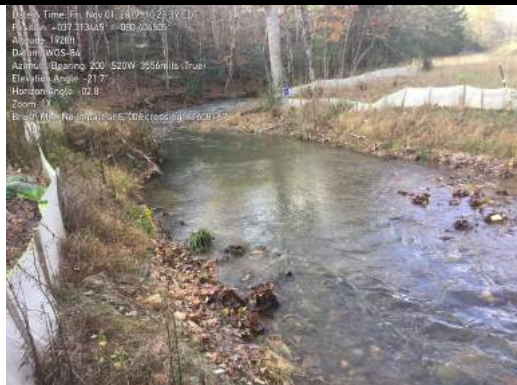
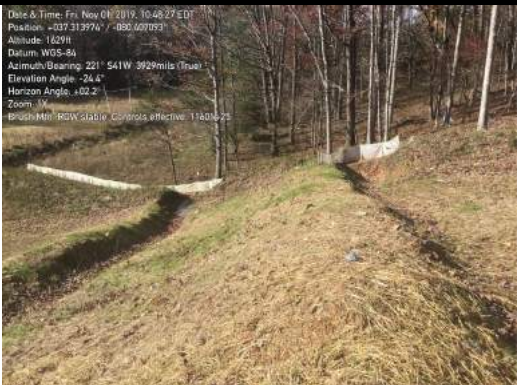
<b>GPS Location</b>	On photo	<b>GPS Location</b>	On photo		
<b>Field Station#</b>	11608+17	<b>Field Station#</b>	11601+25		
<b>Pic 11 Desc.</b>	No resource impact apparent at the S-006 crossing.	<b>Pic 12 Desc.</b>	Perimeter controls in place and functioning. ROW currently stable.
