# Visual Site Inspection Report

<b>Project Name</b>	H-600 Pipeline Spread G	<b>AFE</b>	124300137	<b>Spread</b>	H-600 Pipeline Spread
<b>Contractor</b>	Precision			<b>Report #</b>	101989
<b>Inspector</b>	Garrett Barclay			<b>Date/Time</b>	10/7/2019 7:56 AM
<b>Permit #</b>	TBD	<b>Inspection Type</b>	VA SWPP	<b>Station Begin</b>	10840+00
<b>State</b>	VA	<b>Inspection Area</b>	Partial	<b>Station End</b>	10930+00
<b>County</b>	Giles	<b>Ground</b>	Dry	<b>Temperature (°F)</b>	62.00
<b>Municipality</b>	N/A	<b>Weather</b>	Sunny	<b>Rain Gauge (in)</b>	0.00
				<b>Rain Accumulation Time (days)</b>	1.00

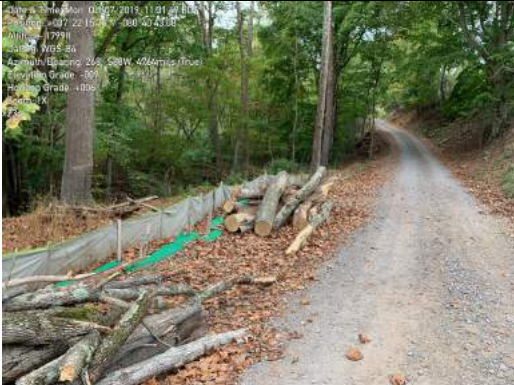
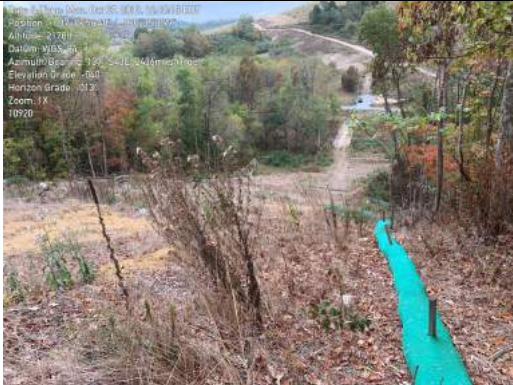
<b>GPS Location</b>	See picture above for GPS coordinates		<b>GPS Location</b>	See picture above for GPS coordinates	
<b>Field Station#</b>	2+34		<b>Field Station#</b>	10820+00	
<b>Pic 1 Desc.</b>	ECD's and row conditions		<b>Pic 2 Desc.</b>	ECD's and row conditions

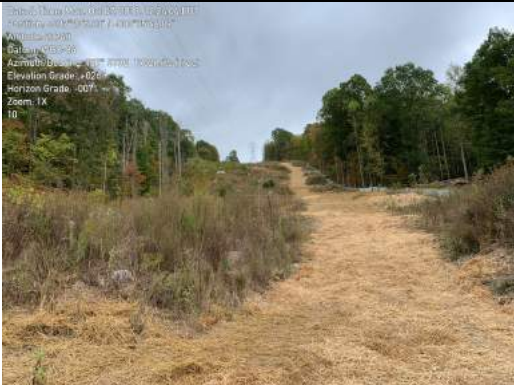
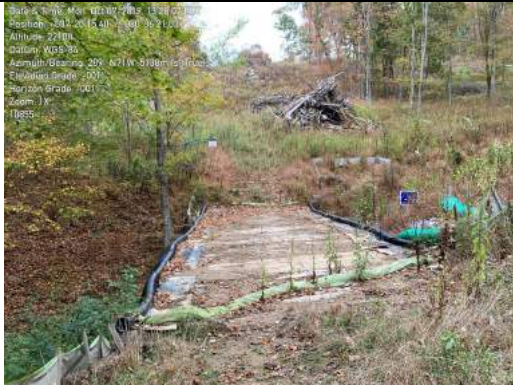
<b>GPS Location</b>	See picture above for GPS coordinates		<b>GPS Location</b>	See picture above for GPS coordinates	
<b>Field Station#</b>	10910+00		<b>Field Station#</b>	10855+00	
<b>Pic 3 Desc.</b>	ECD's and row conditions		<b>Pic 4 Desc.</b>	ECD's and row conditions

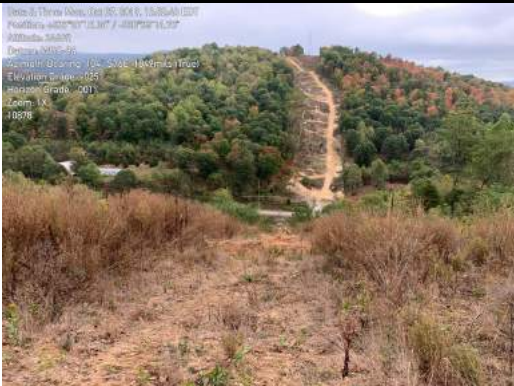
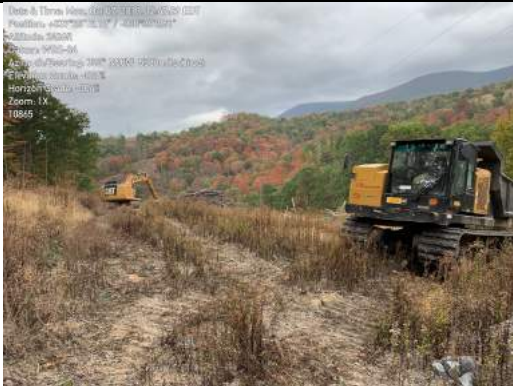
<b>GPS Location</b>	See picture above for GPS coordinates		<b>GPS Location</b>	See picture above for GPS coordinates	
<b>Field Station#</b>	10878+00		<b>Field Station#</b>	10865+00	
<b>Pic 5 Desc.</b>	Crews dressing up water bars in preparation for stabilization		<b>Pic 6 Desc.</b>	Crews dressing up travel lane in preparation of stabilization

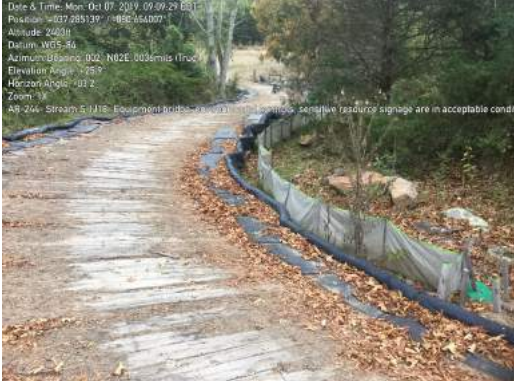
<p>Date &amp; Time: Mon Oct 07 2019 09:09:29 EDT Position: -037.285137 / -68.164077 Altitude: 2950ft Datum: WGS-84 Azimuth Bearing: 002° N28E 303mils (True) Elevation Angle: +23.9° Horizon Angle: -02.4° Zoom: IX Sta#11015+00 Stream S-IJ18- Equipment bridge, buffers, sensitive resource signage are in acceptable condition.</p>

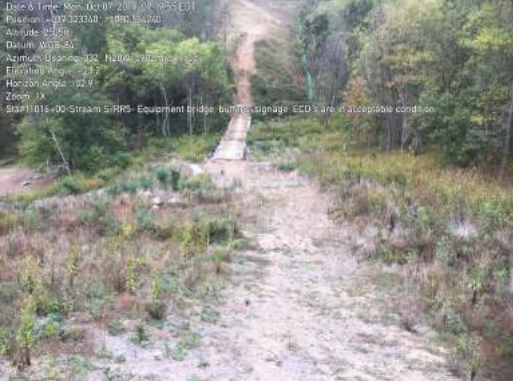
<p>Date &amp; Time: Mon Oct 07 2019 09:25:01 EDT Position: -037.322348 / -68.164201 Altitude: 2951ft Datum: WGS-84 Azimuth Bearing: 002° N28W 300mils (True) Elevation Angle: +23.9° Horizon Angle: -02.4° Zoom: IX Sta#11015+00 Stream S-RR5- Equipment bridge, buffers, sensitive resource signage are in acceptable condition.</p>			
<b>GPS Location</b>	See photo GPS		<b>GPS Location</b>	See photo GPS	
<b>Field Station#</b>	11022+00		<b>Field Station#</b>	11016+00	
<b>Pic 1 Desc.</b>	Stream S-IJ18- Environmental controls, sensitive resource signage, equipment bridge, are in acceptable condition.		<b>Pic 2 Desc.</b>	Stream S-RR5- Equipment bridge, Environmental controls, buffers, sensitive resource signage are in acceptable condition.

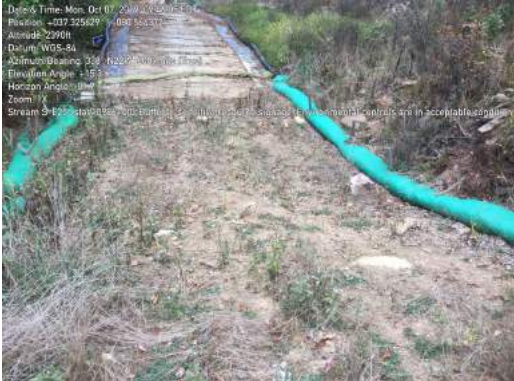
<p>Date &amp; Time: Mon Oct 07 2019 09:51:01 EDT Position: -037.325629 / -68.164312 Altitude: 2960ft Datum: WGS-84 Azimuth Bearing: 002° N28W 303mils (True) Elevation Angle: +15.3° Horizon Angle: -03.7° Zoom: IX Stream S-E25- Sensitive resource signage, ECD's, equipment bridge are in acceptable condition.</p>

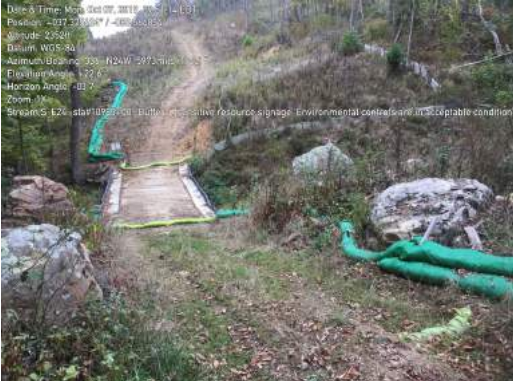
<p>Date &amp; Time: Mon Oct 07 2019 09:51:01 EDT Position: -037.325629 / -68.164312 Altitude: 2960ft Datum: WGS-84 Azimuth Bearing: 002° N28W 303mils (True) Elevation Angle: +15.3° Horizon Angle: -03.7° Zoom: IX Stream S-E24- Sensitive resource signage, environmental controls, equipment bridge, buffers are in acceptable condition.</p>			
<b>GPS Location</b>	See photo GPS		<b>GPS Location</b>	See photo GPS	
<b>Field Station#</b>	10986+00		<b>Field Station#</b>	10985+00	
<b>Pic 3 Desc.</b>	Stream S-E25- Sensitive resource signage, buffers, ECD's, equipment bridge are in acceptable condition.		<b>Pic 4 Desc.</b>	Stream S-E24- Sensitive resource signage, environmental controls, equipment bridge, buffers are in acceptable condition.

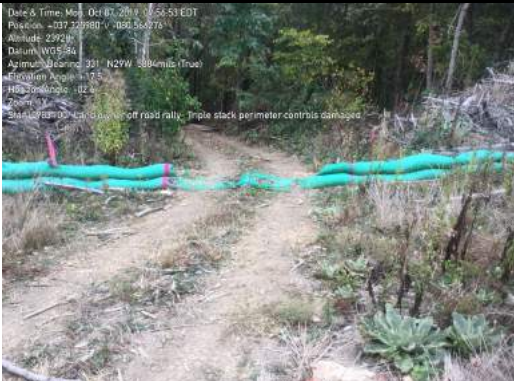
<p>Date &amp; Time: Mon Oct 07 2019 10:56:51 EDT Position: -037.327880 / -68.164278 Altitude: 2990ft Datum: WGS-84 Azimuth Bearing: 331° N29W 309mils (True) Elevation Angle: +17.5° Horizon Angle: -02.5° Zoom: IX Sta#10986+00 Landowner off road rally- Triple stack perimeter controls damaged.</p>

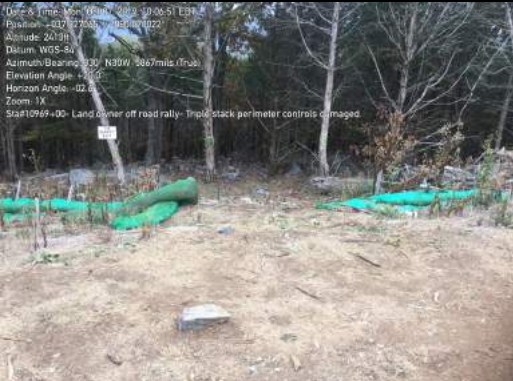
<p>Date &amp; Time: Mon Oct 07 2019 10:56:51 EDT Position: -037.327880 / -68.164278 Altitude: 2990ft Datum: WGS-84 Azimuth Bearing: 330° N30W 306mils (True) Elevation Angle: +17.5° Horizon Angle: -02.5° Zoom: IX Sta#10969+00 Landowner off road rally- Triple stack perimeter controls damaged.</p>			
<b>GPS Location</b>	See photo GPS		<b>GPS Location</b>	See photo GPS	
<b>Field Station#</b>	10983+00		<b>Field Station#</b>	10969+00	
<b>Pic 5 Desc.</b>	Landowner off road rally has caused damaged to triple stack perimeter controls.		<b>Pic 6 Desc.</b>	Sta#10969+00- Landowner off road rally- CFS perimeter controls pulled back & damaged.

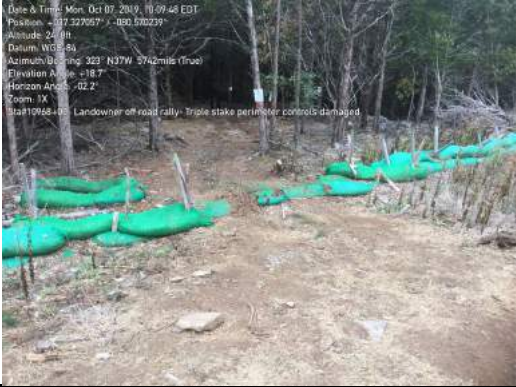
<p><small>Date &amp; Time Mon, Oct 07, 2019, 10:09:48 EDT Position: -107.327959° / -39.030239° Altitude: 24 ft Datum: WGS-84 Azimuth Bearing: 323° N37W 5742mils (true) Declination Angle: +18.7° Horizon Angle: -02.2° Zoom: 1X Size: 10968495 Landowner off road rally - Triple stake perimeter controls damaged</small></p>

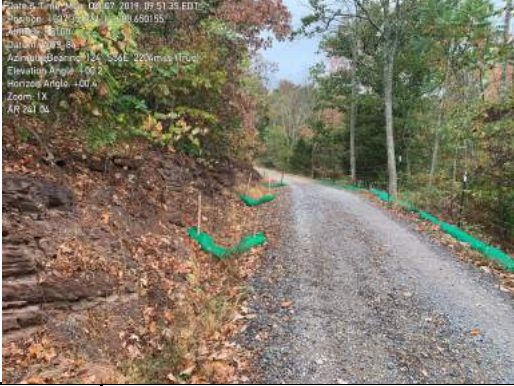
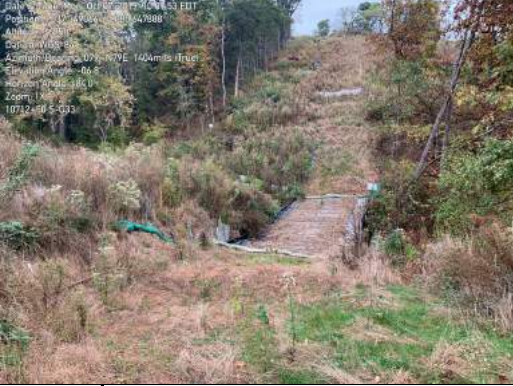
<b>GPS Location</b>	See photo for GPS location.		<b>GPS Location</b>	See photo for GPS location.	
<b>Field Station#</b>	12005+00		<b>Field Station#</b>	10712+50	
<b>Pic 1 Desc.</b>	Compost filter sock checks in place along access road 241.04 bar ditch.		<b>Pic 2 Desc.</b>	Sensitive resource buffer in place at stream S-G33.

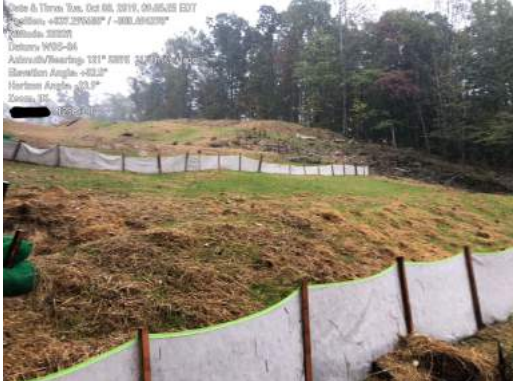
GPS Location	1	GPS Location	2		
Field Station#	11258+00	Field Station#	11264+00		
Pic 1 Desc.	Temporary stabilization.	Pic 2 Desc.	Temporary stabilization.

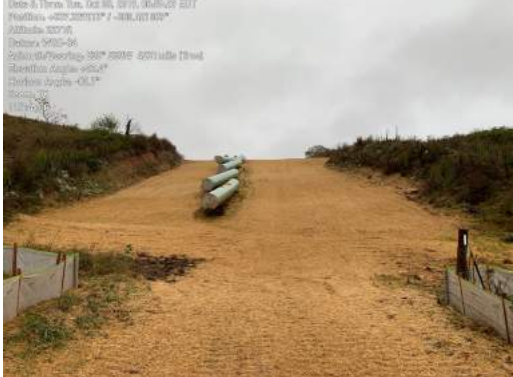
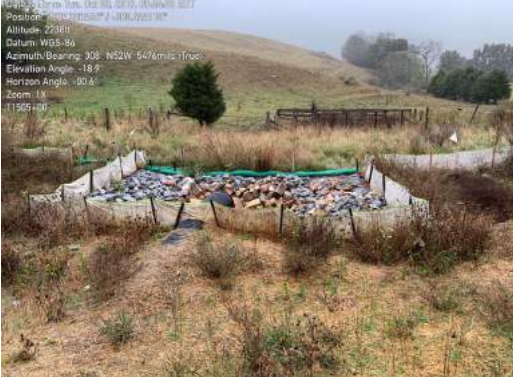
GPS Location	See photo for GPS location.		GPS Location	See photo for GPS location.	
Field Station#	11514+00		Field Station#	11505+00	
Pic 1 Desc.	ROW has been stabilized with seed and mulch. Waterbars in place.		Pic 2 Desc.	Plunge pool in place.

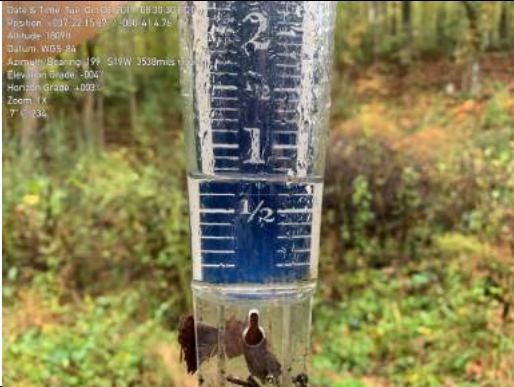
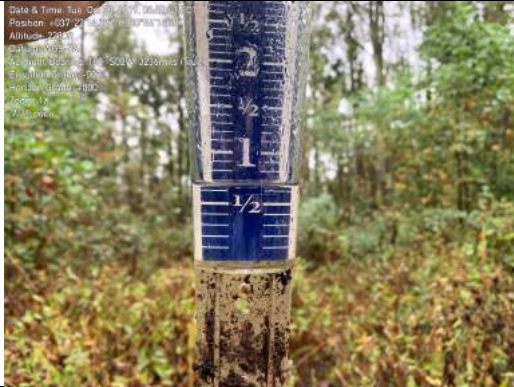
<b>GPS Location</b>	See picture above for GPS coordinates		<b>GPS Location</b>	See picture above for GPS coordinates	
<b>Field Station#</b>	2+34		<b>Field Station#</b>	+1	
<b>Pic 1 Desc.</b>	.7" of rain recorded @ AR 234		<b>Pic 2 Desc.</b>	.7" of rain recorded @ AR Pocahontas

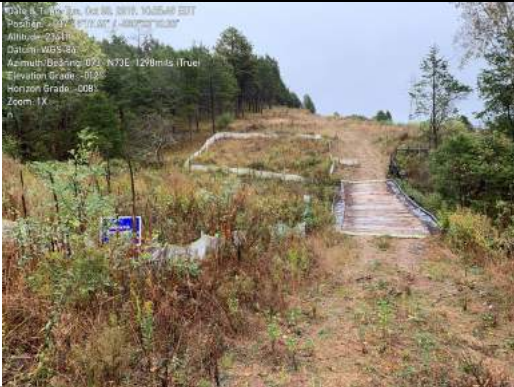
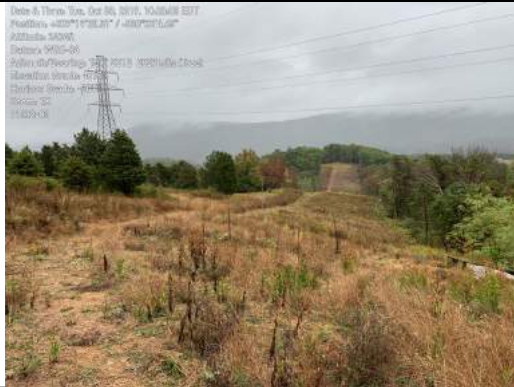
<b>GPS Location</b>	See picture above for GPS coordinates		<b>GPS Location</b>	See picture above for GPS coordinates	
<b>Field Station#</b>	11025+00		<b>Field Station#</b>	11035+00	
<b>Pic 3 Desc.</b>	ECD's and row conditions S-IJ18		<b>Pic 4 Desc.</b>	ECD's and row conditions

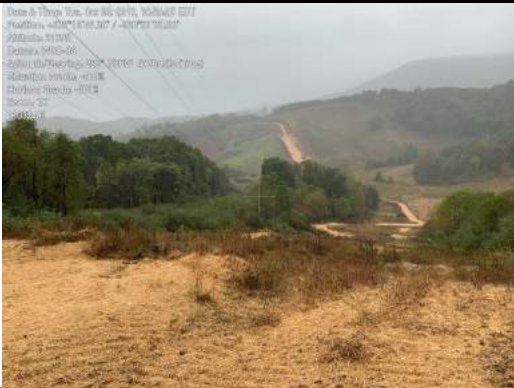
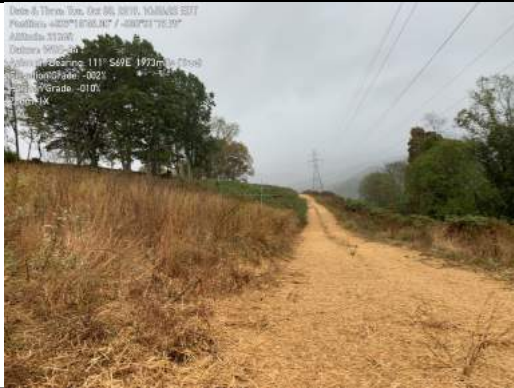
<b>GPS Location</b>	See picture above for GPS coordinates		<b>GPS Location</b>	See picture above for GPS coordinates	
<b>Field Station#</b>	11130+00		<b>Field Station#</b>	11150+00	
<b>Pic 5 Desc.</b>	ECD's and row conditions		<b>Pic 6 Desc.</b>	ECD's and row conditions

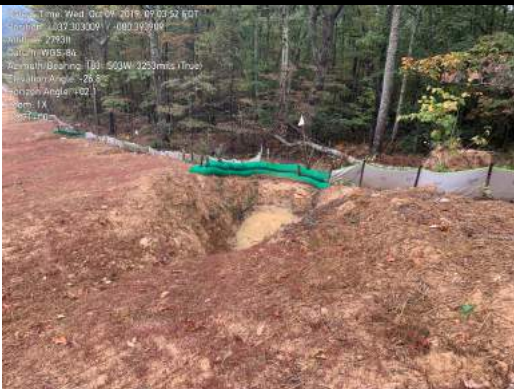
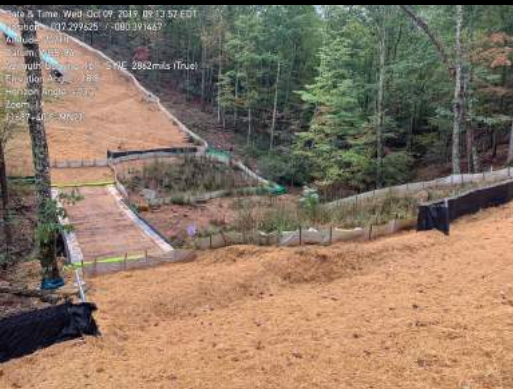
<b>GPS Location</b>	See photo for GPS location.		<b>GPS Location</b>	See photo for GPS location.	
<b>Field Station#</b>	11671+00		<b>Field Station#</b>	11687+40	
<b>Pic 1 Desc.</b>	Waterbar, end treatment, and sump pit in place.		<b>Pic 2 Desc.</b>	Sensitive resource buffer in place at stream S-MN21.

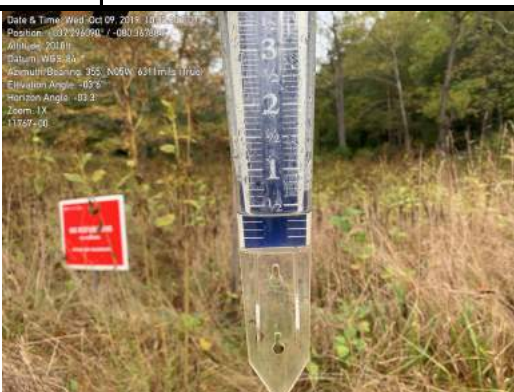
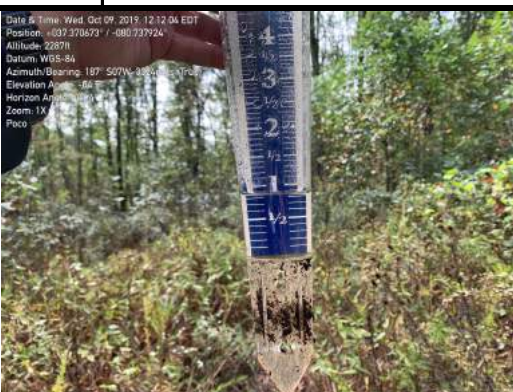
<b>GPS Location</b>	See photo for GPS location.		<b>GPS Location</b>	See photo for GPS location.	
<b>Field Station#</b>	11767+00		<b>Field Station#</b>	12005+00	
<b>Pic 3 Desc.</b>	Rain gauge at Mount Tabor Road reads 0.4 inches.		<b>Pic 4 Desc.</b>	Rain gauge at Pocahontas Road reads 0.9 inched.

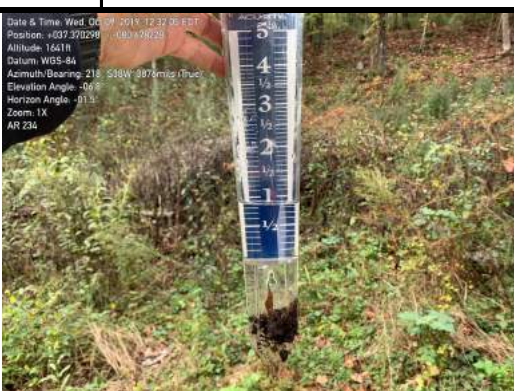
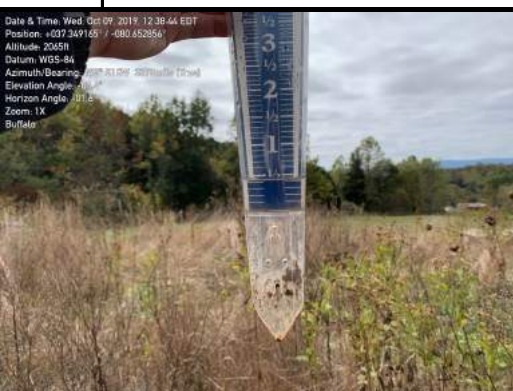
<b>GPS Location</b>	See photo for GPS location.		<b>GPS Location</b>	See photo for GPS location.	
<b>Field Station#</b>	12005+00		<b>Field Station#</b>	12005+00	
<b>Pic 5 Desc.</b>	Rain gauge at Access Road 234 reads 0.9 inches.		<b>Pic 6 Desc.</b>	Rain gauge at Buffalo Anklets Road reads 0.5 inches.

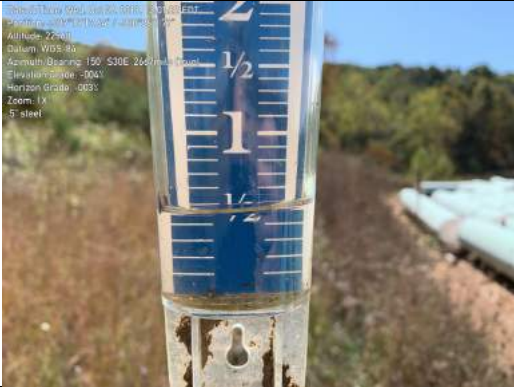
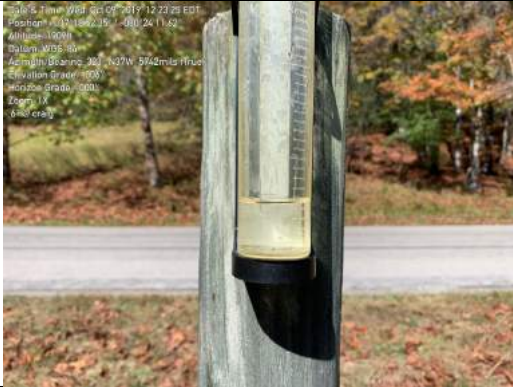
<b>GPS Location</b>	See picture above for GPS coordinates		<b>GPS Location</b>	See picture above for GPS coordinates	
<b>Field Station#</b>	+1		<b>Field Station#</b>	+1	
<b>Pic 1 Desc.</b>	.5" of rain recorded @ Steel Acres		<b>Pic 2 Desc.</b>	.7" of rain recorded @ Craig's Creek

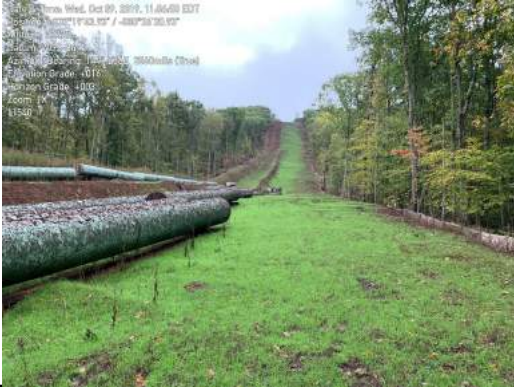
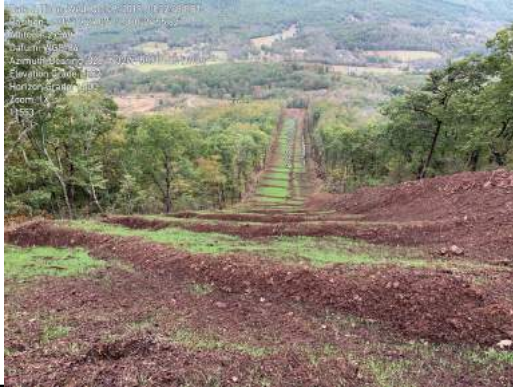
<b>GPS Location</b>	See picture above for GPS coordinates		<b>GPS Location</b>	See picture above for GPS coordinates	
<b>Field Station#</b>	11538+00		<b>Field Station#</b>	11553+00	
<b>Pic 3 Desc.</b>	Private section showing good signs of vegetation		<b>Pic 4 Desc.</b>	Private section showing good signs of vegetation

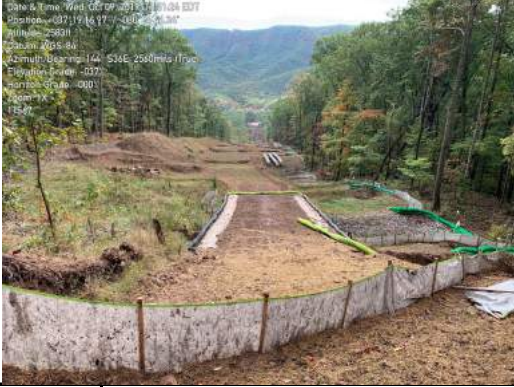
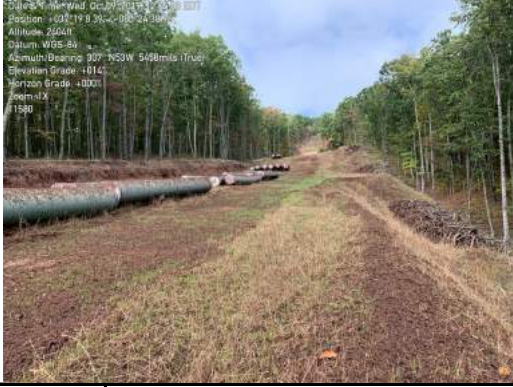
<b>Pic 5 Desc.</b>	ECD's and row conditions on JNF portion		<b>Pic 6 Desc.</b>	JNF portion showing minimal signs of vegetation

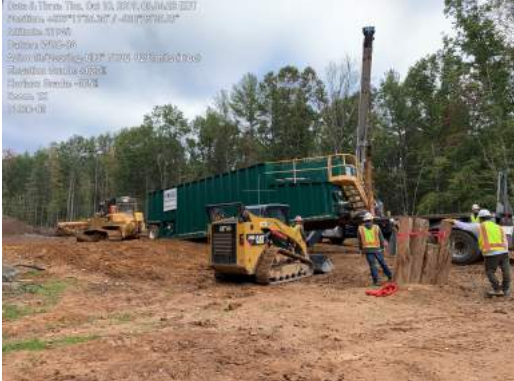
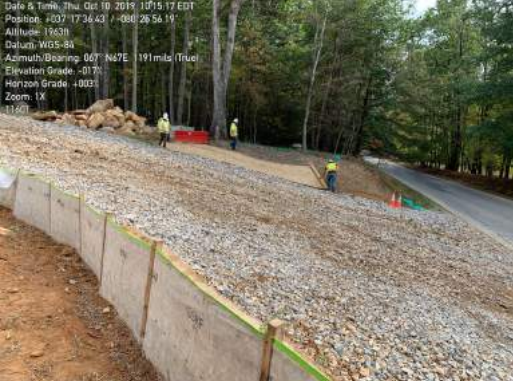
<b>GPS Location</b>	See picture above for GPS coordinates		<b>GPS Location</b>	See picture above for GPS coordinates	
<b>Field Station#</b>	11061+00		<b>Field Station#</b>	11061+00	
<b>Pic 1 Desc.</b>	Crew staging out equipment		<b>Pic 2 Desc.</b>	Crews installing curlex

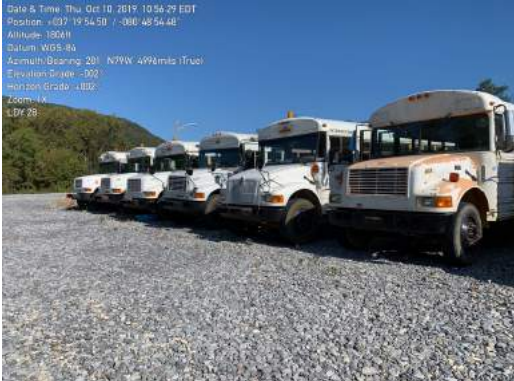
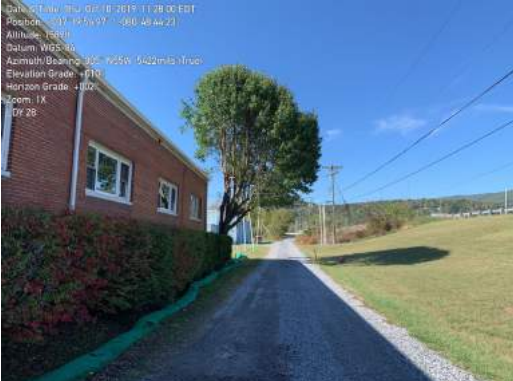
<b>GPS Location</b>	See picture above for GPS coordinates		<b>GPS Location</b>	See picture above for GPS coordinates	
<b>Field Station#</b>	+28		<b>Field Station#</b>	+28	
<b>Pic 3 Desc.</b>	ECD's and row conditions		<b>Pic 4 Desc.</b>	ECD's and row conditions

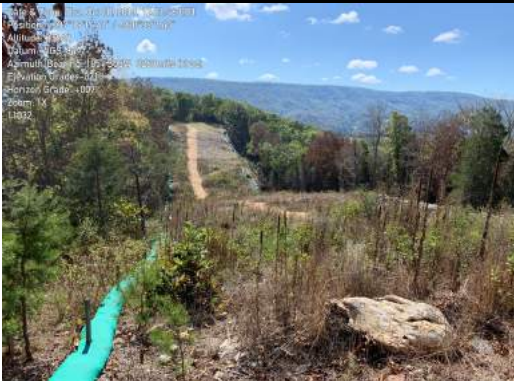
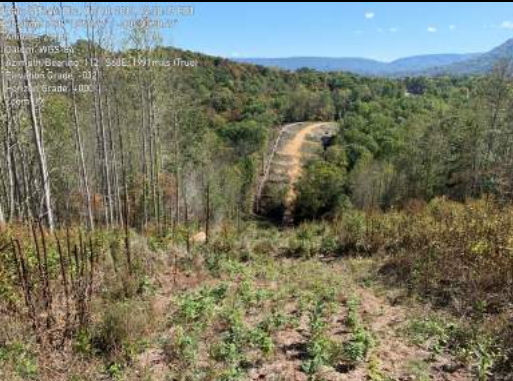
<b>GPS Location</b>	See picture above for GPS coordinates		<b>GPS Location</b>	See picture above for GPS coordinates	
<b>Field Station#</b>	11032+00		<b>Field Station#</b>	11050+00	
<b>Pic 5 Desc.</b>	ECD's and row conditions, travel lane stabilized		<b>Pic 6 Desc.</b>	Crews stabilizing travel lane

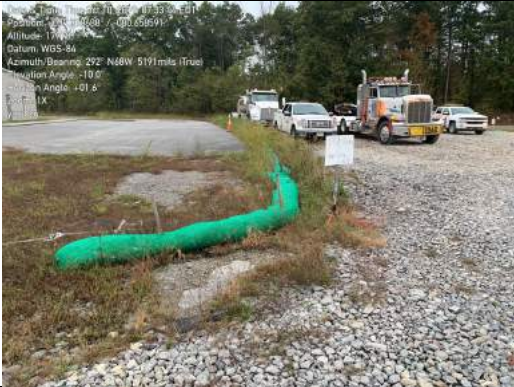
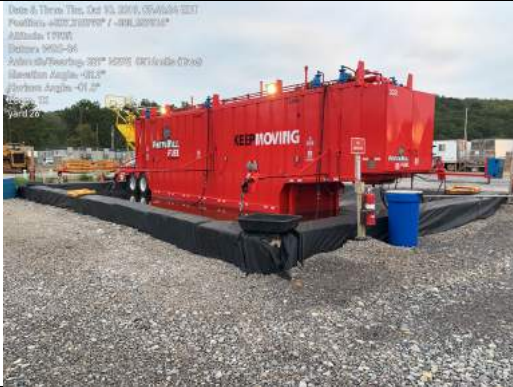
<b>GPS Location</b>	See photo for GPS location.		<b>GPS Location</b>	See photo for GPS location.	
<b>Field Station#</b>	12005+00		<b>Field Station#</b>	12005+00	
<b>Pic 1 Desc.</b>	Compost filter sock in place along LOD AT LDY 26.		<b>Pic 2 Desc.</b>	Secondary containment in place under fuel cell.

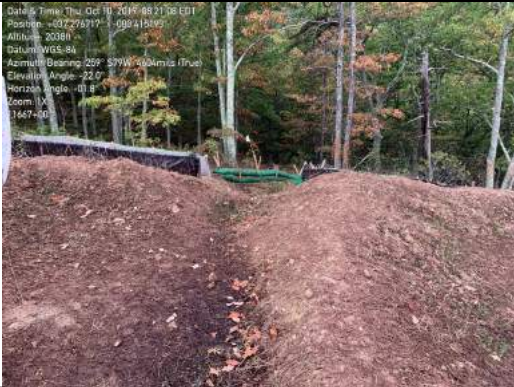
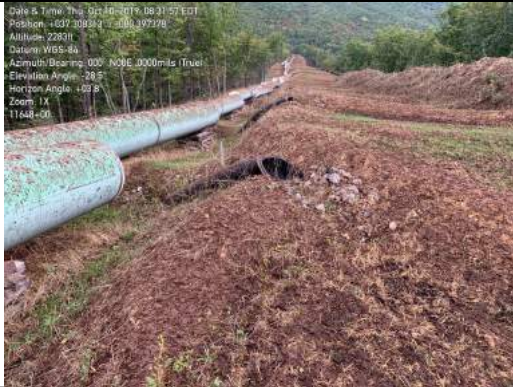
<b>GPS Location</b>	See photo for GPS location.		<b>GPS Location</b>	See photo for GPS location.	
<b>Field Station#</b>	11667+00		<b>Field Station#</b>	11648+00	
<b>Pic 3 Desc.</b>	Waterbar, sump pit, and triple stack compost filter sock end treatment in place.		<b>Pic 4 Desc.</b>	Slope drain with rock inlet and outlet in place over two tone to minimize erosion.

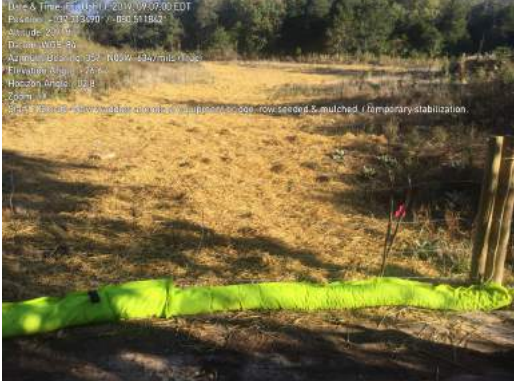
<p>Date &amp; Time: Fri, Oct 11, 2019, 09:09:00 EDT Position: +09.2223297, -080.5311842 Altitude: 2243ft Datum: WGS-84 Azimuth/Bearing: 321° N20W 0142mils (True) Elevation Angle: +17.2° Horizon Angle: -02.8° Zoom: 1X Sta#11022+00- Stream S-1102- AR-244- SSF fabric detached from chain link ending end treatment.</p>

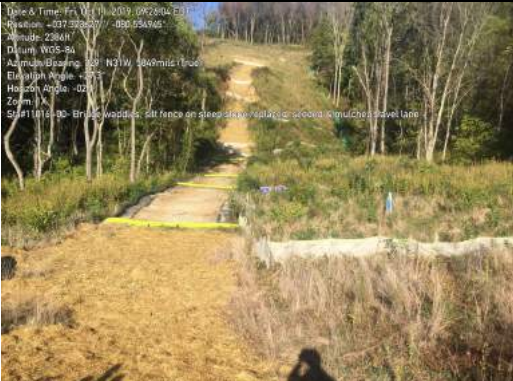
<p>Date &amp; Time: Fri, Oct 11, 2019, 09:29:04 EDT Position: +09.2223297, -080.5311842 Altitude: 2266ft Datum: WGS-84 Azimuth/Bearing: 029° N21W 0340mils (True) Elevation Angle: +17.2° Horizon Angle: -05.8° Zoom: 1X Sta#11016+00- Bridge waddles, dirt fence on steep slope, vegetation, stream, travel lane.</p>			
<b>GPS Location</b>	See photo GPS		<b>GPS Location</b>	See photo GPS	
<b>Field Station#</b>	11022+00		<b>Field Station#</b>	11016+00	
<b>Pic 3 Desc.</b>	AR-244- SSF fabric detached from chain link behind end treatment.		<b>Pic 4 Desc.</b>	Bridge waddles & steep slope controls replaced, travel lane seeded & mulched.

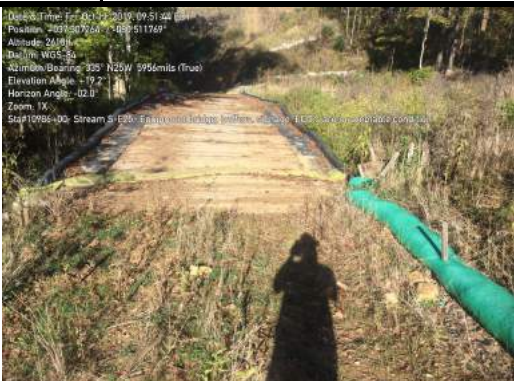
<p>Date &amp; Time: Fri, Oct 11, 2019, 09:51:22 EDT Position: +09.2223297, -080.5311769 Altitude: 2491ft Datum: WGS-84 Azimuth/Bearing: 335° N22W 595mils (True) Elevation Angle: +19.2° Horizon Angle: -02.9° Zoom: 1X Sta#10986+00- Stream S-E25- Equipment bridge, buffers, signage, ECD's are in acceptable condition.</p>

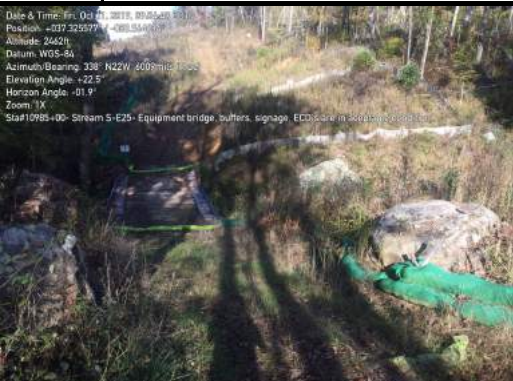
<p>Date &amp; Time: Fri, Oct 11, 2019, 09:53:21 EDT Position: +09.2223297, -080.5311769 Altitude: 2491ft Datum: WGS-84 Azimuth/Bearing: 338° N22W 600mils (True) Elevation Angle: +22.5° Horizon Angle: -01.9° Zoom: 1X Sta#10985+00- Stream S-E25- Equipment bridge, buffers, signage, ECD's are in acceptable condition.</p>			
<b>GPS Location</b>	See photo GPS		<b>GPS Location</b>	See photo GPS	
<b>Field Station#</b>	10986+00		<b>Field Station#</b>	10985+00	
<b>Pic 5 Desc.</b>	Stream S-E25- Equipment bridge, signage, Buffers, ECD's are in acceptable condition.		<b>Pic 6 Desc.</b>	Stream S-E24- Equipment bridge, buffers, signage, ECD's are in acceptable condition.

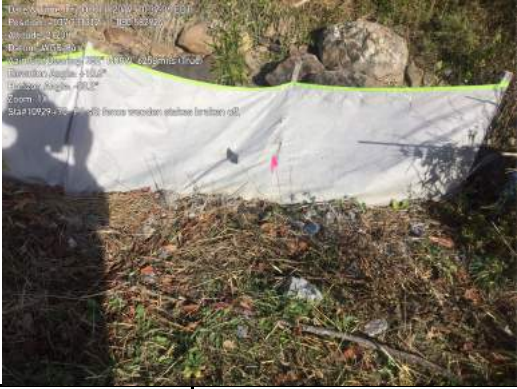
<p>Insert image here</p>			
<b>GPS Location</b>	See photo GPS	<b>GPS Location</b>			
<b>Field Station#</b>	10929+70	<b>Field Station#</b>			
<b>Pic 7 Desc.</b>	P1 silt fence wooden stakes broken off. Contractor notified and made repairs.	<b>Pic 8 Desc.</b>			
<p>Insert image here</p>		<p>Insert image here</p>			
<b>GPS Location</b>		<b>GPS Location</b>			
<b>Field Station#</b>		<b>Field Station#</b>			
<b>Pic 9 Desc.</b>		<b>Pic 10 Desc.</b>			
<p>Insert image here</p>		<p>Insert image here</p>			
<b>GPS Location</b>		<b>GPS Location</b>			
<b>Field Station#</b>		<b>Field Station#</b>			
<b>Pic 11 Desc.</b>		<b>Pic 12 Desc.</b>

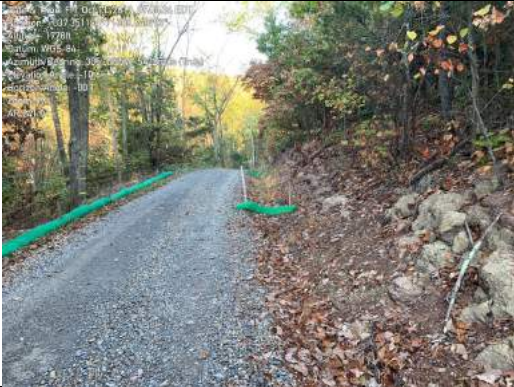
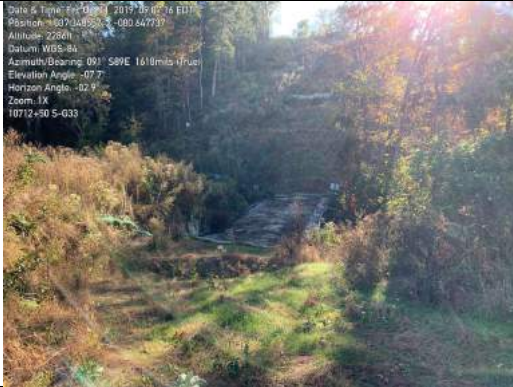
<b>GPS Location</b>	See photo for GPS location.		<b>GPS Location</b>	See photo for GPS location.	
<b>Field Station#</b>	12005+00		<b>Field Station#</b>	10712+50	
<b>Pic 1 Desc.</b>	Compost filter sock checks in place along access road 241.04 in bar ditch.		<b>Pic 2 Desc.</b>	Sensitive resource buffer in place at stream S-G33.

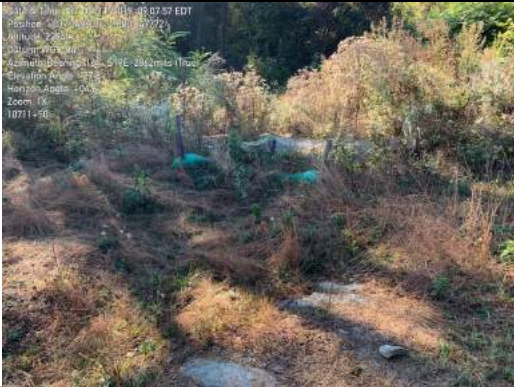
<b>GPS Location</b>	See photo for GPS location.		<b>GPS Location</b>	See photo for GPS location.	
<b>Field Station#</b>	10711+50		<b>Field Station#</b>	10710+00	
<b>Pic 3 Desc.</b>	Waterbar across travel lane with end treatment in place.		<b>Pic 4 Desc.</b>	ROW is stabilized with natural vegetation.

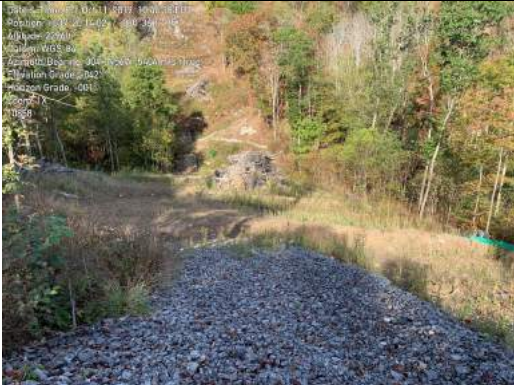
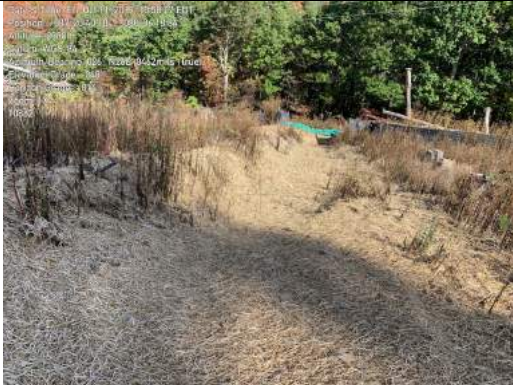
<b>GPS Location</b>	See picture above for GPS coordinates		<b>GPS Location</b>	See picture above for GPS coordinates	
<b>Field Station#</b>	110858+00		<b>Field Station#</b>	11862+00	
<b>Pic 1 Desc.</b>	ECD's and row conditions		<b>Pic 2 Desc.</b>	Water bar and end treatment recently stabilized

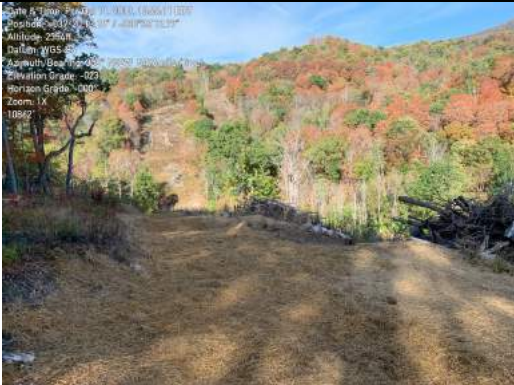
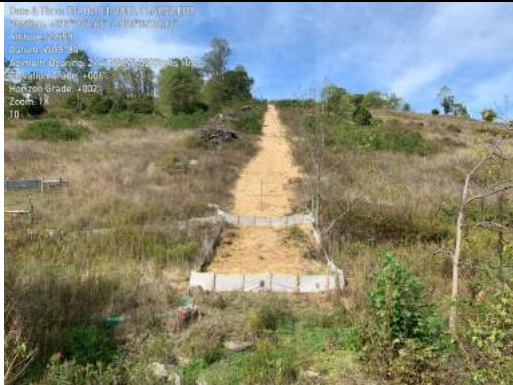
<b>GPS Location</b>	See picture above for GPS coordinates		<b>GPS Location</b>	See picture above for GPS coordinates	
<b>Field Station#</b>	110862+00		<b>Field Station#</b>	10880+00	
<b>Pic 3 Desc.</b>	ECD's and row conditions		<b>Pic 4 Desc.</b>	ECD's and row conditions

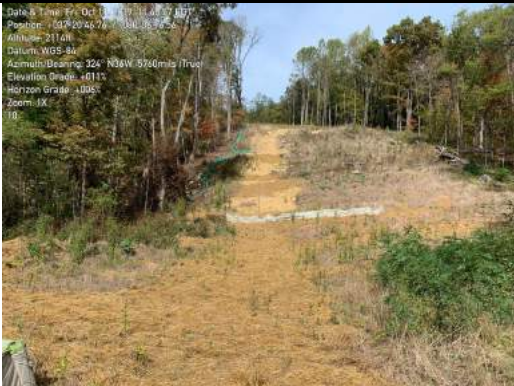
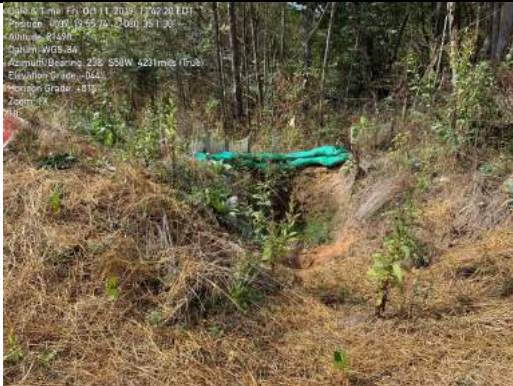
<b>GPS Location</b>	See picture above for GPS coordinates		<b>GPS Location</b>	See picture above for GPS coordinates	
<b>Field Station#</b>	10920+00		<b>Field Station#</b>	109220+00	
<b>Pic 5 Desc.</b>	ECD's and row conditions		<b>Pic 6 Desc.</b>	Water bar and end treatment
