Visual Site Inspection Report

Project Name	H-600 Pipeline Spread G	AFE	124300137	Spread	H-600 Pipeline Spread G
Contractor	Precision			Report #	5767
Inspector	Len Kruizenga			Date/Time	11/11/2019 7:33 AM
Permit #	TBD	Inspection Type	VA SWPP	Station Begin	11354+00
State	VA	Inspection Area	Full	Station End	11161+00
County	Giles	Ground	Wet	Temperature (°F)	50.00
Municipality	N/A	Weather	Sunny	Rain Gauge (in)	0.00
				Rain Accumulation Time (days)	1.00

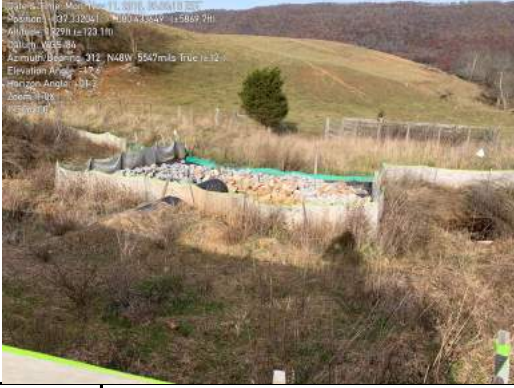
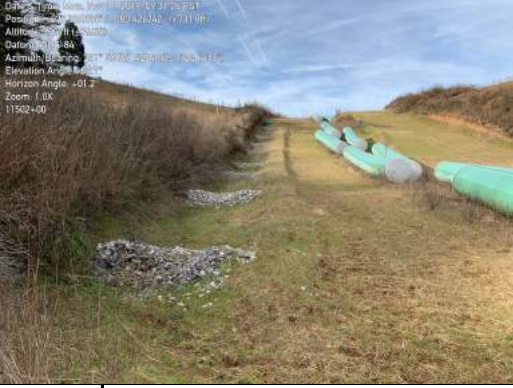
GPS Location	See photo for GPS location.		GPS Location	See photo for GPS location.	
Field Station#	11505+00		Field Station#	11502+00	
Pic 1 Desc.	Clean water diversion pipe and plunge pool in place.		Pic 2 Desc.	Conveyance channel with rock checks in place in section of ROW where double cut is.

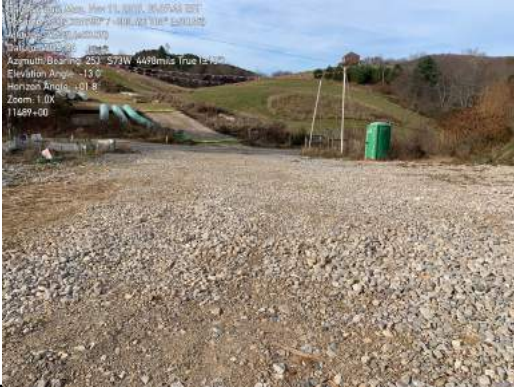
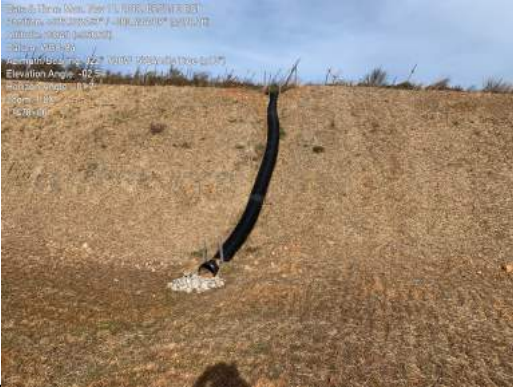
GPS Location	See photo for GPS location.		GPS Location	See photo for GPS location.	
Field Station#	11489+00		Field Station#	11478+00	
Pic 3 Desc.	RCE in place Stevers Gap Road to assist with the prevention of track out.		Pic 4 Desc.	Slope drain with rock inlet and outlet in place Over two-tone.

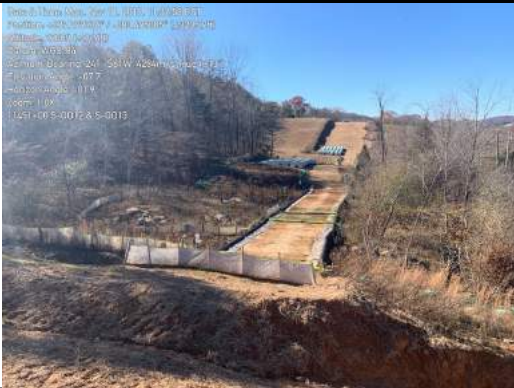
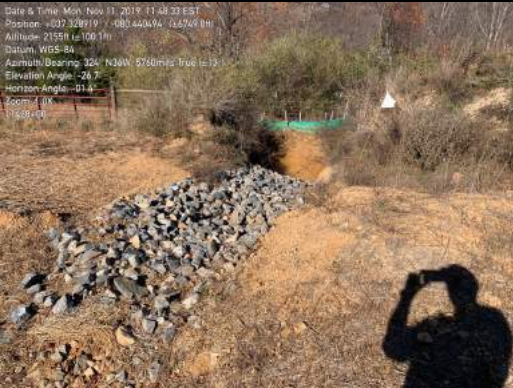
GPS Location	See photo for GPS location.		GPS Location	See photo for GPS location.	
Field Station#	11451+00		Field Station#	11428+00	
Pic 5 Desc.	Sensitive resource buffer in place at stream S-0012 and S-0013.		Pic 6 Desc.	Rock lined channel in place over fill slope to prevent rilling.

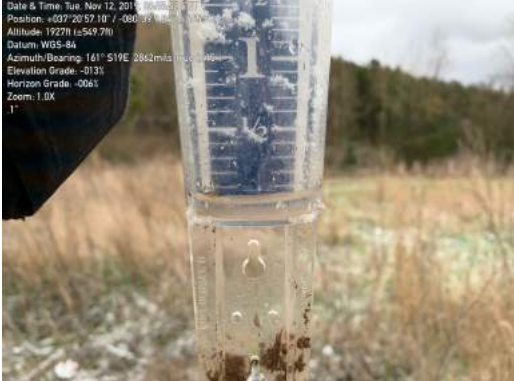
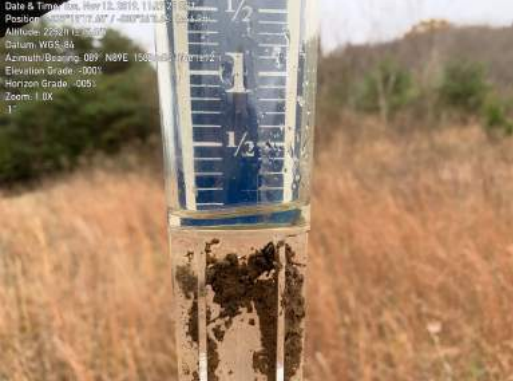
GPS Location	See picture above for GPS coordinates		GPS Location	See picture above for GPS coordinates	
Field Station#	+1		Field Station#	+1	
Pic 1 Desc.	.1" of rain recorded @ Buffalo Anklets		Pic 2 Desc.	.1" @ Steel Acres

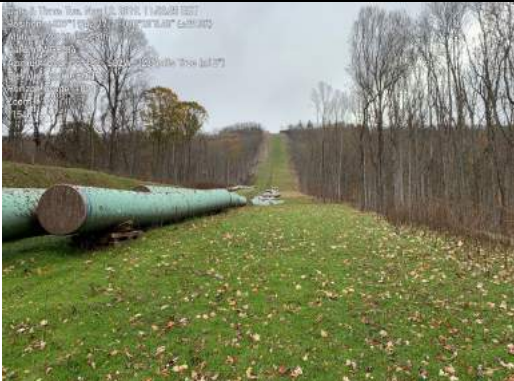
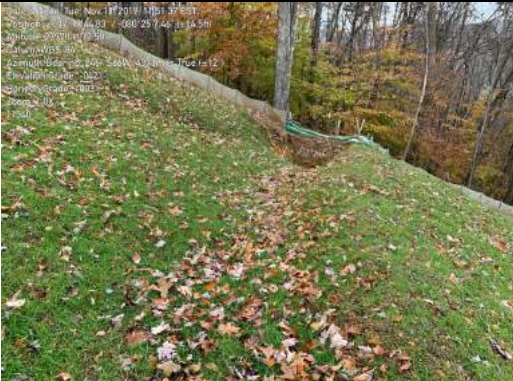
GPS Location	See picture above for GPS coordinates		GPS Location	See picture above for GPS coordinates	
Field Station#	11548+00		Field Station#	11540+00	
Pic 3 Desc.	ECD's and row conditions		Pic 4 Desc.	ECD's and row conditions

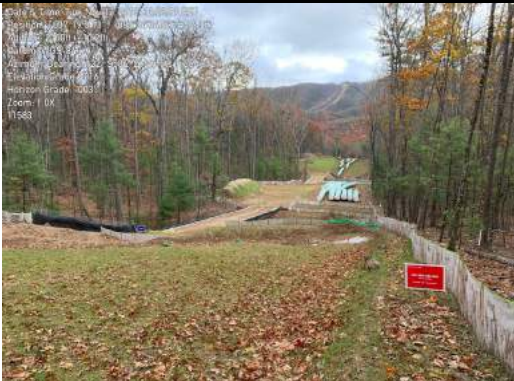
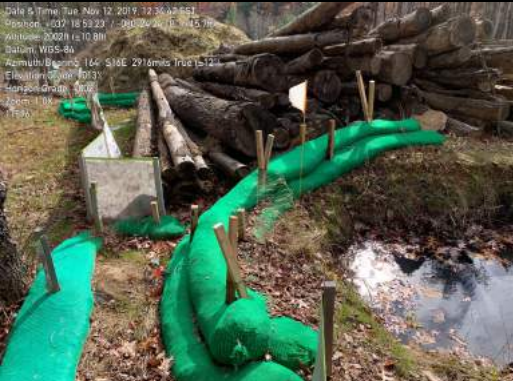
GPS Location	See picture above for GPS coordinates		GPS Location	See picture above for GPS coordinates	
Field Station#	11583+00		Field Station#	11596+00	
Pic 5 Desc.	ECD's and row conditions		Pic 6 Desc.	ECD's and row conditions

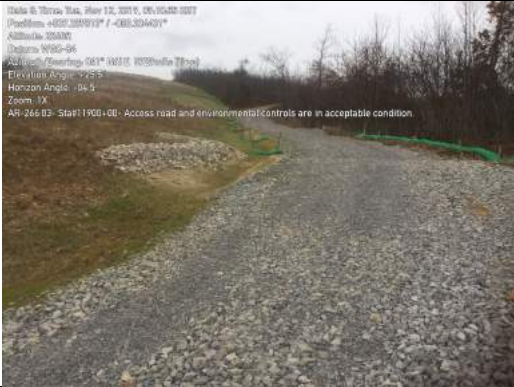
<p>Date & Time: Tue, Nov 12, 2019, 05:10:52 EST Position: +489.189719° / -90.324491° Altitude: 32400 Datum: WGS-84 Azimuth/Bearing: 081° N01E 010° True Elevation Angle: 22.5° Horizon Angle: 126.4° Zoom: IX Sta#11900.03 - Access road and environmental controls are in acceptable condition.</p>

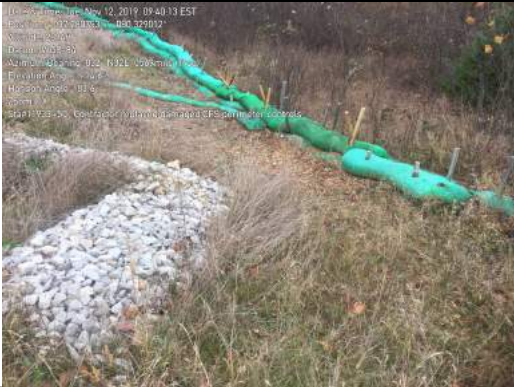
<p>Date & Time: Tue, Nov 12, 2019, 09:40:13 EST Position: +489.189719° / -90.324491° Altitude: 32400 Datum: WGS-84 Azimuth/Bearing: 081° N01E 010° True Elevation Angle: 22.5° Horizon Angle: 126.4° Zoom: IX Sta#11933.55 - Contractor replaced damaged CFS perimeter controls.</p>

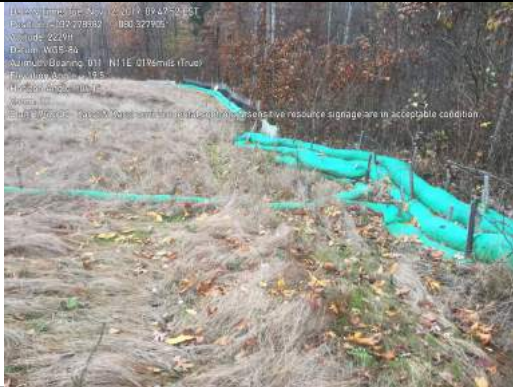
<p>Date & Time: Tue, Nov 12, 2019, 09:40:13 EST Position: +489.189719° / -90.324491° Altitude: 32400 Datum: WGS-84 Azimuth/Bearing: 081° N01E 010° True Elevation Angle: 22.5° Horizon Angle: 126.4° Zoom: IX Sta#11942.00 - Karst and Karst ECD's and sensitive resource signage are in acceptable condition.</p>			
GPS Location	See photo GPS		GPS Location	See photo GPS	
Field Station#	11933+50		Field Station#	11942+00	
Pic 3 Desc.	Contractor replaced damaged CFS perimeter controls		Pic 4 Desc.	Karst and Karst ECD's and sensitive resource signage are in acceptable condition.

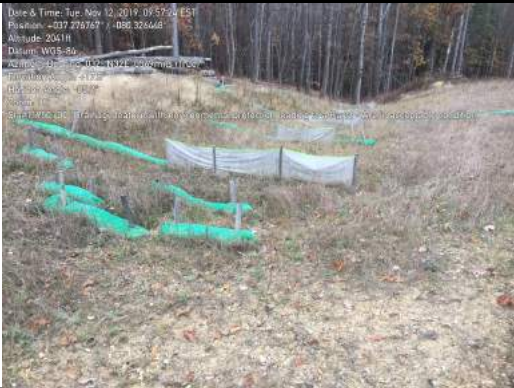
<p>Date & Time: Tue, Nov 12, 2019, 09:57:34 EST Position: +489.189719° / -90.324491° Altitude: 32400 Datum: WGS-84 Azimuth/Bearing: 081° N01E 010° True Elevation Angle: 22.5° Horizon Angle: 126.4° Zoom: IX Sta#11950.00 - Drainage feature with environmental protection leading to a Karst, ECD's are in good condition.</p>

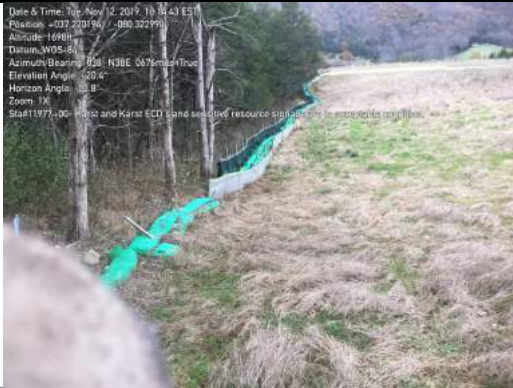
<p>Date & Time: Tue, Nov 12, 2019, 10:43:43 EST Position: +489.189719° / -90.324491° Altitude: 32400 Datum: WGS-84 Azimuth/Bearing: 081° N01E 010° True Elevation Angle: 22.5° Horizon Angle: 126.4° Zoom: IX Sta#11977.00 - Karst and Karst ECD's and sensitive resource signage are in acceptable condition.</p>

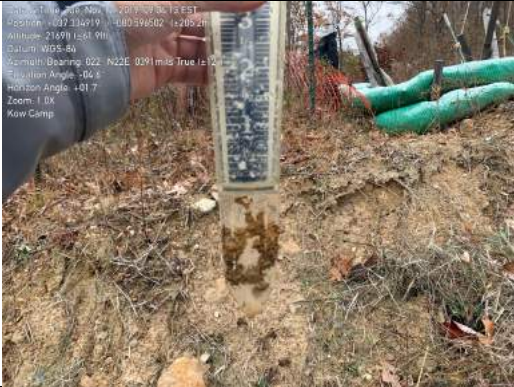
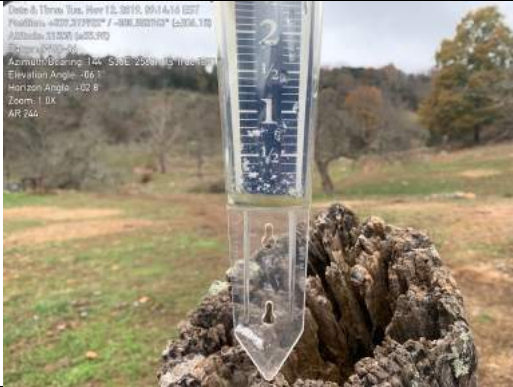
GPS Location	See photo for GPS location.		GPS Location	See photo for GPS location.	
Field Station#	10883+50		Field Station#	11025+00	
Pic 1 Desc.	Rain gauge at Kow Camp Road reads 0.1 inches.		Pic 2 Desc.	Rain gauge at AR 244 reads trace about.

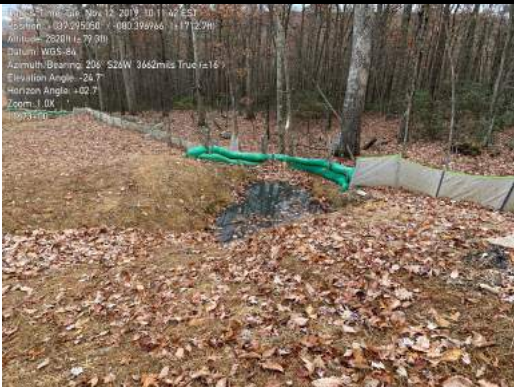
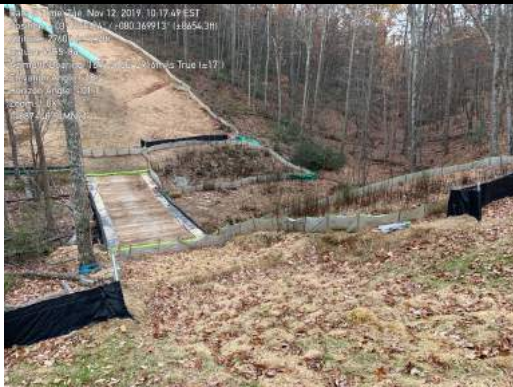
GPS Location	See photo for GPS location.		GPS Location	See photo for GPS location.	
Field Station#	11673+00		Field Station#	11687+40	
Pic 3 Desc.	Waterbar, sump pit, and triple stack compost filter sock end treatment in place.		Pic 4 Desc.	Sensitive resource buffer in place at stream S-MN21.

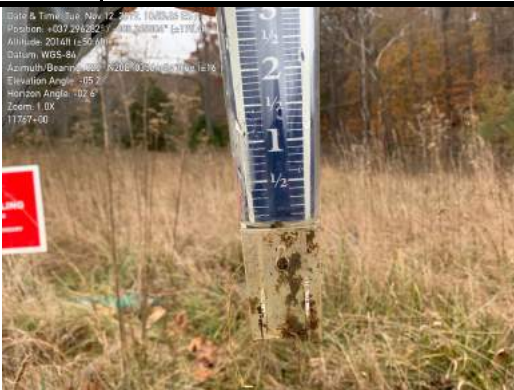
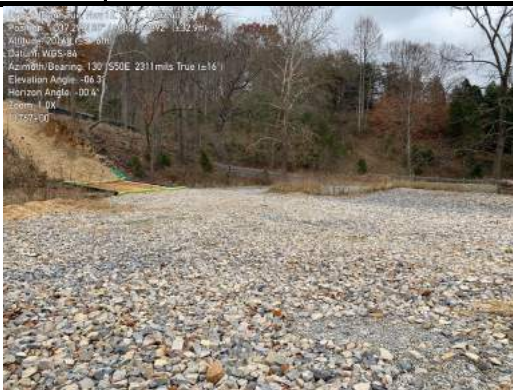
GPS Location	See photo for GPS location.		GPS Location	See photo for GPS location.	
Field Station#	11767+00		Field Station#	11767+00	
Pic 5 Desc.	Trace amount of rain at Main Line Valve 26.		Pic 6 Desc.	RCE in place at main line valve 26 to assist with the prevention of track out onto Mount Tabor Road.

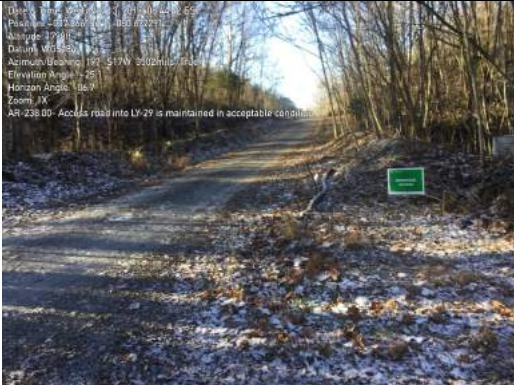
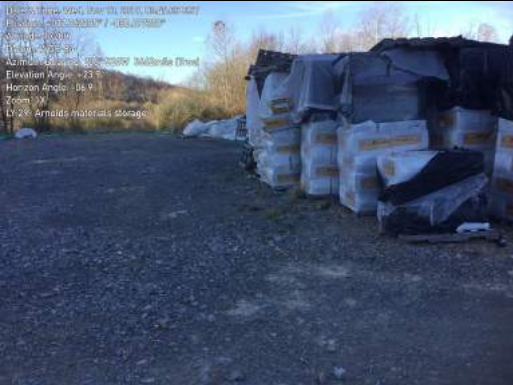
GPS Location	See photo GPS		GPS Location	See photo GPS	
Field Station#	12005+00		Field Station#	12005+00	
Pic 1 Desc.	AR-238.00- access road into LY-29 is maintained in acceptable condition.		Pic 2 Desc.	LY-29- Arnold's materials storage.

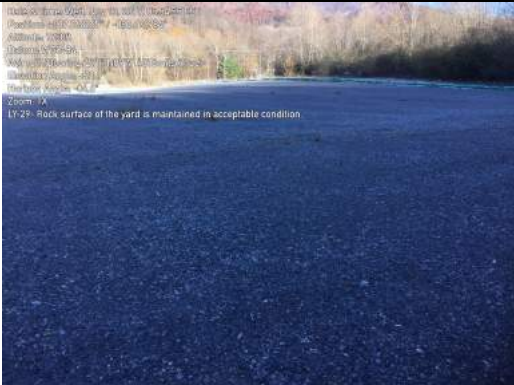
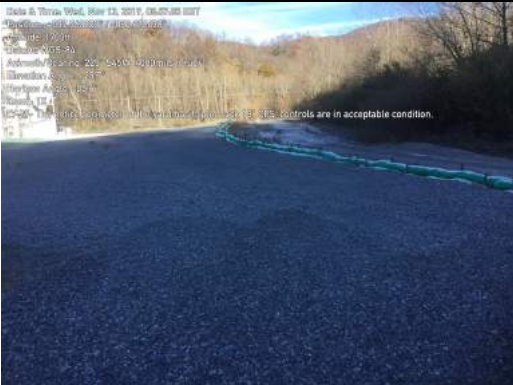
GPS Location	See photo GPS		GPS Location	See photo GPS	
Field Station#	12005+00		Field Station#	12005+00	
Pic 3 Desc.	Rock surface of the yard is maintained in acceptable condition.		Pic 4 Desc.	LY-29- The entire yard has CFS 18" Triple stack perimeter controls, controls are in acceptable condition.

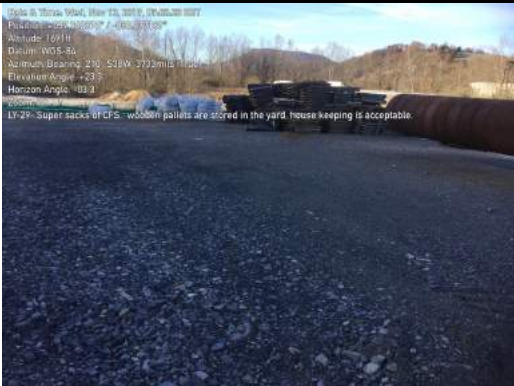
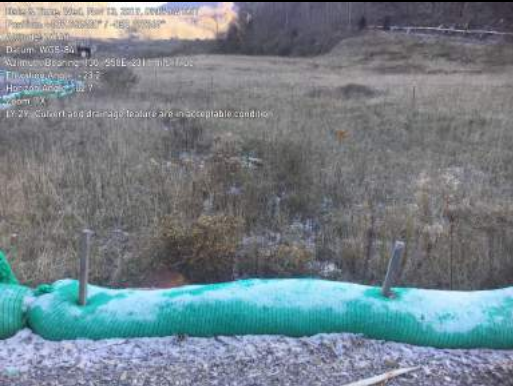
GPS Location	See photo GPS		GPS Location	See photo GPS	
Field Station#	12005+00		Field Station#	12005+00	
Pic 5 Desc.	LY-29- Materials stored in the yard are super sacks of CFS, wooden pallets & uncoated pipe, house keeping is acceptable.		Pic 6 Desc.	LY-29- Culvert and drainage feature are in acceptable condition.

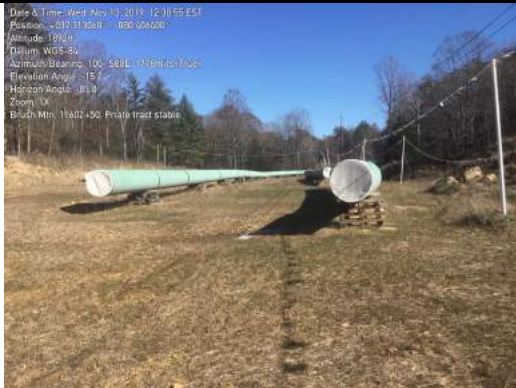
<p><small>Date & Time: Wed, Nov 13, 2019, 12:38:55 EST Position: -83°31'38.00" W - 33°02'50.00" N Altitude: 1994 ft Datum: WGS-84 Azimuth/Bearing: 100° 58'00" 1176mils (true) Declination Angle: -15.7° Horizon Angle: 111.9° Zoom: 1X Brush Mtn. 11602+50, Private tract stable</small></p>		<div style="text-align: center;">Insert image here</div>			
GPS Location	On photo	GPS Location			
Field Station#	11602+50	Field Station#			
Pic 9 Desc.	Straw mulch and grasses effectively controlling sediment movement		Pic 10 Desc.		
<div style="text-align: center;">Insert image here</div>		<div style="text-align: center;">Insert image here</div>			
GPS Location		GPS Location			
Field Station#		Field Station#			
Pic 11 Desc.		Pic 12 Desc.

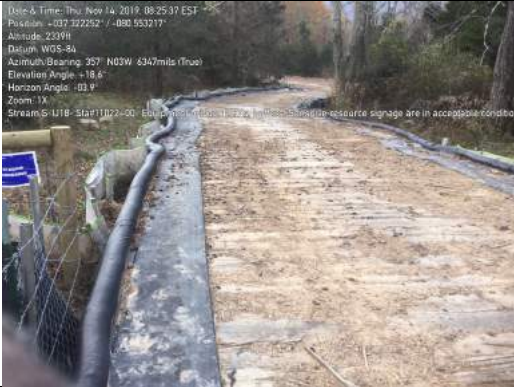
<p>Date & Time: Thu Nov 14, 2019, 08:25:37 EST Position: -037.322252, -082.553217 Altitude: 2539ft Datum: WGS-84 Azimuth/Bearing: 357° N23W 6347mils (True) Elevation Angle: +18.6° Horizon Angle: -03.9° Zoom: 1X Stream S-IJ18 - Start 11022+00. Equipment bridge, buffers, sensitive resource signage are in acceptable condition.</p>

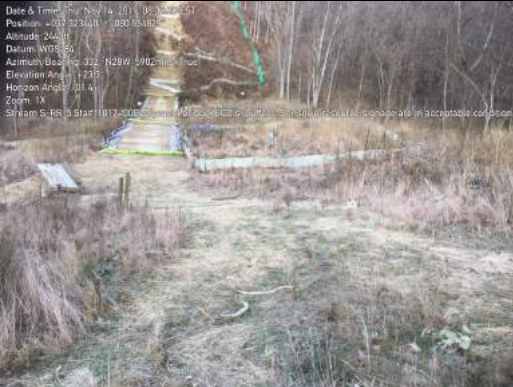
<p>Date & Time: Thu Nov 14, 2019, 08:34:05 EST Position: -037.323648, -082.554707 Altitude: 2455ft Datum: WGS-84 Azimuth/Bearing: 332° N28W 5902mils (True) Elevation Angle: +23.1° Horizon Angle: -01.4° Zoom: 1X Stream S-RR5 - Start 11017+00. Equipment bridge, buffers, sensitive resource signage are in acceptable condition.</p>			
GPS Location	See photo GPS		GPS Location	See photo GPS	
Field Station#	11022+00		Field Station#	11017+00	
Pic 1 Desc.	AR-244- Stream S-IJ18- Equipment bridge, buffers, sensitive resource signage, stream ECD's are in acceptable condition.		Pic 2 Desc.	Stream S- RR5- Equipment bridge, buffers, sensitive resource signage, stream ECD's are in acceptable condition

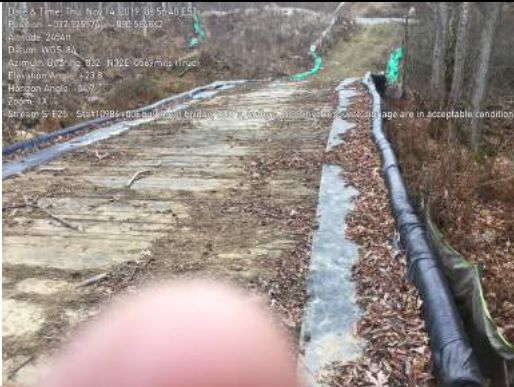
<p>Date & Time: Thu Nov 14, 2019, 08:53:40 EST Position: -037.323475, -082.554852 Altitude: 2654ft Datum: WGS-84 Azimuth/Bearing: 332° N30E 5569mils (True) Elevation Angle: +23.8° Horizon Angle: -04.5° Zoom: 1X Stream S-E25 - Start 10986+00. Equipment bridge, buffers, sensitive resource signage are in acceptable condition.</p>

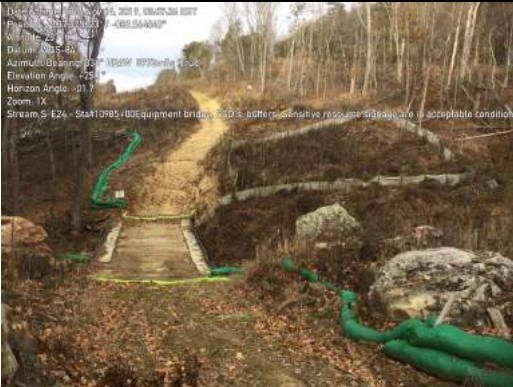
<p>Date & Time: Thu Nov 14, 2019, 09:05:36 EST Position: -037.323475, -082.554852 Altitude: 2654ft Datum: WGS-84 Azimuth/Bearing: 332° N30E 5569mils (True) Elevation Angle: +23.8° Horizon Angle: -04.5° Zoom: 1X Stream S-E24 - Start 10985+00. Equipment bridge, buffers, sensitive resource signage are in acceptable condition.</p>			
GPS Location	See photo GPS		GPS Location	See photo GPS	
Field Station#	10986+00		Field Station#	10985+00	
Pic 3 Desc.	Stream S-E25- Stream ECD's, sensitive resource signage, equipment bridge, are in acceptable condition.		Pic 4 Desc.	Stream ECD's, buffers, equipment bridge, sensitive resource signage are in acceptable condition.

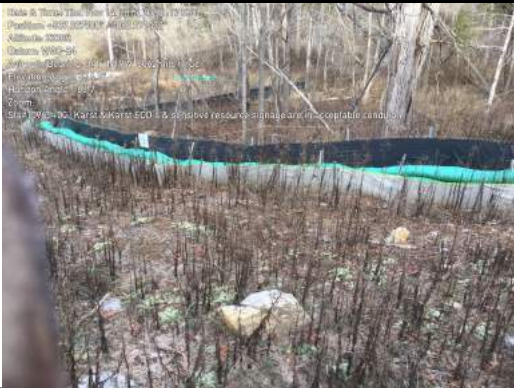
<p>Date & Time: Thu Nov 14, 2019, 09:12:15 EST Position: -037.323475, -082.554852 Altitude: 2654ft Datum: WGS-84 Azimuth/Bearing: 332° N30E 5569mils (True) Elevation Angle: +23.8° Horizon Angle: -04.5° Zoom: 1X Karst and Karst ECD's and sensitive resource signage are in acceptable condition.</p>

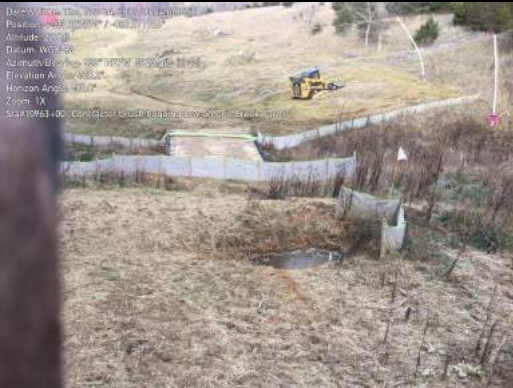
<p>Date & Time: Thu Nov 14, 2019, 09:12:15 EST Position: -037.323475, -082.554852 Altitude: 2654ft Datum: WGS-84 Azimuth/Bearing: 332° N30E 5569mils (True) Elevation Angle: +23.8° Horizon Angle: -04.5° Zoom: 1X Contractor brush hogging row on Doe Creek Farms.</p>			
GPS Location	See photo GPS		GPS Location	See photo GPS	
Field Station#	10964+00		Field Station#	10963+00	
Pic 5 Desc.	Karst and Karst ECD's and sensitive resource signage are in acceptable condition.		Pic 6 Desc.	Contractor brush hogging row on Doe Creek Farms.

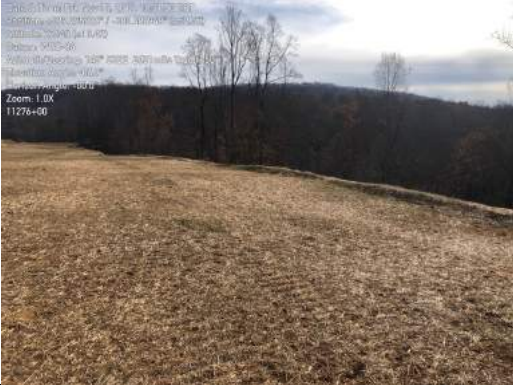
GPS Location	1		GPS Location	2	
Field Station#	11258+00		Field Station#	11276+00	
Pic 1 Desc.	Temporary stabilization.		Pic 2 Desc.	Temporary stabilization.

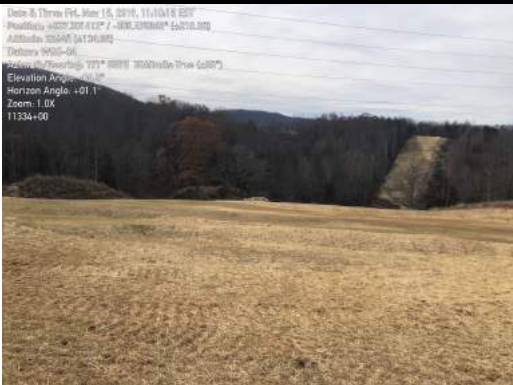
GPS Location	3		GPS Location	4	
Field Station#	11288+00		Field Station#	11334+00	
Pic 3 Desc.	Temporary stabilization.		Pic 4 Desc.	Temporary stabilization.

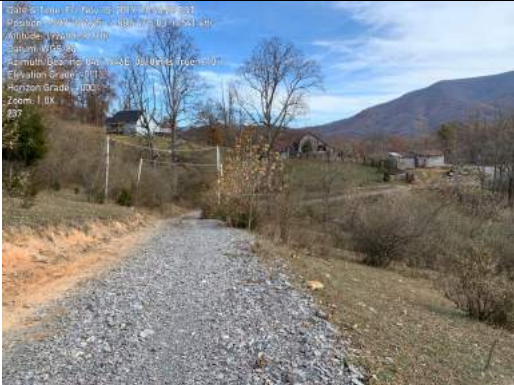
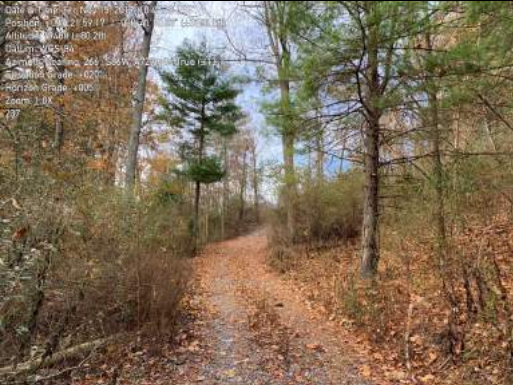
<p> Date & Time: 11/15/2019 7:19 AM Position: 35° 21' 18.00" N 83° 17' 10.00" W Altitude: 1000.00 ft Datum: WGS-84 Azimuth Bearing: 264.50° Elevation Grade: -0.05% Horizon Grade: -0.05% Zoom: 1.0x 11025-00 </p>			
GPS Location	See picture above for GPS coordinates		GPS Location	See picture above for GPS coordinates	
Field Station#	2+37		Field Station#	2+37	
Pic 1 Desc.	ECD's and row conditions		Pic 2 Desc.	ECD's and row conditions

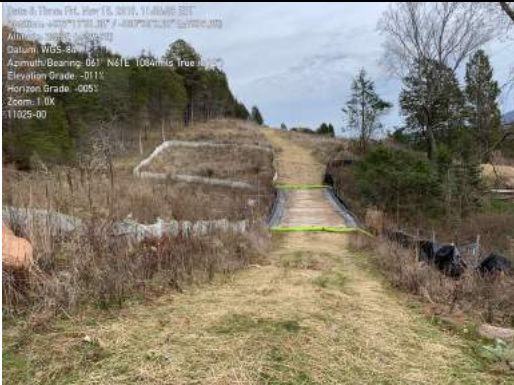
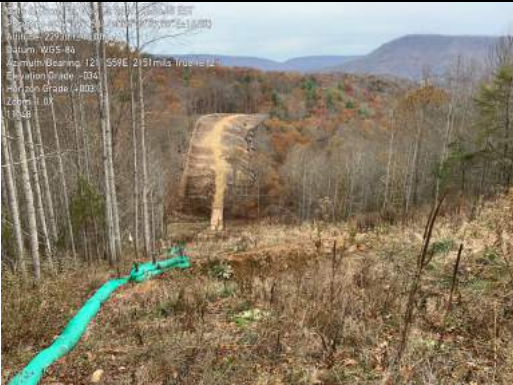
GPS Location	See picture above for GPS coordinates		GPS Location	See picture above for GPS coordinates	
Field Station#	11025+00		Field Station#	11048+00	
Pic 3 Desc.	ECD's and row conditions		Pic 4 Desc.	ECD's and row conditions

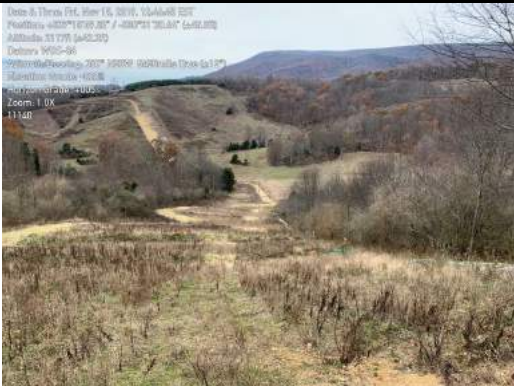
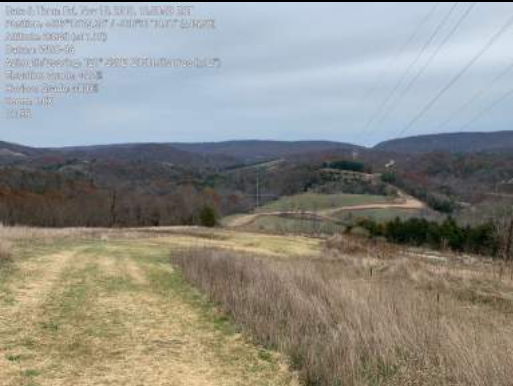
<p> Date & Time: 11/15/2019 7:19 AM Position: 35° 21' 18.00" N 83° 17' 10.00" W Altitude: 1000.00 ft Datum: WGS-84 Azimuth Bearing: 264.50° Elevation Grade: -0.05% Horizon Grade: -0.05% Zoom: 1.0x 11155-00 </p>			
GPS Location	See picture above for GPS coordinates		GPS Location	See picture above for GPS coordinates	
Field Station#	11140+00		Field Station#	11155+00	
Pic 5 Desc.	ECD's and row conditions		Pic 6 Desc.	ECD's and row conditions
