Visual Site Inspection Report

| Project Name | H-600 Pipeline Spread G | AFE | 124300137 | Spread | H-600 Pipeline Spread G |

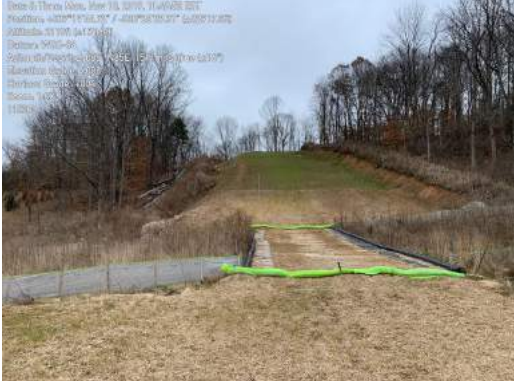
| Field Station# | 11520+00 | | Field Station# | 11530+00 | |

| Pic 1 Desc. | ECD's and row conditions | | Pic 2 Desc. | ECD's and row conditions | |

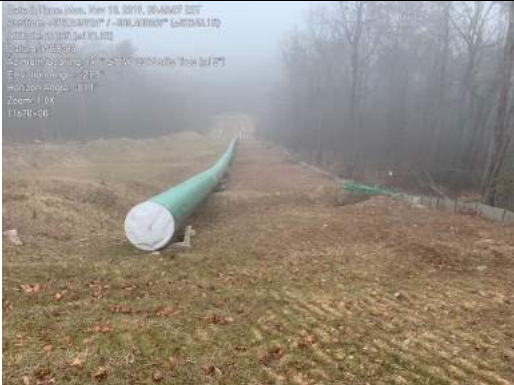
| Field Station# | 11670+00 | | Field Station# | 11687+40 | |

| Pic 1 Desc. | ROW stabilized with seed and mulch. Waterbar sump pits and end treatments in place. | | Pic 2 Desc. | Sensitive resource buffer in place at stream S-MN21. | |

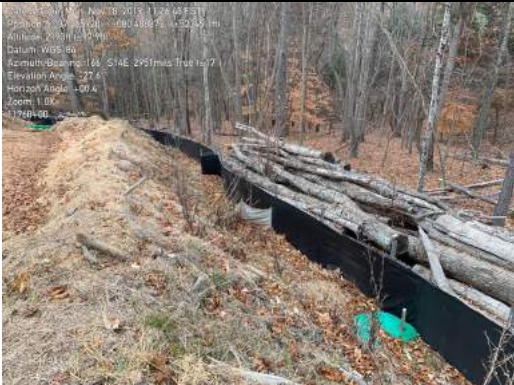
| Field Station# | 11760+00 | | Field Station# | 11767+00 | |

| Pic 3 Desc. | Reinforced super silt fence in place along LOD. | | Pic 4 Desc. | RCE in place at main line valve 26 to assist with the prevention of track out. | |

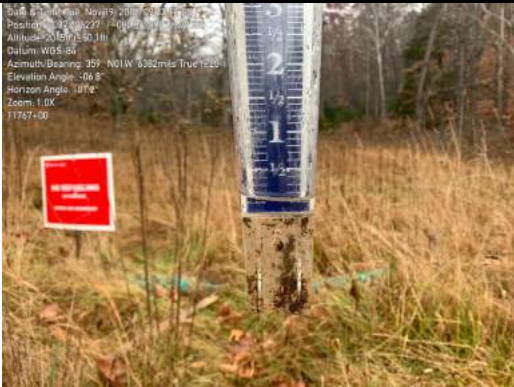
| Field Station# | 11767+00 | | Field Station# | 11990+00 | |

| Pic 1 Desc. | Rain gauge at main line valve 26 reads 0.2 inches. | | Pic 2 Desc. | Rain gauge at Catawba Road reads 0.2 inches. | |

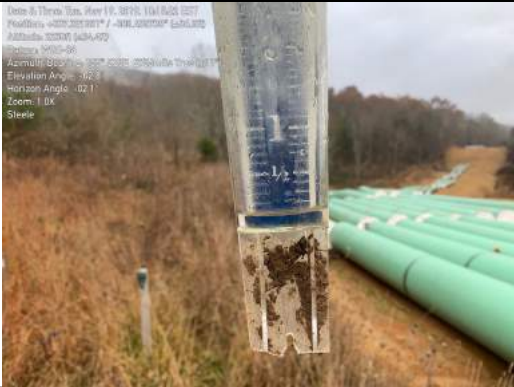
| Field Station# | 11471+00 | | Field Station# | 11118+00 | |

| Pic 3 Desc. | Rain gauge at Steele Acres Road reads 0.1 inches. | | Pic 4 Desc. | Rain gauge at Winding Way reads 0.1 inches. | |

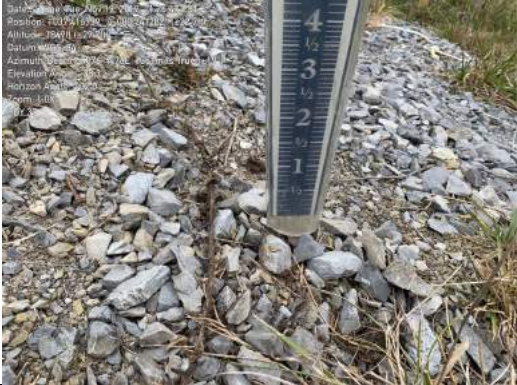
| Field Station# | 12005+00 | Field Station# | 12005+00 | | |

| Pic 7 Desc. | Rain gauge at LDY 37 had no rain water in it. | Pic 8 Desc. | CFS in place along LOD of LDY 26. | | |

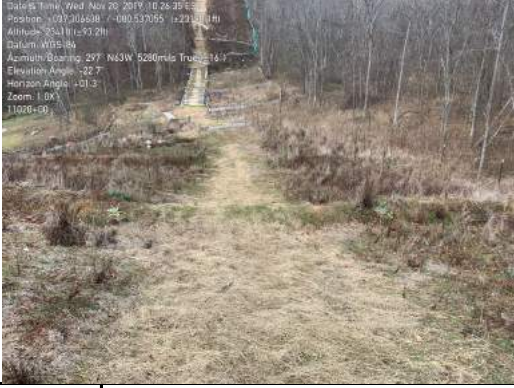
| Field Station# | 11020+00 | | Field Station# | 11008+00 | |

| Pic 1 Desc. | ROW stabilized, waterbars, and end treatments in place. | | Pic 2 Desc. | Reinforced super silt fence in place along LOD. | |

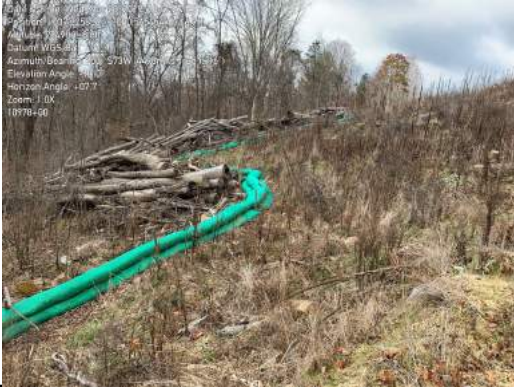
| Field Station# | 10978+00 | | Field Station# | 10945+00 | |

| Pic 3 Desc. | Triple stack 18 inch compost filter sock in place along LOD. | | Pic 4 Desc. | Waterbars in travel with CFS end treatments and ROW stabilized. | |

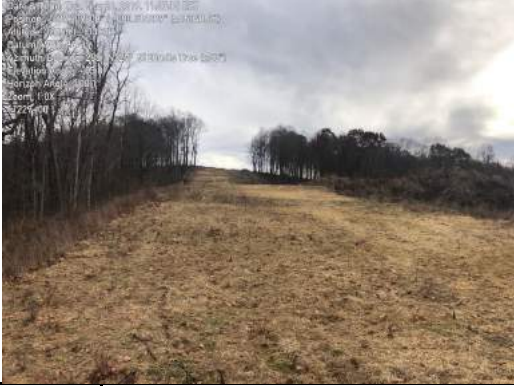
| Field Station# | 11229+00 | Field Station# | 11237+00 | | |

| Pic 1 Desc. | Temporary stabilization. | Pic 2 Desc. | Temporary vegetation on topsoil pile. | | |

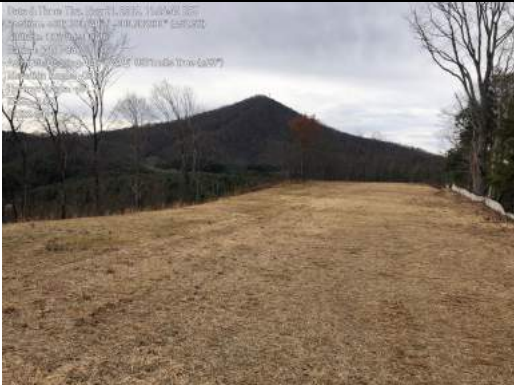
| Field Station# | 11222+00 | Field Station# | 11211+00 | | |

| Pic 3 Desc. | Temporary stabilization. | Pic 4 Desc. | Temporary stabilization. | | |

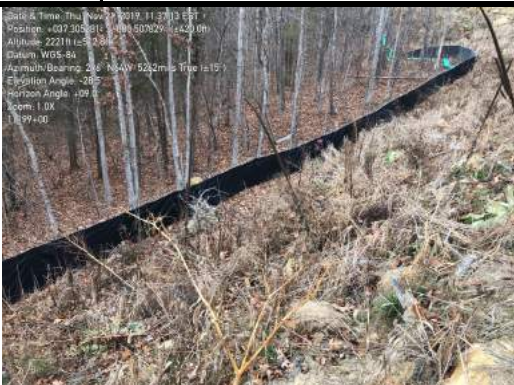
| Field Station# | 11199+00 | Field Station# | 11184+00 | | |

| Pic 5 Desc. | Reinforced fabric silt fence in good condition. | Pic 6 Desc. | Plunge pool in good condition. | | |

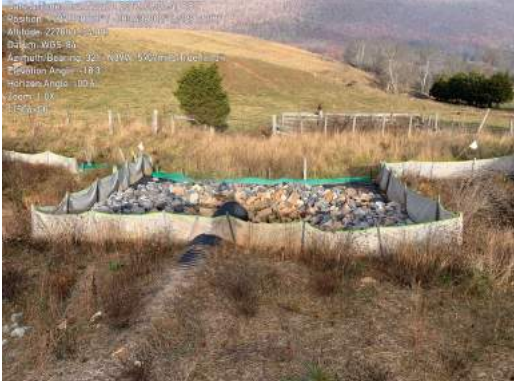
| Field Station# | 11506+00 | | Field Station# | 11502+00 | |

| Pic 1 Desc. | Plunge pool and clean water diversion pipe in place. | | Pic 2 Desc. | Conveyance channel with rock checks in place at double cut section of ROW. | |

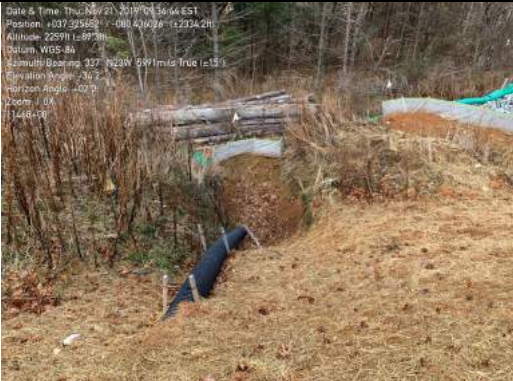
| Field Station# | 11471+00 | | Field Station# | 11468+00 | |

| Pic 3 Desc. | Compost filter sock checks in place along Steele Acres access road. | | Pic 4 Desc. | Slope drain in place with priority one end treatment. | |

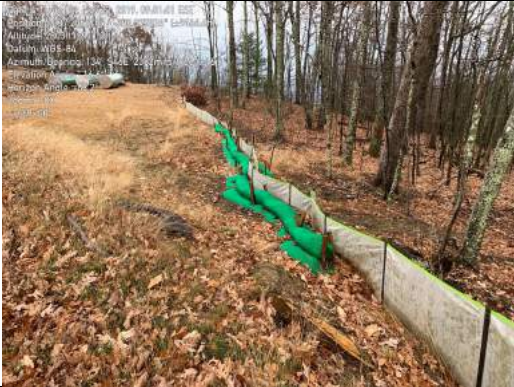
| Field Station# | 11669+00 | | Field Station# | 11670+00 | |

| Pic 1 Desc. | Triple stack compost filter sock with priority one silt fence along LOD. | | Pic 2 Desc. | Waterbar, sump pit, and triple stack compost filter sock end treatment in place. | |

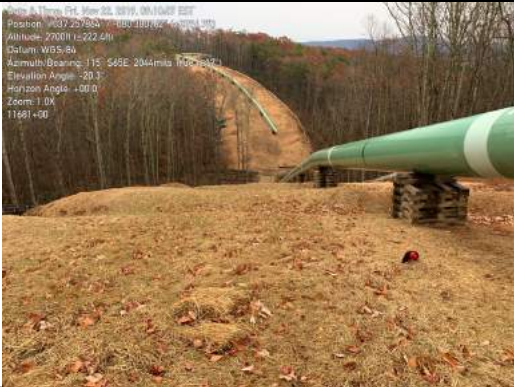
| Field Station# | 11681+00 | | Field Station# | 11687+40 | |

| Pic 3 Desc. | ROW stabilized with seed and mulch. Waterbar in place. | | Pic 4 Desc. | Sensitive resource buffer in place at stream S-MN21. | |
