Visual Site Inspection Report

Project Name	H-600 Pipeline Spread G	AFE	124300137	Spread	H-600 Pipeline Spread G
Contractor	Precision			Report #	6152
Inspector	Garrett Barclay			Date/Time	11/25/2019 7:17 AM
Permit #	TBD	Inspection Type	VA SWPP	Station Begin	12500+00
State	VA	Inspection Area	Partial	Station End	12500+00
County	Giles	Ground	Wet	Temperature (°F)	42.00
Municipality	N/A	Weather	Sunny	Rain Gauge (in)	0.70
				Rain Accumulation Time (days)	1.00

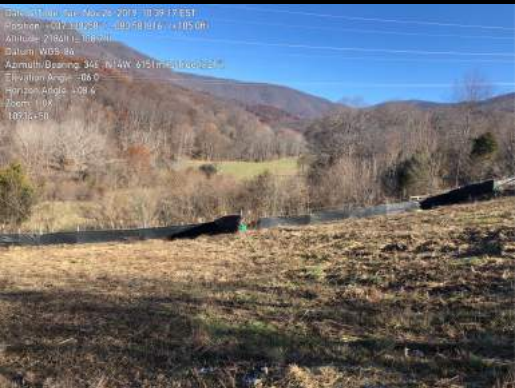
GPS Location 5		GPS Location 6			
Field Station# 10947+00		Field Station# 10934+50			
Pic 5 Desc. Vegetated RoW.		Pic 6 Desc. Reinforced silt fence perimeter control in good condition.

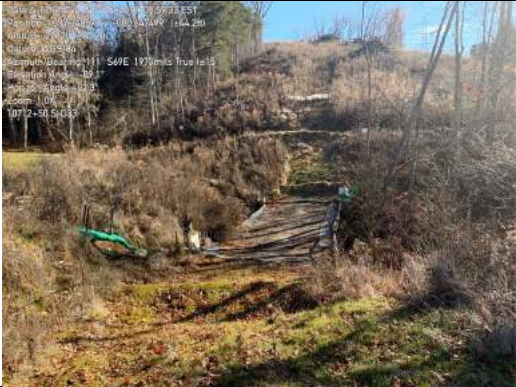
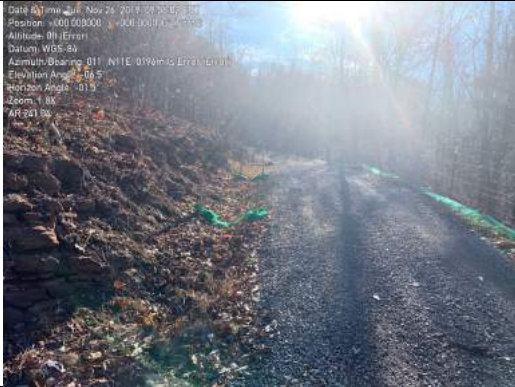
GPS Location	See photo for GPS location		GPS Location	See photo for GPS location	
Field Station#	10712+50		Field Station#	12005+00	
Pic 1 Desc.	Sensitive resource buffer in place at stream S-G33.		Pic 2 Desc.	Compost filter sock checks in place along AR 241.04 in bar ditch.

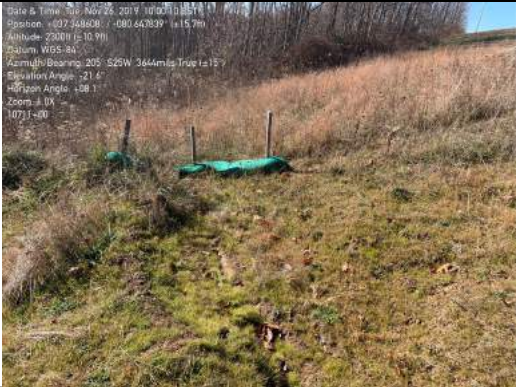
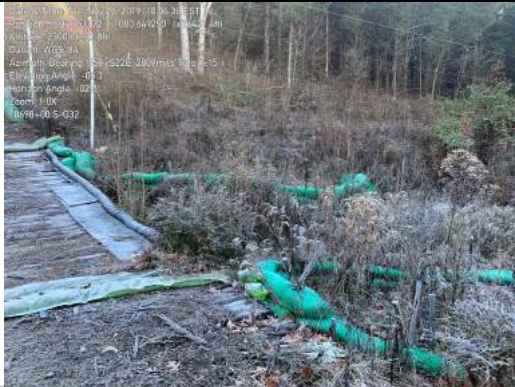
GPS Location	See photo for GPS location		GPS Location	See photo for GPS location	
Field Station#	10711+00		Field Station#	10698+00	
Pic 3 Desc.	Waterbar across travel lane with CFS end treatment.		Pic 4 Desc.	Sensitive resource buffer in place at stream S-G32.

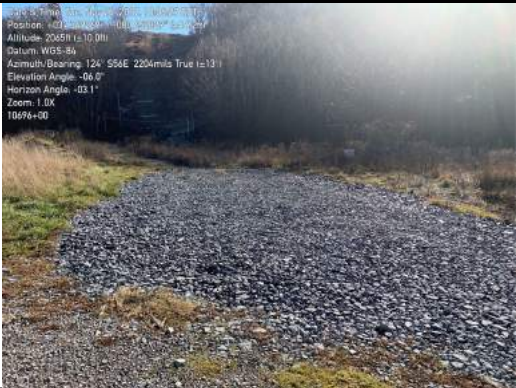
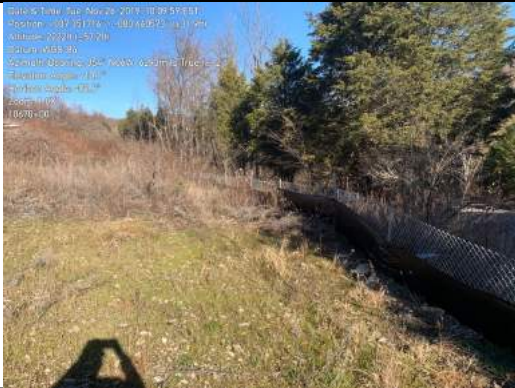
GPS Location	See photo for GPS location		GPS Location	See photo for GPS location	
Field Station#	10696+00		Field Station#	1067+00	
Pic 5 Desc.	RCE in place at Buffalo Anklets Road.		Pic 6 Desc.	Reinforced super silt fence in place along LOD.

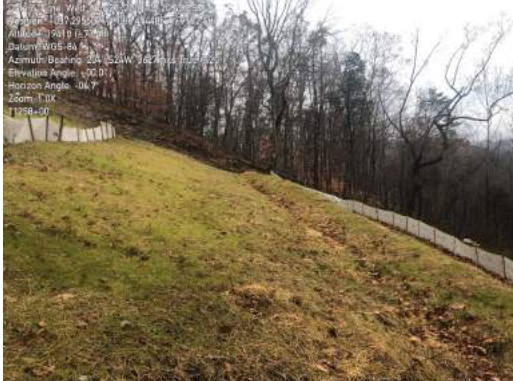
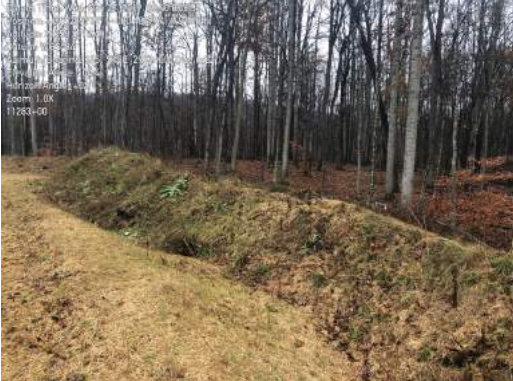
GPS Location	1		GPS Location	2	
Field Station#	11258+00		Field Station#	11283+00	
Pic 1 Desc.	Temporary stabilization.		Pic 2 Desc.	Topsoil pile with temporary stabilization.

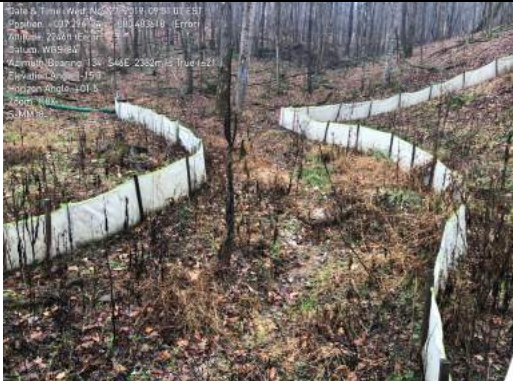
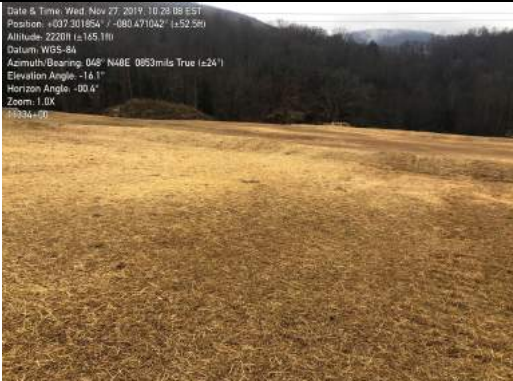
GPS Location	3		GPS Location	4	
Field Station#	11292+80		Field Station#	11334+00	
Pic 3 Desc.	S-MM18.		Pic 4 Desc.	Temporary stabilization.

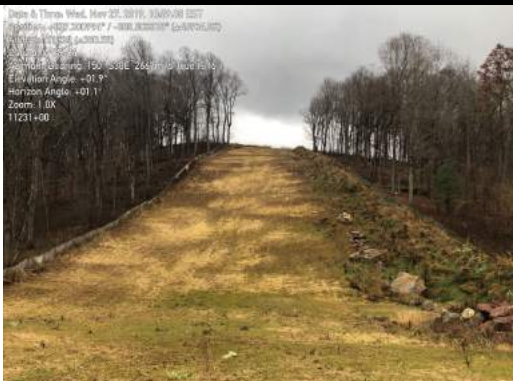
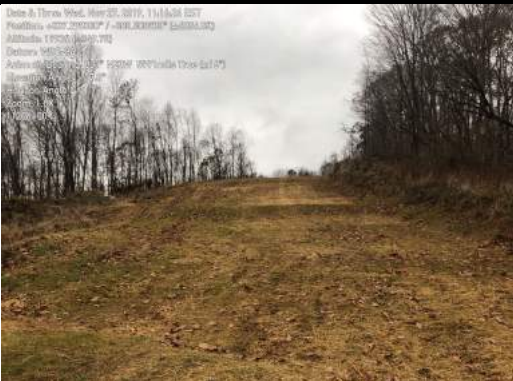
GPS Location	5		GPS Location	6	
Field Station#	11231+00		Field Station#	11206+00	
Pic 5 Desc.	Temporary stabilization.		Pic 6 Desc.	Temporary stabilization.

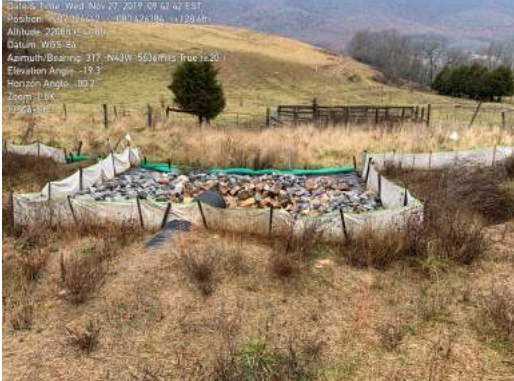
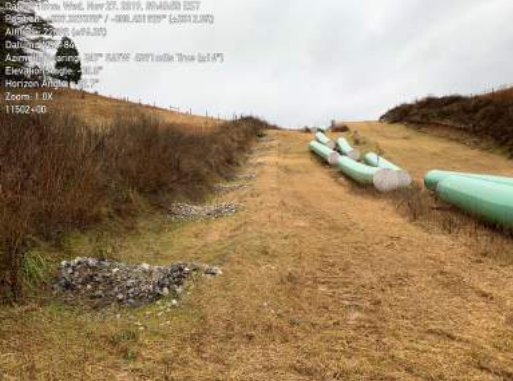
GPS Location	See photo for GPS location.		GPS Location	See photo for GPS location.	
Field Station#	11506+00		Field Station#	11502+00	
Pic 1 Desc.	Clean water diversion pipe and plunge pool in place.		Pic 2 Desc.	Conveyance channel with rock checks in place at double cut area of ROW.

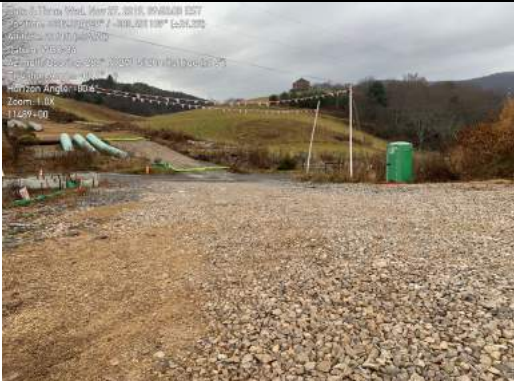
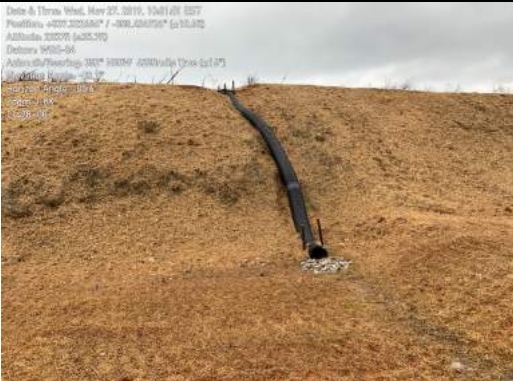
GPS Location	See photo for GPS location.		GPS Location	See photo for GPS location.	
Field Station#	11489+00		Field Station#	11478+00	
Pic 3 Desc.	RCE in place Stevers Gap Road.		Pic 4 Desc.	Slope drain pipe in place over two-tone with rock inlet and outlet.

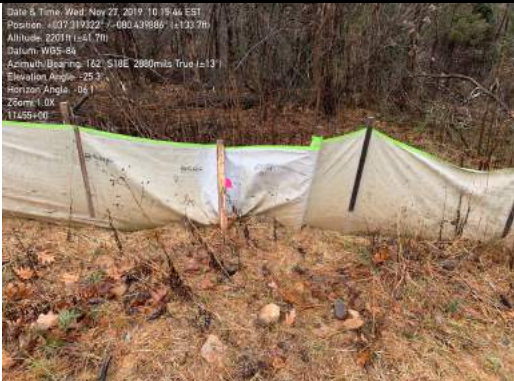
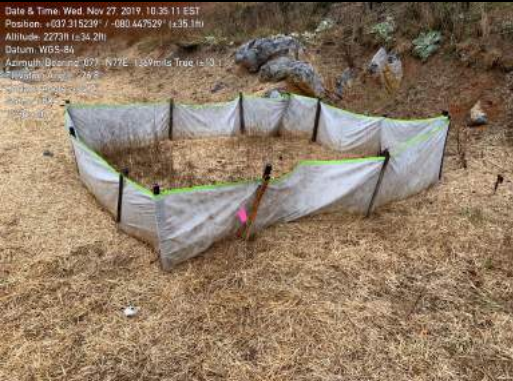
GPS Location	See photo for GPS location.		GPS Location	See photo for GPS location.	
Field Station#	11455+00		Field Station#	11432+00	
Pic 5 Desc.	Broken priority one silt fence stake along LOD.		Pic 6 Desc.	Broken priority one silt fence stake at earthen ditch location.

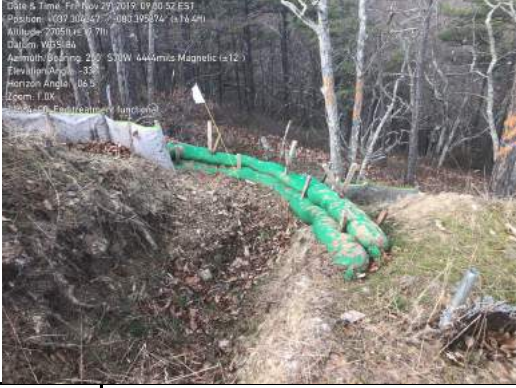
<p>Date & Time: Fri Nov 29, 2019 09:50:52 EST Position: 4397.306N, -7083.192W, 1114.5M Altitude: 2050 ft (625 m) Datum: WGS-84 Azimuth Bearing: 232 S20W 540mils Magnetic (+12) Elevation Angle: -33 Horizon Angle: -90.5 Zoom: 1.0x 11664+00 End treatments in place</p>

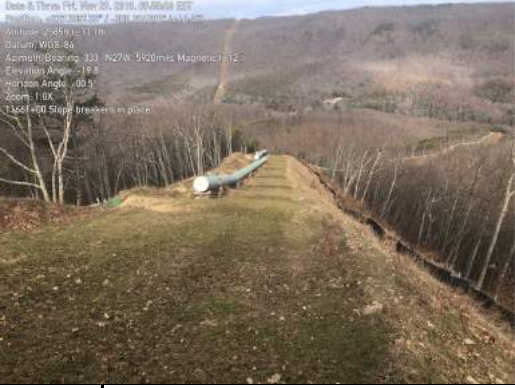
<p>Date & Time: Fri Nov 29, 2019 09:50:52 EST Position: 4397.306N, -7083.192W, 1114.5M Altitude: 2050 ft (625 m) Datum: WGS-84 Azimuth Bearing: 232 S20W 540mils Magnetic (+12) Elevation Angle: -33 Horizon Angle: -90.5 Zoom: 1.0x 11664+00 Slope breakers in place</p>			
GPS Location	On photo	GPS Location	On photo		
Field Station#	11664+00	Field Station#	11661+00		
Pic 1 Desc.	End treatments are in place and functional	Pic 2 Desc.	Slope breakers are working as designed

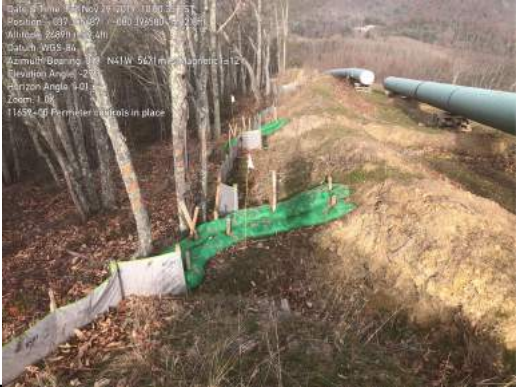
<p>Date & Time: Fri Nov 29, 2019 10:00:00 EST Position: 4397.306N, -7083.192W, 1114.5M Altitude: 2050 ft (625 m) Datum: WGS-84 Azimuth Bearing: 232 S20W 540mils Magnetic (+12) Elevation Angle: -33 Horizon Angle: -90.5 Zoom: 1.0x 11659+00 Perimeter controls in place</p>

GPS Location	On photo	GPS Location	On photo		
Field Station#	11659+00	Field Station#	11648+00		
Pic 3 Desc.	Perimeter controls are functional	Pic 4 Desc.	Perimeter controls are in place and working properly

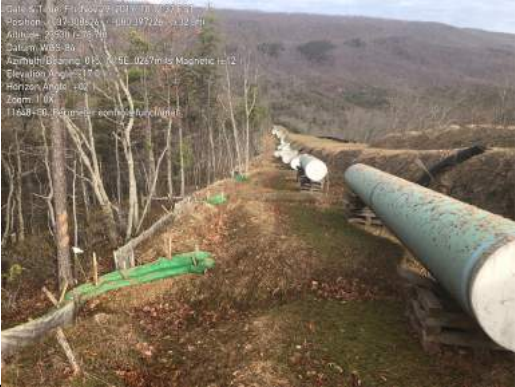
<p>Date & Time: Fri Nov 29, 2019 10:00:00 EST Position: 4397.306N, -7083.192W, 1114.5M Altitude: 2050 ft (625 m) Datum: WGS-84 Azimuth Bearing: 232 S20W 540mils Magnetic (+12) Elevation Angle: -33 Horizon Angle: -90.5 Zoom: 1.0x 11648+00 Perimeter controls in place</p>

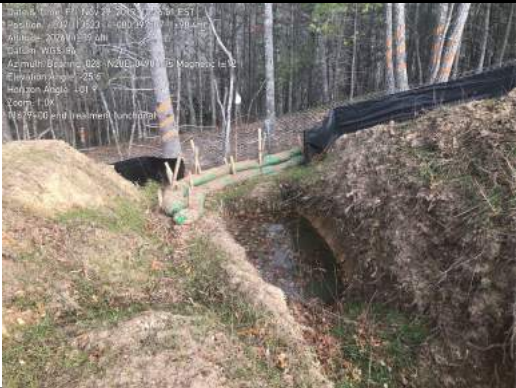
<p>Date & Time: Fri Nov 29, 2019 10:00:00 EST Position: 4397.306N, -7083.192W, 1114.5M Altitude: 2050 ft (625 m) Datum: WGS-84 Azimuth Bearing: 232 S20W 540mils Magnetic (+12) Elevation Angle: -33 Horizon Angle: -90.5 Zoom: 1.0x 11629+00 End treatments functional</p>

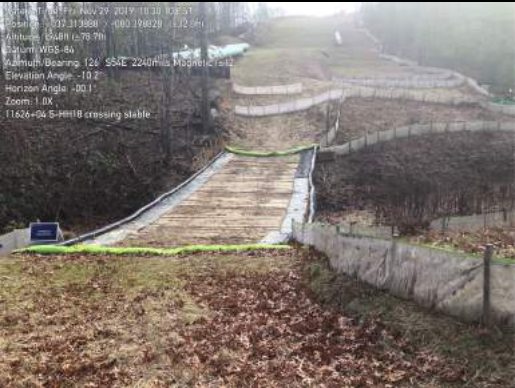
<p>Date & Time: Fri Nov 29, 2019 10:00:00 EST Position: 4397.306N, -7083.192W, 1114.5M Altitude: 2050 ft (625 m) Datum: WGS-84 Azimuth Bearing: 232 S20W 540mils Magnetic (+12) Elevation Angle: -33 Horizon Angle: -90.5 Zoom: 1.0x 11626+04 S-HH18 crossing stable</p>			
GPS Location	On photo	GPS Location	On photo		
Field Station#	11629+00	Field Station#	11626+04		
Pic 5 Desc.	Slope breakers, sumps and end treatment are working properly	Pic 6 Desc.	S-HH18 crossing is stable

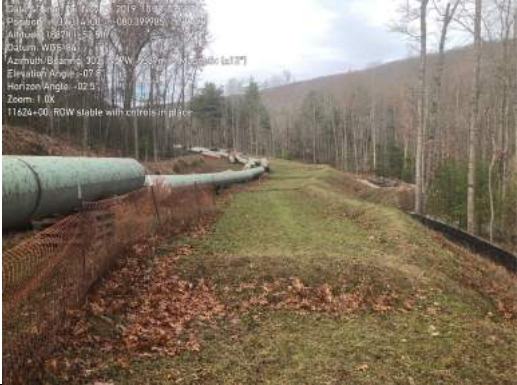
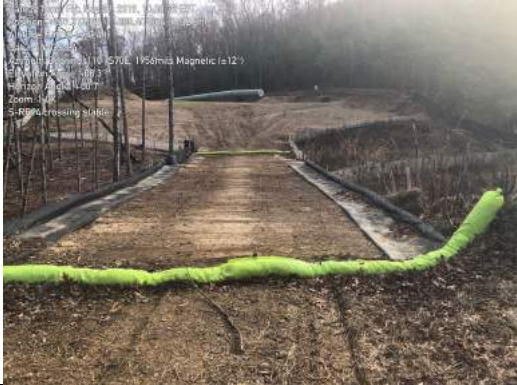
GPS Location	On photo	GPS Location	On photo		
Field Station#	11624+00	Field Station#	11614+20		
Pic 7 Desc.	ECDs in place. No movement of soils	Pic 8 Desc.	S-RR14 crossing stable. Flow disappears into ground at edge of bridge.		
Insert image here		Insert image here			
GPS Location		GPS Location			
Field Station#		Field Station#			
Pic 9 Desc.		Pic 10 Desc.			
Insert image here		Insert image here			
GPS Location		GPS Location			
Field Station#		Field Station#			
Pic 11 Desc.		Pic 12 Desc.

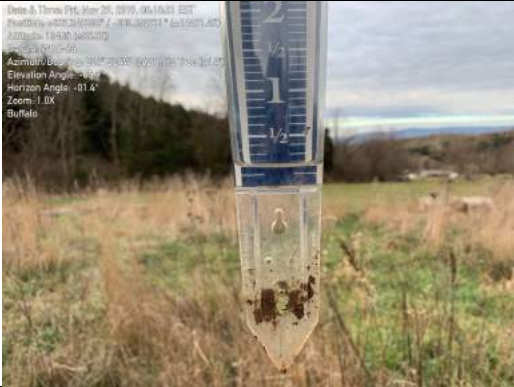
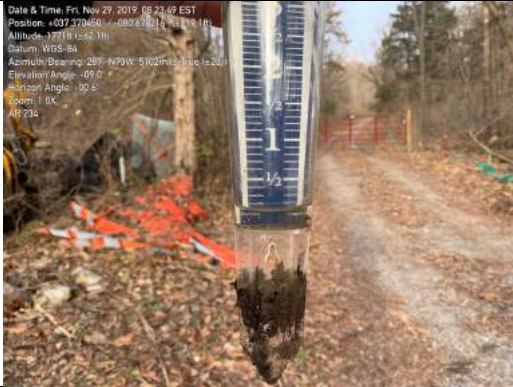
GPS Location	See photo for GPS location.		GPS Location	See photo for GPS location.	
Field Station#	10696+00		Field Station#	12005+00	
Pic 1 Desc.	Rain gauge at Buffalo Anklets Road reads 0.2 inches.		Pic 2 Desc.	Rain gauge at Access Road 234 reads 0.2 inches.

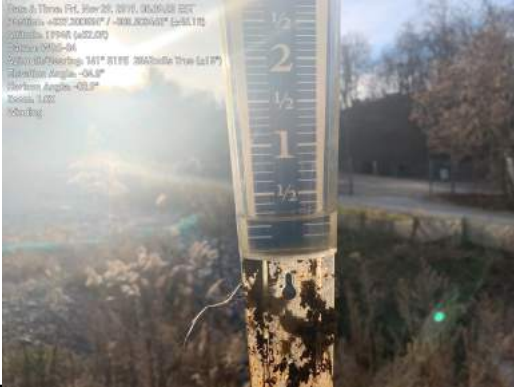
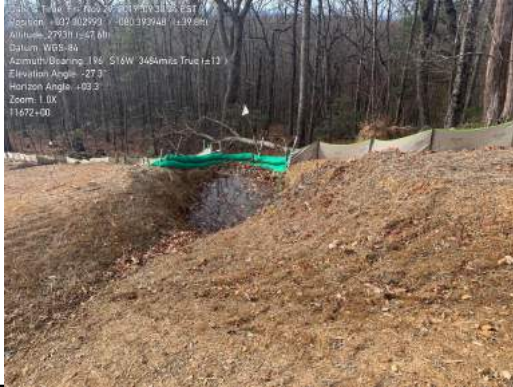
GPS Location	See photo for GPS location.		GPS Location	See photo for GPS location.	
Field Station#	11125+00		Field Station#	11672+00	
Pic 3 Desc.	Rain gauge at Winding Way reads 0.3 inches.		Pic 4 Desc.	Waterbar, end treatment, and sump pit in place.

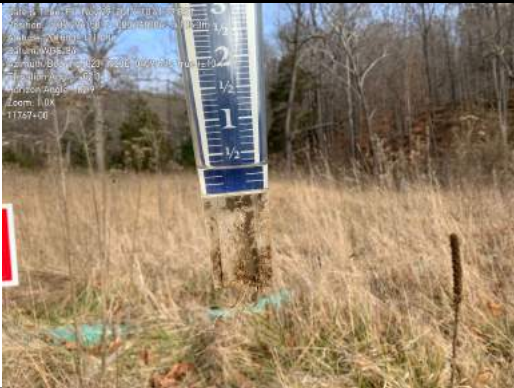
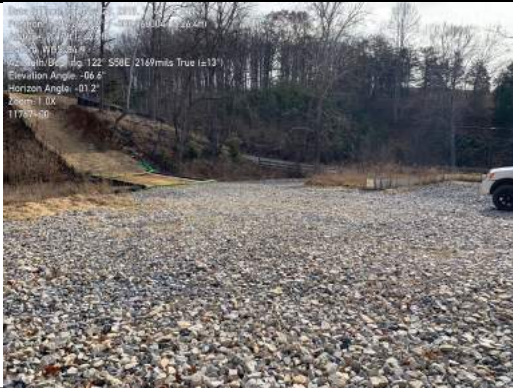
GPS Location	See photo for GPS location.		GPS Location	See photo for GPS location.	
Field Station#	11767+00		Field Station#	11767+00	
Pic 5 Desc.	Rain gauge at Mount Tabor Road reads 0.3 inches.		Pic 6 Desc.	RCE in place at Main Line Valve 26.
