Visual Site Inspection Report

Project Name	H-600 Pipeline Spread G	AFE	124300137	Spread	H-600 Pipeline Spread G
Contractor	Precision			Report #	5568
Inspector	Len Kruizenga			Date/Time	11/4/2019 7:20 AM
Permit #	TBD	Inspection Type	VA SWPP	Station Begin	11022+00
State	VA	Inspection Area	Full	Station End	10930+00
County	Giles	Ground	Wet	Temperature (°F)	35.00
Municipality	N/A	Weather	Sunny	Rain Gauge (in)	0.00
				Rain Accumulation Time (days)	3.00

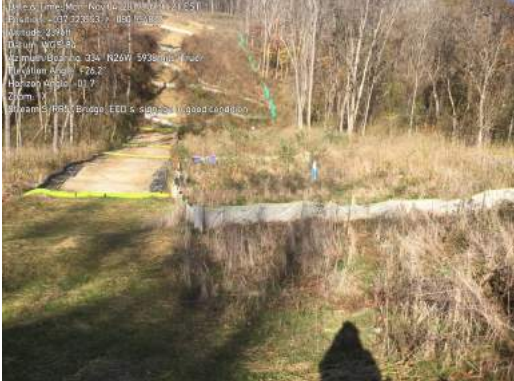
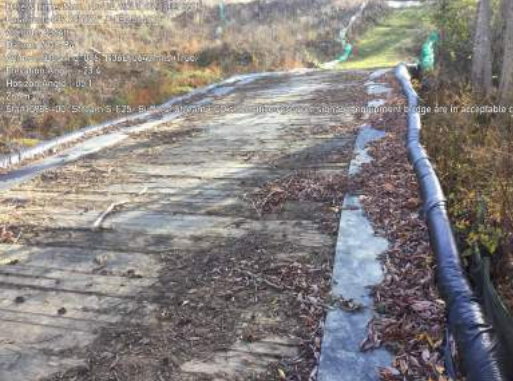
GPS Location	See photo GPS		GPS Location	See photo GPS	
Field Station#	11017+00		Field Station#	10986+00	
Pic 1 Desc.	Stream S-RR5- Buffers, equipment bridge, stream ECD's, sensitive resource signage are in acceptable condition.		Pic 2 Desc.	Stream S-E25- Buffers, Equipment bridge, stream ECD's, sensitive resource signage are in acceptable condition.

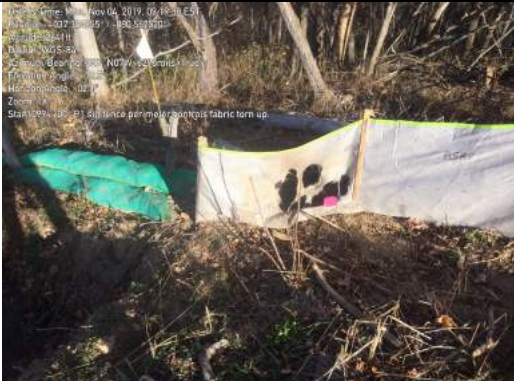
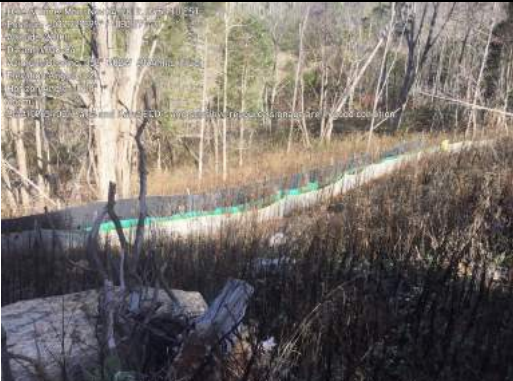
GPS Location	See photo GPS		GPS Location	See photo GPS	
Field Station#	10994+00		Field Station#	10965+00	
Pic 3 Desc.	P1 bear damage, environmental crew replaced silt fence.		Pic 4 Desc.	Karst & Karst ECD's & sensitive resource signage are in acceptable condition.

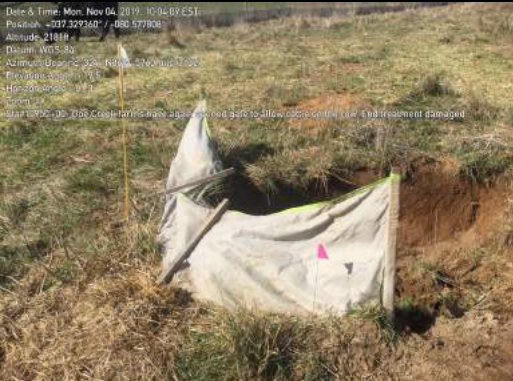
GPS Location	See photo GPS		GPS Location	See photo GPS	
Field Station#	10950+00		Field Station#	10947+00	
Pic 5 Desc.	Doe Creek Farms has again opened gate to allow cattle to graze on row.		Pic 6 Desc.	P1 end treatment damaged by cattle on Doe Creek Farms.

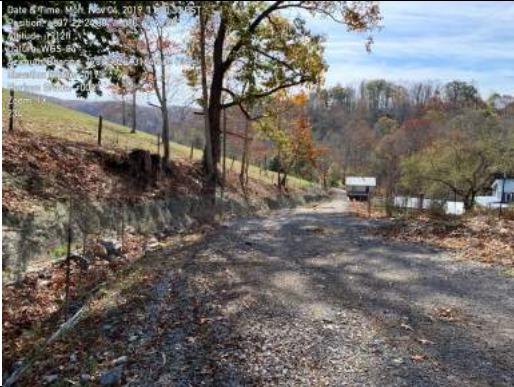
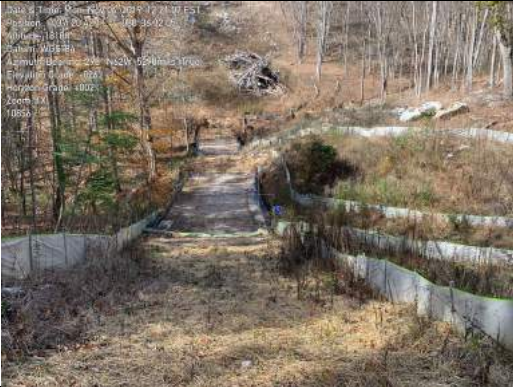
GPS Location	See picture above for GPS coordinates		GPS Location	See picture above for GPS coordinates	
Field Station#	2+34		Field Station#	10856+00	
Pic 1 Desc.	ECD's and row conditions		Pic 2 Desc.	ECD's and row conditions

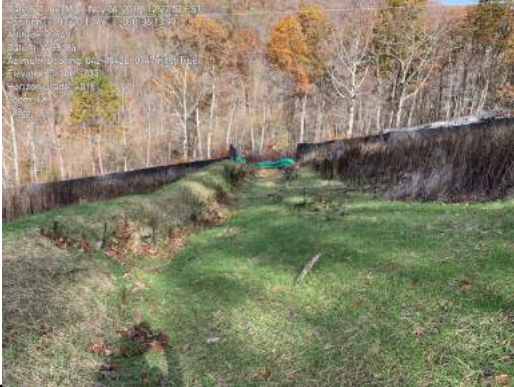
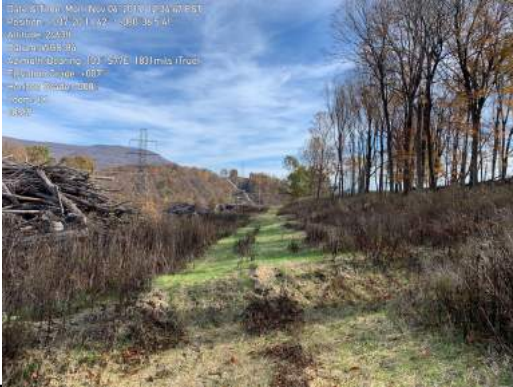
GPS Location	See picture above for GPS coordinates		GPS Location	See picture above for GPS coordinates	
Field Station#	108+61		Field Station#	10869+00	
Pic 3 Desc.	ECD's and row conditions		Pic 4 Desc.	ECD's and row conditions

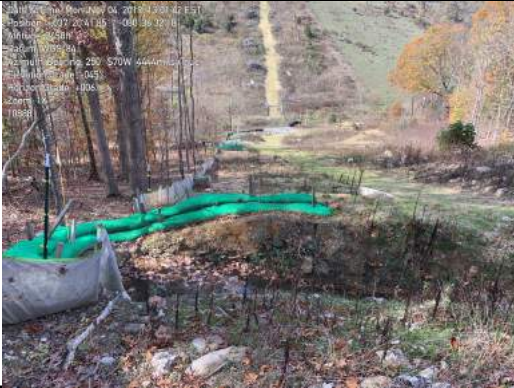
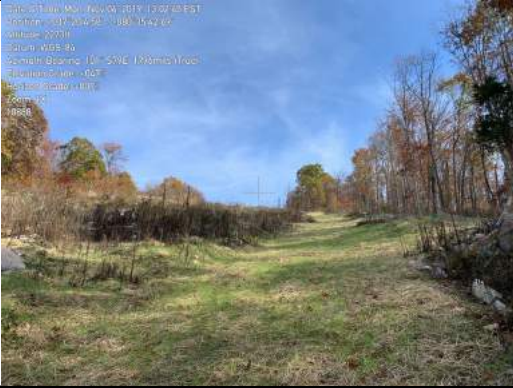
GPS Location	See picture above for GPS coordinates		GPS Location	See picture above for GPS coordinates	
Field Station#	10888+00		Field Station#	108880+00	
Pic 5 Desc.	ECD's and row conditions		Pic 6 Desc.	ECD's and row conditions

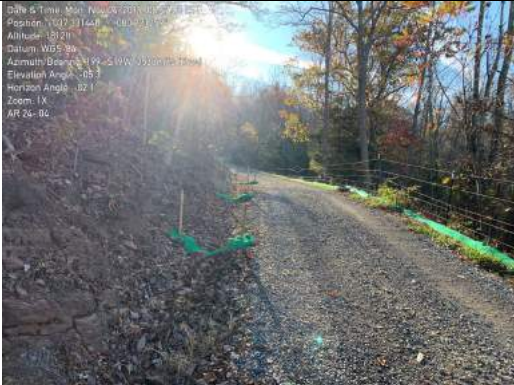
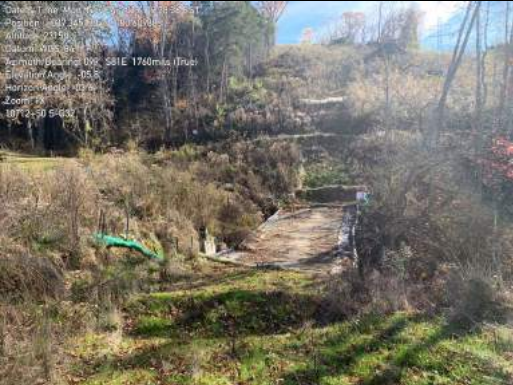
GPS Location	See photo for GPS location.		GPS Location	See photo for GPS location.	
Field Station#	12005+00		Field Station#	10712+50	
Pic 1 Desc.	Compost filter sock checks in place in bar ditch along access road 241.01.		Pic 2 Desc.	Sensitive resource buffer in place at stream S-G33.

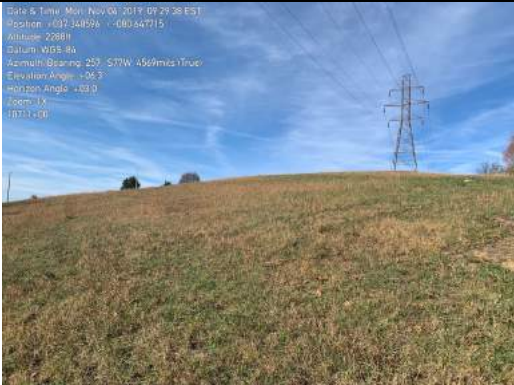
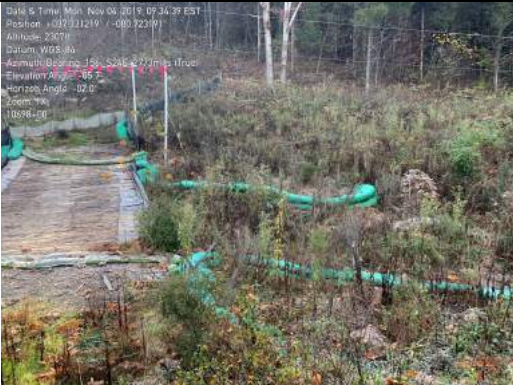
GPS Location	See photo for GPS location.		GPS Location	See photo for GPS location.	
Field Station#	10711+00		Field Station#	10698+00	
Pic 3 Desc.	ROW is stabilized with natural vegetation.		Pic 4 Desc.	Sensitive resource buffer in place at stream S-G32.

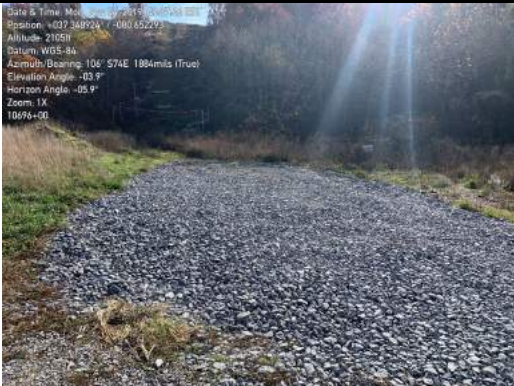
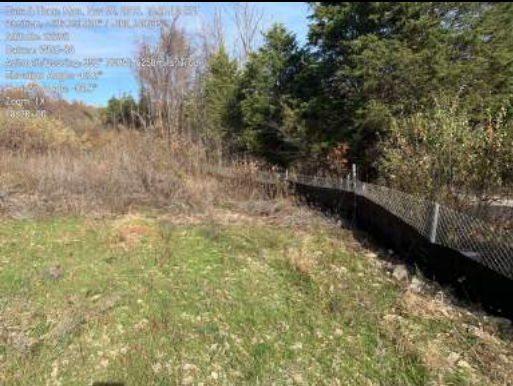
GPS Location	See photo for GPS location.		GPS Location	See photo for GPS location.	
Field Station#	10696+00		Field Station#	10670+00	
Pic 5 Desc.	RCE in place at buffalo Buffalo Anklets Road crossing to assist with the prevention of track out.		Pic 6 Desc.	Reinforced super silt fence in place along LOD.

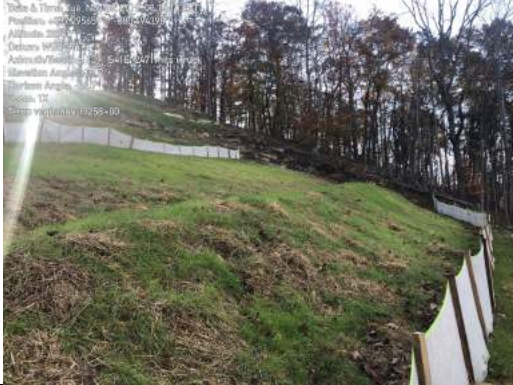
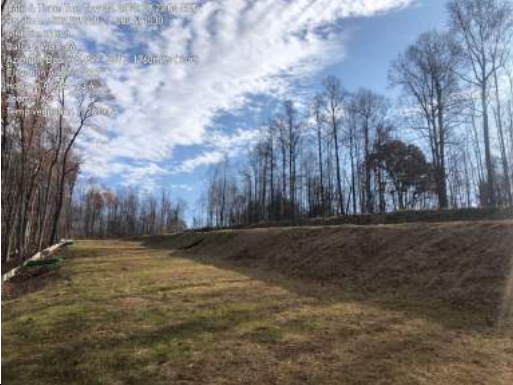
GPS Location	1		GPS Location	2	
Field Station#	11258+00		Field Station#	11263+00	
Pic 1 Desc.	Temporary stabilization.		Pic 2 Desc.	Temporary stabilization.

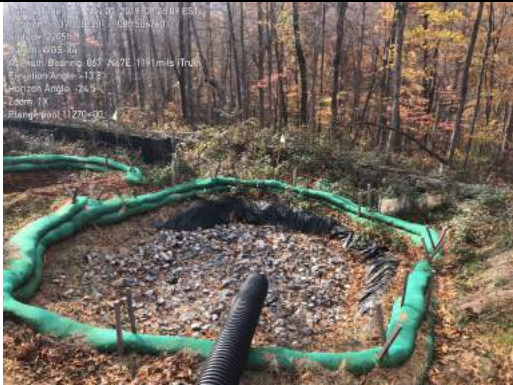
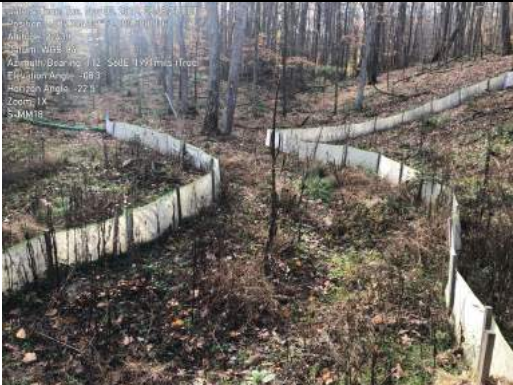
GPS Location	3		GPS Location	4	
Field Station#	11270+00		Field Station#	11292+80	
Pic 3 Desc.	Plunge pool.		Pic 4 Desc.	S-MM18.

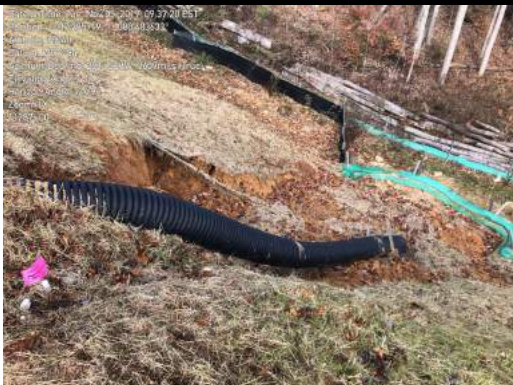
GPS Location	5		GPS Location	6	
Field Station#	11287+00		Field Station#	11287+00	
Pic 5 Desc.	Stuffed fill at slope drain filling sump.		Pic 6 Desc.	Repaired fill slope and rerouted slope drain pipe to new sump and end treatment.

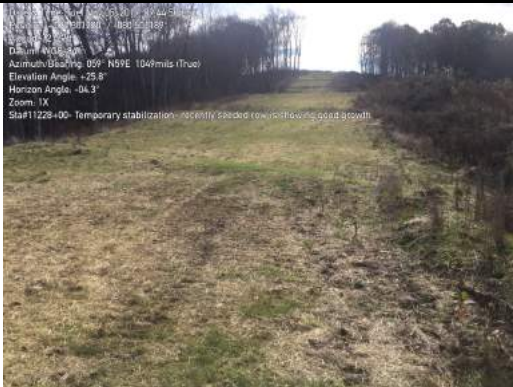
<p>Date & Time: Tue, Nov 05, 2019, 09:54:19 EST Position: +037.301651° / -000.502644° Altitude: 2059ft Datum: WGS-84 Azimuth/Bearing: 059° N59E 1049mils (True) Elevation Angle: +25.8° Horizon Angle: -04.3° Magnetic: +000.0023° Zoom: 1X Sta#11228+00- Temporary stabilization- recently seeded row showing good growth.</p>		  <p>Date & Time: Tue, Nov 05, 2019, 09:54:19 EST Position: +037.301651° / -000.502644° Altitude: 2059ft Datum: WGS-84 Azimuth/Bearing: 355° N05W 6311mils (True) Elevation Angle: +14.6° Horizon Angle: -00.3° Magnetic: +000.0023° Zoom: 1X Sta#11225+00- Slope drain, end treatment & sump pit, rock swale are in acceptable condition.</p>			
GPS Location	See photo GPS	GPS Location	See photo GPS		
Field Station#	11228+00	Field Station#	11225+00		
Pic 1 Desc.	Temporary stabilization- Row showing good growth.	Pic 2 Desc.	Slope drain, end treatment & sump pit, rock swale are in acceptable condition.

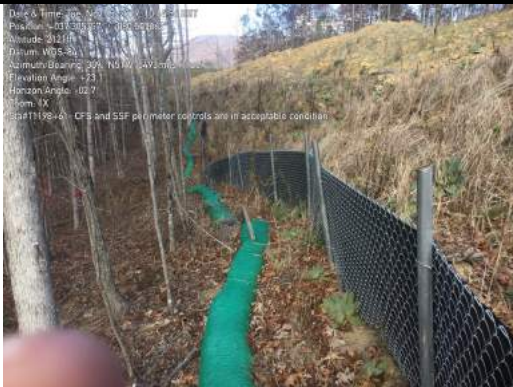
<p>Date & Time: Tue, Nov 05, 2019, 10:25:20 EST Position: +037.300714° / -000.503001° Altitude: 2111ft Datum: WGS-84 Azimuth/Bearing: 306° N30E 5415mils (True) Elevation Angle: +23° Horizon Angle: -02.7° Magnetic: +000.0023° Zoom: 1X Sta#11198+61- CFS and SSF perimeter controls are in acceptable condition.</p>		  <p>Date & Time: Tue, Nov 05, 2019, 10:25:20 EST Position: +037.300714° / -000.503001° Altitude: 2111ft Datum: WGS-84 Azimuth/Bearing: 307° N30E 5509mils (True) Elevation Angle: +23° Horizon Angle: -02.7° Magnetic: +000.0023° Zoom: 1X Sta#11191+00- ECD's at drainage feature are in acceptable condition.</p>			
GPS Location	See photo GPS	GPS Location	See photo GPS		
Field Station#	11198+61	Field Station#	11191+00		
Pic 3 Desc.	CFS and SSF perimeter controls are in acceptable condition.	Pic 4 Desc.	ECD's at drainage feature are in acceptable condition.		
  <p>Date & Time: Tue, Nov 05, 2019, 10:31:49 EST Position: +037.309230° / -000.513127° Altitude: 1858ft Datum: WGS-84 Azimuth/Bearing: 324° N36W 5760mils (True) Elevation Angle: +16.7° Horizon Angle: -03.7° Magnetic: +000.0023° Zoom: 1X Sta#11184+00- CWD pipe, plunge pool, ECD's are in acceptable condition.</p>		  <p>Date & Time: Tue, Nov 05, 2019, 10:31:49 EST Position: +037.309230° / -000.513127° Altitude: 1858ft Datum: WGS-84 Azimuth/Bearing: 324° N36W 5760mils (True) Elevation Angle: +16.7° Horizon Angle: -03.7° Magnetic: +000.0023° Zoom: 1X Sta#11172+70- Slope drain, CFS checks, sump & end treatment are in acceptable condition.</p>

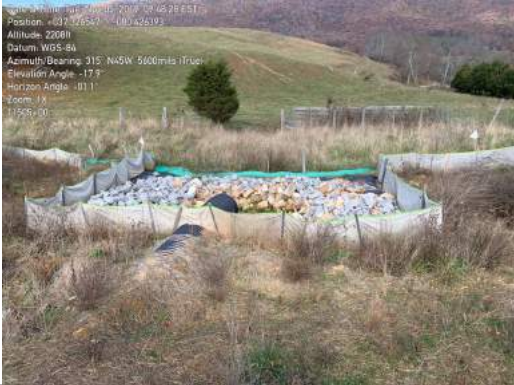
GPS Location	See photo for GPS location.		GPS Location	See photo for GPS location.	
Field Station#	11505+00		Field Station#	11484+00	
Pic 3 Desc.	Plunge pool and clean water diversion pipe in place.		Pic 4 Desc.	Compost filter sock end treatment undermined.	
  <p> Date & Time: Tue Nov 05, 2019 11:47:11 Position: +02 11471+00 Altitude: 2261 ft Datum: WGS 84 Azimuth Bearing: 224 S44W 3982mils (True) Elevation Angle: -10.8° Horizon Angle: 102.8° Zoom: 1X 11471+00 </p>		  <p> Date & Time: Tue Nov 05, 2019 11:36:07 Position: +02 11367+00 Altitude: 2261 ft Datum: WGS 84 Azimuth Bearing: 224 S44W 3982mils (True) Elevation Angle: -10.8° Horizon Angle: 102.8° Zoom: 1X 11367+00 </p>			
GPS Location	See photo for GPS location.		GPS Location	See photo for GPS location.	
Field Station#	11471+00		Field Station#	11367+00	
Pic 5 Desc.	RCE and sock checks in place along bar ditch.		Pic 6 Desc.	Clean water diversion pipe and clean water diversion berm in place.

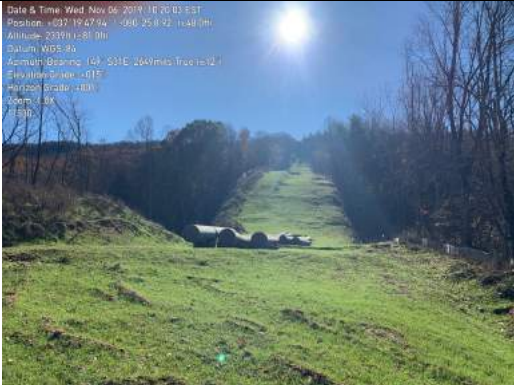
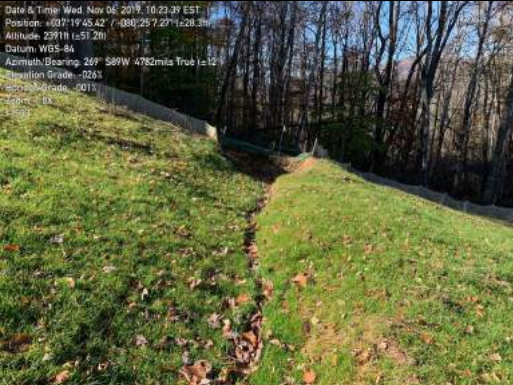
GPS Location	See picture above for GPS coordinates		GPS Location	See picture above for GPS coordinates	
Field Station#	11530+00		Field Station#	11533+00	
Pic 1 Desc.	ECD's and row conditions		Pic 2 Desc.	ECD's and row conditions

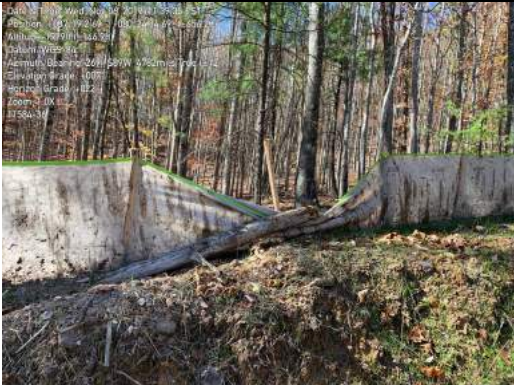
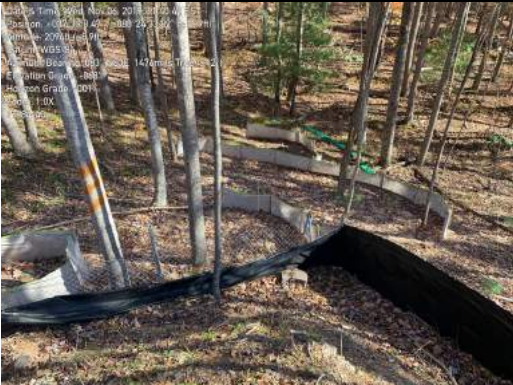
GPS Location	See picture above for GPS coordinates		GPS Location	See picture above for GPS coordinates	
Field Station#	11584+36		Field Station#	11584+40	
Pic 3 Desc.	ECD's and row conditions		Pic 4 Desc.	ECD's and row conditions

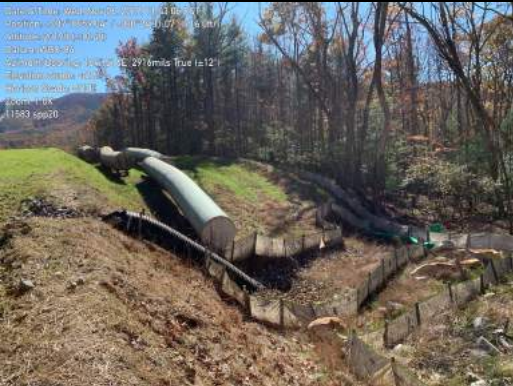
GPS Location	See picture above for GPS coordinates		GPS Location	See picture above for GPS coordinates	
Field Station#	11584+00		Field Station#	11583+00	
Pic 5 Desc.	ECD's and row conditions		Pic 6 Desc.	ECD's and row conditions

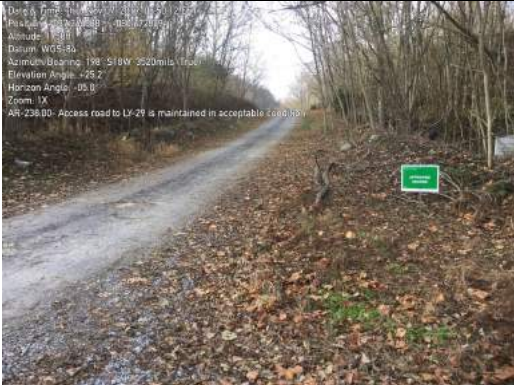
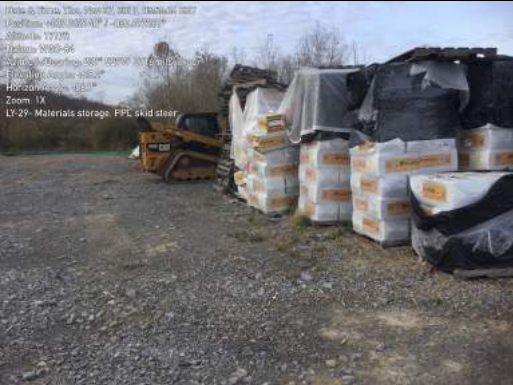
GPS Location	See photo GPS	GPS Location	See photo GPS		
Field Station#	12005+00	Field Station#	12005+00		
Pic 1 Desc.	AR-238.00, access road to LY-29 is maintained in acceptable condition.	Pic 2 Desc.	LY-29- Materials storage and PPL skid steer.

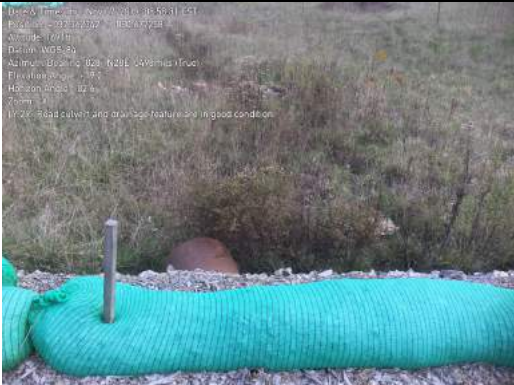
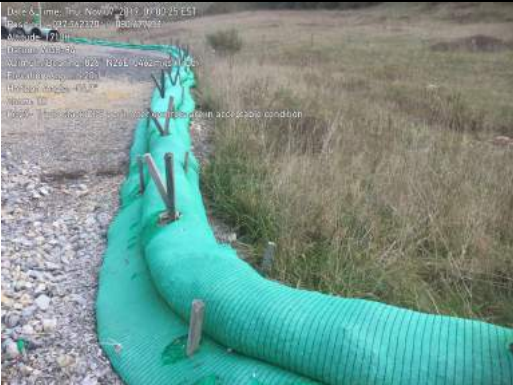
GPS Location	See photo GPS	GPS Location	See photo GPS		
Field Station#	12005+00	Field Station#	12005+00		
Pic 3 Desc.	LY-29- Road culvert and drainage feature are in acceptable condition.	Pic 4 Desc.	LY-29- Triple stack CFS perimeter controls are in acceptable condition.

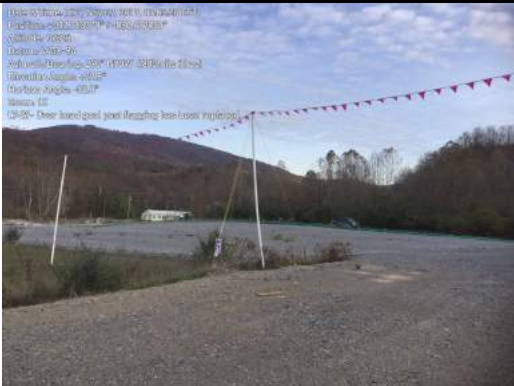
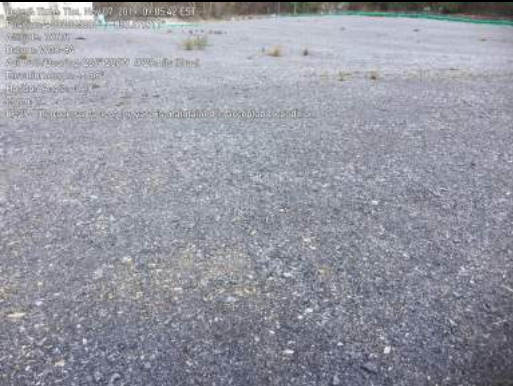
GPS Location	See photo GPS	GPS Location	See photo GPS		
Field Station#	12005+00	Field Station#	12005+00		
Pic 5 Desc.	LY-29- Over head goal post flagging has been replaced.	Pic 6 Desc.	LY-29- The rock surface in the yard is maintained in acceptable condition.

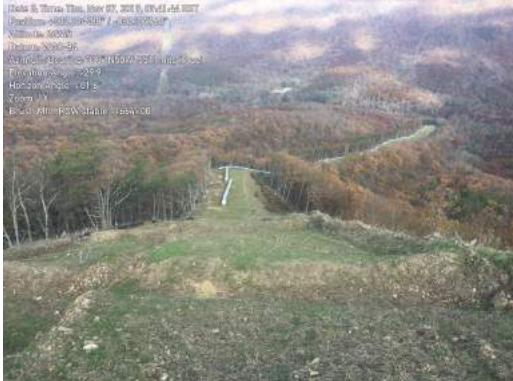
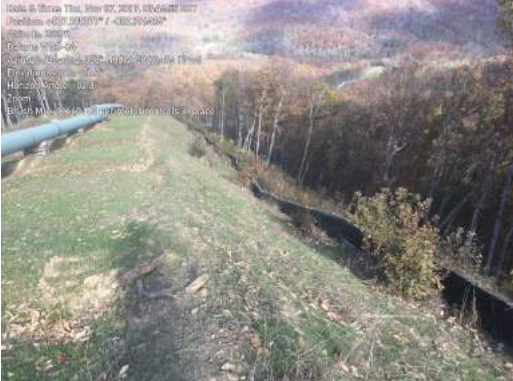
GPS Location	On photo	GPS Location	On photo		
Field Station#	11664+00	Field Station#	11660+00		
Pic 1 Desc.	Slope breakers functional. Grasses present. Surface stable.	Pic 2 Desc.	No erosion. Perimeter controls in place.

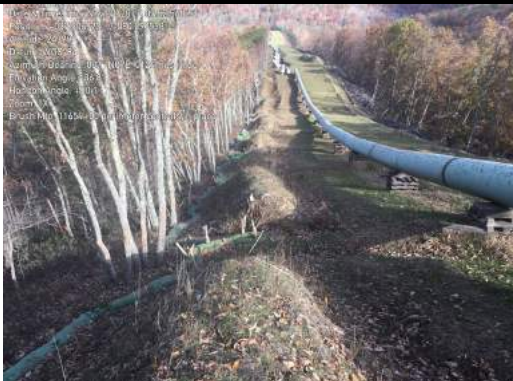
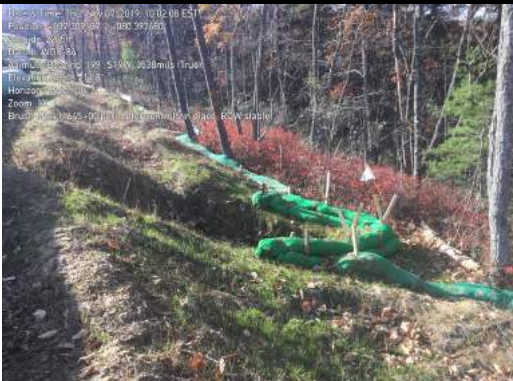
GPS Location	On photo	GPS Location	On photo		
Field Station#	11654+00	Field Station#	11645+00		
Pic 3 Desc.	Perimeter controls in place. ROW stable.	Pic 4 Desc.	Perimeter controls in place.

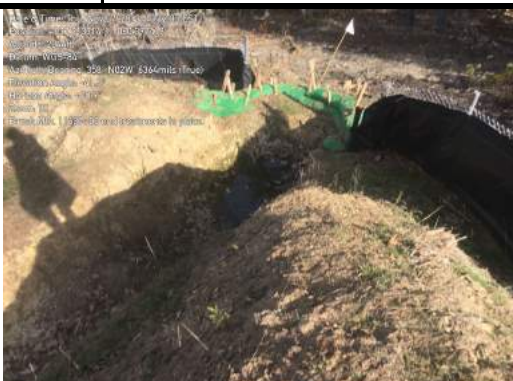
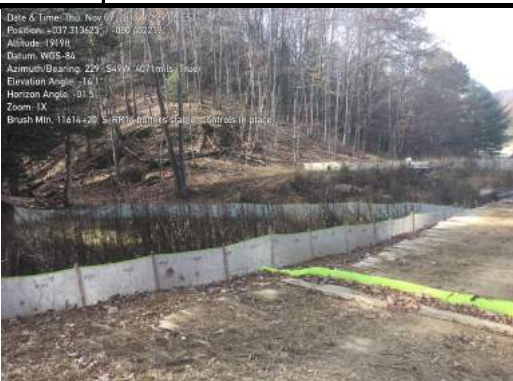
GPS Location	On photo	GPS Location	On photo		
Field Station#	11630+00	Field Station#	11614+20		
Pic 5 Desc.	End treatments in place and functional	Pic 6 Desc.	Stream buffers are stable with controls in place

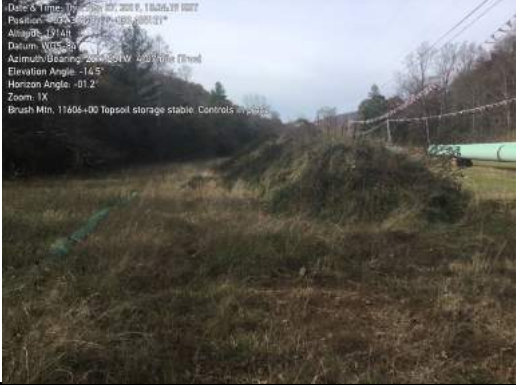
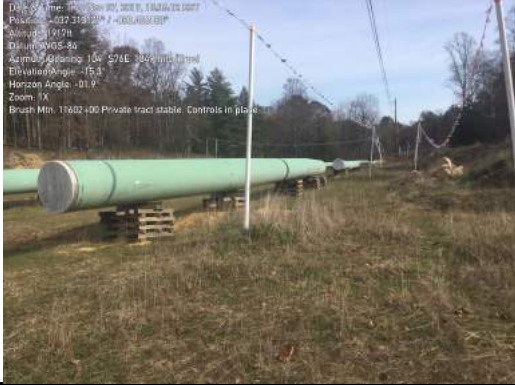
GPS Location	On photo	GPS Location	On photo		
Field Station#	11606+00	Field Station#	11602+00		
Pic 7 Desc.	ROW stable. Perimeter controls are in place.	Pic 8 Desc.	No erosion issues located. ROW stable.		
Insert image here		Insert image here			
GPS Location		GPS Location			
Field Station#		Field Station#			
Pic 9 Desc.		Pic 10 Desc.			
Insert image here		Insert image here			
GPS Location		GPS Location			
Field Station#		Field Station#			
Pic 11 Desc.		Pic 12 Desc.

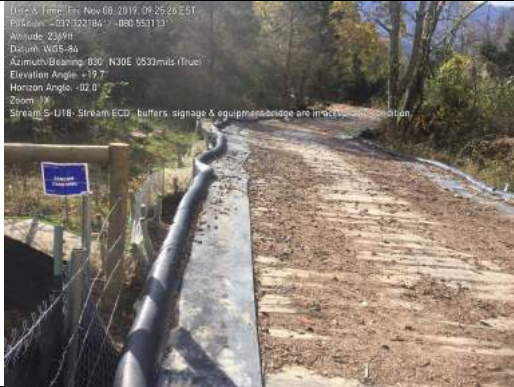
<p>Date & Time: Fri, Nov 08, 2019, 09:25:26 -05 Position: -037.322084 / -080.953113 Altitude: 2369ft Datum: WGS-84 Azimuth/Bearing: 030° N30E 053mils (True) Elevation Angle: +19.7° Horizon Angle: -02.0° Zoom: IX Stream S-IJ18- Stream ECD's, buffers, signage & equipment bridge are in acceptable condition</p>		GPS Location	See photo GPS
Field Station#	11022+00	Field Station#	11022+00	GPS Location	See photo GPS
Pic 1 Desc.	AR-244.00 rain gauge reading- 0.10"	Pic 2 Desc.	Ar-244 - Stream S-IJ18- Equipment bridge, sensitive resource signage, buffers & ECD's are in acceptable condition	GPS Location	See photo GPS

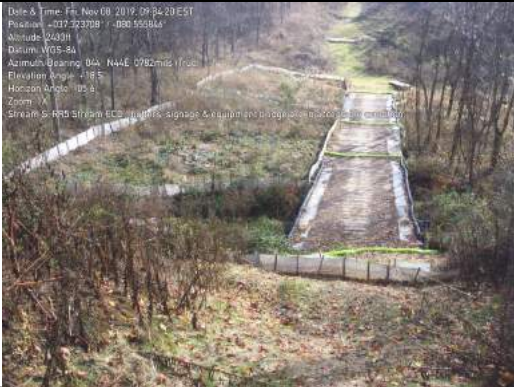
<p>Date & Time: Fri, Nov 08, 2019, 09:34:29 -05 Position: -037.323708 / -080.953864 Altitude: 2639ft Datum: WGS-84 Azimuth/Bearing: 044° N44E 078mils (True) Elevation Angle: +18.5° Horizon Angle: -05.5° Zoom: IX Stream S-RR5- Stream ECD's, buffers, signage & equipment bridge are in acceptable condition</p>

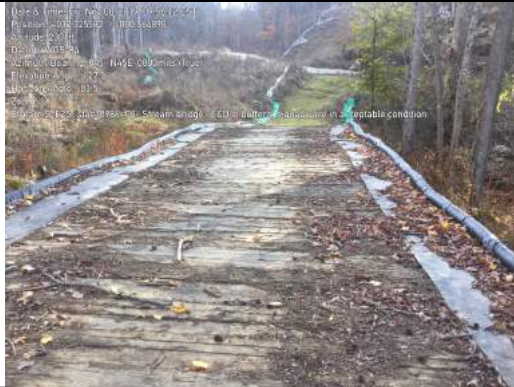
<p>Date & Time: Fri, Nov 08, 2019, 09:36:06 -05 Position: -037.324052 / -080.954090 Altitude: 2531ft Datum: WGS-84 Azimuth/Bearing: 044° N44E 080mils (True) Elevation Angle: +17.2° Horizon Angle: -05.1° Zoom: IX Stream S-E25- Stream ECD's, buffers, signage & equipment bridge are in acceptable condition</p>		GPS Location	See photo GPS
Field Station#	11017+00	Field Station#	10986+00	GPS Location	See photo GPS
Pic 3 Desc.	Stream S-RR5- Equipment bridge, ECD's, sensitive resource signage, buffers are in acceptable condition.	Pic 4 Desc.	Stream S-E25- Equipment bridge, ECD's, sensitive resource signage, buffers are in acceptable condition.	GPS Location	See photo GPS

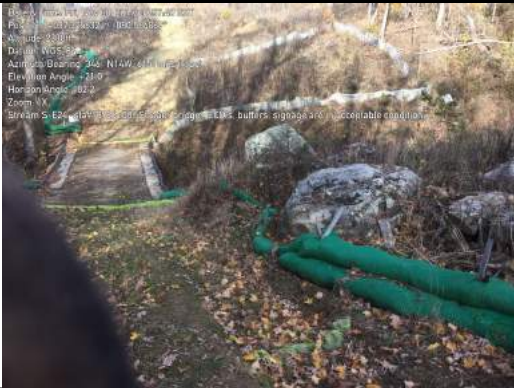
<p>Date & Time: Fri, Nov 08, 2019, 09:46:02 -05 Position: -037.323309 / -080.953888 Altitude: 2880ft Datum: WGS-84 Azimuth/Bearing: 344° N14W 041mils (True) Elevation Angle: +21.0° Horizon Angle: -02.3° Zoom: IX Stream S-E24- Equipment bridge, buffers, ECD's, sensitive resource signage are in acceptable condition</p>

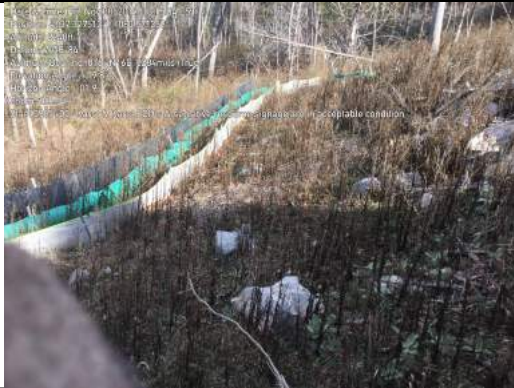
<p>Date & Time: Fri, Nov 08, 2019, 09:47:07 -05 Position: -037.323309 / -080.953888 Altitude: 2880ft Datum: WGS-84 Azimuth/Bearing: 344° N14W 041mils (True) Elevation Angle: +21.0° Horizon Angle: -02.3° Zoom: IX Karst and Karst ECD's and sensitive resource signage are in acceptable condition</p>		GPS Location	See photo GPS
Field Station#	10985+00	Field Station#	10965+00	GPS Location	See photo GPS
Pic 5 Desc.	Stream S-E24- Equipment bridge, buffers, ECD's, sensitive resource signage are in acceptable condition.	Pic 6 Desc.	Karst and Karst ECD's and sensitive resource signage are in acceptable condition	GPS Location	See photo GPS

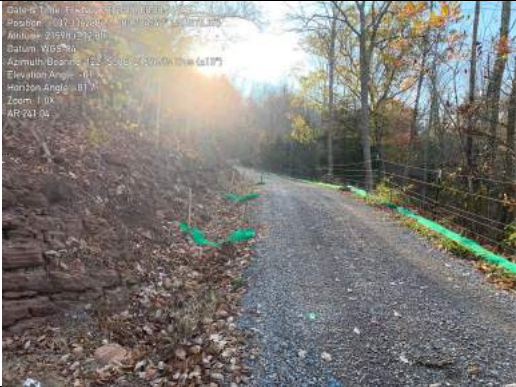
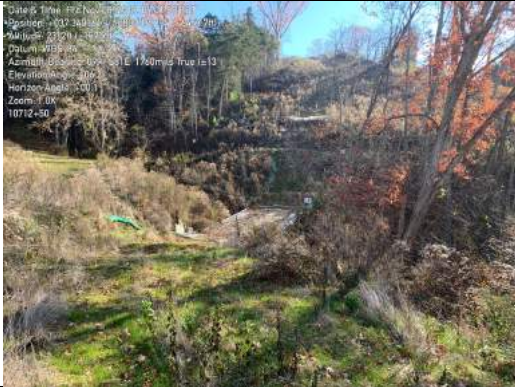
GPS Location	See photo for GPS location.		GPS Location	See photo for GPS location.	
Field Station#	12005+00		Field Station#	10712+50	
Pic 1 Desc.	Compost filter sock check in place in bar ditch along access road.		Pic 2 Desc.	Sensitive resource buffer in place at stream S-G33.

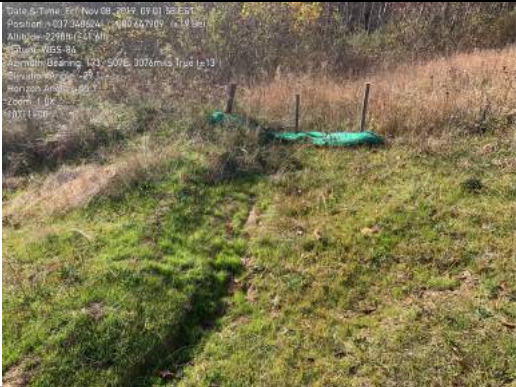
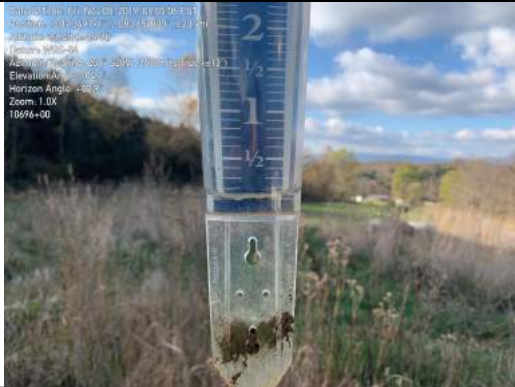
GPS Location	See photo for GPS location.		GPS Location	See photo for GPS location.	
Field Station#	10711+00		Field Station#	10696+00	
Pic 3 Desc.	Waterbar in place across travel lane with compost filter sock end treatment.		Pic 4 Desc.	Rain gauge at Buffalo Anklets Road reads 0.2 inches.

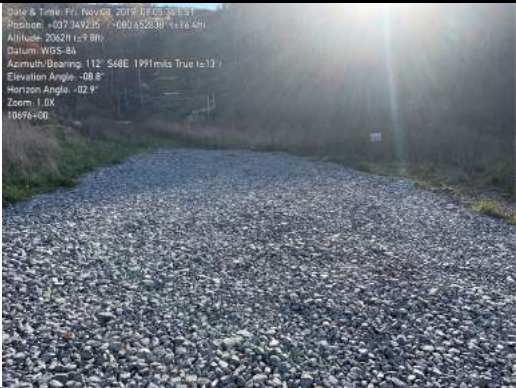
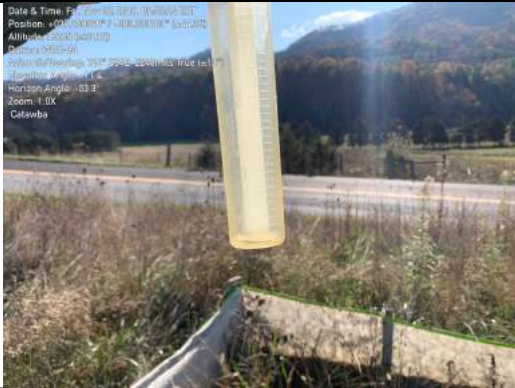
GPS Location	See photo for GPS location.		GPS Location	See photo for GPS location.	
Field Station#	10696+00		Field Station#	11990+00	
Pic 5 Desc.	RCE in place at Buffalo Anklets Road to assist with the prevention of track out.		Pic 6 Desc.	Rain gauge at Catawba Road reads 0.1 inches.
