Visual Site Inspection Report

Project Name	H-600 Pipeline Spread G	AFE	124300137	Spread	H-600 Pipeline Spread
Contractor	Precision			Report #	100003
Inspector	Garrett Barclay			Date/Time	9/19/2019 3:28 PM
Permit #	TBD	Inspection Type	VA SWPP	Station Begin	10840+00
State	VA	Inspection Area	Partial	Station End	10920+00
County	Giles	Ground	Dry	Temperature (°F)	63.00
Municipality	N/A	Weather	Sunny	Rain Gauge (in)	0.00
				Rain Accumulation Time (days)	1.00

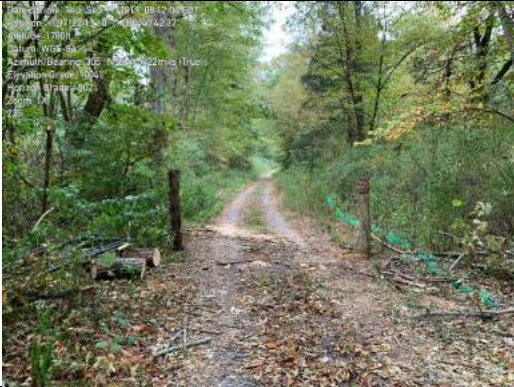
GPS Location	See picture above for GPS coordinates		GPS Location	See picture above for GPS coordinates	
Field Station#	2+35		Field Station#	2+34	
Pic 1 Desc.	Damaged tree and gate removed from AR 235		Pic 2 Desc.	ECD's and row conditions for AR 234

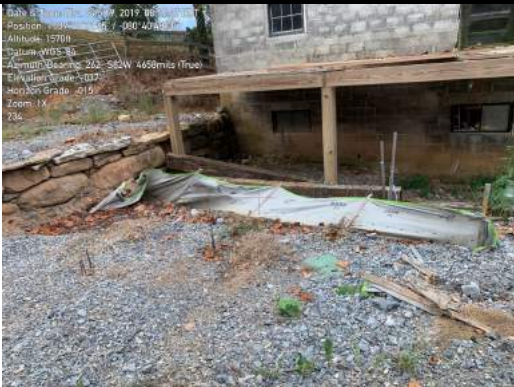
GPS Location	See picture above for GPS coordinates		GPS Location	See picture above for GPS coordinates	
Field Station#	2+34		Field Station#	10900+00	
Pic 3 Desc.	LO damaged P1SF @ AR 234		Pic 4 Desc.	ECD's and row conditions

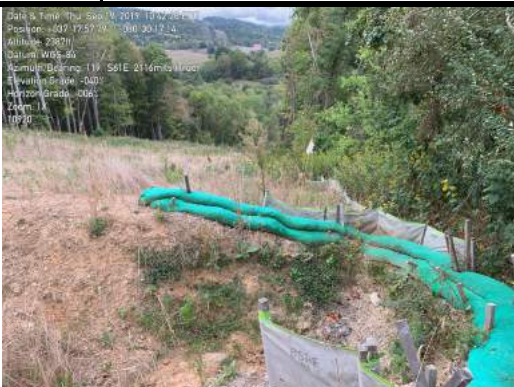
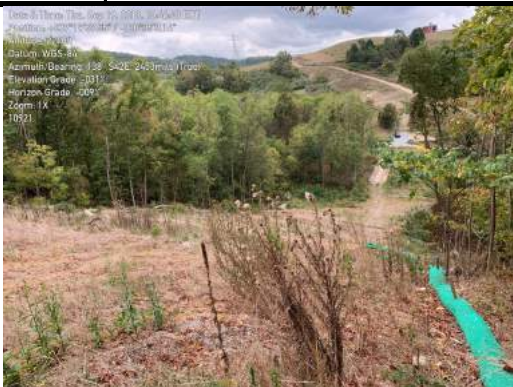
GPS Location	See picture above for GPS coordinates		GPS Location	See picture above for GPS coordinates	
Field Station#	10920+00		Field Station#	10921+00	
Pic 5 Desc.	ECD's and row conditions		Pic 6 Desc.	ECD's and row conditions

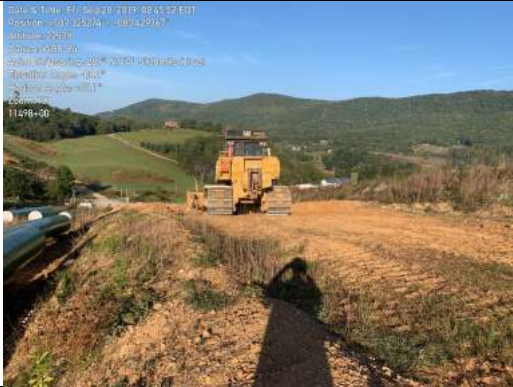
<p>Date & Time: Fri, Sep 20, 2019 8:43:52 EDT Position: -017 332222 / -080 439117 Altitude: 2088 ft Datum: WGS 84 Azimuth/Bearing: 45° S 51° W 4044mils (True) Elevation Angle: -10.5° Horizon Angle: +00.2° Zoom: 1x 11498+00</p>			
GPS Location	See photo for GPS location.		GPS Location	See photo for GPS location.	
Field Station#	11502+00		Field Station#	11498+00	
Pic 1 Desc.	Conveyance channel with rock checks in place through area with double cut.		Pic 2 Desc.	Environmental crew reinstalling waterbar.

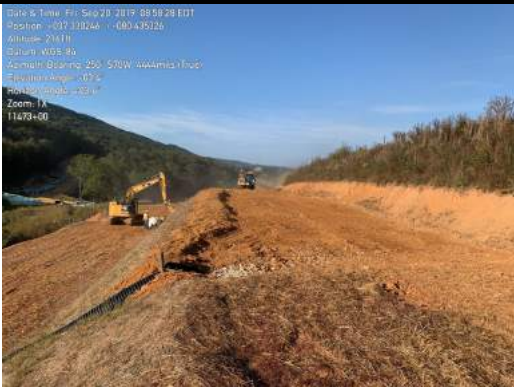
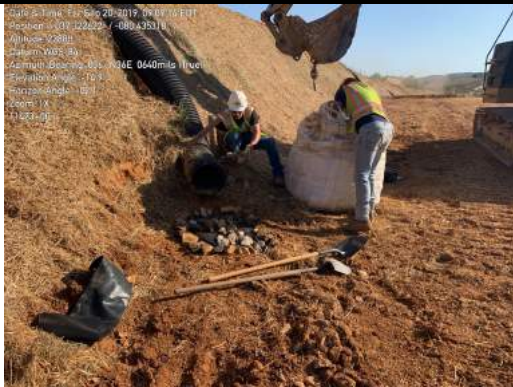
GPS Location	See photo for GPS location.		GPS Location	See photo for GPS location.	
Field Station#	11473+00		Field Station#	11473+00	
Pic 3 Desc.	Environmental crew spreading seed and mulch.		Pic 4 Desc.	Environmental crew reworking rock outlet at slope drains.

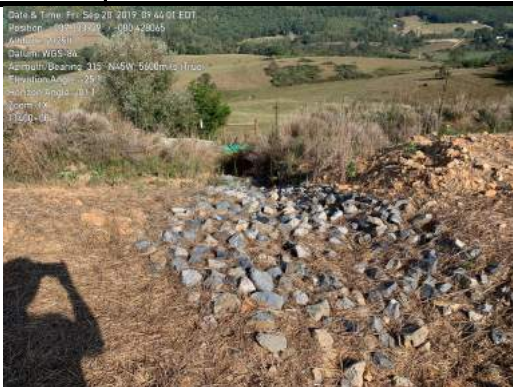
<p>Date & Time: Fri, Sep 20, 2019 9:44:01 EDT Position: -017 330244 / -080 435126 Altitude: 2161 ft Datum: WGS 84 Azimuth/Bearing: 45° S 51° W 4044mils (True) Elevation Angle: -10.5° Horizon Angle: +00.2° Zoom: 1x 11400+00</p>			
GPS Location	See photo for GPS location.		GPS Location	See photo for GPS location.	
Field Station#	11451+00		Field Station#	11400+00	
Pic 5 Desc.	Sensitive resource buffer in place at stream S-0012 and S-0013.		Pic 6 Desc.	Rock lined channel in place over fill slope to limit erosion.

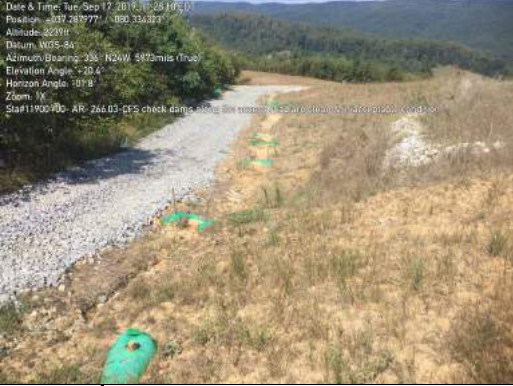
<p>Date & Time: Tue, Sep 17, 2019, 10:28:10 EDT Position: -83.728977° / -35.336317° Altitude: 2091ft Datum: WGS-84 Azimuth/Bearing: 235° N24W 583mils (True) Elevation Angle: +20.4° Horizon Angle: -18.8° Zoom: IX Sta#11900+00- AR-26603-CFS check dams along the road are in acceptable condition</p>			
GPS Location	See photo GPS		GPS Location	See photo GPS	
Field Station#	11818+00		Field Station#	11900+00	
Pic 1 Desc.	Restored row.		Pic 2 Desc.	AR-26603- CFS check dams are in acceptable condition.

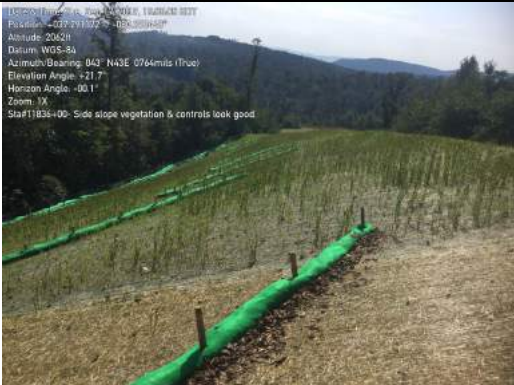
<p>Date & Time: Tue, Sep 17, 2019, 10:30:10 EDT Position: -83.7291172° / -35.3369469° Altitude: 2062ft Datum: WGS-84 Azimuth/Bearing: 043° N43E 076mils (True) Elevation Angle: +21.7° Horizon Angle: -00.1° Zoom: IX Sta#11836+00- Side slope vegetation & controls look good</p>

GPS Location	See photo GPS		GPS Location	See photo GPS	
Field Station#	11836+00		Field Station#	11942+00	
Pic 3 Desc.	Side slope vegetation is growing, controls are in acceptable condition.		Pic 4 Desc.	Karst and Karst ECD's are in acceptable condition.

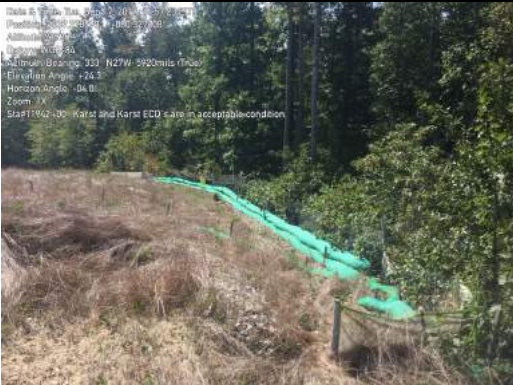
<p>Date & Time: Tue, Sep 17, 2019, 12:05:02 EDT Position: -83.7277069° / -35.326225° Altitude: 2000ft Datum: WGS-84 Azimuth/Bearing: 333° N27W 592mils (True) Elevation Angle: +24.3° Horizon Angle: -04.9° Zoom: IX Sta#11942+00- Karst and Karst ECD's are in acceptable condition</p>

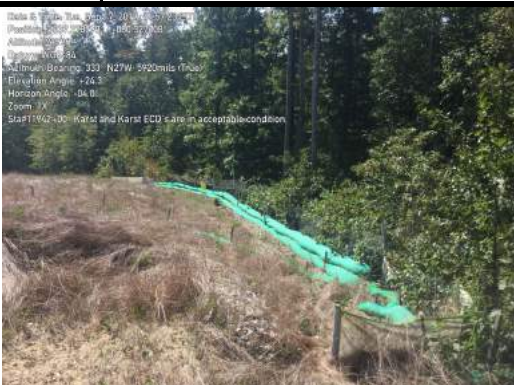
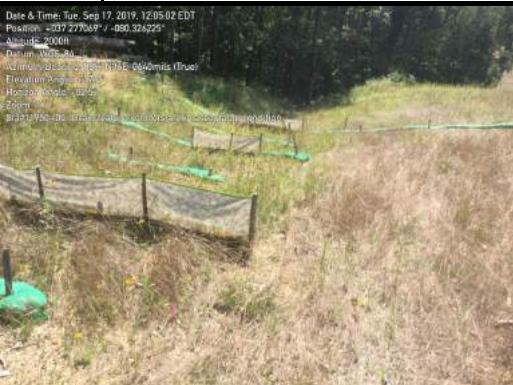
Pic 5 Desc.	Karst and Karst ECD's & signage are in acceptable condition.		Pic 6 Desc.	Drainage feature controls are in acceptable condition.

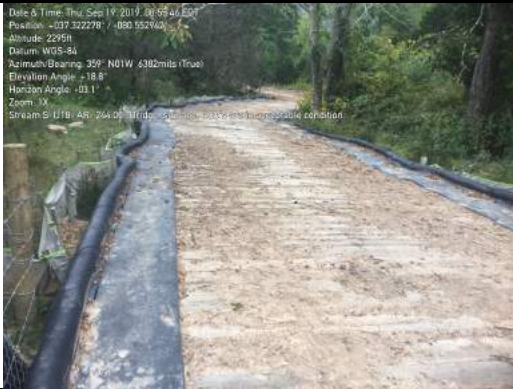
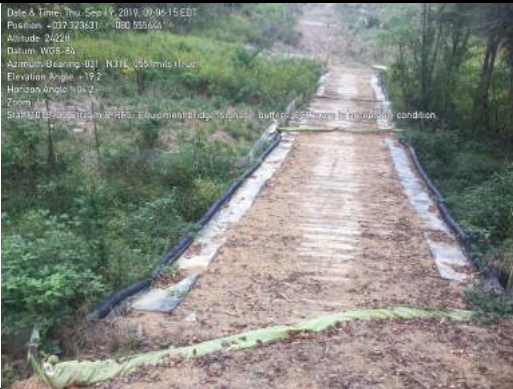
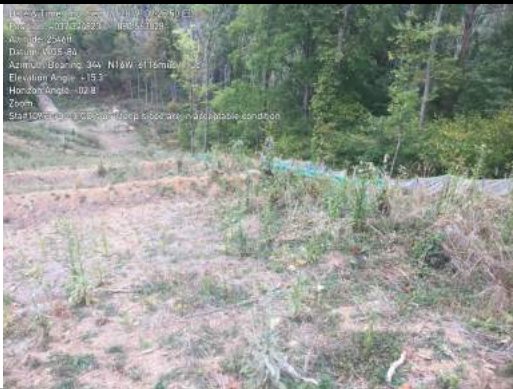
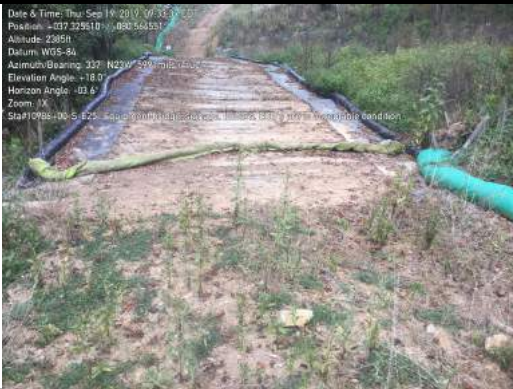
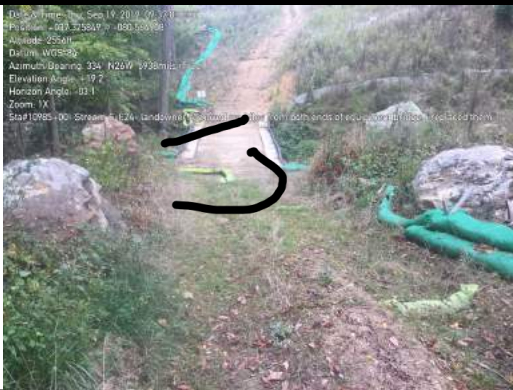
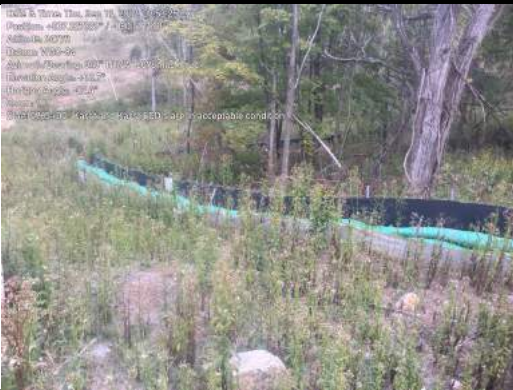
<p>Date & Time: Thu, Sep 19, 2019, 06:55:44 EDT Position: +037.322278, -080.552442 Altitude: 2295ft Datum: WGS-84 Azimuth/Bearing: 359° N01W 6382mils (True) Elevation Angle: +18.8° Horizon Angle: -03.1° Zoom: IX Stream S-IJ18- AR-244- Equipment bridge, signage, ECD's are in acceptable condition.</p>

<p>Date & Time: Thu, Sep 19, 2019, 07:04:15 EDT Position: +037.323631, -080.555003 Altitude: 2424ft Datum: WGS-84 Azimuth/Bearing: 021° N31E 655mils (True) Elevation Angle: +19.2° Horizon Angle: -04.2° Zoom: IX Stream -S-RR5- Equipment Bridge, ECD's, signage, buffers are in acceptable condition.</p>			
GPS Location	See photo GPS	GPS Location	See photo GPS		
Field Station#	11022+00	Field Station#	11016+00		
Pic 1 Desc.	Stream S-IJ18- AR-244- Equipment bridge, signage, ECD's are in acceptable condition.	Pic 2 Desc.	Stream -S-RR5- Equipment Bridge, ECD's, signage, buffers are in acceptable condition.

GPS Location	See photo GPS	GPS Location	See photo GPS		
Field Station#	10985+00	Field Station#	10965+00		
Pic 5 Desc.	Stream S-E24- Waddles removed from both ends of equipment bridge, by landowner, I replaced them.	Pic 6 Desc.	Karst and Karst ECD's are in acceptable condition.

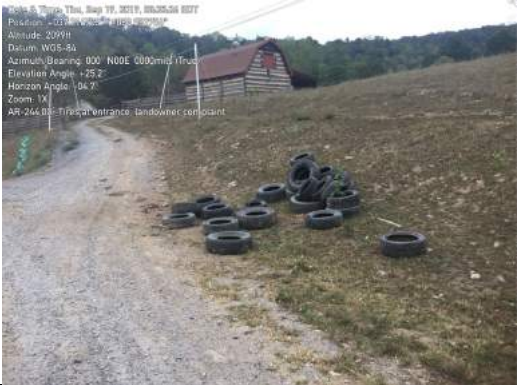
<p>Photo & Time: Thu, Sep 19, 2019, 10:05:28 EDT Position: 43.01414000, -80.01133000 Altitude: 209ft Datum: WGS-84 Azimuth/Bearing: 000° N00E 000mils (true) Elevation Angle: +25.2° Horizon Angle: 104.7° Zoom: 1X AR-244.00- Tires at entrance, landowner's request</p>

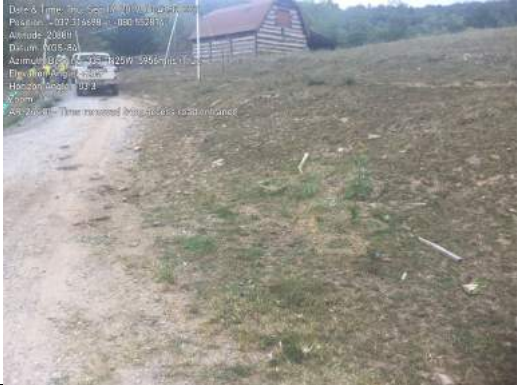
<p>Photo & Time: Thu, Sep 19, 2019, 10:05:59 EDT Position: 43.01414000, -80.01133000 Altitude: 208ft Datum: WGS-84 Azimuth/Bearing: 000° N00E 000mils (true) Elevation Angle: +25.2° Horizon Angle: 104.7° Zoom: 1X AR-244.00- Tires removed from access road as requested by landowner</p>		
GPS Location	See photo GPS		GPS Location	See photo GPS	
Field Station#	11022+00		Field Station#	11022+00	
Pic 7 Desc.	AR-244.00- Landowner requested that tires be removed.		Pic 8 Desc.	AR-244.00- Tires removed from access road as requested by landowner.

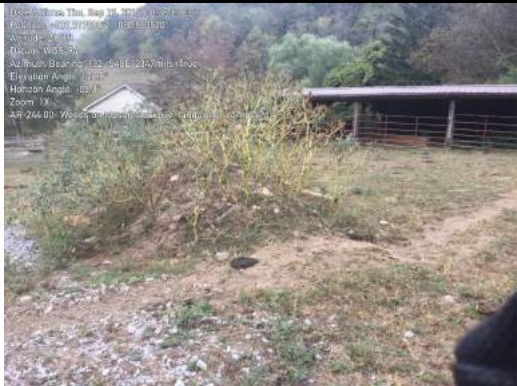
<p>Photo & Time: Thu, Sep 19, 2019, 10:07:17 EDT Position: 43.01414000, -80.01133000 Altitude: 209ft Datum: WGS-84 Azimuth/Bearing: 000° N00E 000mils (true) Elevation Angle: +25.2° Horizon Angle: 104.7° Zoom: 1X AR-244.00- Weeds on topsoil stockpile, landowner's request</p>

GPS Location	See photo GPS		GPS Location	See photo GPS	
Field Station#	11022+00		Field Station#	11022+00	
Pic 9 Desc.	AR-244.00- Landowner requested that weeds on topsoil stockpile be removed.		Pic 10 Desc.	AR-244.00- weeds on topsoil stockpile removed & hauled away, as requested by landowner.	
Insert image here			Insert image here		
GPS Location			GPS Location		
Field Station#			Field Station#		
Pic 11 Desc.			Pic 12 Desc.

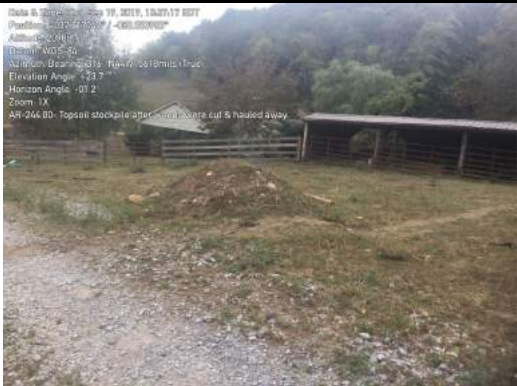
<p>Photo & Time: Thu, Sep 19, 2019, 10:07:17 EDT Position: 43.01414000, -80.01133000 Altitude: 209ft Datum: WGS-84 Azimuth/Bearing: 000° N00E 000mils (true) Elevation Angle: +25.2° Horizon Angle: 104.7° Zoom: 1X AR-244.00- Topsoil stockpile after weeds were cut & hauled away</p>

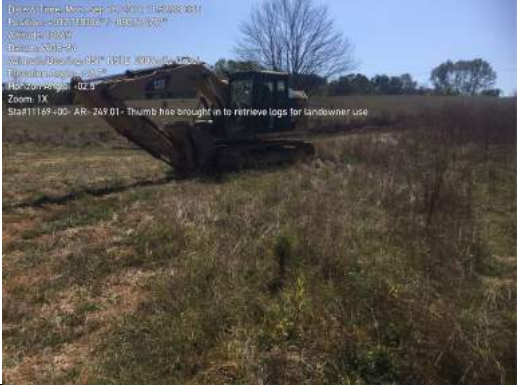
GPS Location	See photo GPS	GPS Location			
Field Station#	11169+00	Field Station#			
Pic 7 Desc.	AR-249.01- Contractor has brought in a thumb hoe to retrieve logs for landowner use.	Pic 8 Desc.			
Insert image here		Insert image here			
GPS Location		GPS Location			
Field Station#		Field Station#			
Pic 9 Desc.		Pic 10 Desc.			
Insert image here		Insert image here			
GPS Location		GPS Location			
Field Station#		Field Station#			
Pic 11 Desc.		Pic 12 Desc.

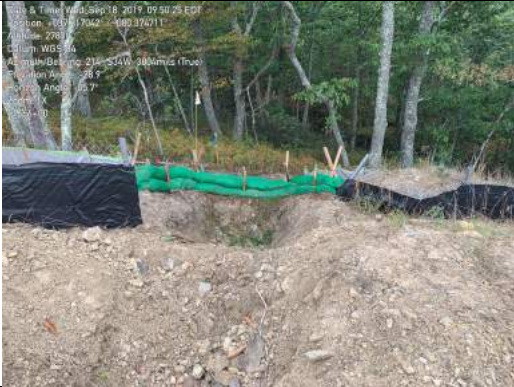
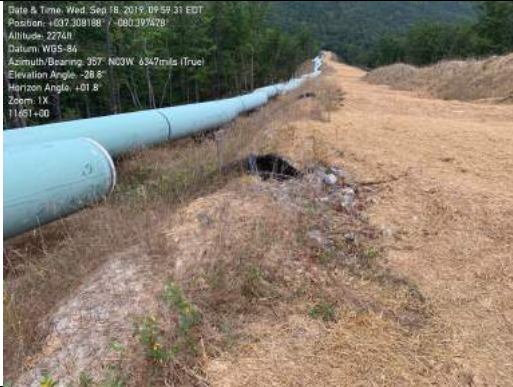
GPS Location	See photo for GPS location.		GPS Location	See photo for GPS location.	
Field Station#	11666+00		Field Station#	11651+00	
Pic 1 Desc.	Waterbar, sump pit, and triple stack compost filter sock in place.		Pic 2 Desc.	Slope drain with rock inlet and outlet in place over two tons.

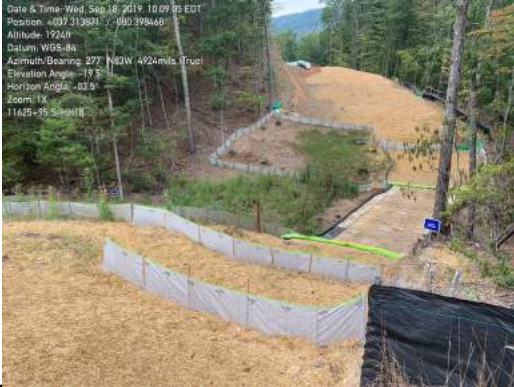
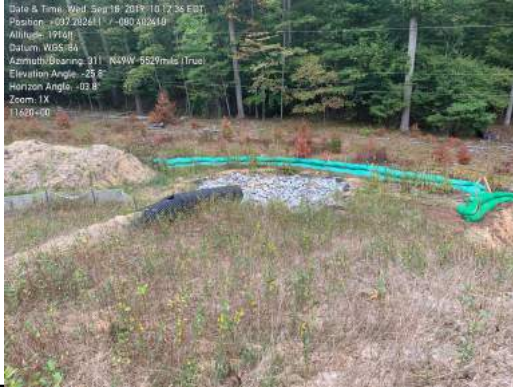
GPS Location	See photo for GPS location.		GPS Location	See photo for GPS location.	
Field Station#	11625+95		Field Station#	11620+00	
Pic 3 Desc.	Sensitive resource buffer in place at stream S-HH18.		Pic 4 Desc.	Clean water diversion pipe and plunge in place.

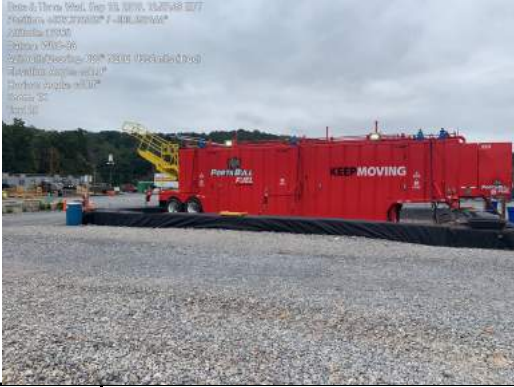
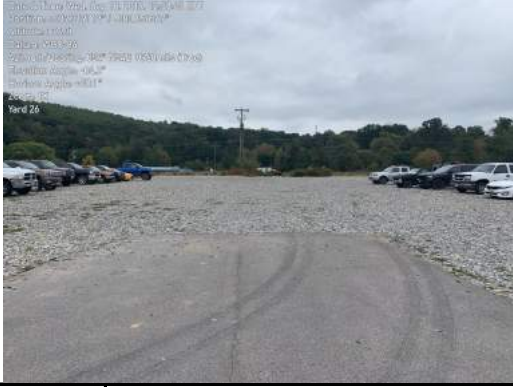
GPS Location	See photo for GPS location.		GPS Location	See photo for GPS location.	
Field Station#	12005+00		Field Station#	12005+00	
Pic 5 Desc.	Secondary containment in place under fuel cell.		Pic 6 Desc.	RCE in place at employee parking.

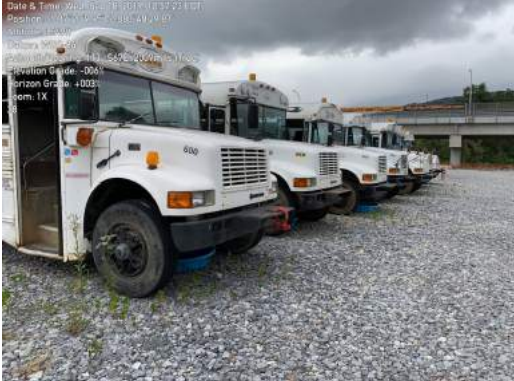
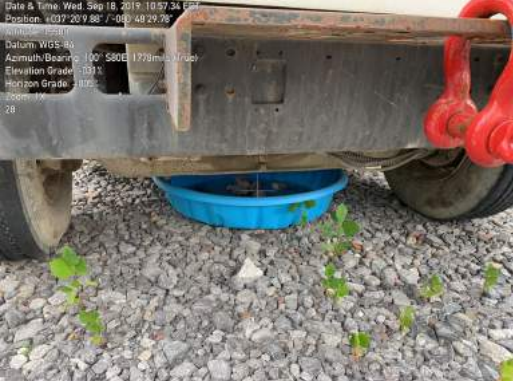
GPS Location	See picture above for GPS coordinates		GPS Location	See picture above for GPS coordinates	
Field Station#	+28		Field Station#	+28	
Pic 1 Desc.	ECD's and row conditions		Pic 2 Desc.	Proper secondary containment

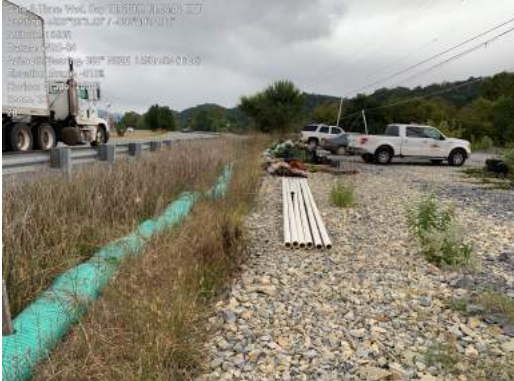
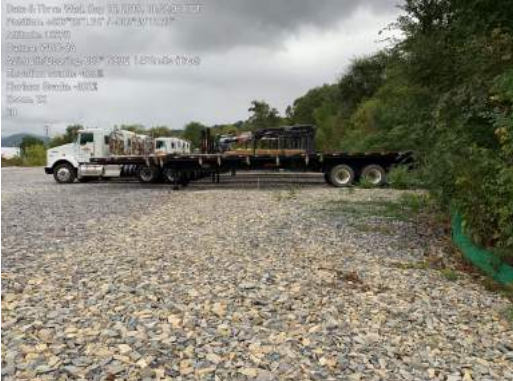
GPS Location	See picture above for GPS coordinates		GPS Location	See picture above for GPS coordinates	
Field Station#	+28		Field Station#	+28	
Pic 3 Desc.	ECD's and row conditions		Pic 4 Desc.	ECD's and row conditions

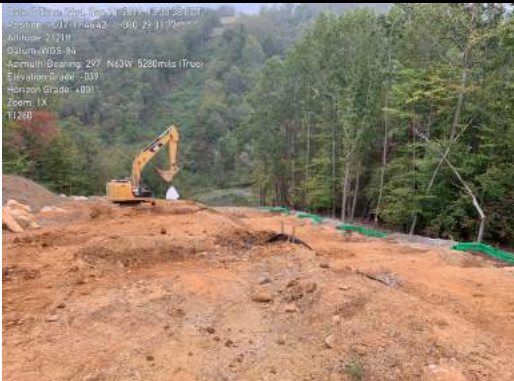
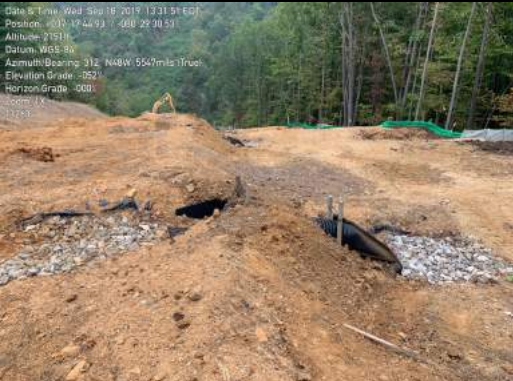
GPS Location	See picture above for GPS coordinates		GPS Location	See picture above for GPS coordinates	
Field Station#	11260+00		Field Station#	11263+00	
Pic 5 Desc.	Crews repairing slope drains and end treatment		Pic 6 Desc.	Crews repairing slope drains and end treatment
