# Visual Site Inspection Report

<b>Project Name</b>	H-600 Pipeline Spread G	<b>AFE</b>	124300137	<b>Spread</b>	H-600 Pipeline Spread
<b>Contractor</b>	Precision			<b>Report #</b>	100031
<b>Inspector</b>	Garrett Barclay			<b>Date/Time</b>	9/27/2019 2:43 PM
<b>Permit #</b>	TBD	<b>Inspection Type</b>	VA SWPP	<b>Station Begin</b>	11520+00
<b>State</b>	VA	<b>Inspection Area</b>	Partial	<b>Station End</b>	11630+00
<b>County</b>	Giles	<b>Ground</b>	Dry	<b>Temperature (°F)</b>	78.00
<b>Municipality</b>	N/A	<b>Weather</b>	Sunny	<b>Rain Gauge (in)</b>	0.00
				<b>Rain Accumulation Time (days)</b>	1.00

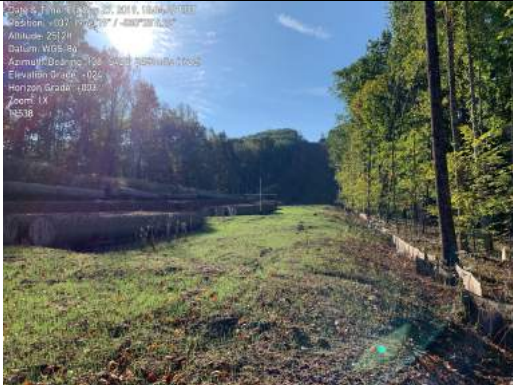
<b>GPS Location</b>	See picture above for GPS coordinates		<b>GPS Location</b>	See picture above for GPS coordinates	
<b>Field Station#</b>	11530+00		<b>Field Station#</b>	11541+00	
<b>Pic 1 Desc.</b>	Stabilization starting to show signs of vegetation		<b>Pic 2 Desc.</b>	Stabilization starting to show signs of vegetation

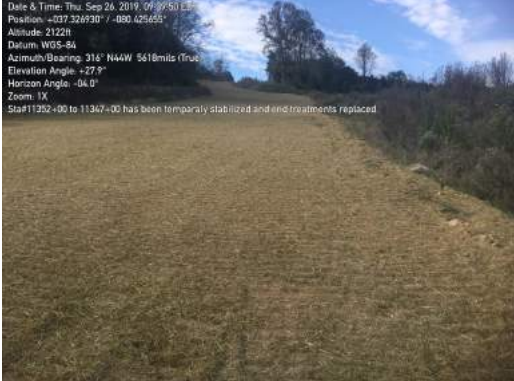
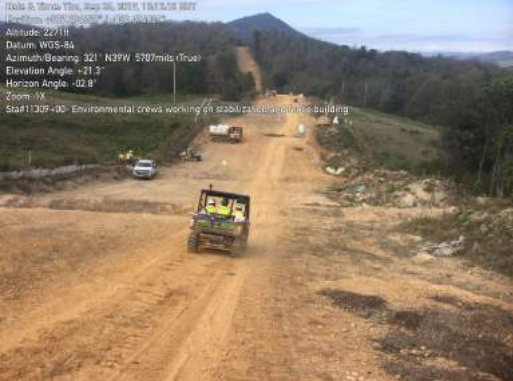
<b>GPS Location</b>	See photo GPS		<b>GPS Location</b>	See photo GPS	
<b>Field Station#</b>	11352+00		<b>Field Station#</b>	11309+00	
<b>Pic 1 Desc.</b>	Temporary stabilization completed from sta#11352+00 to 11347+00		<b>Pic 2 Desc.</b>	Environmental crews working on stabilization and fencing.

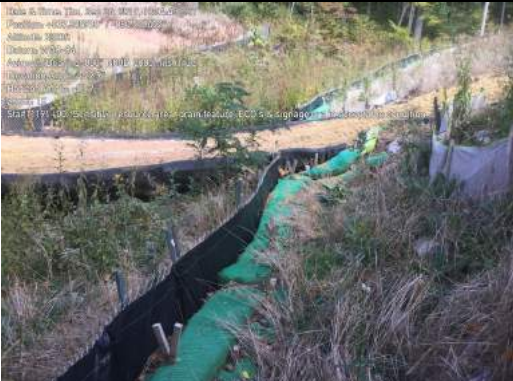
<b>GPS Location</b>	See photo GPS		<b>GPS Location</b>	See photo GPS	
<b>Field Station#</b>	11298+00		<b>Field Station#</b>	11191+00	
<b>Pic 3 Desc.</b>	Sta# 11258+00 to 11298+00 stabilization is complete.		<b>Pic 4 Desc.</b>	Sensitive resource area, drainage feature, ECD's and signage are in acceptable condition.

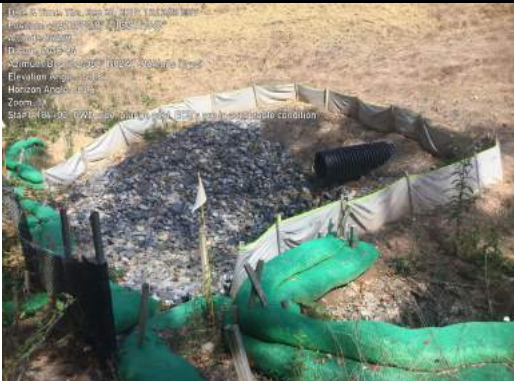
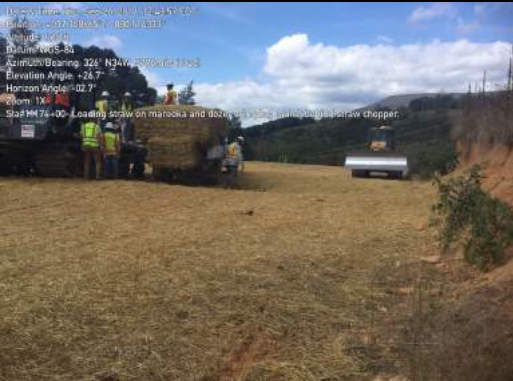
<b>GPS Location</b>	See photo GPS		<b>GPS Location</b>	See photo GPS	
<b>Field Station#</b>	11184+00		<b>Field Station#</b>	11174+00	
<b>Pic 5 Desc.</b>	CWD pipe and plunge pool, ECD's are in acceptable condition.		<b>Pic 6 Desc.</b>	Crew loading straw on Marooka, dozer crimping mulch.

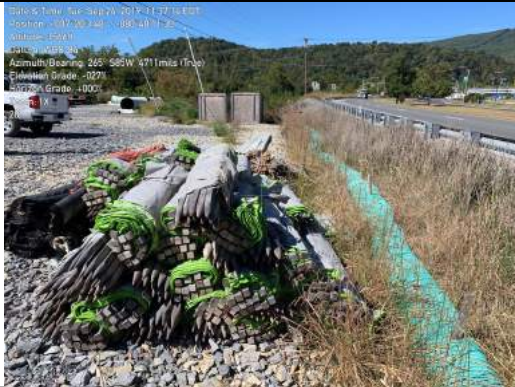
<b>GPS Location</b>	See picture above for GPS coordinates		<b>GPS Location</b>	See picture above for GPS coordinates	
<b>Field Station#</b>	+28		<b>Field Station#</b>	+28	
<b>Pic 3 Desc.</b>	ECD's and row conditions @ LDY 28		<b>Pic 4 Desc.</b>	ECD's and row conditions @ LDY 28

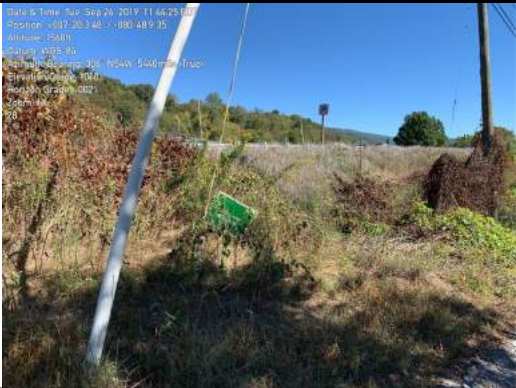
<b>GPS Location</b>	See picture above for GPS coordinates		<b>GPS Location</b>	See picture above for GPS coordinates	
<b>Field Station#</b>	+28		<b>Field Station#</b>	11290+00	
<b>Pic 5 Desc.</b>	ECD's and row conditions @ LDY 28		<b>Pic 6 Desc.</b>	Crews repairing water bars and stabilizing Row

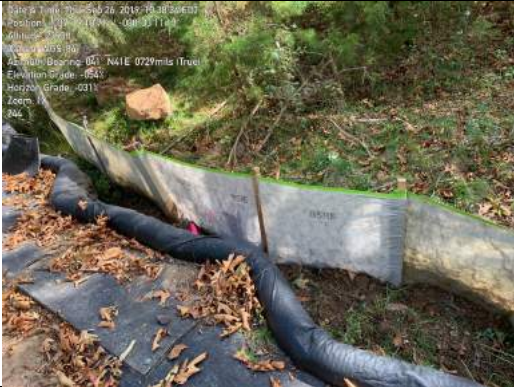
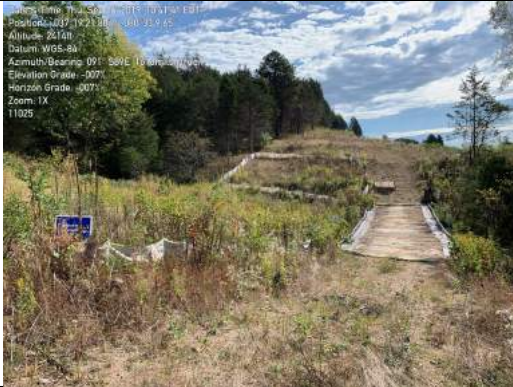
<b>Field Station#</b>	11025+00		<b>Field Station#</b>	11025+00	
<b>Pic 1 Desc.</b>	Crews repaired damaged P1SF		<b>Pic 2 Desc.</b>	ECD's and row conditions @ S-IJ18

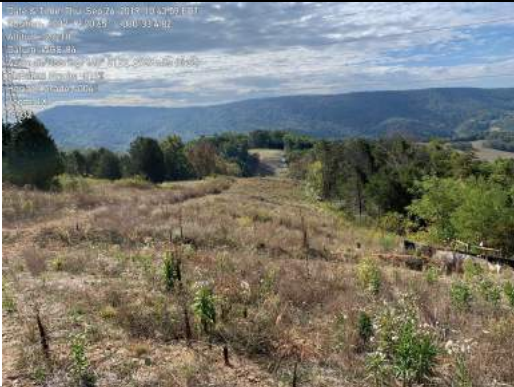
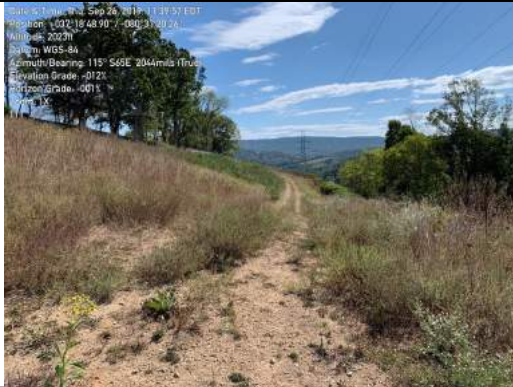
<b>Field Station#</b>	11032+00		<b>Field Station#</b>	11148+00	
<b>Pic 3 Desc.</b>	ECD's and row conditions		<b>Pic 4 Desc.</b>	Travel requiring additional stabilization due to LO accessing ROW

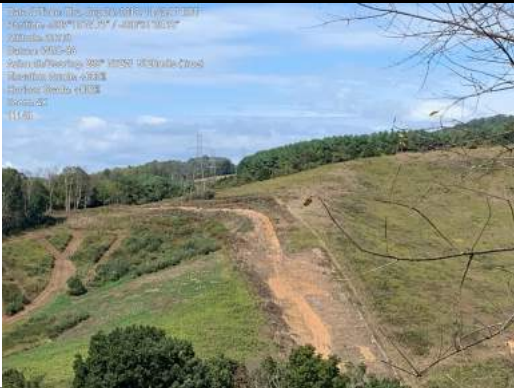
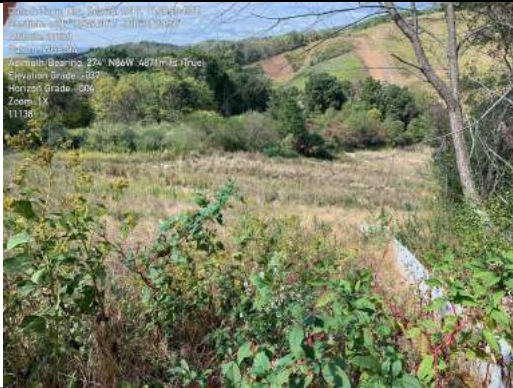
<b>GPS Location</b>	See picture above for GPS coordinates		<b>GPS Location</b>	See picture above for GPS coordinates	
<b>Field Station#</b>	11135+00		<b>Field Station#</b>	11149+00	
<b>Pic 5 Desc.</b>	Travel requiring additional stabilization due to LO accessing ROW		<b>Pic 6 Desc.</b>	ECD's and row conditions

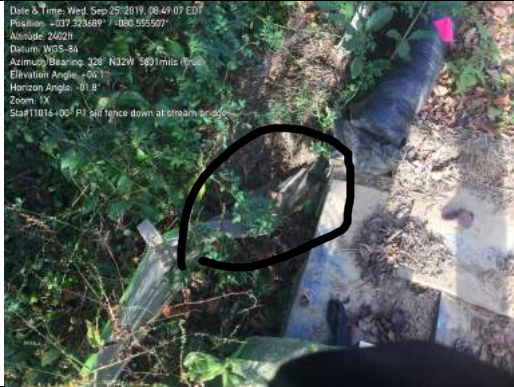
<p>Date &amp; Time: Wed, Sep 25, 2019, 08:49:07 EDT Position: 4017° 23' 36" N 77° 00' 55" W Altitude: 2420 ft Datum: WGS 84 Azimuth Bearing: 328° N 32W 5631mils (1000) Elevation Angle: +06.1° Horizon Angle: -11.8° Zoom: IX Sta#11016+00 P1 silt fence down at stream S-RR5.</p>			
<b>GPS Location</b>	See photo GPS	<b>GPS Location</b>	See photo GPS		
<b>Field Station#</b>	11022+00	<b>Field Station#</b>	11016+00		
<b>Pic 1 Desc.</b>	AR-244, Equipment bridge, ECD's, signage are in acceptable condition.	<b>Pic 2 Desc.</b>	P1 silt fence down along Equipment bridge at stream S-RR5.

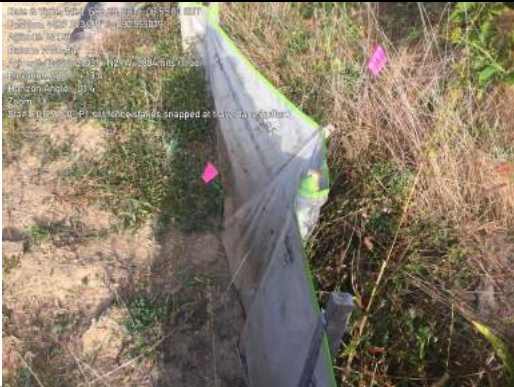
<p>Date &amp; Time: Wed, Sep 25, 2019, 09:05:04 EDT Position: 4009° 42' 00" N 77° 00' 55" W Altitude: 2420 ft Datum: WGS 84 Azimuth Bearing: 328° N 32W 5631mils (1000) Elevation Angle: +06.1° Horizon Angle: -11.8° Zoom: IX Sta#11017+00 P1 silt fence stakes snapped at stream buffer.</p>

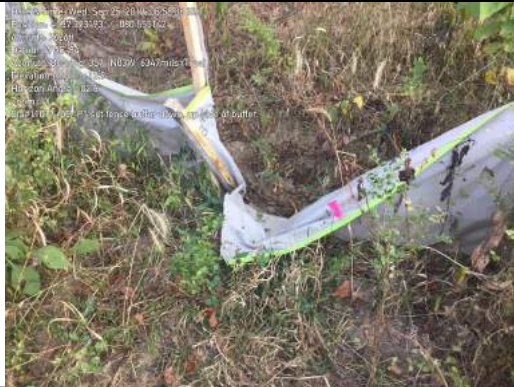
<p>Date &amp; Time: Wed, Sep 25, 2019, 09:04:04 EDT Position: 4009° 42' 00" N 77° 00' 55" W Altitude: 2420 ft Datum: WGS 84 Azimuth Bearing: 328° N 32W 5631mils (1000) Elevation Angle: +06.1° Horizon Angle: -11.8° Zoom: IX Sta#11017+00 P1 silt fence down on up side of buffer.</p>			
<b>GPS Location</b>	See photo GPS	<b>GPS Location</b>	See photo GPS		
<b>Field Station#</b>	11017+00	<b>Field Station#</b>	11017+00		
<b>Pic 3 Desc.</b>	P1 silt fence stakes snapped at stream buffer.	<b>Pic 4 Desc.</b>	P1 silt fence down on up side of buffer.

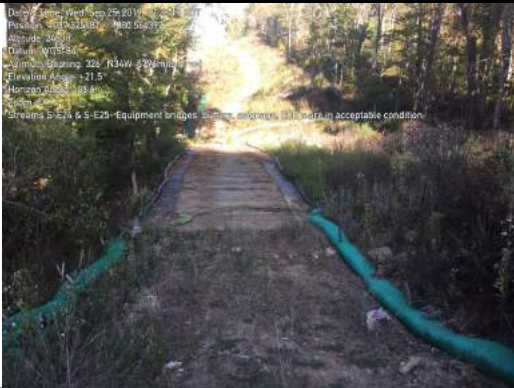
<p>Date &amp; Time: Wed, Sep 25, 2019, 09:38:01 EDT Position: 4017° 23' 36" N 77° 00' 55" W Altitude: 2420 ft Datum: WGS 84 Azimuth Bearing: 328° N 32W 5631mils (1000) Elevation Angle: +21.5° Horizon Angle: -12.1° Zoom: IX Streams S-E24 &amp; S-E25- Equipment bridge's, ECD's, signage, buffers are in acceptable condition.</p>

<b>GPS Location</b>	See photo GPS	<b>GPS Location</b>	See photo GPS		
<b>Field Station#</b>	10986+00	<b>Field Station#</b>	10964+00		
<b>Pic 5 Desc.</b>	Streams S-E24 & S-E25- Equipment bridge's, ECD's, signage, buffers are in acceptable condition.	<b>Pic 6 Desc.</b>	P1 silt fence down at drainage feature.

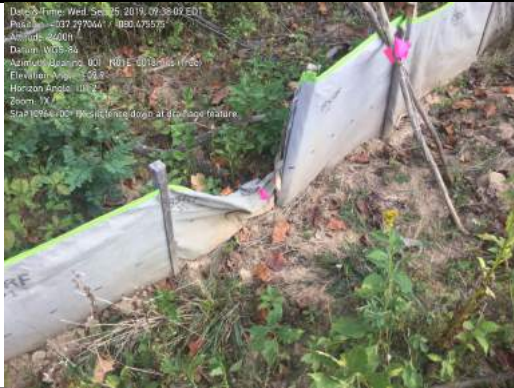
<p>Date &amp; Time: Wed, Sep 25, 2019, 09:38:01 EDT Position: 4017° 23' 36" N 77° 00' 55" W Altitude: 2420 ft Datum: WGS 84 Azimuth Bearing: 328° N 32W 5631mils (1000) Elevation Angle: +21.5° Horizon Angle: -12.1° Zoom: IX Sta#11096+00 P1 silt fence down at drainage feature.</p>

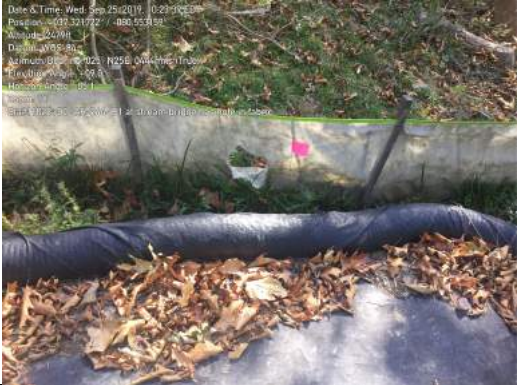
<b>GPS Location</b>	See photo GPS	<b>GPS Location</b>			
<b>Field Station#</b>	11022+00	<b>Field Station#</b>			
<b>Pic 7 Desc.</b>	AR- 244- Stream bridge- P1 fabric torn.	<b>Pic 8 Desc.</b>			
Insert image here		Insert image here			
<b>GPS Location</b>		<b>GPS Location</b>			
<b>Field Station#</b>		<b>Field Station#</b>			
<b>Pic 9 Desc.</b>		<b>Pic 10 Desc.</b>			
Insert image here		Insert image here			
<b>GPS Location</b>		<b>GPS Location</b>			
<b>Field Station#</b>		<b>Field Station#</b>			
<b>Pic 11 Desc.</b>		<b>Pic 12 Desc.</b>

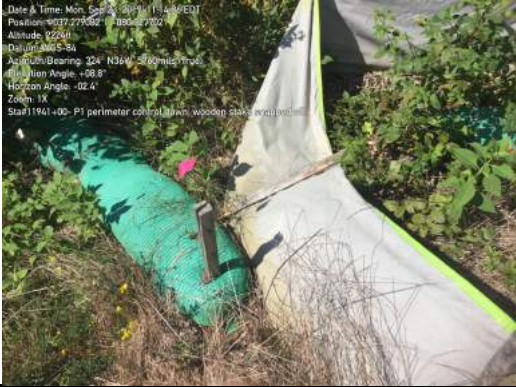
<small>Date &amp; Time: Mon, Sep 23, 2019, 11:34:51 EDT  Position: +037 273527 / -080 225296  Altitude: 1919ft  Datum: WGS-84  Azimuth/Bearing: 319° N41W 587mils (1000)  Elevation Angle: +03.8°  Horizon Angle: -03.4°  Zoom: 1X  Staff 11964+00- P1 perimeter control down, wooden stake snapped off, Karst area.</small>

<b>GPS Location</b>	See photo GPS	<b>GPS Location</b>	See photo GPS		
<b>Field Station#</b>	11941+00	<b>Field Station#</b>	11964+00		
<b>Pic 7 Desc.</b>	P1 silt fence perimeter control down, wooden stake snapped off.	<b>Pic 8 Desc.</b>	P1 silt fence perimeter controls down in Karst area.

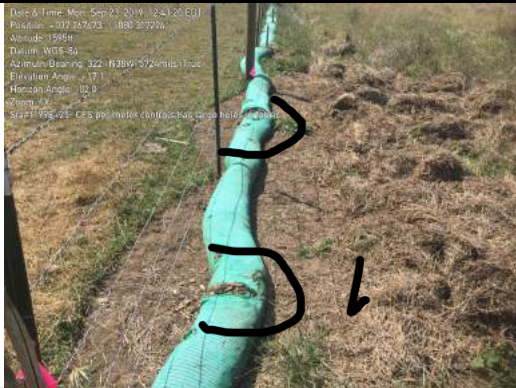
<small>Date &amp; Time: Mon, Sep 23, 2019, 12:41:20 EDT  Position: +037 287693 / -080 217226  Altitude: 1959ft  Datum: WGS-84  Azimuth/Bearing: 322° N38W 572mils (1000)  Elevation Angle: +37.1°  Horizon Angle: -02.0°  Zoom: 1X  Staff 11998+25- CFS perimeter controls have holes in fabric.</small>

<div style="text-align: center;">Insert image here</div>			
<b>GPS Location</b>	See photo GPS	<b>GPS Location</b>			
<b>Field Station#</b>	11998+25	<b>Field Station#</b>			
<b>Pic 9 Desc.</b>	CFS perimeter controls have holes in fabric	<b>Pic 10 Desc.</b>			
<div style="text-align: center;">Insert image here</div>		<div style="text-align: center;">Insert image here</div>			
<b>GPS Location</b>		<b>GPS Location</b>			
<b>Field Station#</b>		<b>Field Station#</b>			
<b>Pic 11 Desc.</b>		<b>Pic 12 Desc.</b>

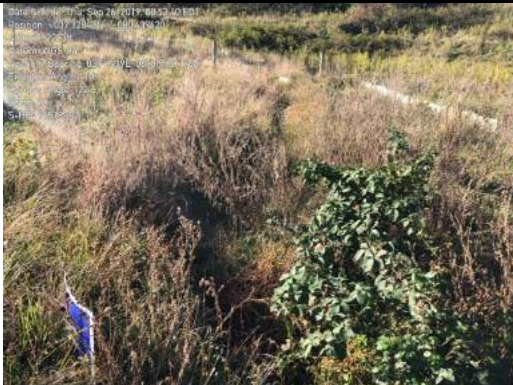
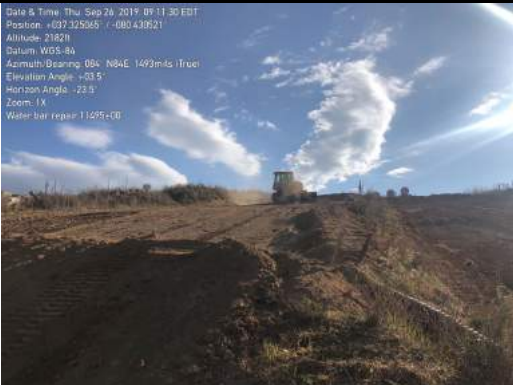
<b>GPS Location</b>	1	<b>GPS Location</b>	2		
<b>Field Station#</b>	11518+32	<b>Field Station#</b>	11495+00		
<b>Pic 1 Desc.</b>	S-PP4.	<b>Pic 2 Desc.</b>	Repairing temporary water bars.

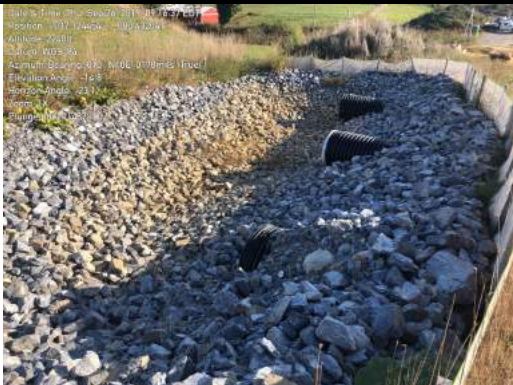
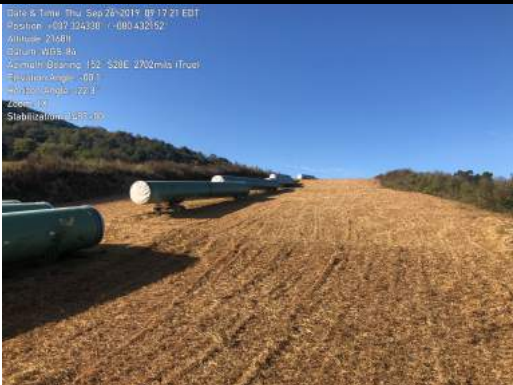
<b>GPS Location</b>	3	<b>GPS Location</b>	4		
<b>Field Station#</b>	11487+00	<b>Field Station#</b>	11487+00		
<b>Pic 3 Desc.</b>	Plunge pool.	<b>Pic 4 Desc.</b>	Temporary stabilization.

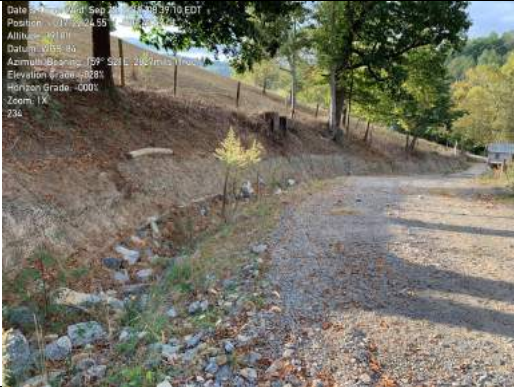
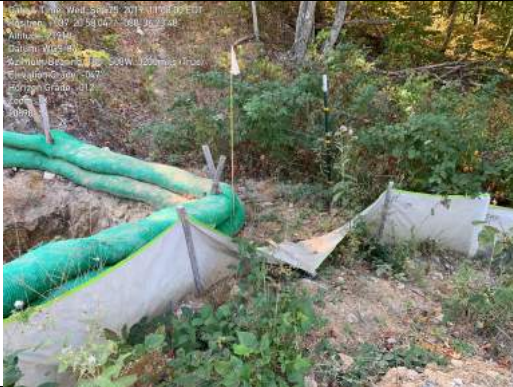
<b>GPS Location</b>	See picture above for GPS coordinates		<b>GPS Location</b>	See picture above for GPS coordinates	
<b>Field Station#</b>	2+34		<b>Field Station#</b>	10890+00	
<b>Pic 1 Desc.</b>	ECD's and row conditions		<b>Pic 2 Desc.</b>	Damaged P1 from bears

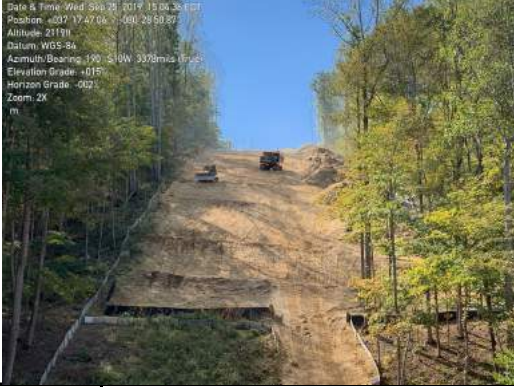
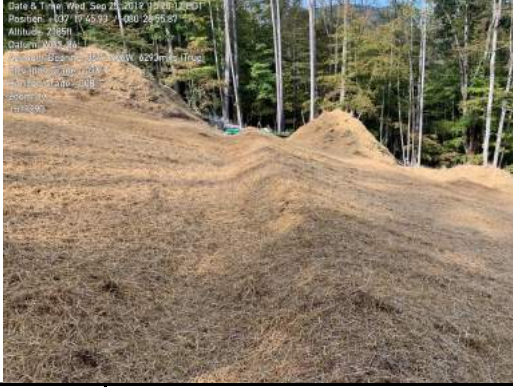
<b>GPS Location</b>	See picture above for GPS coordinates		<b>GPS Location</b>	See picture above for GPS coordinates	
<b>Field Station#</b>	11290+00		<b>Field Station#</b>	11290+00	
<b>Pic 5 Desc.</b>	Crews reworking water bars and stabilizing		<b>Pic 6 Desc.</b>	Reworked waterbars

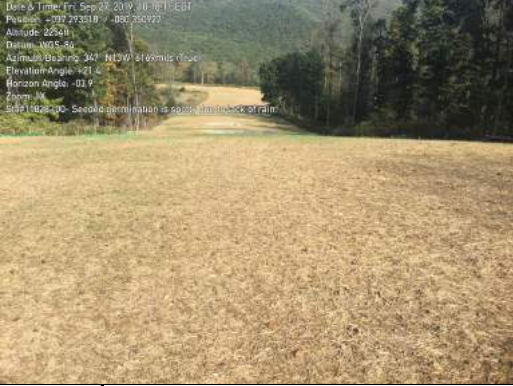
<p>Date &amp; Time: Fri, Sep 27, 2019, 10:10:11 EDT Position: 4307.29318 / -88.756727 Altitude: 2254 ft Datum: WGS 84 Azimuth Bearing: 347° N135W 316mils True Elevation Angle: +21.6° Horizon Angle: -03.9° Zoom: IX Sta# 11828+00 - Seed germination is spotty due to the lack of rain</p>		<b>GPS Location</b>	See photo GPS
<b>Field Station#</b>	11798+00	<b>Field Station#</b>	11828+00	<b>GPS Location</b>	See photo GPS
<b>Pic 1 Desc.</b>	Completed water bar level spreader after final restoration.	<b>Pic 2 Desc.</b>	Seed germination is spotty due to the lack of rain.	<b>GPS Location</b>	See photo GPS

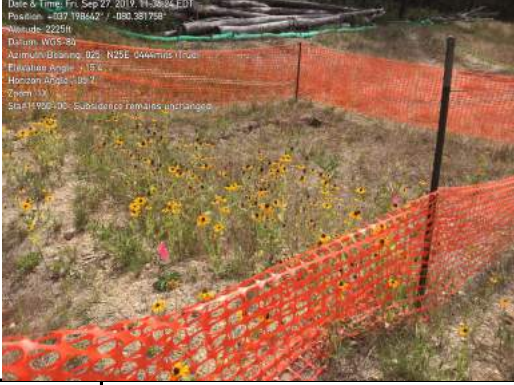
<p>Date &amp; Time: Fri, Sep 27, 2019, 11:58:04 EDT Position: 4307.29318 / -88.756727 Altitude: 2254 ft Datum: WGS 84 Azimuth Bearing: 347° N135W 316mils True Elevation Angle: +21.6° Horizon Angle: -03.9° Zoom: IX Sta# 11950+00 - Subsidence remains unchanged</p>

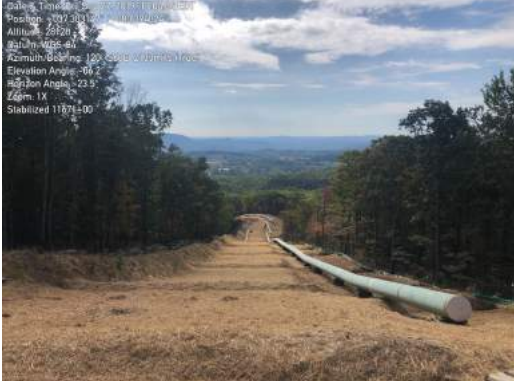
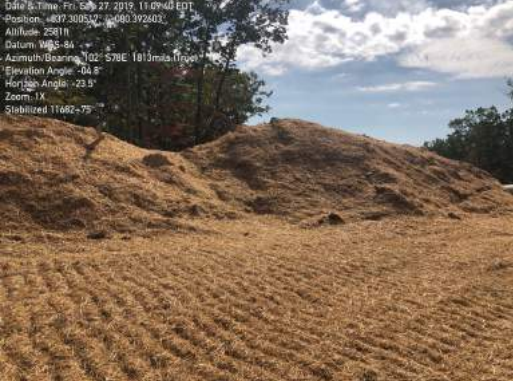
<b>GPS Location</b>	1	<b>GPS Location</b>	2		
<b>Field Station#</b>	11671+00	<b>Field Station#</b>	11682+75		
<b>Pic 1 Desc.</b>	Temporary stabilization.	<b>Pic 2 Desc.</b>	Temporary stabilization of topsoil piles.

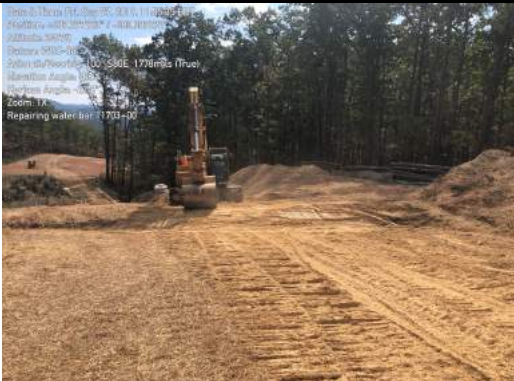
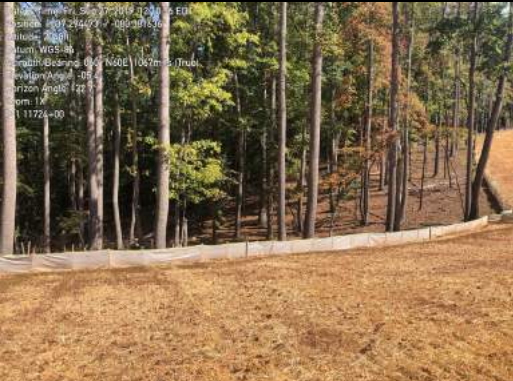
<b>GPS Location</b>	5	<b>GPS Location</b>	6		
<b>Field Station#</b>	11703+00	<b>Field Station#</b>	11724+00		
<b>Pic 5 Desc.</b>	Repairing temporary water bar.	<b>Pic 6 Desc.</b>	Recently replaced P-1.
