Visual Site Inspection Report

Project Name	H-600 Pipeline Spread G	AFE	124300137	Spread	H-600 Pipeline Spread
Contractor	Precision			Report #	100304
Inspector	Garrett Barclay			Date/Time	9/3/2019 2:30 PM
Permit #	TBD	Inspection Type	VA SWPP	Station Begin	10830+00
State	VA	Inspection Area	Partial	Station End	10929+00
County	Giles	Ground	Dry	Temperature (°F)	86.00
Municipality	N/A	Weather	Sunny	Rain Gauge (in)	0.00
				Rain Accumulation Time (days)	1.00

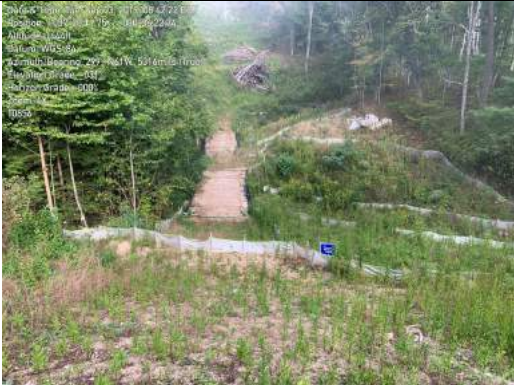
GPS Location	See picture above for GPS coordinates		GPS Location	See picture above for GPS coordinates	
Field Station#	10856+00		Field Station#	10868+00	
Pic 1 Desc.	ECD's and row conditions		Pic 2 Desc.	ECD's and row conditions

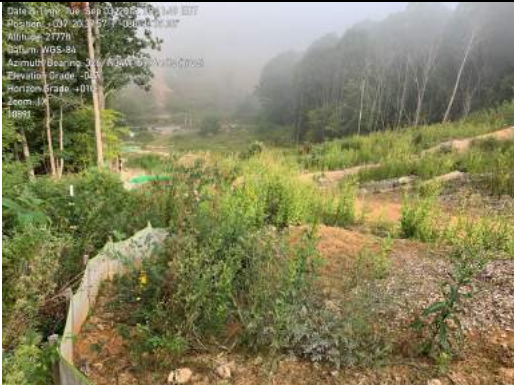
GPS Location	See picture above for GPS coordinates		GPS Location	See picture above for GPS coordinates	
Field Station#	10891+00		Field Station#	10925+00	
Pic 3 Desc.	ECD's and row conditions		Pic 4 Desc.	ECD's and row conditions

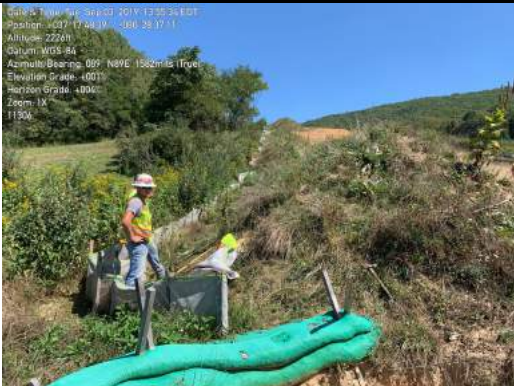
GPS Location	See picture above for GPS coordinates		GPS Location	See picture above for GPS coordinates	
Field Station#	11306+00		Field Station#	11306+00	
Pic 5 Desc.	Crews repairing damaged P1SF		Pic 6 Desc.	Crews rebuilding water bars

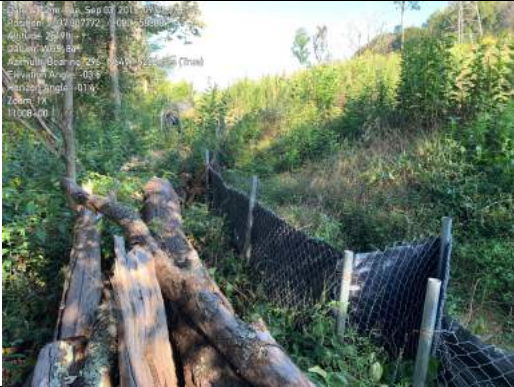
GPS Location	See photo for GPS location.		GPS Location	See photo for GPS location.	
Field Station#	11008+00		Field Station#	10995+00	
Pic 1 Desc.	Reinforced super silt fence in place along LOD.		Pic 2 Desc.	ROW has been stabilized with seed, mulch, and natural vegetation.

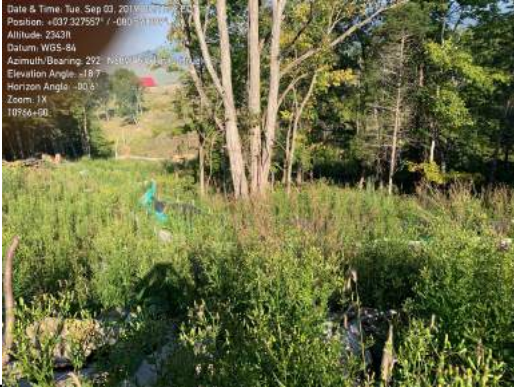
GPS Location	See photo for GPS location.		GPS Location	See photo for GPS location.	
Field Station#	10966+00		Field Station#	10698+00	
Pic 3 Desc.	Triple barrier ECDs in place at off ROW karst feature.		Pic 4 Desc.	Sensitive resource buffer in place at stream S-G32.

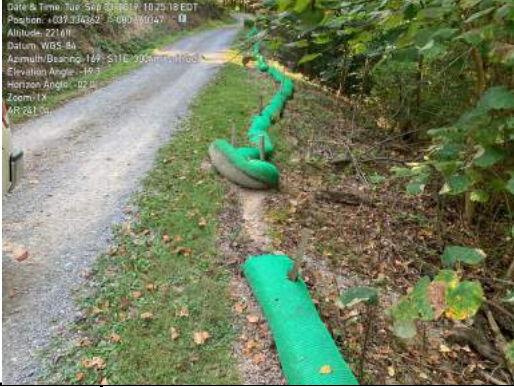
GPS Location	See photo for GPS location.		GPS Location	See photo for GPS location.	
Field Station#	12005+00		Field Station#	12005+00	
Pic 5 Desc.	Damaged compost filter sock along access road.		Pic 6 Desc.	Area needs stabilized. Land owner removed top soil spoil pile.

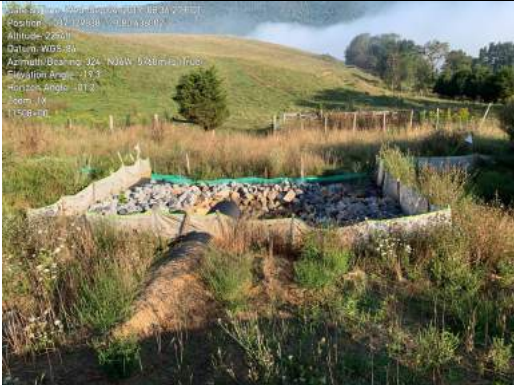
GPS Location	See photo for GPS location.		GPS Location	See photo for GPS location.	
Field Station#	11508+00		Field Station#	11502+00	
Pic 1 Desc.	Plunge pool in place.		Pic 2 Desc.	Conveyance channel with rock checks in place.

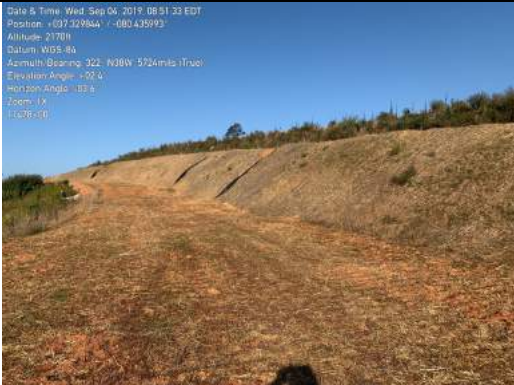
GPS Location	See photo for GPS location.		GPS Location	See photo for GPS location.	
Field Station#	11478+00		Field Station#	11456+00	
Pic 3 Desc.	Two tone stabilized with ECB and slope drains in place to minimize scouring.		Pic 4 Desc.	Slope drain rock inlet repaired.

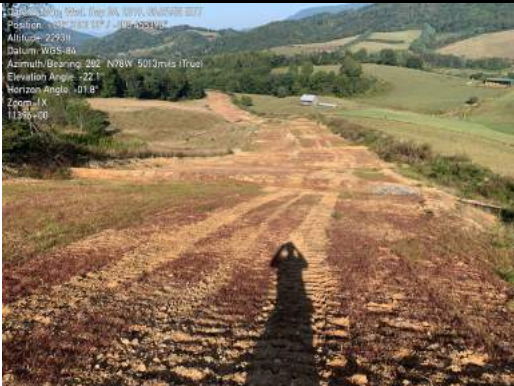
GPS Location	See photo for GPS location.		GPS Location	See photo for GPS location.	
Field Station#	11396+00		Field Station#	11194+00	
Pic 5 Desc.	ROW has been stabilized and minor vegetation growth present.		Pic 6 Desc.	Area where ROW has been stabilized but on the travel lane. Contacted LEI regarding issue.

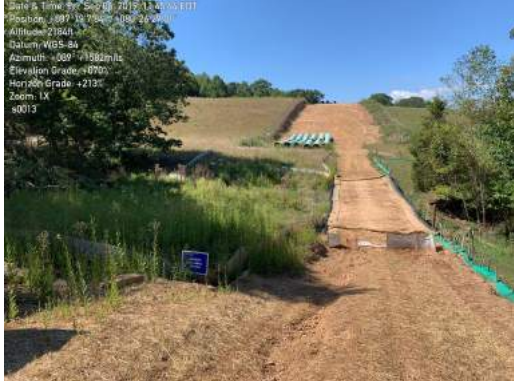
<p>Date & Time: Fri, Sep 06, 2019, 11:00:00 EDT Position: +037° 19' 0.85" / -080° 47' 41.41" Altitude: 2184ft Datum: WGS 84 Azimuth/Bearing: +089° N186mils Elevation Grade: +0705° Horizon Grade: +213° Zoom: 1X +0013</p>			
GPS Location	See picture above for GPS coordinates		GPS Location	See picture above for GPS coordinates	
Field Station#	+29		Field Station#	11448+00	
Pic 5 Desc.	ECD's and row conditions @ LDY 29		Pic 6 Desc.	Disturbed stabilization from 3rd party

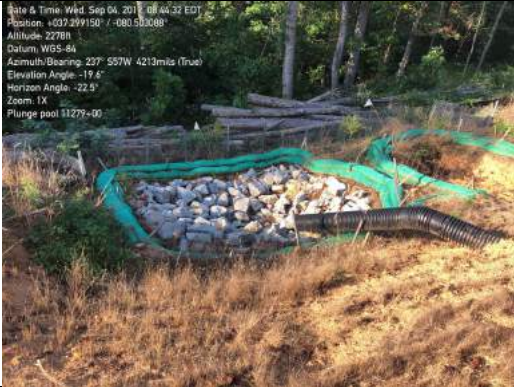
<p>Date & Time: Wed, Sep 04, 2019 08:56:25 EDT Position: +037.296340° / -080.532207° Altitude: 2283ft Datum: WGS-84 Azimuth/Bearing: 059° 00'E 1047mils (True) Elevation Angle: -11.7° Horizon Angle: -22.3° Zoom: 1X S-MM18</p>			
GPS Location	1	GPS Location	2		
Field Station#	11279+00	Field Station#	11292+85		
Pic 1 Desc.	Functional plunge pool.	Pic 2 Desc.	S-MM18.

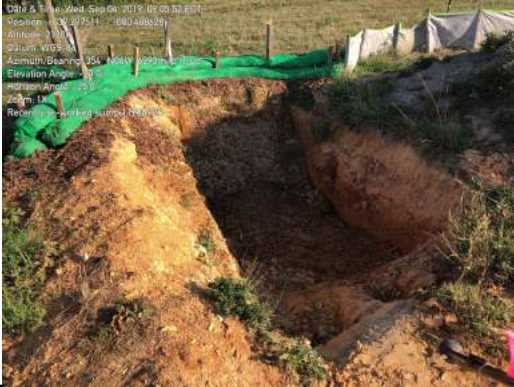
GPS Location	3	GPS Location	4		
Field Station#	11298+25	Field Station#	11327+85		
Pic 3 Desc.	Freshly re-worked sump.	Pic 4 Desc.	S-NN12.

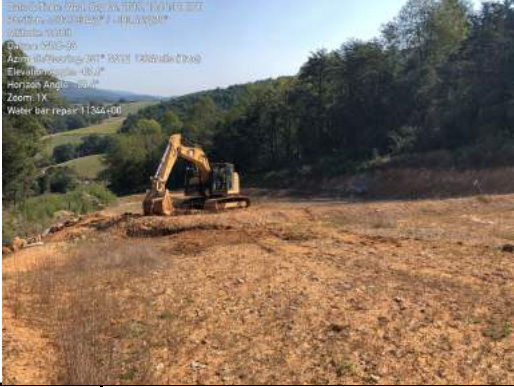
<p>Date & Time: Wed, Sep 04, 2019 10:12:41 EDT Position: +037.335548° / -080.467816° Altitude: 2280ft Datum: WGS-84 Azimuth/Bearing: 301° 00'W 1000mils (True) Elevation Angle: -08.0° Horizon Angle: -20.0° Zoom: 1X S-NN11</p>			
GPS Location	5	GPS Location	6		
Field Station#	11344+00	Field Station#	11352+97		
Pic 5 Desc.	Repairing water bar.	Pic 6 Desc.	S-NN11.
