Visual Site Inspection Report

Project Name	H-600 Pipeline Spread G	AFE	124300137	Spread	H-600 Pipeline Spread
Contractor	Precision			Report #	100067
Inspector	Garrett Barclay			Date/Time	10/3/2019 2:41 PM
Permit #	TBD	Inspection Type	VA SWPP	Station Begin	11520+00
State	VA	Inspection Area	Partial	Station End	11630+00
County	Giles	Ground	Dry	Temperature (°F)	92.00
Municipality	N/A	Weather	Sunny	Rain Gauge (in)	0.00
				Rain Accumulation Time (days)	1.00

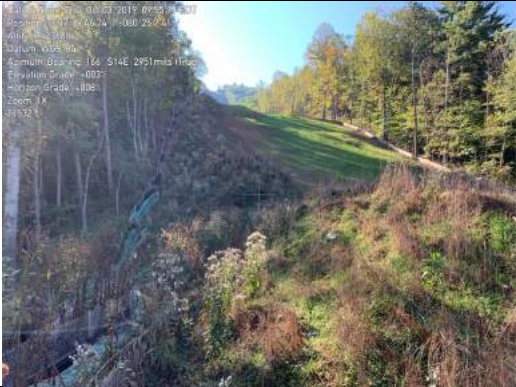
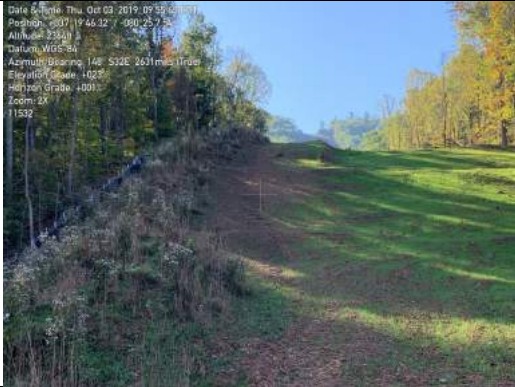
GPS Location	See picture above for GPS coordinates		GPS Location	See picture above for GPS coordinates	
Field Station#	11530+00		Field Station#	11534+00	
Pic 1 Desc.	ECD's and row conditions		Pic 2 Desc.	Travel lane showing signs of vegetation

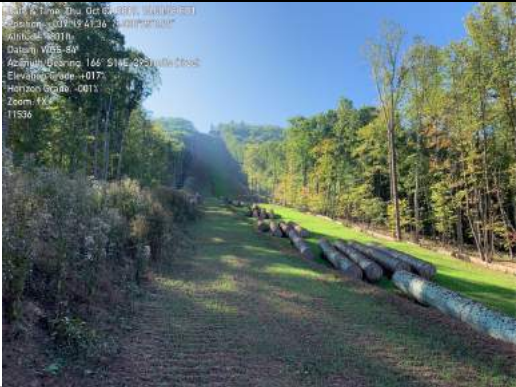
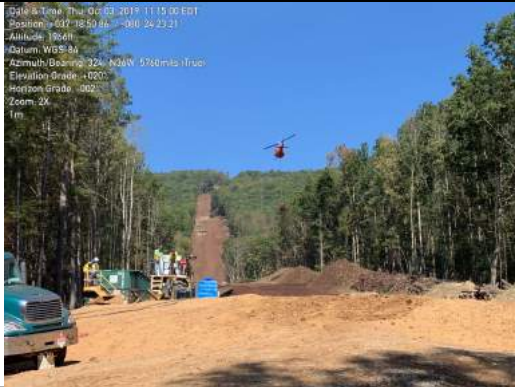
GPS Location	See picture above for GPS coordinates		GPS Location	See picture above for GPS coordinates	
Field Station#	11540+00		Field Station#	11620+00	
Pic 3 Desc.	ECD's and row conditions		Pic 4 Desc.	Crew applying stabilization via helicopter

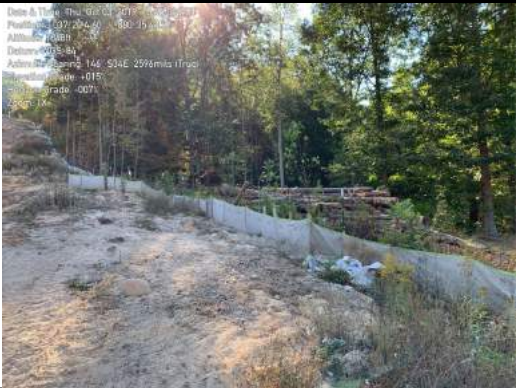
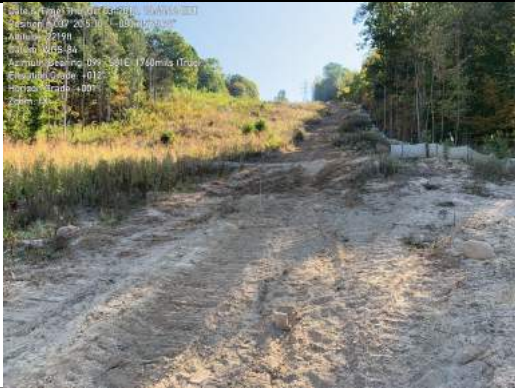
GPS Location	See picture above for GPS coordinates		GPS Location	See picture above for GPS coordinates	
Field Station#	10890+00		Field Station#	10890+00	
Pic 5 Desc.	Crews replaced damaged P1SF		Pic 6 Desc.	Crew preparing to stabilize travel lane

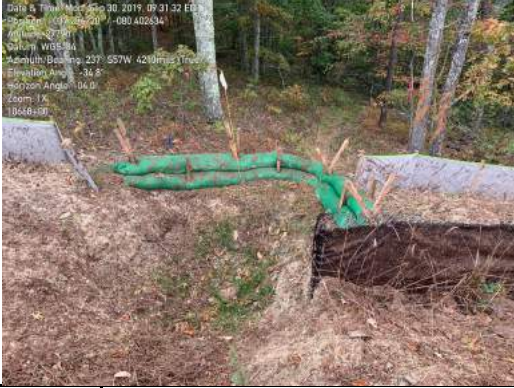
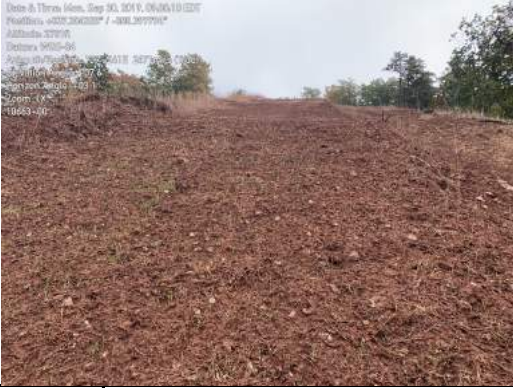
GPS Location	See photo for GPS location.		GPS Location	See photo for GPS location.	
Field Station#	10668+00		Field Station#	10663+00	
Pic 1 Desc.	Triple stack compost filter sock in place as end treatment.		Pic 2 Desc.	Right of way stabilized with hydro mulch.

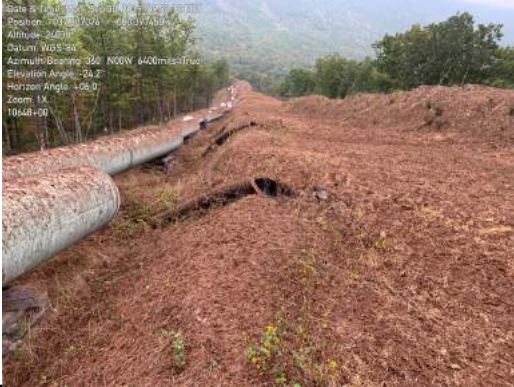
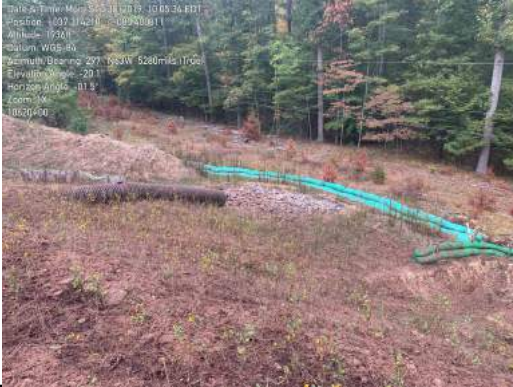
GPS Location	See photo for GPS location.		GPS Location	See photo for GPS location.	
Field Station#	10648+00		Field Station#	106+20	
Pic 3 Desc.	Slope drain with rock inlet and outlet in place along two tone to minimize erosion.		Pic 4 Desc.	Clean water diversion pipe with plunge pool in place.

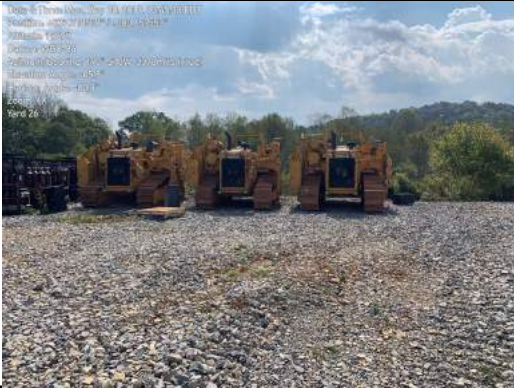
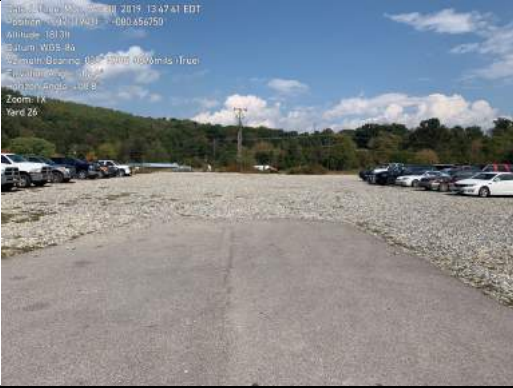
GPS Location	See photo for GPS location.		GPS Location	See photo for GPS location.	
Field Station#	12005+00		Field Station#	12005+00	
Pic 5 Desc.	Equipment staged at lay down yard 26. No leaks observed during inspection.		Pic 6 Desc.	RCE in place at employee parking lot to assist in preventing track out.

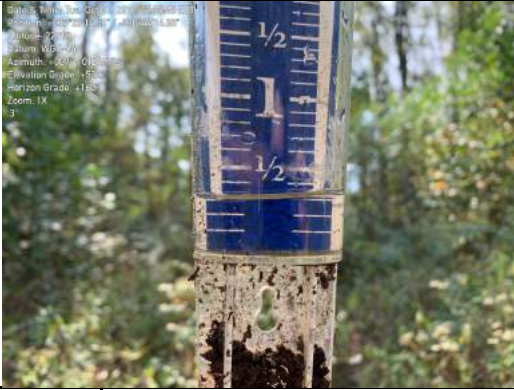
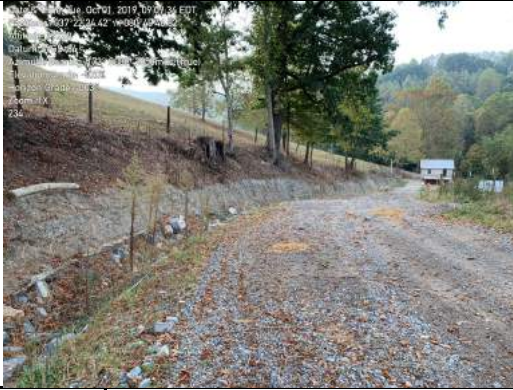
GPS Location	See picture above for GPS coordinates		GPS Location	See picture above for GPS coordinates	
Field Station#	+1		Field Station#	2+34	
Pic 1 Desc.	.3" of rain recorded		Pic 2 Desc.	AR 234

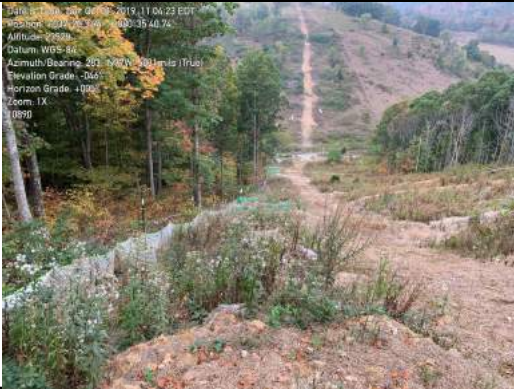
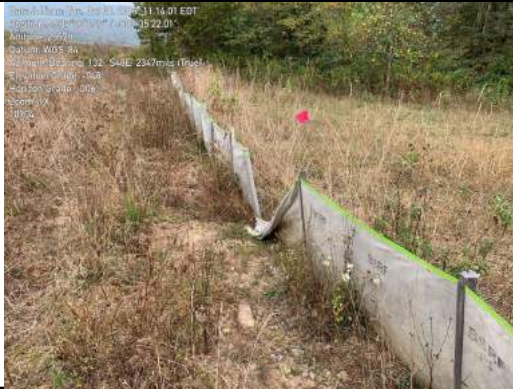
GPS Location	See picture above for GPS coordinates		GPS Location	See picture above for GPS coordinates	
Field Station#	10890+00		Field Station#	10904+00	
Pic 3 Desc.	ECD's and row conditions		Pic 4 Desc.	Wild life damage to P1SF

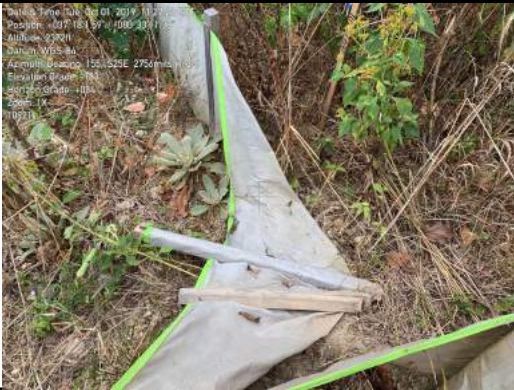
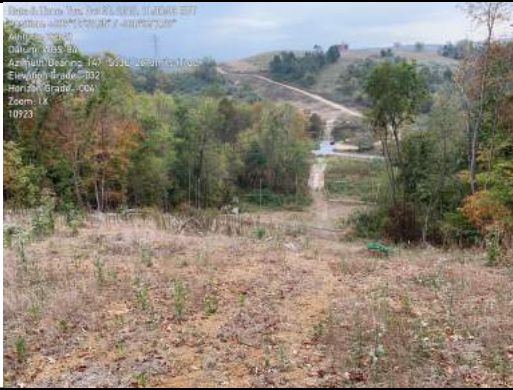
GPS Location	See picture above for GPS coordinates		GPS Location	See picture above for GPS coordinates	
Field Station#	10921+00		Field Station#	10923+00	
Pic 5 Desc.	Wild life damage to P1SF		Pic 6 Desc.	ECD's and row conditions

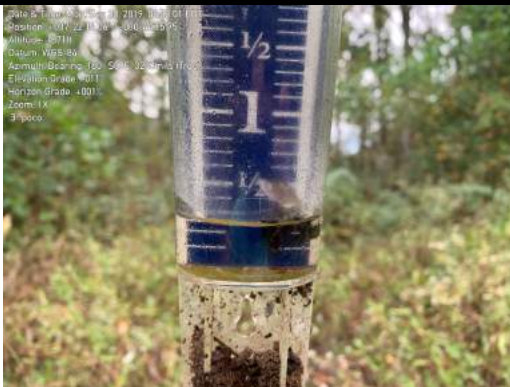
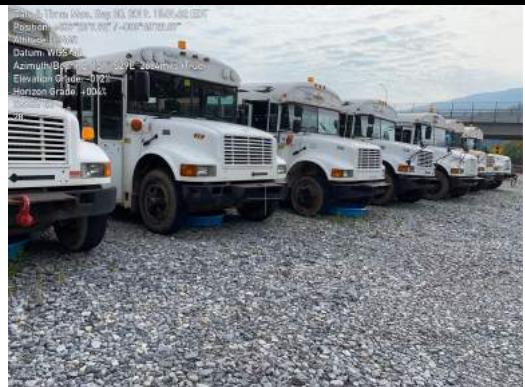
GPS Location	See picture above for GPS coordinates		GPS Location	See picture above for GPS coordinates	
Field Station#	+1		Field Station#	+28	
Pic 1 Desc.	.3" of rain collected @ Pocahontas rd		Pic 2 Desc.	Secondary containment and ECD's @ LDY 28

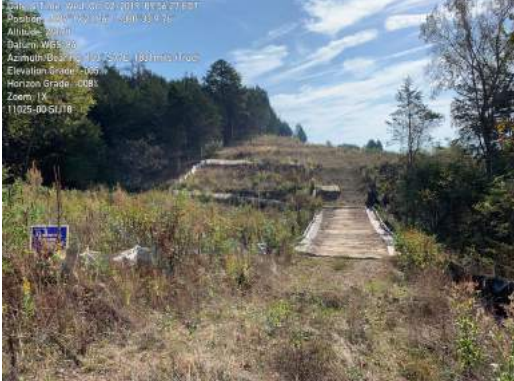
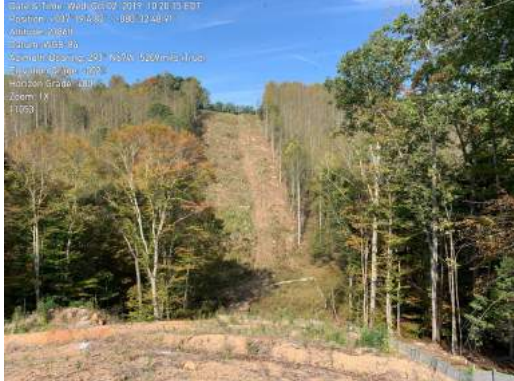
GPS Location	See picture above for GPS coordinates		GPS Location	See picture above for GPS coordinates	
Field Station#	11025+00		Field Station#	11053+00	
Pic 1 Desc.	ECD's and row conditions		Pic 2 Desc.	ECD's and row conditions

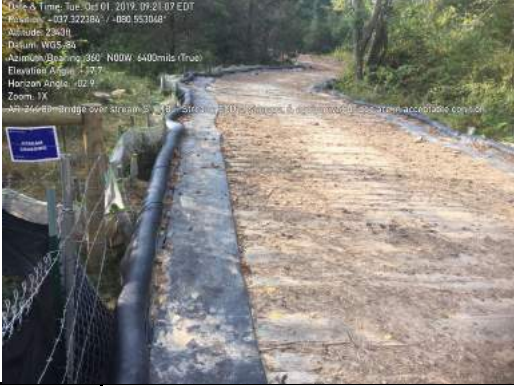
<p>Date & Time: Tue Oct 01, 2019 09:21:07 EDT Position: -037.322286, -400.553048 Altitude: 2293ft Datum: WGS-84 Azimuth Bearing: 360° N00W 6400mils (True) Elevation Angle: +27.7 Horizon Angle: -02.9 Zoom: 1X Scale 11017+00- Stream S-IJ18- Equipment bridge & signage are in acceptable condition.</p>

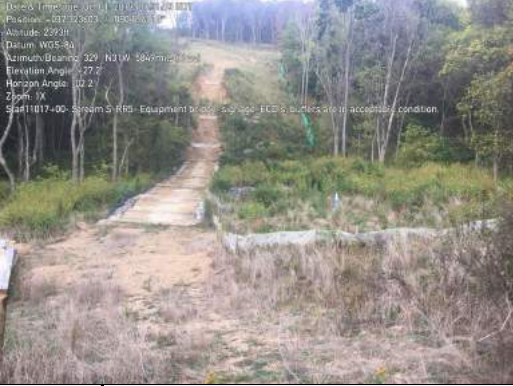
<p>Date & Time: Tue Oct 01, 2019 09:24:08 EDT Position: -037.322673, -400.553177 Altitude: 2293ft Datum: WGS-84 Azimuth Bearing: 329° N21W 3847mils (True) Elevation Angle: +27.2 Horizon Angle: -02.2 Zoom: 1X Scale 11017+00- Stream S-RR5- Equipment bridge, ECD's, buffers are in acceptable condition.</p>			
GPS Location	See photo GPS		GPS Location	See photo GPS	
Field Station#	11022+00		Field Station#	11017+00	
Pic 1 Desc.	AR-244- stream S-IJ18- Equipment bridge, ECD's, signage are in acceptable condition.		Pic 2 Desc.	Stream S-RR5- Equipment bridge, ECD's, signage, buffers are in acceptable condition, travel lane will be reseeded & mulched.

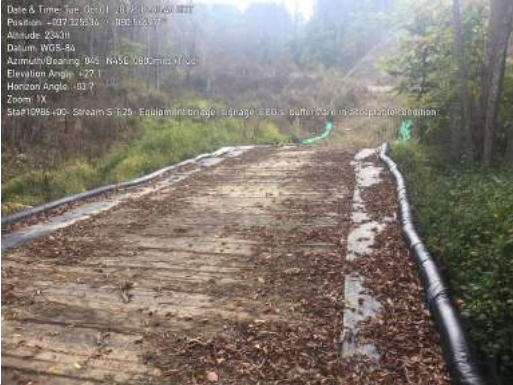
<p>Date & Time: Tue Oct 01, 2019 10:00:00 EDT Position: -037.325536, -400.563377 Altitude: 2243ft Datum: WGS-84 Azimuth Bearing: 345° N45E 6000mils (True) Elevation Angle: +22.1 Horizon Angle: -03.7 Zoom: 1X Scale 10986+00- Stream S-RR29- Equipment bridge, signage, ECD's, buffers are in acceptable condition.</p>			
GPS Location	See photo GPS		GPS Location	See photo GPS	
Field Station#	10993+00		Field Station#	10986+00	
Pic 3 Desc.	Steep slope ECD's are in acceptable condition, row is dry & stable.		Pic 4 Desc.	Equipment bridge, buffers, ECD's, sensitive resource signage are in acceptable condition.m

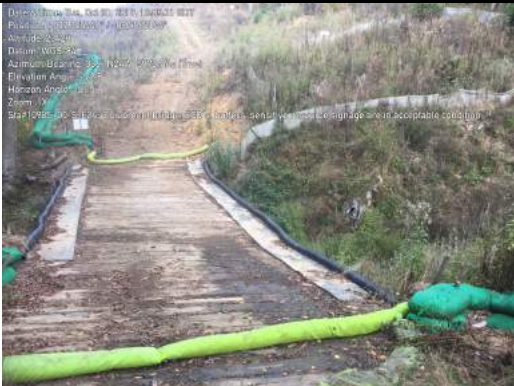
<p>Date & Time: Tue Oct 01, 2019 10:00:35 EDT Position: -037.325773, -400.563723 Altitude: 2220ft Datum: WGS-84 Azimuth Bearing: 330° N30W 6700mils (True) Elevation Angle: +21.5 Horizon Angle: -03.5 Zoom: 1X Scale 10985+00- Stream S-E24- Equipment bridge, buffers, ECD's, sensitive resource signage are in acceptable condition.</p>

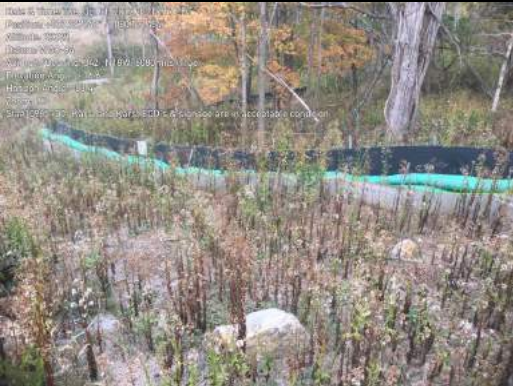
<p>Date & Time: Tue Oct 01, 2019 10:01:00 EDT Position: -037.325773, -400.563723 Altitude: 2220ft Datum: WGS-84 Azimuth Bearing: 330° N30W 6700mils (True) Elevation Angle: +21.5 Horizon Angle: -03.5 Zoom: 1X Scale 10965+00- Stream S-RR65- Karst & Karst ECD's & signage are in acceptable condition.</p>			
GPS Location	See photo GPS		GPS Location	See photo GPS	
Field Station#	10985+00		Field Station#	10965+00	
Pic 5 Desc.	Stream S-E24- Equipment bridge, buffers, ECD's, sensitive resource signage are in acceptable condition.		Pic 6 Desc.	Karst & Karst ECD's and signage are in acceptable condition.

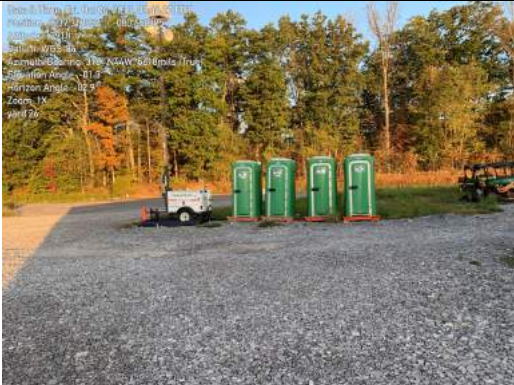
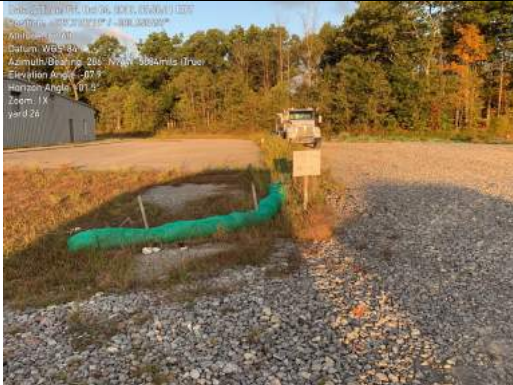
GPS Location	See photo for GPS location.		GPS Location	See photo for GPS location.	
Field Station#	12005+00		Field Station#	12005+00	
Pic 1 Desc.	Light plants and port-a-potties in containment.		Pic 2 Desc.	18 inch compost filter sock in place.

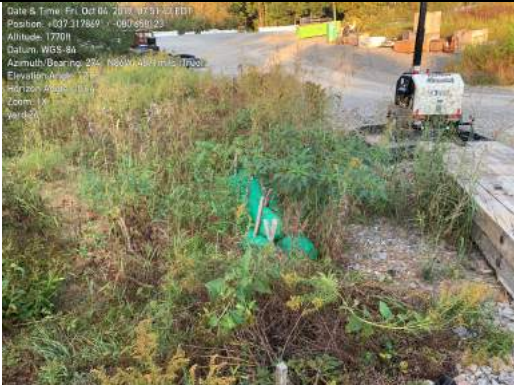
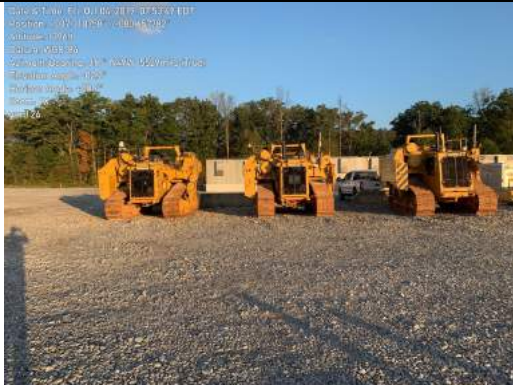
GPS Location	See photo for GPS location.		GPS Location	See photo for GPS location.	
Field Station#	12005+00		Field Station#	12005+00	
Pic 3 Desc.	Triple stack 12 inch compost filter sock in place.		Pic 4 Desc.	No leaks observed under equipment parked in yard.

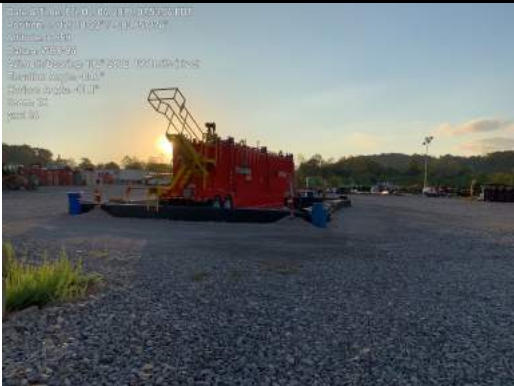
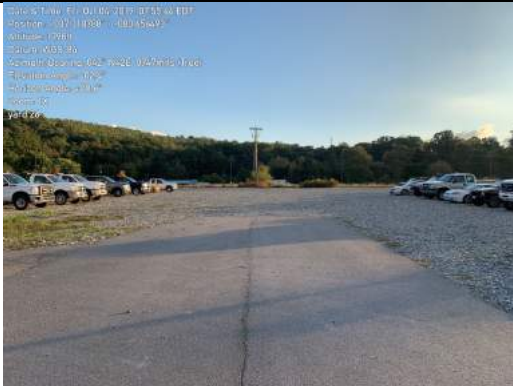
GPS Location	See photo for GPS location.		GPS Location	See photo for GPS location.	
Field Station#	12005+00		Field Station#	12005+00	
Pic 5 Desc.	Secondary containment in place under fuel cell.		Pic 6 Desc.	RCE in place at employee parking lot.

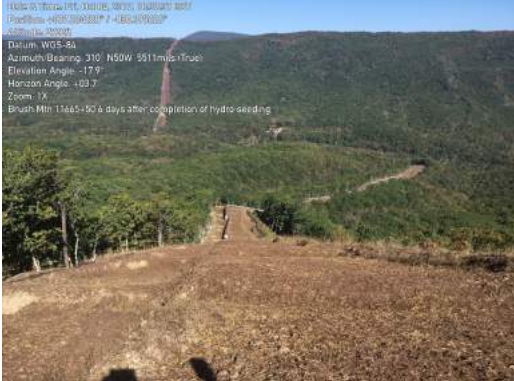
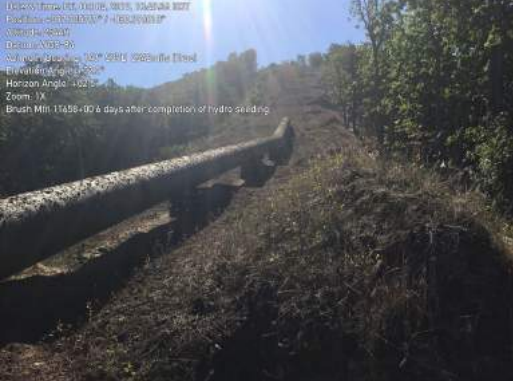
GPS Location	On photo	GPS Location	On photo		
Field Station#	11665+50	Field Station#	11658+00		
Pic 1 Desc.	Very dry soils. Hydro mulch dry. No germination to date in many areas	Pic 2 Desc.	Dry conditions inhibiting growth

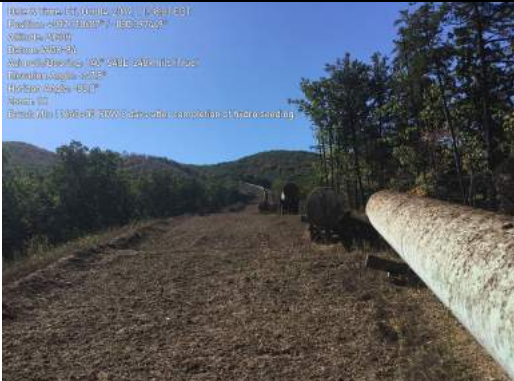
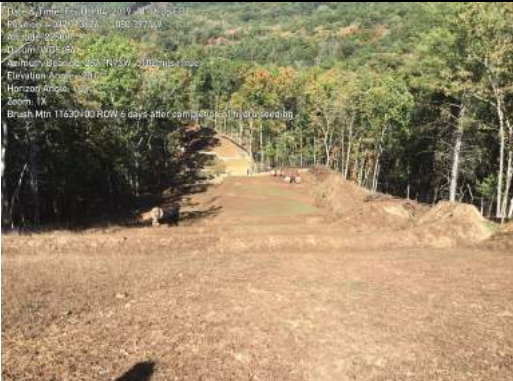
GPS Location	On photo	GPS Location	On photo		
Field Station#	11640+00	Field Station#	11630+00		
Pic 3 Desc.	Some seed sprouting where surface hydro seeded	Pic 4 Desc.	Soil dusty dry underneath hydro mulch

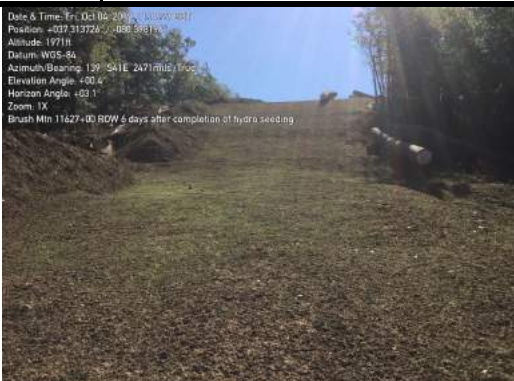
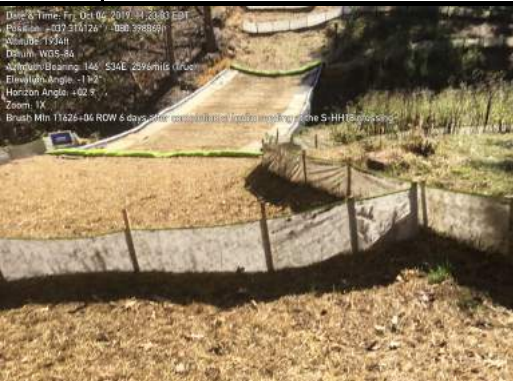
GPS Location	On photo	GPS Location	On photo		
Field Station#	11627+00	Field Station#	11626+04		
Pic 5 Desc.	Some germination obvious where hydro seeding occurred on JNF	Pic 6 Desc.	Resource crossings are stable with environmental controls placed

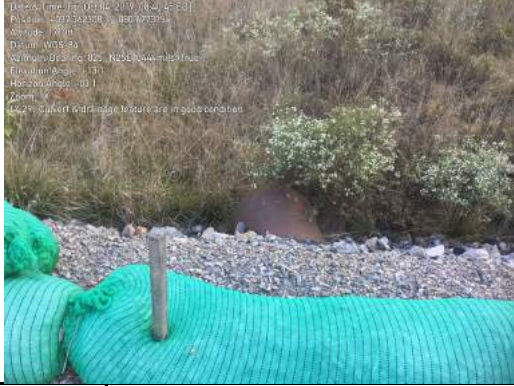
<p>Date & Time: Fri, Oct 4, 2019, 7:17 AM Position: +037.3231877 / -86.4050027 Altitude: 12000 Datum: WGS 84 Azimuth/Heading: 022° N25E 100m (18deg) Elevation Angle: +1.1° Horizon Angle: -03.1° Zoom: 1X LY-29: Culvert and drainage feature are in acceptable condition.</p>			
GPS Location	See photo GPS		GPS Location	See photo GPS	
Field Station#	12005+00		Field Station#	12005+00	
Pic 1 Desc.	Arnold's materials storage.		Pic 2 Desc.	Culvert and drainage feature are in acceptable condition.	
  <p>Date & Time: Fri, Oct 4, 2019, 8:05:03 EDT Position: +037.3207967 / -86.4779307 Altitude: 12000 Datum: WGS 84 Azimuth/Heading: 212° S22W 308m (18deg) Elevation Angle: +22.9° Horizon Angle: -04.1° Zoom: 1X LY-29: PPL materials storage, house, keeping is acceptable.</p>

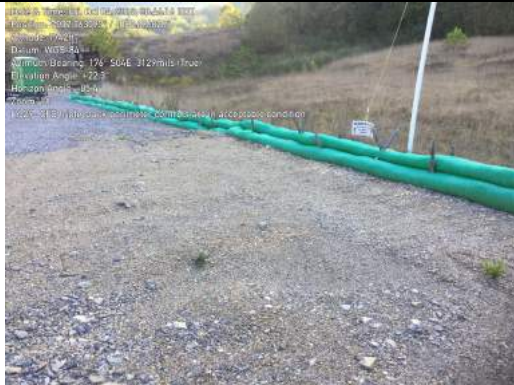
<p>Date & Time: Fri, Oct 4, 2019, 8:06:14 EDT Position: +037.3208223 / -86.4781643 Altitude: 12000 Datum: WGS 84 Azimuth/Heading: 176° S04E 312m (18deg) Elevation Angle: +22.3° Horizon Angle: -05.4° Zoom: 1X LY-29: CFS triple stack perimeter controls are in acceptable condition.</p>

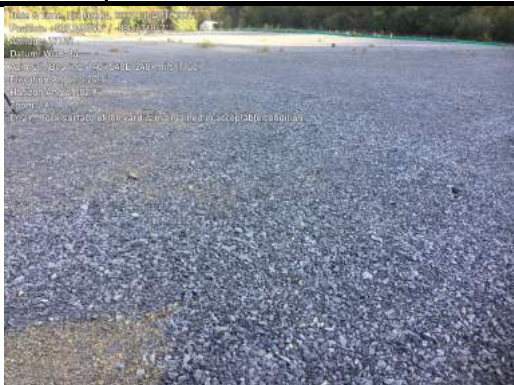
<p>Date & Time: Fri, Oct 4, 2019, 8:07:14 EDT Position: +037.3208223 / -86.4781643 Altitude: 12000 Datum: WGS 84 Azimuth/Heading: 176° S04E 312m (18deg) Elevation Angle: +22.3° Horizon Angle: -05.4° Zoom: 1X LY-29: Rock surface (drainage) is in acceptable condition.</p>			
GPS Location	See photo GPS		GPS Location	See photo GPS	
Field Station#	12005+00		Field Station#	12005+00

Pic 5 Desc.	Side boom staged in the yard, no fluid leaks observed from equipment at the time of inspection.		Pic 6 Desc.	Rock surface is maintained in acceptable condition.

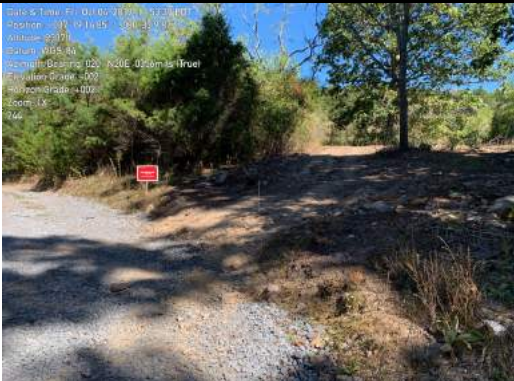
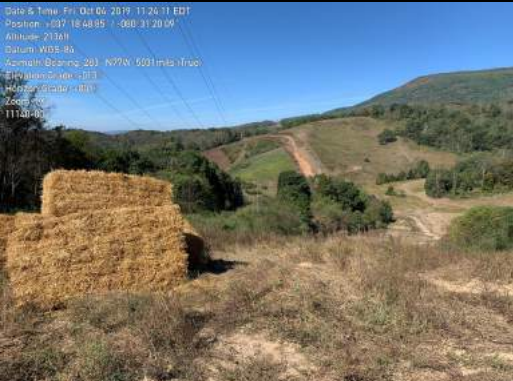
Field Station#		2+44		Field Station#	
Pic 5 Desc.		LO cutting trees and disturbing AR 244		Pic 6 Desc.	
				Crews staging straw bales for travel lane stabilization

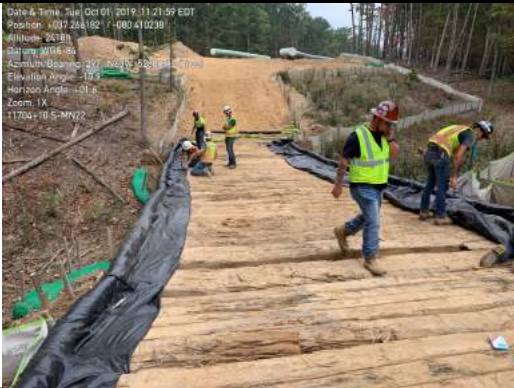
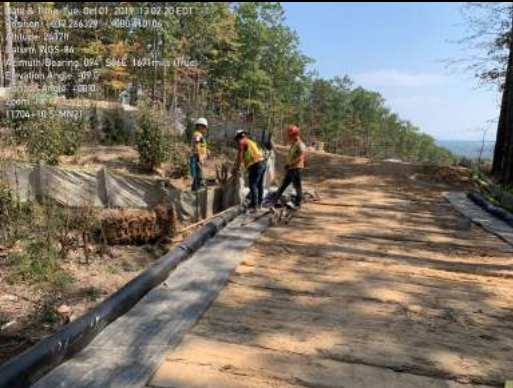
GPS Location	See photo for GPS location.		GPS Location	See photo for GPS location.	
Field Station#	11704+10		Field Station#	11704+10	
Pic 5 Desc.	Environmental crew stapling geotextile fabric over side board.		Pic 6 Desc.	Environmental crew installing priority one silt along buffer zone.
