# Visual Site Inspection Report

| <b>Project Name</b> | H-600 Pipeline Spread H | <b>AFE</b> | 124300138 | <b>Spread</b> | H-600 Pipeline Spread | |
| <b>Contractor</b> | Precision | | | <b>Report #</b> | 4746 | |
| <b>Inspector</b> | Pat Davis | | | <b>Date/Time</b> | 10/16/2019 5:04 PM | |

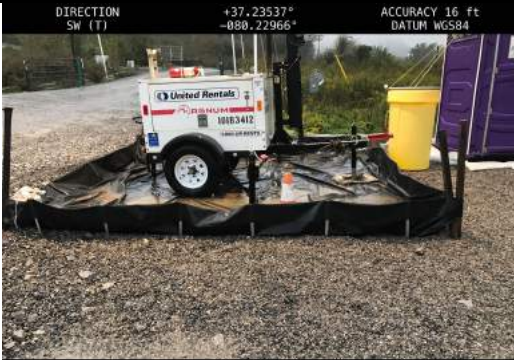
| <b>Pic 1 Desc.</b> | Condition of containment under light plant. Looking SW. | | <b>Pic 2 Desc.</b> | Flagging and signage in place at buffer for feature. Looking NE. | |

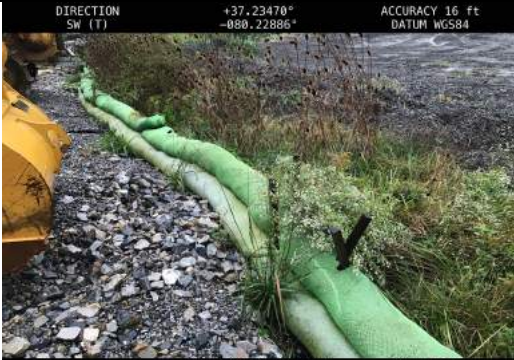
| <b>Pic 3 Desc.</b> | Condition of compost filter sock along west boundary. Looking SW. | | <b>Pic 4 Desc.</b> | No loose trash around dumpsters. Looking SW. | |

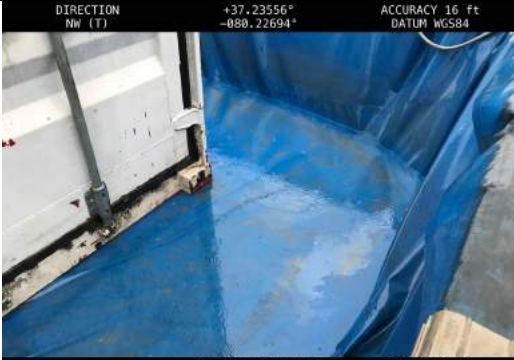
| <b>Pic 5 Desc.</b> | Off Road Fuel unit containment holding stormwater, sheen present on sto. Looking N. | | <b>Pic 6 Desc.</b> | Blue Bulk Fuel tanks no leaky fittings. Looking W. | |

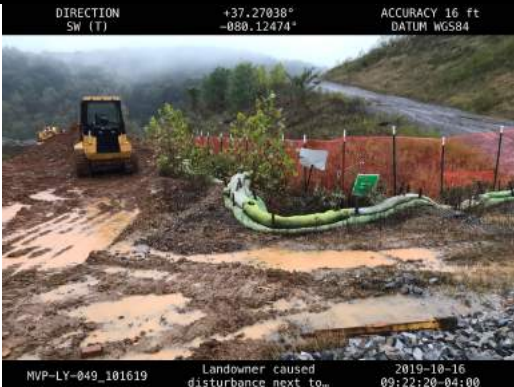
| <b>Pic 3 Desc.</b> | Landowner caused earth disturbance next to feature and CFS. No impact to feature or CFS. Looking SW. | <b>Pic 4 Desc.</b> | Status of row debris pile. Looking S. | | |

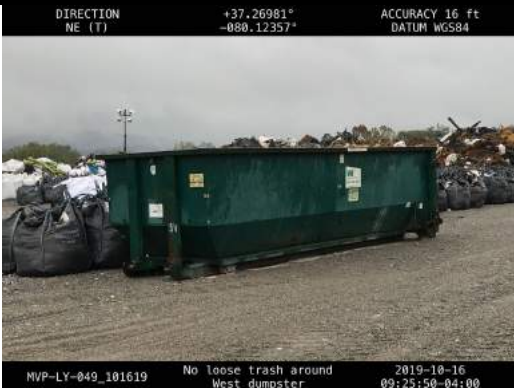
| <b>Pic 5 Desc.</b> | No loose trash around West dumpster. Looking NE. | <b>Pic 6 Desc.</b> | Condition of compost filter sock & safety fence along south boundary. Looking NW. | | |

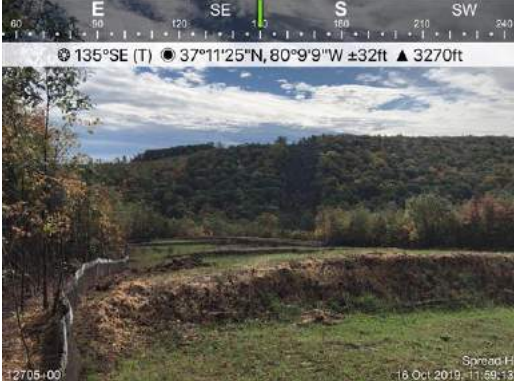
| <b>Pic 1 Desc.</b> | Controls on the GAS of AR-280 remain in good condition with vegetation continuing to fill in. | <b>Pic 2 Desc.</b> | Sumps throughout the area have received minimal amounts of water | | |

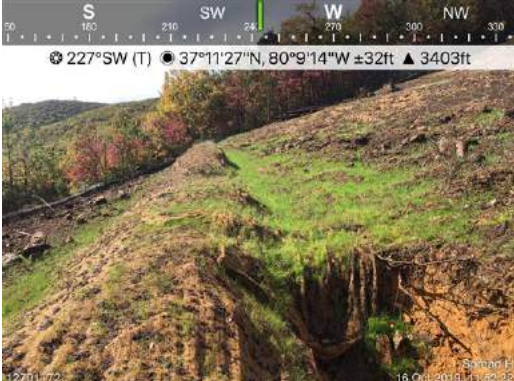
| <b>Pic 3 Desc.</b> | Waterbars remain in good condition and are functioning. | <b>Pic 4 Desc.</b> | Slope on the the GAS of Honeysuckle Rd. remains in good condition after the rain. Controls in place and functioning. | | |

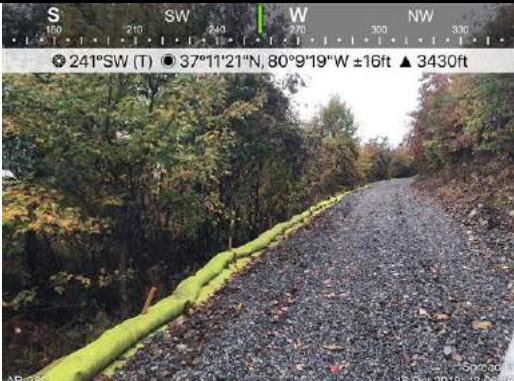
| <b>Pic 5 Desc.</b> | AR-280 remains in good condition with controls in place. | <b>Pic 6 Desc.</b> | ATWS at the start of AR-280 remains inactive with controls in place. | | |

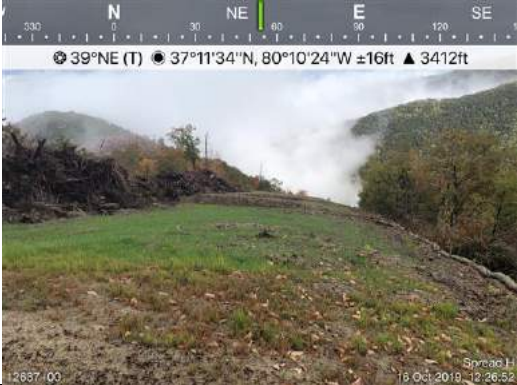
| <b>Pic 7 Desc.</b> | Slope on the GAS of AR-279.01 remains in good condition. Controls are functioning and vegetation continues fill in. | <b>Pic 8 Desc.</b> | Sumps on this slope remain in good condition with minimal amounts of rain water. | | |

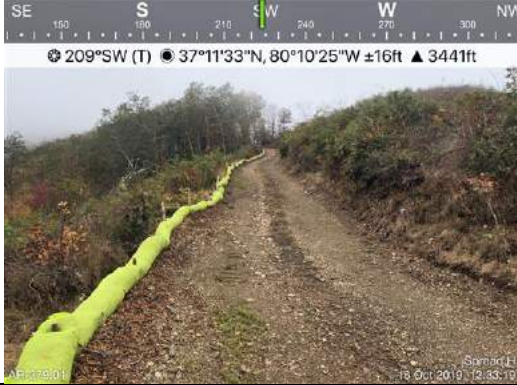
| <b>Pic 9 Desc.</b> | Controls along AR-279.01 are in good condition and functioning. | <b>Pic 10 Desc.</b> | | | |

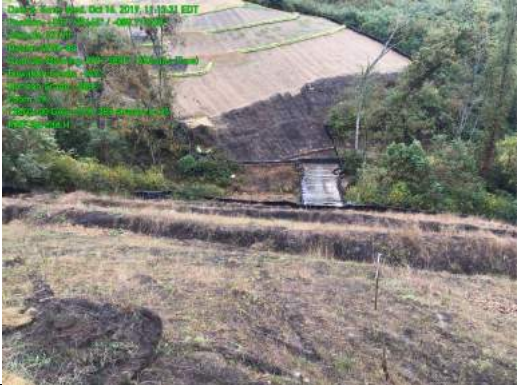
| <b>Pic 7 Desc.</b> | No issues or impacts observed at stream S-H1. The ROW on the CIS and the GAS are stabilized with vegetation and curlex. | | <b>Pic 8 Desc.</b> | Slope above stream S-G26, on the CIS, remains stabilized and shows good vegetation growing. | |

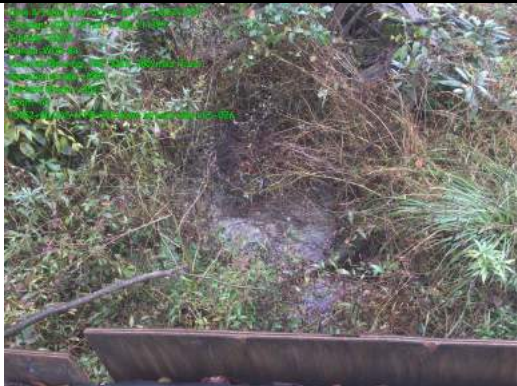
| <b>Pic 9 Desc.</b> | Downstream side of S-G26 had no signs of impact from the project. | | <b>Pic 10 Desc.</b> | Downstream side of S-G27 had no signs of impact from the project. | |

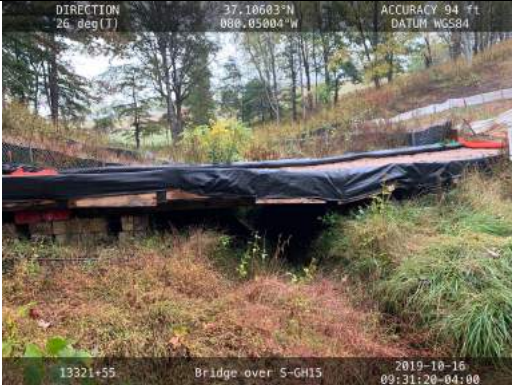
| <b>Pic 1 Desc.</b> | Photo shows the bridge over stream S-GH15. | | <b>Pic 2 Desc.</b> | Photo shows the bridge over stream S-GH14. | |

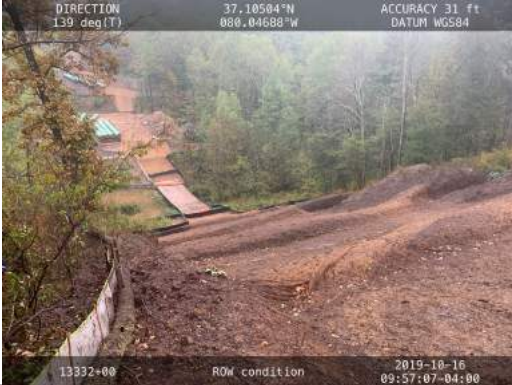
| <b>Pic 3 Desc.</b> | Photo shows the ROW condition from about 13332+00 to 13335+00. | | <b>Pic 4 Desc.</b> | Photo shows the bridge over stream S-RR11. | |

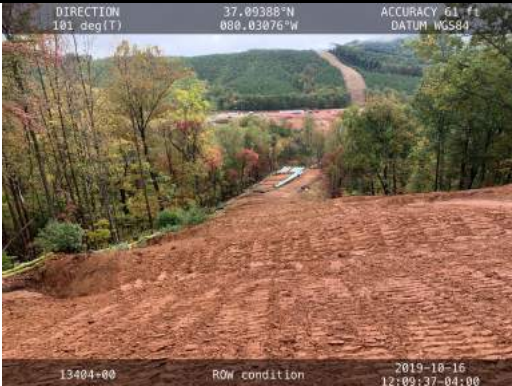
| <b>Pic 5 Desc.</b> | Photo shows the ROW condition from about 13404+00 to 13410+00. | | <b>Pic 6 Desc.</b> | Photo shows the bridge over stream S-IJ1. | |

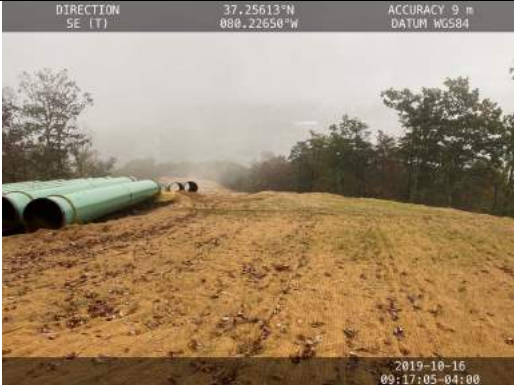
| <b>Pic 1 Desc.</b> | Stabilized ROW with pipe staged. | | <b>Pic 2 Desc.</b> | Stabilized ROW. | |

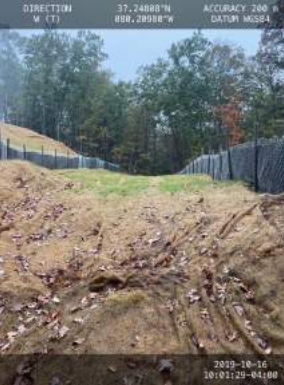
| <b>Pic 3 Desc.</b> | Land owner access crossing the ROW. | | <b>Pic 4 Desc.</b> | Bridge over stream crossing S-NN19 | |

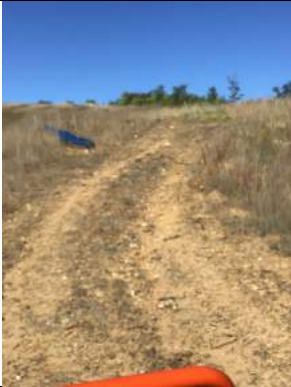
| <b>Pic 1 Desc.</b> | Area recommended for winter seed | | <b>Pic 2 Desc.</b> | Vegetation photo | |
