Visual Site Inspection Report

Project Name	H-600 Pipeline Spread H	AFE	124300138	Spread	H-600 Pipeline Spread H
Contractor	Precision	Report #	5020		
Inspector	Pat Davis	Date/Time	10/22/2019 5:33 PM		
Permit #	TBD	Inspection Type	VA SWPP	Station Begin	+0
State	VA	Inspection Area	Partial	Station End	+0
County	Montgomery	Ground	Damp	Temperature (°F)	67.00
Municipality	N/A	Weather	Light Rain	Rain Gauge (in)	0.70
				Rain Accumulation Time (days)	0.00

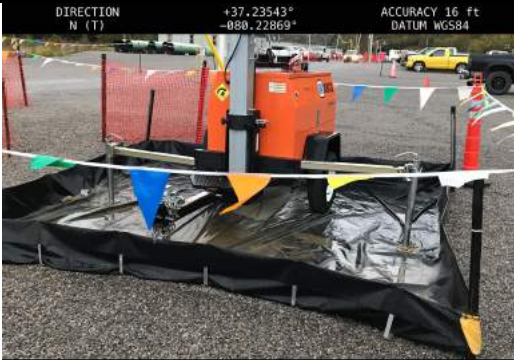
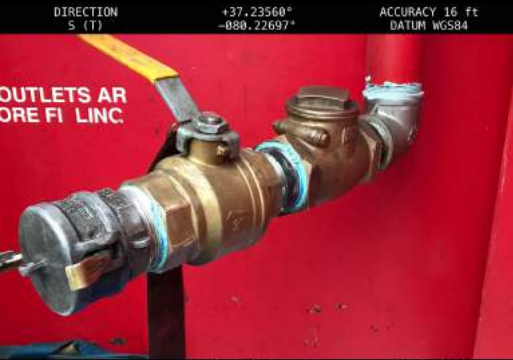
GPS Location	MVP-PY-006 See photo for gps data	GPS Location	MVP-PY-006 See photo for gps data		
Field Station#	+0	Field Station#	+0		
Pic 1 Desc.	Condition of containment under light plant. Looking N.	Pic 2 Desc.	Off Road Fuel unit no leaky fittings. Looking SW

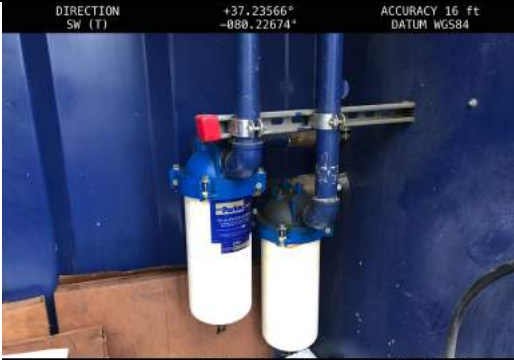
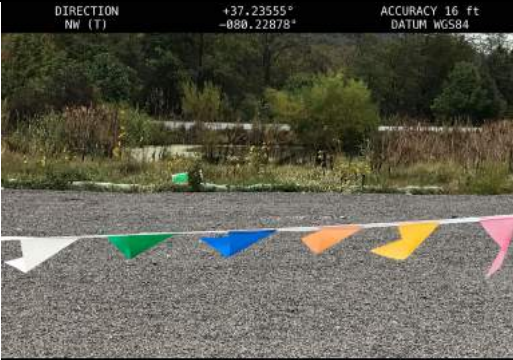
GPS Location	MVP-PY-006 See photo for gps data	GPS Location	MVP-PY-006 See photo for gps data		
Field Station#	+0	Field Station#	+0		
Pic 3 Desc.	Blue Bulk Fuel tanks no leaky fittings. Looking SW.	Pic 4 Desc.	Signage and buffer flagging for Off LOD feature. Looking NW.

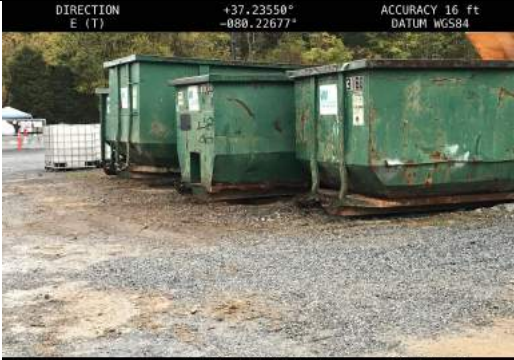
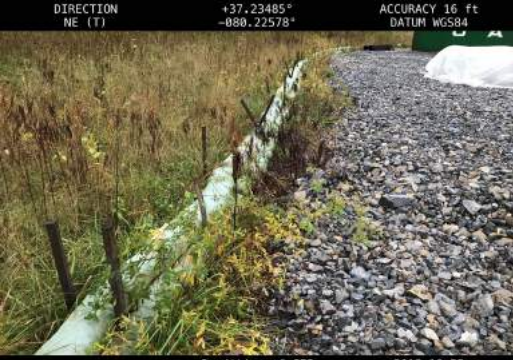
GPS Location	MVP-PY-006 See photo for gps data	GPS Location	MVP-PY-006 See photo for gps data		
Field Station#	+0	Field Station#	+0		
Pic 5 Desc.	No loose trash around dumpsters. Looking E.	Pic 6 Desc.	Condition of Compost Filter Sock along East boundary. Looking SE.

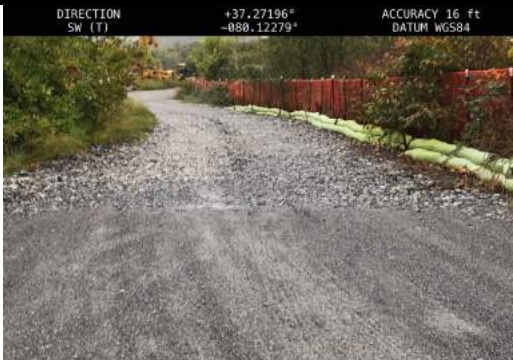
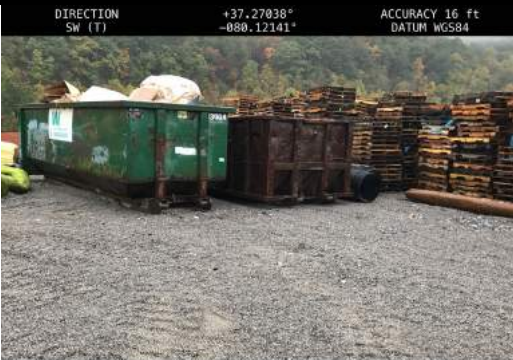
GPS Location		MVP-LY-049 See photo for gps data		GPS Location	
Field Station#		+0		MVP-LY-049 See photo for gps data	
Pic 1 Desc.		Condition of rock entrance on north drive. Looking SW.		Pic 2 Desc.	
				No loose trash around FAB Area dumpsters. Looking SW.

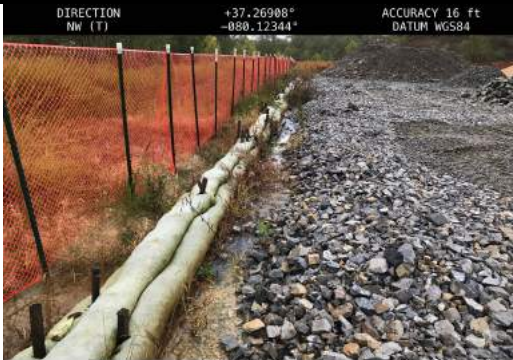
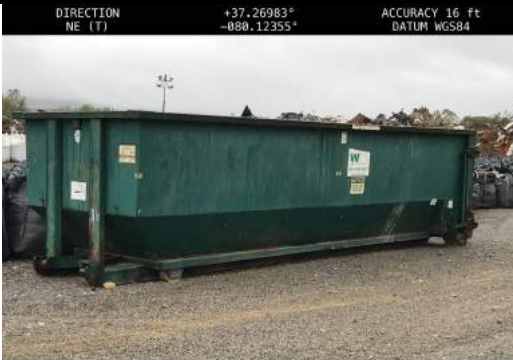
GPS Location		MVP-LY-049 See photo for gps data		GPS Location	
Field Station#		+0		MVP-LY-049 See photo for gps data	
Pic 3 Desc.		Condition of Compost Filter Sock and Safety fence along South boundary. Looking NW.		Pic 4 Desc.	
				No loose trash around West dumpster. Looking NE.

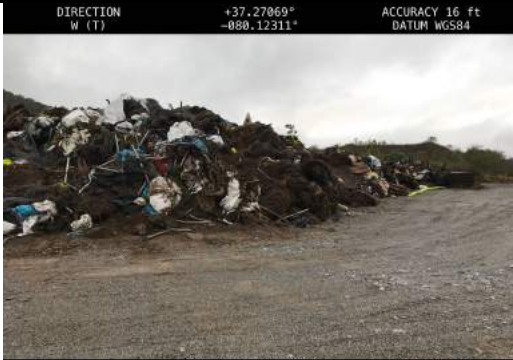
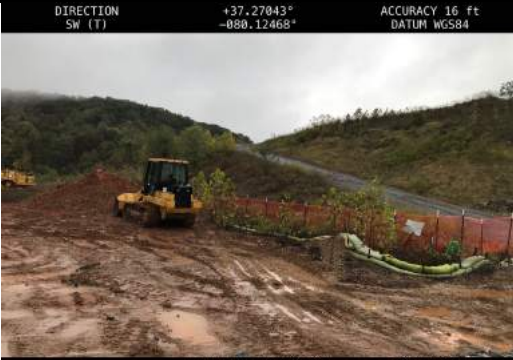
GPS Location		MVP-LY-049 See photo for gps data		GPS Location	
Field Station#		+0		MVP-LY-049 See photo for gps data	
Pic 5 Desc.		Status of row debris pile. Looking W.		Pic 6 Desc.	
				Landowner parked equipment next to CFS and off LOD feature. No impact. Looking SW.

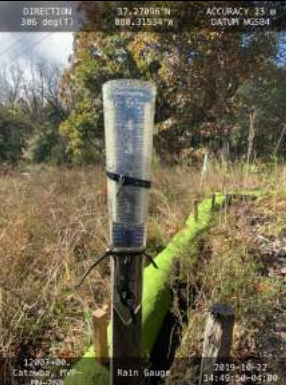
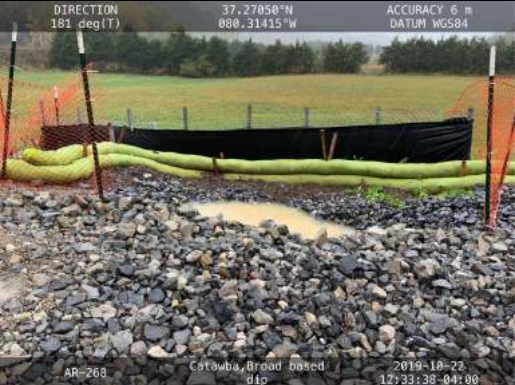
GPS Location	See photo GPS for location		GPS Location	See photo GPS for location	
Field Station#	12007+00		Field Station#	12007+00	
Pic 1 Desc.	Rain gauge 0.7".		Pic 2 Desc.	Broad based dip functioned acceptably through recent rain events.

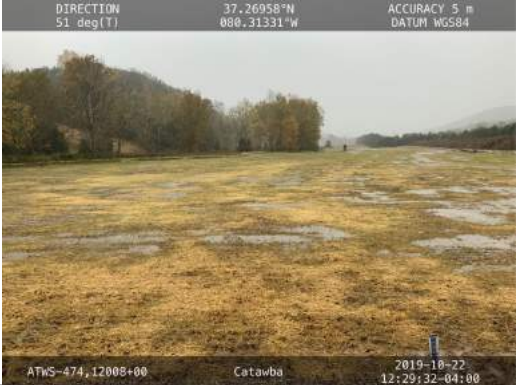
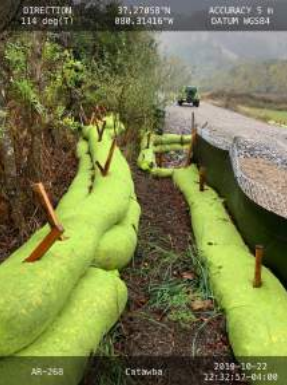
GPS Location	See photo GPS for location		GPS Location	See photo GPS for location	
Field Station#	12008+00		Field Station#	12007+00	
Pic 3 Desc.	ATWS-474 vegetation is progressing acceptably.		Pic 4 Desc.	18" triple stack CFS functioning properly by deterring stream overflow away from access road.

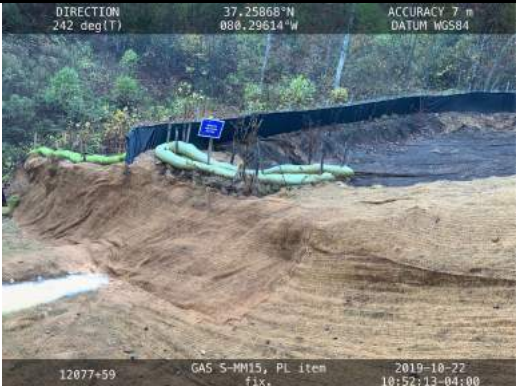
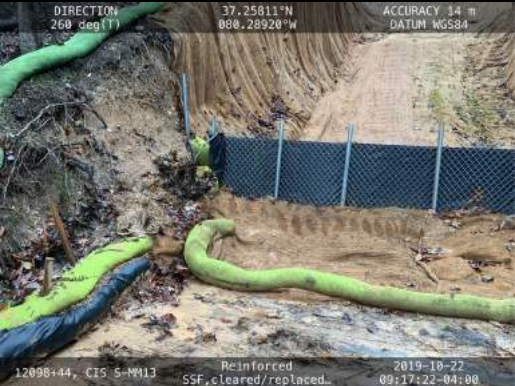
GPS Location	See photo GPS for location		GPS Location	See photo GPS for location	
Field Station#	12077+59		Field Station#	12098+44	
Pic 5 Desc.	New erosion blanket in place on cut bank .		Pic 6 Desc.	New erosion blanket and CFS checks installed.

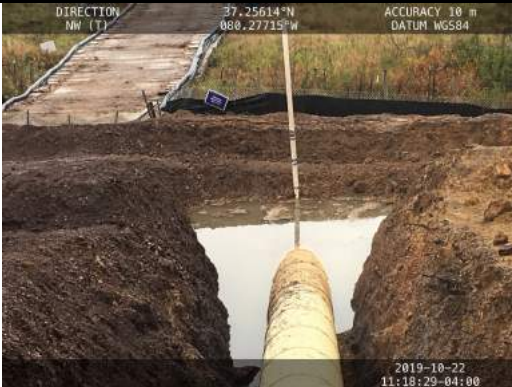
GPS Location	See photo		GPS Location	See photo	
Field Station#	12133+50		Field Station#	12163+05	
Pic 1 Desc.	Triple stacked CFS needs to be reinstalled around the bottom of this open bell hole on the going away side of stream S-C29.		Pic 2 Desc.	Stream S-C25, facing east

E&S BMPs	Compliance Level	Corrective Action	Corrective Time Frame	Date Repaired
Compost Filter Sock	Communication	12133+50: install CFS at bell hole		
Compost Filter Sock	Communication	12167+50: install CFS at bell hole		
Compost Filter Sock	Communication	Repair CFS next to Reese Mt Rd		
Silt Fence (Filter Fabric Fence)	Acceptable			
Silt Fence (Reinforced Filter Fabric Fence)	Acceptable			
Waterbar	Acceptable			
Waterbar End Treatment	Acceptable			
Sump Pit	Acceptable			
Hydraulically Applied Blanket	Acceptable

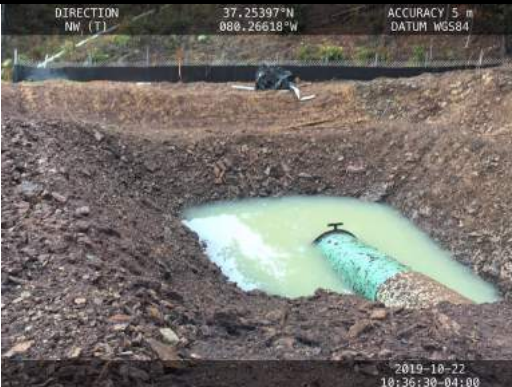
GPS Location	See photo		GPS Location	See photo	
Field Station#	12166+47		Field Station#	12167+50	
Pic 3 Desc.	Stream S-C24, facing east		Pic 4 Desc.	Triple stacked CFS needs to be reinstalled around the bottom edge of this open bell hole on the going away side of stream S-C24.

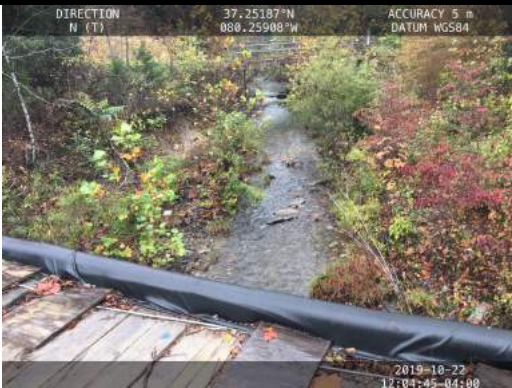
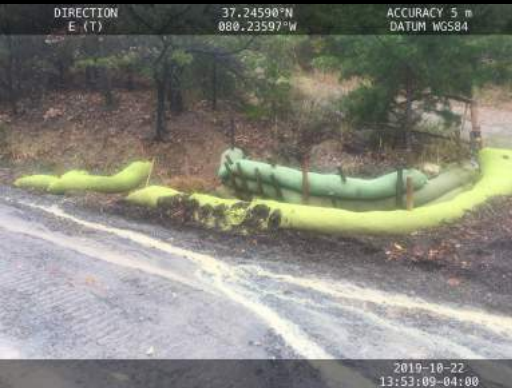
GPS Location	See photo		GPS Location	See photo	
Field Station#	12192+50		Field Station#	12234+50	
Pic 5 Desc.	Stream S-C21, Bradshaw Creek, facing north, downstream. No visible plumes of sediment during today's rain even.		Pic 6 Desc.	CFS damaged next to this culvert under a driveway on access road MVP-MN-276.03. Needs to be replaced.

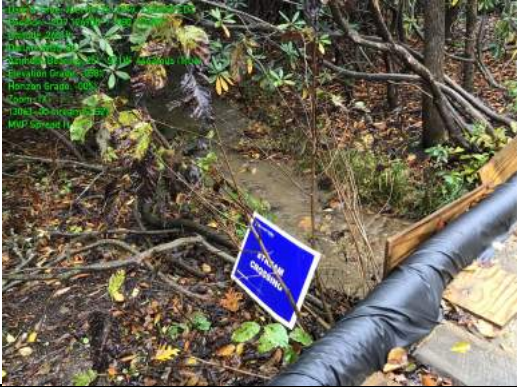
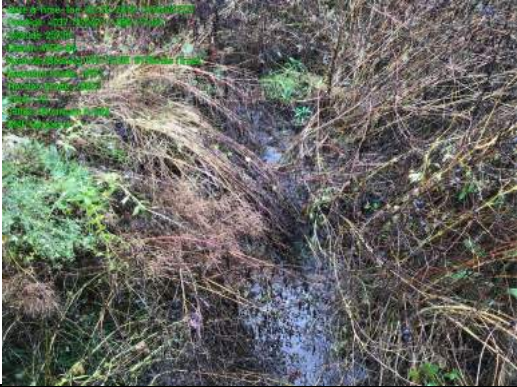
GPS Location	See pic for GPS location		GPS Location	See pic for GPS location	
Field Station#	13063+00		Field Station#	13062+00	
Pic 7 Desc.	Cloudy water in stream S-G27 originates from off ROW upstream of the project.		Pic 8 Desc.	No impacts to stream S-G26 were found.

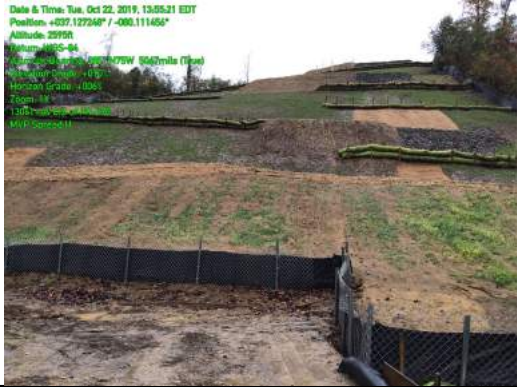
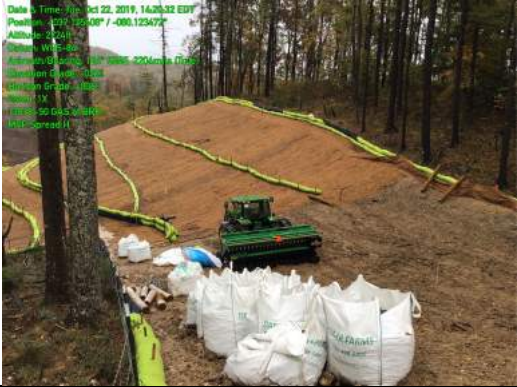
GPS Location	See pic for GPS location		GPS Location	See pic for GPS location	
Field Station#	13061+44		Field Station#	13018+50	
Pic 9 Desc.	CIS of FR-290 showed no signs of further erosion from today's rain showers.		Pic 10 Desc.	No issues or impacts were observed on the GAS of the BRP.

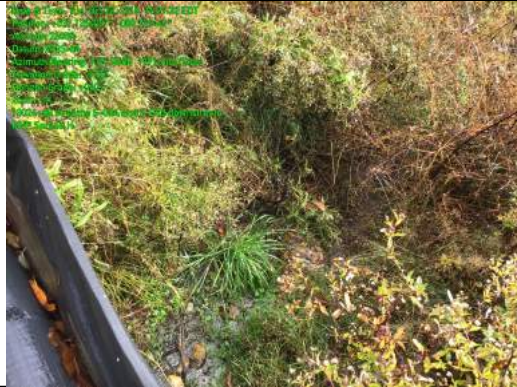
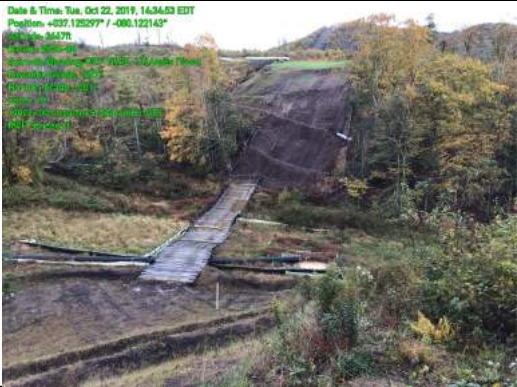
GPS Location	See pic for GPS location		GPS Location	See pic for GPS location	
Field Station#	13024+00		Field Station#	13022+00	
Pic 11 Desc.	Streams S-G24 and S-G25 were not impacted by today's rain event.		Pic 12 Desc.	No issues or impacts observed in the area of streams S-G24&25.

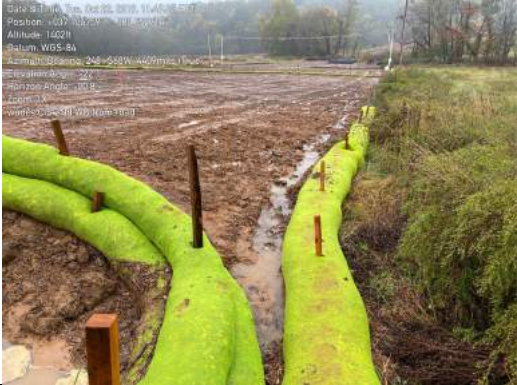
GPS Location	See photo for coordinates.	GPS Location	See photo for coordinates.		
Field Station#	13311+00	Field Station#	13309+09		
Pic 7 Desc.	Outlet protection undermined, rill developing along perimeter control down ROW.	Pic 8 Desc.	S-GH7, looking upstream of equipment bridge, no sediment release noted.

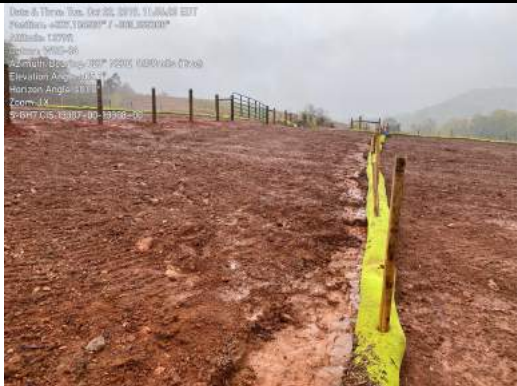
<div style="text-align: center;">Insert image here</div>			
GPS Location	See photo for coordinates.	GPS Location			
Field Station#	13306+00	Field Station#			
Pic 9 Desc.	Sediment build up along CFS waterbar replacements in agricultural field.	Pic 10 Desc.			
<div style="text-align: center;">Insert image here</div>		<div style="text-align: center;">Insert image here</div>			
GPS Location		GPS Location			
Field Station#		Field Station#			
Pic 11 Desc.		Pic 12 Desc.

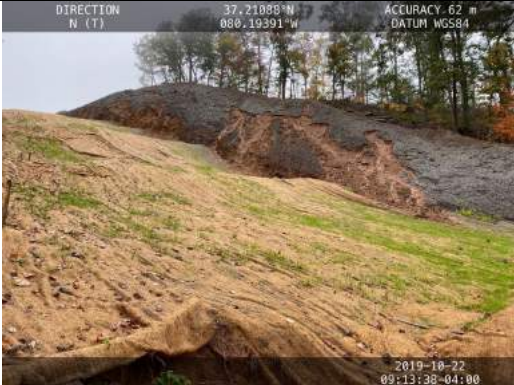
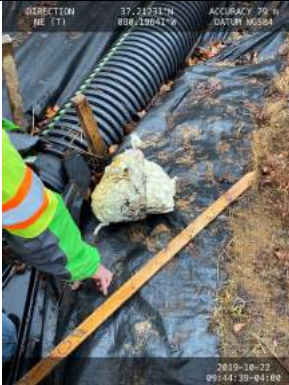
GPS Location	See picture for GPS data		GPS Location	See picture for GPS data	
Field Station#	12542+50		Field Station#	12533+00	
Pic 1 Desc.	Spoil pile CIS of Yellow Finch Road eroding into ROW.		Pic 2 Desc.	Chunk of expanding foam removed from inlet of fill slope drain.

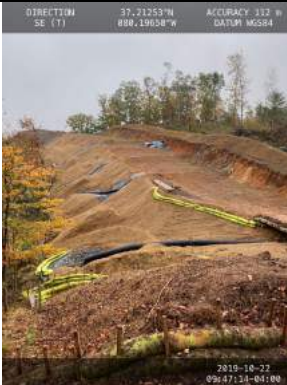
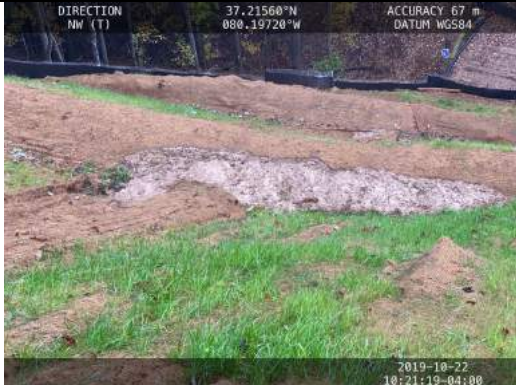
GPS Location	See picture for GPS data		GPS Location	See picture for GPS data	
Field Station#	12536+00		Field Station#	12521+00	
Pic 3 Desc.	Stabilized ROW and clear water crossing.		Pic 4 Desc.	Sediment eroding into waterbar.

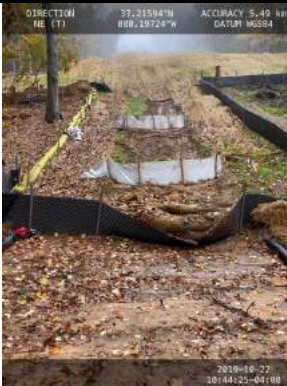
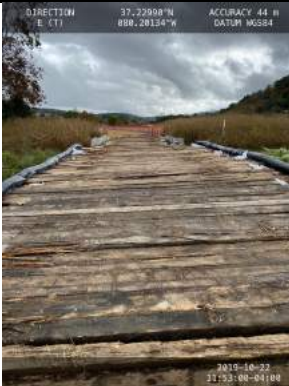
GPS Location	See picture for GPS data		GPS Location	See picture for GPS data	
Field Station#	12519+30		Field Station#	12460+58	
Pic 5 Desc.	SSF over half full and needs cleaned out and repaired.		Pic 6 Desc.	Bridge crossing S-12CDB

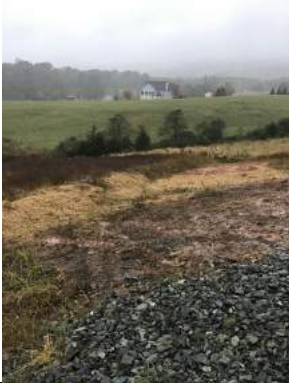
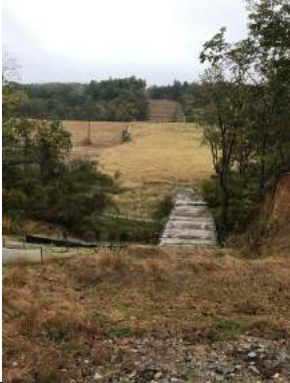
GPS Location	0000	GPS Location	0000		
Field Station#	13547+31	Field Station#	13543+11		
Pic 1 Desc.	Photo showing water bar repaired	Pic 2 Desc.	Row photo during rain event showing ECDs and vegetation

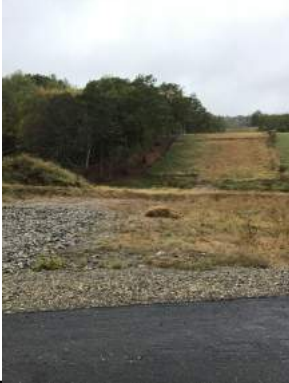
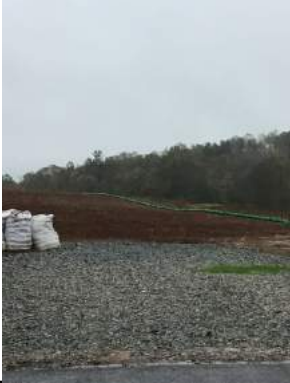
GPS Location	0000	GPS Location	0000		
Field Station#	13541+60	Field Station#	13644+73		
Pic 3 Desc.	RCE and row photo at House Rock rd during rain event	Pic 4 Desc.	RCE inspected at Leaning Oak rd		
Insert image here			Insert image here		
GPS Location		GPS Location			
Field Station#		Field Station#			
Pic 5 Desc.		Pic 6 Desc.
