Visual Site Inspection Report

Project Name	H-600 Pipeline Spread H	AFE	124300138	Spread	H-600 Pipeline Spread H
Contractor	Precision	Report #	5821		
Inspector	Pat Davis	Date/Time	11/13/2019 4:00 PM		
Permit #	TBD	Inspection Type	VA SWPP	Station Begin	+0
State	VA	Inspection Area	Partial	Station End	+0
County	Montgomery	Ground	Dry	Temperature (°F)	35.00
Municipality	N/A	Weather	Sunny	Rain Gauge (in)	0.00
				Rain Accumulation Time (days)	0.00

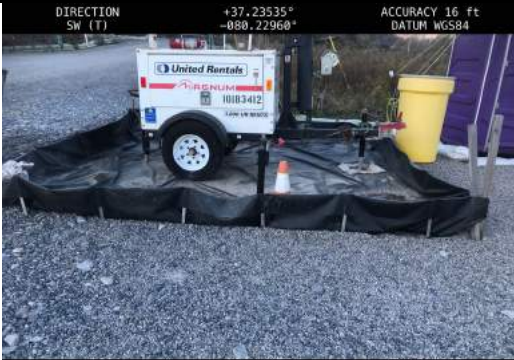
<p>DIRECTION SW (T) +37.23535° -880.22968° ACCURACY 16 ft DATUM WGS84</p> <p>MVP-PY-006_111319 Condition of containment 2019-11-13 07:41:07-05:00</p>

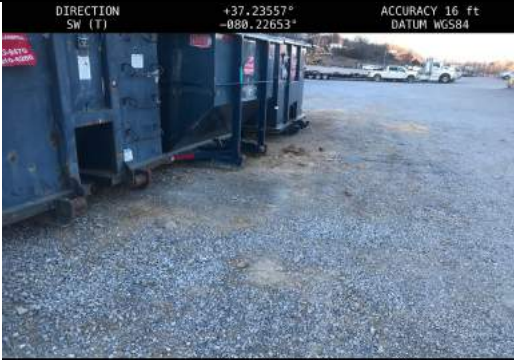
<p>DIRECTION SW (T) +37.23557° -880.22653° ACCURACY 16 ft DATUM WGS84</p> <p>MVP-PY-006_111319 No loose trash around dumpsters 2019-11-13 07:53:38-05:00</p>

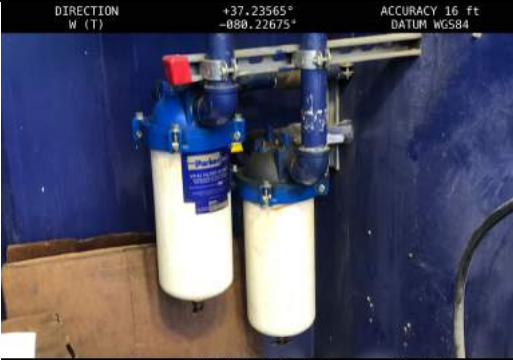
<p>DIRECTION W (T) +37.23565° -880.22675° ACCURACY 16 ft DATUM WGS84</p> <p>MVP-PY-006_111319 Blue bulk fuel tanks no leaky fittings 2019-11-13 07:54:35-05:00</p>		GPS Location MVP-PY-006 See photo for gps data

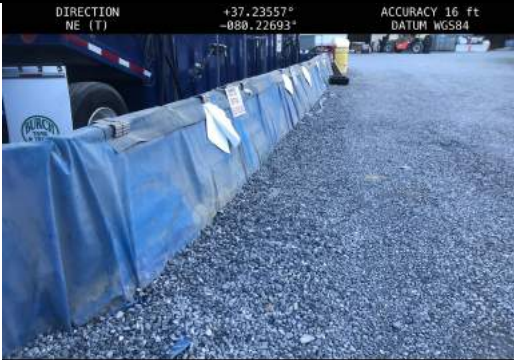
<p>DIRECTION NE (T) +37.23557° -880.22693° ACCURACY 16 ft DATUM WGS84</p> <p>MVP-PY-006_111319 No fluid deposits south of bulk tanks 2019-11-13 07:58:07-05:00</p>

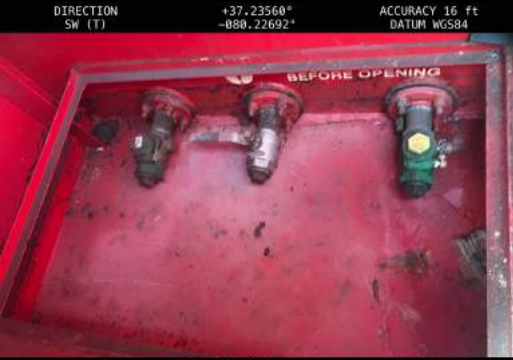
<p>DIRECTION SW (T) +37.23560° -880.22692° ACCURACY 16 ft DATUM WGS84</p> <p>MVP-PY-006_111319 Off Road Fuel unit no leaky fittings 2019-11-13 07:57:31-05:00</p>		GPS Location MVP-PY-006 See photo for gps data	
Field Station# +0		Field Station# +0		Pic 5 Desc. No fluid deposits on the south side of the bulk fuel tanks. Looking NE.	
Pic 6 Desc. Off Road Fuel unit no leaky fittings. Looking SW.		Pic 6 Desc. Off Road Fuel unit no leaky fittings. Looking SW.		GPS Location MVP-PY-006 See photo for gps data

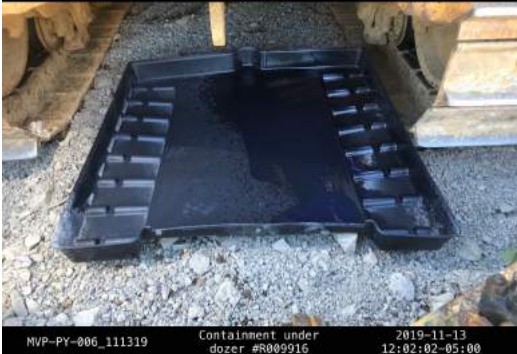
Insert image here			
GPS Location	MVP-PY-006 See photo for gps data		GPS Location		
Field Station#	+0		Field Station#		
Pic 7 Desc.	Dozer #R009916 fluid deposit cleaned up and containment placed. Looking SW.		Pic 8 Desc.		
Insert image here			Insert image here		
GPS Location			GPS Location		
Field Station#			Field Station#		
Pic 9 Desc.			Pic 10 Desc.		
Insert image here			Insert image here		
GPS Location			GPS Location		
Field Station#			Field Station#		
Pic 11 Desc.			Pic 12 Desc.

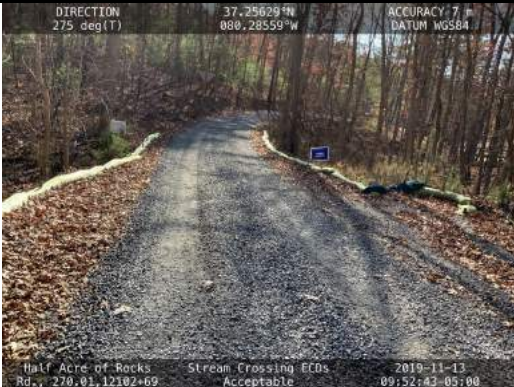
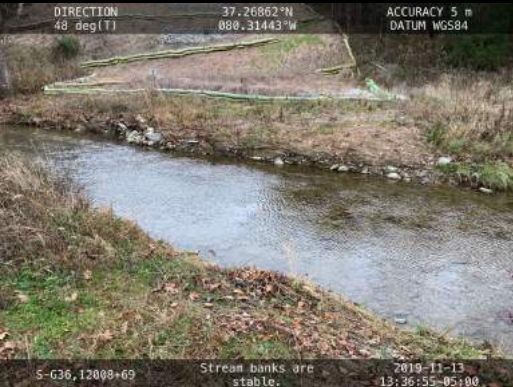
GPS Location	See photo GPS for location		GPS Location	See photo GPS for location	
Field Station#	12102+69		Field Station#	12008+69	
Pic 1 Desc.	ECDs on AR270.01 by stream crossing are in acceptable condition.		Pic 2 Desc.	Stream banks are stable.

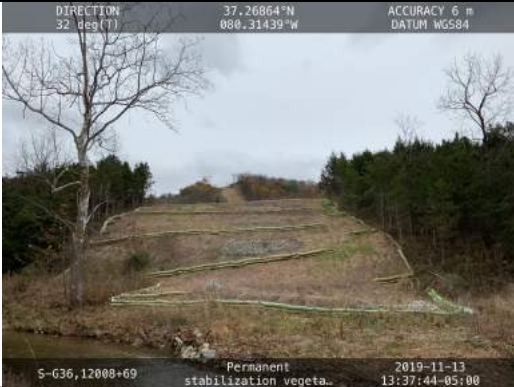
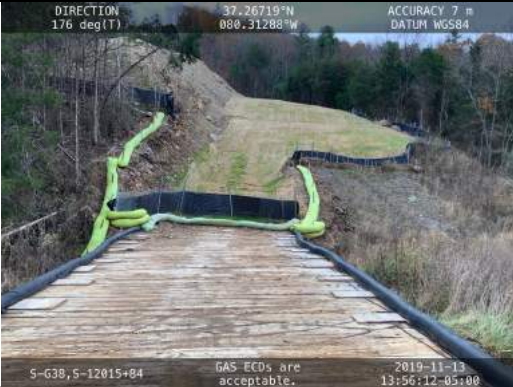
GPS Location	See photo GPS for location		GPS Location	See photo GPS for location	
Field Station#	12008+69		Field Station#	12015+84	
Pic 3 Desc.	Vegetation, rock weirs, and earthen berms are in good condition on this permanently restored area GAS S-G36.		Pic 4 Desc.	ECDs on sloped GAS of S-G38 are in acceptable condition.

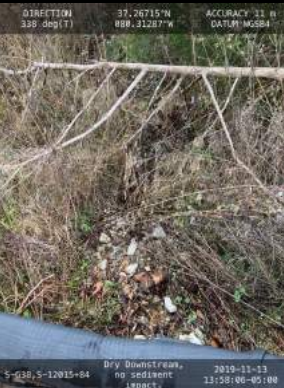
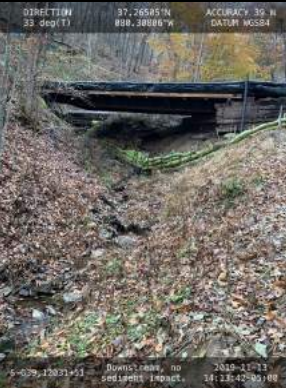
GPS Location	See photo GPS for location		GPS Location	See photo GPS for location	
Field Station#	12015+84		Field Station#	12031+51	
Pic 5 Desc.	No sediment impact to stream.		Pic 6 Desc.	No sediment impact to stream.

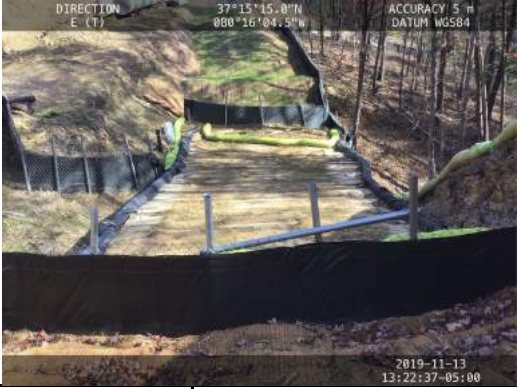
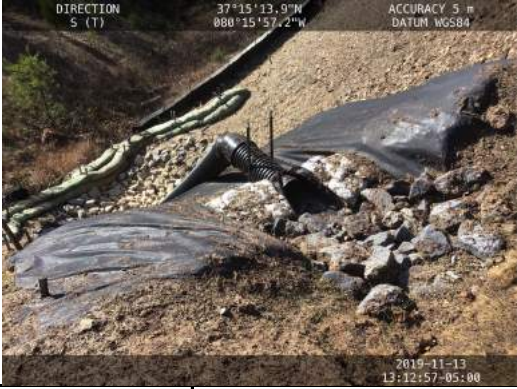
GPS Location	See photo		GPS Location	See photo	
Field Station#	12163+05		Field Station#	12170+00	
Pic 7 Desc.	Stream S-C25, facing east		Pic 8 Desc.	Fill slope drains are functioning as needed.	
Insert image here			Insert image here		
GPS Location			GPS Location		
Field Station#			Field Station#		
Pic 9 Desc.			Pic 10 Desc.		
Insert image here			Insert image here		
GPS Location			GPS Location		
Field Station#			Field Station#		
Pic 11 Desc.			Pic 12 Desc.

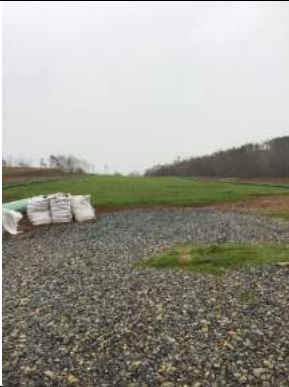
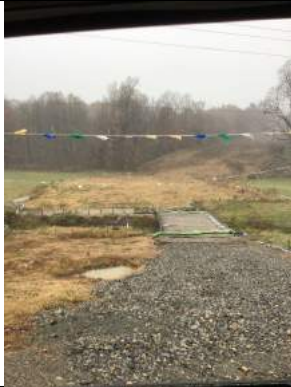
GPS Location	00000	GPS Location	00000		
Field Station#	13644+90	Field Station#	13498+12		
Pic 1 Desc.	RCE photo and vegetation growth	Pic 2 Desc.	Photo showing ECDs in place and functioning at stream crossing

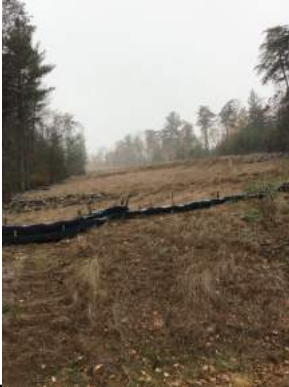
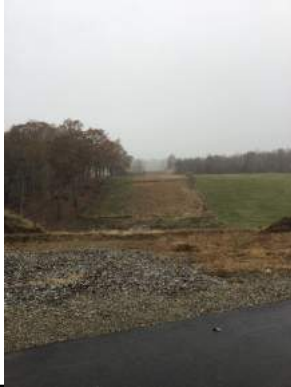
GPS Location	00000	GPS Location	00000		
Field Station#	13496+76	Field Station#	13541+60		
Pic 3 Desc.	Vegetation photo during winter mix events	Pic 4 Desc.	RCE photo during winter mix		
Insert image here			Insert image here		
GPS Location		GPS Location			
Field Station#		Field Station#			
Pic 5 Desc.		Pic 6 Desc.

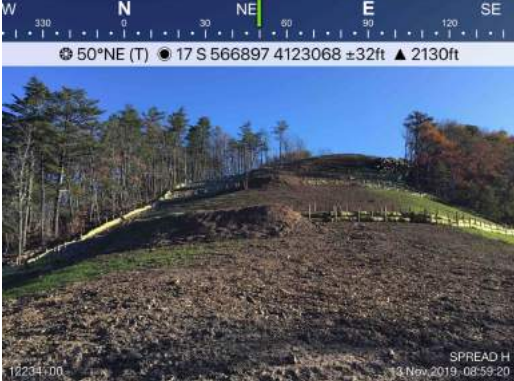
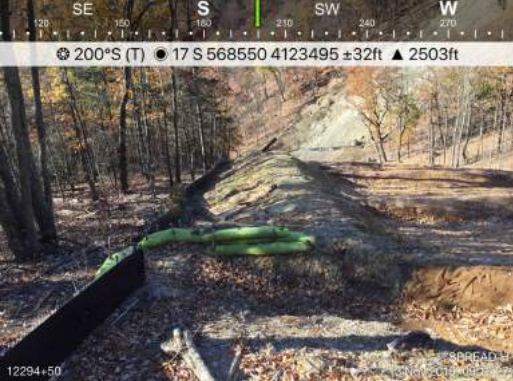
GPS Location	See Photo Above		GPS Location	See Photo Above	
Field Station#	12234+00		Field Station#	12294+50	
Pic 1 Desc.	Perm waterbars and stabilized row in good condition		Pic 2 Desc.	SSF in good condition with waterbar end treatment in good condition

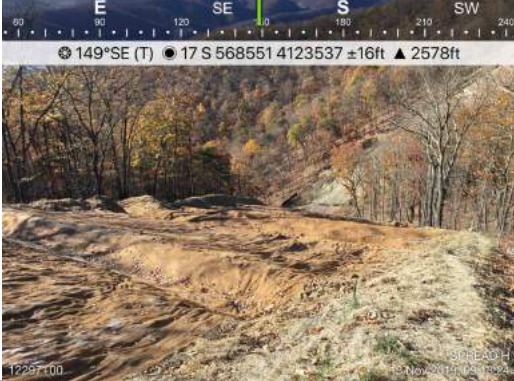
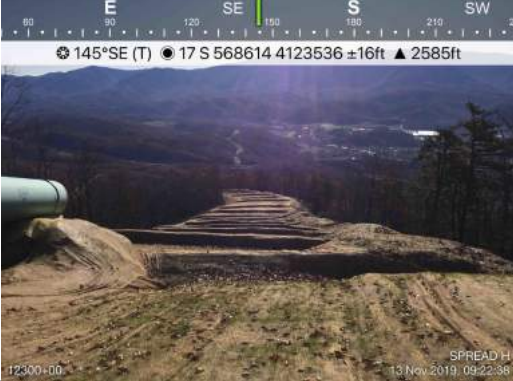
GPS Location	See Photo Above		GPS Location	See Photo Above	
Field Station#	12297+00		Field Station#	12300+00	
Pic 3 Desc.	Erosion control blanket in good condition here with waterbars in good condition		Pic 4 Desc.	Overview of row with erosion control blanket in good condition and waterbars in good condition

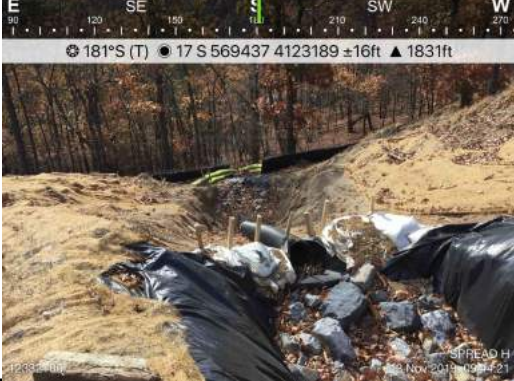
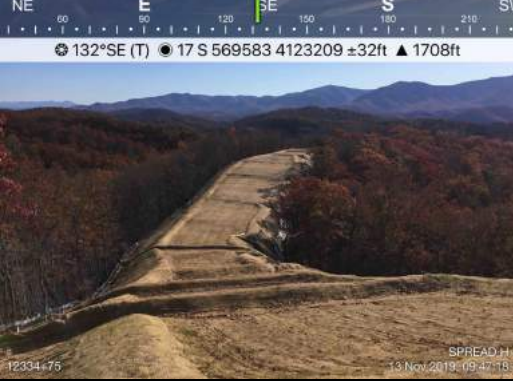
GPS Location	See Photo Above		GPS Location	See Photo Above	
Field Station#	12332+00		Field Station#	12334+75	
Pic 5 Desc.	Slope drain pipe, stone inlet protection, and rock filter outlet all in good condition		Pic 6 Desc.	Overview of row with erosion control blanket in good condition.

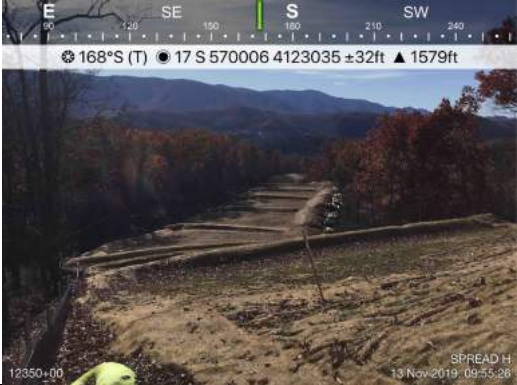
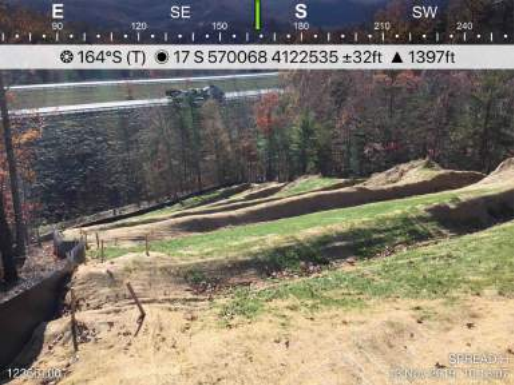
GPS Location	See Photo Above		GPS Location	See Photo Above	
Field Station#	12350+00		Field Station#	12366+00	
Pic 7 Desc.	Overview of row with erosion control blanket in good condition with waterbars.		Pic 8 Desc.	Erosion control blanket in good condition with grass growing. Waterbars in place and functional

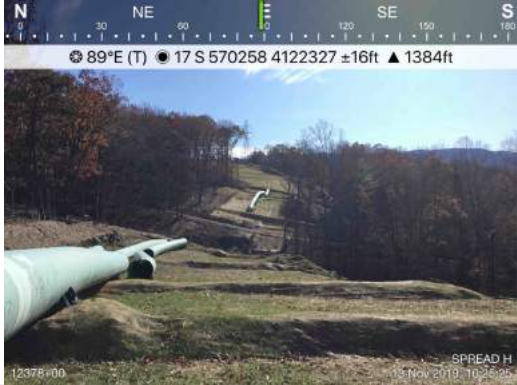
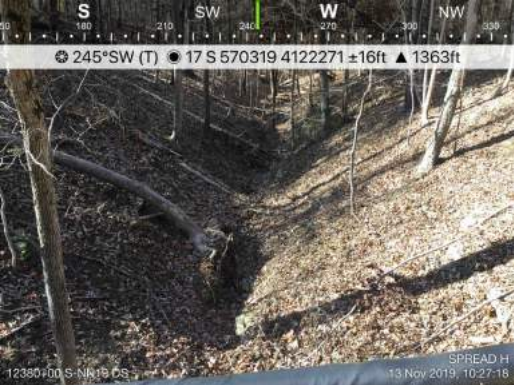
GPS Location	See Photo Above		GPS Location	See Photo Above	
Field Station#	12378+00		Field Station#	12380+00	
Pic 9 Desc.	GAS of 81 looking good with erosion control blanket and water bars in good condition		Pic 10 Desc.	S-NN19 DS looking fine

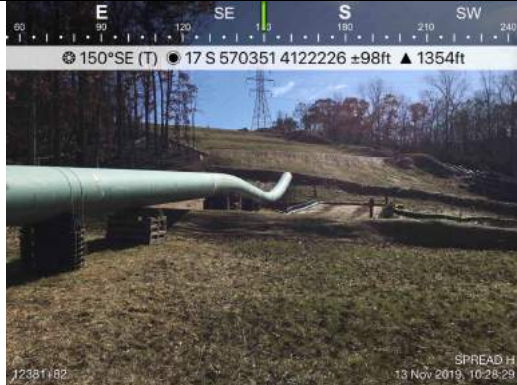
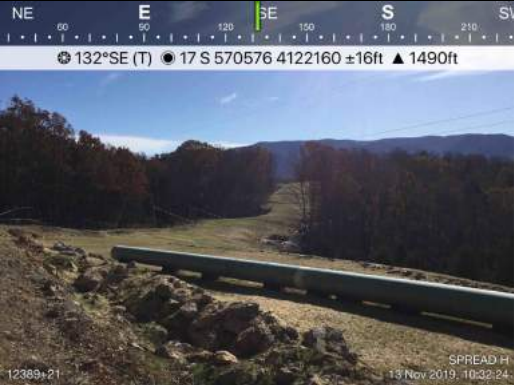
GPS Location	See Photo Above		GPS Location	See Photo Above	
Field Station#	12381+82		Field Station#	12389+21	
Pic 11 Desc.	Overview of row		Pic 12 Desc.	Overview of row with erosion control blanket in good condition and grass growing

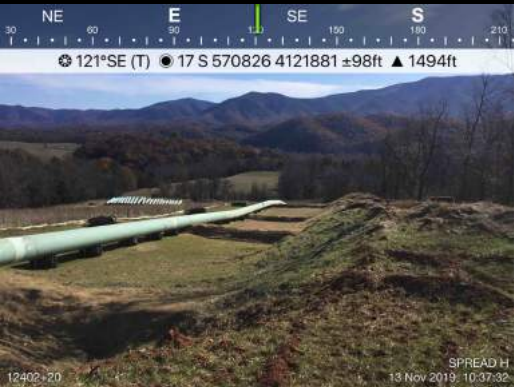
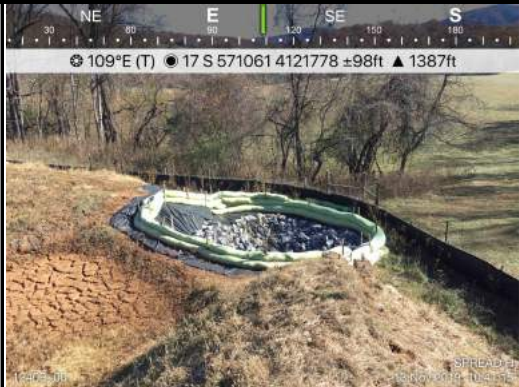
GPS Location	See Photo Above		GPS Location	See Photo Above	
Field Station#	12402+20		Field Station#	12409+00	
Pic 13 Desc.	Slope going down to MLV 27 P.I looks good with waterbars and stabilization		Pic 14 Desc.	CWD Berm and Rock filter outlet in good condition

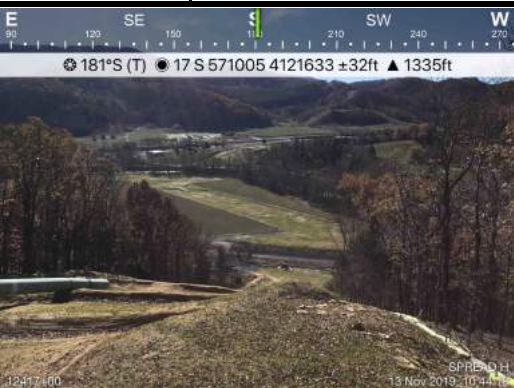
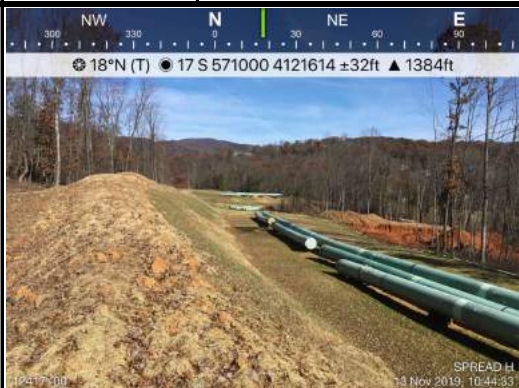
GPS Location	See Photo Above		GPS Location	See Photo Above	
Field Station#	12417+00		Field Station#	12417+00	
Pic 15 Desc.	Slope CIS of RRX and Roanoke River in good condition		Pic 16 Desc.	Berm stabilized and in good condition with row looking good in.	
Insert image here		Insert image here			
GPS Location			GPS Location		
Field Station#			Field Station#		
Pic 17 Desc.			Pic 18 Desc.

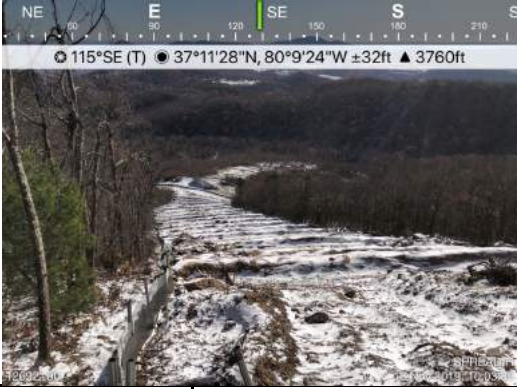
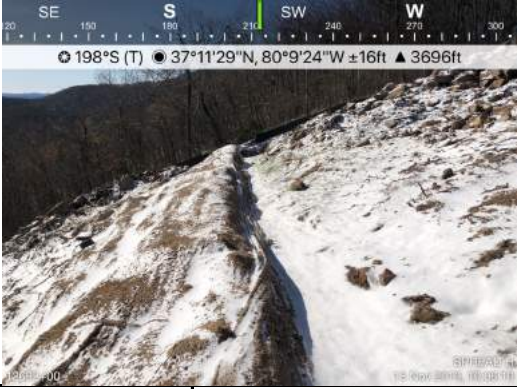
GPS Location	see photo		GPS Location	see photo	
Field Station#	12692+00		Field Station#	12692+00	
Pic 7 Desc.	Controls in place and in good condition on this slope.		Pic 8 Desc.	Waterbars in place and functioning.

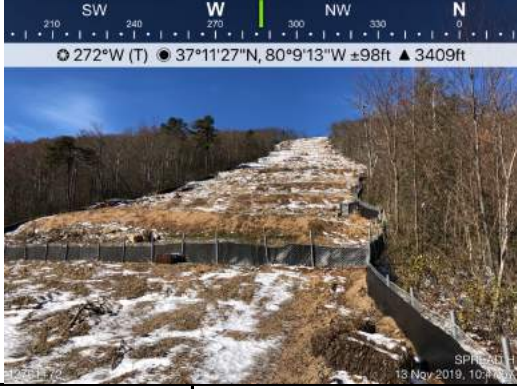
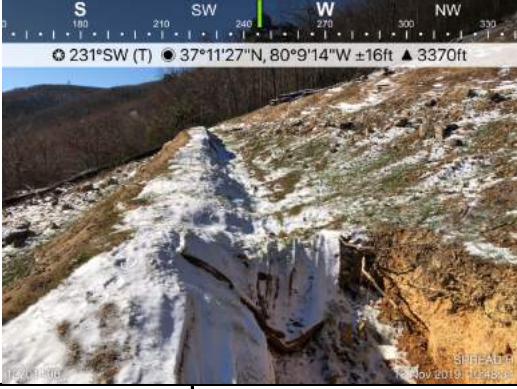
GPS Location	see photo		GPS Location	see photo	
Field Station#	12701+72		Field Station#	12701+00	
Pic 9 Desc.	SSF in good condition.		Pic 10 Desc.	Waterbar end treatments in good condition.

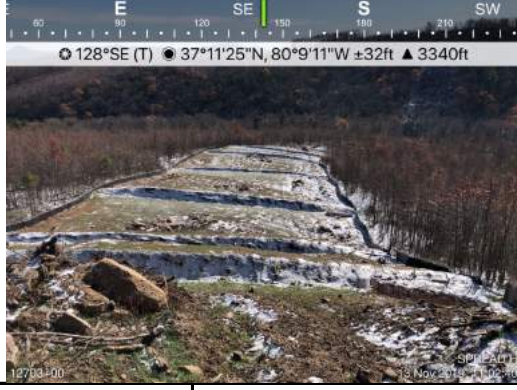
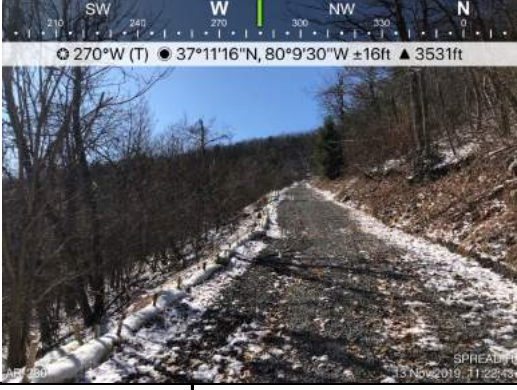
GPS Location	see photo		GPS Location	see photo	
Field Station#	12703+00		Field Station#	280+00	
Pic 11 Desc.	Controls in good condition and functioning on the GAS of AR-280		Pic 12 Desc.	AR-280 controls in place

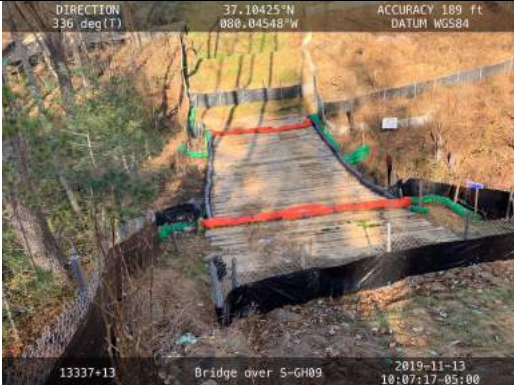
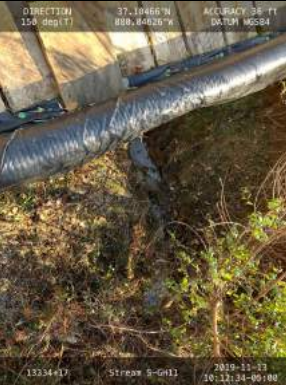
GPS Location	See photo for gps data.		GPS Location	See photo for gps data.	
Field Station#	13337+13		Field Station#	13334+17	
Pic 1 Desc.	Photo shows the bridge over stream S-GH9.		Pic 2 Desc.	Photo shows stream S-GH11.

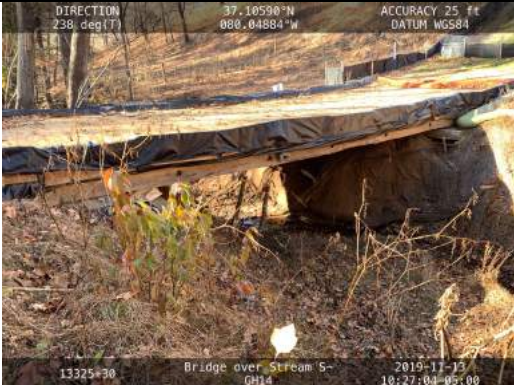
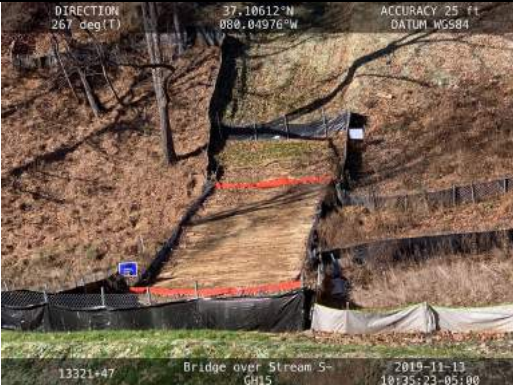
GPS Location	See photo for gps data.		GPS Location	See photo for gps data.	
Field Station#	13325+30		Field Station#	13321+47	
Pic 3 Desc.	Photo shows the bridge over stream S-GH14.		Pic 4 Desc.	Photo shows the bridge over stream S-GH15.

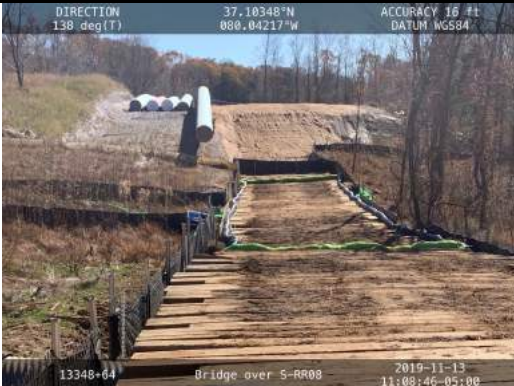
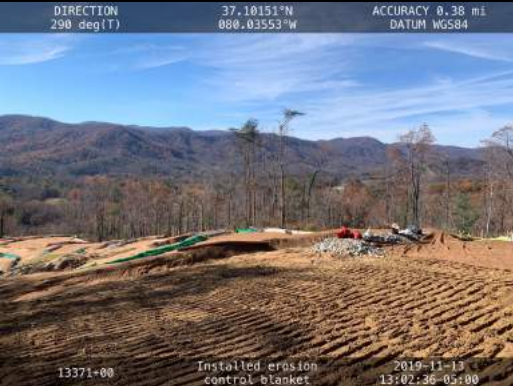
GPS Location	See photo for gps data.		GPS Location	See photo for gps data.	
Field Station#	13348+64		Field Station#	13371+00	
Pic 5 Desc.	Photo shows the bridge over stream S-RR08.		Pic 6 Desc.	Photo shows the erosion control blanket installed at about 13371+00.

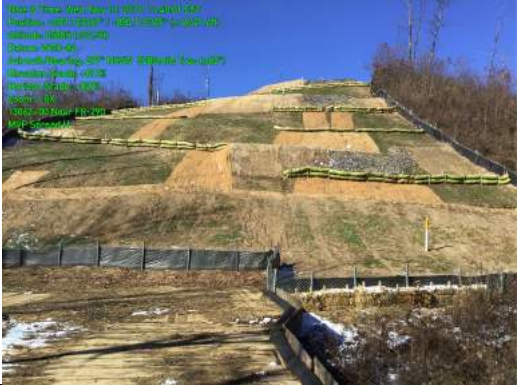
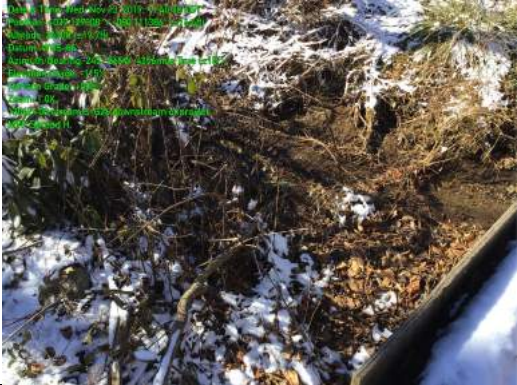
GPS Location	See pic for GPS location	GPS Location	See pic for GPS location		
Field Station#	13062+00	Field Station#	13062+00		
Pic 7 Desc.	Erosion rills recently repaired and stabilized with curlex on the CIS of FR-290.	Pic 8 Desc.	No stream impacts at S-G26.

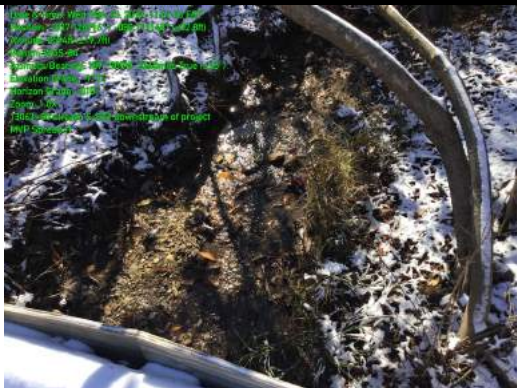
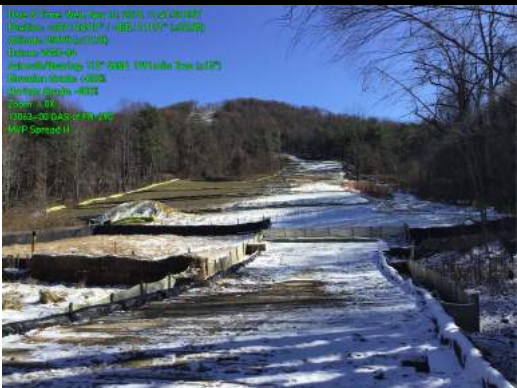
GPS Location	See pic for GPS location	GPS Location	See pic for GPS location		
Field Station#	13063+00	Field Station#	13063+00		
Pic 9 Desc.	No stream impacts at S-G27	Pic 10 Desc.	No issues or impacts from FR-290 to FR-291.

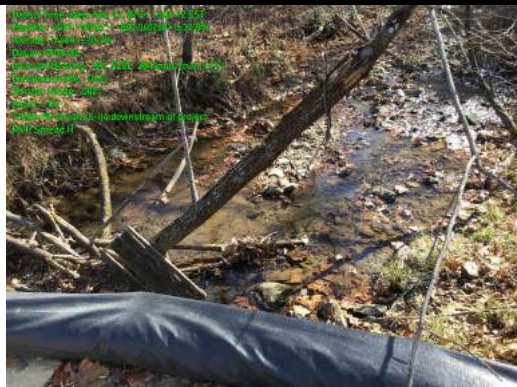
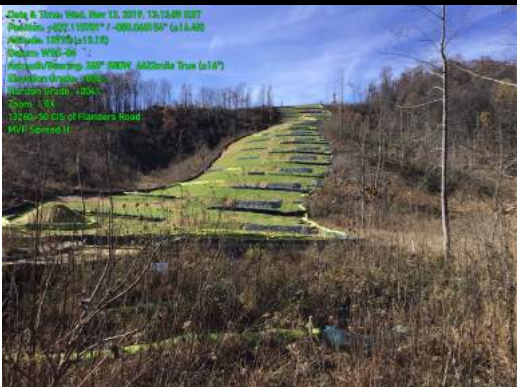
GPS Location	See pic for GPS location	GPS Location	See pic for GPS location		
Field Station#	13260+50	Field Station#	13260+50		
Pic 11 Desc.	No stream impacts at S-II4.	Pic 12 Desc.	Good permanent vegetation growing in on the CIS of Flanders Road.

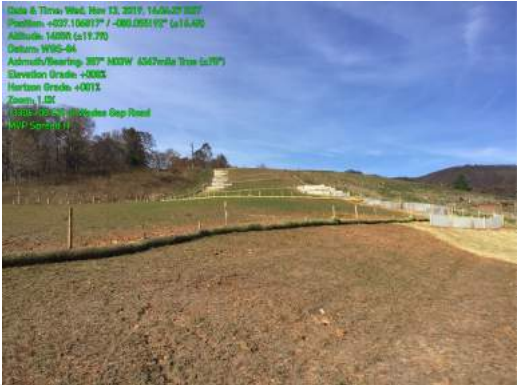
GPS Location	See pic for GPS location		GPS Location	See pic for GPS location	
Field Station#	13306+00		Field Station#	13309+00	
Pic 15 Desc.	Permanent restoration performed and no issues or impacts observed.		Pic 16 Desc.	No stream impacts at S-GH7.	
 		<p>Insert image here</p>			
GPS Location	See pic for GPS location		GPS Location		
Field Station#	13306+00		Field Station#		
Pic 17 Desc.	No issues or impacts observed throughout the area on the CIS of Wade's Gap.		Pic 18 Desc.
