Visual Site Inspection Report

Project Name	H-600 Pipeline Spread H	AFE	124300138	Spread	H-600 Pipeline Spread H
Contractor	Precision			Report #	5637
Inspector	Logan Box			Date/Time	11/7/2019 11:16 AM
Permit #	TBD	Inspection Type	VA SWPP	Station Begin	13415+55
State	VA	Inspection Area	Partial	Station End	13670+00
County	Franklin	Ground	Damp	Temperature (°F)	61.00
Municipality	N/A	Weather	Sunny	Rain Gauge (in)	0.00
				Rain Accumulation Time (days)	0.00

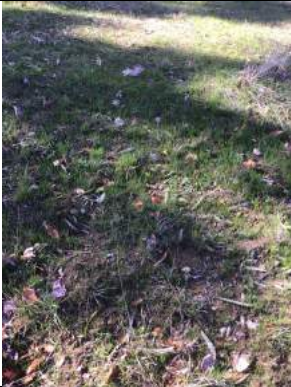
GPS Location	00000	GPS Location	0000		
Field Station#	13620+00	Field Station#	13630+00		
Pic 1 Desc.	Photo showing winter grass growing	Pic 2 Desc.	ROW view

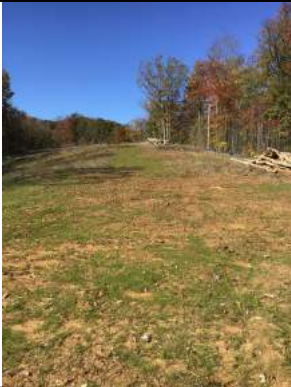
GPS Location	00000	GPS Location	00000		
Field Station#	13620+00	Field Station#	13618+21		
Pic 3 Desc.	Photo showing vegetation	Pic 4 Desc.	Photo showing access rd in good shape leading up to the row.		
Insert image here			Insert image here		
GPS Location		GPS Location			
Field Station#		Field Station#			
Pic 5 Desc.		Pic 6 Desc.

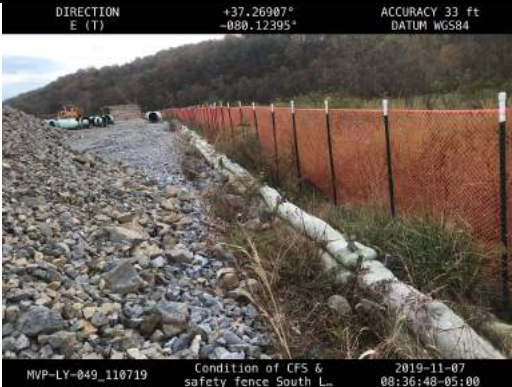
GPS Location	MVP-LY-049 See photo for gps data		GPS Location	MVP-LY-049 See photo for gps data	
Field Station#	+0		Field Station#	+0	
Pic 1 Desc.	Condition of compost filter sock and safety fence along south LOD. Looking E.		Pic 2 Desc.	Condition of compost filter sock around sand pile. Looking SE.

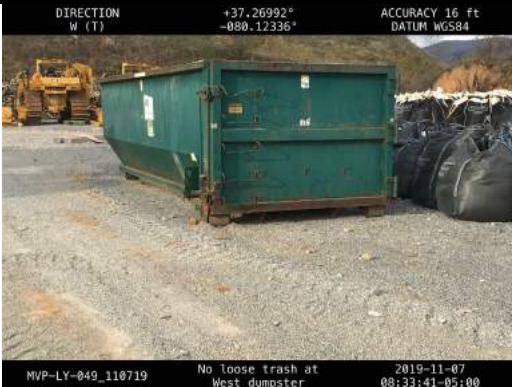
GPS Location	MVP-LY-049 See photo for gps data		GPS Location	MVP-LY-049 See photo for gps data	
Field Station#	+0		Field Station#	+0	
Pic 3 Desc.	No loose trash around West dumpster. Looking W.		Pic 4 Desc.	Condition of trays and containment under toilets. Looking NE.

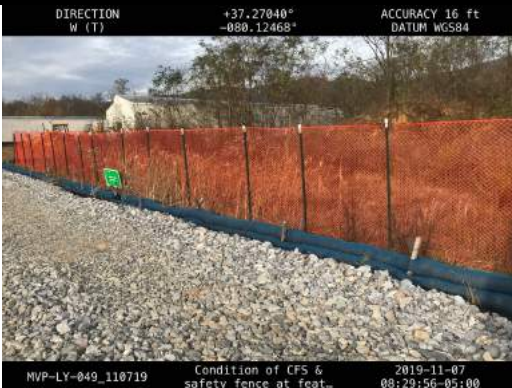
GPS Location	MVP-LY-049 See photo for gps data		GPS Location	MVP-LY-049 See photo for gps data	
Field Station#	+0		Field Station#	+0	
Pic 5 Desc.	Condition of compost filter sock and safety fence at feature CV-21A. Looking W.		Pic 6 Desc.	Landowner has parked his equipment next to compost filter sock and feature CV-21B. No impacts. Looking S.

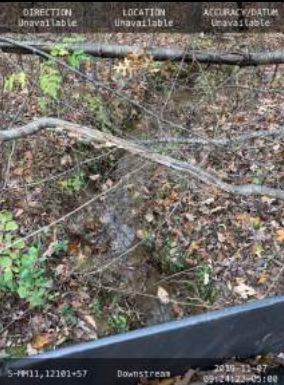
GPS Location	See photo GPS for location		GPS Location	See photo GPS for location	
Field Station#	12101+57		Field Station#	12101+57	
Pic 3 Desc.	No sediment impact in stream.		Pic 4 Desc.	ECDs functioning acceptably.

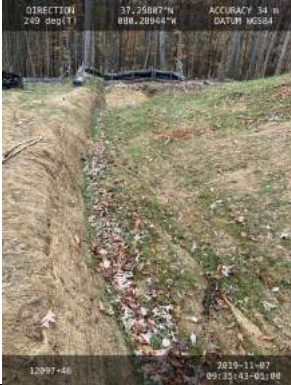
GPS Location	See photo GPS for location		GPS Location	See photo GPS for location	
Field Station#	12097+46		Field Station#	12086+56	
Pic 7 Desc.	Water bar and sump are in acceptable condition.		Pic 8 Desc.	No sediment impact in stream.

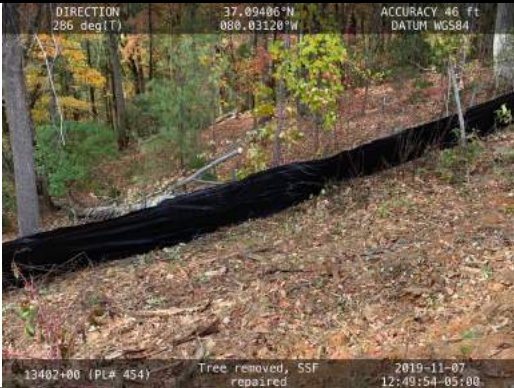
GPS Location	See photo for gps data.		GPS Location	See photo for gps data.	
Field Station#	13402+00		Field Station#	13358+64	
Pic 5 Desc.	Photo shows the area where the fallen tree was removed and the perimeter SSF was repaired. Punch list item 454.		Pic 6 Desc.	Photo shows stream S-RR11.

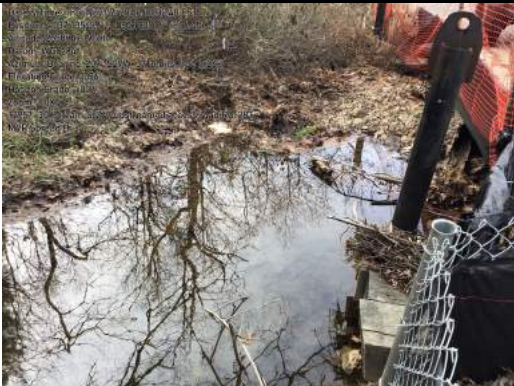
GPS Location	See pic for GPS location		GPS Location	See pic for GPS location	
Field Station#	12957+30		Field Station#	12995+50	
Pic 5 Desc.	Upstream side of RO-287 crossing damned up with leaves and tree limbs from upstream and no influence from the project.		Pic 6 Desc.	Substantial temporary stabilization present on the GAS of US-221.

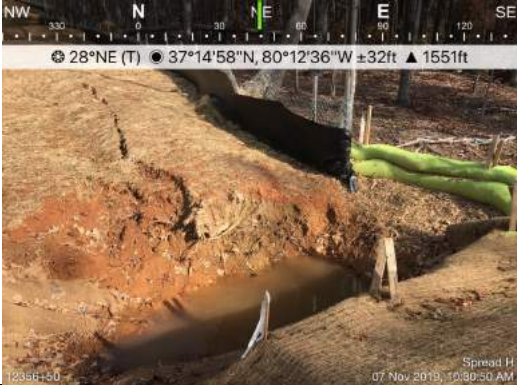
GPS Location	See photo	GPS Location	See photo		
Field Station#	12356+50	Field Station#	12379+95		
Pic 7 Desc.	Subsidence occurring in this area, this will be a maintenance item, continue to monitor this area closely.		Pic 8 Desc.	Bridge controls in good condition.

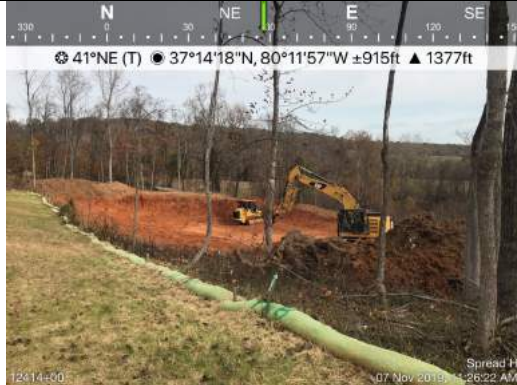
GPS Location	See photo	GPS Location	See photo		
Field Station#	12414+00	Field Station#	12443+08		
Pic 11 Desc.	Excavating and grading work occurring adjacent to the ROW		Pic 12 Desc.	Controls in good condition between Roanoke River Crossing and Rte 11.

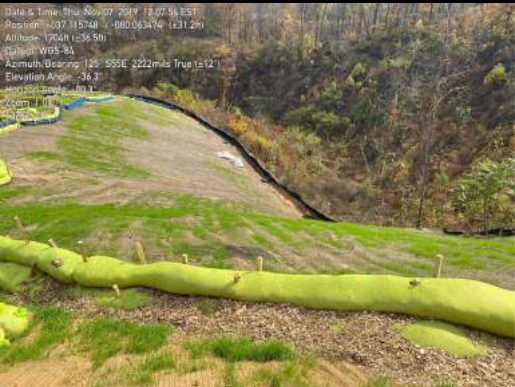
GPS Location	See photo for coordinates.		GPS Location	See photo for coordinates.	
Field Station#	13260+70		Field Station#	13252+00	
Pic 1 Desc.	S-II4, looking upstream of equipment bridge, ECDs functioning acceptably, geotech and sideboards in acceptable condition.		Pic 2 Desc.	ROW, head of drainage feature, vegetation taking hold, erosion control blanket stable, some sediment noted in SSF.

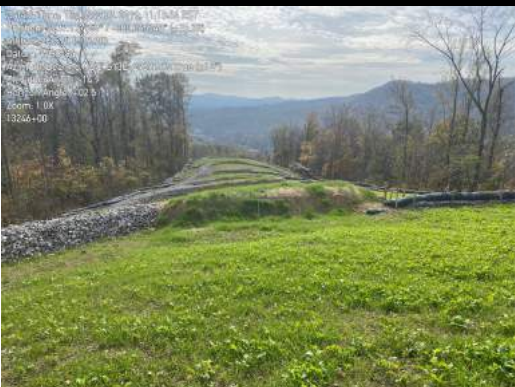
GPS Location	See photo for coordinates.		GPS Location	See photo for coordinates.	
Field Station#	13251+00		Field Station#	13246+00	
Pic 3 Desc.	ROW, permanent vegetation establishing across limits of disturbance, waterbars stable..		Pic 4 Desc.	ROW, good vegetative cover noted, some bare areas on waterbar berms.

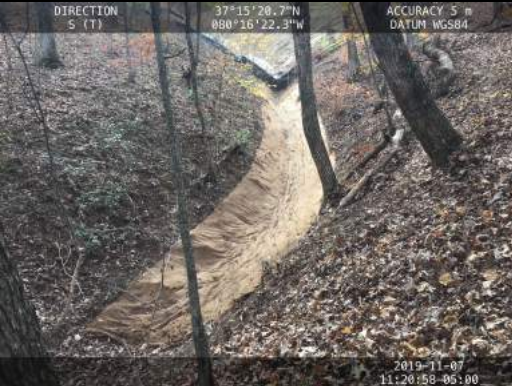
GPS Location	See photo		GPS Location	See photo	
Field Station#	12163+05		Field Station#	12148+00	
Pic 5 Desc.	Stream S-C25, facing east		Pic 6 Desc.	Sediment and debris have been clean up from off ROW in the drainage feature between AR 272 and 273 and channel was stabilized.

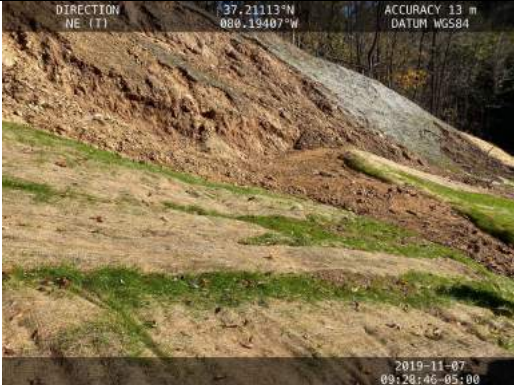
GPS Location	See picture for GPS data		GPS Location	See picture for GPS data	
Field Station#	12542+00		Field Station#	12541+50	
Pic 1 Desc.	Sediment field waterbar.		Pic 2 Desc.	Environmental crew cleaning out waterbars.

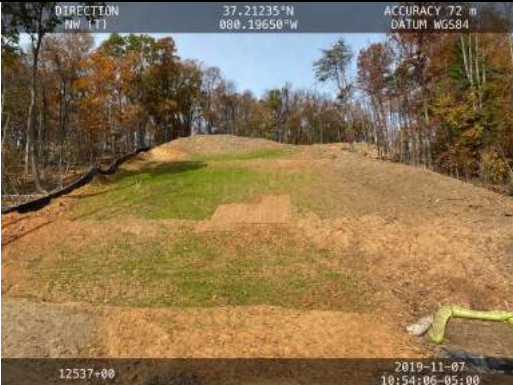
GPS Location	See picture for GPS data		GPS Location	See picture for GPS data	
Field Station#	12519+49		Field Station#	12537+00	
Pic 3 Desc.	Bridge crossing S-EF19		Pic 4 Desc.	Repaired rill erosion within the row.

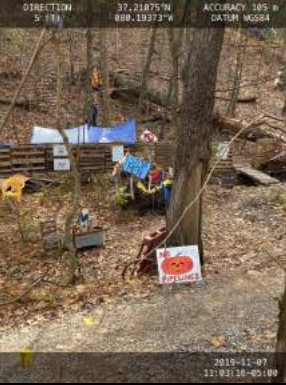
GPS Location	See picture for GPS data		GPS Location	See picture for GPS data	
Field Station#	12542+00		Field Station#	12543+56	
Pic 5 Desc.	Environmental crew rolling out curlex over the repaired waterbars.		Pic 6 Desc.	Opposition wall and trash just outside the LOD
