Visual Site Inspection Report

Project Name	H-600 Pipeline Spread H	AFE	124300138	Spread	H-600 Pipeline Spread H	
Contractor	Precision			Report #	17785	
Inspector	Pat Davis			Date/Time	5/29/2019 6:26 PM	
Permit #	TBD	Inspection Type	VA SWPP	Station Begin	+0	
State	VA	Inspection Area	Partial	Station End	+0	
County	Montgomery	Ground	Dry	Temperature (°F)	89.00	
Municipality	N/A	Weather	Sunny	Rain Gauge (in)	0.00	
				Rain Accumulation Time (days)	0.00

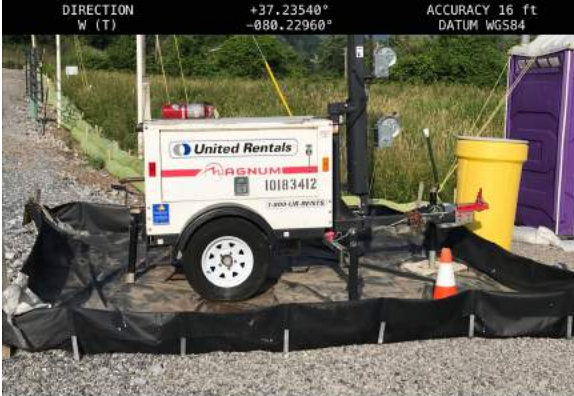
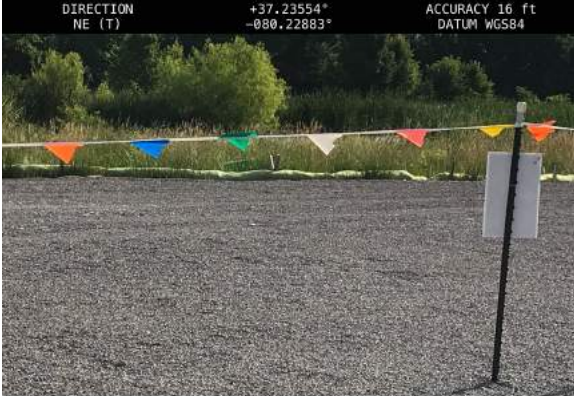
GPS Location		37.23		Field Station#		+0		GPS Location		37.23	
Description		MVP-PY-006_052919 condition of containment under light plant. Looking W. See photo for gps data.						Description		MVP-PY-006_052919 flagging and buffer in place at feature. Looking NE. See photo for gps data.

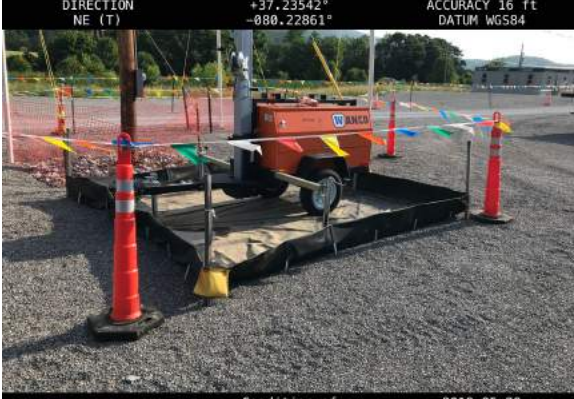
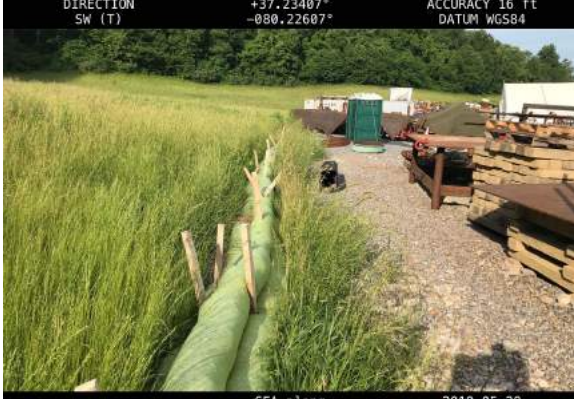
GPS Location		37.23		Field Station#		+0		GPS Location		37.23	
Description		MVP-PY-006_052919 condition of containment under light plant. Looking NE. See photo for gps data.						Description		MVP-PY-006_052919 condition of compost filter sock along South boundary. Looking SW. See photo for gps data.

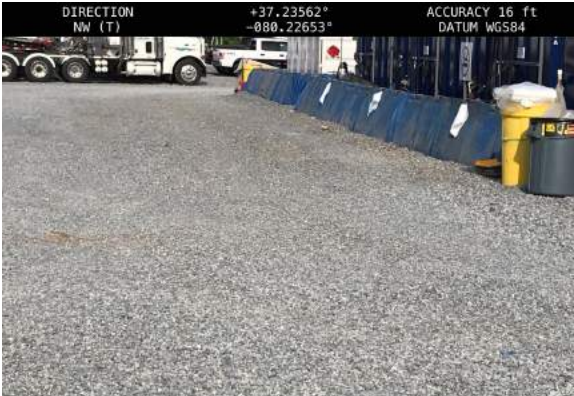
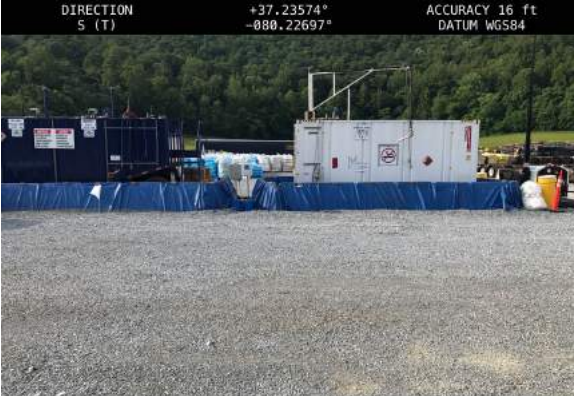
GPS Location		37.23		Field Station#		+0		GPS Location		37.23	
Description		MVP-PY-006_052919 no fluid deposits on the south side of the bulk fuel tanks. Looking NW. See photo for gps data.						Description		MVP-PY-006_052919 no fluid deposits on the North side of the bulk fuel tanks. Looking S. See photo for gps data.

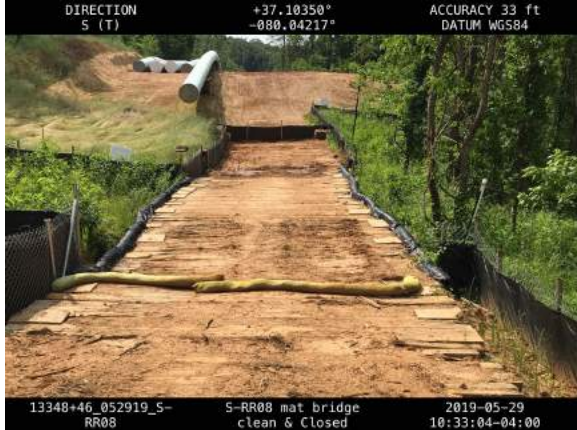
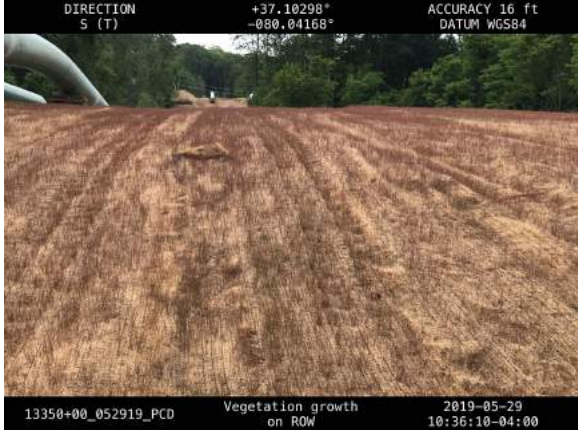
GPS Location	37.10	Field Station#	13348+46	GPS Location	37.27	Field Station#	13350+00
Description	13348+46_052919_S-RR08 mat ridge clean and closed. Looking S. See photo for gps data.			Description	13350+00_052919 vegetation growth on ROW. Looking S. See photo for gps data.

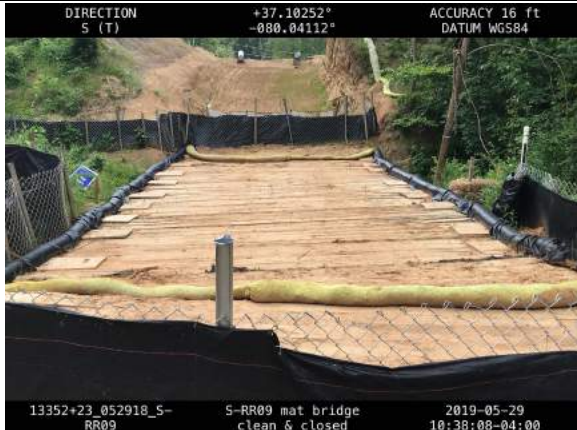
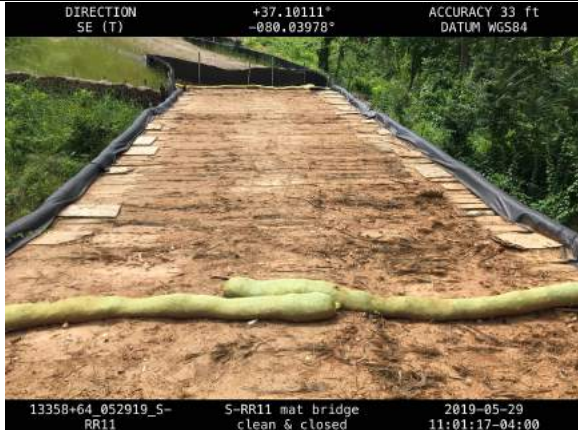
GPS Location	37.27	Field Station#	13352+23	GPS Location	37.27	Field Station#	13358+64
Description	13352+23_052919 S-RR09 mat bridge clean and closed. Looking S. See photo for gps data.			Description	13358+64_052919 S-RR11 mat bridge clean and closed. Looking SE. See photo for gps data.

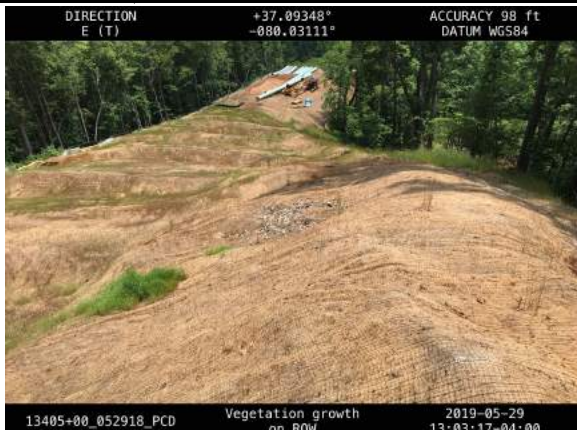
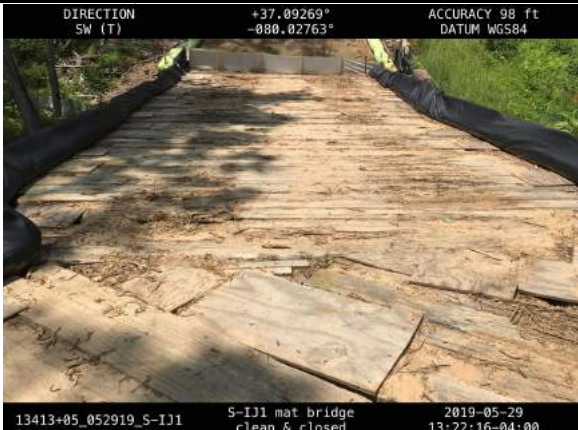
GPS Location	37.27	Field Station#	13405+00	GPS Location	37.27	Field Station#	13413+05
Description	13405+00_052919 vegetation growth on the ROW. Looking E. See photo for gps data.			Description	13413+05_052919 S-IJ1 mat bridge clean and closed. Looking SW. See photo for gps data.

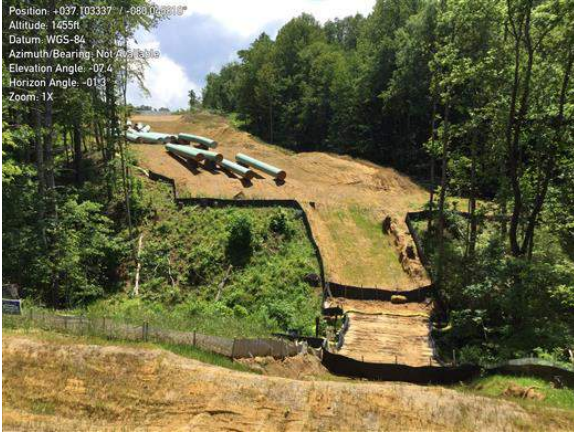
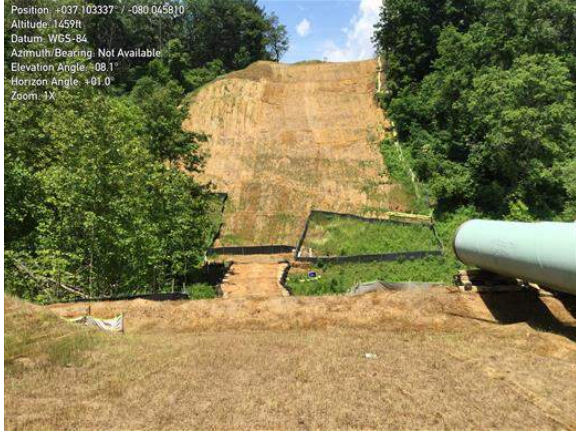
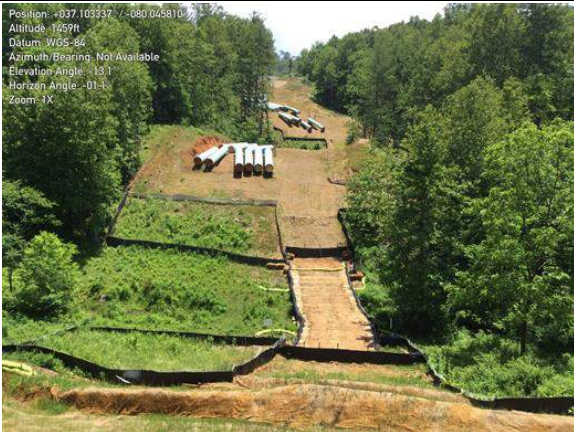
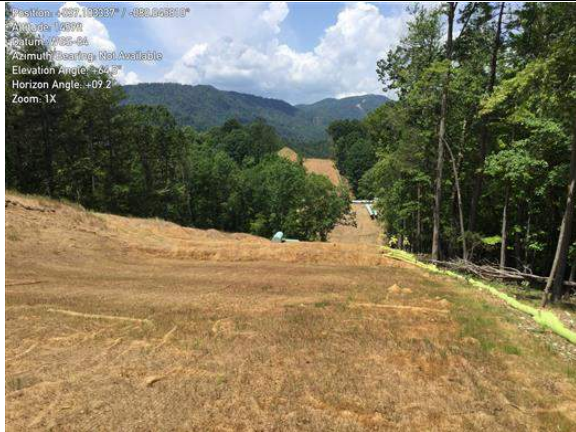
<p>Position: +037.103337° / -080.045810° Altitude: 1459ft Datum: WGS-84 Azimuth/Bearing: Not Available Elevation Angle: +08.1° Horizon Angle: +01.0° Zoom: 1X</p>											
GPS Location		33.83		Field Station#		13336+41		GPS Location		33.83		Field Station#		13335+41	
Description		Waterway S-GH9 in the foreground. View: East from center of LOD, see photo for GPS data.						Description		Waterway S-GH11 in the foreground. View: West from center of LOD, see photo for GPS data.

GPS Location		33.83		Field Station#		13332+24		GPS Location		33.83		Field Station#		13330+00	
Description		Waterway S-GH11 in the foreground. View: East from center of LOD, see photo for GPS data.						Description		Personnel conducting a walk-through along the northern perimeter of the LOD. View: West from northern edge of LOD, see photo for GPS data.

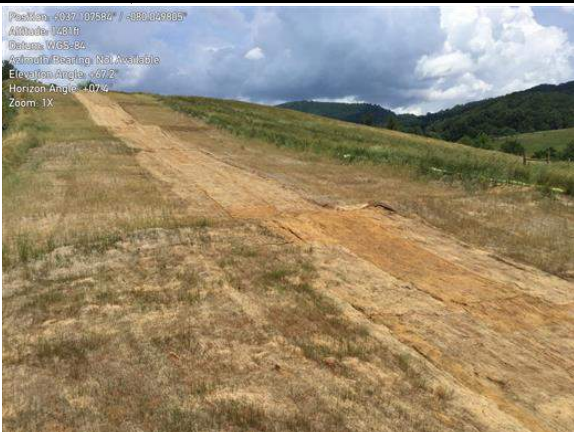
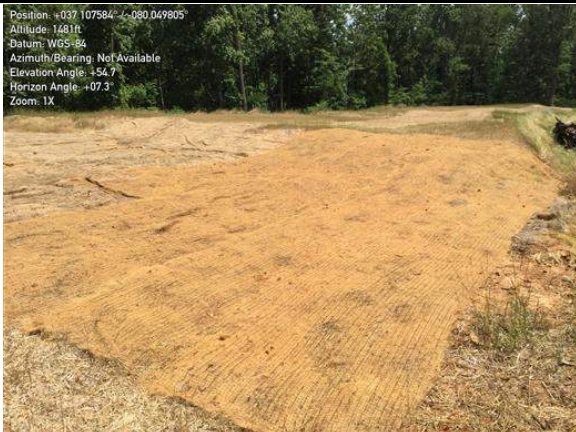
<p>Position: +037.107584° / -080.049805° Altitude: 1481ft Datum: WGS-84 Azimuth/Bearing: Not Available Elevation Angle: +54.7° Horizon Angle: +07.3° Zoom: 1X</p>											
GPS Location		33.83		Field Station#		13305+00		GPS Location		33.83		Field Station#		13283+00	
Description		Recently re-blanketed travel lane. View: Northeast from center of LOD, see photo for GPS data.						Description		Recently re-stabilized disturbance at travel lane & where timber was restored to within LOD boundaries. View: West from center of LOD, see photo for GPS data.

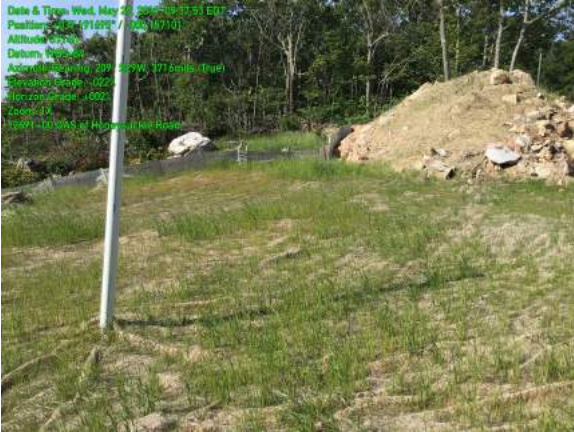
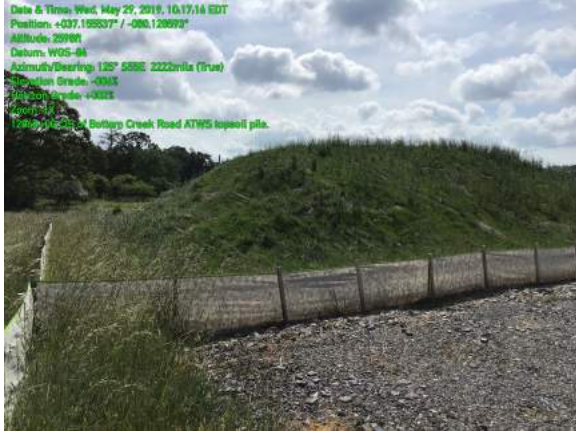
GPS Location	37.19	Field Station#	12691+00	GPS Location	37.15	Field Station#	12865+00
Description	All ECD's and BMP's remain in good condition throughout the area.			Description	No issues or impacts found throughout the area at Bottom Creek Road.

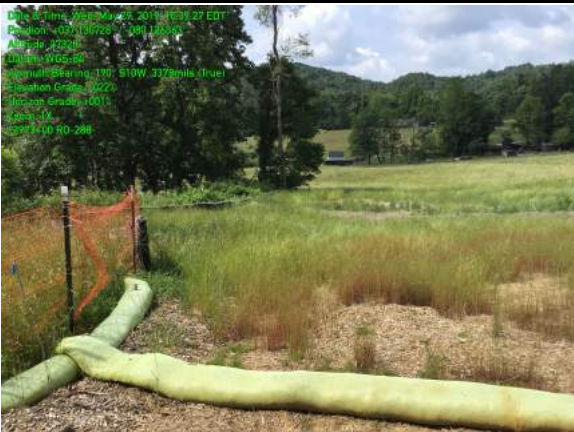
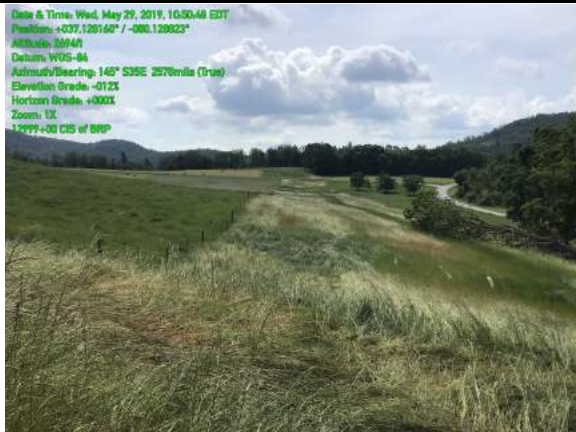
GPS Location	37.13	Field Station#	12973+00	GPS Location	37.12	Field Station#	12999+00
Description	Area has become well vegetated. No issues or impacts observed.			Description	BRP, very well vegetated. No issues found.

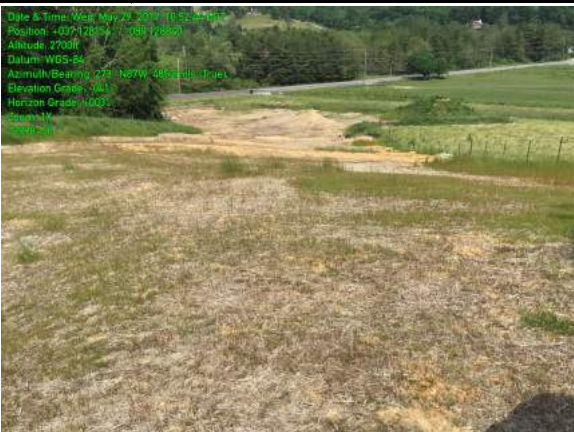
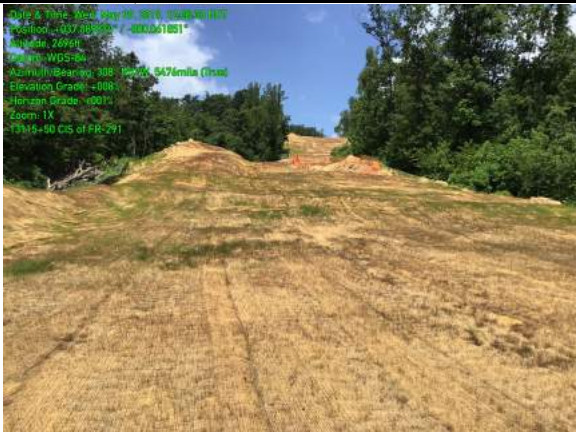
GPS Location	37.12	Field Station#	12998+50	GPS Location	37.12	Field Station#	13115+50
Description	GAS of US-221. Nothing out of compliance observed in the area.			Description	CIS of FR-291. No issues or impacts observed throughout the area.

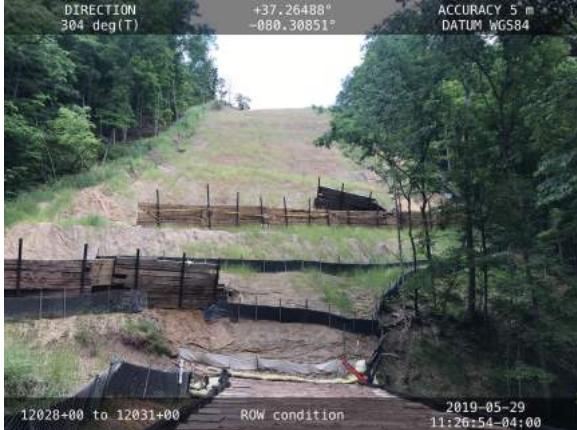
GPS Location	37.26	Field Station#	12031+00	GPS Location	37.26	Field Station#	12031+50
Description	See photo for gps data. Photo shows the ROW condition from about 12028+00 to 12031+00.			Description	See photo for gps data. Photo shows stream S-G39.

GPS Location	37.26	Field Station#	12031+25	GPS Location	37.26	Field Station#	12035+11
Description	See photo for gps data. Photo shows the tension crack near S-G39.			Description	See photo for gps data. Photo shows stream S-G40.

GPS Location	37.26	Field Station#	12037+00	GPS Location	37.26	Field Station#	12036+00
Description	See photo for gps data. Photo shows the ROW condition from about 12037+00 to 12052+00.			Description	See photo for gps data. Photo shows stream S-PP23.

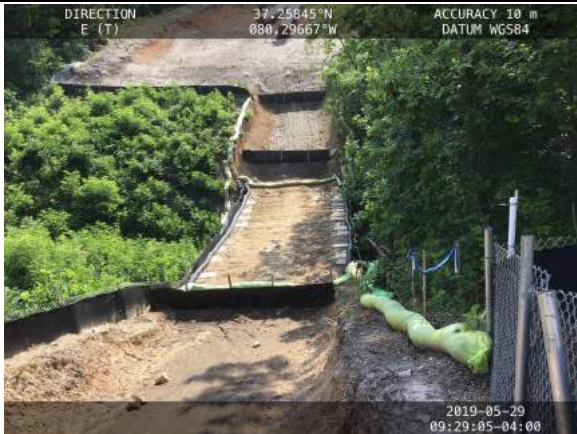
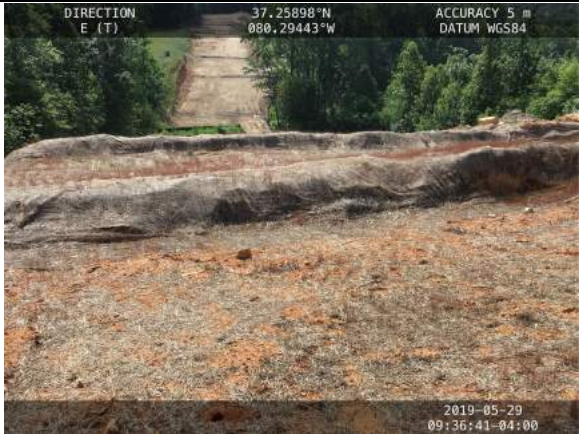
GPS Location		37.25		Field Station#		12076+95		GPS Location		37.25	
Field Station#		12076+95		Description		Stream S-MM15, facing northwest.		Field Station#		12083+00	
Description		Stream S-MM15, facing northwest.		Description		There is sparse vegetation on this slope leading down to stream S-MM14, but the blanket is still intact and providing stability.

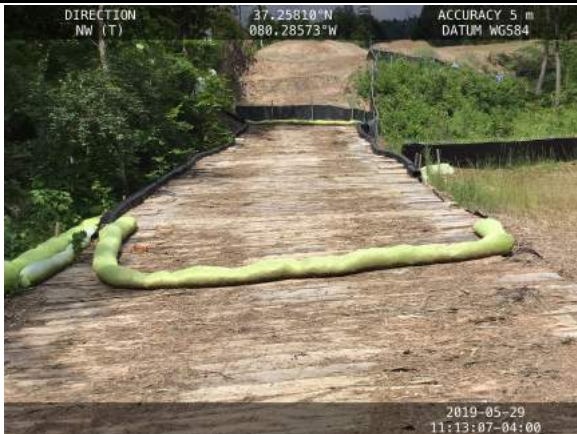
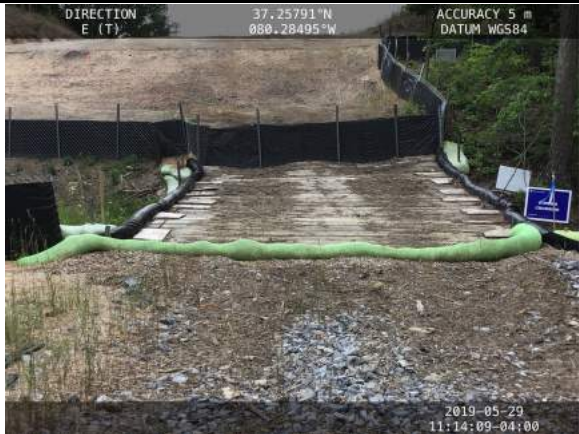
GPS Location		37.25		Field Station#		12108+41		GPS Location		37.25	
Field Station#		12108+41		Description		Stream S-F15, facing northwest.		Field Station#		12112+13	
Description		Stream S-F15, facing northwest.		Description		Stream S-F16A/B, facing east.

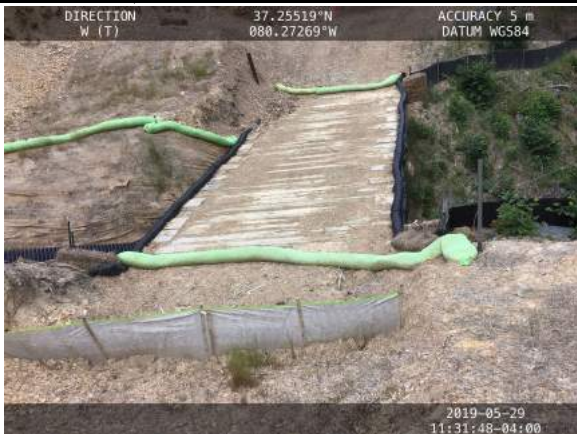
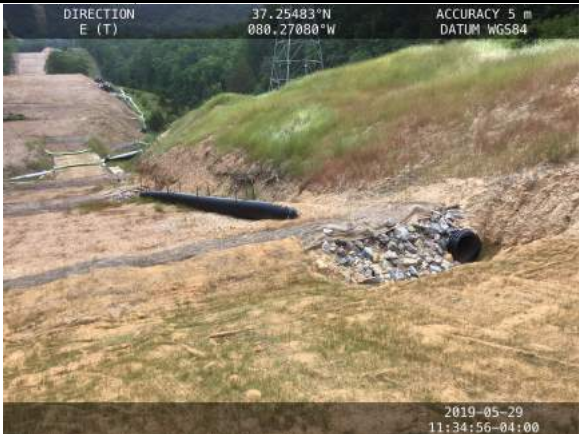
GPS Location		37.25		Field Station#		12148+00		GPS Location		37.25	
Field Station#		12148+00		Description		Clean water conveyance is functioning properly and ECDs are intact.		Field Station#		12155+00

Description		Clean water conveyance is functioning properly and ECDs are intact.		Description		The sump drain on the going away side of access road MVP-MN-273 is in satisfactory condition and performing properly.

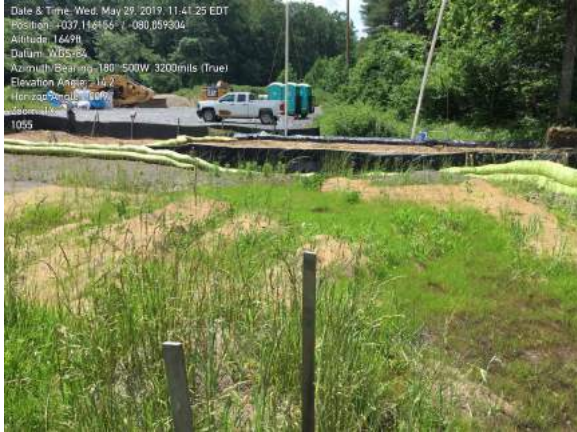
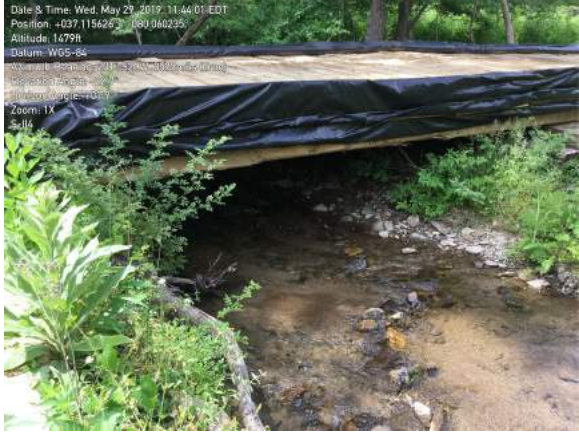
GPS Location	37.32	Field Station#	13261+28	GPS Location	37.32	Field Station#	13260+75
Description	Please see photo for accurate coordinates. ATWS-1055, standing water observed from off ROW wetland W-II4.			Description	Please see photo for accurate coordinates. S-II4, bridge over stream crossing in acceptable condition, no environmental issues noted.		
<p>Date & Time: Wed, May 29, 2019 12:00:36 EDT Position: +037.115665° / -080.060217° Altitude: 1666ft Datum: WGS-84 Azimuth/Bearing: 264° S84W 4493mils (True) Elevation Angle: -90.6° Horizon Angle: +00.9° Zoom: 1X S-II4</p>

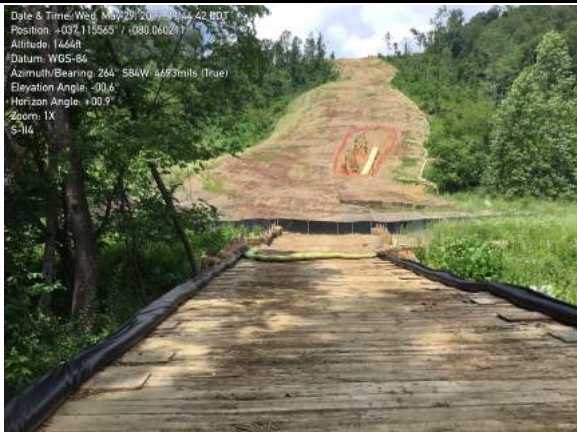
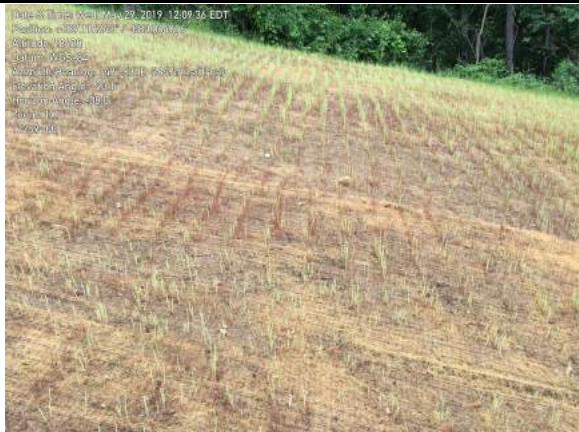
GPS Location	37.32	Field Station#	13260+75	GPS Location	37.32	Field Station#	13259+00
Description	Please see photo for accurate coordinates. S-II4, CIS of stream crossing, ROW stabilized with moderate vegetation noted.			Description	Please see photo for accurate coordinates. ROW, temporary vegetation establishing through curlex.		
<p>Date & Time: Wed, May 29, 2019 12:37:16 EDT Position: +037.123141° / -080.067746° Altitude: 1025ft Datum: WGS-84 Azimuth/Bearing: 264° S84W 4373mils (True) Elevation Angle: -92.3° Horizon Angle: +00.5° Zoom: 2X AR-29</p>

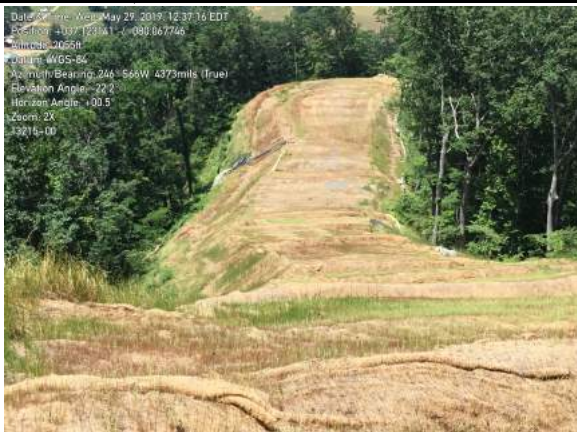
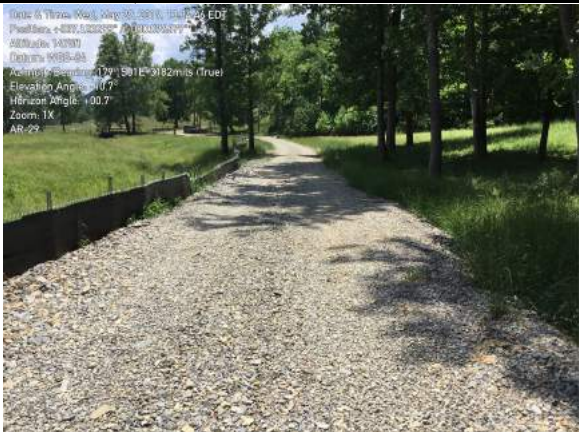
GPS Location	37.32	Field Station#	13215+00	GPS Location	37.32	Field Station#	13167+00
Description	Please see photo for accurate coordinates. ROW, waterbars and waterbar outlets functioning acceptably.			Description	Please see photo for accurate coordinates. MVP-MLV-AR-29, access road well maintained, no recent cattle damage noted.

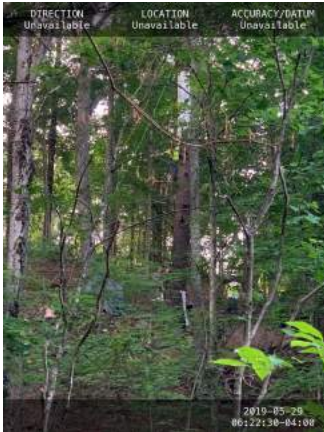
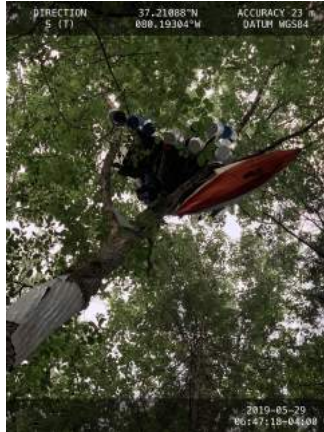
GPS Location	37.33	Field Station#	12546+00	GPS Location	37.33	Field Station#	12546+00
Description	NCI attempting to climb the unoccupied tree sit.			Description	Occupied tree sit. Looking S. See picture for GPS data.

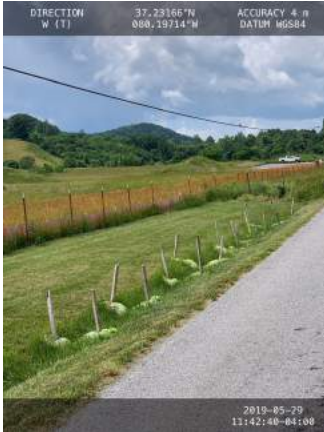
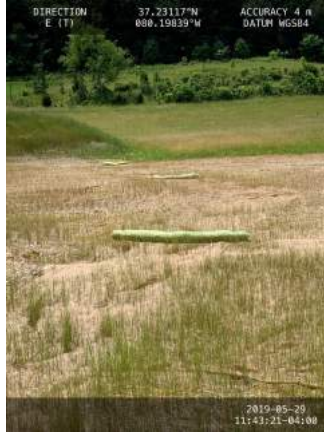
GPS Location	37.33	Field Station#	12445+40	GPS Location	37.33	Field Station#	12445+80
Description	CFS checks in drain. Looking W. See picture for GPS data.			Description	Curlexed drain allowing water to cross ROW without erosion. Looking E. See picture for GPS data.

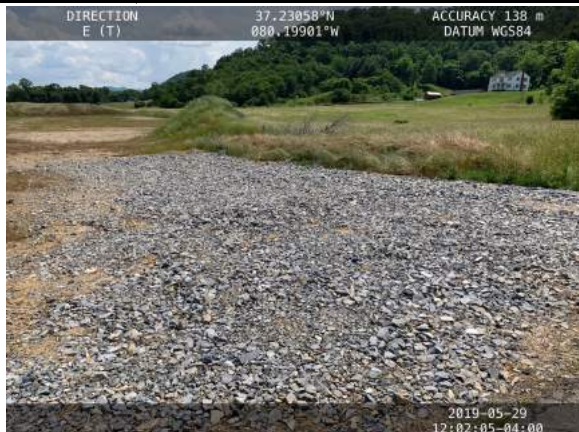
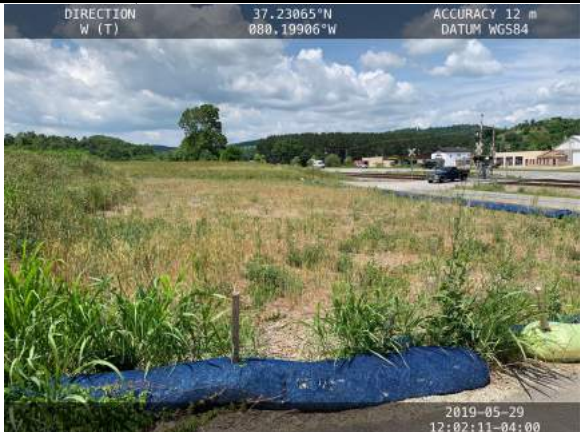
GPS Location	37.33	Field Station#	12448+12	GPS Location	37.33	Field Station#	12448+50
Description	RCE. Looking E. See picture for GPS data.			Description	Stabilized ROW. Looking W. See picture for GPS data.

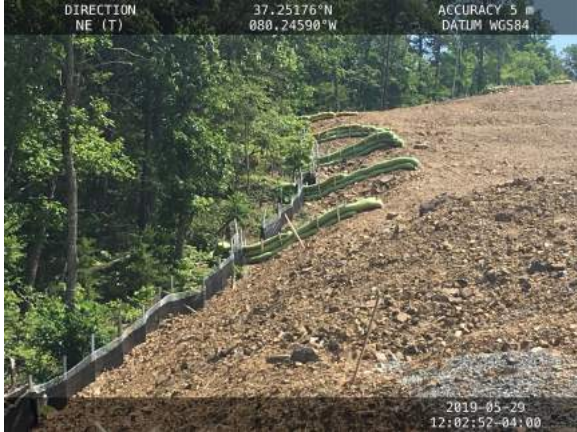
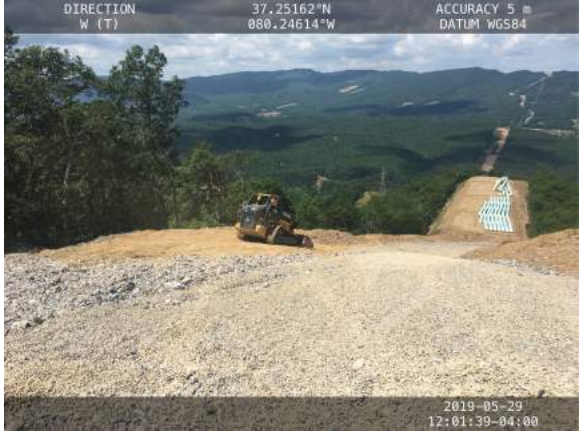
GPS Location	37.33	Field Station#	12235+50	GPS Location	37.33	Field Station#	12234+00
Description	Water bar end treatments. Looking NE. See picture for GPS data.			Description	Skid steer working on making the road accessible for land owner use. Looking W. See picture for GPS data.

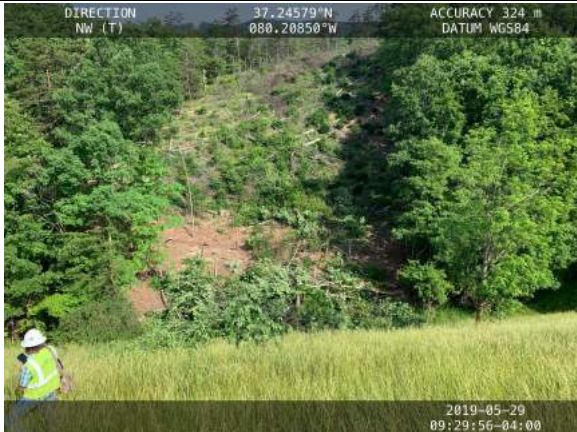
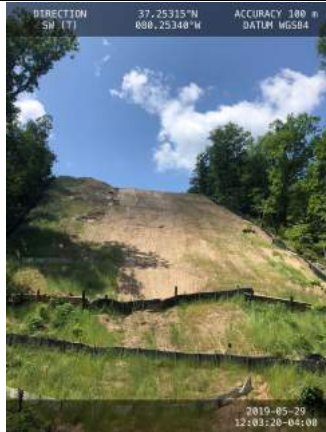
GPS Location	37.33	Field Station#	12371+23	GPS Location	37.33	Field Station#	12211+21
Description	Completed tree felling in CIS of I81 crossing. Looking NW. See picture for GPS data.			Description	Stabilized hillside. Looking SW. See picture for GPS data.

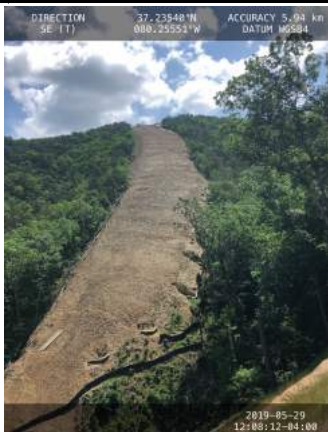
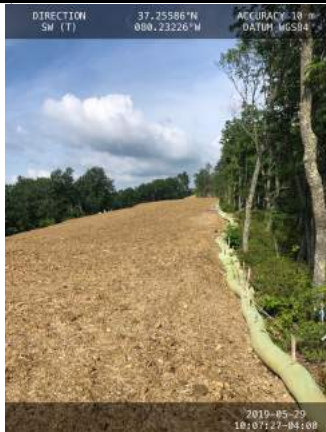
GPS Location	37.33	Field Station#	12225+00	GPS Location	37.33	Field Station#	1226+80
Description	Stabilized hillside. Looking SE. See picture for GPS data.			Description	Stabilized ROW and CFS perimeter control. Looking SW. See picture for GPS data.

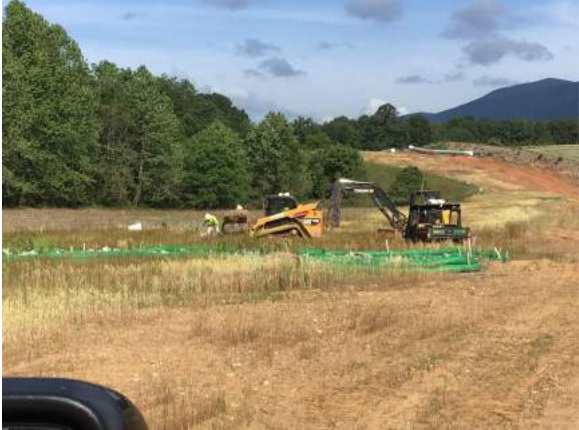
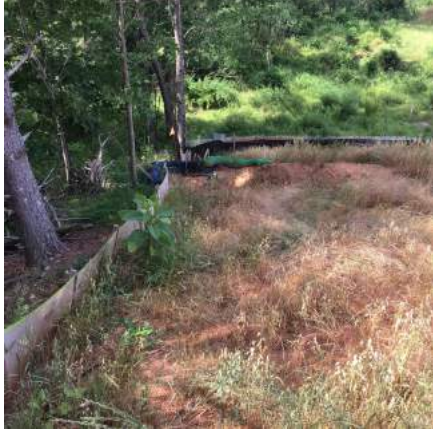
GPS Location	36.95	Field Station#	13669+00	GPS Location	36.95
Field Station#	13660+00	Description	Approximately 13669+00. Crews working on maintenance issues and replacing weather worn ECDs.

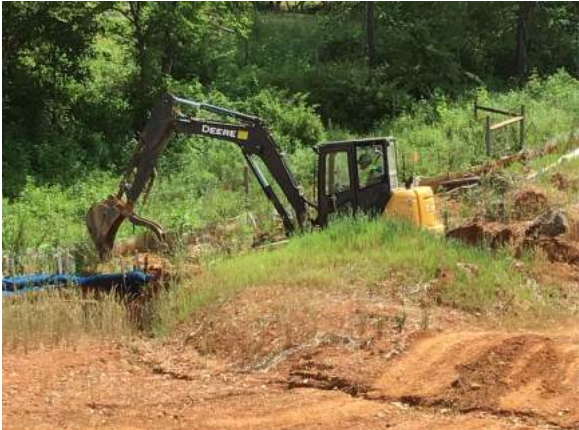
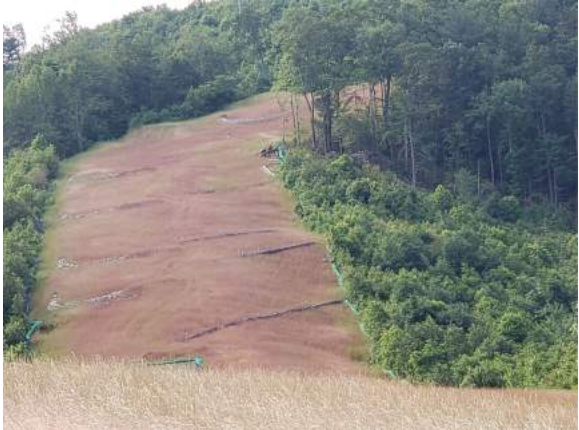
GPS Location	36.95	Field Station#	13656+53	GPS Location	36.95
Field Station#	13440+00	Description	Approximately 13656+53. Environmental crew removing dated de-water structure and installing new LOD ECDs.		
<p>Insert image here</p>			<p>Insert image here</p>		
GPS Location		Field Station#		GPS Location	
Field Station#		Description
