# Visual Site Inspection Report

<b>Project Name</b>	H-600 Pipeline Spread H	<b>AFE</b>	124300138	<b>Spread</b>	H-600 Pipeline Spread H
<b>Contractor</b>	Precision			<b>Report #</b>	18426
<b>Inspector</b>	Pat Davis			<b>Date/Time</b>	6/10/2019 5:17 PM
<b>Permit #</b>	TBD	<b>Inspection Type</b>	VA SWPP	<b>Station Begin</b>	+0
<b>State</b>	VA	<b>Inspection Area</b>	Partial	<b>Station End</b>	+0
<b>County</b>	Montgomery	<b>Ground</b>	Wet	<b>Temperature (°F)</b>	74.00
<b>Municipality</b>	N/A	<b>Weather</b>	Light Rain	<b>Rain Gauge (in)</b>	1.00
				<b>Rain Accumulation Time (days)</b>	0.00

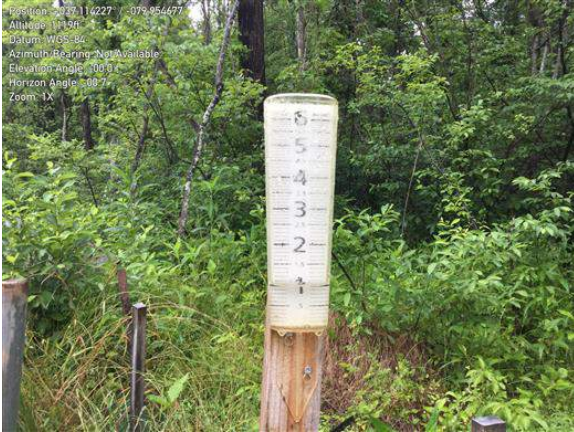
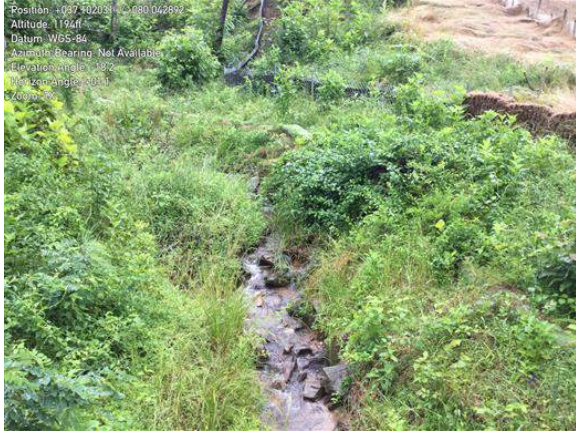
GPS Location	35.75	Field Station#	13415+00	GPS Location	35.75	Field Station#	13358+64
Description	Rain gauge at CIS of Cahas Mountain Road reads 1.0" View: Northwest from northern perimeter of LOD, see photo for GPS data.			Description	Upstream side of Waterway S-RR11. View: Northeast from north side of equipment bridge, see photo for GPS data.

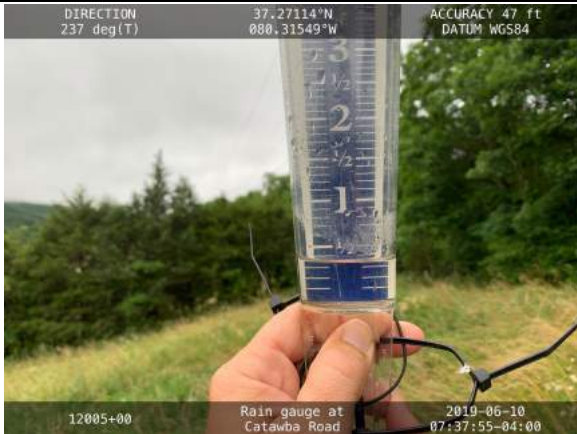
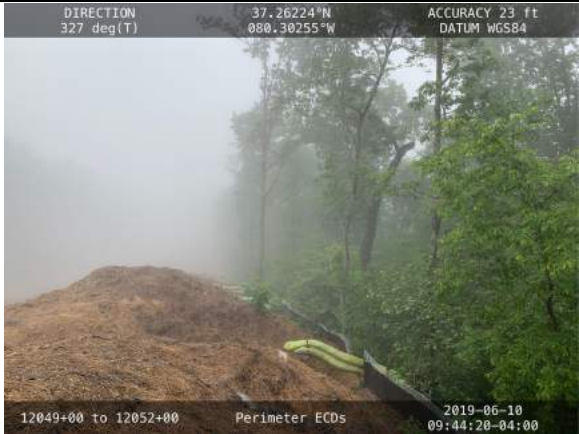
GPS Location	37.26	Field Station#	12005+00	GPS Location	37.26	Field Station#	12052+00
Description	See photo for gps data. Photo shows the rain gauge at Catawba. 0.4" of rainfall since 4:00 pm on 6-8-19.			Description	See photo for gps data. Photo shows the perimeter ECDs from about 12049+00 to 12052+00.

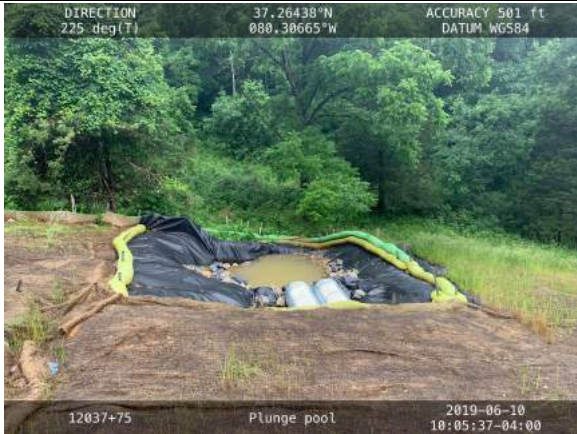
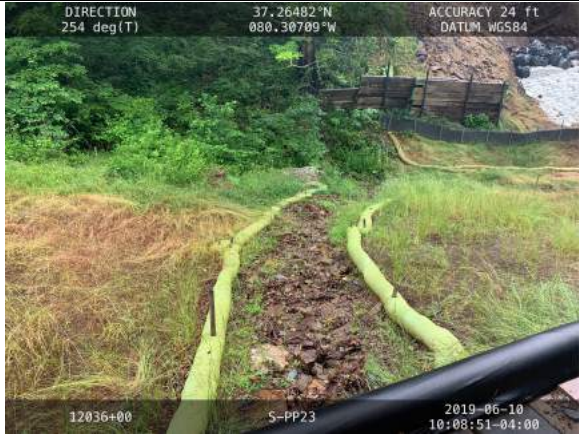
GPS Location	37.26	Field Station#	12037+75	GPS Location	37.26	Field Station#	12036+00
Description	See photo for gps data. Photo shows the plunge pool at 12037+75.			Description	See photo for gps data. Photo shows stream S-PP23.

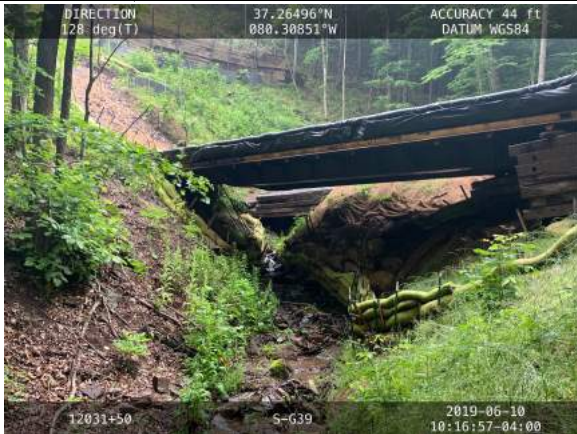
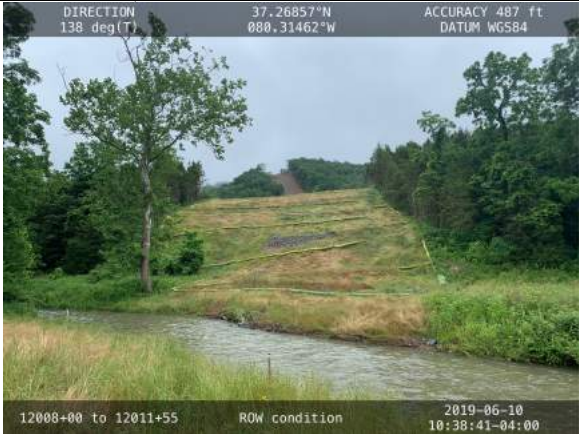
GPS Location	37.26	Field Station#	13031+50	GPS Location	37.26	Field Station#	12008+00
Description	See photo for gps data. Photo shows stream S-G39.			Description	See photo for gps data. Photo shows the ROW condition from about 12008+00 to 12011+55.

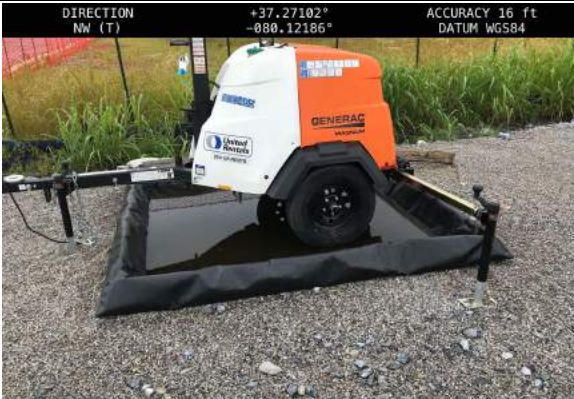
<div>MVP-LY-049_061019_PCD</div> <div>Containment under light plant.</div> <div>2019-06-10 12:33:41-04:00</div>			<div>DIRECTION N (T)</div> <div>+37.27121° -080.12156°</div> <div>ACCURACY 16 ft DATUM WGS84</div>

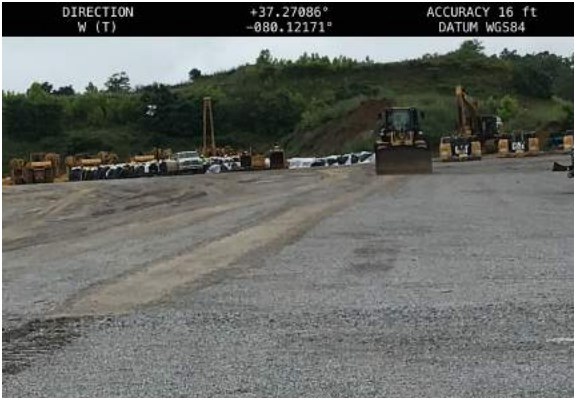
<div>MVP-LY-049_061019_PCD</div> <div>Preforming maintenance on stone.</div> <div>2019-06-10 12:39:07-04:00</div>			<div>DIRECTION W (T)</div> <div>+37.27048° -080.12446°</div> <div>ACCURACY 16 ft DATUM WGS84</div>

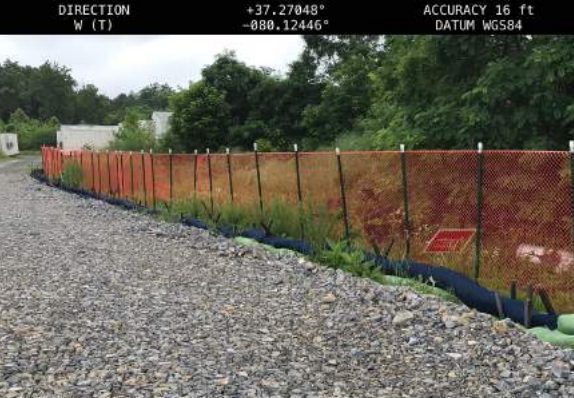
<div>MVP-LY-049_061019_W- CV21A</div> <div>Signage, safety fence and CFS at feature</div> <div>2019-06-10 12:43:03-04:00</div>

GPS Location	37.27	Field Station#	+0		
Description	MVP-LY-049_061019 condition of compost filter sock & safety fence by feature. Looking W. See photo for gps data.

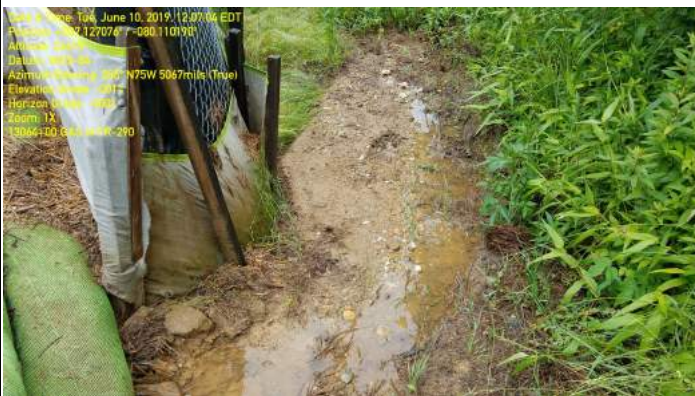
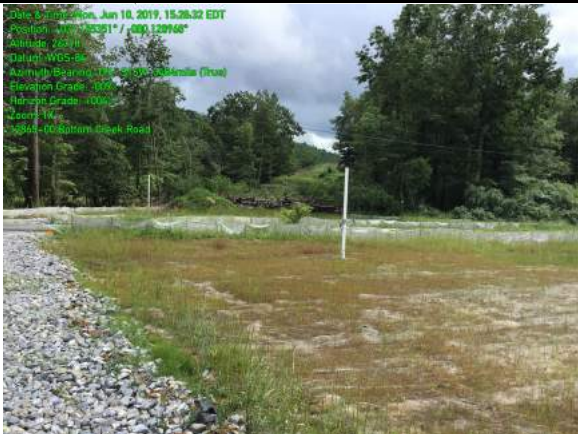
GPS Location	37.12	Field Station#	13064+00	GPS Location	37.12	Field Station#	12865+00
Description	Sediment beyond end treatment where it was undermined. Sediment is within the LOD stakes.			Description	No issues or impacts observed near Bottom Creek road.

E&S BMPs	Compliance Level	Corrective Action	Corrective Time Frame	Date Repaired
Waterbar End Treatment	Communication	Repair where undermined	24 Hours	6/11/2019
Sump Pit	Communication	Clean out full sumps	24 Hours	6/11/2019
Broad-Based Dip	Acceptable			
Cleanwater Diversion Berm	Acceptable			
Cleanwater Diversion Pipe	Acceptable			
Compost Filter Sock	Acceptable			
Equipment Bridge	Acceptable			
Erosion Control Blanket	Acceptable			
Plunge Pool	Acceptable

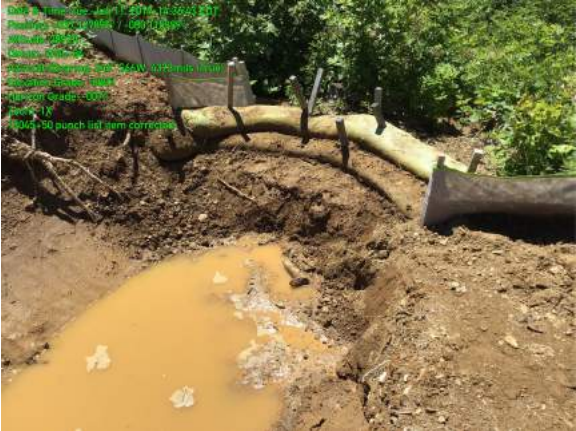
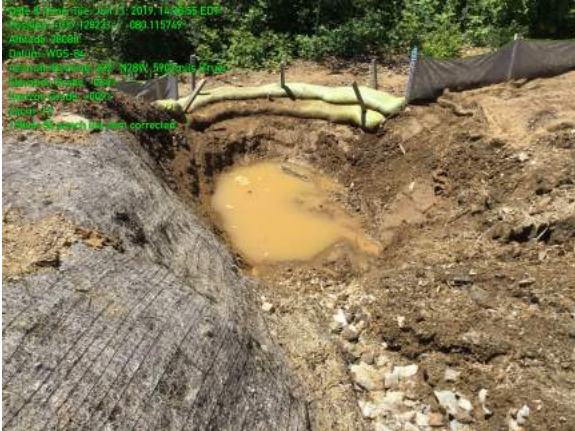
<b>GPS Location</b>	37.12	<b>Field Station#</b>	13045+50	<b>GPS Location</b>	37.12
<b>Description</b>	Punch list item completed.		<b>Description</b>	Punch list item completed.	
Insert image here			Insert image here		
<b>GPS Location</b>	37.12	<b>Field Station#</b>		<b>GPS Location</b>	37.12
<b>Description</b>			<b>Description</b>		
Insert image here			Insert image here		
<b>GPS Location</b>		<b>Field Station#</b>		<b>GPS Location</b>	
<b>Description</b>			<b>Description</b>

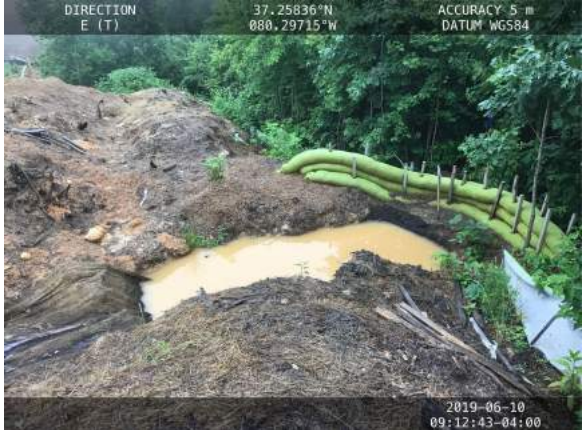
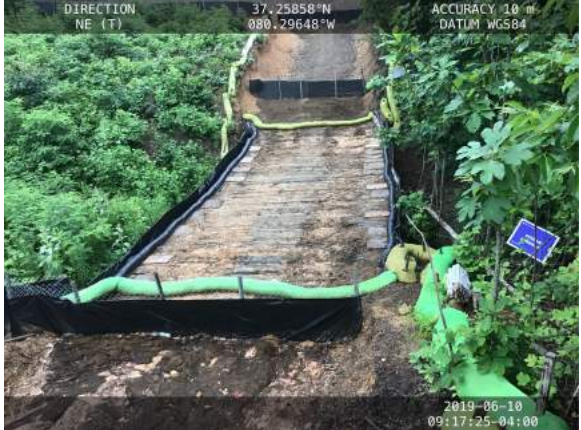
GPS Location	37.25	Field Station#	12174+00	GPS Location	37.25	Field Station#	12076+95
Description	Sumps were functional and end treatments did not appear to have been overwhelmed by the ongoing rain events.			Description	Stream S-MM15, facing northeast. No impacts observed in or around waterbody from rain events.

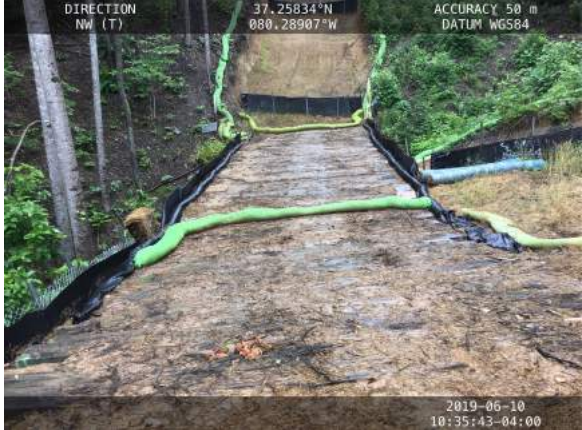
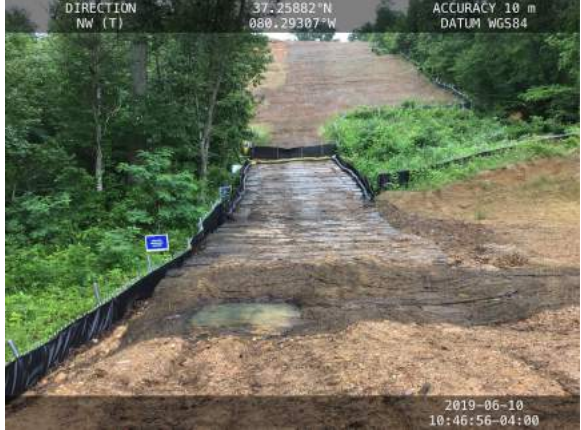
GPS Location	37.25	Field Station#	12098+44	GPS Location	37.25	Field Station#	12086+56
Description	Stream S-MM13, facing northwest. No impacts to stream from ongoing rain events.			Description	Stream S-MM14, facing northwest. No impacts due to significant rain events.

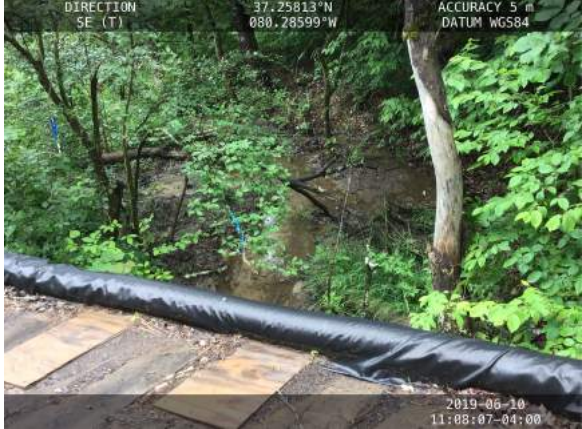
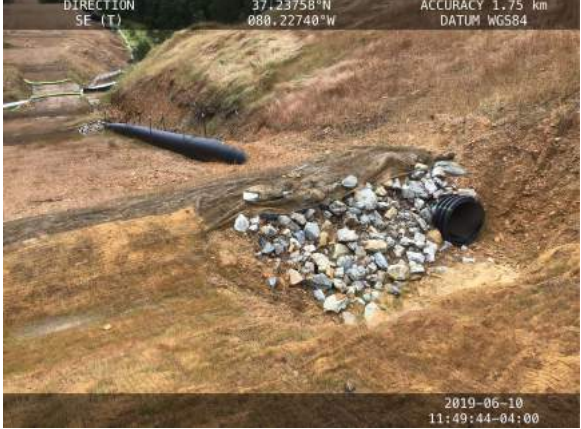
GPS Location	37.25	Field Station#	12108+41	GPS Location	37.25	Field Station#	12155+00
Description	Stream S-F15, facing southeast, downstream. No impacts from recent rain activity.			Description	The sump drain on the going away side of access road MVP-MN-273 is functioning well an in good condition after significant rainfall.

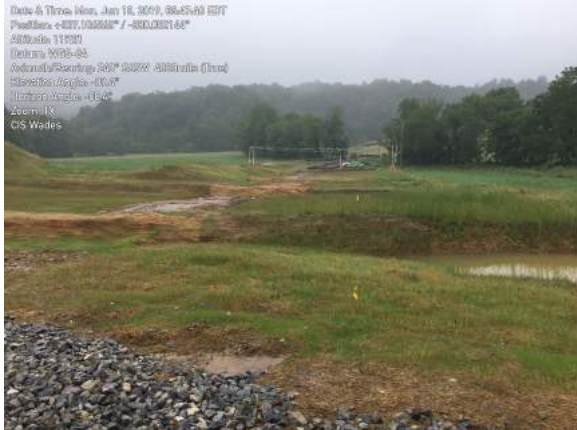
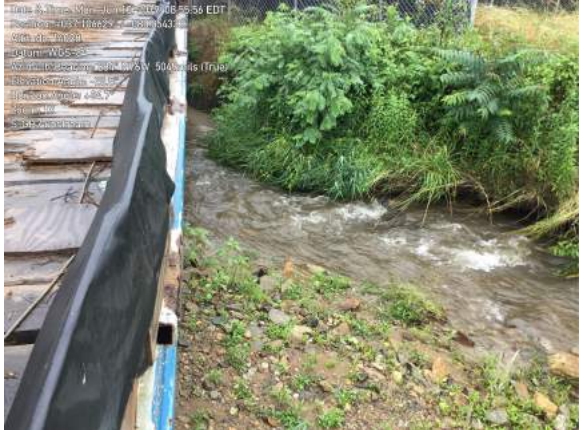
GPS Location	37.32	Field Station#	13315+70	GPS Location	37.32	Field Station#	13309+09
Description	Please see photo for accurate coordinates. Wade's Gap, sumps full with water, no off ROW impacts noted.			Description	Please see photo for accurate coordinates. S-GH7, upstream side of bridge, erosion noted on right descending bank.		
<p>Date &amp; Time: Mon, Jun 10, 2019, 06:56:00 EDT Position: +037.106716° / -880.000200° Altitude: 1480ft Datum: WGS-84 Azimuth/Bearing: 084° NS4E, 149.3mis (True) Elevation Angle: -07.5° Horizon Angle: -00.3° Zoom: 1X S-GH7</p>

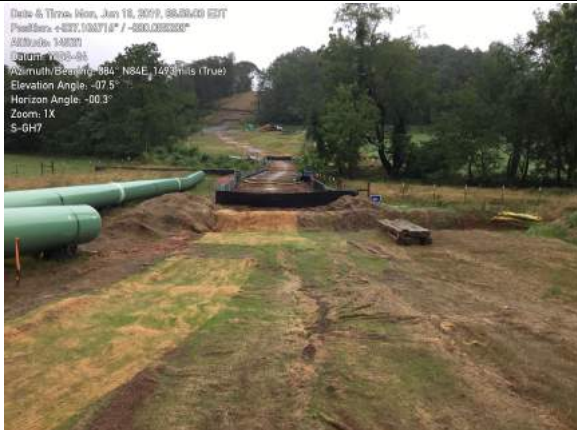
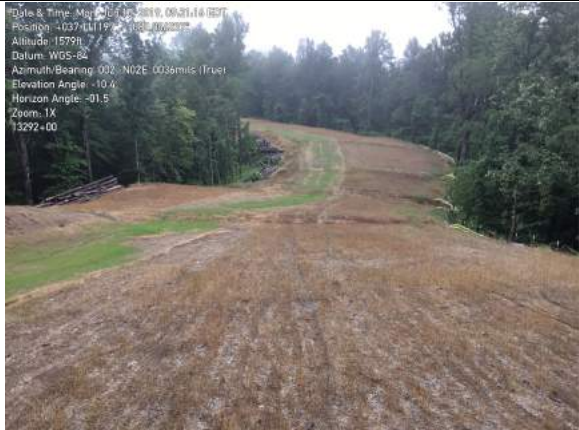
GPS Location	37.32	Field Station#	13311+00	GPS Location	37.32	Field Station#	13292+00
Description	Please see photo for accurate coordinates. S-GH7, ECDs functioning acceptably at stream crossing.			Description	Please see photo for accurate coordinates. ROW, stabilized with no off ROW impacts noted.		
<p>Date &amp; Time: Mon, Jun 10, 2019, 09:35:19 EDT Position: +037.118214° / -880.006318° Altitude: 1481ft Datum: WGS-84 Azimuth/Bearing: 258° 578W, 4587mis (True) Elevation Angle: -13.2° Horizon Angle: +02.1° Zoom: 1X PI GAS Flanders</p>

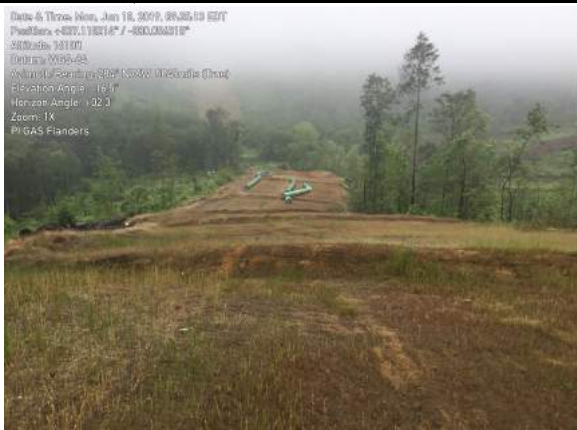
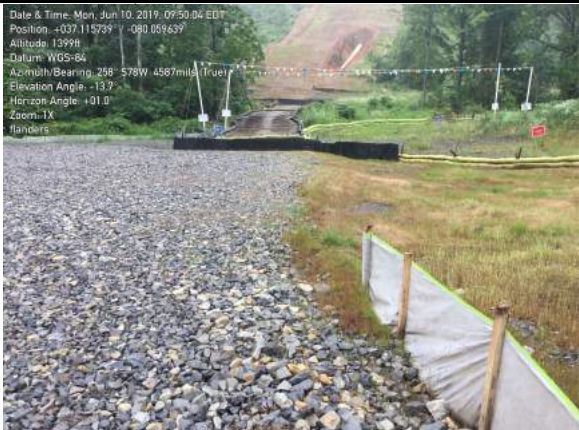
GPS Location	37.32	Field Station#	13273+46	GPS Location	37.32	Field Station#	13262+58
Description	Please see photo for accurate coordinates. ROW, waterbars functioning acceptably, no environmental issues noted.			Description	Please see photo for accurate coordinates. ATWS-1055, RCE and perimeter controls maintained, disturbed ground stabilized.

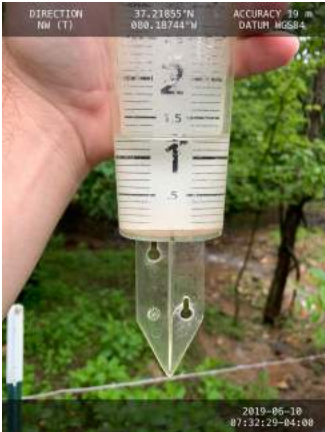
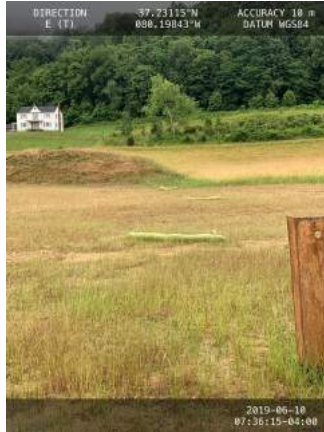
GPS Location		37.33	Field Station#		12543+56	GPS Location		37.33	Field Station#		12445+86
Description		Yellow Finch Rain Gauge. (1.3"). Looking NW. See picture for GPS data.				Description		Curlexed channel to allow rain water to cross row. Looking E. See picture for GPS data.

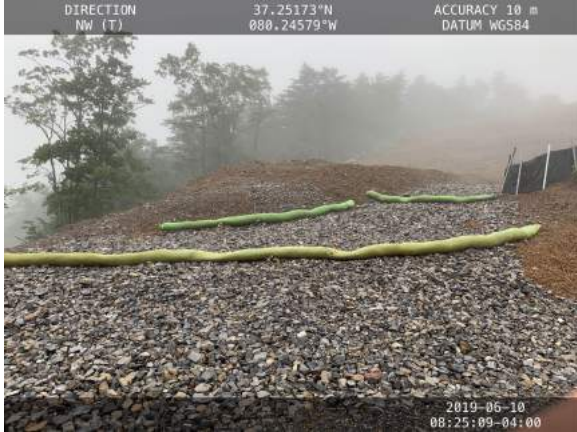
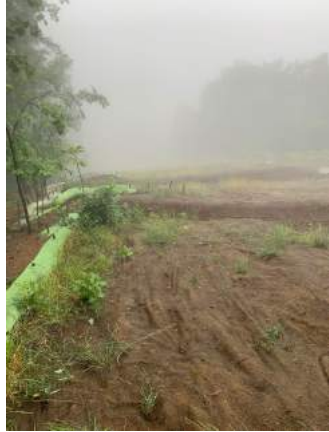
GPS Location	37.23	Field Station#	12234+77	GPS Location	37.23	Field Station#	12286+60
Description	RCE. Looking NW. See picture for GPS data.			Description	Stabilized ROW and end treatments.

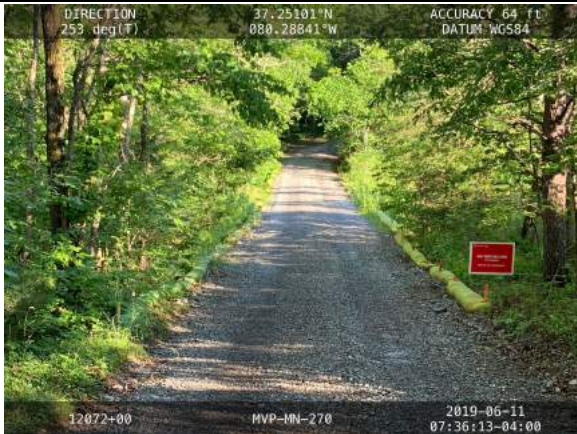
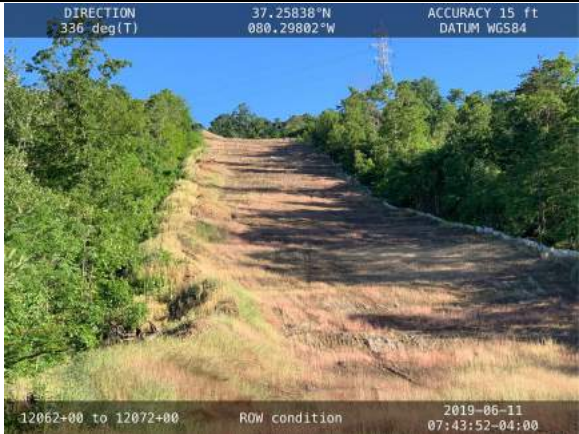
GPS Location	37.26	Field Station#	12072+00	GPS Location	37.26
Description	See photo for gps data. Photo shows the ECDs along access road MVP-MN-268.0.			Description	See photo for gps data. Photo shows the ROW condition from about 12062+00 to 12072+00.

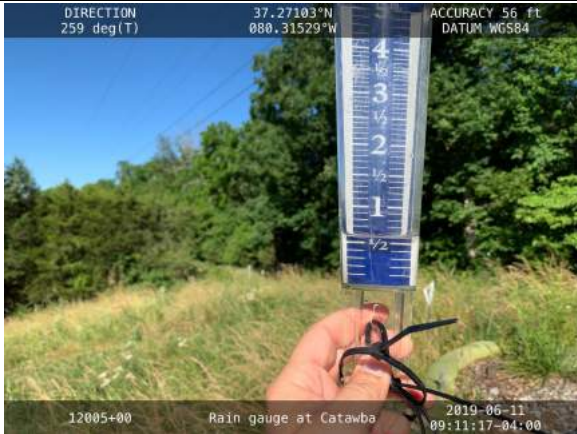
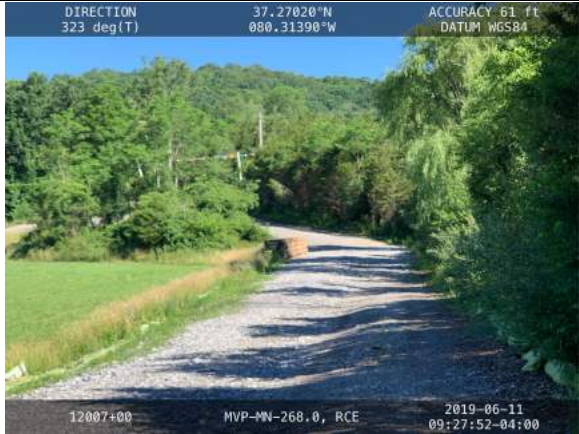
GPS Location	37.26	Field Station#	12005+00	GPS Location	37.26
Description	See photo for gps data. Photo shows the rain gauge at Catawba Road. 0.6" of rainfall.			Description	See photo for gps data. Photo shows the RCE on access road MVP-MN-268.0.

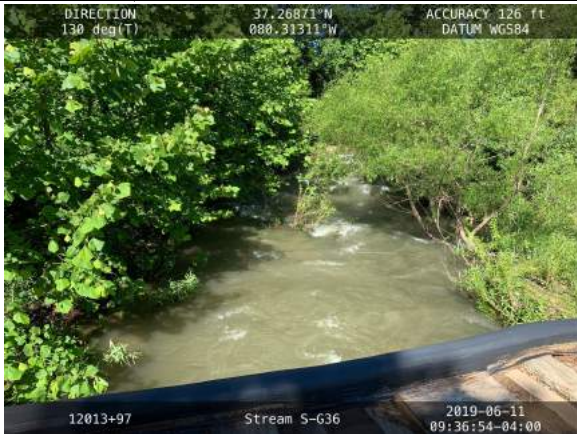
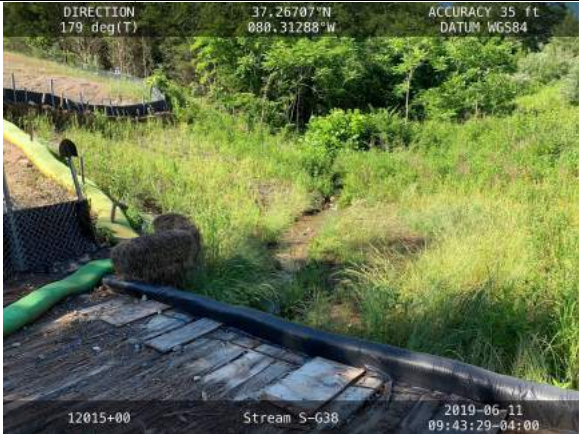
GPS Location	37.26	Field Station#	12013+97	GPS Location	37.26
Description	See photo for gps data. Photo shows stream S-G36 downstream from access road MVP-MN-268.01.			Description	See photo for gps data. Photo shows stream S-G38 at the ROW crossing.

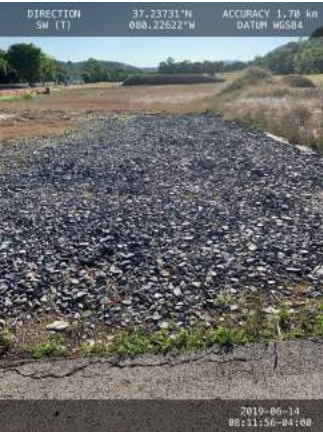
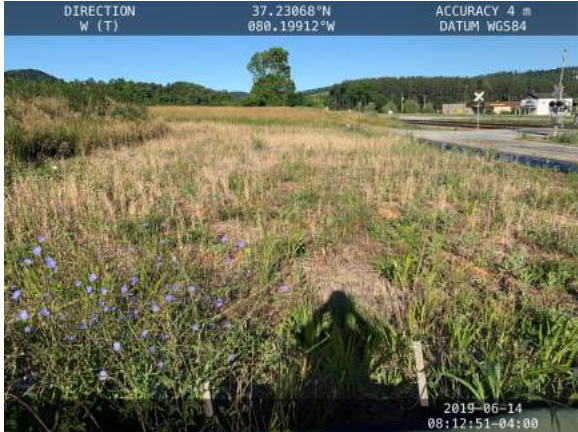
GPS Location	37.33	Field Station#	12448+12	GPS Location	37.33	Field Station#	12448+50
Description	RCE. Looking SW. See picture for GPS data.			Description	Stabilized ROW. Looking W. See picture for GPS data.

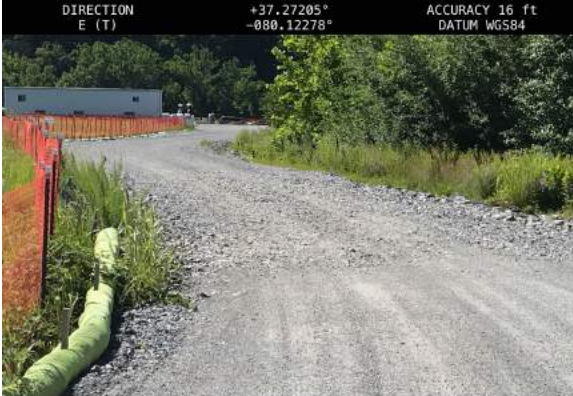
<div>MVP-LY-049_061419_PCD Condition of rock entrance 2019-06-14 10:28:29-04:00</div>			<div>DIRECTION E (T) +37.27159° -080.12230° ACCURACY 16 ft DATUM WGS84</div>

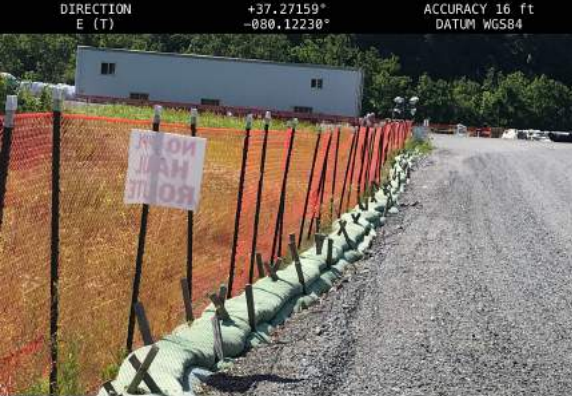
<div>MVP-LY-049_061419_PCD Condition of CFS along drive 2019-06-14 10:28:56-04:00</div>		
GPS Location	37.27	Field Station#	+0		
Description	MVP-LY-049_061419 condition of rock entrance on the center drive. Looking E. See photo for gps data.				
<div>DIRECTION N (T) +37.27096° -080.12193° ACCURACY 16 ft DATUM WGS84</div>

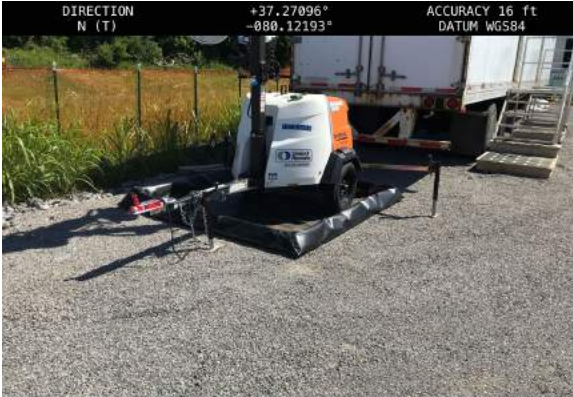
<div>MVP-LY-049_061419_PCD Condition of containment 2019-06-14 10:29:25-04:00</div>			<div>DIRECTION SE (T) +37.27111° -080.12153° ACCURACY 16 ft DATUM WGS84</div>

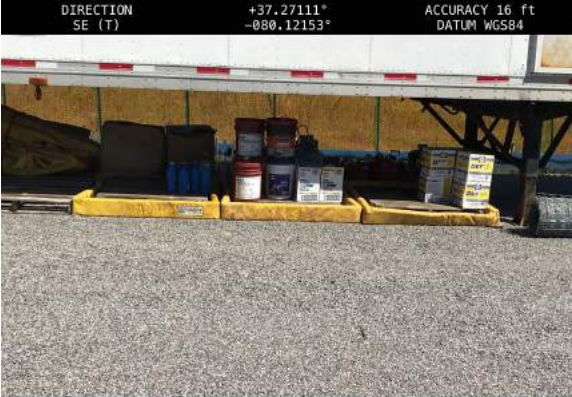
<div>MVP-LY-049_061419_PCD Containment for supplies 2019-06-14 10:37:16-04:00</div>		
GPS Location	37.27	Field Station#	+0

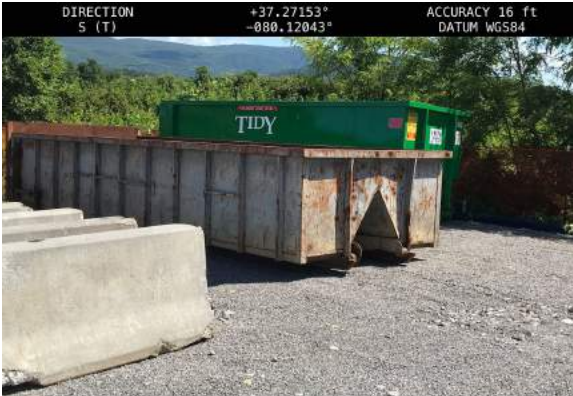
<div>MVP-LY-049_061429_PCD 2nd dumpster added to the yard 2019-06-14 10:37:49-04:00</div>			<div>DIRECTION SE (T) +37.27001° -080.12353° ACCURACY 16 ft DATUM WGS84</div>

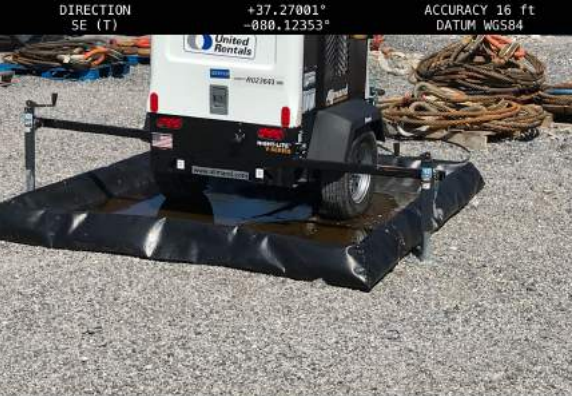
<div>MVP-LY-049_061419_PCD Condition of containment 2019-06-14 10:41:30-04:00</div>		
GPS Location	37.27	Field Station#	+0		
Description	MVP-LY049_061419 2nd dumpster added to the yard. Looking NE. See photo for gps data.				
<div>DIRECTION SE (T) +37.27001° -080.12353° ACCURACY 16 ft DATUM WGS84</div>

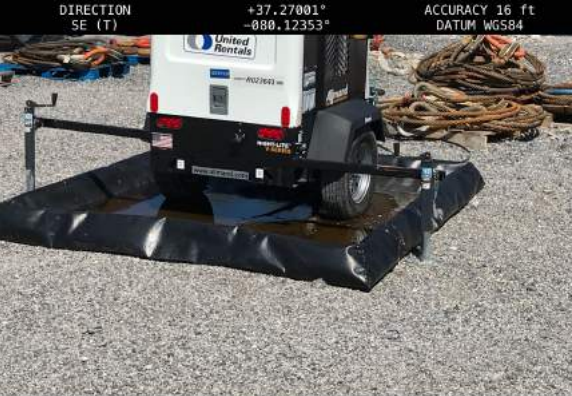
<div>MVP-LY-049_061419_PCD Condition of containment 2019-06-14 10:41:30-04:00</div>			<div>DIRECTION SE (T) +37.27001° -080.12353° ACCURACY 16 ft DATUM WGS84</div>

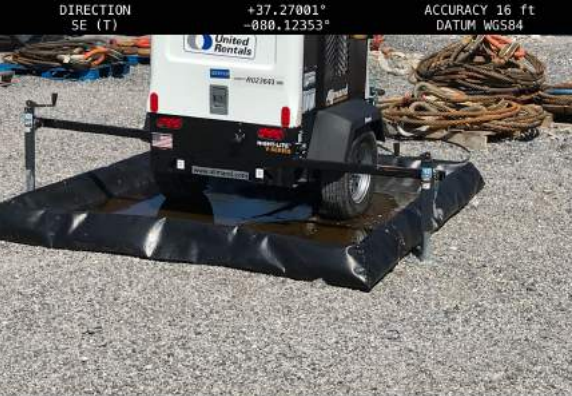
<div>MVP-LY-049_061419_PCD Condition of containment 2019-06-14 10:41:30-04:00</div>

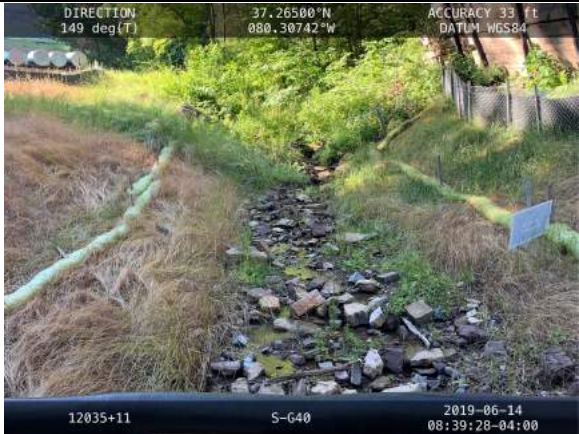
GPS Location	37.25	Field Station#	12031+50	GPS Location	37.25	Field Station#	12035+11
Description	See photo for gps data. Photo shows stream S-G39.			Description	See photo for gps data. Photo shows stream S-G40.

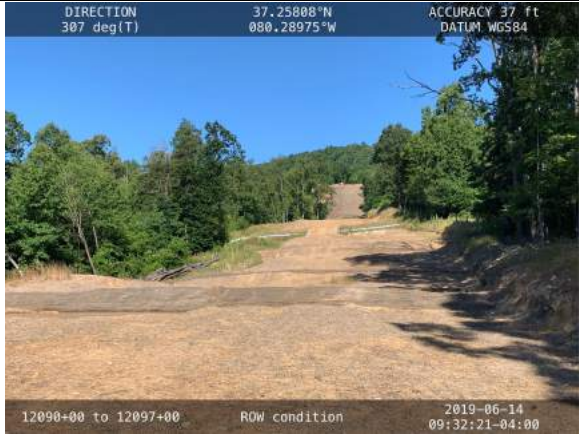
GPS Location	37.25	Field Station#	12098+75	GPS Location	37.25	Field Station#	12090+00
Description	See photo for gps data. Photo shows stream S-MM13.			Description	See photo for gps data. Photo shows the ROW condition from about 12090+00 to 12097+00.

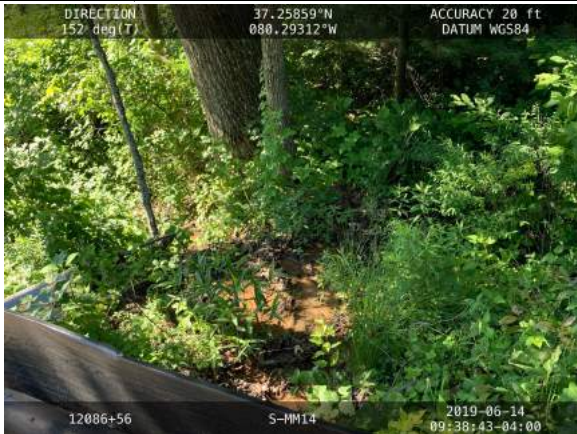
GPS Location	37.25	Field Station#	12086+56	GPS Location	37.25	Field Station#	12110+00
Description	See photo for gps data. Photo shows stream S-MM14.			Description	See photo for gps data. Photo shows the ROW condition from about 12005+00 to 12110+00.

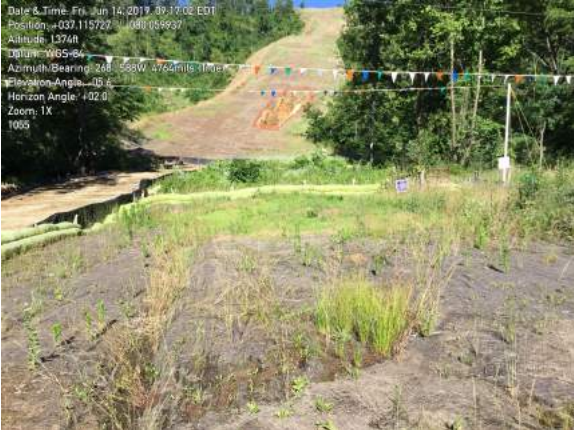
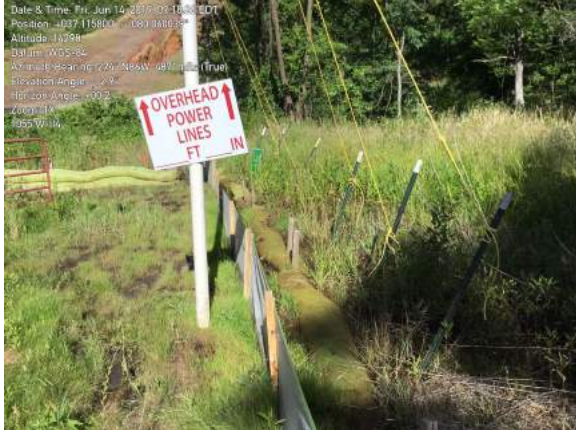
GPS Location	37.07	Field Station#	13262+00	GPS Location	37.07	Field Station#	13261+28
Description	Please see photo for accurate coordinates. ATWS-1055, cleanse water conveyance holding water but not flowing.			Description	Please see photo for accurate coordinates. W-114, wetland draining against perimeter controls, ECDs functioning acceptably.

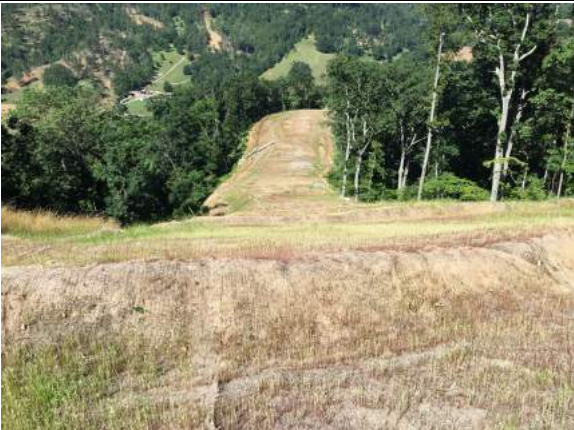
GPS Location	37.10	Field Station#	13218+53	GPS Location	37.10	Field Station#	13294+26
Description	Please see photo for accurate coordinates. ROW, waterbars and sumps functioning acceptably, soil piles stable.			Description	Please see photo for accurate coordinates. ROW, soil piles and waters bars stable, moderate vegetative cover observed.

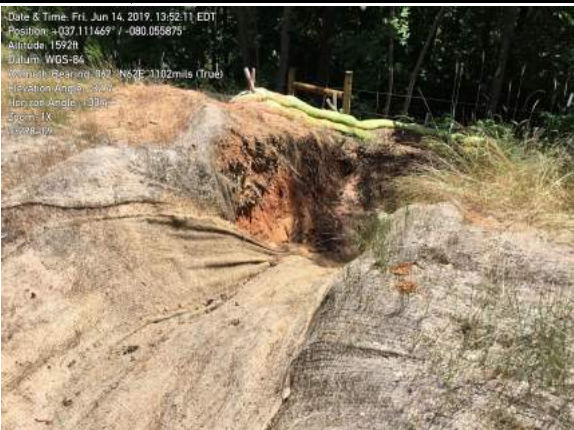
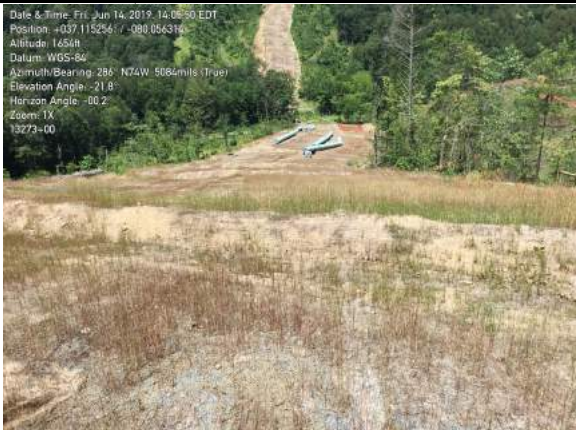
GPS Location	37.10	Field Station#	13298+09	GPS Location	37.10	Field Station#	13273+00
Description	Please see photo for accurate coordinates. ROW, sumps functioning acceptably, no off ROW sediment observed.			Description	Please see photo for accurate coordinates. ROW, waterbars stable, moderate vegetative cover, no environmental issues noted.

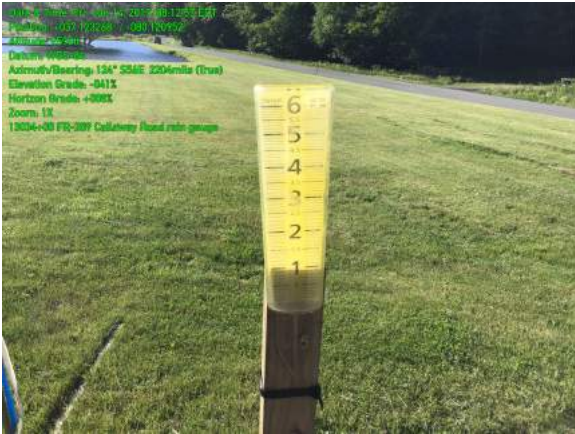
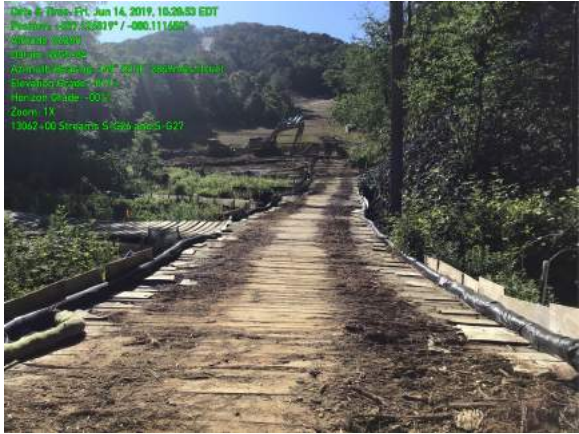
GPS Location	37.12	Field Station#	13034+00	GPS Location	37.12	Field Station#	13062+00
Description	No rain fall accumulation at Callaway Road from the previous day.			Description	Bore crew working in the area preparing to bore under the streams.

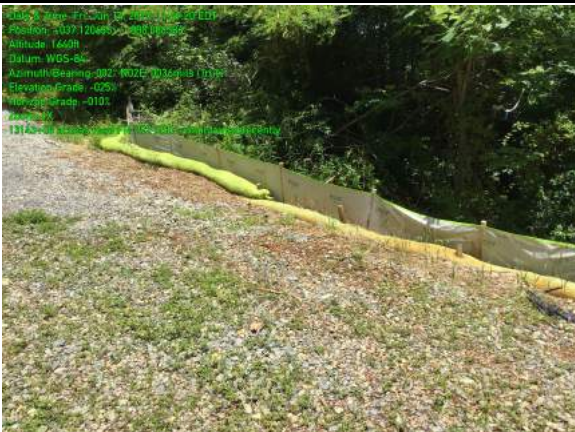
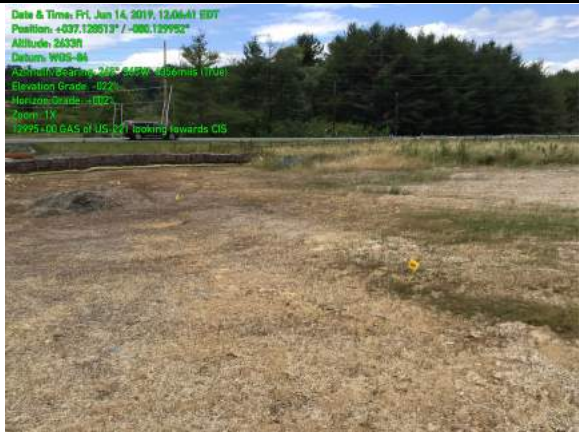
GPS Location	37.12	Field Station#	13143+00	GPS Location	37.12	Field Station#	12995+00
Description	No issues or impacts observed at access road FR-292.			Description	Good ROW conditions throughout the area near US-221

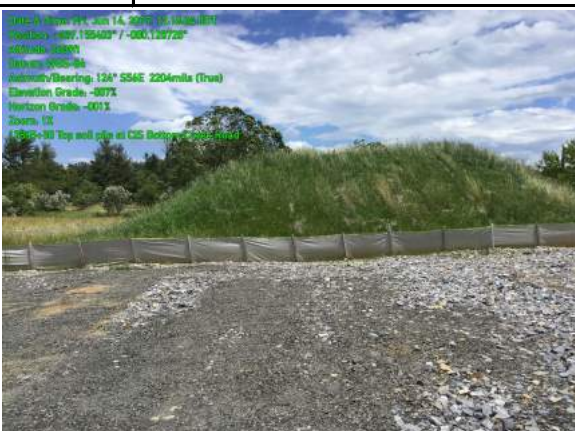
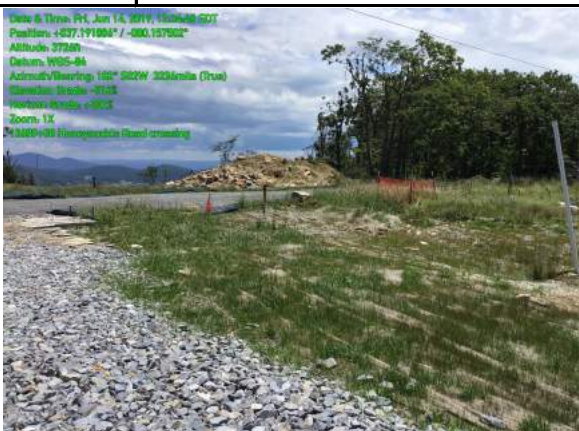
GPS Location	37.15	Field Station#	12865+50	GPS Location	37.19	Field Station#	12689+00
Description	All ECD's and stabilization at Bottom Creek Road remain in good condition.			Description	No issues or impacts observed near Honeysuckle Road.
