Visual Site Inspection Report

Project Name	H-600 Pipeline Spread H	AFE	124300138	Spread	H-600 Pipeline Spread H
Contractor	Precision			Report #	18616
Inspector	Logan Box			Date/Time	6/17/2019 6:11 PM
Permit #	TBD	Inspection Type	VA SWPP	Station Begin	13415+51
State	VA	Inspection Area	Partial	Station End	13670+00
County	Franklin	Ground	Damp	Temperature (°F)	74.00
Municipality	N/A	Weather	Sunny	Rain Gauge (in)	0.00
				Rain Accumulation Time (days)	0.00

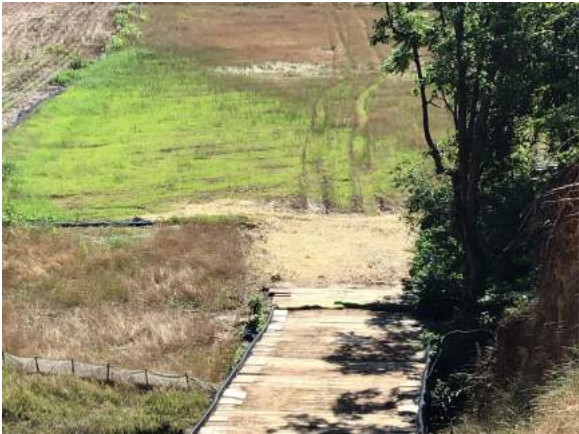
GPS Location	37.08	Field Station#	13543+54	GPS Location	37.08	Field Station#	13624+32
Description	Recently repaired punch list item , erosion issue repaired and stabilized.			Description	Photo showing vegetation

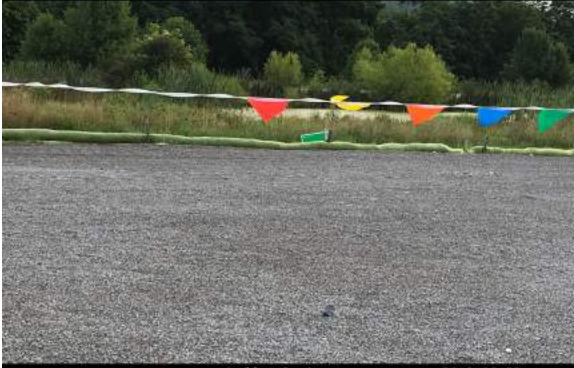
<div>MVP-PY-006_062019 Buffer & signage at feature 2019-06-20 07:53:19-04:00</div>			<div>DIRECTION S (T) +37.23507° -080.22875° ACCURACY 16 ft DATUM WGS84</div>

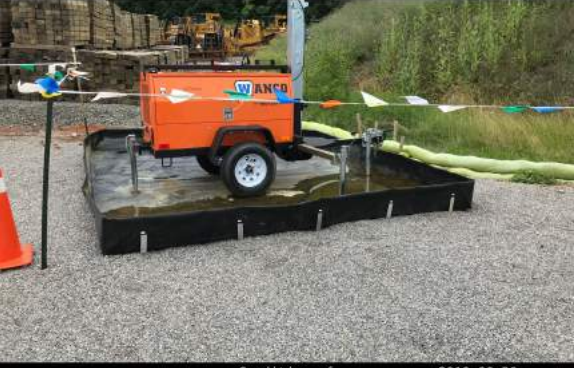
<div>MVP-PY-006_062019 Condition of containment 2019-06-20 11:03:36-04:00</div>		
GPS Location	37.23	Field Station#	+0		
Description	MVP-PY-006_062019 fagging and signage for wetland. Looking E. See photo for gps data.				
<div>DIRECTION E (T) +37.23549° -080.22708° ACCURACY 16 ft DATUM WGS84</div>

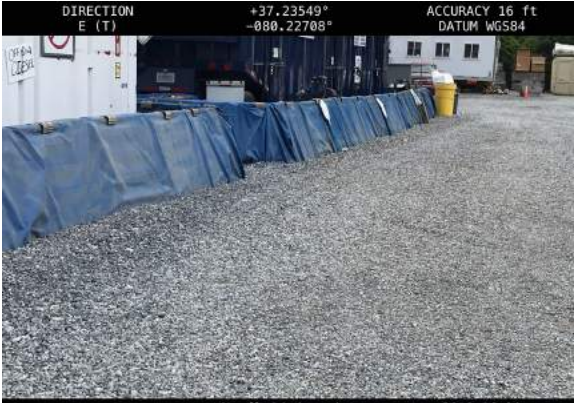
<div>MVP-PY-006_062019 No fluid deposits south of tanks 2019-06-20 10:39:51-04:00</div>			<div>DIRECTION E (T) +37.23560° -080.22701° ACCURACY 16 ft DATUM WGS84</div>

Description	MVP-PY-006_062019 no fluid deposits on the south side of the bulk fuel tanks. Looking E. See photo for gps data.				
<div>DIRECTION N (T) +37.23560° -080.22702° ACCURACY 16 ft DATUM WGS84</div>

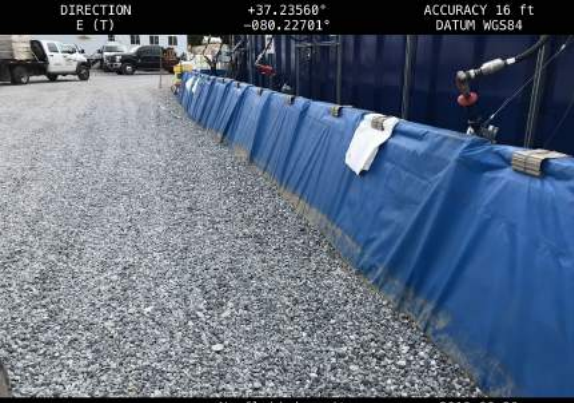
<div>MVP-PY-006_062019 No fluid deposits north of tanks 2019-06-20 10:42:19-04:00</div>		
GPS Location	37.23	Field Station#	+0

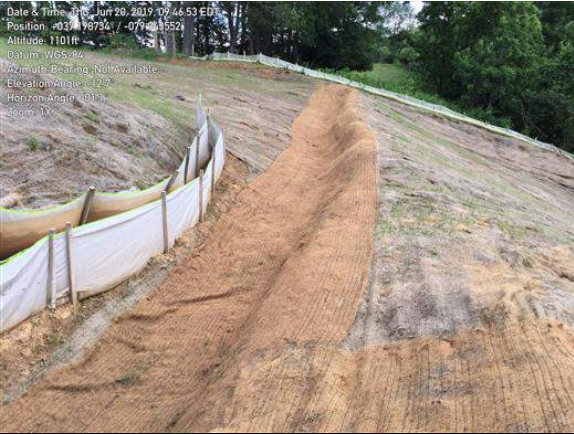
GPS Location	37.19	Field Station#	13331+10	GPS Location	37.19
Description	Waterbar recently had fresh ECB installed. View: north		Field Station#	13331+11	Description

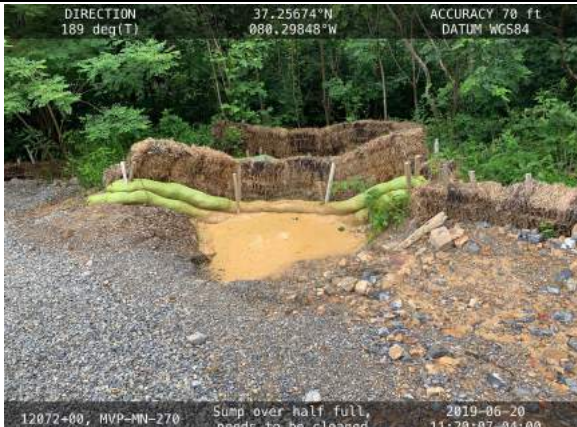
4. E&S BMPs (List BMPs and note if installed and maintained as per the plan. If corrective action is needed, a picture is required.)					
E&S BMPs	Compliance Level	Corrective Action		Corrective Time Frame	Date Repaired
Compost Filter Sock	Acceptable				
Equipment Bridge	Acceptable				
Erosion Control Blanket	Acceptable				
Silt Fence (Filter Fabric Fence)	Acceptable				
Silt Fence (Reinforced Filter Fabric Fence)	Acceptable				
Sump Pit	Communication	Sump over 1/2 full, needs cleaning		24 Hours	
Waterbar	Acceptable

GPS Location	37.26	Field Station#	12072+00	GPS Location	37.26	Field Station#	12031+51
Description	See photo for gps data. Photo shows the sump along access road MVP-MN-270 that was over half full. Should be cleaned out.			Description	See photo for gps data. Photo shows stream S-39.

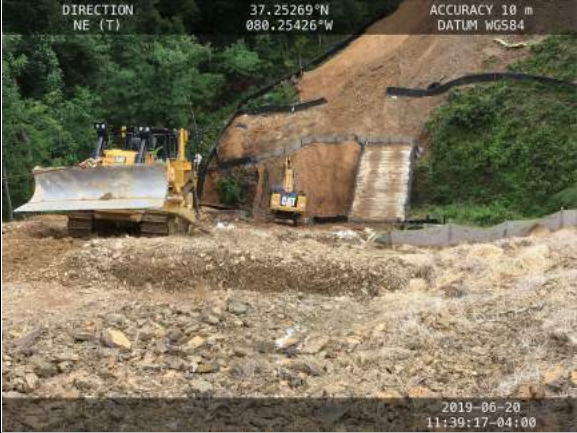
<p>Insert image here</p>			
GPS Location 37.25		Field Station# 12211+00		GPS Location	
Description		<p>A track hoe was winched to the bottom of the ravine to smooth out grade where the blast was and restore waterbars.</p>			
<p>Insert image here</p>		<p>Insert image here</p>			
GPS Location		Field Station#		GPS Location	
Description		Description			
<p>Insert image here</p>		<p>Insert image here</p>			
GPS Location		Field Station#		GPS Location	
Description		Description			
<p>Insert image here</p>		<p>Insert image here</p>			
GPS Location		Field Station#		GPS Location	
Description		Description

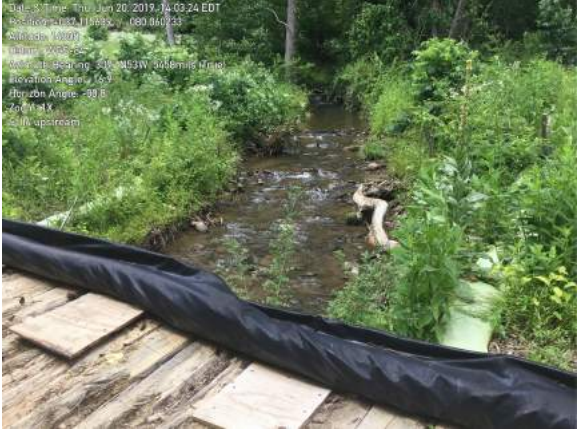
<p>Date & Time: Thu, Jun 20, 2019 14:03:24 EDT Position: +037.115732 / -080.063282 Altitude: 1528ft Datum: WGS-84 Azimuth/Bearing: 340° N63W 3080mils (True) Elevation Angle: -35.0 Horizon Angle: +00.8 Zoom: 1X S-II4 looking upstream</p>		
GPS Location	37.32	Field Station#	13190+00	GPS Location	37.32 Field Station# 13260+75
Description			Please see photo for accurate coordinates. MVP-MLV-AR-29, ECDs functioning acceptably along access road.

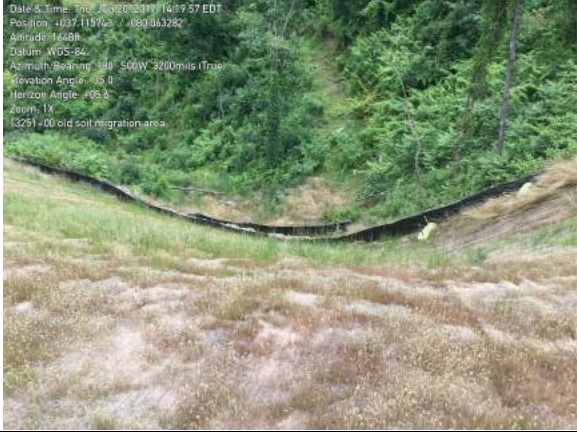
<p>Date & Time: Thu, Jun 20, 2019 16:19:57 EDT Position: +037.115732 / -080.063282 Altitude: 1528ft Datum: WGS-84 Azimuth/Bearing: 340° S00W 3200mils (True) Elevation Angle: -35.0 Horizon Angle: +00.8 Zoom: 1X 13251+00 old soil migration area</p>
