Visual Site Inspection Report

Project Name	H-600 Pipeline Spread H	AFE	124300138	Spread	H-600 Pipeline Spread H	
Contractor	Precision			Report #	19261	
Inspector	Pat Davis			Date/Time	6/26/2019 5:44 PM	
Permit #	TBD	Inspection Type	VA SWPP	Station Begin	+0	
State	VA	Inspection Area	Partial	Station End	+0	
County	Montgomery	Ground	Dry	Temperature (°F)	89.00	
Municipality	N/A	Weather	Sunny	Rain Gauge (in)	0.00	
				Rain Accumulation Time (days)	0.00

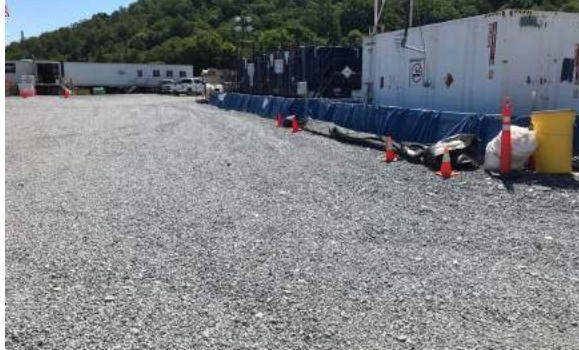
<div>MVP-PY-006_062619</div> <div>No fluid deposits N of tanks</div> <div>2019-06-26 11:12:52-04:00</div>			<div>DIRECTION SW (T)</div> <div>+37.23553° -080.22708°</div> <div>ACCURACY 16 ft DATUM WGS84</div>

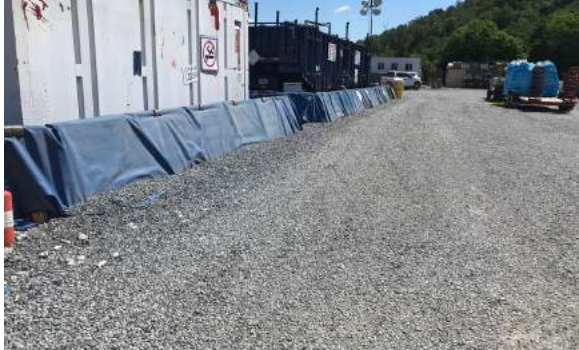
<div>MVP-PY-006_062619</div> <div>No fluid deposits S of tanks</div> <div>2019-06-26 11:13:02-04:00</div>		
GPS Location	37.23	Field Station#	+0		
Description	MVP-PY-006_062619 no fluid deposits on the north side of the bulk fuel tanks. Looking W. See photo for gps data.				
<div>DIRECTION SW (T)</div> <div>+37.23565° -080.22703°</div> <div>ACCURACY 16 ft DATUM WGS84</div>

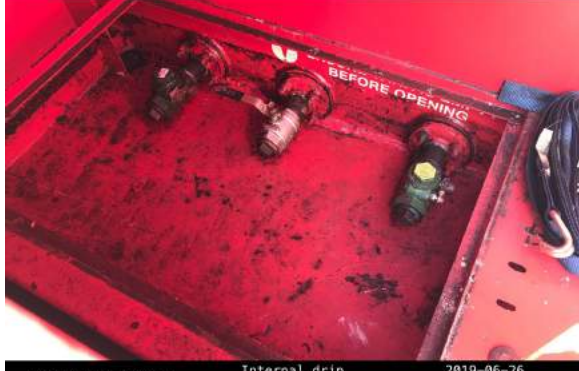
<div>MVP-PY-006_062619</div> <div>Internal drip tray empty</div> <div>2019-06-26 11:14:18-04:00</div>			<div>DIRECTION NW (T)</div> <div>+37.23564° -080.22702°</div> <div>ACCURACY 16 ft DATUM WGS84</div>

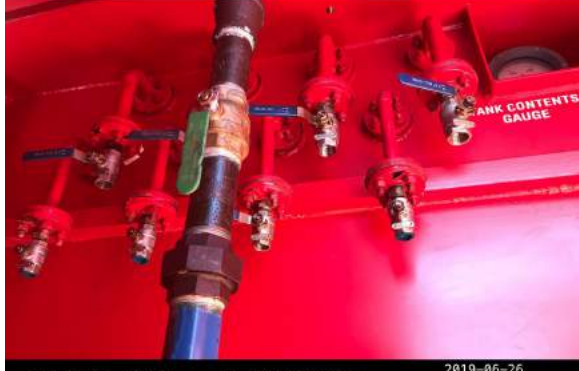
<div>MVP-PY-006_062619</div> <div>No leaky fittings</div> <div>2019-06-26 11:14:28-04:00</div>

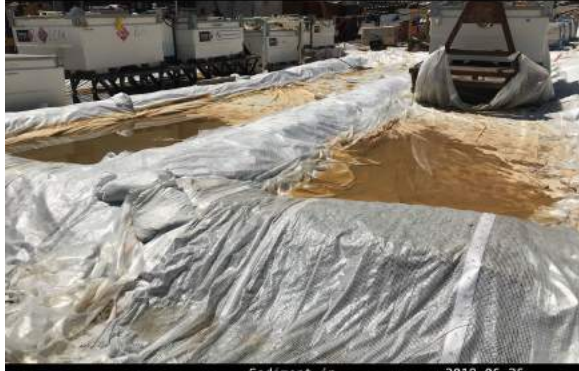
<div>MVP-PY-006_062619</div> <div>Sediment in containments</div> <div>2019-06-26 11:22:03-04:00</div>			<div>DIRECTION N (T)</div> <div>+37.23453° -080.22894°</div> <div>ACCURACY 16 ft DATUM WGS84</div>

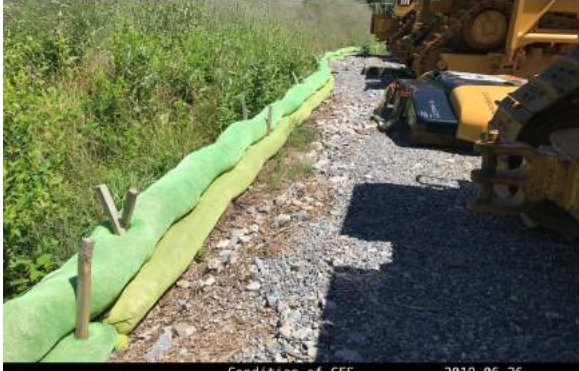
<div>MVP-PY-006_062619</div> <div>Condition of CFS W boundary</div> <div>2019-06-26 11:32:29-04:00</div>		
GPS Location	37.23	Field Station#	+0		
Description	MVP-PY-006_062619 sediment in containment. Looking SE. See photo for gps data.				
GPS Location	37.23	Field Station#	+0		
Description	MVP-PY-006_062629 condition of compost filter sock along west boundary. Looking N. See photo for gps data.

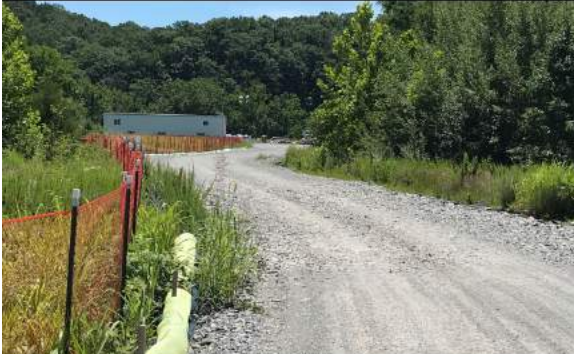
<div>MVP-LY-049_062619</div> <div>Condition of rock entrance</div> <div>2019-06-26 12:49:28-04:00</div>			<div>DIRECTION S (T)</div> <div>+37.27160° -080.12232°</div> <div>ACCURACY 16 ft DATUM WGS84</div>

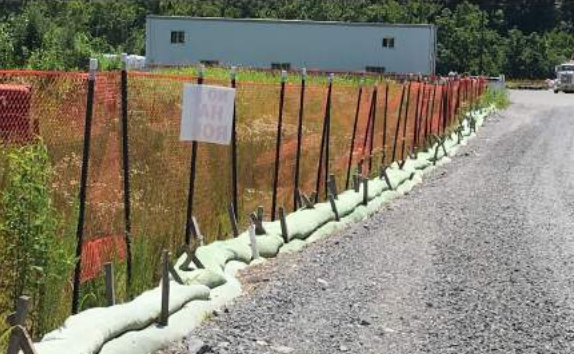
<div>MVP-LY-049_062619</div> <div>Condition of safety fence & CFS along dr...</div> <div>2019-06-26 12:49:58-04:00</div>			
GPS Location	37.27	Field Station#	+0	GPS Location	37.27	
Description	MVP-LY-049_062619 condition of rock entrance on center drive. Looking S. See photo for gps data.			Description	MVP-LY-049_062619 condition of CFS and safety fence along drive. Looking S. See photo for gps data.	
<div>DIRECTION NE (T)</div> <div>+37.27099° -080.12194°</div> <div>ACCURACY 16 ft DATUM WGS84</div>

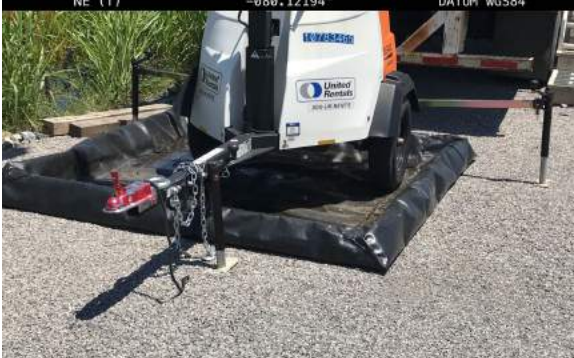
<div>MVP-LY-049_062619</div> <div>Condition of containment</div> <div>2019-06-26 12:50:26-04:00</div>			<div>DIRECTION NE (T)</div> <div>+37.27108° -080.12162°</div> <div>ACCURACY 16 ft DATUM WGS84</div>

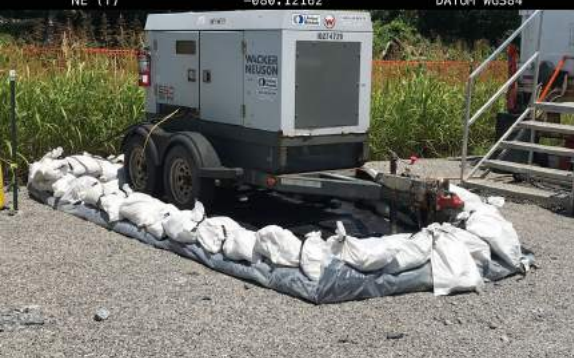
<div>MVP-LY-049_062619</div> <div>Condition of containment</div> <div>2019-06-26 12:50:43-04:00</div>

GPS Location	37.27	Field Station#	+0	GPS Location	37.27	
Description	MVP-LY-049_062619 condition of containment under light plant. Looking NE. See photo for gps data.			Description	MVP-LY-049_062619 condition of containment under generator. Looking NE. See photo for gps data.	
<div>DIRECTION NE (T)</div> <div>+37.27151° -080.12034°</div> <div>ACCURACY 16 ft DATUM WGS84</div>

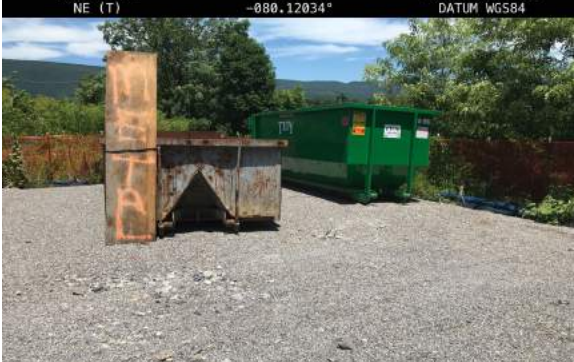
<div>MVP-LY-049_062619</div> <div>No loose trash in E dumpsters area</div> <div>2019-06-26 12:57:44-04:00</div>			<div>DIRECTION NW (T)</div> <div>+37.27165° -080.12048°</div> <div>ACCURACY 16 ft DATUM WGS84</div>

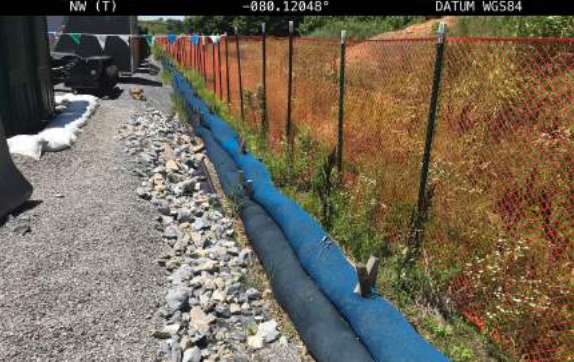
<div>MVP-LY-049_062619</div> <div>Condition of CFS along N boundary</div> <div>2019-06-26 12:58:03-04:00</div>			
GPS Location	37.27	Field Station#	+0	GPS Location	37.27	
Description	MVP-LY-049_062619 no loose trash around Eastern dumpster area. Looking NE. See photo for gps data.			Description	MVP-LY-049_062619 condition of CFS and safety fence along North boundary. Looking NW. See photo for gps data.

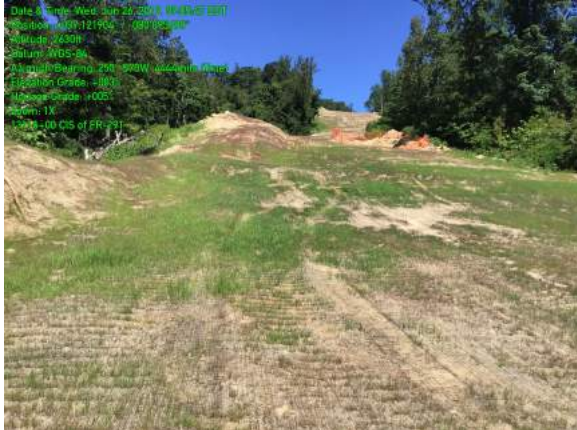
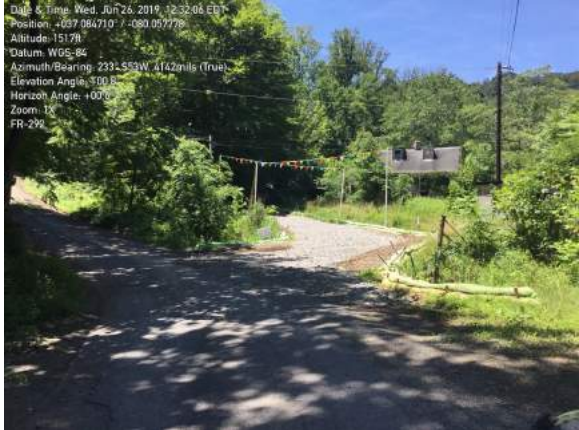
GPS Location	37.12	Field Station#	13116+00		GPS Location	37.12	Field Station#	13143+00
Description	No issues or impacts observed throughout the area today.			Description	All ECD's and BMP's were in good condition.

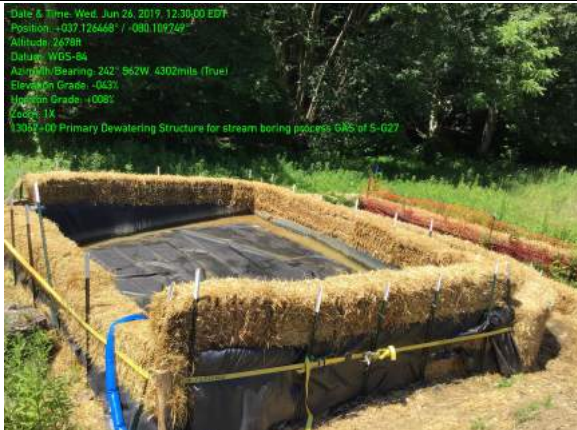
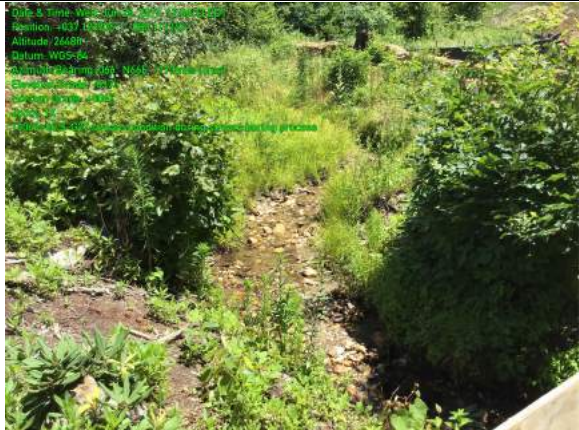
GPS Location	37.12	Field Station#	13067+00		GPS Location	37.12	Field Station#	13063+00
Description	Primary dewatering structure being utilized again with less water volume now that the secondary dewatering structure is also being used.			Description	Condition of stream S-G27 remains unchanged since the bore process began.

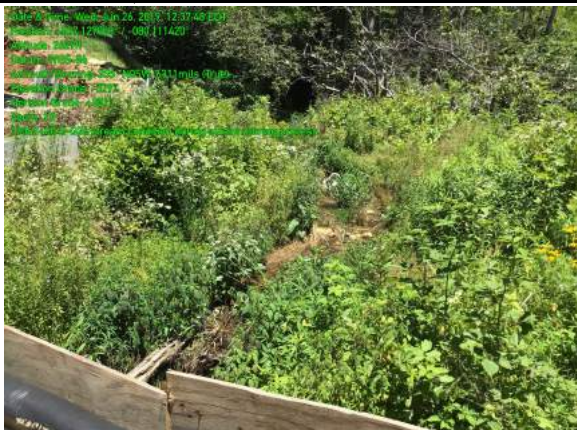
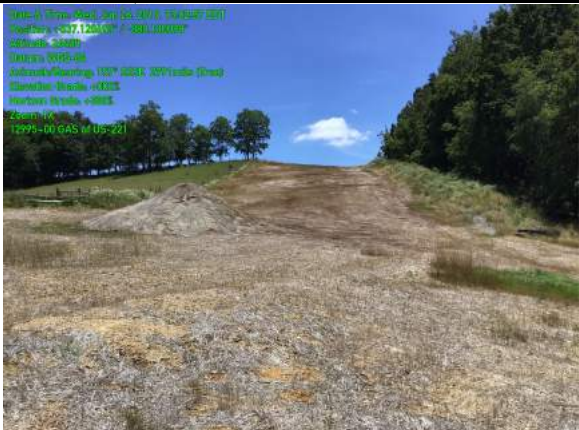
GPS Location	37.12	Field Station#	13062+00		GPS Location	37.12	Field Station#	12995+00
Description	Condition of stream S-G26 remains unchanged since the bore process began.			Description	ROW conditions remain well stabilized with no issues.

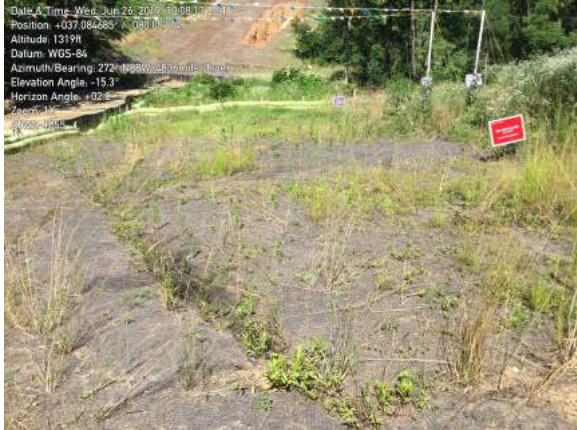
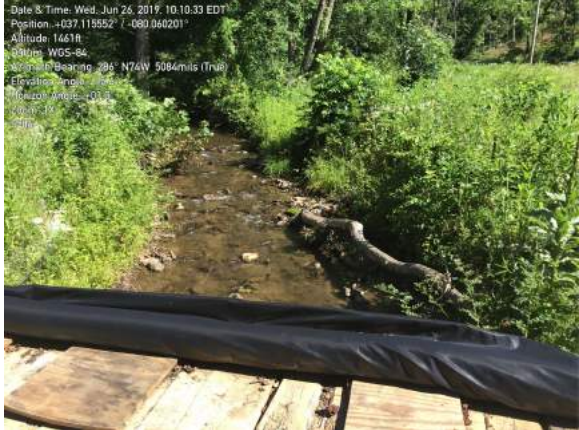
GPS Location	37.32	Field Station#	13262+00	GPS Location	37.32	Field Station#	13260+85
Description	Please see photo for accurate coordinates. ATWS-1055, no flow noted in clean water conveyance.			Description	Please see photo for accurate coordinates. S-II4, water flow moderate and clear, no environmental issues noted.

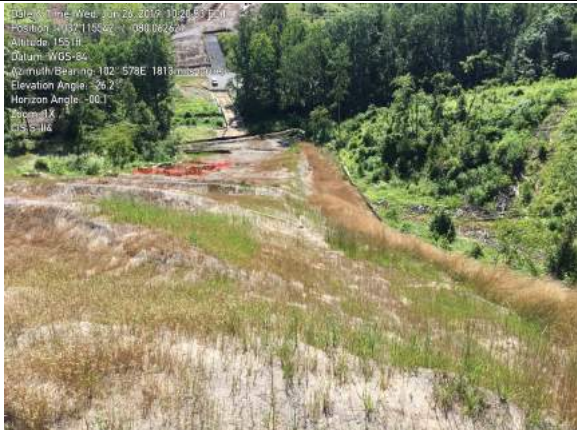
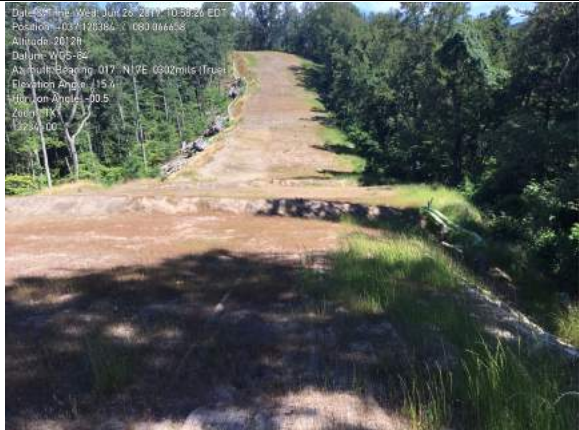
GPS Location	37.32	Field Station#	13252+00	GPS Location	37.32	Field Station#	13234+00
Description	Please see photo for accurate coordinates. ROW, soil piles stabilized, temporary vegetative cover acceptable.			Description	Please see photo for accurate coordinates. ROW, waterbars, sumps, and outlet protection functioning acceptably.

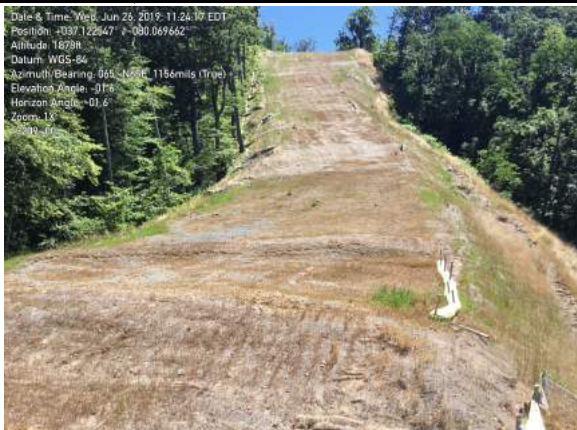
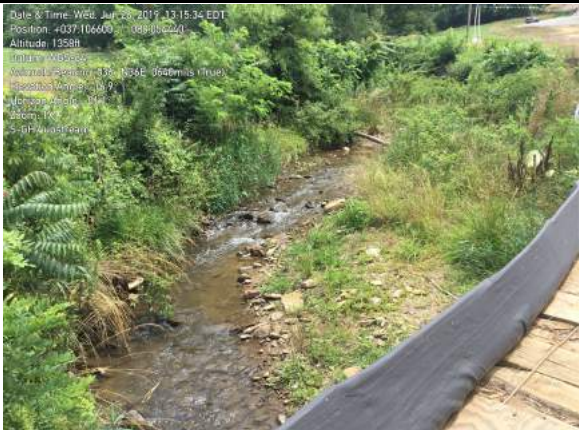
GPS Location	37.32	Field Station#	13209+00	GPS Location	37.32	Field Station#	13309+09
Description	Please see photo for accurate coordinates. ROW, right of way stabilized, soil piles sable, no environmental issues noted.			Description	Please see photo for accurate coordinates. S-GH7, looking upstream, natural erosion observed, ECDs functioning acceptably.
