# Visual Site Inspection Report

<b>Project Name</b>	H-600 Pipeline Spread H	<b>AFE</b>	124300138	<b>Spread</b>	H-600 Pipeline Spread H	
<b>Contractor</b>	Precision			<b>Report #</b>	18084	
<b>Inspector</b>	Pat Davis			<b>Date/Time</b>	6/4/2019 2:13 PM	
<b>Permit #</b>	TBD	<b>Inspection Type</b>	VA SWPP	<b>Station Begin</b>	+0	
<b>State</b>	VA	<b>Inspection Area</b>	Partial	<b>Station End</b>	+0	
<b>County</b>	Montgomery	<b>Ground</b>	Dry	<b>Temperature (°F)</b>	79.00	
<b>Municipality</b>	N/A	<b>Weather</b>	Sunny	<b>Rain Gauge (in)</b>	0.00	
				<b>Rain Accumulation Time (days)</b>	0.00

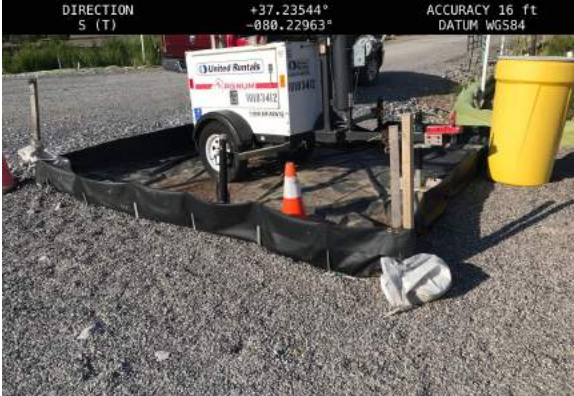
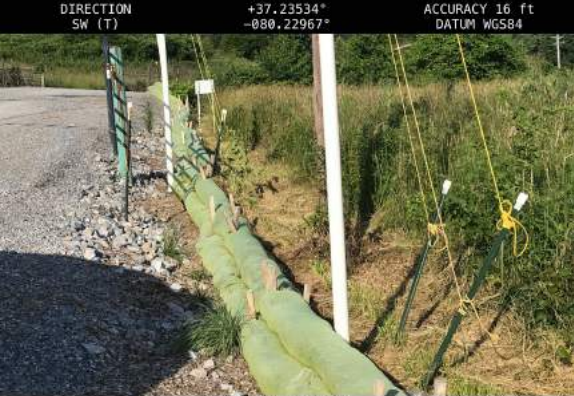
DIRECTION S (T) +37.23544° -080.22963° ACCURACY 16 ft DATUM WGS84			DIRECTION SW (T) +37.23534° -080.22967° ACCURACY 16 ft DATUM WGS84				
MVP-PY-006_060419_PCD Condition of containment 2019-06-04 08:19:06-04:00			MVP-PY-006_060419_PCD Condition of CFS along drive 2019-06-04 08:19:25-04:00				
GPS Location	37.23	Field Station#	+0	GPS Location	37.23	Field Station#	+0
Description	MVP-PY-006_060419 condition of containment under light plant. Looking S. See photo for gps data.			Description	MVP-PY-006_060419 condition of triple stack compost filter along drive. Looking SW. See photo for gps data.

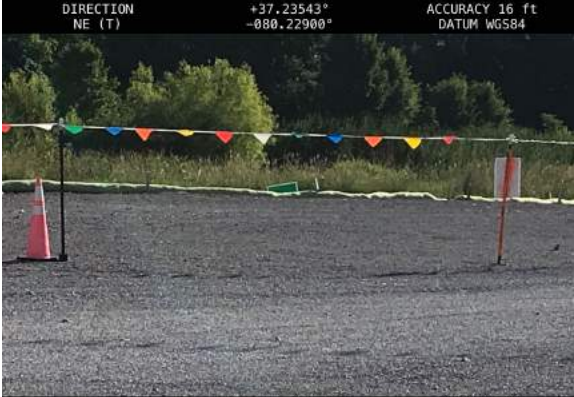
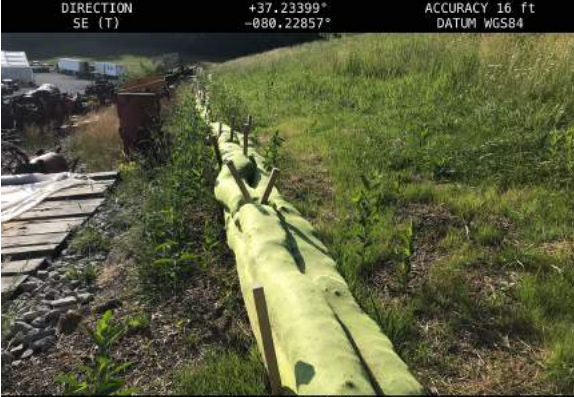
DIRECTION NE (T) +37.23543° -080.22900° ACCURACY 16 ft DATUM WGS84			DIRECTION SE (T) +37.23399° -080.22857° ACCURACY 16 ft DATUM WGS84				
MVP-PY-006_060419_PCD Signage & buffer for feature 2019-06-04 08:21:16-04:00			MVP-PY-006_060419_PCD Condition of CFS along south boundary 2019-06-04 08:23:25-04:00

GPS Location	37.23	Field Station#	+0	GPS Location	37.23	Field Station#	+0
Description	MVP-PY-006_060419 signage and buffer for feature. Looking NE. See photo for gos data.			Description	MVP-PY-006_060419 condition of triple stack compost filter sock along south boundary. Looking SE. See photo for gps data.

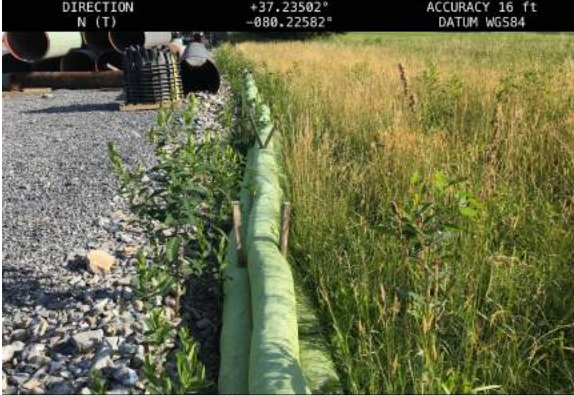
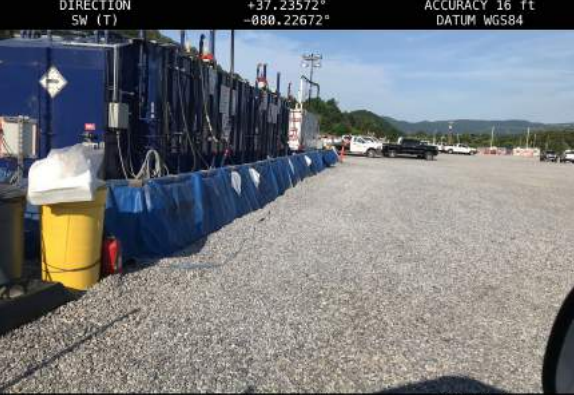
DIRECTION N (T) +37.23502° -080.22582° ACCURACY 16 ft DATUM WGS84			DIRECTION SW (T) +37.23572° -080.22672° ACCURACY 16 ft DATUM WGS84				
MVP-PY-006_060419_PCD Condition of CFS along east boundary 2019-06-04 08:32:34-04:00			MVP-PY-006_060419_PCD No fluid deposits on the north of tanks 2019-06-04 08:34:47-04:00				
GPS Location	37.23	Field Station#	+0	GPS Location	37.23	Field Station#	+0
Description	MVP-PY-006_060419 condition of triple stack compost filter sock along east boundary. Looking N. See photo for gps data.			Description	MVP-PY-006_060419 no fluid deposits on the north side of the bulk fuel tanks. Looking SW. See photo for gps data.

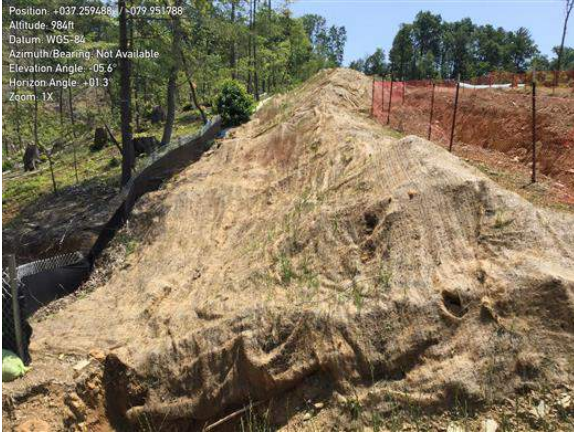
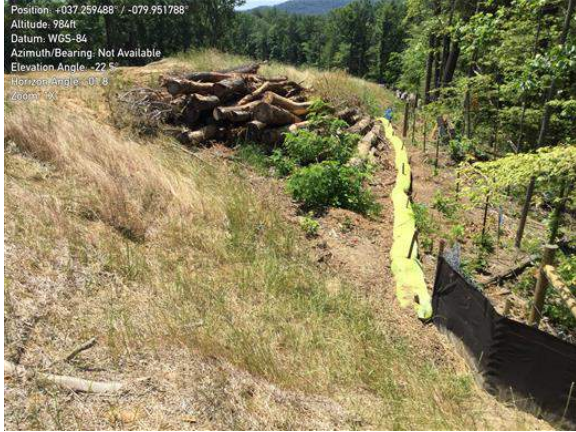
GPS Location	37.09	Field Station#	13267+50	GPS Location	37.09	Field Station#	13274+53
Description	Super saver silt fence & blanketed spoil pile along northern edge of LOD. View: East from northern perimeter of LOD, see photo for GPS data.			Description	Perimeter controls, topsoil piles & timber pile. View: South from western perimeter of LOD, see photo for GPS data.

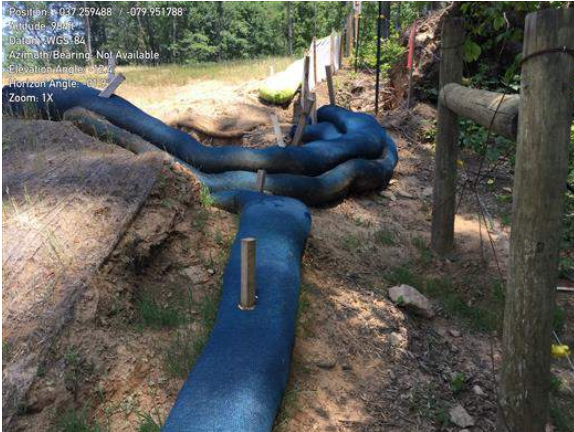
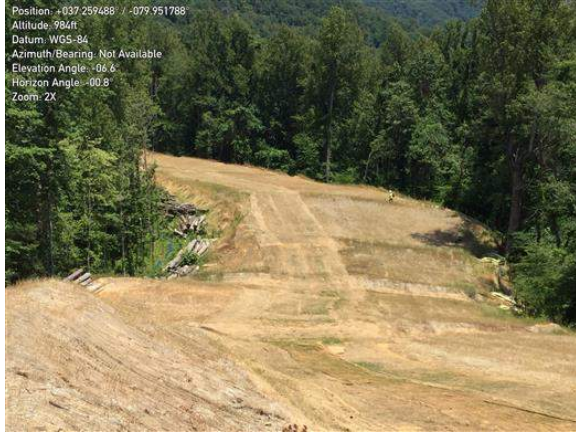
GPS Location	37.09	Field Station#	13274+63	GPS Location	37.09	Field Station#	13289+24
Description	Waterbar outlet/treatment & fence line. View: North from eastern edge of LOD, see photo for GPS data.			Description	Personnel walking the LOD for monitoring & maintenance issues. View: North from center of LOD, see photo for GPS data.

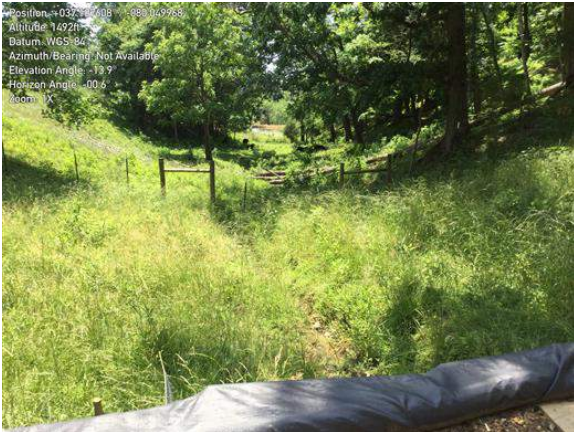
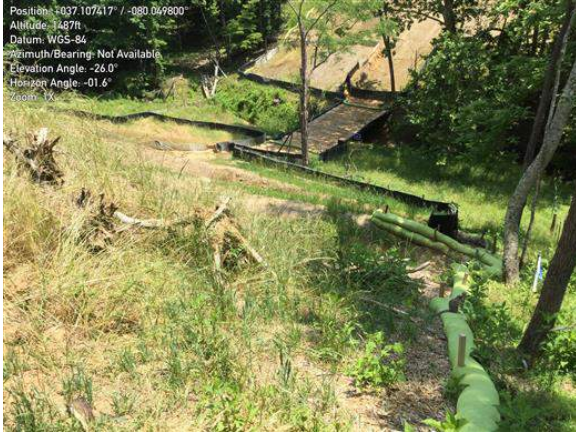
GPS Location	37.09	Field Station#	13321+47	GPS Location	37.09	Field Station#	13323+43

Description	Downstream of waterway S-GH15 (cows within high water mark) View: South from southern edge of LOD & equipment bridge, see photo for GPS data.			Description	Looking down upon waterway S-GH14. View: East from southern perimeter of LOD, see photo for GPS data.

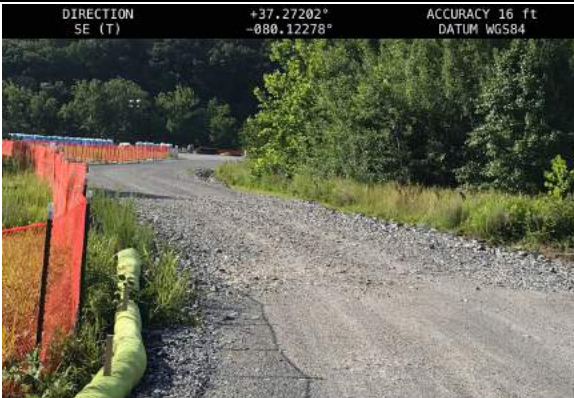
<div>MVP-LY-049_060419_PCD Condition of rock entrance 2019-06-04 08:48:46-04:00</div>			<div>DIRECTION SE (T) +37.27163° -080.12234° ACCURACY 16 ft DATUM WGS84</div>

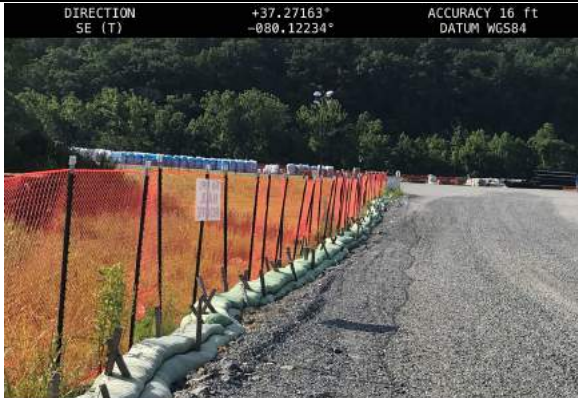
<div>MVP-PY-049_060419_PCD CFS &amp; safety fence along drive 2019-06-04 08:49:20-04:00</div>				
GPS Location 37.26		Field Station# +0		GPS Location 37.27		Field Station# +0	
Description		MVP-LY-049_060419 condition of rock entrance on center drive. Looking SE. See photo for gps data.		Description		MVP-LY-049_060419 condition of triple stack compost filter sock along center drive. Looking SE. See photo for gps data.	
<div>DIRECTION N (T) +37.27096° -080.12188° ACCURACY 16 ft DATUM WGS84</div>

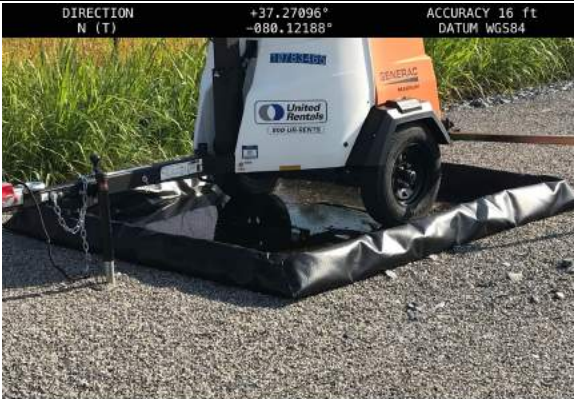
<div>MVP-LY-049_060419_PCD Condition of containment 2019-06-04 08:49:49-04:00</div>			<div>DIRECTION NE (T) +37.27119° -080.12155° ACCURACY 16 ft DATUM WGS84</div>

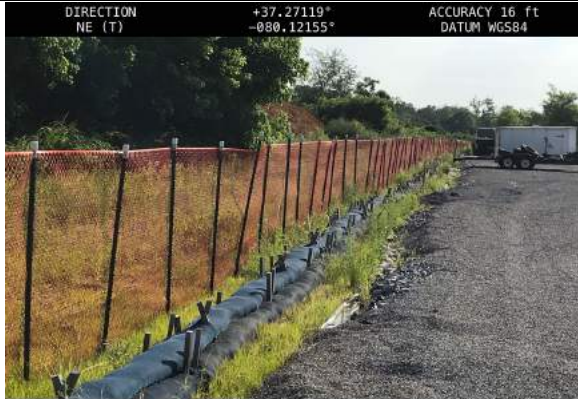
<div>MVP-LY-049_060419_PCD CFS &amp; safety Fence north boundary 2019-06-04 08:50:15-04:00</div>

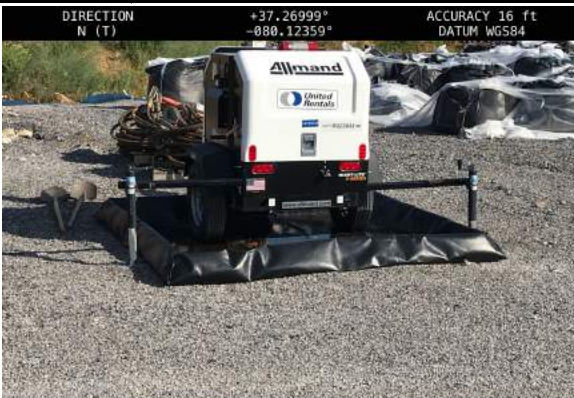
<div>MVP-LY-049_060419_PCD Condition of containment 2019-06-04 08:55:23-04:00</div>			<div>DIRECTION N (T) +37.27165° -080.12306° ACCURACY 16 ft DATUM WGS84</div>

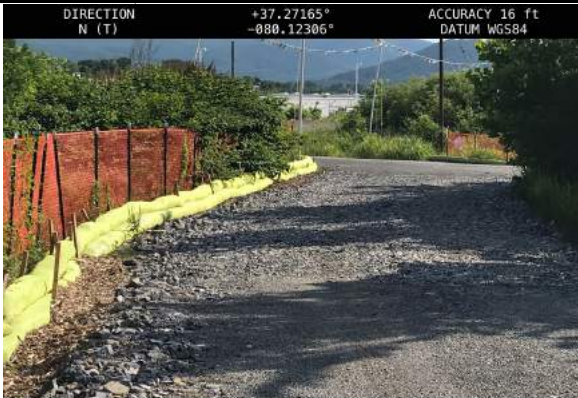
<div>MVP-LY-049_060419_PCD Condition of north rock entrance 2019-06-04 08:57:35-04:00</div>				
GPS Location 37.27		Field Station# +0		GPS Location 37.27		Field Station# +0	
Description		MVP-LY-049_060419 condition of containment under light plant. Looking N. See photo for gps data.		Description		MVP-LY-049_060419 condition of rock entrance on north drive. Looking N. See photo for gps data.

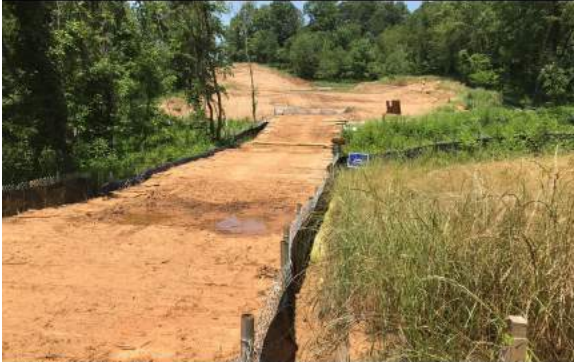
</div></div> <div>+37.10313° -080.04182° ACCURACY 16 ft DATUM WGS84</div> <div>13348+46_060419_S- RR08_PCD S-RR11 mat bridge clean &amp; closed 2019-06-04 12:50:52-04:00</div>			<div>DIRECTION SE (T) <div>

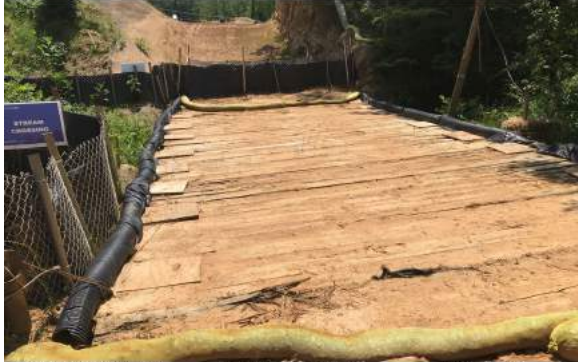
</div></div> <div>+37.10254° -080.04114° ACCURACY 16 ft DATUM WGS84</div> <div>13352+23_060419_S- RR09_PCD S-RR09 mat bridge clean &amp; closed 2019-06-04 12:40:15-04:00</div>			
GPS Location	37.27	Field Station#	13348+46	GPS Location	37.27	
Description	13348+46_060419 S-RR08 mat ridge clean and closed. Looking N. See photo for gps data.			Description	13352+23_060419 S-RR09 mat bridge clean and closed. Looking SE. See photo for gps data.	
<div>DIRECTION SW (T) <div>

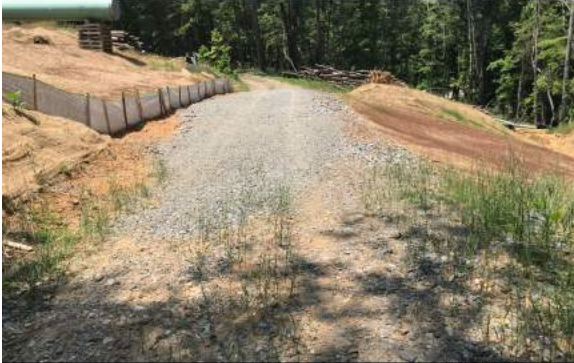
</div></div> <div>+37.12287° -080.05936° ACCURACY 1.92 mi DATUM WGS84</div> <div>13355+94_060419_PCD Condition of private drive 2019-06-04 12:32:26-04:00</div>			<div>DIRECTION NW (T) <div>

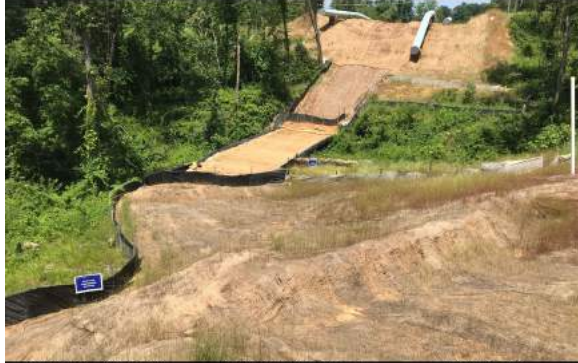
</div></div> <div>+37.10096° -080.03924° ACCURACY 16 ft DATUM WGS84</div> <div>13358+64_060419_S- RR11_PCD S-RR11 mat ridge &amp; ROW growth 2019-06-04 12:17:06-04:00</div>

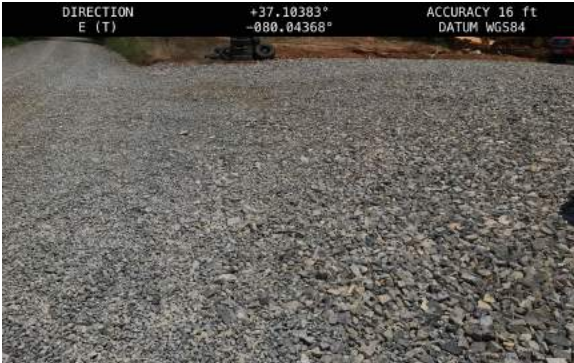
</div></div> <div>+37.10383° -080.04368° ACCURACY 16 ft DATUM WGS84</div> <div>13342+67_060419_PCD Webster's Corner East rock entrance 2019-06-04 13:20:17-04:00</div>			<div>DIRECTION NW (T) <div>

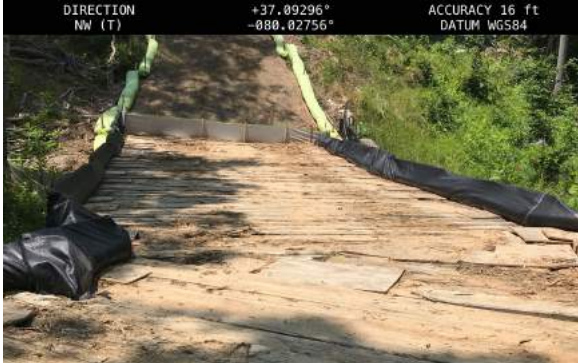
</div></div> <div>+37.09296° -080.02756° ACCURACY 16 ft DATUM WGS84</div> <div>13413+05_060419_S- IJ1_PCD Mat bridge clean &amp; closed 2019-06-04 13:30:30-04:00</div>			
GPS Location	37.27	Field Station#	13342+67	GPS Location	37.27	
Description	13342+67_060419 Webster's Corner east rock entrance. Looking E. See photo for gps data.			Description	13413+05_060419 S-IJ1 mat bridge clean and closed. Looking NW. See photo for gps data.

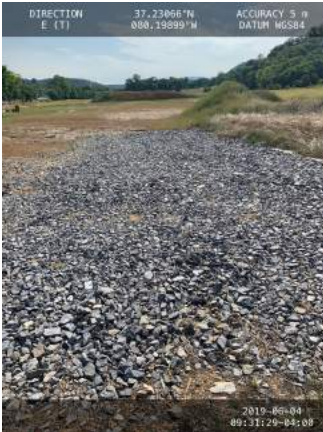
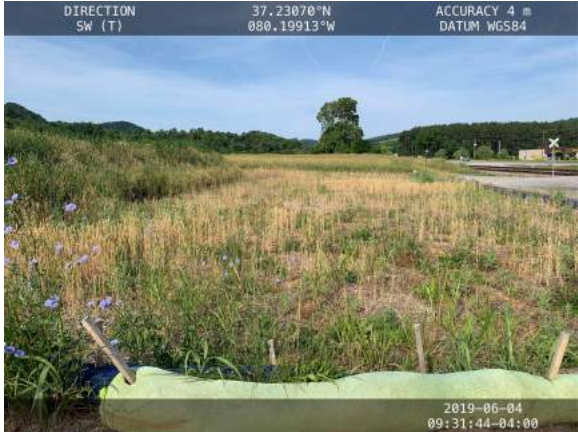
GPS Location	37.23	Field Station#	12448+12	GPS Location	37.23	Field Station#	12448+50
Description	RCE. Looking E. See picture for GPS data.			Description	Stabilized ROW. Looking SW. See picture for GPS data.

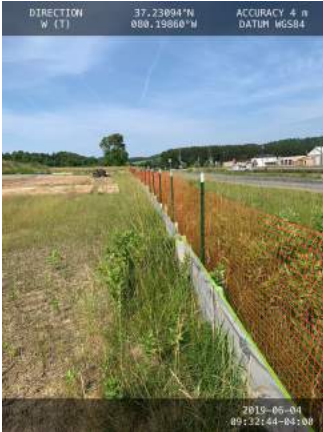
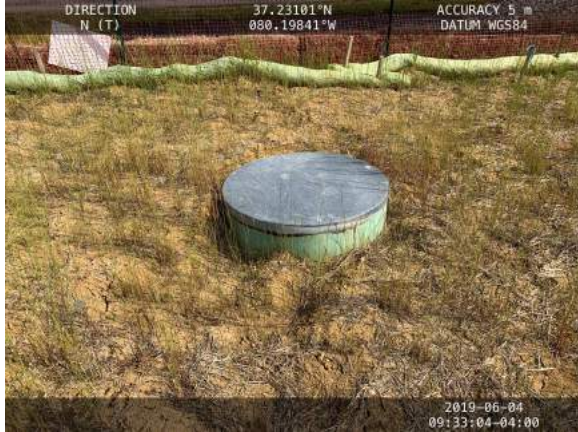
GPS Location	37.23	Field Station#	12447+50	GPS Location	37.23	Field Station#	12445+50
Description	P1 and safety fence perimeter controls. Looking W. See picture for GPS data.			Description	End cap covering well point system. Looking N. See picture for GPS data.

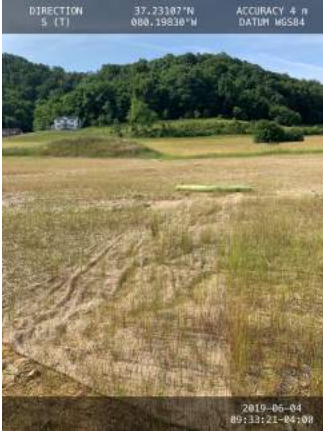
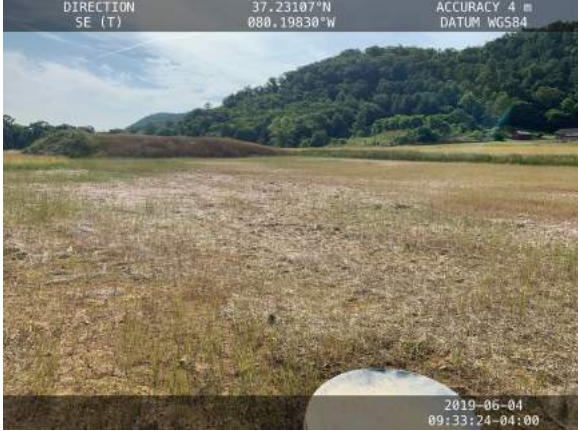
GPS Location	37.23	Field Station#	12445+86	GPS Location	37.23	Field Station#	12445+87
Description	Curlexed drain crossing the ROW. Looking S. See picture for GPS data.			Description	Stabilized ROW. Looking SE. See picture for GPS data.

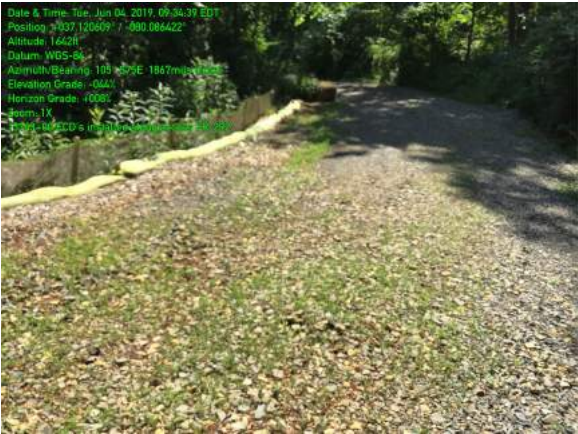
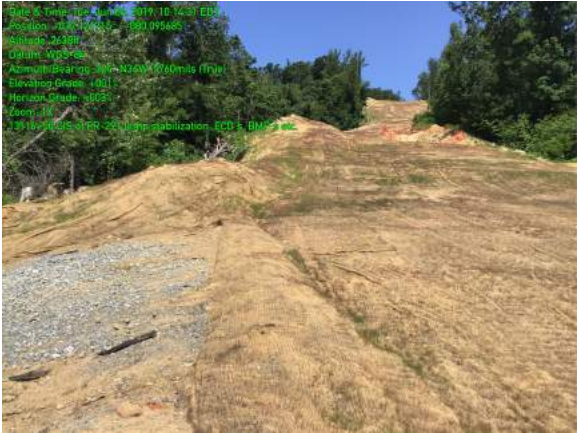
GPS Location		37.12		Field Station#		13143+00		GPS Location		37.12		Field Station#		13116+50	
Description		No issues or impacts observed at FR-292.										Description		ROW has been temporarily stabilized with Curlex and Vegetation. No compliance issues observed throughout the area.

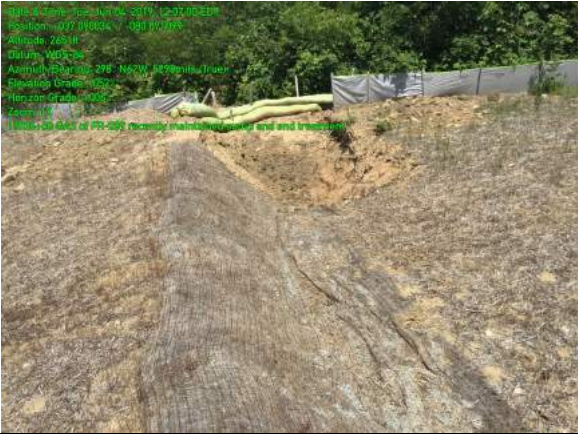
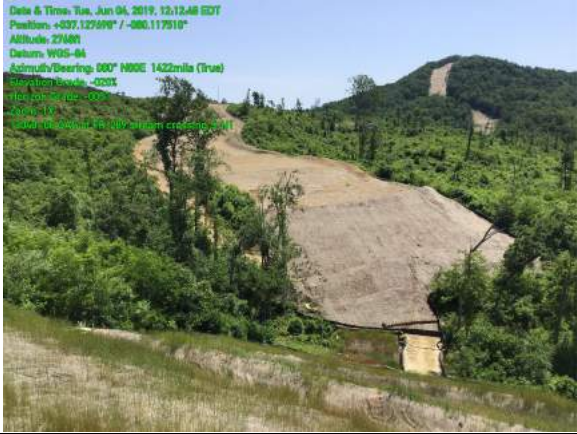
GPS Location		37.12		Field Station#		13036+00		GPS Location		37.12		Field Station#		13040+00	
Description		Environmental crew recently performed maintenance to sump and end treatment.										Description		No issues or impacts found in the area near S-H1.

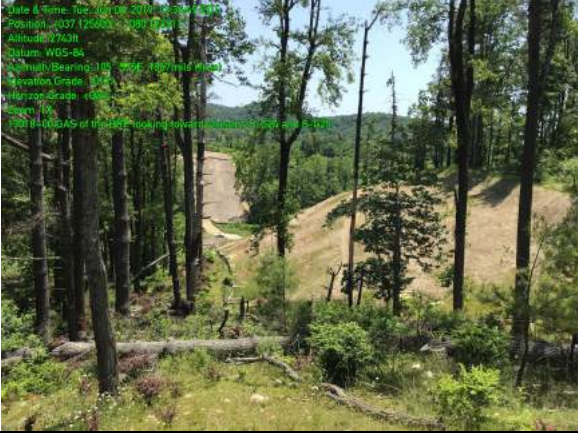
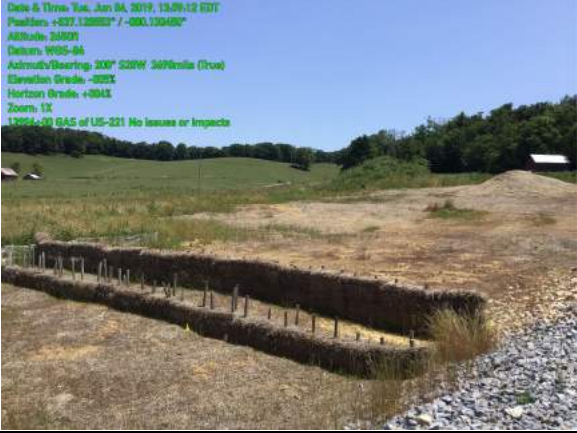
GPS Location		37.12		Field Station#		13018+00		GPS Location		37.12		Field Station#		12994+00	
Description		No issues or impacts found throughout the area today.										Description		ECD's, BMP's and stabilization were adequate. No compliance issues found. Ssss

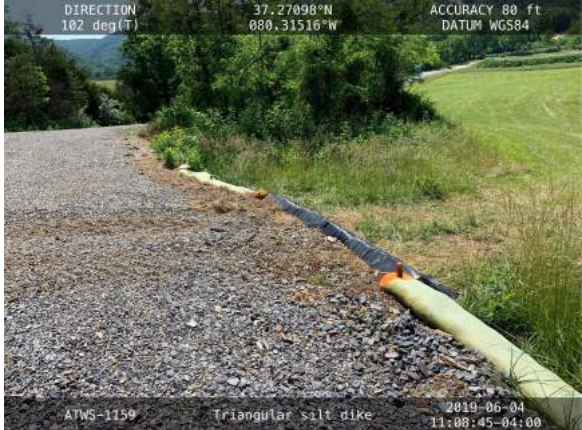
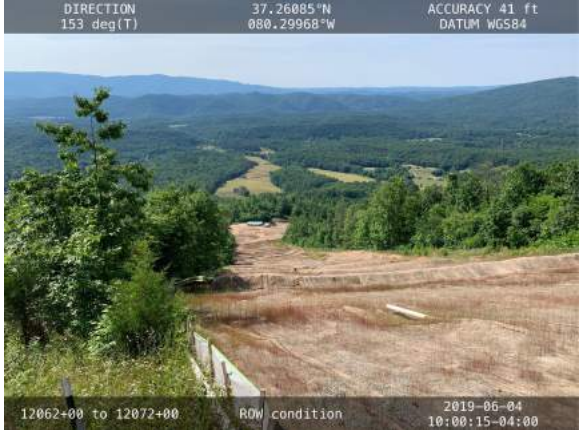
GPS Location	37.27	Field Station#	12007+00	GPS Location	37.27	Field Station#	12062+00
Description	See photo for gps data. Triangular silt dike along ATWS-1159 allows the landowner to access the adjacent field, installed 5/28/19.			Description	See photo for gps data. Photo shows the ROW condition from about 12062+00 to 12072+00.

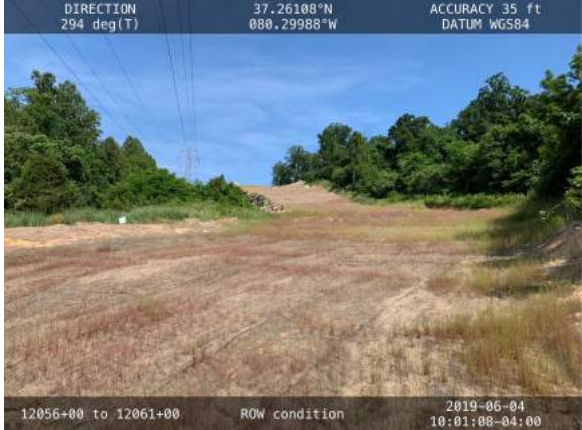
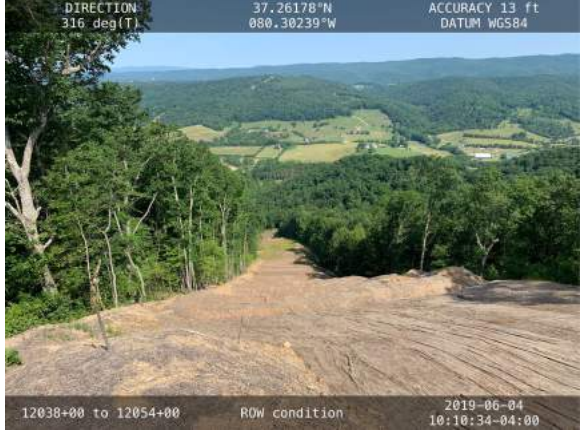
GPS Location	37.27	Field Station#	12061+00	GPS Location	37.27	Field Station#	12054+00
Description	See photo for gps data. Photo shows the ROW condition from about 12056+00 to 12061+00.			Description	See photo for gps data. Photo shows the ROW condition from about 12038+00 to 12054+00.

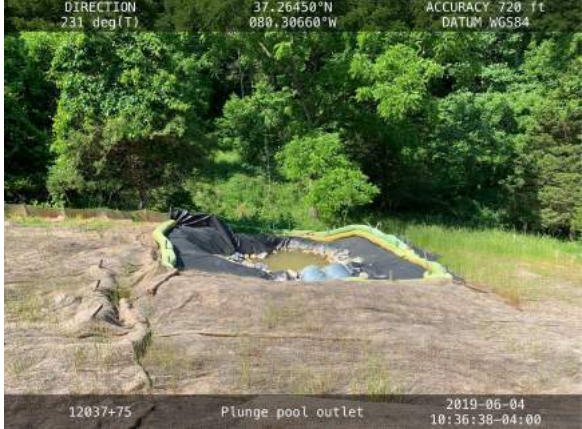
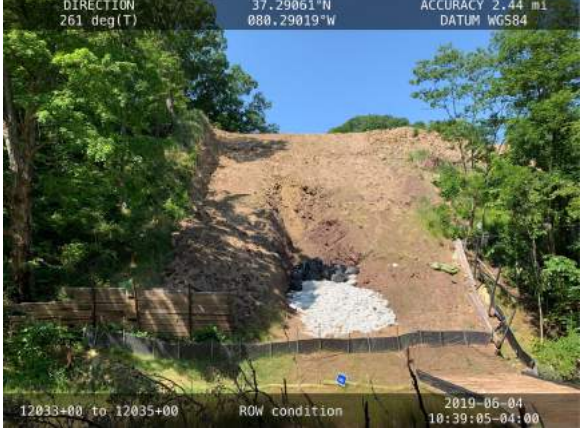
GPS Location	37.27	Field Station#	12037+75	GPS Location	37.27	Field Station#	12035+00
Description	See photo for gps data. Photo shows the plunge pool outlet at about 12037+75.			Description	See photo for gps data. Photo shows the ROW condition from about 12033+00 to 12035+00.

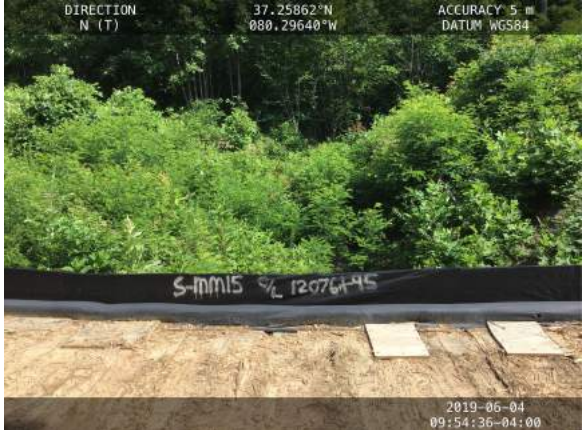
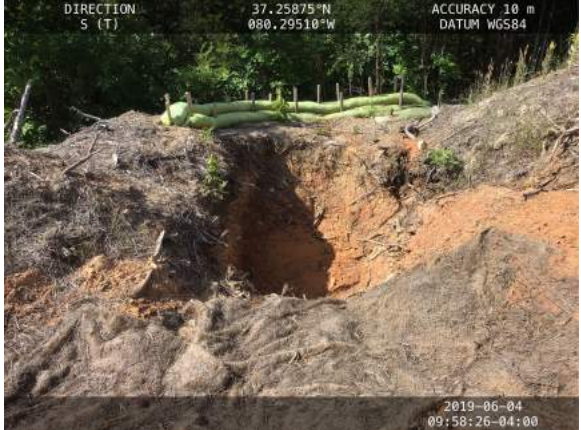
GPS Location	37.25	Field Station#	12076+96	GPS Location	37.25	Field Station#	12082+00
Description	Stream S-MM15, facing north, upstream.			Description	Sumps are in good condition and functioning properly.

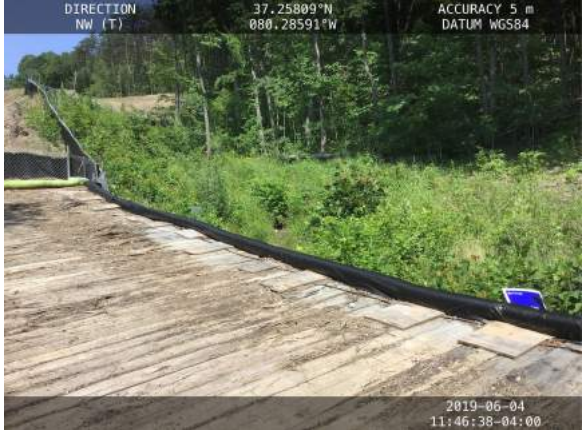
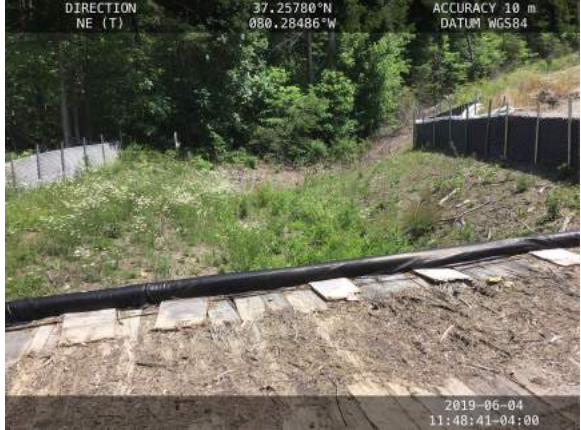
GPS Location	37.25	Field Station#	12108+41	GPS Location	37.25	Field Station#	12112+13
Description	Stream S-F15, facing northwest, upstream.			Description	Stream S-F16A/B, facing northeast, upstream.

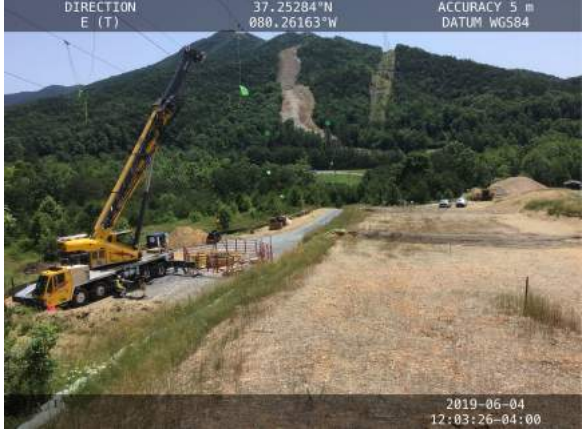
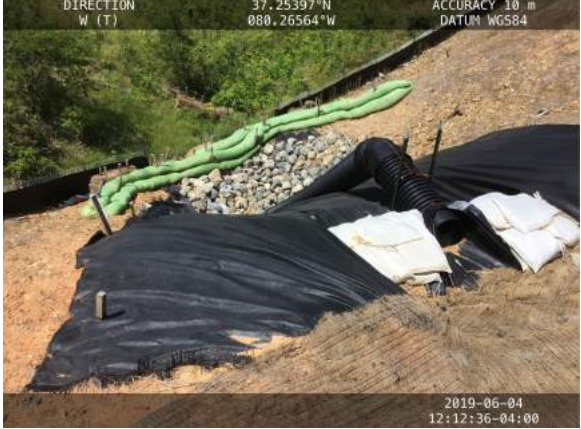
GPS Location	37.25	Field Station#	12185+00	GPS Location	37.25	Field Station#	12170+00
Description	AEP contractor preparing to pour a cement pier next to the MVP ROW.			Description	Fill slope drain in satisfactory condition and performing as needed.

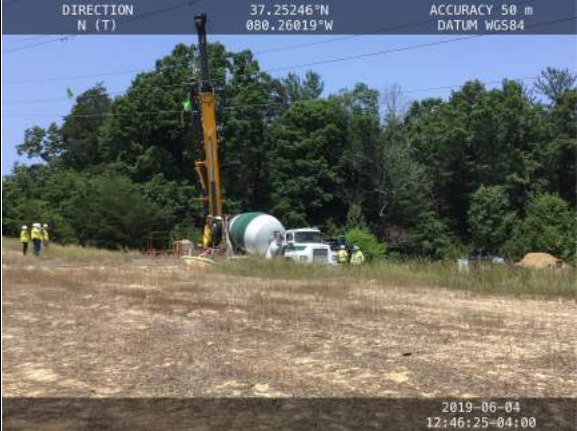
<p>Insert image here</p>			
<b>GPS Location</b>	37.25	<b>Field Station#</b>	12185+00	<b>GPS Location</b>	
<b>Description</b>	The AEP contractor poured the concrete pier that was bored for yesterday.			<b>Description</b>	
<p>Insert image here</p>		<p>Insert image here</p>			
<b>GPS Location</b>		<b>Field Station#</b>		<b>GPS Location</b>	
<b>Description</b>				<b>Description</b>	
<p>Insert image here</p>		<p>Insert image here</p>			
<b>GPS Location</b>		<b>Field Station#</b>		<b>GPS Location</b>	
<b>Description</b>				<b>Description</b>	
<p>Insert image here</p>		<p>Insert image here</p>			
<b>GPS Location</b>		<b>Field Station#</b>		<b>GPS Location</b>	
<b>Description</b>				<b>Description</b>

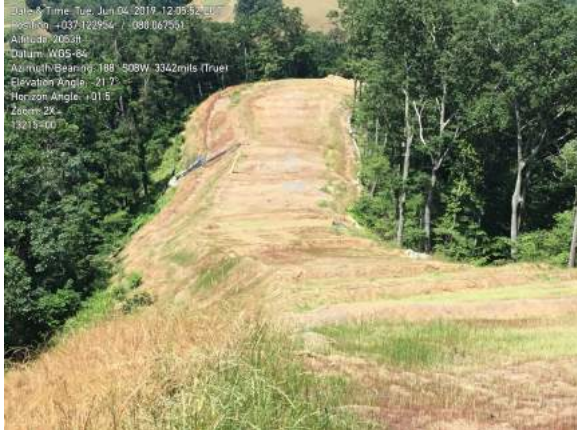
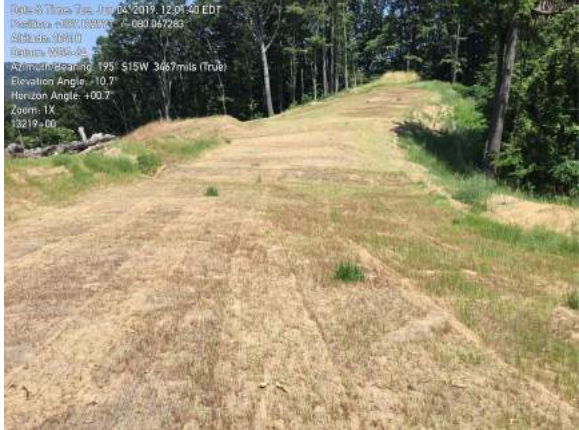
GPS Location	37.32	Field Station#	13216+00	GPS Location	37.32	Field Station#	13219+00
Description	Please see photo for accurate coordinates. ROW, soil piles stabilized, waterbars and end treatments functioning acceptably.			Description	Please see photo for accurate coordinates. ROW, temporary vegetative cover acceptable, no environmental issues noted.

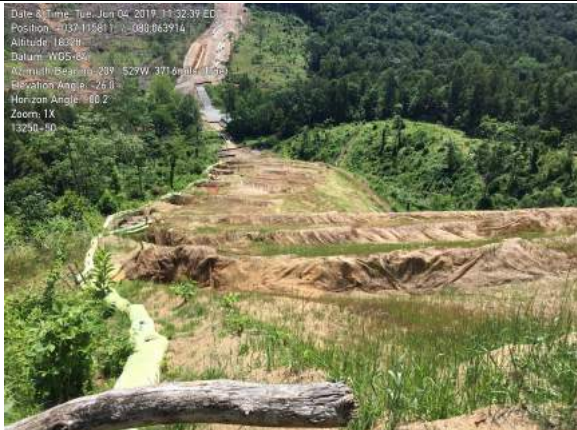
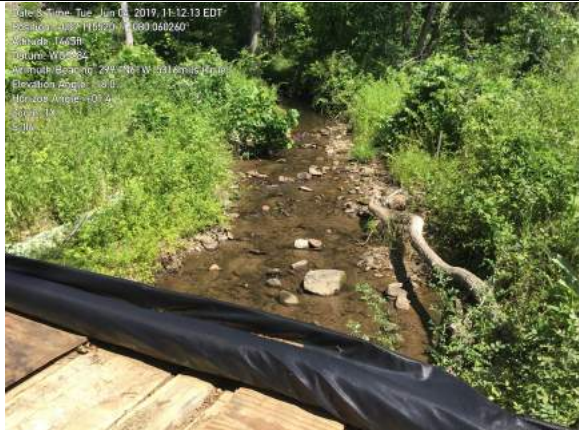
GPS Location	37.32	Field Station#	13250+50	GPS Location	37.32	Field Station#	13260+60
Description	Please see photo for accurate coordinates. ROW, waterbars and end treatments functioning acceptably.			Description	Please see photo for accurate coordinates. S-II4, looking upstream at resource crossing, no environmental issues noted.

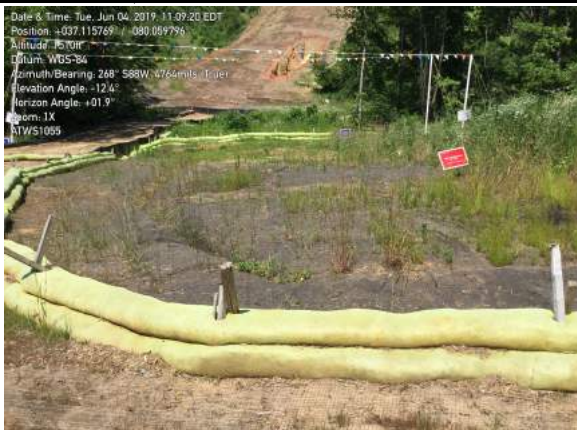
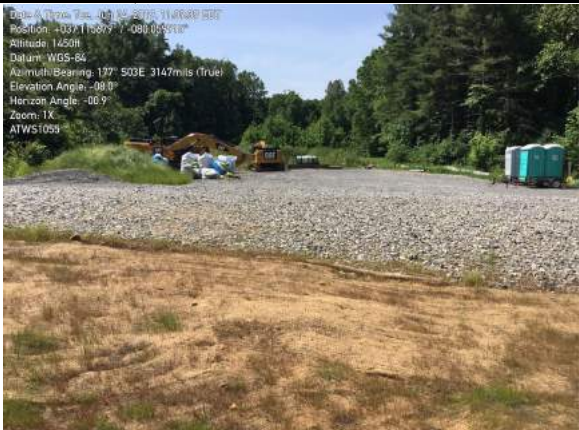
GPS Location	37.32	Field Station#	13262+00	GPS Location	37.32	Field Station#	13262+00
Description	Please see photo for accurate coordinates. ATWS-1055, clean water conveyance mostly dry, ECDs functioning acceptably.			Description	Please see photo for accurate coordinates. ATWS-1055, topsoil stable, perimeter controls maintained, no environmental issues present.

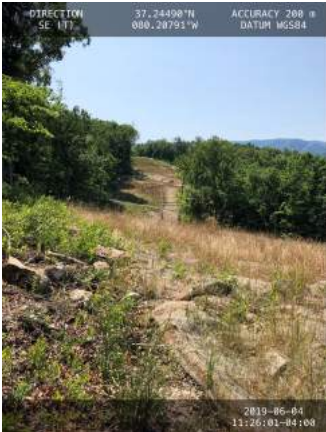
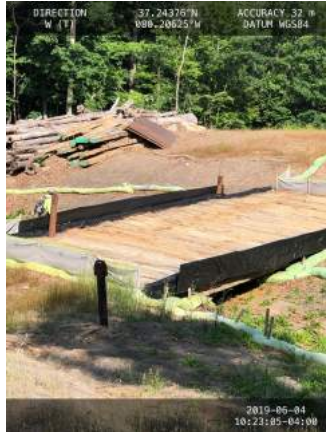
GPS Location	37.23	Field Station#	12378+84	GPS Location	37.23	Field Station#	12383+00
Description	Stabilized ROW. Looking SE. See picture for GPS data.			Description	Bridge crossing the clear water crossing. Looking W. See picture for GPS data.

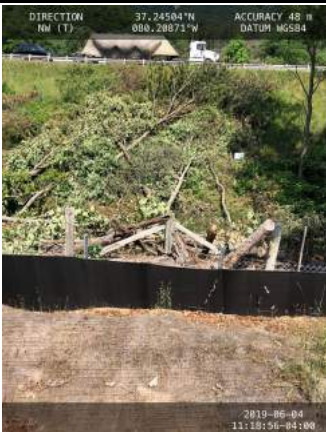
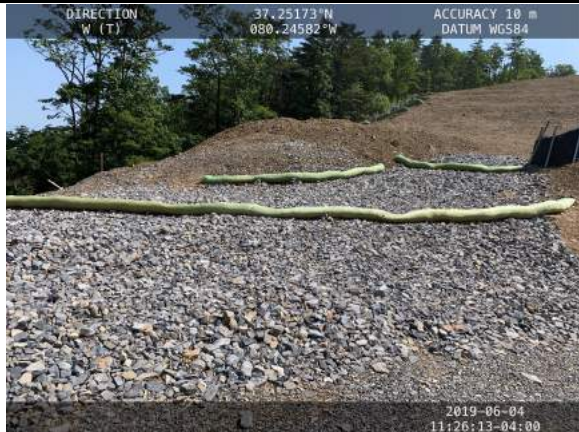
GPS Location	37.23	Field Station#	12373+76	GPS Location	37.23	Field Station#	12234+77
Description	Felled trees on the GAS of I-81. Looking NE. See picture for GPS data.			Description	RCE. Looking W. See picture for GPS data.

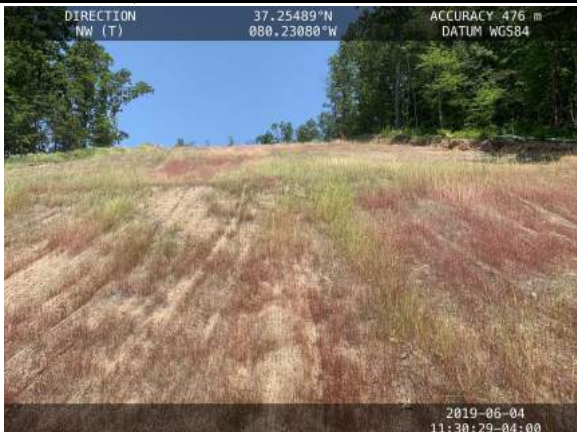
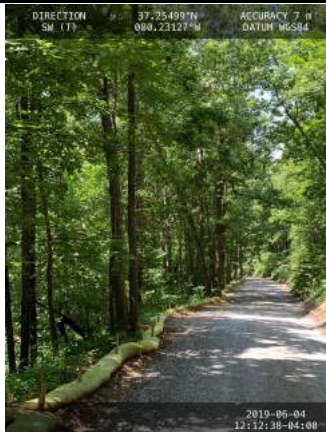
GPS Location	37.23	Field Station#	12283+00	GPS Location	37.23	Field Station#	12234+00
Description	Stabilized hill side. Looking NW. See picture for GPS data.			Description	CFS perimeter control along access road MVP-MN-276.03
