Visual Site Inspection Report

Project Name	H-600 Pipeline Spread H	AFE	124300138	Spread	H-600 Pipeline Spread H
Contractor	Precision			Report #	20377
Inspector	Logan Box			Date/Time	7/16/2019 12:54 PM
Permit #	TBD	Inspection Type	VA SWPP	Station Begin	13415+55
State	VA	Inspection Area	Partial	Station End	13670+00
County	Franklin	Ground	Dry	Temperature (°F)	86.00
Municipality	N/A	Weather	Cloudy	Rain Gauge (in)	0.00
				Rain Accumulation Time (days)	0.00

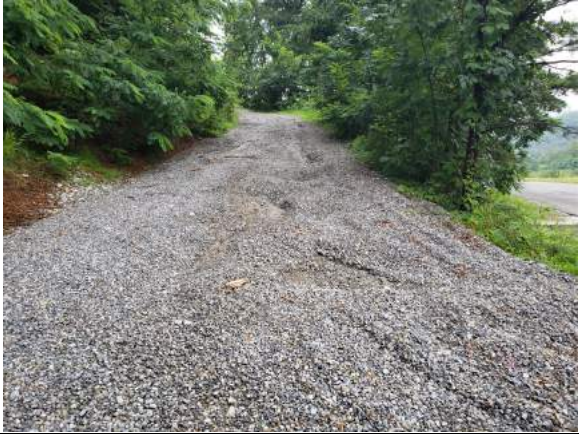
GPS Location	37.02	Field Station#	13437+47	GPS Location	37.03
Field Station#	13496+98	Pic 1 Description		Pic 2 Description	
Access rd after maintenance done to repair wash outs		Gravel to be added to the RCE

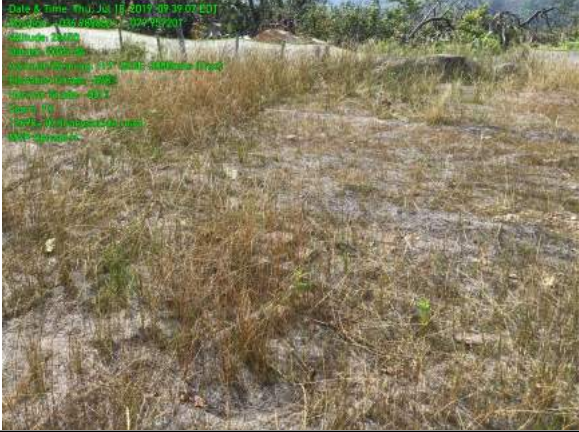
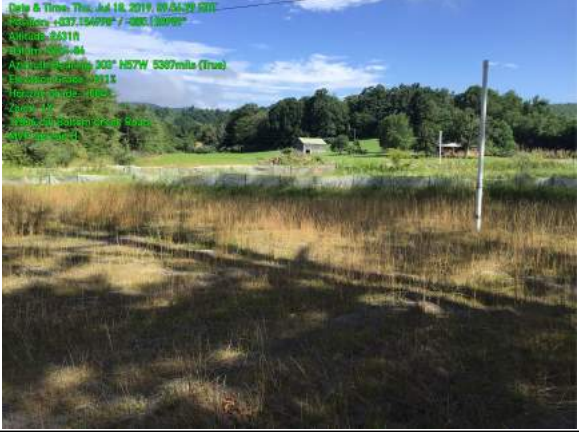
GPS Location	37.19	Field Station#	12690+30	GPS Location	37.15
Pic 1 Description	Honeysuckle Road remains well stabilized with vegetation on both sides of the road crossing. No issues or impacts were found in the area.		Pic 2 Description	At Bottom Creek Road no issues or impacts were found.

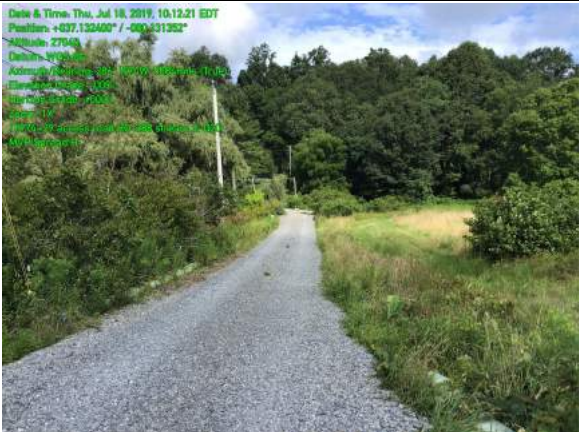
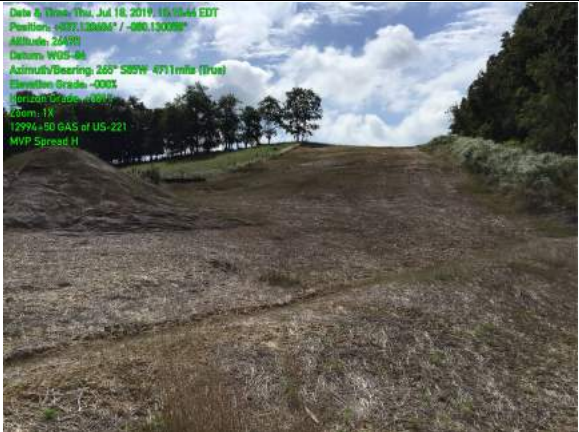
GPS Location	37.13	Field Station#	12974+29	GPS Location	37.12
Pic 3 Description	Access road RO-288 remains in good condition.		Pic 4 Description	The GAS of US-221 had no issues or impacts to report.

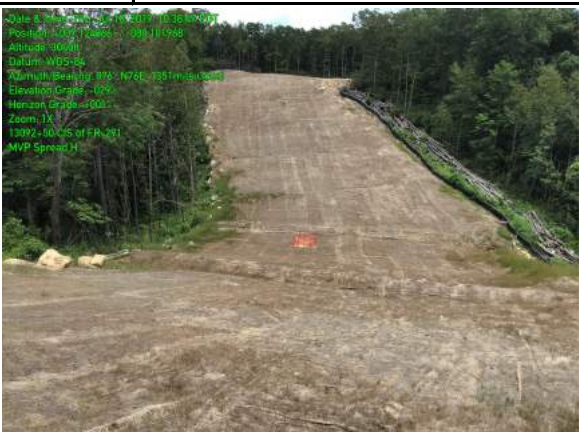
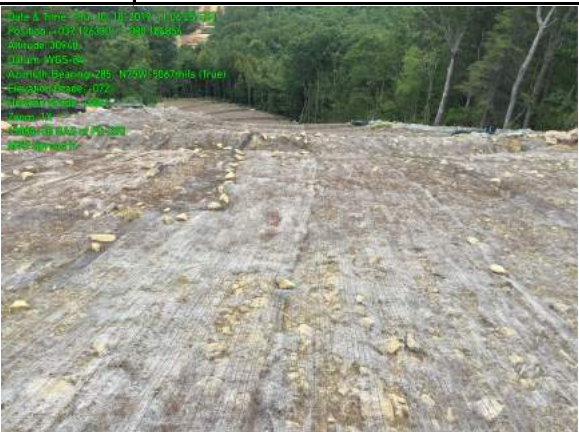
GPS Location	37.12	Field Station#	13092+50	GPS Location	37.12
Pic 5 Description	ROW is well stabilized and no issues observed.		Pic 6 Description	Very rocky section of ROW remains stabilized with Curlex.

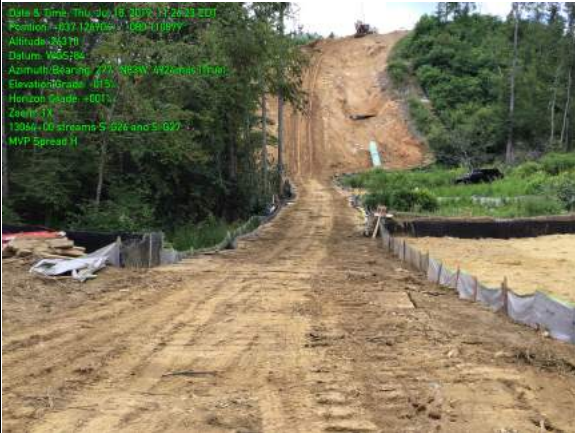
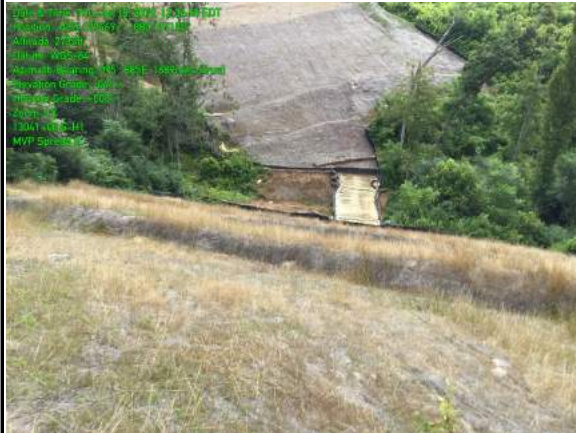
GPS Location	37.12	Field Station#	13064+00	GPS Location	37.12	Field Station#	13041+00
Pic 7 Description	There were no issues in the area at the time.			Pic 8 Description	No in stream impacts found at S-H1.

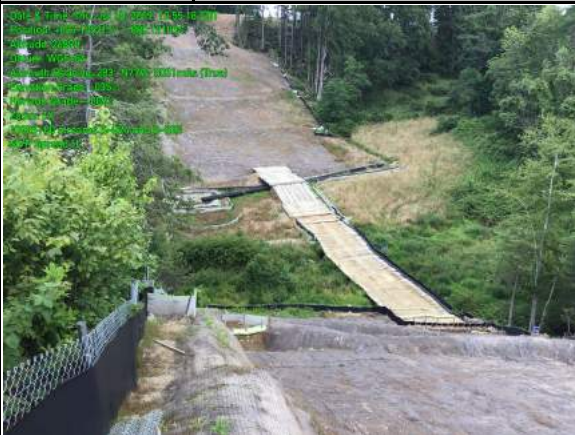
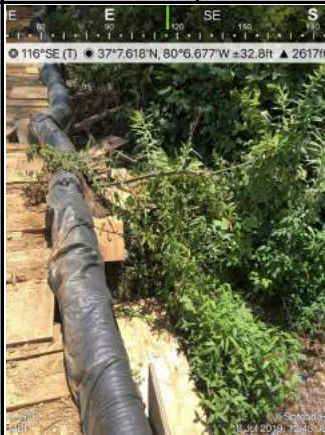
image here			
GPS Location	37.12	Field Station#	12025+00	GPS Location	37.12	Field Station#	13062+00
Pic 9 Description	No issues or impacts observed throughout the area near streams S-G24 and S-G25.			Pic 10 Description	Sideboards falling off of bridge.

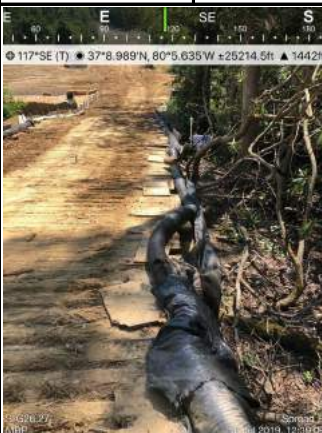
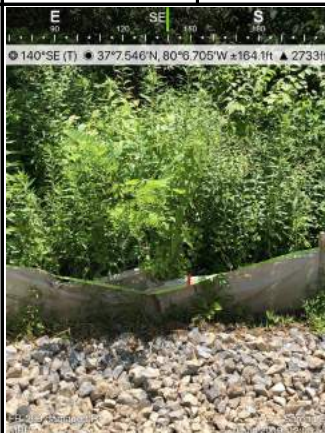
image here			
GPS Location	37.12	Field Station#	13062+00	GPS Location	37.12	Field Station#	13061+44
Pic 11 Description	Geotech fabric has come loose along edge of mat bridge.			Pic 12 Description	P1 silt fence damaged and needs repair.

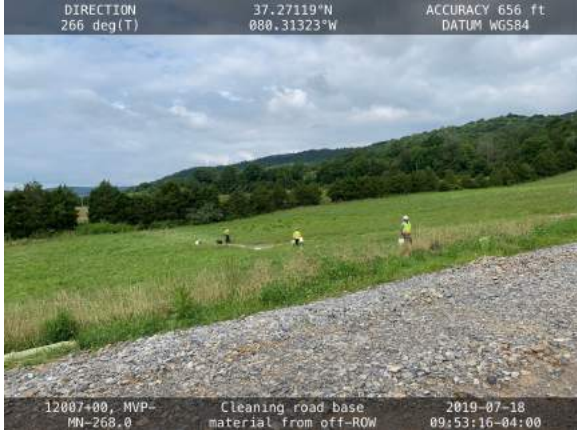
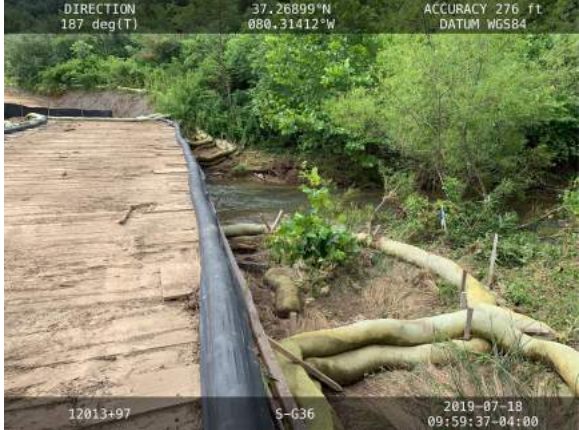
GPS Location	37.26	Field Station#	12007+00	GPS Location	37.26	Field Station#	12013+97
Pic 1 Description	See photo for gps data. Photo shows the contractor cleaning up the road base material adjacent to MVP-MN-268.0.			Pic 2 Description	See photo for gps data. Photo shows the bridge and ECDs along the downstream side of the bridge over SG36.

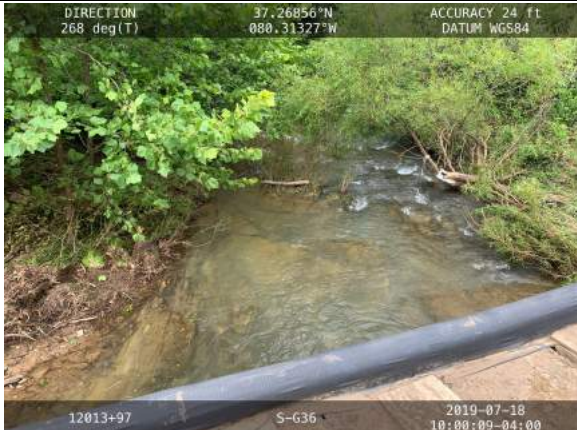
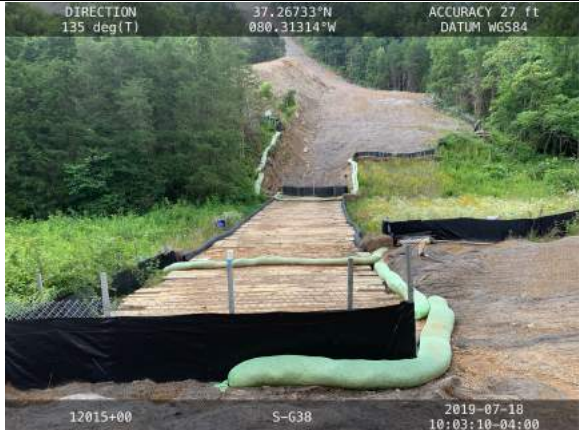
GPS Location	37.26	Field Station#	12013+97	GPS Location	37.26	Field Station#	12015+00
Pic 3 Description	See photo for gps data. Photo shows stream S-G36 downstream from the bridge on MVP-MN-268.01.			Pic 4 Description	See photo for gps data. Photo shows the bridge over stream S-G38.

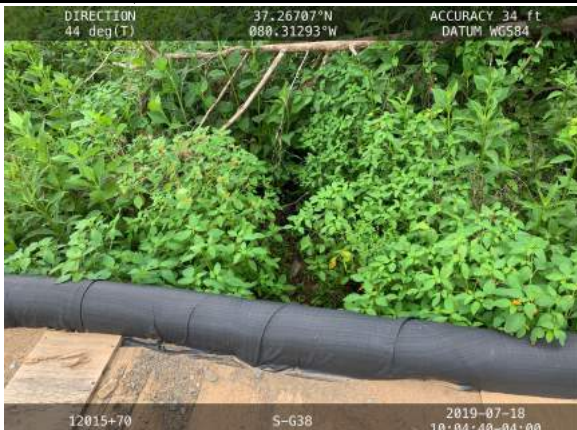
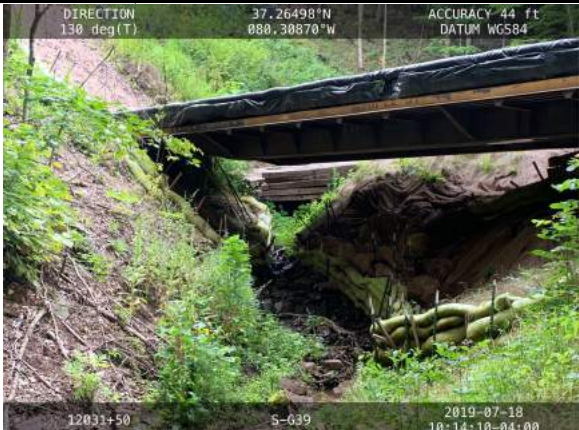
GPS Location	37.26	Field Station#	12015+70	GPS Location	37.26	Field Station#	12031+51
Pic 5 Description	See photo for gps data. Photo shows stream S-G38 downstream from the ROW.			Pic 6 Description	See photo for gps data. Photo shows stream S-G39.

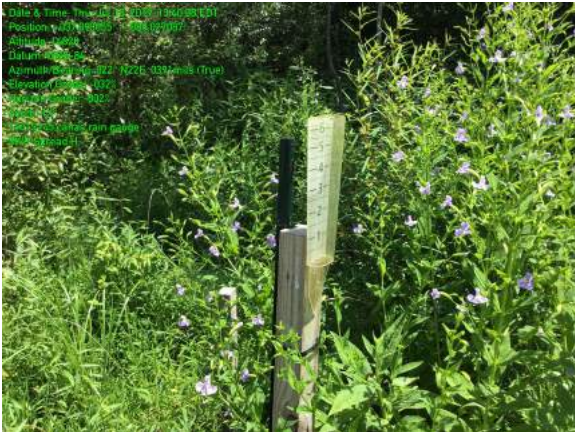
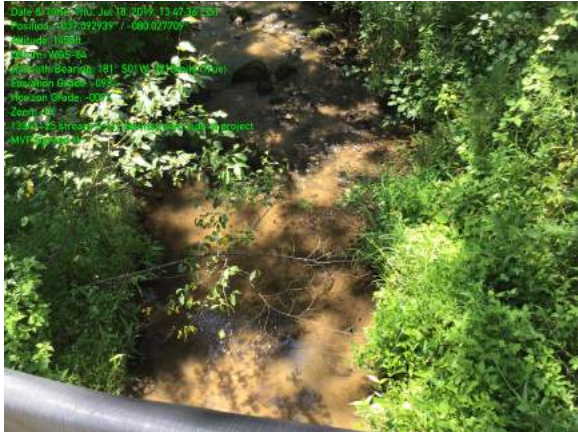
GPS Location	37.09	Field Station#	13415+45	GPS Location	37.09	Field Station#	13341+25
Pic 1 Description	0.0 total precipitation at Cahas			Pic 2 Description	No signs of sediment impact from project in stream.

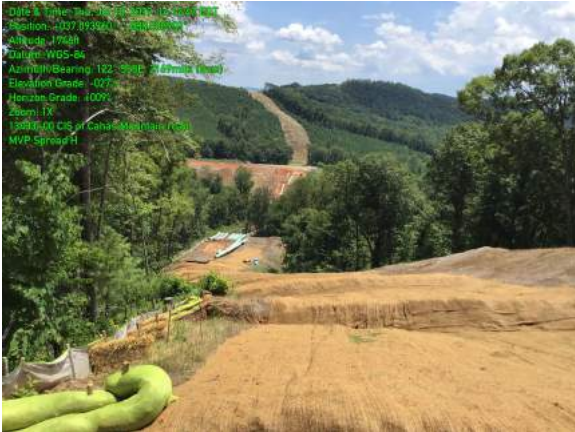
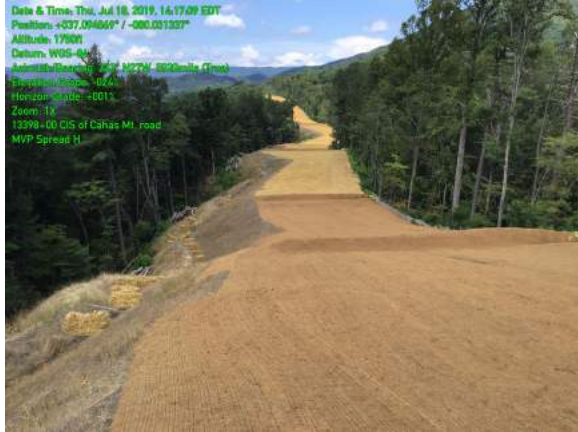
GPS Location	37.09	Field Station#	13403+00	GPS Location	37.09	Field Station#	13398+00
Pic 3 Description	Curlex reapplied in the areas that were regraded or the travel lane for equipment.			Pic 4 Description	Hay bale checks installed and additional bales in areas where needed.

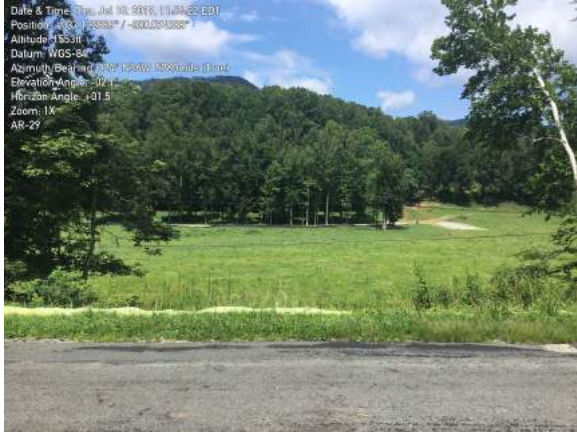
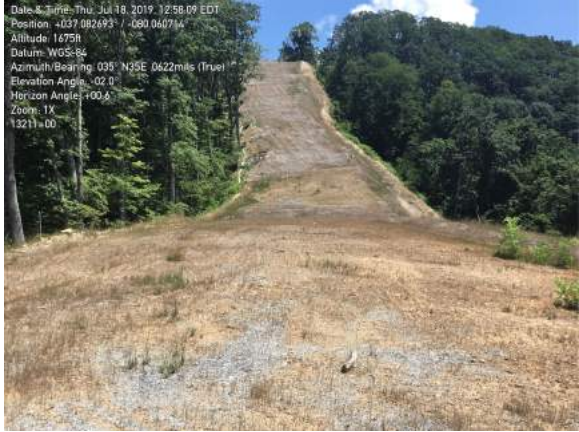
GPS Location	37.11	Field Station#	13197+47	GPS Location	37.11	Field Station#	13211+00
Pic 1 Description	Please see photo for accurate coordinates. Dillon's Mill, looking towards MVP-MLV-AR-29, ECDs functioning acceptably.			Pic 2 Description	Please see photo for accurate coordinates. ROW, vegetation dry, waterbars and sumps functioning acceptably.

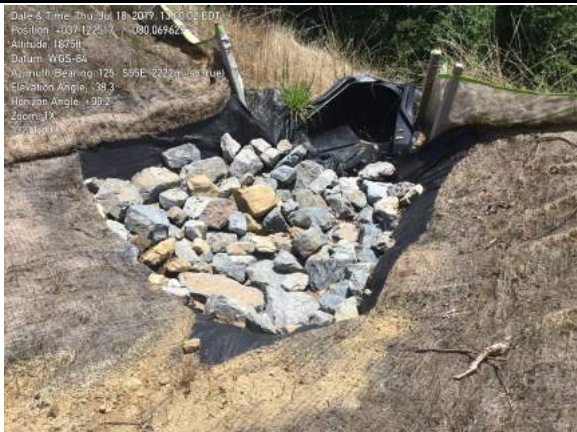
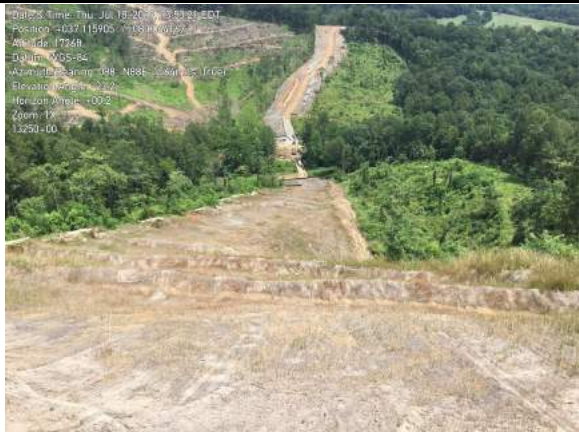
GPS Location	37.11	Field Station#	13211+50	GPS Location	37.11	Field Station#	13250+00
Pic 3 Description	Please see photo for accurate coordinates. ROW, inlet protection for side slope drain clean and pipe clear of sediment and debris.			Pic 4 Description	Please see photo for accurate coordinates. ROW, minor erosion noted in waterbar channel, outlets functioning acceptably.

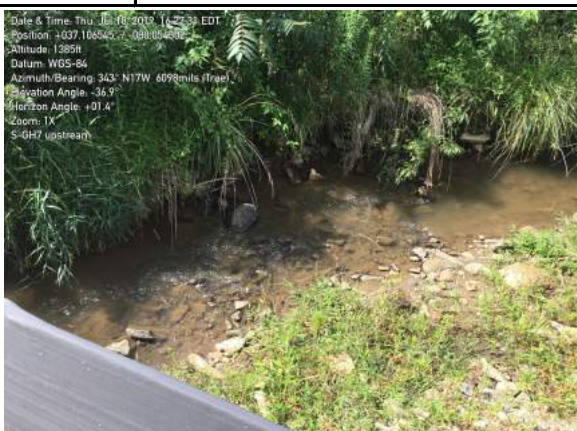
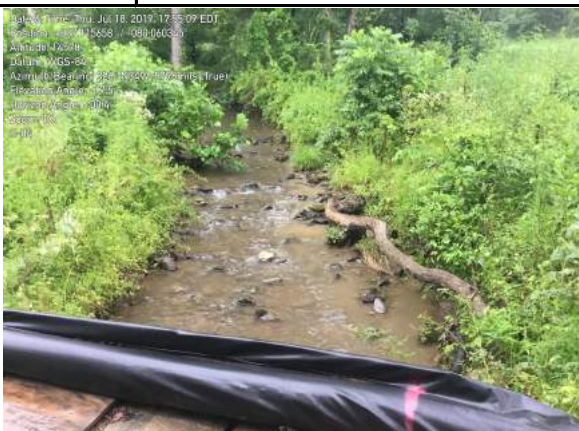
GPS Location	37.11	Field Station#	13309+09	GPS Location	37.11	Field Station#	13260+70

Pic 5 Description	Please see photo for accurate coordinates. S-GH7, looking upstream of equipment bridge, water flowing clear, no environmental issues.			Pic 6 Description	Please see photo for accurate coordinates. S-II4, looking upstream of bridge, sediment laden water from off ROW channel noted during rain.

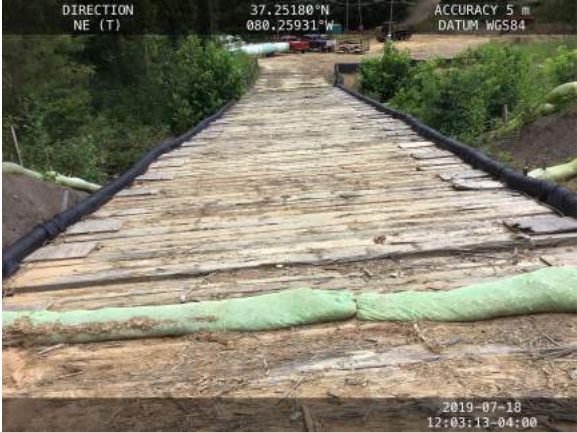
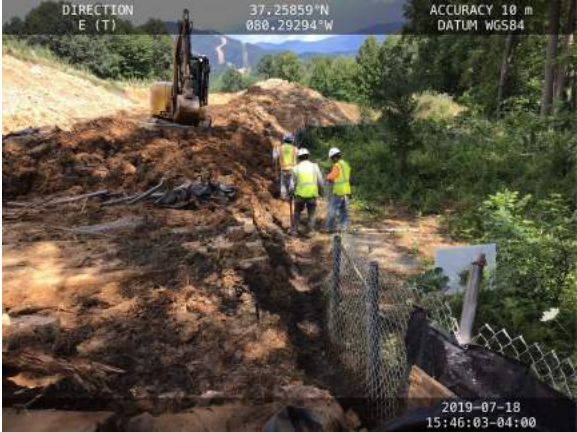
GPS Location 37.25		Field Station# 12192+50		GPS Location 37.25	
Field Station# 12192+50		Field Station# 12187+50		Field Station# 12187+50	
Pic 13 Description		Stream S-C21, Bradshaw Creek, facing northeast.		Pic 14 Description	
Pic 14 Description		SSF was cleaned out and repaired on the going away side of the bridge at stream S-MM14 per PL item.		Pic 14 Description

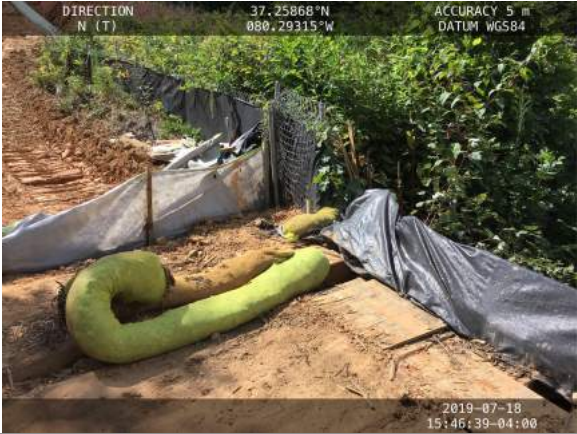
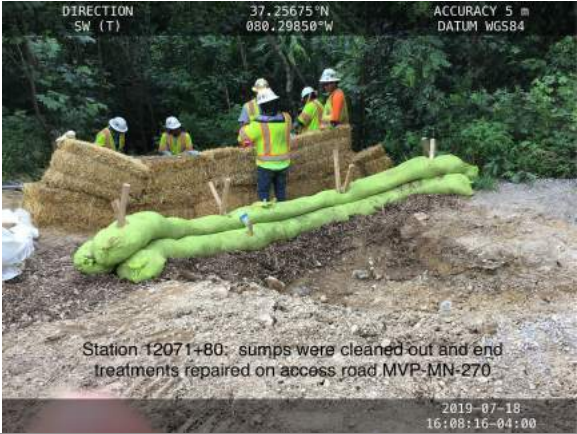
GPS Location 37.25		Field Station# 12086+50		GPS Location 37.23	
Field Station# 12086+50		Field Station# 12071+80		Field Station# 12071+80	
Pic 15 Description		CFS was used to fill in gap between SSF and bridge and holes in CFS wattle were fixed per PL item.		Pic 16 Description	
Pic 16 Description		Sumps were cleaned out and end treatments repaired on access road MVP-MN-270 per MBP action item.		Pic 16 Description

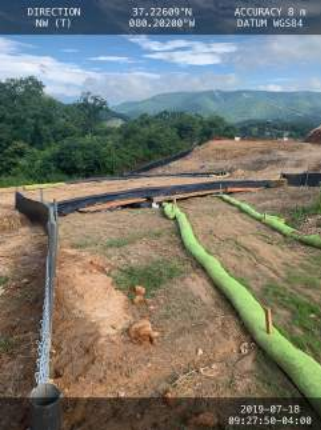
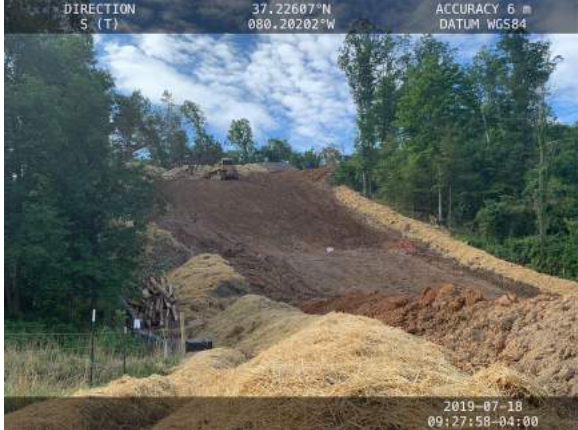
GPS Location	37.23	Field Station#	12481+00	GPS Location	37.23	Field Station#	12484+50
Pic 1 Description	Clear water crossing. Looking NW. See picture for GPS data.			Pic 2 Description	Bull dozer grading ROW. Looking S. See picture for GPS data.

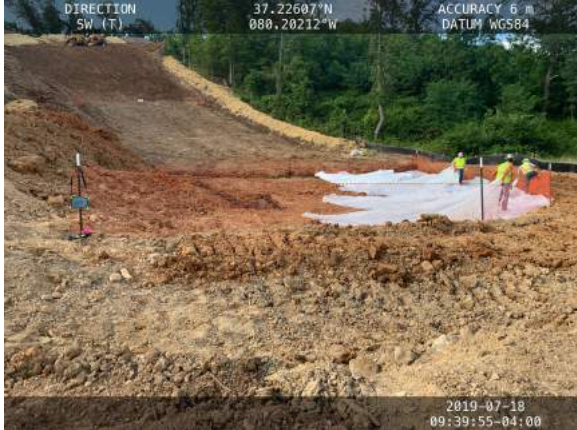
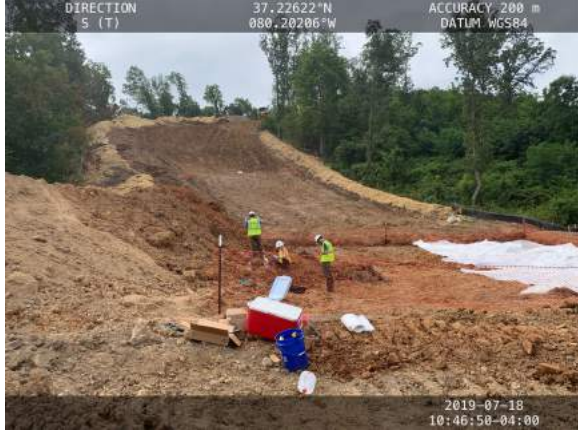
GPS Location	37.23	Field Station#	12482+04	GPS Location	37.23	Field Station#	12482+04
Pic 3 Description	Environmental crew removing plastic for the soil samples to be taken. Looking SW. See picture for GPS data.			Pic 4 Description	Soil experts taking samples of the contaminated area. Looking S. See picture for GPS data.

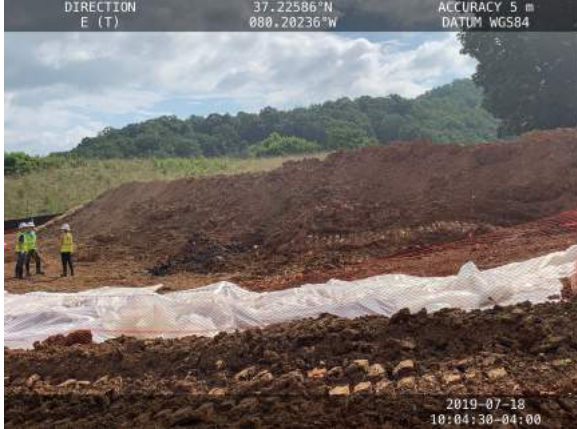
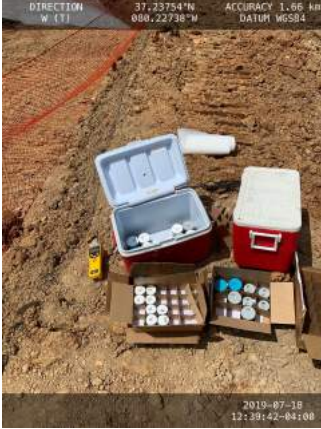
GPS Location	37.23	Field Station#	12482+04	GPS Location	37.23	Field Station#	12482+04
Pic 5 Description	Grid for soil sampling marked by pink flagging. Looking E. See picture for GPS.			Pic 6 Description	Solid samples after being collected. Looking W. See picture for GPS data.

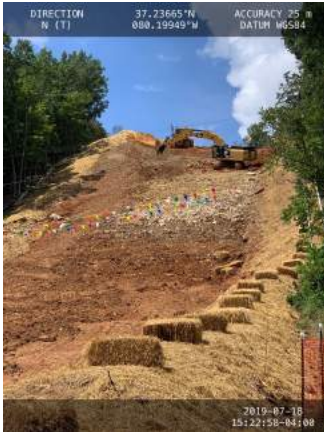
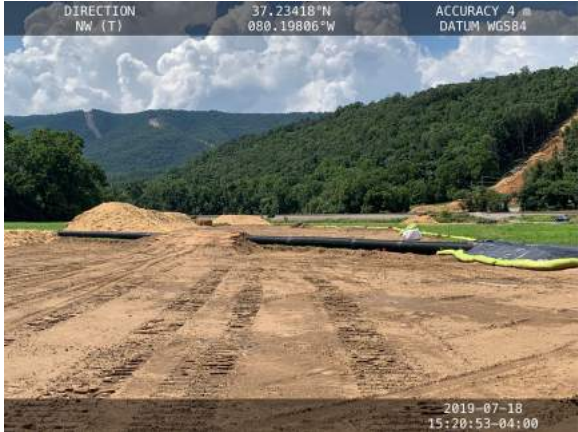
GPS Location	37.23	Field Station#	12420+00	GPS Location	37.23	Field Station#	12430+00
Pic 1 Description	Ditching crew digging ditch on steep slope. Looking N. See picture for GPS data.			Pic 2 Description	Clear water drain pipe. Looking NW. See picture for GPS data.

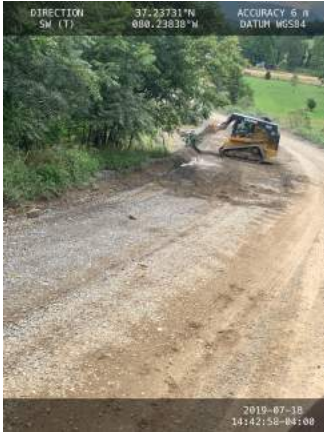
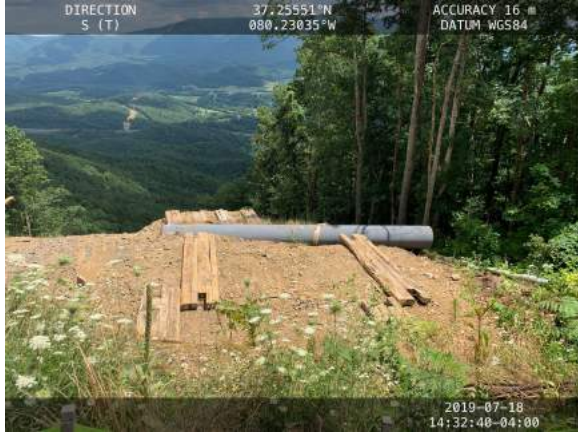
GPS Location	37.23	Field Station#	12234+50	GPS Location	37.23	Field Station#	12284+70
Pic 3 Description	Skid steer performing maintenance to the access road MVP-MN-276.03			Pic 4 Description	Materials staged in staging area. Looking S. See picture for GPS data.

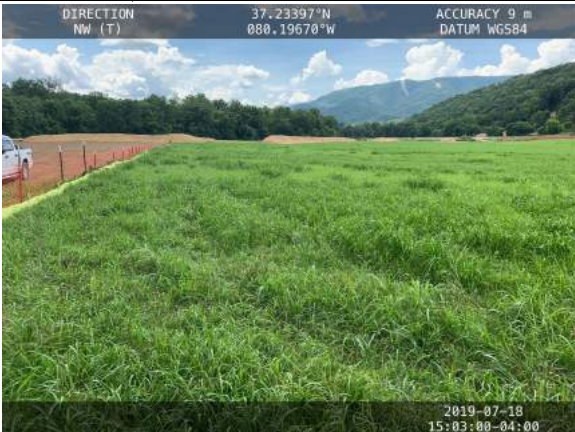
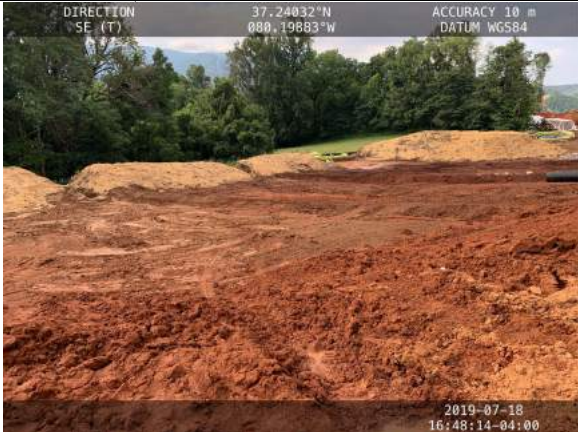
GPS Location	37.23	Field Station#	12433+50	GPS Location	37.13	Field Station#	12409+04
Pic 5 Description	Desired location of dewatering structure. Looking NW. See picture for GPS data.			Pic 6 Description	Water bars exiting through top soil piles. Looking SE. See picture for GPS.
