## Visual Site Inspection Report

<b>Project Name</b>	H-600 Pipeline Spread H	<b>AFE</b>	124300138	<b>Spread</b>	H-600 Pipeline Spread H
<b>Contractor</b>	Precision			<b>Report #</b>	19595
<b>Inspector</b>	Pat Davis			<b>Date/Time</b>	7/2/2019 6:14 AM
<b>Permit #</b>	TBD	<b>Inspection Type</b>	VA SWPP	<b>Station Begin</b>	+0
<b>State</b>	VA	<b>Inspection Area</b>	Partial	<b>Station End</b>	+0
<b>County</b>	Montgomery	<b>Ground</b>	Dry	<b>Temperature (°F)</b>	93.00
<b>Municipality</b>	N/A	<b>Weather</b>	Sunny	<b>Rain Gauge (in)</b>	0.00
				<b>Rain Accumulation Time (days)</b>	0.00

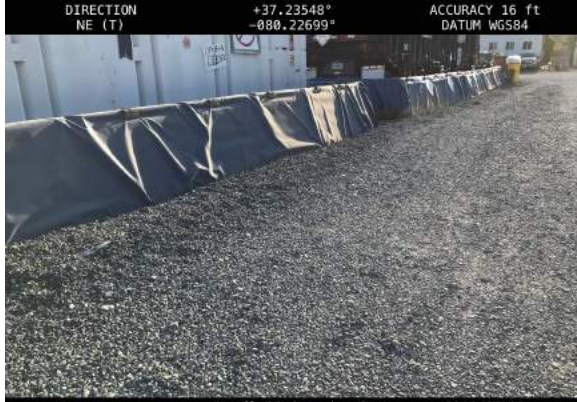
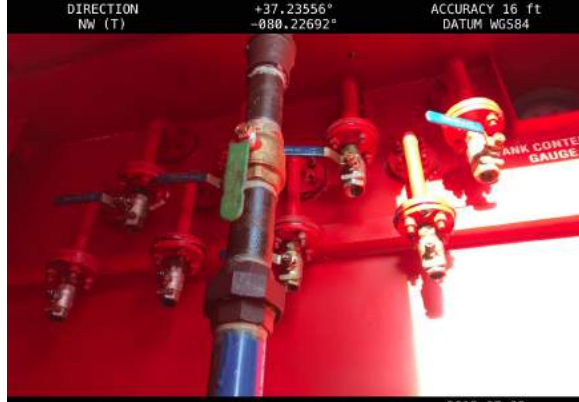
GPS Location	37.23	Field Station#	+0		
Description	MVP-PY-006_070219 no fluid deposits on the south side of the bulk fuel tanks. Looking NE. See photo for gps data.

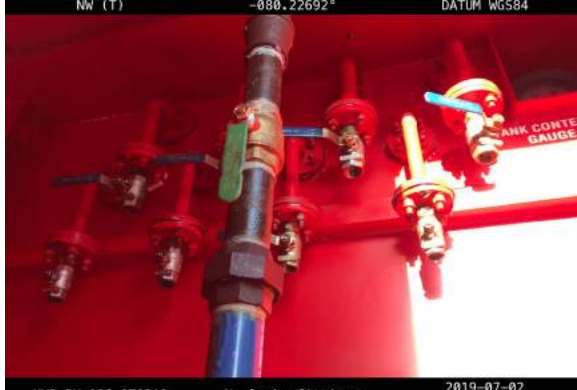
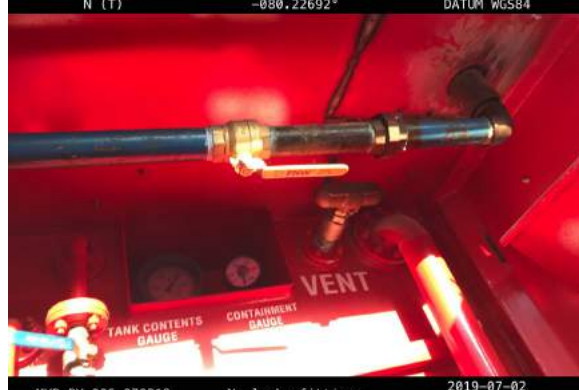
GPS Location	37.23	Field Station#	+0		
Description	MVP-PY-006_070219 Off road Fuel tank storage. No leaky fittings. Looking NW. See photo for gps data.

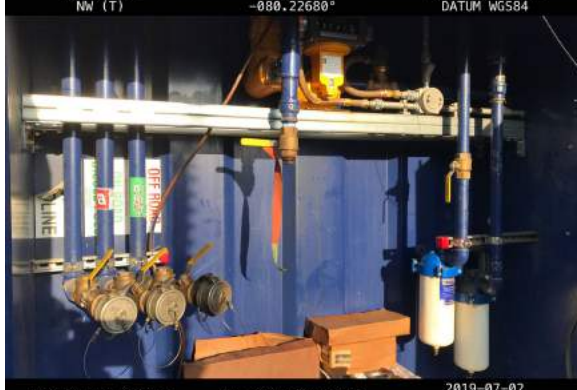
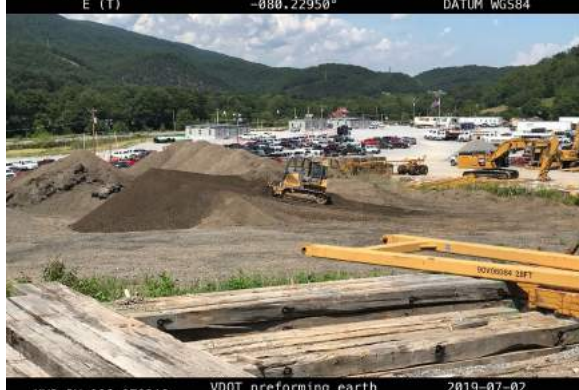
GPS Location	37.23	Field Station#	+0		
Description	MVP-PY-006_070219 Bulk Fuel tanks no leaky fittings. Looking NW. See photo for gps data.				
GPS Location	37.23	Field Station#	+0		
Description	MVP-PY-006_070219 VDOT preforming earth disturbance activity west of our yard. Looking E. See photo for gps data.

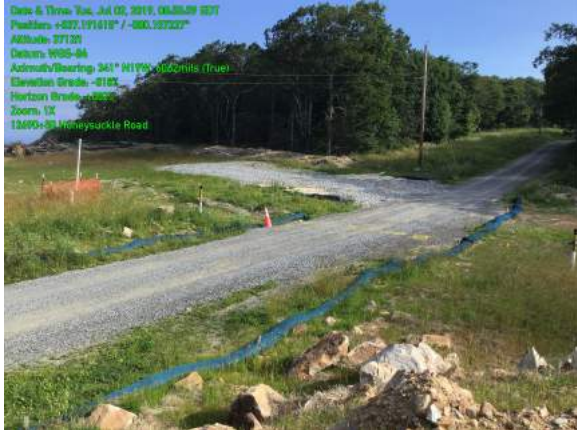
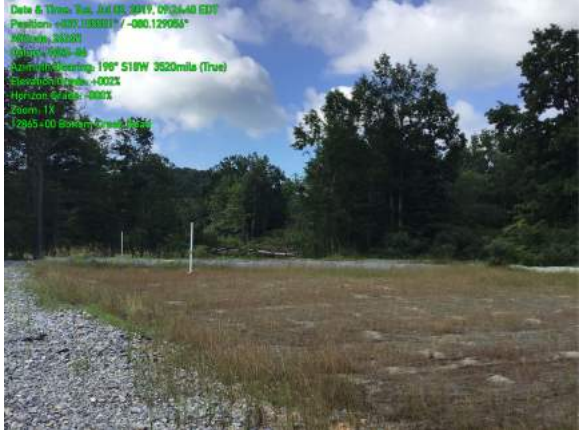
GPS Location	37.19	Field Station#	12690+50	GPS Location	37.15	Field Station#	12865+00
Description	No issues or impacts observed near Honeysuckle Road.			Description	No issues or impacts found throughout the area near Bottom Creek Road.

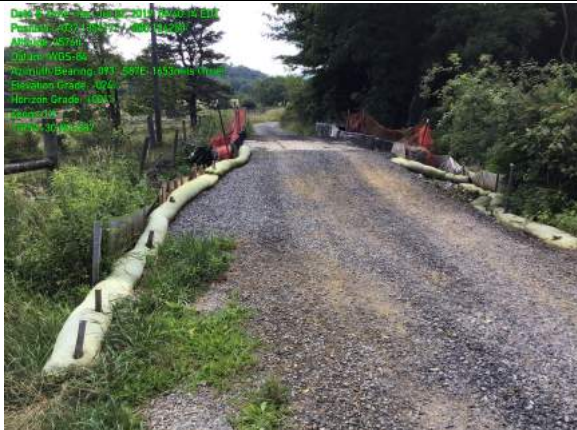
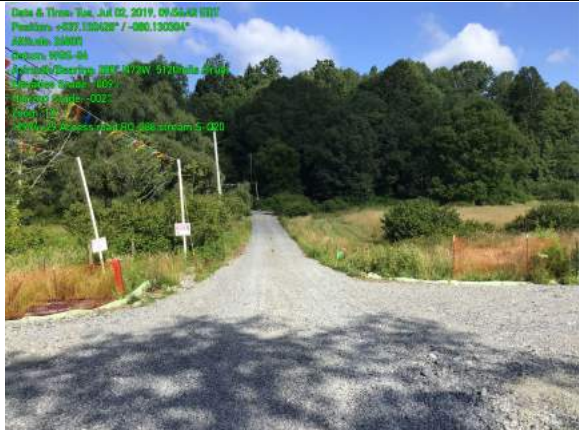
GPS Location	37.13	Field Station#	12957+30	GPS Location	37.12	Field Station#	12974+29
Description	No observed issues or impacts along the access road RO-287 or streams.			Description	No deficiencies or maintenance issues found in the area near RO-288

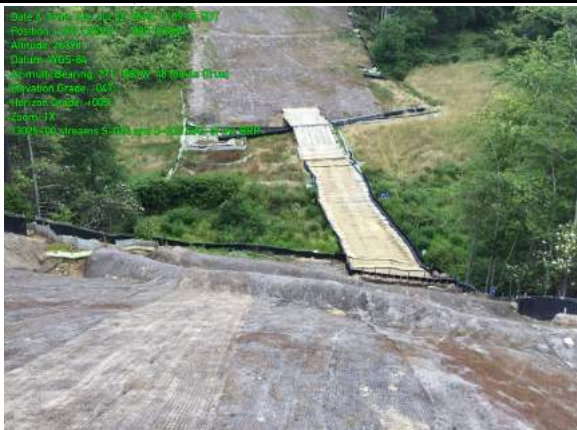
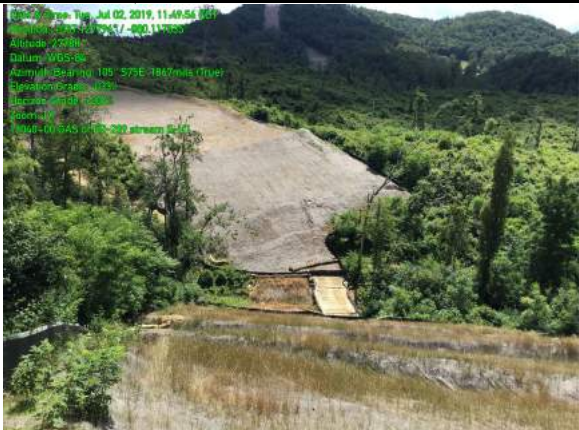
GPS Location	37.12	Field Station#	13025+00	GPS Location	37.12	Field Station#	13040+00
Description	ROW stabilized, ECD's sufficient, no impacts observed in the area. S-G24 and S-G25.			Description	No observed issues or impacts off ROW or in stream. ROW stabilized well with vegetation, curlex, straw mulch, and EarthGuard.

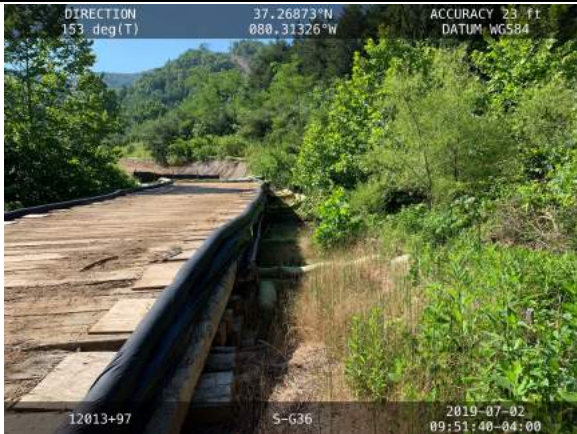
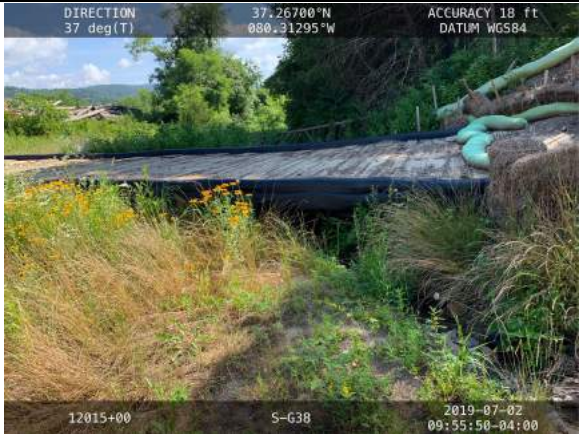
GPS Location	37.26	Field Station#	12013+97	GPS Location	37.26	Field Station#	12015+00
Description	See photo for gps data. Photo shows ECDs along the bridge over S-G36.			Description	See photo for gps data. Photo shows the bridge over S-G38.

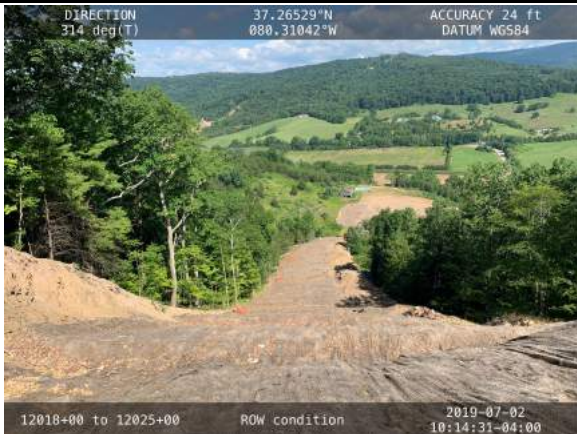
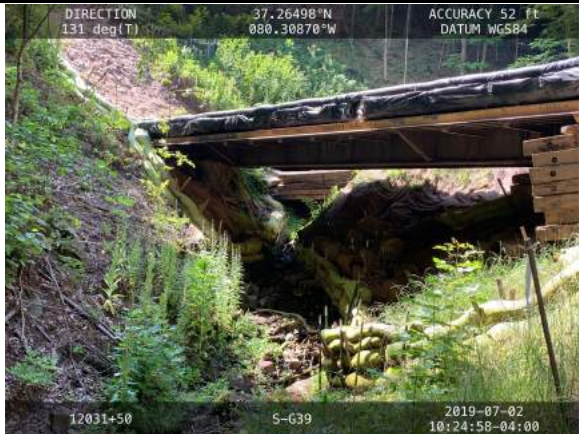
GPS Location	37.26	Field Station#	12025+00	GPS Location	37.26	Field Station#	12031+50
Description	See photo for gps data. Photo shows the ROW condition from about 12018+00 to 12025+00.			Description	See photo for gps data. Photo shows stream S-G39.

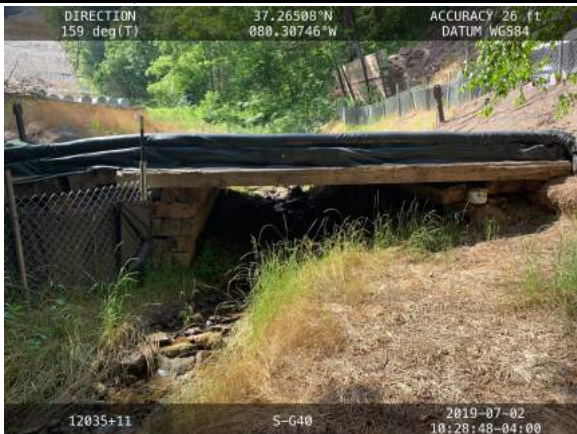
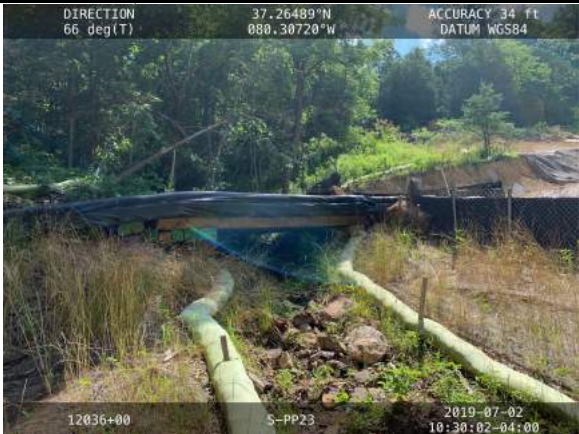
GPS Location	37.26	Field Station#	12035+11	GPS Location	37.26	Field Station#	12036+00
Description	See photo for gps data. Photo shows stream S-G40.			Description	See photo for gps data. Photo shows stream S-PP23.

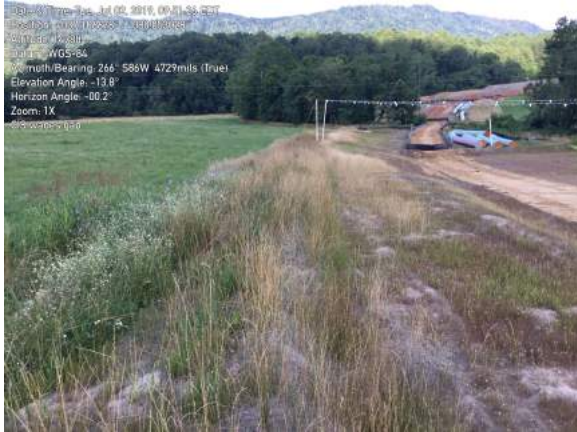
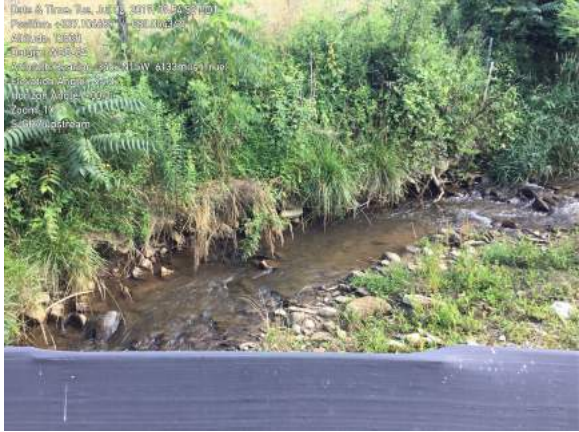
GPS Location	37.23	Field Station#	13315+00	GPS Location	37.23	Field Station#	13309+09
Description	Please see photo for accurate coordinates. ROW, soil piles stabilized, travel lane disturbed, no environmental issues noted.			Description	Please see photo for accurate coordinates. S-GH7, looking upstream, no additional erosion noted.

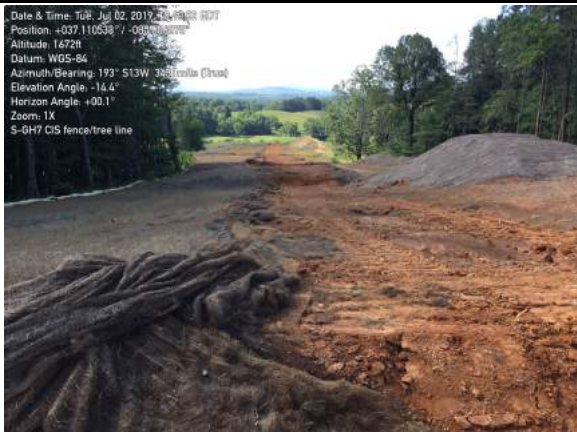
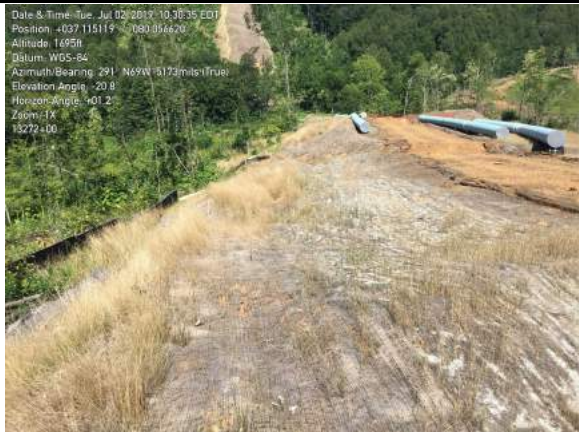
GPS Location	37.23	Field Station#	13293+00	GPS Location	37.23	Field Station#	13272+00
Description	Please see photo for accurate coordinates. ROW, travel lane disturbed, waterbar berms repaired.			Description	Please see photo for accurate coordinates. ROW, soil piles stable, no off ROW impacts noted.

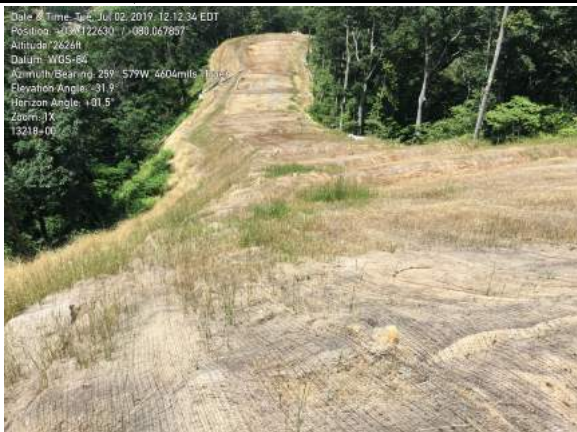
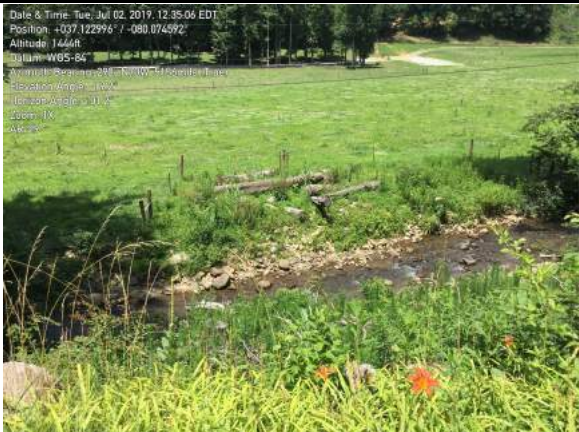
GPS Location	37.23	Field Station#	13218+00	GPS Location	37.23	Field Station#	13197+47
Description	Please see photo for accurate coordinates. ROW stabilized, waterbars and sumps functioning acceptably.			Description	Please see photo for accurate coordinates. S-D8, looking towards MVP-MLV-AR-29, no disturbance at stream.

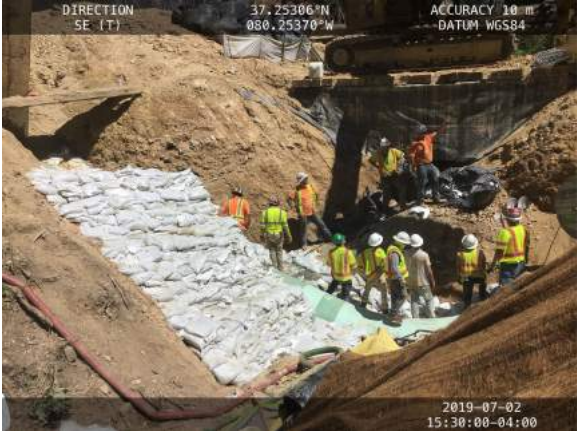
<p>Insert image here</p>			
<b>GPS Location</b>	37.23	<b>Field Station#</b>	12211+00	<b>GPS Location</b>	
<b>Description</b>	Zane Hudson's laborers continued installing the sand bags for the steep slope revetment in the bottom of the ravine on GAS Bradshaw Rd.			<b>Description</b>	
<p>Insert image here</p>		<p>Insert image here</p>			
<b>GPS Location</b>		<b>Field Station#</b>		<b>GPS Location</b>	
<b>Description</b>				<b>Description</b>	
<p>Insert image here</p>		<p>Insert image here</p>			
<b>GPS Location</b>		<b>Field Station#</b>		<b>GPS Location</b>	
<b>Description</b>				<b>Description</b>	
<p>Insert image here</p>		<p>Insert image here</p>			
<b>GPS Location</b>		<b>Field Station#</b>		<b>GPS Location</b>	
<b>Description</b>				<b>Description</b>
