Visual Site Inspection Report

Project Name	H-600 Pipeline Spread H	AFE	124300138	Spread	H-600 Pipeline Spread H	
Contractor	Precision			Report #	20785	
Inspector	Pat Davis			Date/Time	7/24/2019 5:30 PM	
Permit #	TBD	Inspection Type	VA SWPP	Station Begin	+0	
State	VA	Inspection Area	Partial	Station End	+0	
County	Montgomery	Ground	Wet	Temperature (°F)	81.00	
Municipality	N/A	Weather	Sunny	Rain Gauge (in)	1.10	
				Rain Accumulation Time (days)	0.00

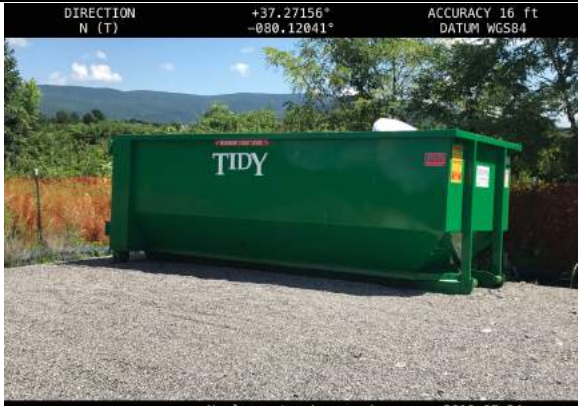
GPS Location 37.23		Field Station# +0		GPS Location 37.23		Field Station# +0	
Pic 1 Description		MVP-LY-049_072419 Condition of CFS & safety fence along drive. Looking SE. See photo for gps data.		Pic 2 Description		MVP-LY-049_072419 no loose trash around East dumpster. Looking N. See photo for gps data.

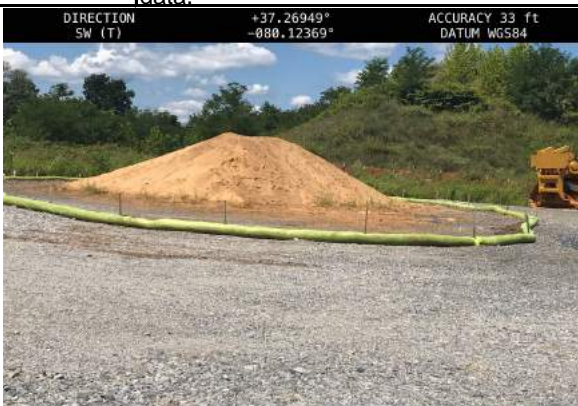
GPS Location 37.23		Field Station# +0		GPS Location 37.23		Field Station# +0	
Pic 3 Description		MVP-LY-049_072419 condition of CFS & safety fence along drive. Looking SW. See photo for gps data.		Pic 4 Description		MVP-LY-049_072419 eight covered dumpsters to collect contaminated materials from the ROW. Looking W. See photo for gps data.

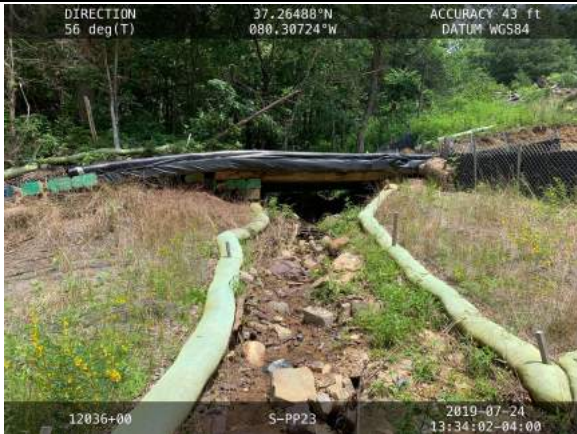
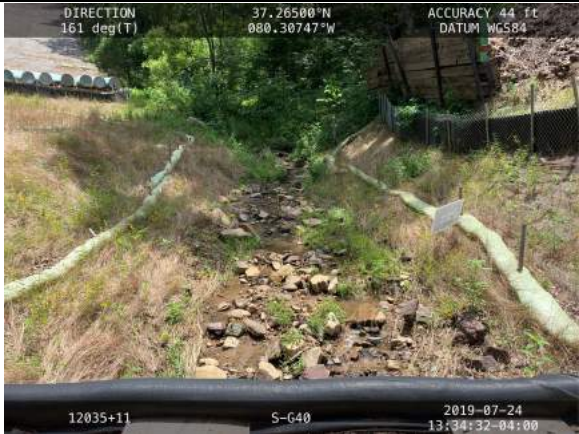
GPS Location	37.27	Field Station#	12036+00	GPS Location	37.27	Field Station#	12035+11
Pic 1 Description	See photo for gps data. Photo shows stream S-PP23.			Pic 2 Description	See photo for gps data. Photo shows stream S-G40 upstream from the ROW.

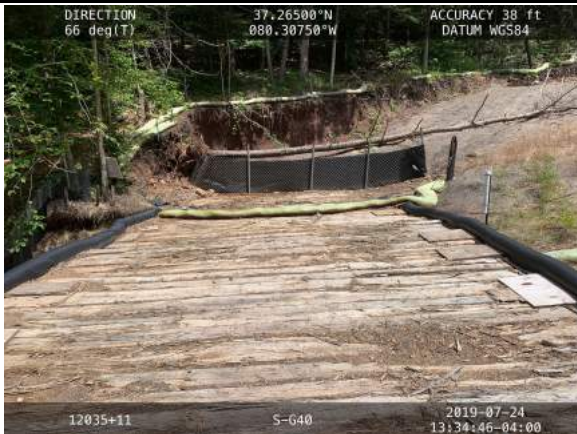
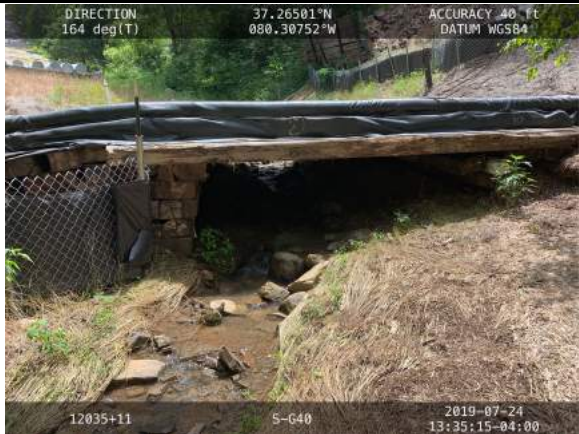
GPS Location	37.27	Field Station#	12035+11	GPS Location	37.27	Field Station#	12035+11
Pic 3 Description	See photo for gps data. Photo shows the bridge over stream S-G40.			Pic 4 Description	See photo for gps data. Photo shows stream S-G40.

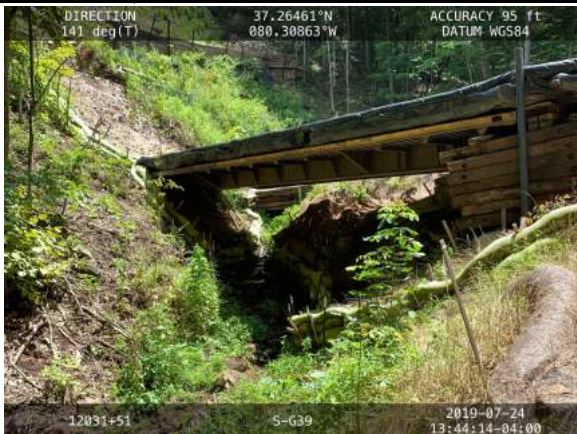
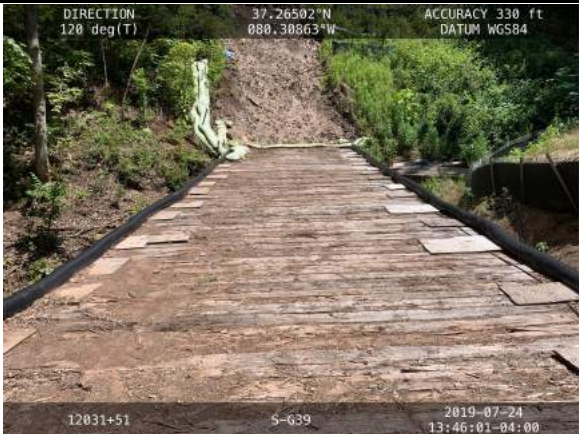
GPS Location	37.27	Field Station#	12031+51	GPS Location	37.27	Field Station#	12031+51
Pic 5 Description	See photo for gps data. Photo shows the bridge over stream S-G39.			Pic 6 Description	See photo for gps data. Photo shows the bridge over stream S-G39.

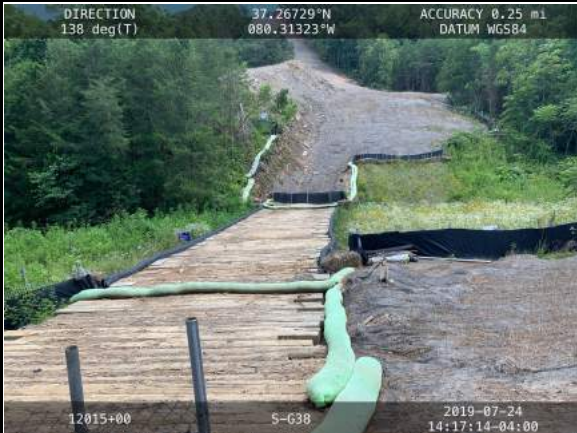
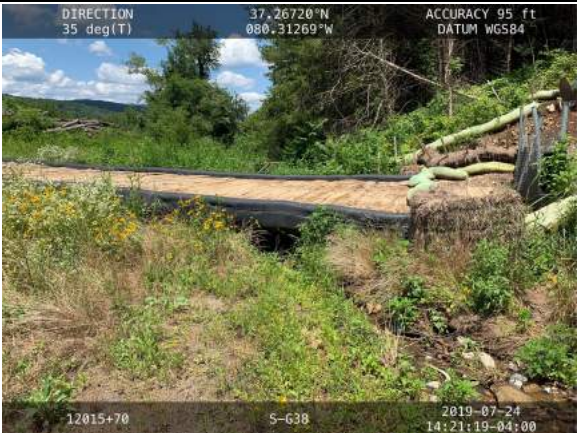
GPS Location	37.27	Field Station#	12015+00	GPS Location	37.27	Field Station#	12015+70
Pic 7 Description	See photo for gps data. Photo shows the bridge over stream S-G38.			Pic 8 Description	See photo for gps data. Photo shows stream S-G38.

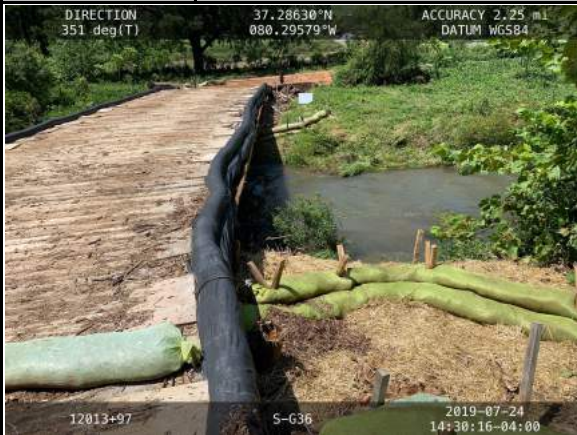
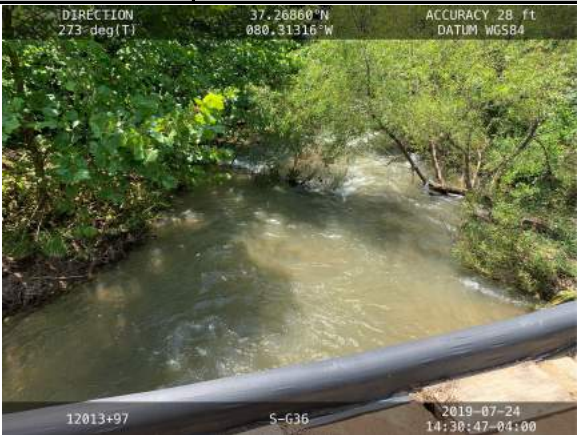
GPS Location	37.27	Field Station#	12013+97	GPS Location	37.27	Field Station#	12013+97
Pic 9 Description	See photo for gps data. Photo shows the ECDs along the bridge over S-G36.			Pic 10 Description	See photo for gps data. Photo shows stream S-G36 downstream from the ROW.

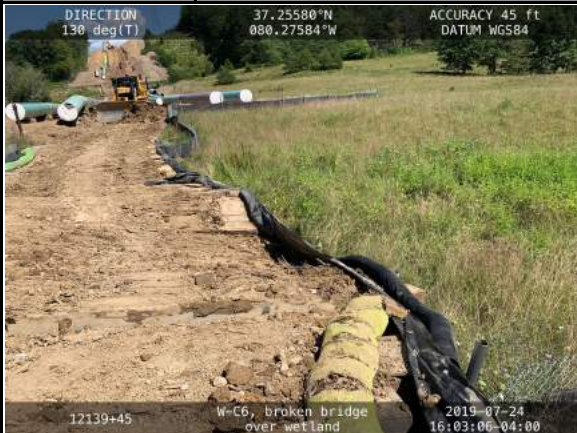
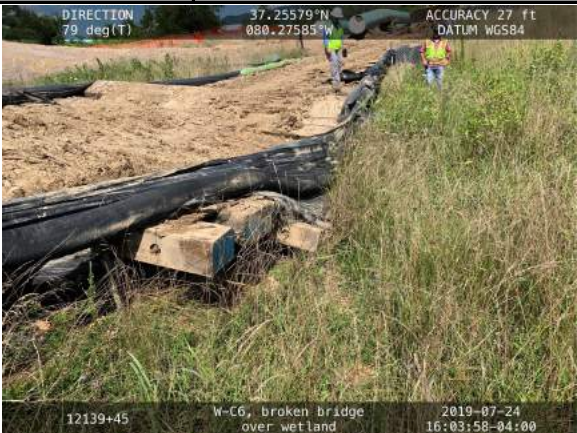
GPS Location	37.27	Field Station#	12139+45	GPS Location	37.27	Field Station#	12139+45
Pic 11 Description	See photo for gps data. Photo shows the broken equipment bridge over wetland W-C6 at 12139+45.			Pic 12 Description	See photo for gps data. Photo shows the broken bridge over wetland W-C6. Mats impacted the ground surface.

4. E&S BMPs (List BMPs and note if installed and maintained as per the plan. If corrective action is needed, a picture is required.)					
E&S BMPs	Compliance Level	Corrective Action	Corrective Time Frame	Date Repaired	
Vegetative Stabilization (Temporary)	Communication	Temp. stabilization needed @ 1209	48 Hours		
Slope Drain Pipe	Communication	Inlet/Outlet needs clean out.	24 Hours		
Waste Management	Communication	Coating material needs clean up.	24 Hours		
Other - Explain in Comments	Communication	Eroded slope needs regrade	24 Hours		
Culvert (Ditch Relief)	Communication	Ditch next to RR needs clean out			
Rock Construction Entrance	Acceptable	N/A			
Cleanwater Diversion Berm	Acceptable	N/A			
Dewatering Work Area	Acceptable	N/A			
Equipment Bridge	Communication	Bridge needs repair at W-C6	24 Hours

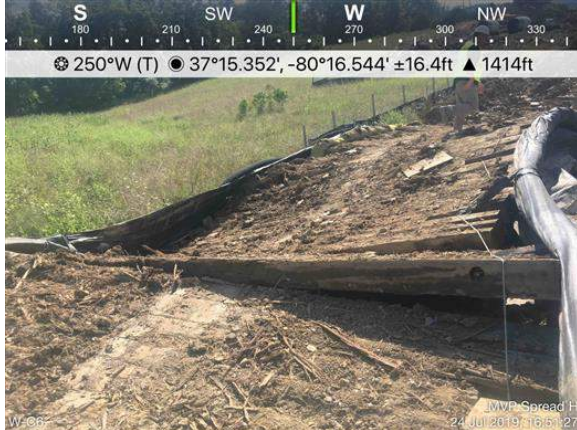
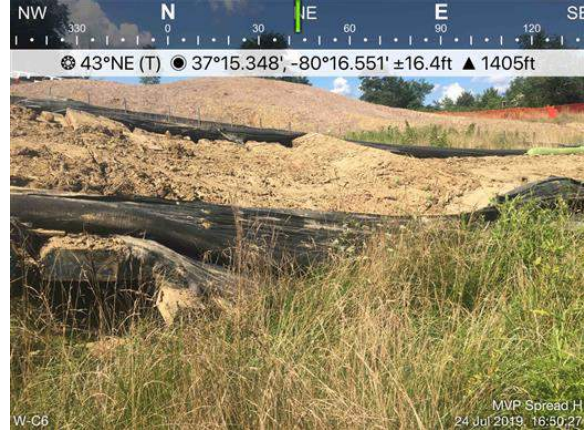
GPS Location	37.19	Field Station#	12140+00	GPS Location	37.19	Field Station#	12140+00
Pic 1 Description	Bridge collapse at W-C6.			Pic 2 Description	Bridge collapse at W-C6.

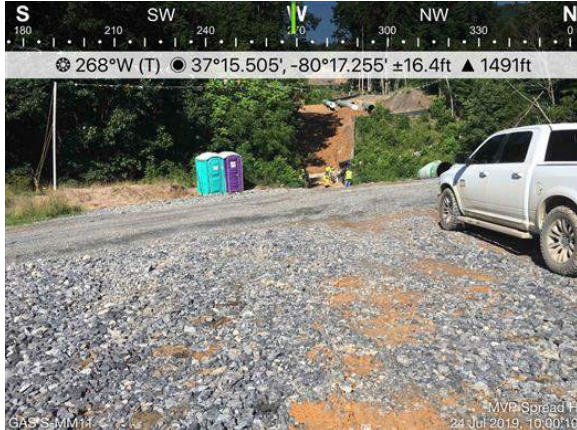
GPS Location	37.33	Field Station#	12102+00	GPS Location	37.33	Field Station#	12169+00
Pic 3 Description	Rock construction entrance in good condition			Pic 4 Description	Slope drain inlet needs clean out.

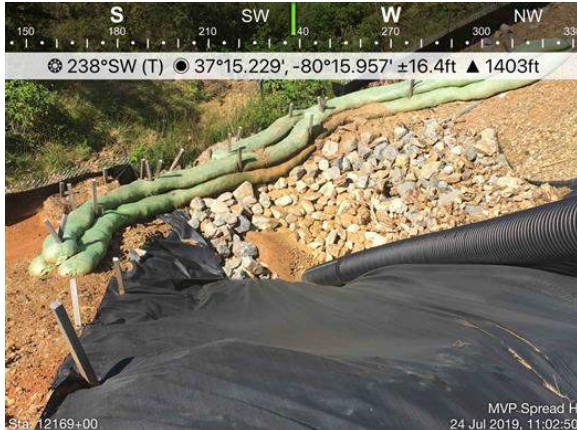
GPS Location	37.33	Field Station#	12169+00	GPS Location	37.33	Field Station#	12180+00
Pic 5 Description	Slope drain outlet needs clean out			Pic 6 Description	Slope needs to be regraded and sediment along SSF cleaned out.

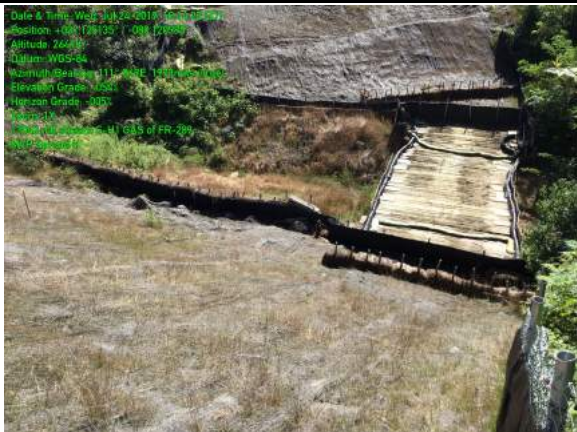
GPS Location	37.12	Field Station#	13042+00	GPS Location	37.12	Field Station#	13062+00
Pic 3 Description	Stream S-H1. No signs of stream impacts and no ECD/BMP deficiencies observed throughout the area.			Pic 4 Description	No stream impacts observed at S-G26.

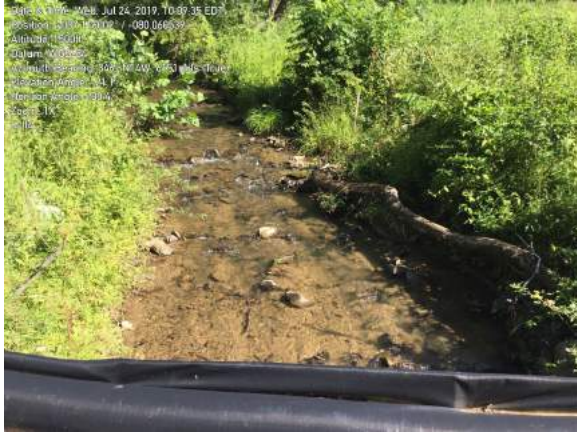
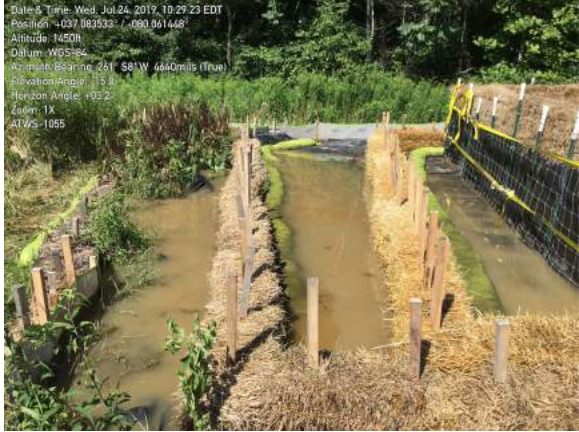
Date & Time: Wed, Jul 24, 2019, 10:39:35 EDT Position: +037.115761 / -080.063925 Altitude: 1790ft Datum: WGS-84 Azimuth/Bearing: 100° 58'00" E 1776mils (True) Elevation Angle: -36.8° Horizon Angle: -02.3° Zoom: 1X S-114		Date & Time: Wed, Jul 24, 2019, 10:29:23 EDT Position: +037.083333 / -080.061448° Altitude: 1450ft Datum: WGS-84 Azimuth/Bearing: 84° 58'10" W 4440mils (True) Elevation Angle: -13.1° Horizon Angle: +03.2° Zoom: 1X ATWS-1055					
GPS Location	37.32	Field Station#	13260+65	GPS Location	37.32	Field Station#	13262+00
Pic 1 Description	Please see photo for accurate coordinates. S-II4, looking upstream of equipment bridge, stream clear, no environmental issues.			Pic 2 Description	Please see photo for accurate coordinates. ATWS-1055, dewatering structure performing acceptably, no silt leaving structure.

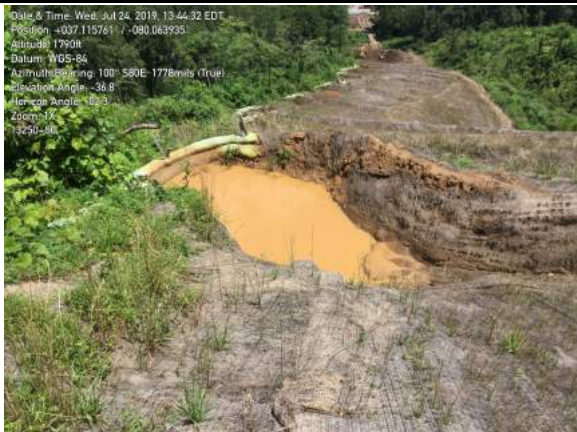
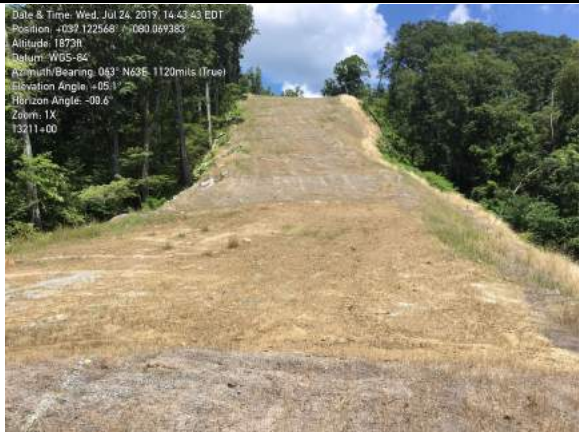
Date & Time: Wed, Jul 24, 2019, 13:44:32 EDT Position: +037.115761 / -080.063925 Altitude: 1790ft Datum: WGS-84 Azimuth/Bearing: 100° 58'00" E 1776mils (True) Elevation Angle: -36.8° Horizon Angle: -02.3° Zoom: 1X 13250+50		Date & Time: Wed, Jul 24, 2019, 14:43:43 EDT Position: +037.122568 / -080.069383 Altitude: 1873ft Datum: WGS-84 Azimuth/Bearing: 043° N 63E 1120mils (True) Elevation Angle: -05.1° Horizon Angle: -09.6° Zoom: 1X 13211+00					
GPS Location	37.32	Field Station#	13250+50	GPS Location	37.32	Field Station#	13211+00
Pic 3 Description	Please see photo for accurate coordinates. ROW, waterbars and waterbar outlets functioning acceptably, sumps holding water.			Pic 4 Description	Please see photo for accurate coordinates. ROW and soil piles stabilized, waterbars functioning acceptably.

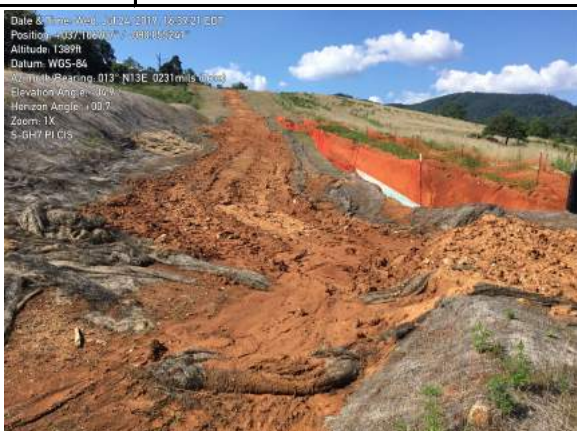
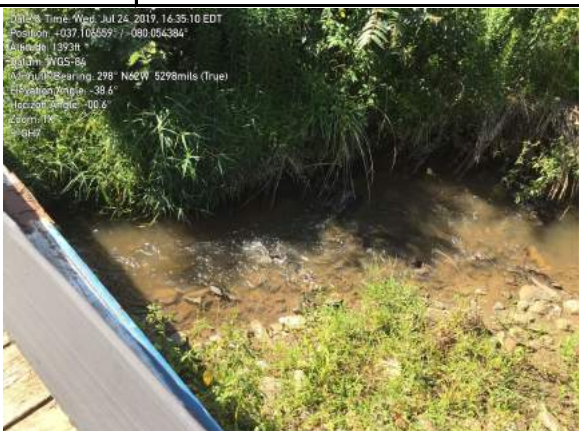
GPS Location	37.11	Field Station#	13306+16	GPS Location	37.11	Field Station#	13309+09
Pic 5 Description	Please see photo for accurate coordinates. ROW, travel lane open with waterbars repaired.			Pic 6 Description	Please see photo for accurate coordinates. S-GH7, looking upstream of equipment bridge, stream clear

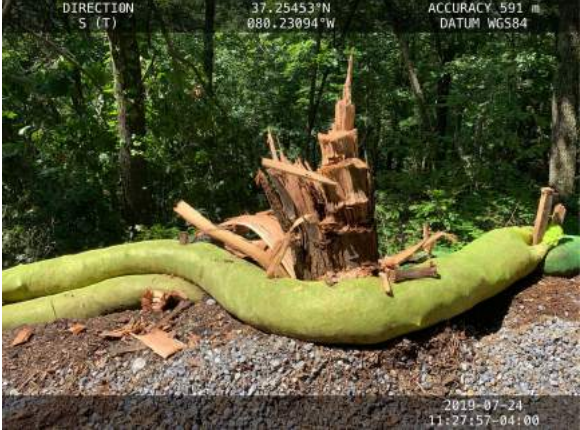
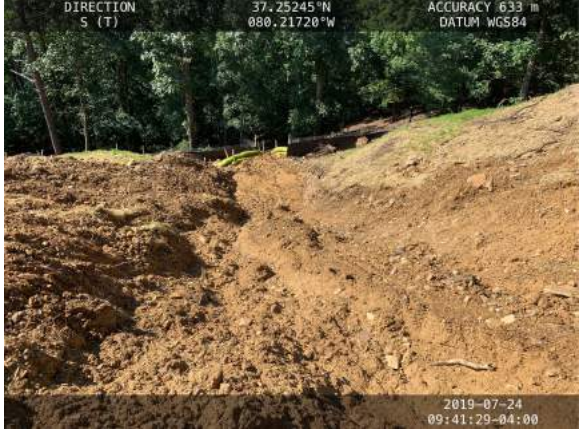
GPS Location	37.23	Field Station#	12298+39	GPS Location	12232+50
Pic 1 Description	Tree on side of access road MVP-MN-276.03 that was knocked down by equipment tracking by. Looking S. See picture for GPS data.			Pic 2 Description	Sump full and needs cleaned out then fill slope drain needs to be installed. Looking S. See picture for GPS data.

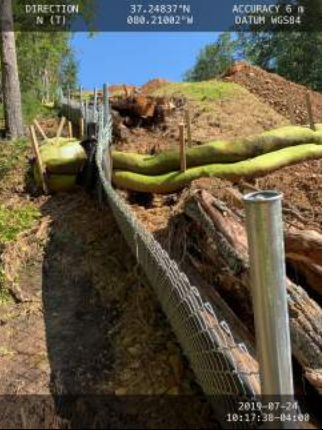
GPS Location	37.23	Field Station#	12360+00	GPS Location	12343+00
Pic 3 Description	CFS end treatment undermined. Looking N. See picture for GPS data.			Pic 4 Description	Second section where additional fill slope drains need to be installed. Looking E. See picture for GPS data.

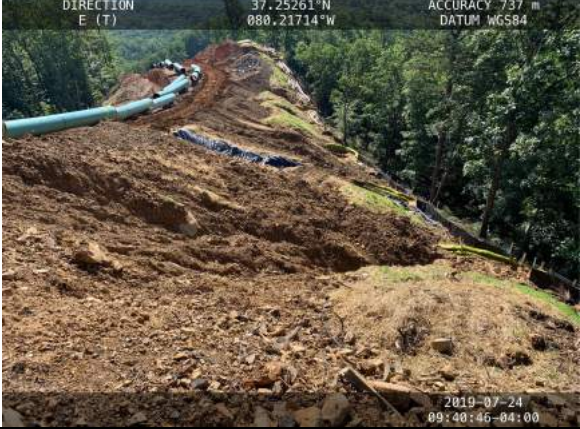
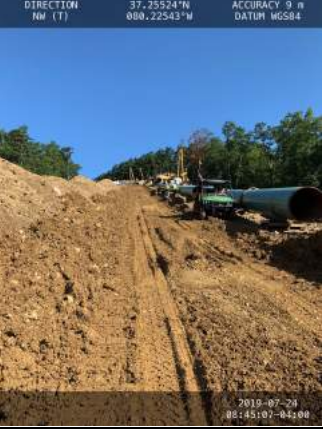
GPS Location	37.34	Field Station#	12232+50	GPS Location	12300+00
Pic 5 Description	First section that needs additional fill slope drains installed. Looking E. See picture for GPS data.			Pic 6 Description	Pipe Gand beginning to weld the section down to I-81 Looking NW. See picture for GPS data.

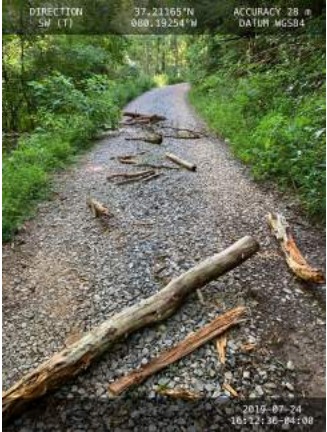
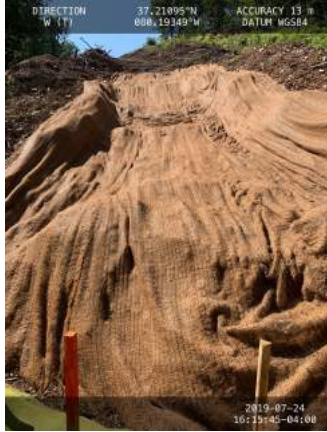
GPS Location	37.23	Field Station#	12543+55	GPS Location	37.23
Pic 1 Description	Debris placed on Yellow Finch Rd by the opposition to block PPL from entering and exiting. Looking SW. See picture for GPS data.		Pic 2 Description	Curlexed travel lane on the CIS of Yellow Finch Rd. Looking W. See picture for GPS data.

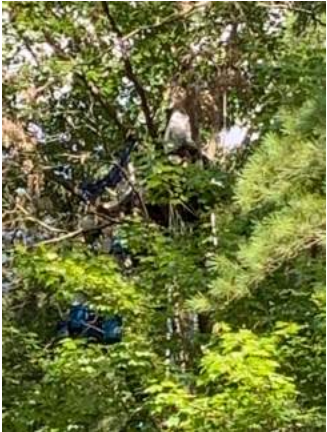
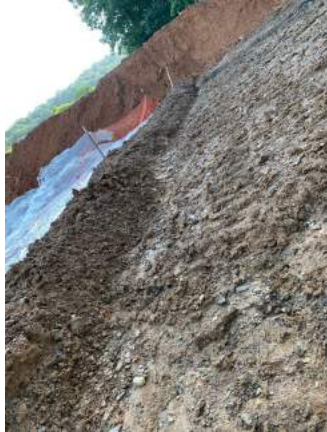
GPS Location	37.23	Field Station#	12545+50	GPS Location	37.23
Pic 3 Description	Opposition tree sits yelling and harassing the crews as they try to work in the area.		Pic 4 Description	Water bar channel cleaned out by the environmental crew.

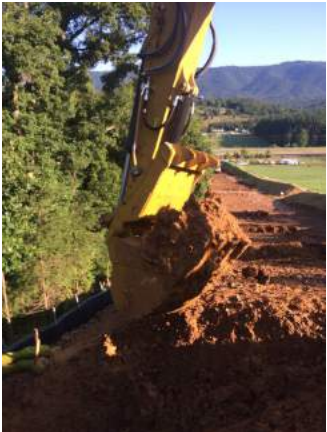
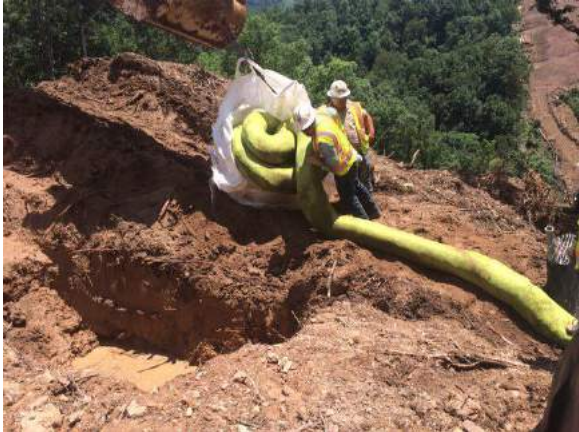
GPS Location	37.23	Field Station#	12478+15	GPS Location	37.23
Pic 5 Description	Excavator cleaning the sumps that filled over half full following the recent rain event.		Pic 6 Description	Environmental crew installing end treatments to water bars.
