Visual Site Inspection Report

Project Name	H-600 Pipeline Spread H	AFE	124300138	Spread	H-600 Pipeline Spread	
Contractor	Precision			Report #	42	
Inspector	Pat Davis			Date/Time	7/30/2019 5:30 PM	
Permit #	TBD	Inspection Type	VA SWPP	Station Begin	+0	
State	VA	Inspection Area	Partial	Station End	+0	
County	Montgomery	Ground	Dry	Temperature (°F)	91.00	
Municipality	N/A	Weather	Sunny	Rain Gauge (in)	0.00	
				Rain Accumulation Time (days)	0.00

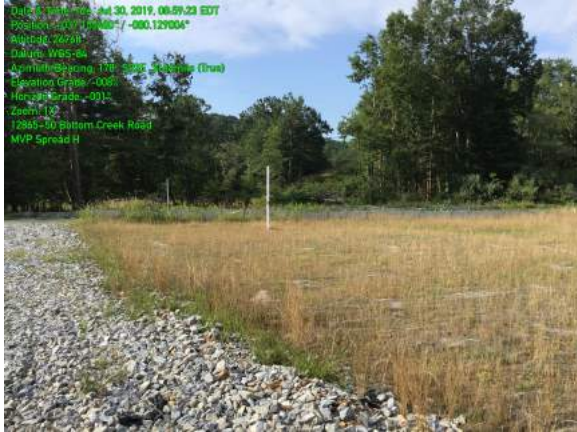
GPS Location	See pic for GPS	GPS Location	See pic for GPS		
Field Station#	12865+50	Field Station#	12957+30		
Pic 1 Desc.	Bottom Creek road crossing	Pic 2 Desc.	Green Hollow Drive RO-287

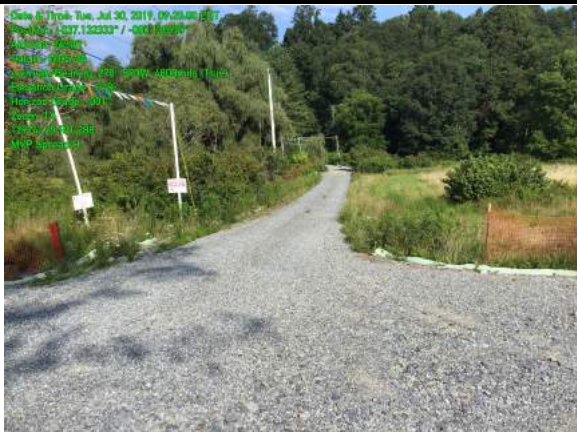
GPS Location	See pic for GPS	GPS Location	See pic for GPS		
Field Station#	12974+29	Field Station#	13025+25		
Pic 3 Desc.	RO-288 Montuori Way	Pic 4 Desc.	Gas of the BRP streams S-G24 and S-G25

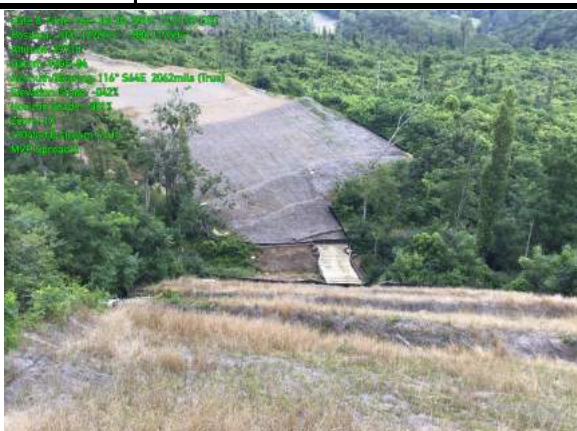
GPS Location	See pic for GPS	GPS Location	See pic for GPS		
Field Station#	13040+00	Field Station#	13062+00		
Pic 5 Desc.	GAS of FR-289 stream S-H1	Pic 6 Desc.	Streams S-G26 and S-G27

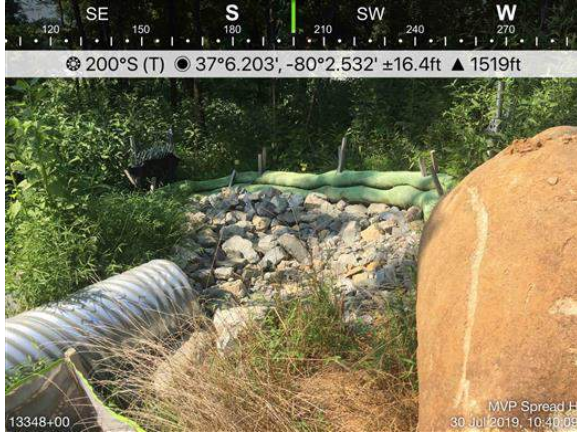
GPS Location	N/A		GPS Location	N/A	
Field Station#	13348+00		Field Station#	13353+00	
Pic 1 Desc.	Functioning CWD outlet.		Pic 2 Desc.	Installed and functioning stream crossing bridge.

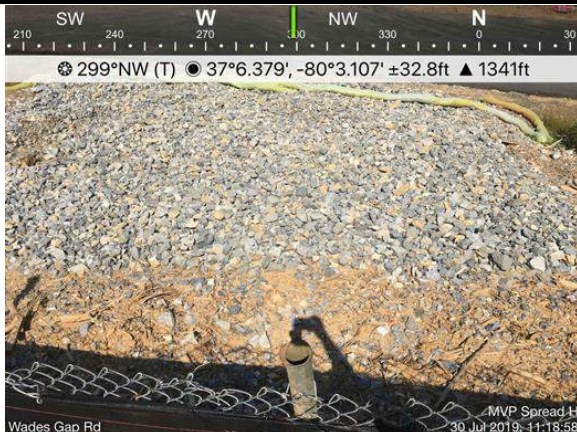
GPS Location	N/A		GPS Location	N/A	
Field Station#	13316+10		Field Station#	13403+08	
Pic 3 Desc.	Installed and functional construction entrance		Pic 4 Desc.	Temp. stabilization matting in good condition.

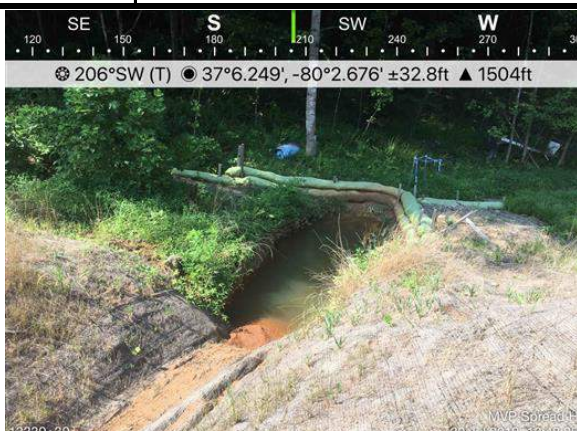
GPS Location	N/A		GPS Location	N/A	
Field Station#	13339+30		Field Station#	13385+00	
Pic 5 Desc.	Installed and functional WB end treatment.		Pic 6 Desc.	Installed and functioning waterbar.

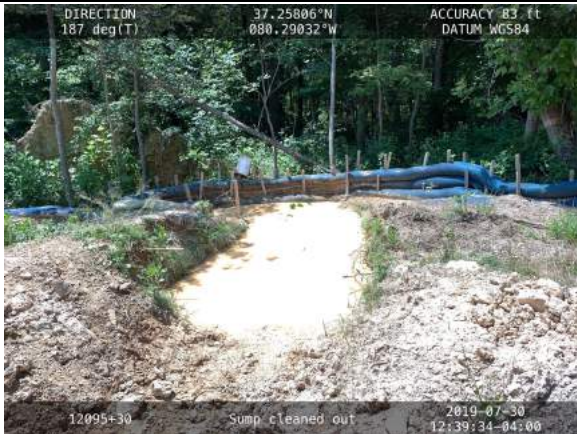
GPS Location	See photo for gps data.		GPS Location	See photo for gps data.	
Field Station#	12095+30		Field Station#	12078+00	
Pic 1 Desc.	Cleaned out sump at 12095+30		Pic 2 Desc.	Cleaned out sump at 1207800

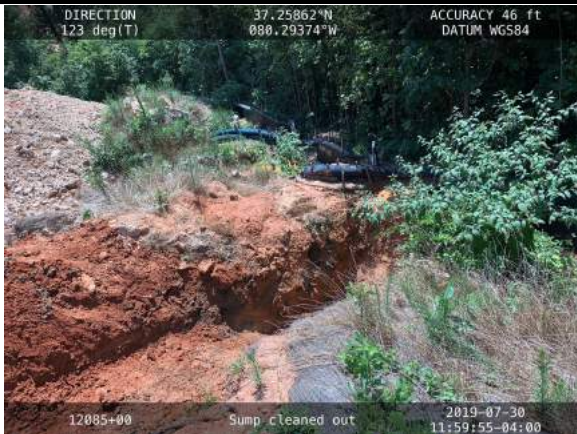
GPS Location	See photo for gps data.		GPS Location	See photo for gps data.	
Field Station#	12085+00		Field Station#	12112+00	
Pic 3 Desc.	Cleaned out sump at 12085+00		Pic 4 Desc.	New CFS wattle install at S-F16A/B.

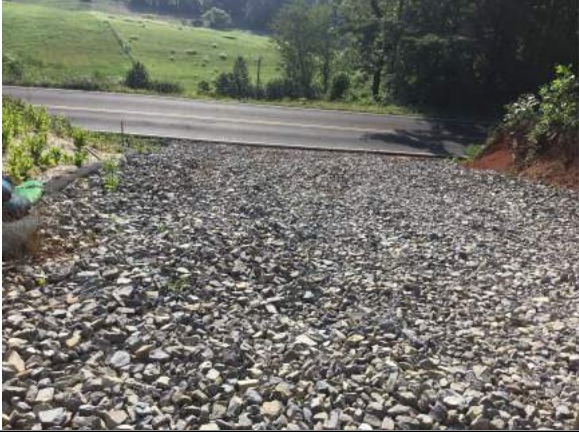
GPS Location	000000000		GPS Location	000000000	
Field Station#	13562+33		Field Station#	13562+99	
Pic 1 Desc.	RCE CIS Bethlehem rd		Pic 2 Desc.	Row photo showing permanent grass after land owner cut hay from row

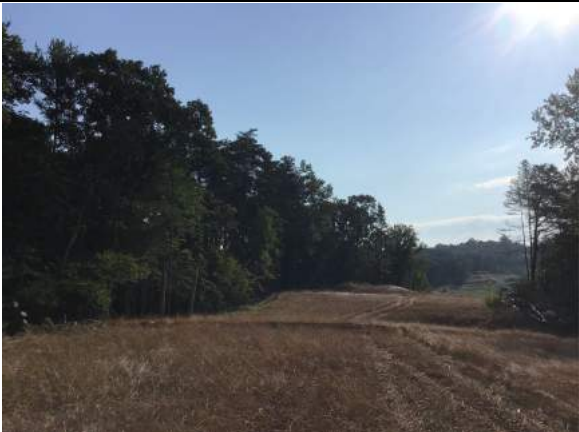
GPS Location	000000000		GPS Location	000000000	
Field Station#	13560+00		Field Station#	13554+33	
Pic 3 Desc.	Row photo showing temporary vegetation		Pic 4 Desc.	Temporary vegetation with little to no permanent grass	
Insert image here			Insert image here		
GPS Location			GPS Location		
Field Station#			Field Station#		
Pic 5 Desc.			Pic 6 Desc.

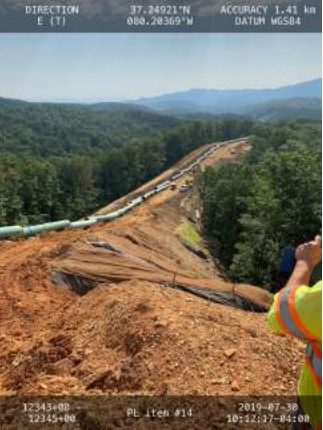
GPS Location	See picture for GPS data		GPS Location	See picture for GPS data	
Field Station#	12343+00		Field Station#	12421+73	
Pic 1 Desc.	All fill slope drains have been installed		Pic 2 Desc.	X-Ray and pipe gang activity

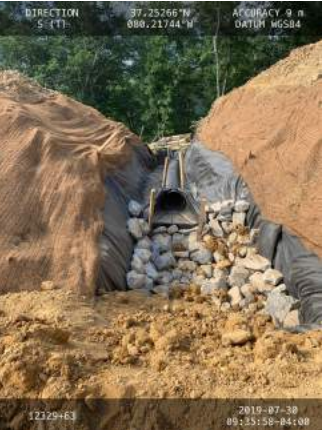
GPS Location	See picture for GPS data		GPS Location	See picture for GPS data	
Field Station#	12329+63		Field Station#	12361+00	
Pic 3 Desc.	Rock inlet for fill slope drain.		Pic 4 Desc.	Area where P1 or SSF needs to be installed

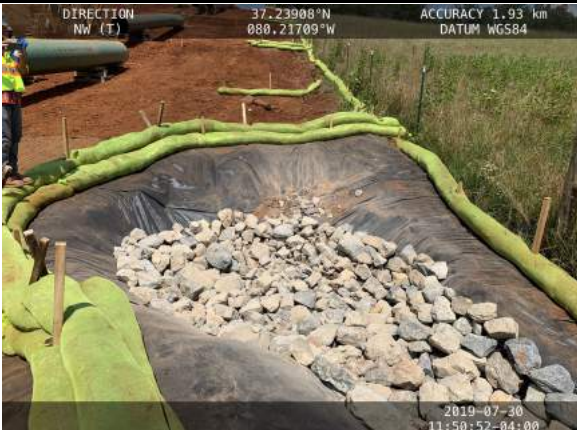
GPS Location	See picture for GPS data		GPS Location	See picture for GPS data	
Field Station#	12409+00		Field Station#	12409+80	
Pic 5 Desc.	Berm built at drop inlet for Clear water crossing		Pic 6 Desc.	Clear water crossing outlet needs cleaned.

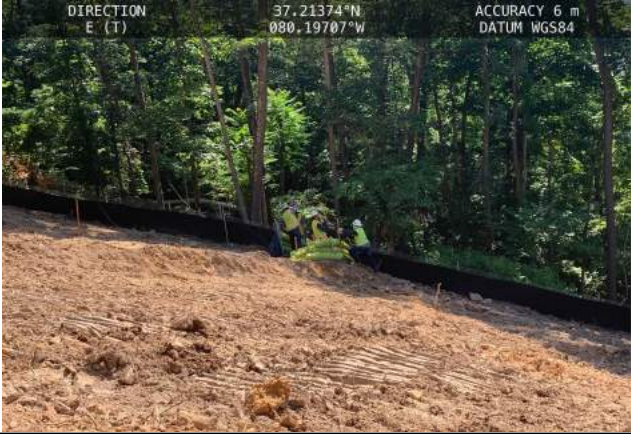
GPS Location	See picture for GPS data.		GPS Location	See picture for GPS data.	
Field Station#	12518+00		Field Station#	12517+00	
Pic 1 Desc.	Environmental crew installing end treatment		Pic 2 Desc.	Steep slope with multiple water bars.

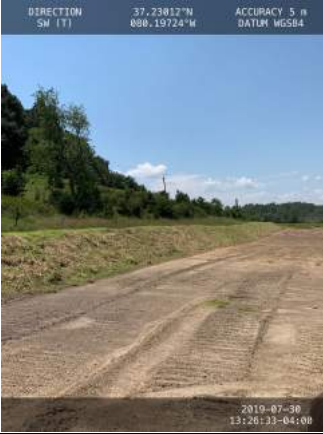
GPS Location	See picture for GPS data.		GPS Location	See picture for GPS data.	
Field Station#	12453+58		Field Station#	12451+23	
Pic 3 Desc.	Portable Toilet location.		Pic 4 Desc.	Clean water diversion berm.

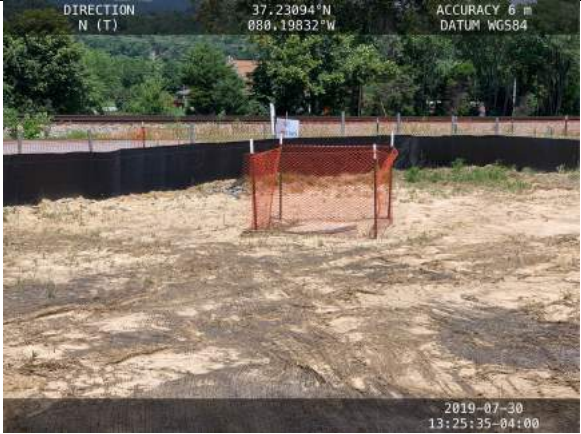
GPS Location	See picture for GPS data.		GPS Location	See picture for GPS data.	
Field Station#	12543+56		Field Station#	12450+80	
Pic 5 Desc.	Yellow Finch rain gauge (0.0")		Pic 6 Desc.	Night cap covering well point system.

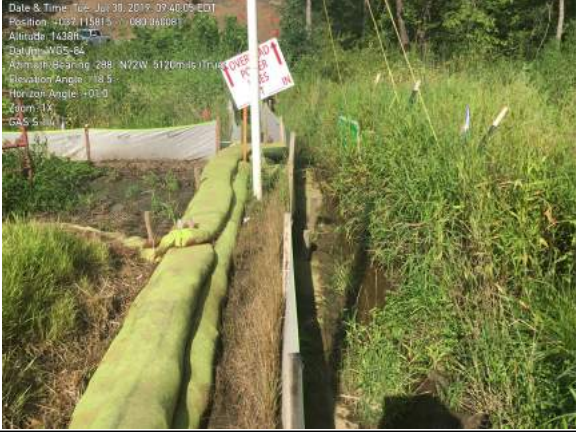
GPS Location	Please see photo for accurate coordinates.		GPS Location	Please see photo for accurate coordinates.	
Field Station#	13260+70		Field Station#	13261+28	
Pic 1 Desc.	S-II4, looking upstream, no issues noted.		Pic 2 Desc.	W-II4, wetland drainage along LOD.

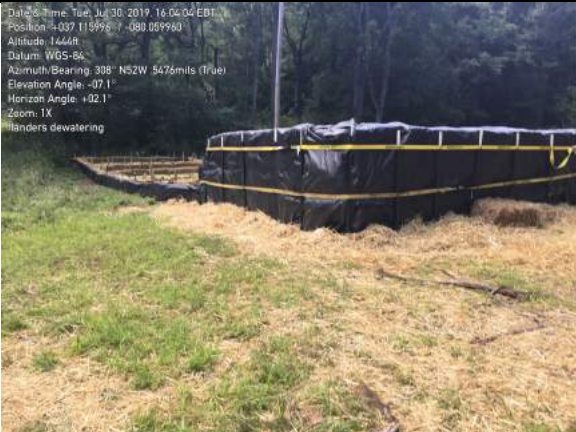
GPS Location	Please see photo for accurate coordinates.		GPS Location	Please see photo for accurate coordinates.	
Field Station#	13309+09		Field Station#	13261+00	
Pic 5 Desc.	S-GH7, looking upstream, no issues noted.		Pic 6 Desc.	Approved off ROW dewatering structure.

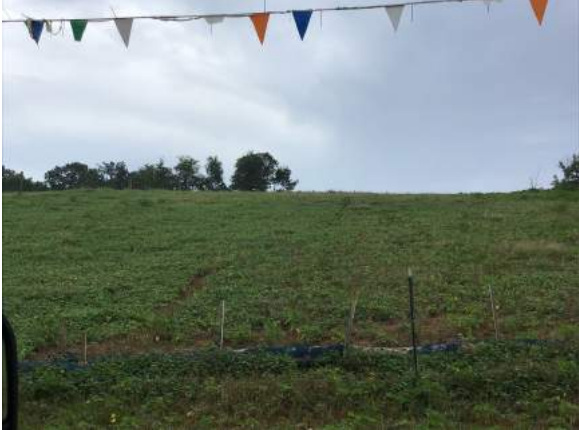
GPS Location	00000000	GPS Location	00000000		
Field Station#	13526+03	Field Station#	13525+12		
Pic 1 Desc.	Permanent vegetation coverage on a section of row		Pic 2 Desc.	ECDs in place and functioning on stream crossing

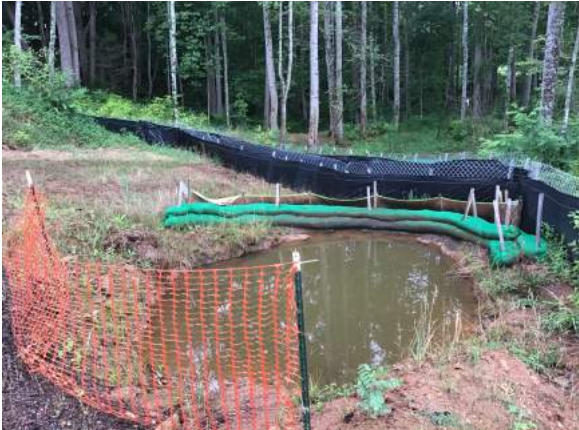
GPS Location	000000	GPS Location	0000000		
Field Station#	13415+96	Field Station#	13415+89		
Pic 3 Desc.	Sump pit and ECDs functioning to filter out sediment		Pic 4 Desc.	Temporary vegetation starting to grow on hill side after being broadcast	
Insert image here			Insert image here		
GPS Location		GPS Location			
Field Station#		Field Station#			
Pic 5 Desc.		Pic 6 Desc.
