# Visual Site Inspection Report

<b>Project Name</b>	H-600 Pipeline Spread H	<b>AFE</b>	124300138	<b>Spread</b>	H-600 Pipeline Spread H
<b>Contractor</b>	Precision			<b>Report #</b>	19883
<b>Inspector</b>	Tyler Cremeens			<b>Date/Time</b>	7/8/2019 6:31 AM
<b>Permit #</b>	TBD	<b>Inspection Type</b>	VA SWPP	<b>Station Begin</b>	13316+13
<b>State</b>	VA	<b>Inspection Area</b>	Partial	<b>Station End</b>	13415+57
<b>County</b>	Franklin	<b>Ground</b>	Damp	<b>Temperature (°F)</b>	89.
<b>Municipality</b>	N/A	<b>Weather</b>	Cloudy	<b>Rain Gauge (in)</b>	0.1
				<b>Rain Accumulation Time (days)</b>	2.

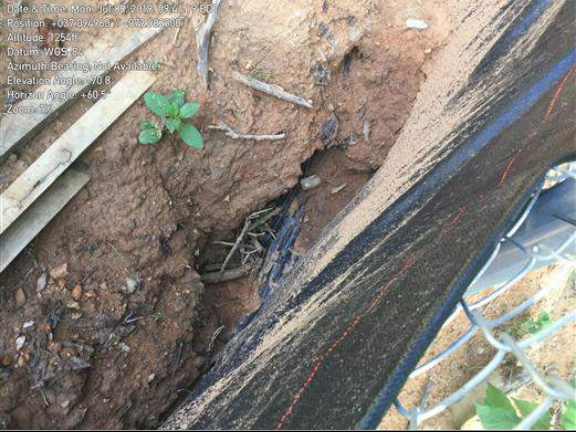
<p>Insert image here</p>			
<b>GPS Location</b>	37.19	<b>Field Station#</b>	13406+15	<b>GPS Location</b>	37.19
<b>Pic 1 Description</b>	See Photo for GPS data. Punchlist item: Undermining of SSF at sump outlet. View: Northwest.			<b>Pic 2 Description</b>

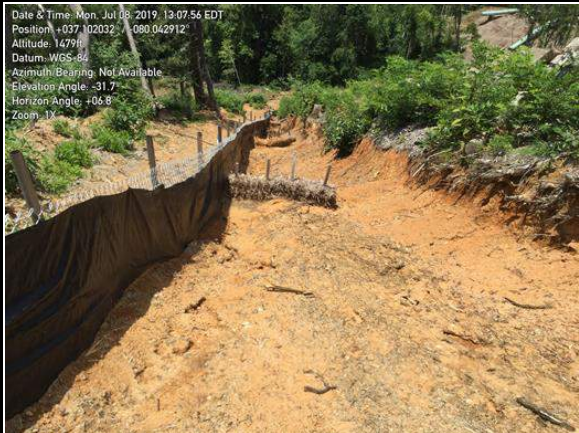
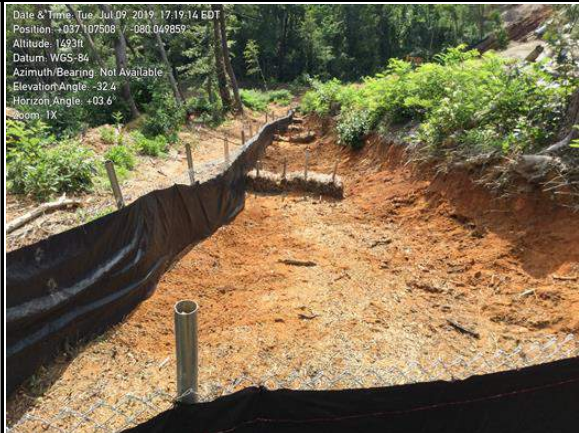
</div></div></div>				
GPS Location	37.26	Field Station#	13362+00	GPS Location	37.26	Field Station#	13362+00
Pic 13 Description	See Photo for GPS data. Punchlist item, included erosion and sediments at bales above 50%, SF flap exposed.View: West.			Pic 14 Description	See Photo for GPS data. Erosion has been addressed, sediments removed from bales, SF flap reburied. View: West.

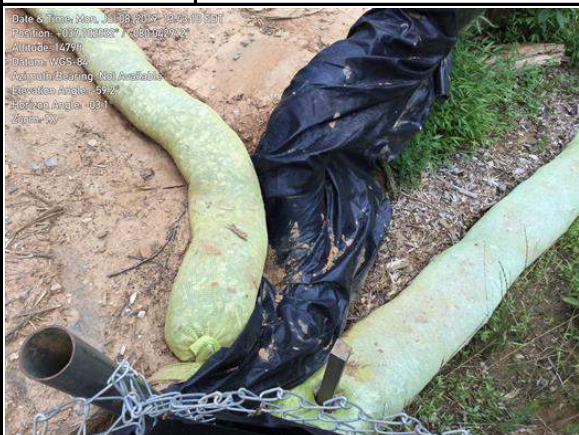
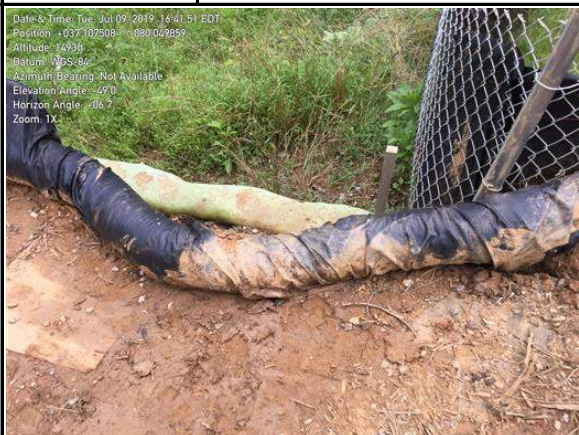
</div></div></div>				
GPS Location	37.26	Field Station#	13354+00	GPS Location	37.26	Field Station#	13354+00
Pic 15 Description	See Photo for GPS data.Drain tile "sideboard has become displaced.View: West.			Pic 16 Description	See Photo for GPS data.Drain tile "sideboard has been reattached to side of mat bridge.View: West.		
<div><div><div>Date &amp; Time: Mon, Jul 08, 2019, 13:24:00 EDT Position: +037.101004, -080.041004 Altitude: 1479ft Datum: WGS-84 Azimuth/Bearing: Not Available Elevation Angle: -52.8° Horizon Angle: +03.1° Zoom: 1X</div><div>

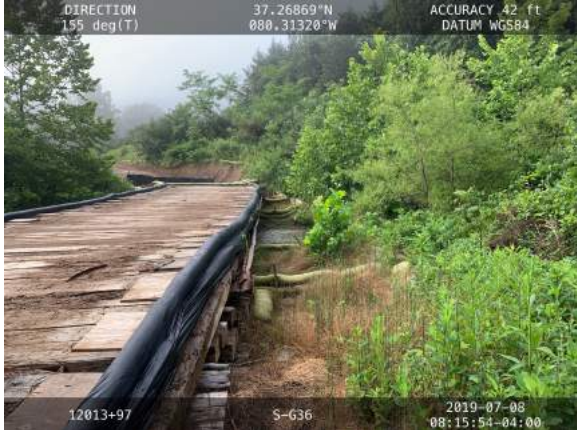
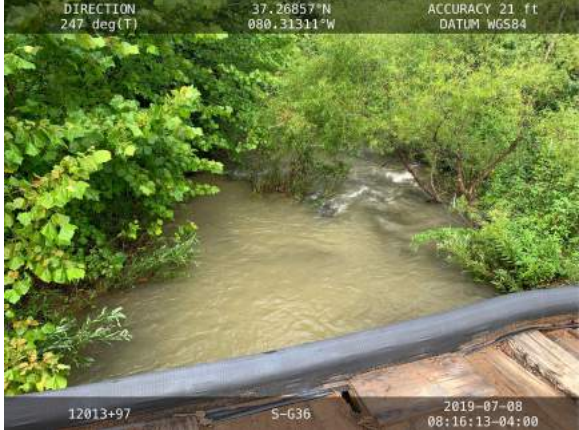
GPS Location	37.26	Field Station#	12013+96	GPS Location	37.26	Field Station#	12013+97
Description	See photo for gps data. Photo shows the bridge and ECDs over stream S-G36.			Description	See photo for gps data. Photo shows stream S-G36 downstream from the bridge n MVP-MN-268.01.

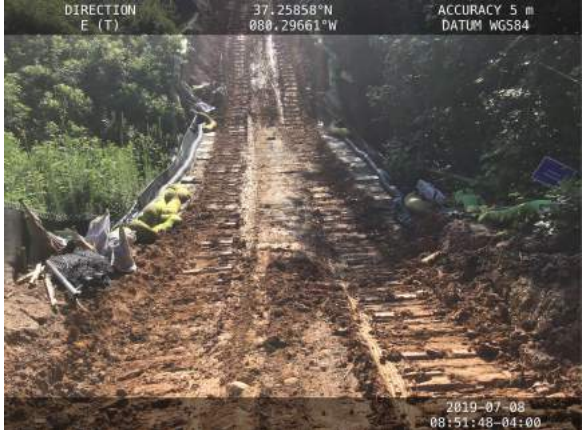
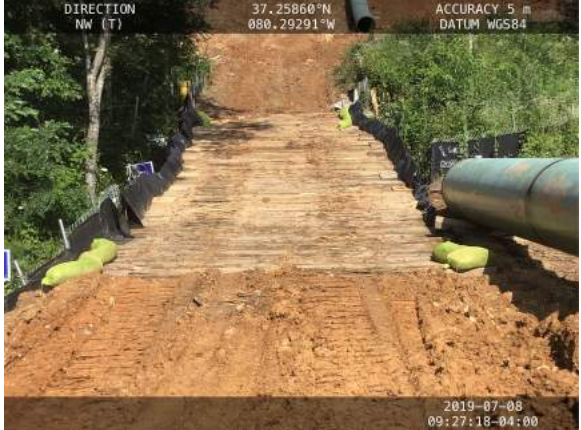
GPS Location	37.25	Field Station#	12076+95	GPS Location	37.25	Field Station#	12086+56
Description	Stream S-MM15, facing east. Bridge is in satisfactory condition as steady traffic continues through this area.			Description	Stream S-MM14, facing northwest. Bridge and ECDs in good condition.

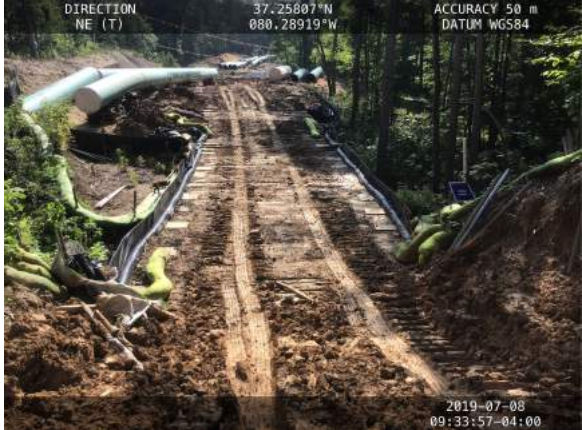
GPS Location	37.25	Field Station#	12098+44	GPS Location	37.25	Field Station#	12101+57
Description	Stream S-MM13, facing northeast. Bridge dirty from heavy traffic at start of day, but will be cleaned by end of day.			Description	Stream S-MM11, facing east. Bridge dirty from heavy traffic at the start of day. Will be cleaned by end of the day.

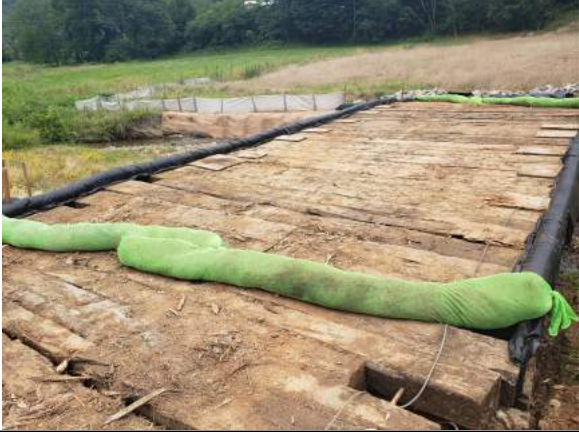
<b>GPS Location</b>	37.08	<b>Field Station#</b>	13498+00	<b>GPS Location</b>	37.08
<b>Pic 1 Description</b>	S-IJ10 equipment bridge after maintenance repairs done		<b>Pic 2 Description</b>	S-IJ10 equipment bridge damaged during flash flooding

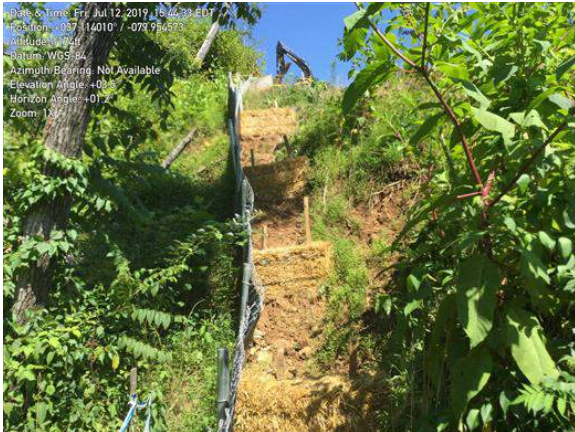
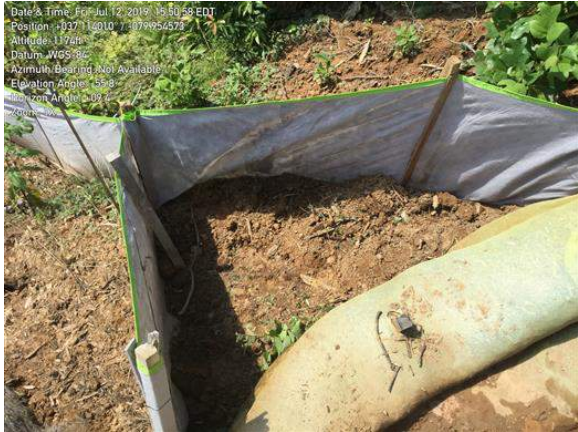
GPS Location	37.23	Field Station#	13359+20	GPS Location	37.23	Field Station#	13360+15
Pic 1 Description	See Photo for GPS data. Punchlist item: eroded silt fence trench repaired & bale checks installed. View: East.			Pic 2 Description	See Photo for GPS data. Punchlist item: undermined sump repaired & P1 silt fence installed. View: Northwest.

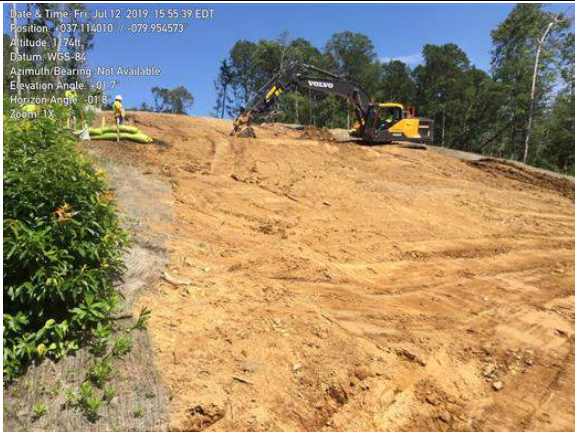
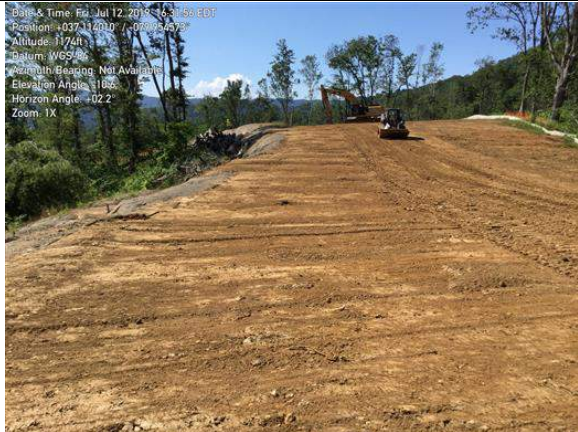
GPS Location	37.23	Field Station#	13364+00	GPS Location	37.23	Field Station#	13374+20
Pic 3 Description	See Photo for GPS data. Punchlist item: Undermined sump & rilling being repaired. View: East.			Pic 4 Description	See Photo for GPS data. Punchlist error: Item was listed as undermined sump but no sump or waterbar exists at this location. View: West.

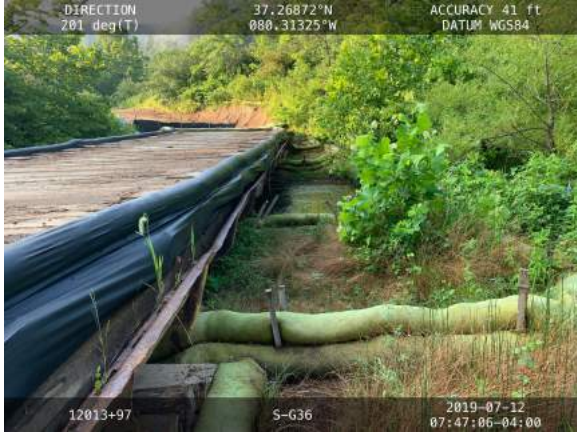
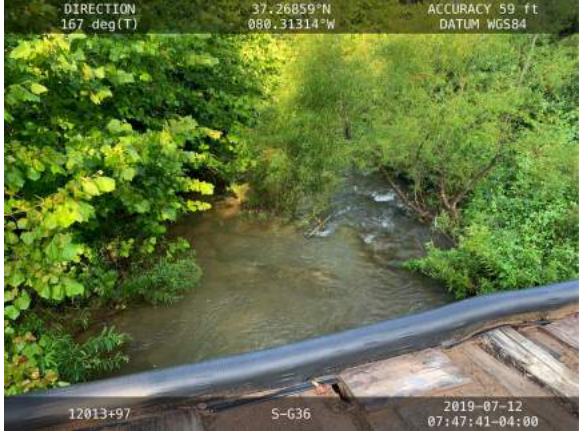
GPS Location	37.26	Field Station#	12013+97	GPS Location	37.26	Field Station#	12013+97
Pic 1 Description	See photo for gps data. Photo shows the ECDs along the downstream side of the bridge over S-G36.			Pic 2 Description	See photo for gps data. Photo shows stream S-G36, downstream from the bridge on MVP-MN-268.01.

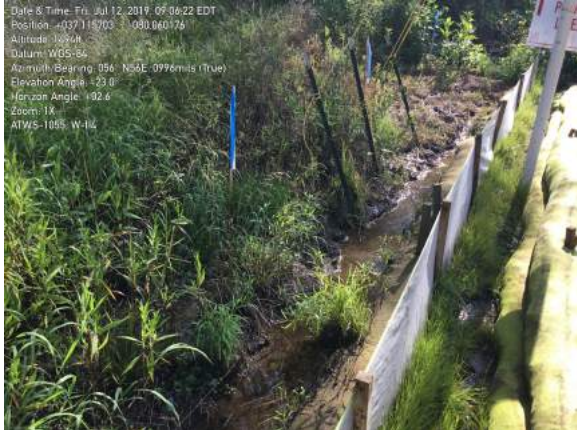
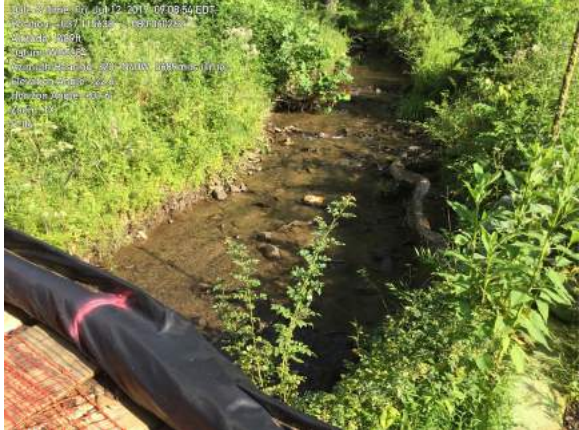
GPS Location	37.32	Field Station#	13261+28	GPS Location	37.32	Field Station#	13260+70
Pic 1 Description	Please see photo for accurate coordinates. W-II4, drainage from adjacent wetland flowing along LOD.			Pic 2 Description	Please see photo for accurate coordinates. S-II4, looking upstream, geotech on bridge in acceptable condition.

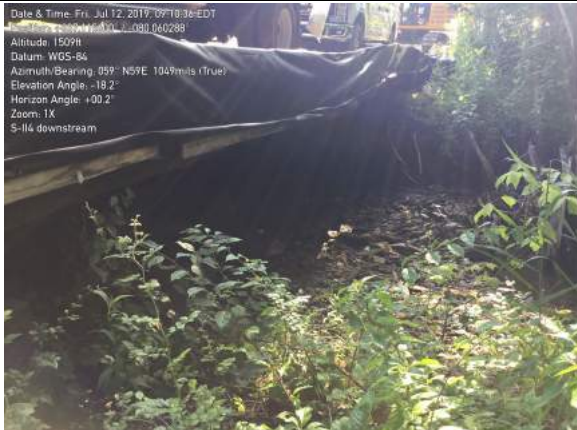
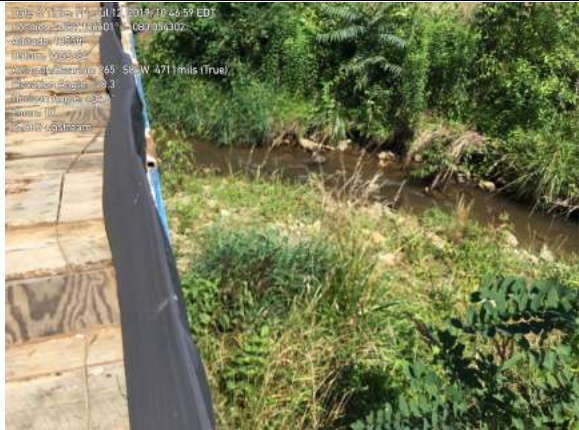
GPS Location	37.32	Field Station#	13260+65	GPS Location	37.32	Field Station#	13309+09
Pic 3 Description	Please see photo for accurate coordinates. S-II4, downstream side of bridge, no issues noted on bridge.			Pic 4 Description	Please see photo for accurate coordinates. S-GH7, looking at upstream, water mostly clear, no additional erosion noted.

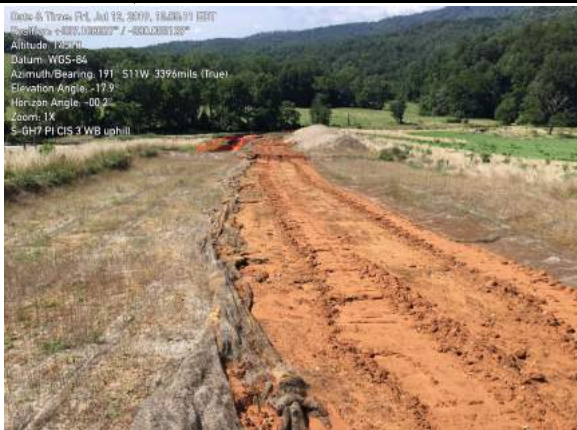
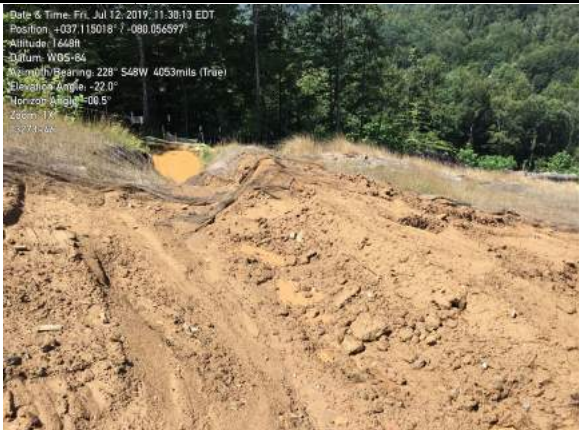
GPS Location	37.32	Field Station#	13301+00	GPS Location	37.32	Field Station#	13273+46
Pic 5 Description	Please see photo for accurate coordinates. ROW, travel lane open with waterbars put back in travel lane.			Pic 6 Description	Please see photo for accurate coordinates. ROW, sumps holding sediment laden water, outlet functioning acceptably.

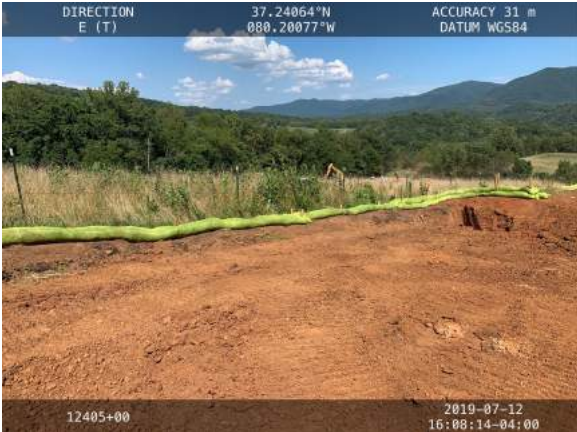
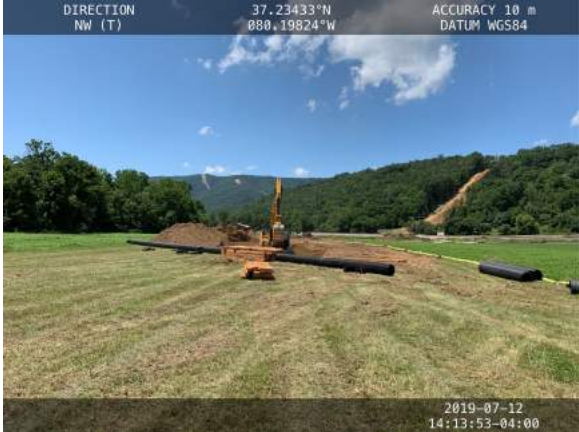
<div>2019-07-12 14:13:53-04:00</div>				
GPS Location	37.33	Field Station#	12405+00	GPS Location	37.33	Field Station#	12430+00
Pic 5 Description	Repairs CFS along the perimeter of the ECDs Looking E. See picture for GPS.			Pic 6 Description	Operator building an air bridge over the clear water drain pipe. Looking NW. See picture for GPS data.
