Visual Site Inspection Report

Project Name	H-600 Pipeline Spread H	AFE	124300138	Spread	H-600 Pipeline Spread
Contractor	Roberts Corrosion			Report #	774
Inspector	Logan Box			Date/Time	8/14/2019 6:34 PM
Permit #	TBD	Inspection Type	VA SWPP	Station Begin	13415+55
State	VA	Inspection Area	Partial	Station End	13670+00
County	Franklin	Ground	Dry	Temperature (°F)	86.00
Municipality	N/A	Weather	Sunny	Rain Gauge (in)	0.00
				Rain Accumulation Time (days)	0.00

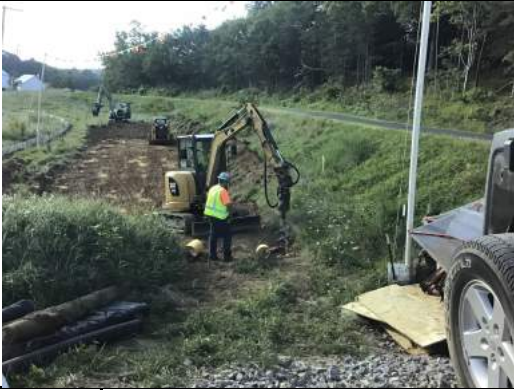
GPS Location	0000	GPS Location	0000		
Field Station#	13496+96	Field Station#	13496+96		
Pic 1 Desc.	Roberts Corrosion removing top soil to begin work on anode beds at CAHAS #2		Pic 2 Desc.	Roberts Corrosion removing top soil to begin work on anode beds at CAHAS #2

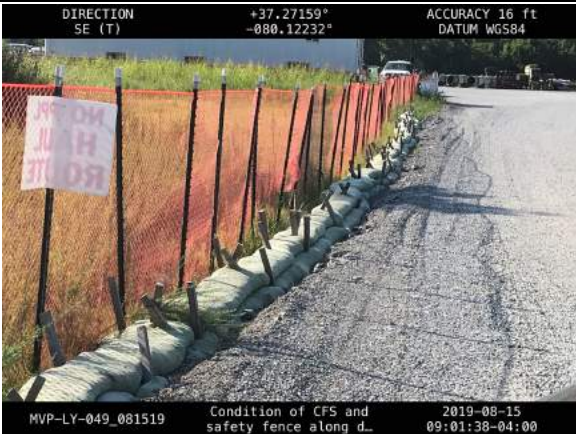
GPS Location	MVP-LY-049 See photo for gps data		GPS Location	MVP-LY-049 See photo for gps data	
Field Station#	+0		Field Station#	+0	
Pic 1 Desc.	Condition of CFS & safety fence. Looking SE		Pic 2 Desc.	No loose trash around E dumpster. Looking N

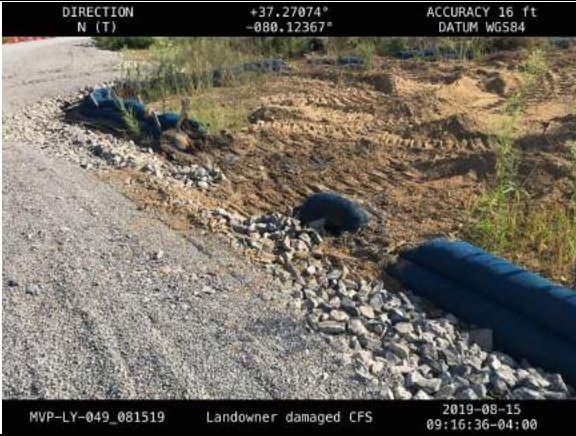
GPS Location	MVP-LY-049 See photo for gps data		GPS Location	MVP-LY-049 See photo for gps data	
Field Station#	+0		Field Station#	+0	
Pic 5 Desc.	3rd party damage to CFS. Looking N		Pic 6 Desc.	3rd party damage to CFS. Looking S.

4. E&S BMPs (List BMPs and note if installed and maintained as per the plan. If corrective action is needed, a picture is required.)						
E&S BMPs		Compliance Level	Corrective Action	Corrective Time Frame	Date Repaired	
Compost Filter Sock		Acceptable				
Housekeeping		Acceptable				
Rock Construction Entrance		Acceptable				
Secondary Containment		Acceptable				
Sensitive Resource Buffer		Acceptable				
Sensitive Resource Signage		Acceptable				
3rd Party Damages		Communication	Repair damaged CFS	24 Hours

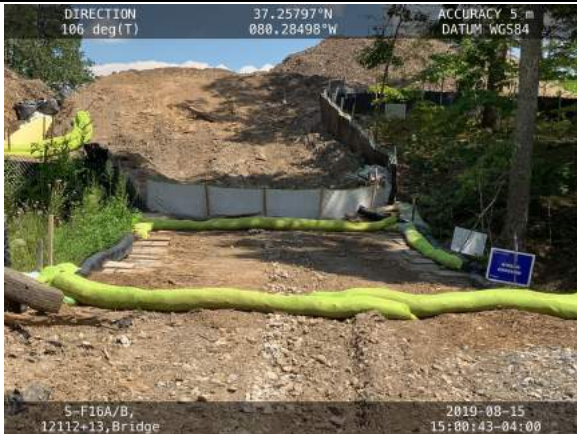
GPS Location	See photo GPS data		GPS Location	See photo GPS data	
Field Station#	12112+13		Field Station#	12098+44	
Pic 1 Desc.	S-F16A/B Bridge is in acceptable condition.		Pic 2 Desc.	Bridge/buffer/stream ECDs in good condition

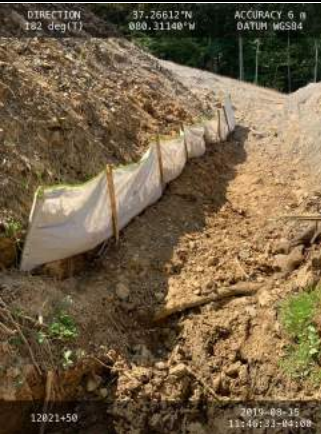
GPS Location	See photo GPS data		GPS Location	See photo GPS data	
Field Station#	12021+50		Field Station#	12022+50	
Pic 3 Desc.	P1 installed to prevent stockpile erosion		Pic 4 Desc.	Sump in acceptable condition at this time

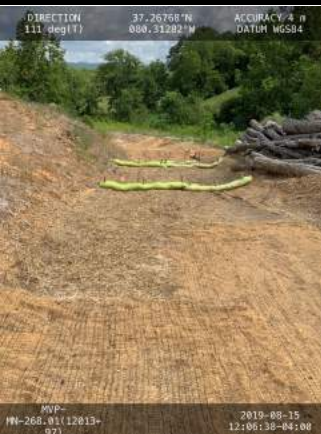
GPS Location	See photo GPS data		GPS Location	See photo GPS data	
Field Station#	12013+97		Field Station#	12013+97	
Pic 5 Desc.	New erosion blanket and 12" CFS		Pic 6 Desc.	Upstream side of bridge over S-G36.

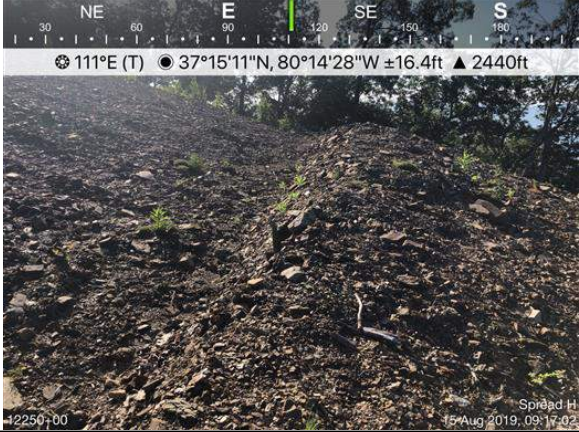
GPS Location	See Photo	GPS Location	See Photo		
Field Station#	12250+00	Field Station#	12282+00		
Pic 1 Desc.	Waterbars installed and functioning on this slope.	Pic 2 Desc.	Waterbars installed and functioning on slope leading to MVP-AR-276.03

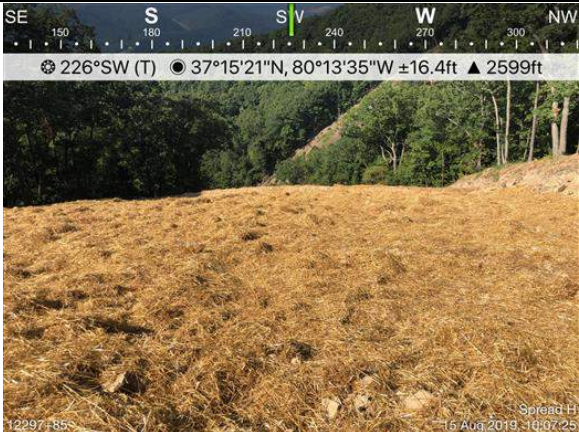
GPS Location	See Photo	GPS Location	See Photo		
Field Station#	12297+85	Field Station#	12329+63		
Pic 3 Desc.	"V" temporarily stabilized.	Pic 4 Desc.	Slope drains throughout this section have been improved using sandbags.

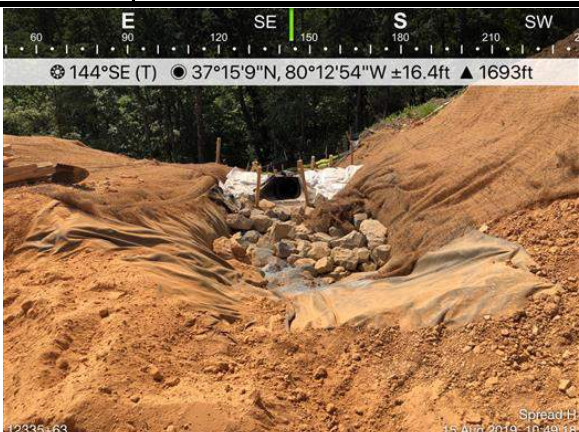
GPS Location	See Photo	GPS Location	See Photo		
Field Station#	12335+63	Field Station#	12361+00		
Pic 5 Desc.	Slope drain improvements cont'd.	Pic 6 Desc.	Trench relief sump installation per Tetrattech specs.

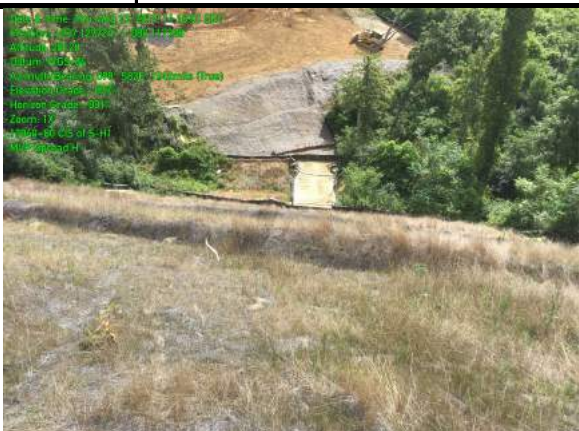
GPS Location	See pic for GPS location		GPS Location	See pic for GPS location	
Field Station#	12944+00		Field Station#	13040+80	
Pic 5 Desc.	GAS of US-221.		Pic 6 Desc.	Stream crossing S-H1. No impacts observed.

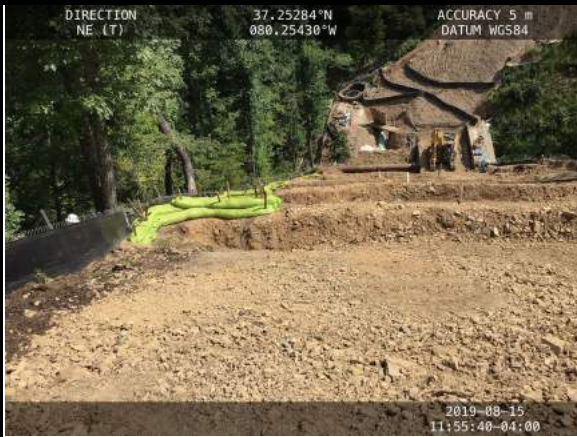
GPS Location	See photo		GPS Location	See photo	
Field Station#	12209+00		Field Station#	12228+00	
Pic 9 Desc.	New CFS end treatments were installed		Pic 10 Desc.	Fabric has fallen down on SSF

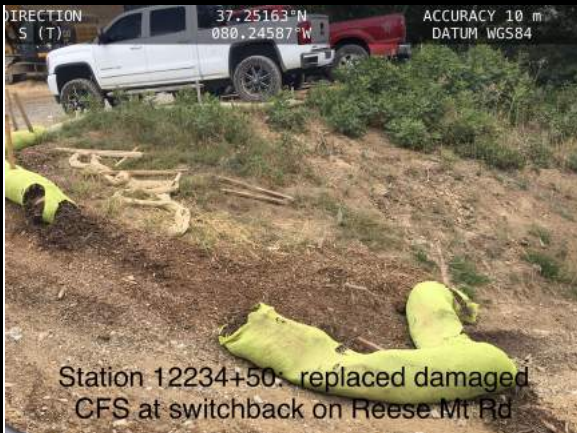
Insert image here		
GPS Location	See photo		GPS Location		
Field Station#	12234+50		Field Station#		
Pic 11 Desc.	CFS damaged @ switchback on AR276.03		Pic 12 Desc.

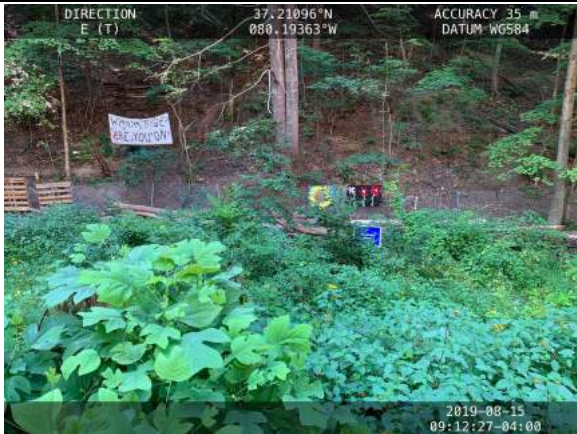
GPS Location	See picture for GPS		GPS Location	See picture for GPS data	
Field Station#	12543+56		Field Station#	12533+00	
Pic 1 Desc.	SSF materials stolen and used by opposition		Pic 2 Desc.	Clear water crossing outlet.

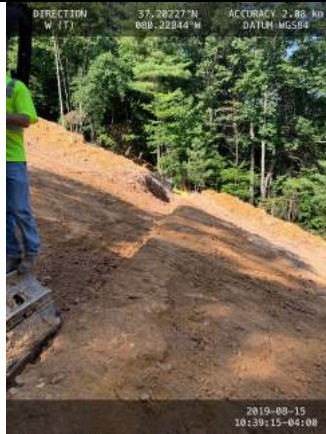
GPS Location	See picture for GPS data		GPS Location	See picture for GPS data	
Field Station#	12533+00		Field Station#	12521+50	
Pic 3 Desc.	Clear water entrance.		Pic 4 Desc.	Water bar rebuilt with positive drainage

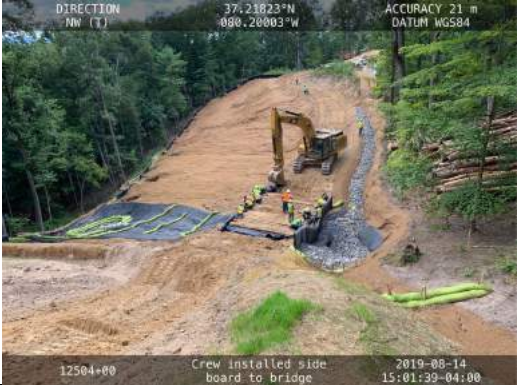
Insert image here			
GPS Location	See picture for GPS data		GPS Location		
Field Station#	12504+00		Field Station#		
Pic 7 Desc.	Crew installing geotech and side boards to the air bridge over the clean water crossing pipe.		Pic 8 Desc.		
Insert image here			Insert image here		
GPS Location			GPS Location		
Field Station#			Field Station#		
Pic 9 Desc.			Pic 10 Desc.		
Insert image here			Insert image here		
GPS Location			GPS Location		
Field Station#			Field Station#		
Pic 11 Desc.			Pic 12 Desc.
