Visual Site Inspection Report

Project Name	H-600 Pipeline Spread H	AFE	124300138	Spread	H-600 Pipeline Spread
Contractor	Precision			Report #	1114
Inspector	Logan Box			Date/Time	8/20/2019 8:22 PM
Permit #	TBD	Inspection Type	VA SWPP	Station Begin	13415+55
State	VA	Inspection Area	Partial	Station End	13670+00
County	Franklin	Ground	Dry	Temperature (°F)	93.00
Municipality	N/A	Weather	Sunny	Rain Gauge (in)	0.00
				Rain Accumulation Time (days)	0.00

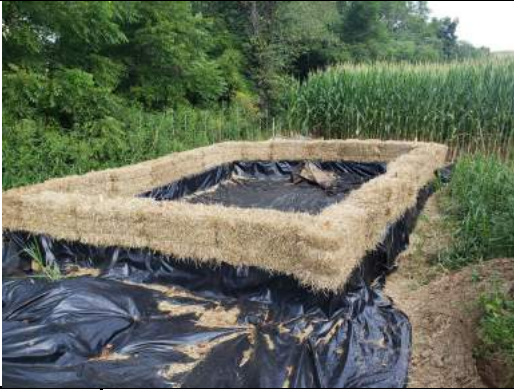
GPS Location	00000	GPS Location	00000		
Field Station#	13644+00	Field Station#	13643+63		
Pic 1 Desc.	Photo showing new de-water structure	Pic 2 Desc.	Row photo showing vegetation

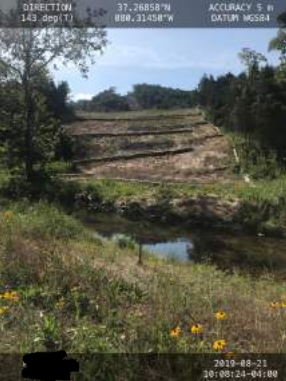
GPS Location	See photo GPS for location		GPS Location	See photo GPS for location	
Field Station#	12008+69		Field Station#	12031+51	
Pic 1 Desc.	.S-G36 and permanently restored ROW growing permanent vegetation.		Pic 2 Desc.	Bridge over S-G39 and coming in side.

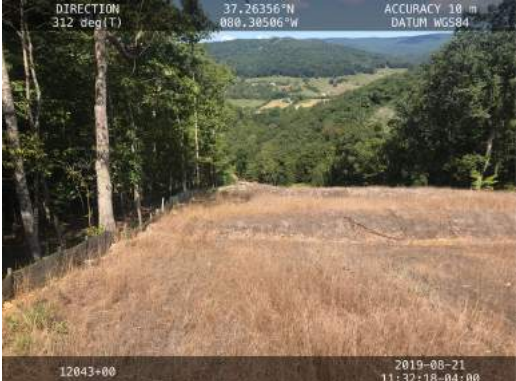
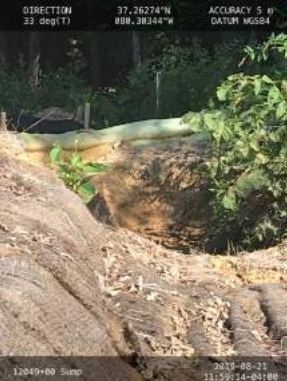
GPS Location	See photo GPS for location		GPS Location	See photo GPS for location	
Field Station#	12043+00		Field Station#	12049+00	
Pic 3 Desc.	CIS from 12043+00. Stable.		Pic 4 Desc.	Sump in good condition.

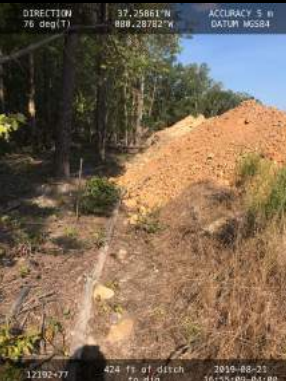
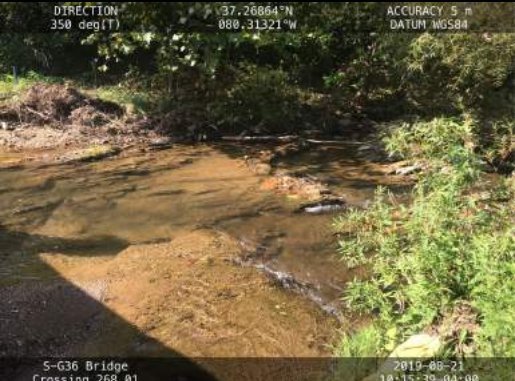
GPS Location	See photo GPS for location		GPS Location	See photo GPS for location	
Field Station#	12192+77		Field Station#	12013+97	
Pic 5 Desc.	Ditching soil piles within LOD.		Pic 6 Desc.	Downstream view from bridge over S-G36 on AR268.01.

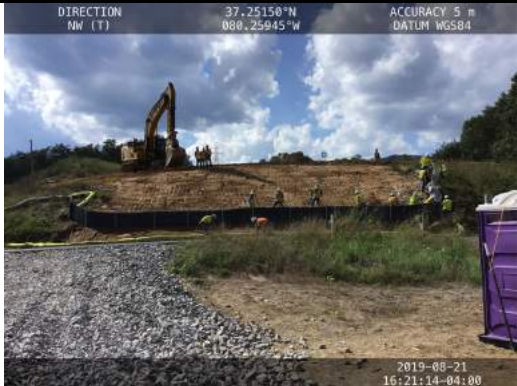
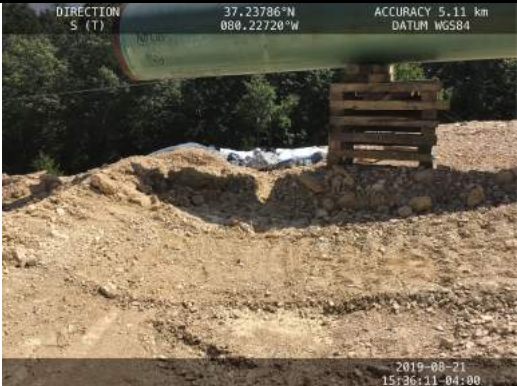
GPS Location	See photo		GPS Location	See photo	
Field Station#	12190+30		Field Station#	12161+00	
Pic 9 Desc.	Justin Jackson's crew restored grade at the road bank on the CIS of Bradshaw Road, and an env crew was there to stabilize.		Pic 10 Desc.	Clear the flow path of the waterbar below the staged pipe on the going away side of access road MVP-MN-273.	
Insert image here			Insert image here		
GPS Location			GPS Location		
Field Station#			Field Station#		
Pic 11 Desc.			Pic 12 Desc.

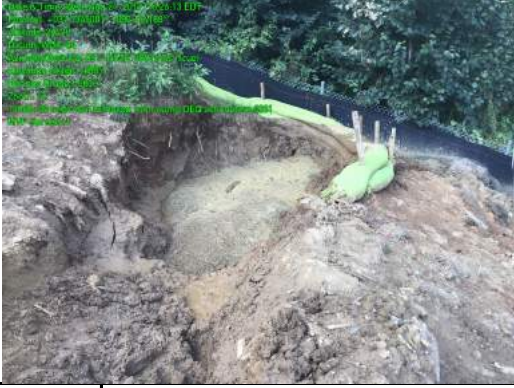
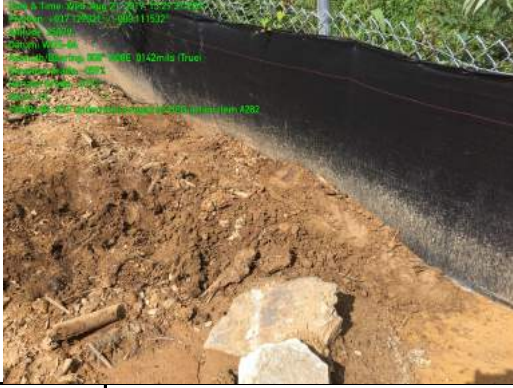
GPS Location	See pic for GPS location		GPS Location	See pic for GPS location	
Field Station#	13060+00		Field Station#	13060+00	
Pic 1 Desc.	DEQ action item Sediment removed from sump		Pic 2 Desc.	DEQ action item Undermined SSF repaired.

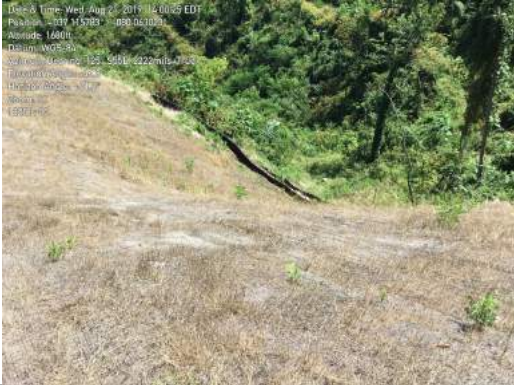
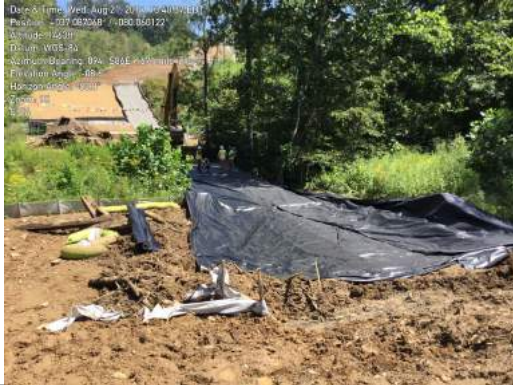
GPS Location	See Photo for Coordinates.	GPS Location	See Photo for Coordinates.		
Field Station#	13251+00	Field Station#	13260+00		
Pic 3 Desc.	ROW, existing soil migration area stable, perimeter ECDs functioning acceptably.	Pic 4 Desc.	S-II4, equipment bridge maintenance, environmental crew replacing geotech and mats.

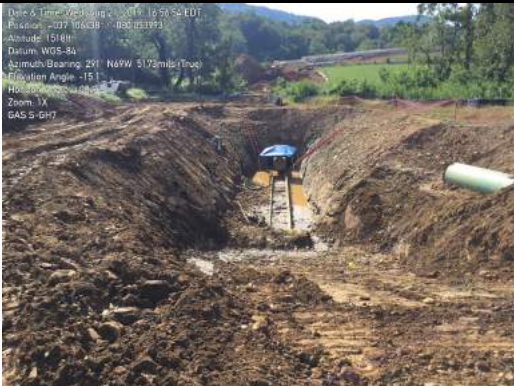
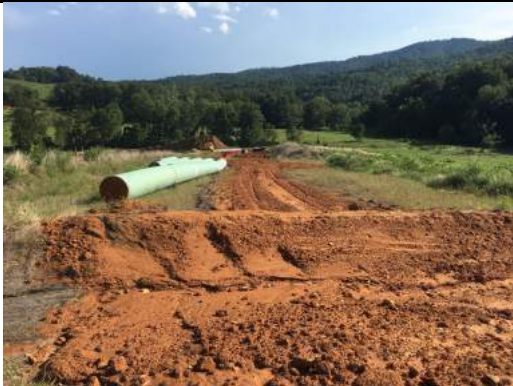
GPS Location	See Photo for Coordinates.	GPS Location	See Photo for Coordinates.		
Field Station#	13310+00	Field Station#	13300+00		
Pic 5 Desc.	S-GH7, GAS of stream crossing, bore pit.	Pic 6 Desc.	ROW, waterbars and sumps functioning acceptably, travel lane left open (not stabilized).
