Visual Site Inspection Report

Project Name	H-600 Pipeline Spread H	AFE	124300138	Spread	H-600 Pipeline Spread
Contractor	Precision			Report #	344
Inspector	Pat Davis			Date/Time	8/5/2019 8:32 AM
Permit #	TBD	Inspection Type	VA SWPP	Station Begin	13315+70
State	VA	Inspection Area	Partial	Station End	13415+51
County	Franklin	Ground	Dry	Temperature (°F)	85.00
Municipality	N/A	Weather	Cloudy	Rain Gauge (in)	0.00
				Rain Accumulation Time (days)	0.00

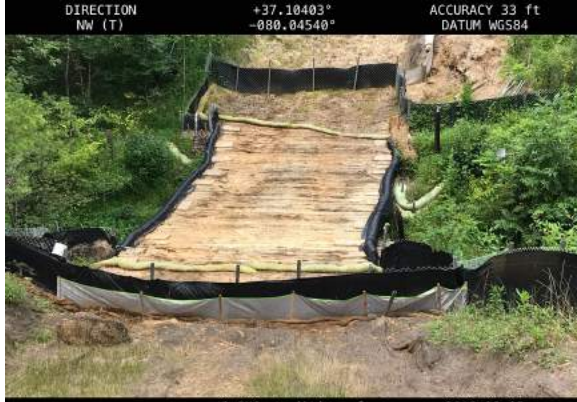
<p>DIRECTION NW (T) +37.10403° -080.04540° ACCURACY 33 ft DATUM WGS84</p> <p>13337+13_080519 S-GH9 condition of mat bridge 2019-08-05 14:10:57-04:00</p>

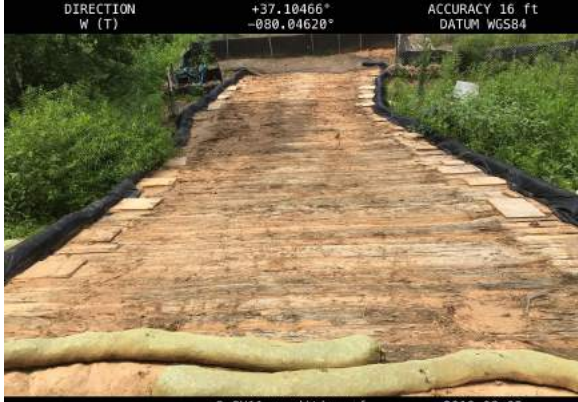
<p>DIRECTION W (T) +37.10466° -080.04620° ACCURACY 16 ft DATUM WGS84</p> <p>13334+17_080519 S-GH11 condition of mat bridge 2019-08-05 14:21:47-04:00</p>		
GPS Location	See photo for gps data		GPS Location	See photo for gps data	
Field Station#	13337+13		Field Station#	13334+17	
Pic 1 Desc.	S-GH9 condition of mat bridge. Looking NW.		Pic 2 Desc.	S-GH11 condition of mat bridge. Looking W.

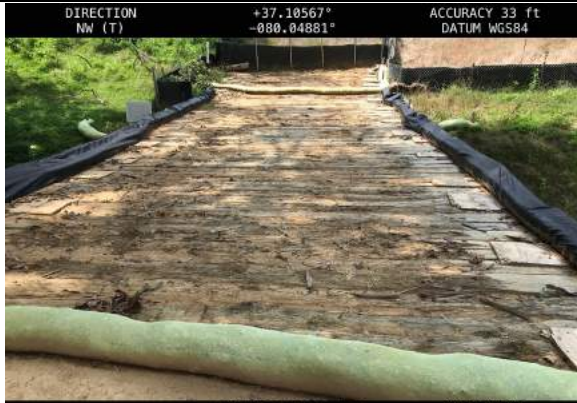
<p>DIRECTION NW (T) +37.10567° -080.04881° ACCURACY 33 ft DATUM WGS84</p> <p>13325+30_080519 S-GH14 condition of mat bridge 2019-08-05 15:12:49-04:00</p>

GPS Location	See photo for gps data		GPS Location	See photo for gps data	
Field Station#	13325+30		Field Station#	13321+47	
Pic 3 Desc.	S-GH14 condition of mat bridge. Looking NW.		Pic 4 Desc.	S-GH15 condition of mat bridge. Looking W.

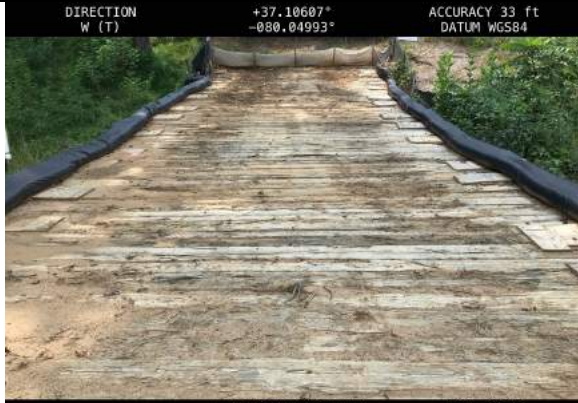
<p>DIRECTION W (T) +37.10607° -080.04993° ACCURACY 33 ft DATUM WGS84</p> <p>13321+47_080519 S-GH15 condition of containment 2019-08-05 15:40:13-04:00</p>

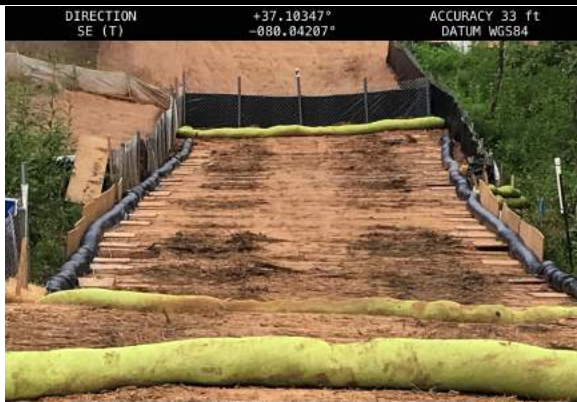
<p>DIRECTION SE (T) +37.10347° -080.04207° ACCURACY 33 ft DATUM WGS84</p> <p>13348+40_080519 S-RR08 condition of mat bridge 2019-08-05 17:14:47-04:00</p>

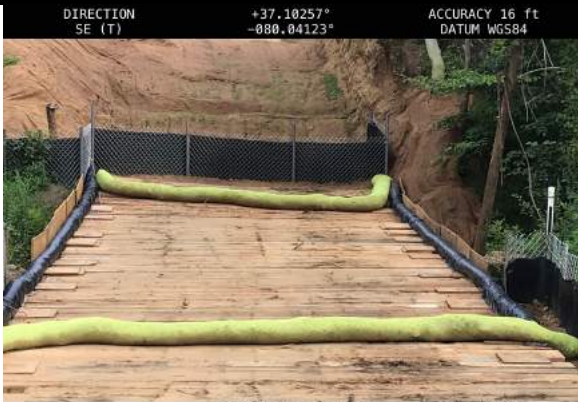
<p>DIRECTION SE (T) +37.10257° -080.04123° ACCURACY 16 ft DATUM WGS84</p> <p>13352+23_080519 S-RR09 condition of mat bridge 2019-08-05 17:23:10-04:00</p>		
GPS Location	See photo for gps data		GPS Location	See photo for gps data	
Field Station#	13348+40		Field Station#	13352+23	
Pic 5 Desc.	S-RR08 condition of mat bridge. Looking SE.		Pic 6 Desc.	S-RR09 condition of mat bridge. Looking SE.

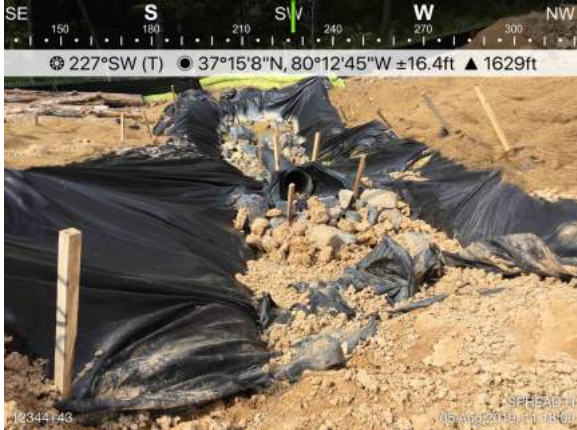
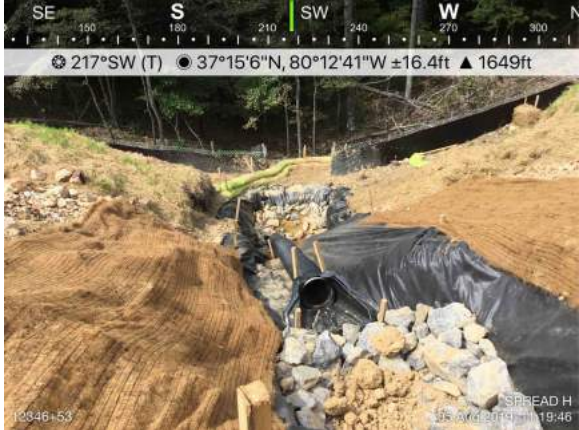
GPS Location	37 15,8 N 80 12,45 W		GPS Location	37 15,6 N 80 12,41 W	
Field Station#	12344+43		Field Station#	12346+53	
Pic 1 Desc.	Filter fabric should be cleared of dirt and sediment and keyed in better where needed		Pic 2 Desc.	Sump is too shallow for grade of slope. CFS will continue to be overtopped if sump isn't

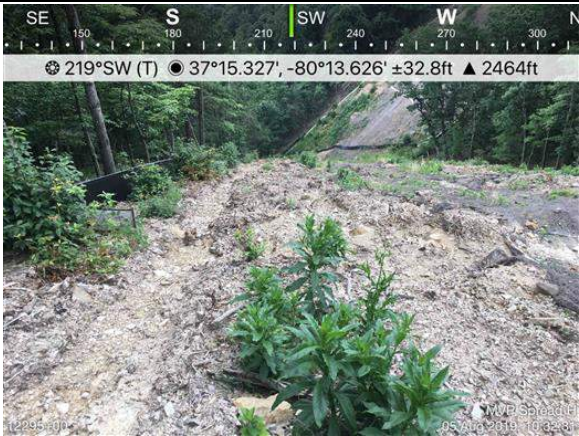
GPS Location	See picture watermark	GPS Location	See picture watermark		
Field Station#	12295+00	Field Station#	12295+00		
Pic 1 Desc.	Waterbar needs rebuilt/maintenance	Pic 2 Desc.	Waterbar inadequate/needs rebuild

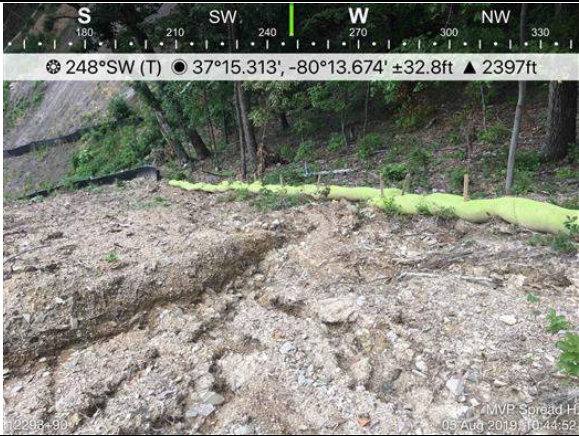
GPS Location	See picture watermark	GPS Location	See picture watermark		
Field Station#	12293+90	Field Station#	12292+00		
Pic 3 Desc.	Eroded waterbar at edge of LOD.	Pic 4 Desc.	SSF not entrenched properly.

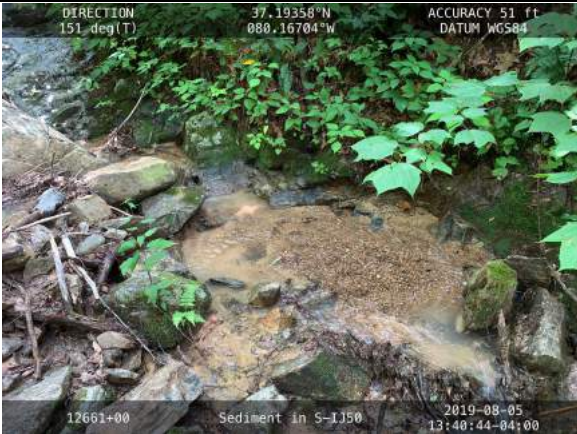
<div>12661+00 Sediment in S-IJ50 2019-08-05 13:40:44-04:00</div>			<div>DIRECTION 103 deg(T) 37.19382°N 080.16754°W ACCURACY 389 ft DATUM WGS84</div>

GPS Location	See photo for gps location		GPS Location	See photo for gps location.	
Field Station#	12661+00		Field Station#	12661+00	
Pic 3 Desc.	Sediment in S-IJ50		Pic 4 Desc.	Retrieving sediment from S-IJ50	
<div>DIRECTION 294 deg(T) 37.19877°N 080.15365°W ACCURACY 68 ft DATUM WGS84</div>

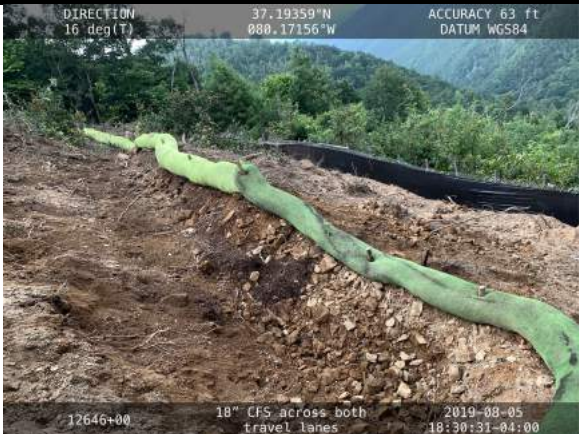
<div>12646+00 18" CFS across both travel lanes 2019-08-05 18:30:31-04:00</div>		
GPS Location	See photo for gps location		GPS Location	See photo for gps location	
Field Station#	12701+72		Field Station#	12646+00	
Pic 5 Desc.	ROW condition, cleared, grubbing incomplete		Pic 6 Desc.	18" CFS across disturbed areas.

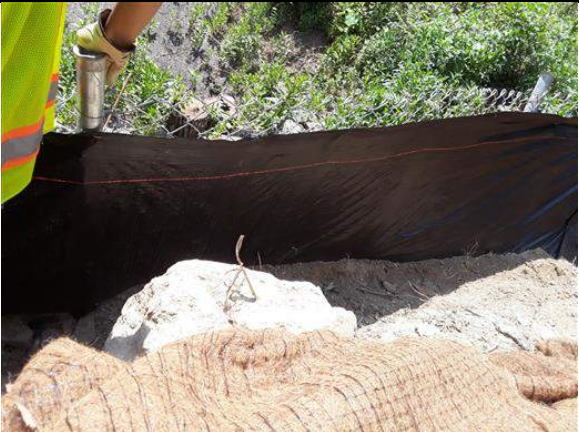
GPS Location	See picture watermark	GPS Location	N/A		
Field Station#	12290+00	Field Station#	12291+50		
Pic 5 Desc.	CIS "V" controls/stabilization functional.	Pic 6 Desc.	Repaired SSF at bottom GAS "V"

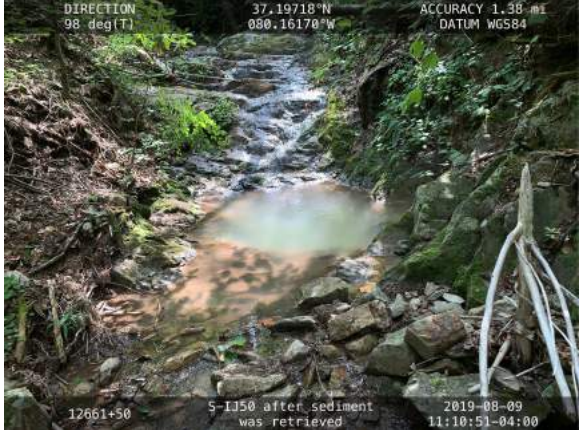
GPS Location	See photo for gps data.		GPS Location	See photo for gps data.	
Field Station#	12644+00		Field Station#	12661+50	
Pic 1 Desc.	Triple stacked 18" CFS ROW diversions		Pic 2 Desc.	Stream after sediment retrieval

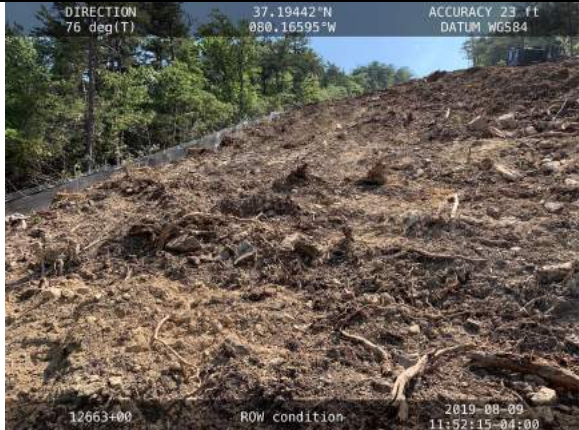
GPS Location	See photo for gps data.		GPS Location	See photo for gps data.	
Field Station#	12663+00		Field Station#	12663+00	
Pic 3 Desc.	SSF across ROW near end of disturbance.		Pic 4 Desc.	ROW condition, not grubbed or topsoiled

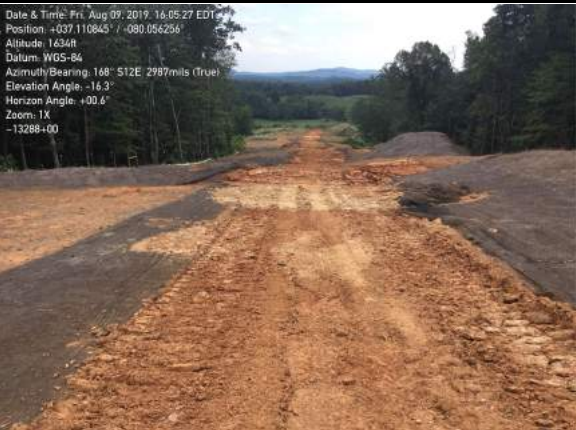
GPS Location	See photo for coordinates.		GPS Location	See photo for coordinates.	
Field Station#	13288+99		Field Station#	13309+09	
Pic 5 Desc.	Travel lane not stabilized.		Pic 6 Desc.	S-GH7, no environmental issues noted.
