Visual Site Inspection Report

Project Name	H-600 Pipeline Spread H	AFE	124300138	Spread	H-600 Pipeline Spread	
Contractor	Precision			Report #	100312	
Inspector	Pat Davis			Date/Time	9/15/2019 8:53 AM	
Permit #	TBD	Inspection Type	VA SWPP	Station Begin	+0	
State	VA	Inspection Area	Partial	Station End	+0	
County	Roanoke	Ground	Wet	Temperature (°F)	81.00	
Municipality	N/A	Weather	Sunny	Rain Gauge (in)	0.30	
				Rain Accumulation Time (days)	0.00

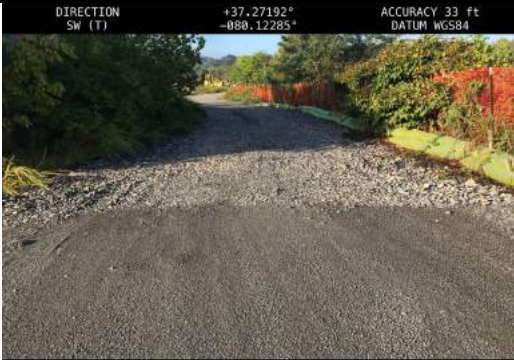
<p>DIRECTION SW (T) +37.27192° -080.12285° ACCURACY 33 ft DATUM WGS84</p> <p>MVP-LY-049_091519 Rock entrance on North drive 2019-09-15 08:19:38-04:00</p>			  <p>DIRECTION SE (T) +37.27157° -080.12233° ACCURACY 16 ft DATUM WGS84</p> <p>MVP-LY-049_091519 CFS & safety fence along drive 2019-09-15 08:20:23-04:00</p>	
GPS Location	MVP-LY-049 See photo for gps data		GPS Location	MVP-LY-049 See photo for gps data	
Field Station#	+0		Field Station#	+0	
Pic 1 Desc.	Condition of rock entrance on north drive. Looking SW		Pic 2 Desc.	Condition of CFS and safety fence along center drive. Looking SE

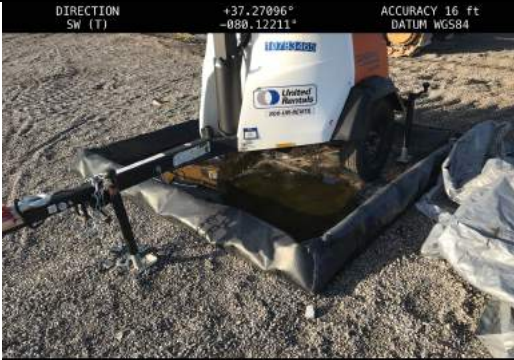
<p>DIRECTION SW (T) +37.27096° -080.12211° ACCURACY 16 ft DATUM WGS84</p> <p>MVP-LY-049_091519 Condition of containment 2019-09-15 08:21:01-04:00</p>			  <p>DIRECTION N (T) +37.27152° -080.12053° ACCURACY 16 ft DATUM WGS84</p> <p>MVP-LY-049_091519 Condition of trays & containment 2019-09-15 08:22:09-04:00</p>

GPS Location	MVP-LY-049 See photo for gps data		GPS Location	MVP-LY-049 See photo for gps data	
Field Station#	+0		Field Station#	+0	
Pic 3 Desc.	Condition of containment under light plant. Looking SW.		Pic 4 Desc.	Condition of trays and containment under toilets. Looking N.

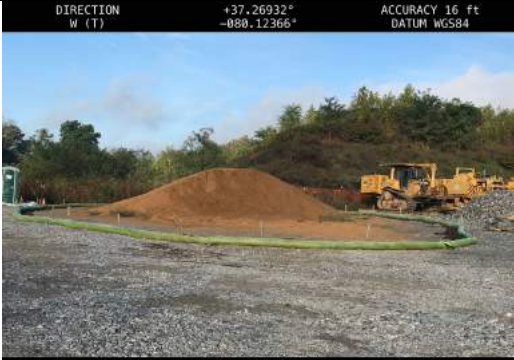
<p>DIRECTION W (T) +37.26932° -080.12366° ACCURACY 16 ft DATUM WGS84</p> <p>MVP-LY-049_091519 Condition of CFS around sand pile 2019-09-15 08:28:38-04:00</p>			  <p>DIRECTION N (T) +37.26982° -080.12351° ACCURACY 16 ft DATUM WGS84</p> <p>MVP-LY-049_091519 No loose trash around W dumpster 2019-09-15 08:28:56-04:00</p>	
GPS Location	MVP-LY-049 See photo for gps data		GPS Location	MVP-LY-049 See photo for gps data	
Field Station#	+0		Field Station#	+0	
Pic 5 Desc.	Condition of CFS along sand pile. Looking W.		Pic 6 Desc.	No loose trash around West dumpster. Looking N.

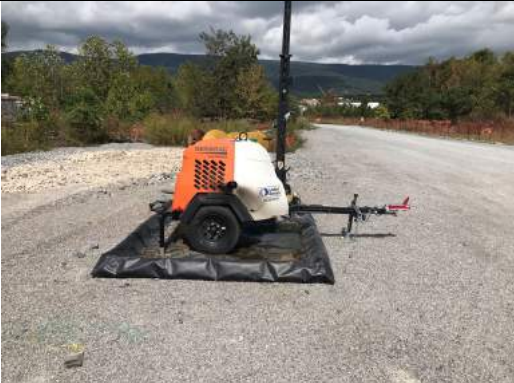
GPS Location	No GPS Data		GPS Location	No GPS Data	
Field Station#	0+00		Field Station#	0+00	
Pic 1 Desc.	Entrance perimeter compost filter sock in place and functional.		Pic 2 Desc.	Secondary containment under light plant found to be in good condition.

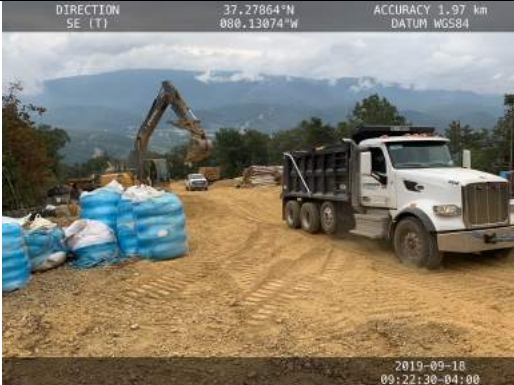
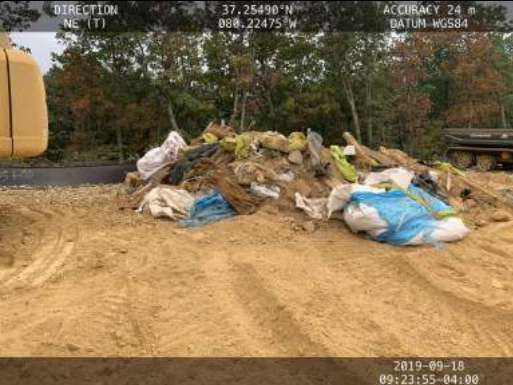
GPS Location	See picture for GPS data		GPS Location	See picture for GPS data	
Field Station#	12330+00		Field Station#	12330+00	
Pic 1 Desc.	Environmental crew hauling off trash		Pic 2 Desc.	Pile of construction debris to be hauled off.

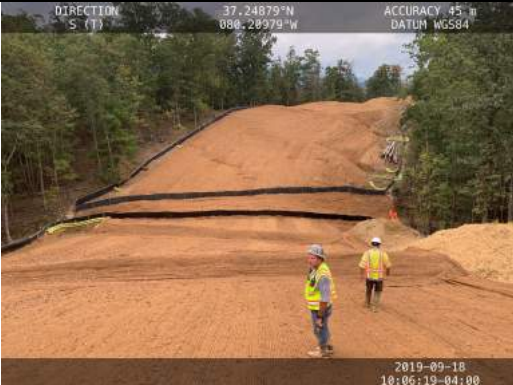
GPS Location	See picture for GPS data		GPS Location	See picture for GPS data	
Field Station#	12345+00		Field Station#	12361+02	
Pic 3 Desc.	Excavator installing temporary waterbars		Pic 4 Desc.	Stabilized ROW with landowner access crossing.

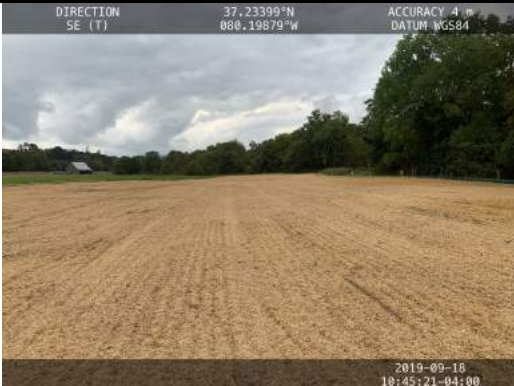
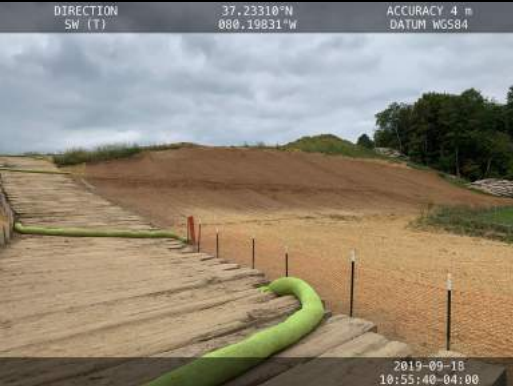
GPS Location	See picture for GPS data.		GPS Location	See picture for GPS data	
Field Station#	12433+87		Field Station#	12437+70	
Pic 5 Desc.	Stabilized ATWS after being crimped in.		Pic 6 Desc.	Stabilized hill side.

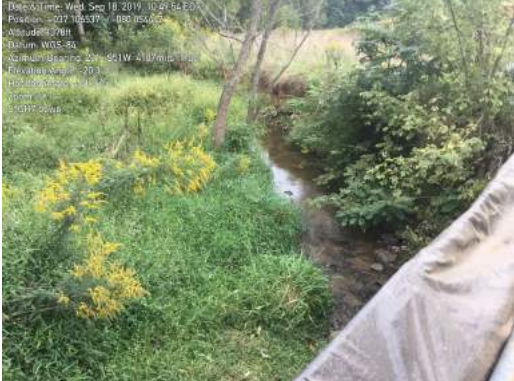
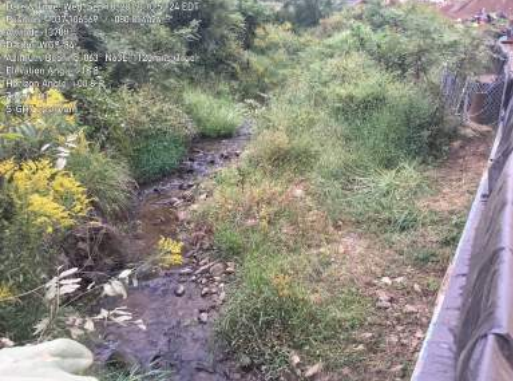
GPS Location	See photo for coordinates.		GPS Location	See photo for coordinates.	
Field Station#	13309+09		Field Station#	13309+09	
Pic 1 Desc.	S-GH7, looking downstream of equipment bridge, no turbidity noted, no changes observed to steam bed or banks.		Pic 2 Desc.	S-GH7, looking upstream of equipment bridge, no turbidity noted, no changes to stream bed or banks, no environmental issues.

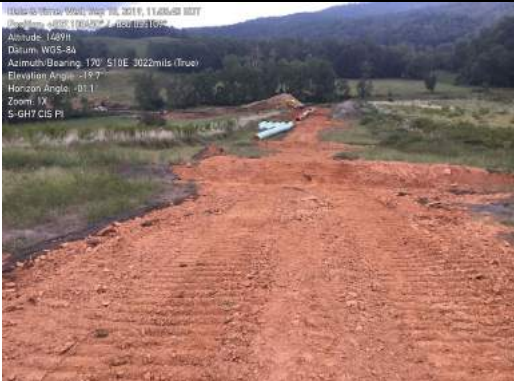
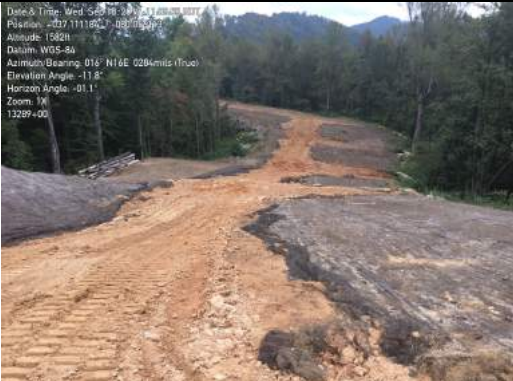
GPS Location	See photo for coordinates.		GPS Location	See photo for coordinates.	
Field Station#	13300+00		Field Station#	13289+00	
Pic 3 Desc.	ROW, travel lane not stabilized, waterbars, sumps and outlet protection functioning acceptably.		Pic 4 Desc.	ROW, soil piles and areas outside travel lane stable, with curlex and sparse vegetation.

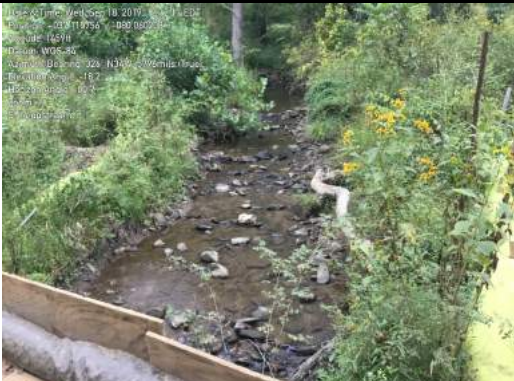
Field Station#	13260+70		Field Station#	13261+00	
Pic 5 Desc.	S-II4, looking upstream of equipment bridge, ECDs functioning acceptably, no environmental issues noted at stream.		Pic 6 Desc.	S-II4, equipment bridge in good condition, no holes noted in geotech.

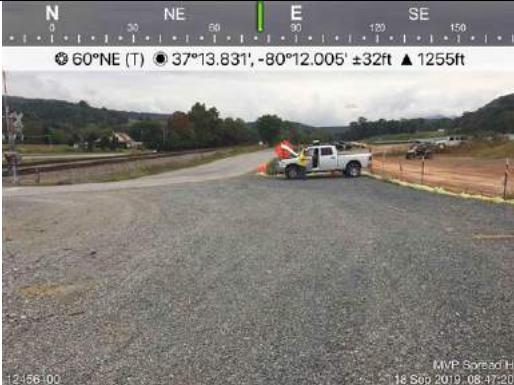
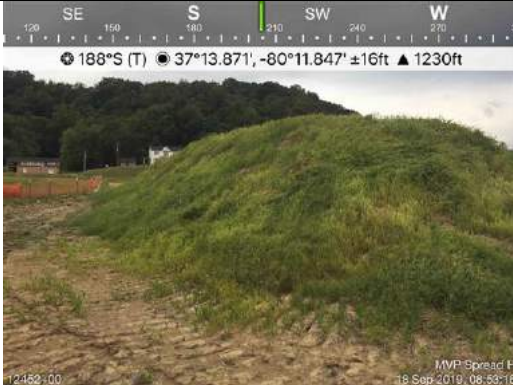
GPS Location	See picture watermark		GPS Location	See picture watermark	
Field Station#	12456+00		Field Station#	12452+00	
Pic 1 Desc.	Rock construction entrance at Route 11/Cove Hollow Rd.		Pic 2 Desc.	Temporary stabilization of stockpiles near GAS Route 11 bore location.

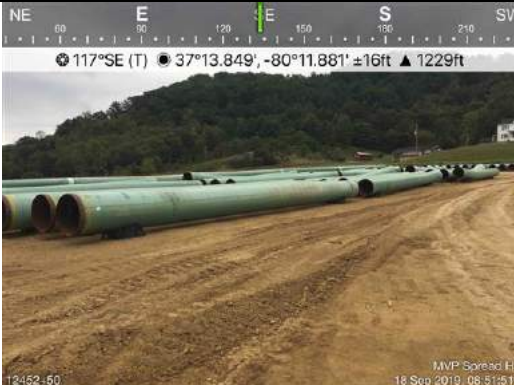
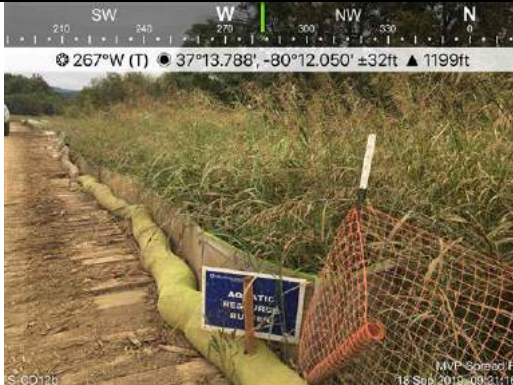
GPS Location	See picture watermark		GPS Location	See picture watermark	
Field Station#	12452+50		Field Station#	12460+00	
Pic 3 Desc.	Pipe storage area on GAS Route 11.		Pic 4 Desc.	Resource protection buffer in good condition at S-CD12b.

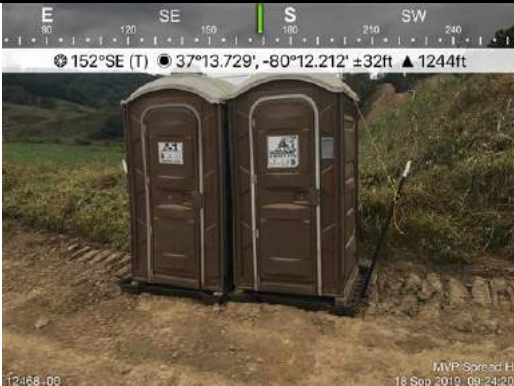
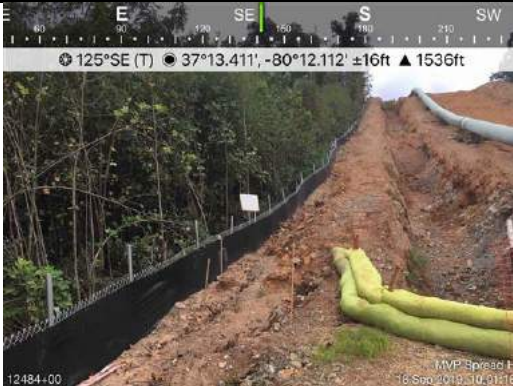
GPS Location	See picture watermark		GPS Location	See picture watermark	
Field Station#	12468+00		Field Station#	12484+00	
Pic 5 Desc.	Secondary containment under permanent portable toilets on ROW.		Pic 6 Desc.	SSF installed and in good functional condition.

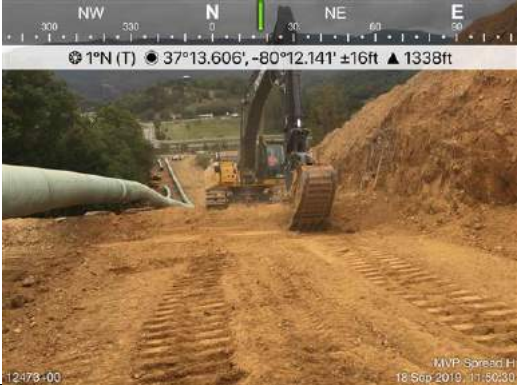
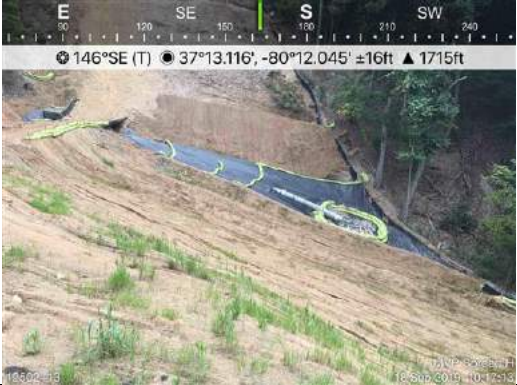
GPS Location	See picture watermark		GPS Location	See picture watermark	
Field Station#	12473+00		Field Station#	12503+00	
Pic 13 Desc.	Travel lane waterbars being restored after sump pit maintenance and pig burial site work.		Pic 14 Desc.	Temporary stabilization of drainage area around CWD. Vegetation has begun to germinate.

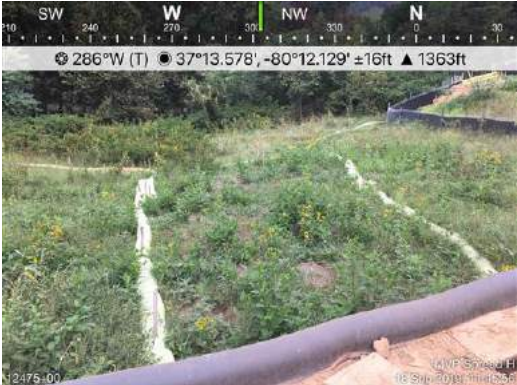
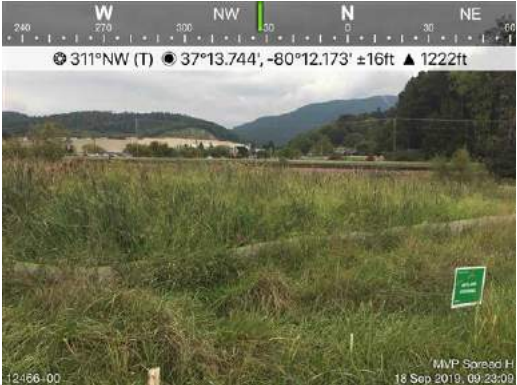
GPS Location	See picture watermark		GPS Location	See picture watermark	
Field Station#	12475+00		Field Station#	12466+00	
Pic 15 Desc.	Drainage feature buffer area and controls in good condition.		Pic 16 Desc.	Wetland resource buffer signage and controls in good condition at W-KL58.

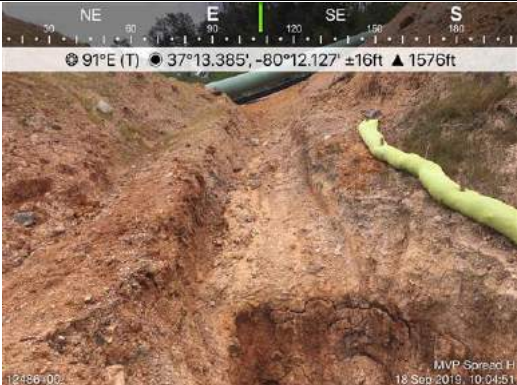
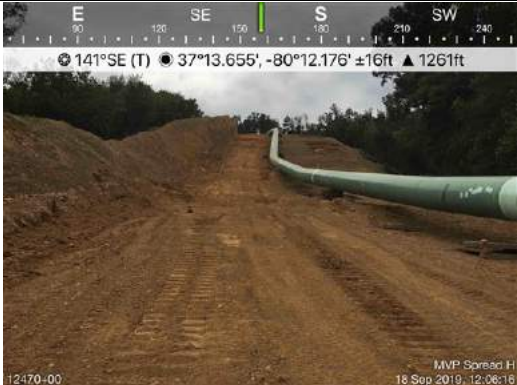
GPS Location	See picture watermark		GPS Location	See picture watermark	
Field Station#	12486+00		Field Station#	12470+00	
Pic 17 Desc.	In spec waterbar along ROW.		Pic 18 Desc.	Travel lane waterbars that were disturbed have been restored. No further work expected in area today.

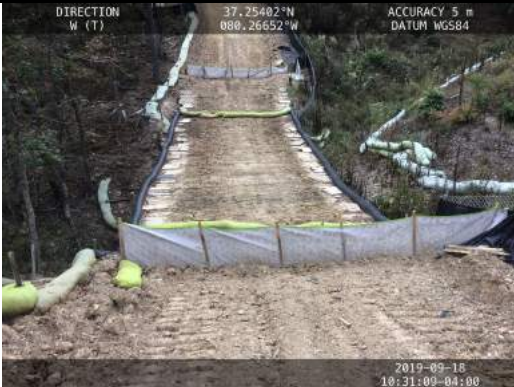
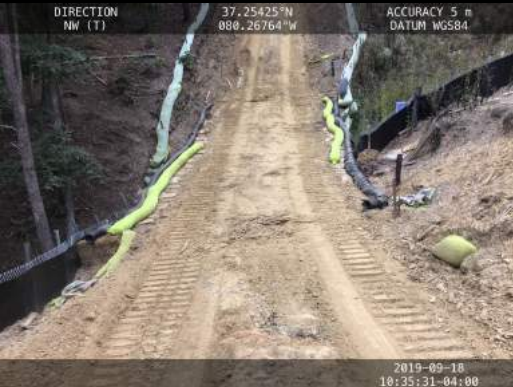
GPS Location	See photo		GPS Location	See photo	
Field Station#	12166+47		Field Station#	12163+05	
Pic 1 Desc.	Stream S-C24, facing west		Pic 2 Desc.	Stream S-C25, facing west

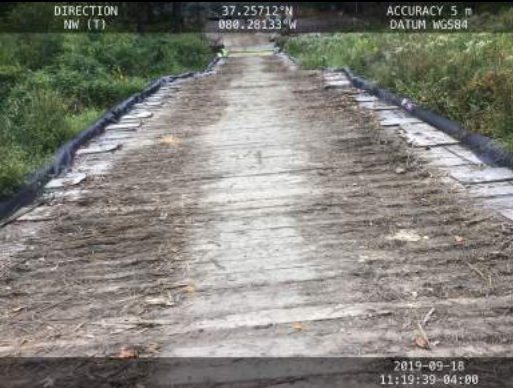
GPS Location	See photo		GPS Location	See photo	
Field Station#	12125+65		Field Station#	12121+82	
Pic 5 Desc.	Stream S-MM31, facing west		Pic 6 Desc.	Stream S-C36, facing west

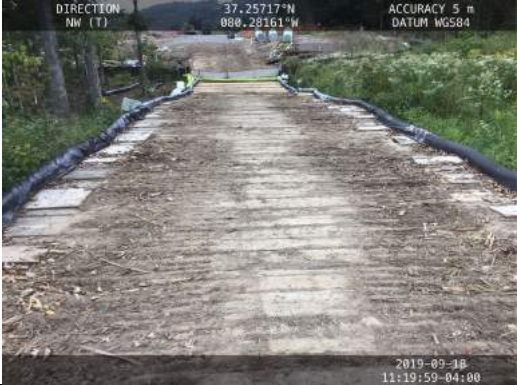
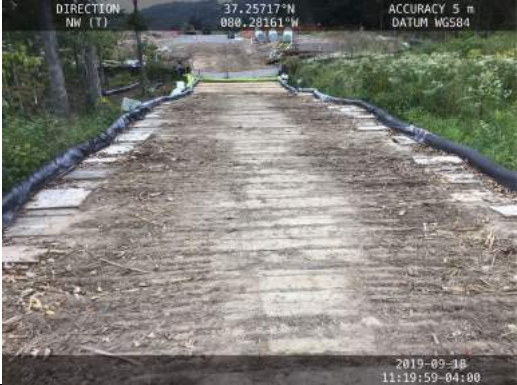
GPS Location	See photo		GPS Location	See photo	
Field Station#	12121+33		Field Station#	12210+00	
Pic 7 Desc.	Stream S-C33, facing west		Pic 8 Desc.	Vegetation is slowly developing on the recently stabilized slope on the coming in side of the ravine between Bradshaw Rd & Reese Mt.

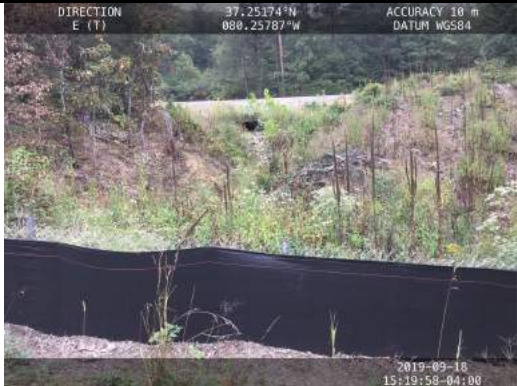
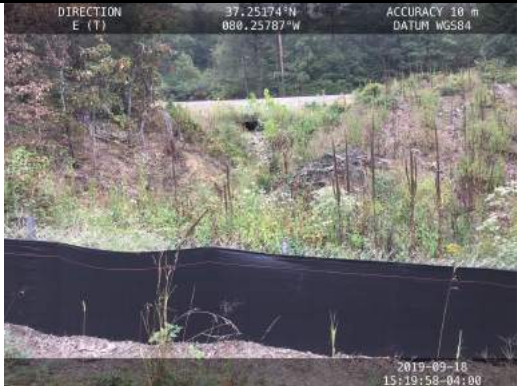
GPS Location	See photo		GPS Location	See photo	
Field Station#	12196+25		Field Station#	12193+50	
Pic 9 Desc.	Stream S-OO11, facing east		Pic 10 Desc.	Buffer zone and bridge of stream S-C21, Bradshaw Creek, facing west.

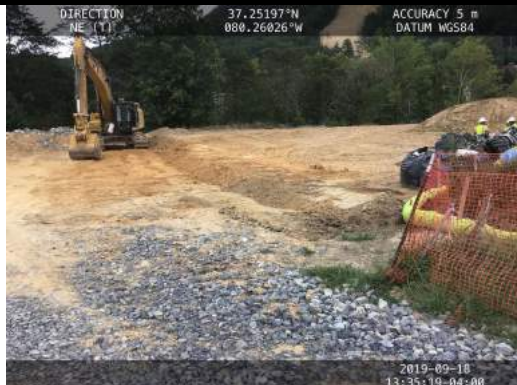
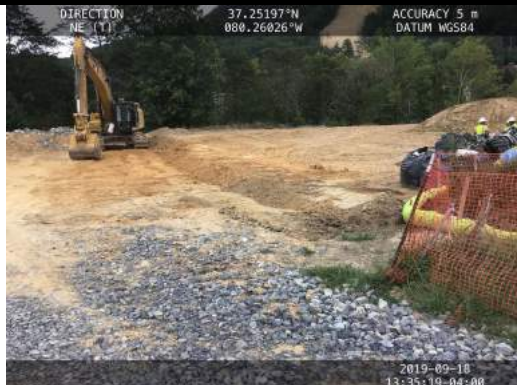
GPS Location	See photo		GPS Location	See photo	
Field Station#	12189+00		Field Station#	12189+00	
Pic 11 Desc.	Another waterbar was built per DEQ/MBP action item immediately to the going away side of where AR 274 meets the ROW.		Pic 12 Desc.	ROW was temporarily stabilized per DEQ/MBP action item between AR 274 and the top of the road bank of Bradshaw Road.

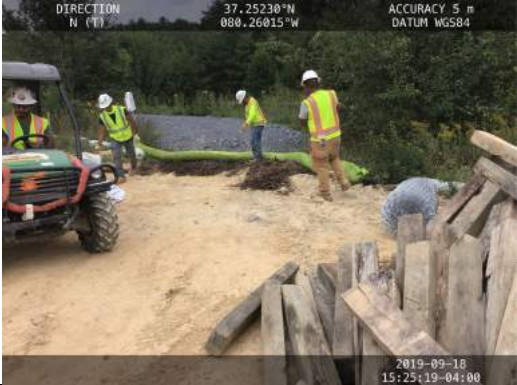
E&S BMPs	Compliance Level	Corrective Action	Corrective Time Frame	Date Repaired
Compost Filter Sock	Communication	12188+00: damaged CFS	Addressed	9/18/2019
Silt Fence (Filter Fabric Fence)	Acceptable			
Silt Fence (Reinforced Filter Fabric Fence)	Acceptable			
Waterbar	Acceptable			
Waterbar End Treatment	Acceptable			
Sump Pit	Acceptable			
Rock Construction Entrance	Acceptable			
Erosion Control Blanket	Acceptable			
Housekeeping	Acceptable

Insert image here			
GPS Location	See photo	GPS Location			
Field Station#	12188+00	Field Station#			
Pic 13 Desc.	Damaged CFS was replaced per DEQ/MBP action item across the AEP access road.	Pic 14 Desc.			
Insert image here		Insert image here			
GPS Location		GPS Location			
Field Station#		Field Station#			
Pic 15 Desc.		Pic 16 Desc.			
Insert image here		Insert image here			
GPS Location		GPS Location			
Field Station#		Field Station#			
Pic 17 Desc.		Pic 18 Desc.

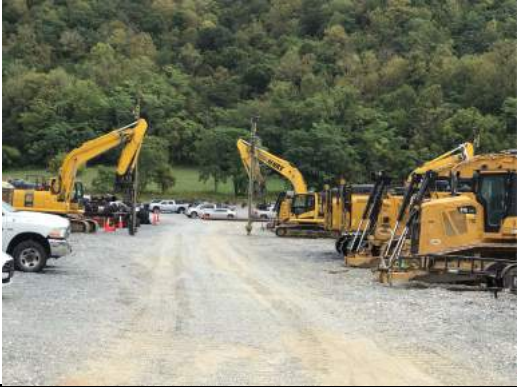
GPS Location	No GPS data		GPS Location		
Field Station#	+0		Field Station#		
Pic 7 Desc.	MVP-PY-006 maintained rock surface		Pic 8 Desc.		
Insert image here			Insert image here		
GPS Location			GPS Location		
Field Station#			Field Station#		
Pic 9 Desc.			Pic 10 Desc.		
Insert image here			Insert image here		
GPS Location			GPS Location		
Field Station#			Field Station#		
Pic 11 Desc.			Pic 12 Desc.
