Visual Site Inspection Report

Project Name	H-600 Pipeline Spread H	AFE	124300138	Spread	H-600 Pipeline Spread
Contractor	Precision			Report #	100377
Inspector	Jason Nielsen			Date/Time	9/24/2019 7:21 PM
Permit #	TBD	Inspection Type	VA SWPP	Station Begin	12234+50
State	VA	Inspection Area	Partial	Station End	12448+01
County	Montgomery	Ground	Dry	Temperature (°F)	83.00
Municipality	N/A	Weather	Sunny	Rain Gauge (in)	0.00
				Rain Accumulation Time (days)	0.00

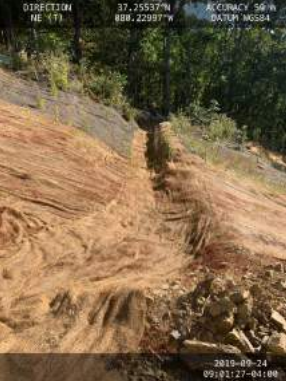
GPS Location	See picture for GPS data		GPS Location	See picture for GPS data	
Field Station#	12286+00		Field Station#	12291+64	
Pic 1 Desc.	Waterbar crossing the stabilized ROW.		Pic 2 Desc.	Well vegetated clear water crossing.

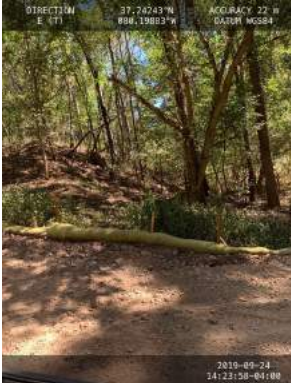
Insert image here		Insert image here	
GPS Location	See picture for GPS data		GPS Location		
Field Station#	12409+39		Field Station#		
Pic 7 Desc.	CFS replaced and repaired.		Pic 8 Desc.		
Insert image here		Insert image here		Insert image here	
GPS Location			GPS Location		
Field Station#			Field Station#		
Pic 9 Desc.			Pic 10 Desc.		
Insert image here		Insert image here		Insert image here	
GPS Location			GPS Location		
Field Station#			Field Station#		
Pic 11 Desc.			Pic 12 Desc.

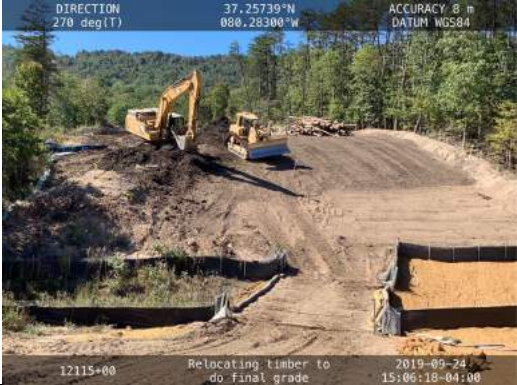
GPS Location	See photo GPS for location		GPS Location	See photo GPS for location	
Field Station#	12115+00		Field Station#	12015+84	
Pic 7 Desc.	Permanent restoration in progress.		Pic 8 Desc.	Seeded and blanketed area has not sprouted yet on GAS of S-G38, but is stable waiting for aerial seeding of soil piles.

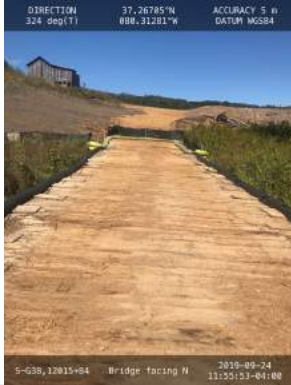
GPS Location	See photo GPS for location		GPS Location	See photo GPS for location	
Field Station#	12015+84		Field Station#	12013+97	
Pic 9 Desc.	Bridge is in good condition and seed and mulch are in place waiting for rain.		Pic 10 Desc.	Sump along Access road is in good condition.	
Insert image here			Insert image here		
GPS Location			GPS Location		
Field Station#			Field Station#		
Pic 11 Desc.			Pic 12 Desc.

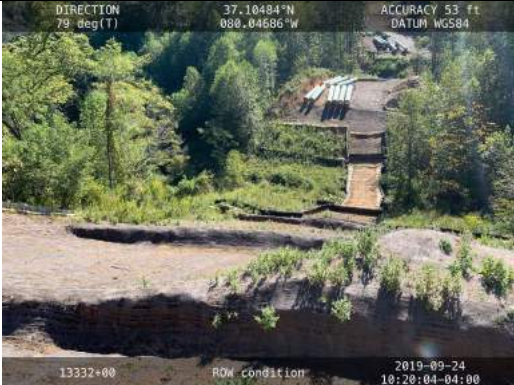
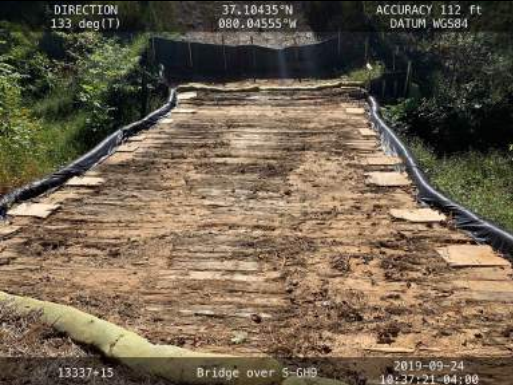
GPS Location	See photo for gps data.		GPS Location	See photo for gps data.	
Field Station#	13332+00		Field Station#	13337+15	
Pic 1 Desc.	Photo shows the ROW condition from about 13332+00 to 13334+00.		Pic 2 Desc.	Photo shows the bridge over stream S-GH9.

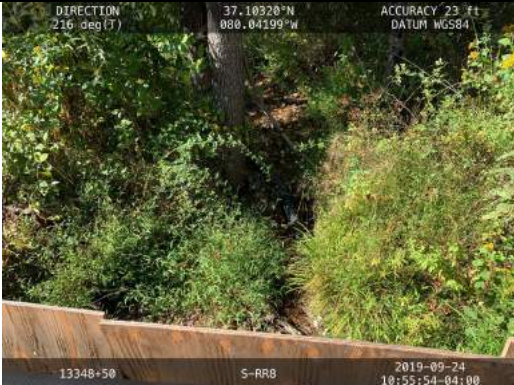
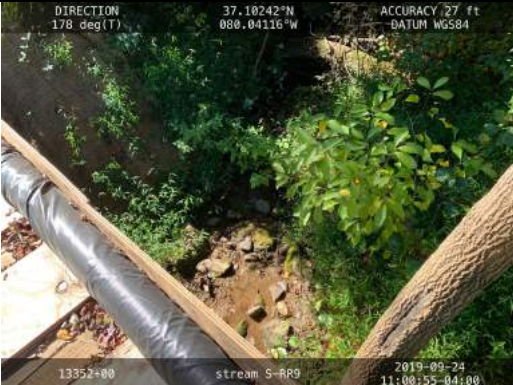
GPS Location	See photo for gps data.		GPS Location	See photo for gps data.	
Field Station#	13348+50		Field Station#	13352+00	
Pic 3 Desc.	Photo shows stream S-RR08		Pic 4 Desc.	Photo shows stream S-RR09.

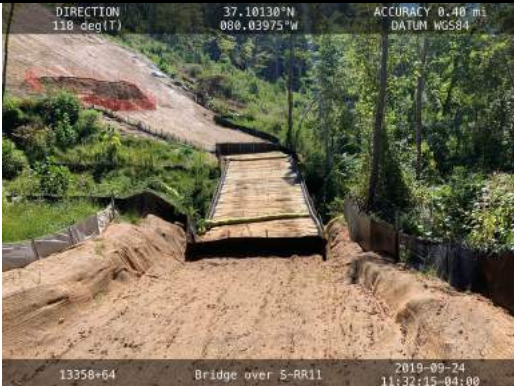
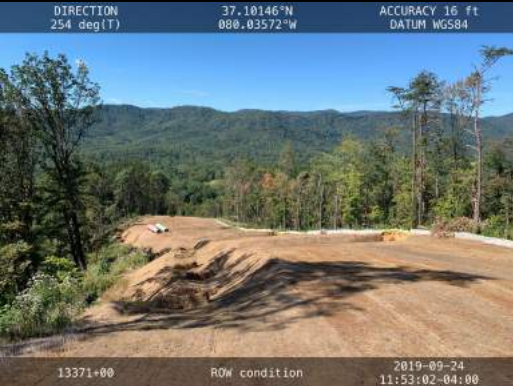
GPS Location	See photo for gps data.		GPS Location	See photo for gps data.	
Field Station#	13358+64		Field Station#	13371+00	
Pic 5 Desc.	Photo shows the bridge over stream S-RR11.		Pic 6 Desc.	Photo shows the ROW condition from about 13368+00 to 13371+00

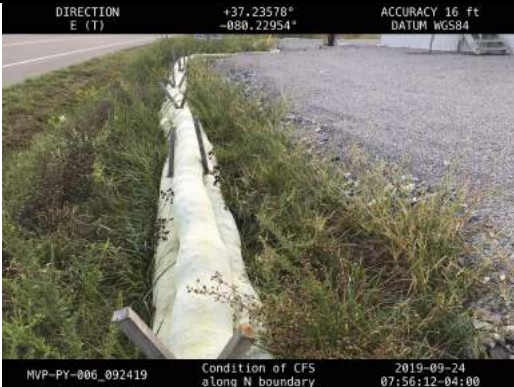
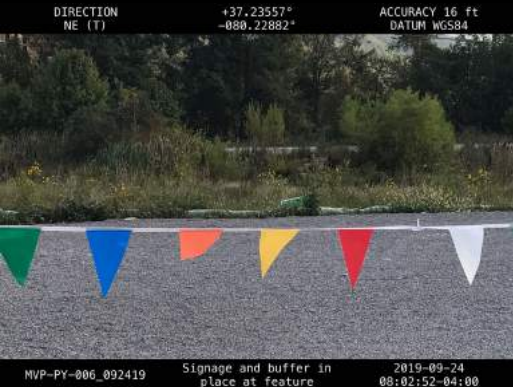
GPS Location	MVP-PY-006 See photo for gps data		GPS Location	MVP-PY-006 See photo for gps data	
Field Station#	+0		Field Station#	+0	
Pic 1 Desc.	Condition of compost filter sock along North boundary. Looking E.		Pic 2 Desc.	Signage and buffer in place for off ROW feature. Looking NE.

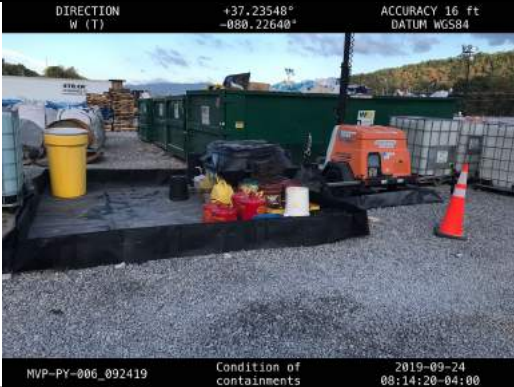
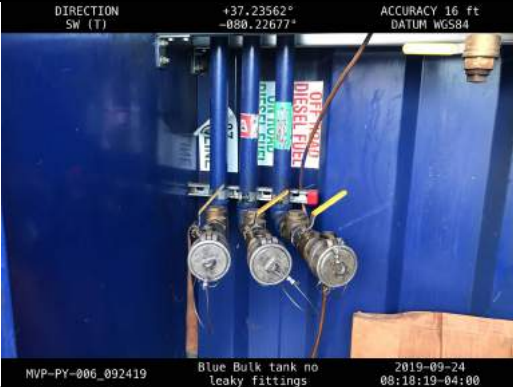
GPS Location	MVP-PY-006 See photo for gps data		GPS Location	MVP-PY-006 See photo for gps data	
Field Station#	+0		Field Station#	+0	
Pic 3 Desc.	Condition of containments under light plant and supplies. Looking W.		Pic 4 Desc.	Blue Bulk Fuel tanks no leaky fittings. Looking SW.

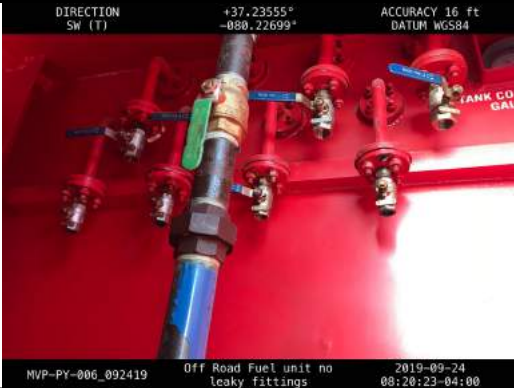
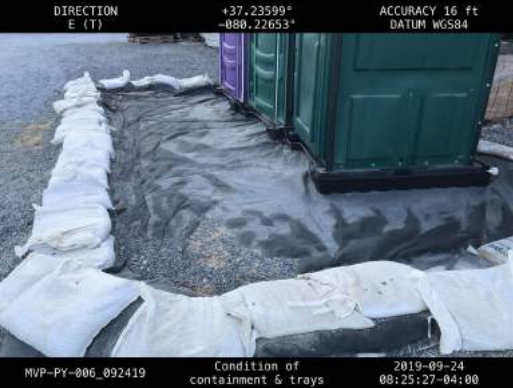
GPS Location	MVP-PY-006 See photo for gps data		GPS Location	MVP-PY-006 See photo for gps data	
Field Station#	+0		Field Station#	+0	
Pic 5 Desc.	Off Road Fuel unit no leaky fittings. Looking SW.		Pic 6 Desc.	Condition of trays and containment under toilets. Looking E.

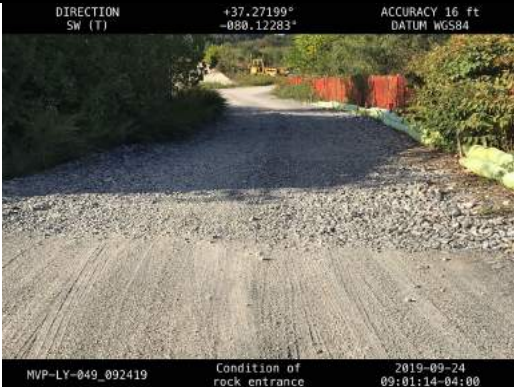
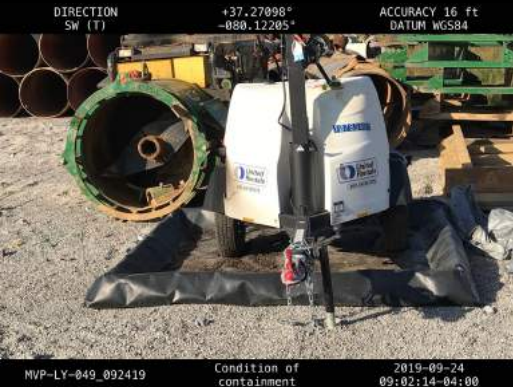
GPS Location	MVP-LY-049 See photo for gps data		GPS Location	MVP-LY-049 See photo for gps data	
Field Station#	+0		Field Station#	+0	
Pic 1 Desc.	Condition of North rock entrance. Looking SW.		Pic 2 Desc.	Condition of containment under light plant. Looking SW.

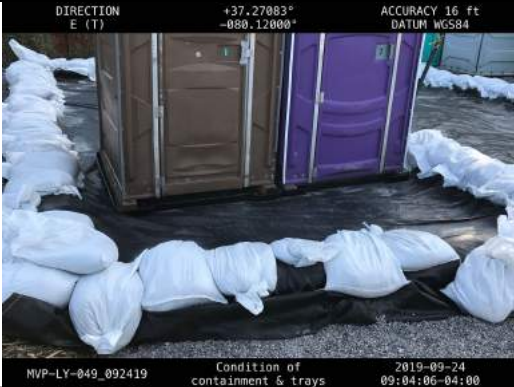
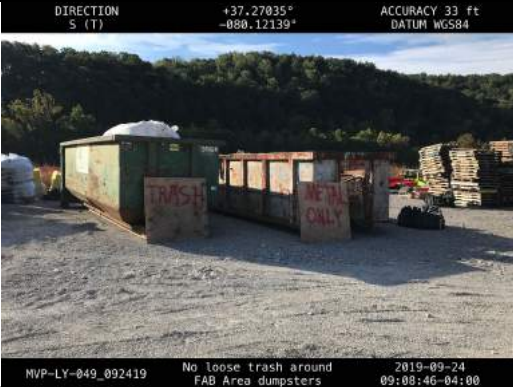
GPS Location	MVP-LY-049 See photo for gps data		GPS Location	MVP-LY-049 See photo for gps data	
Field Station#	+0		Field Station#	+0	
Pic 3 Desc.	Condition of trays and containment under toilets. Looking E.		Pic 4 Desc.	No loose trash around FAB Area dumpsters. Looking S.

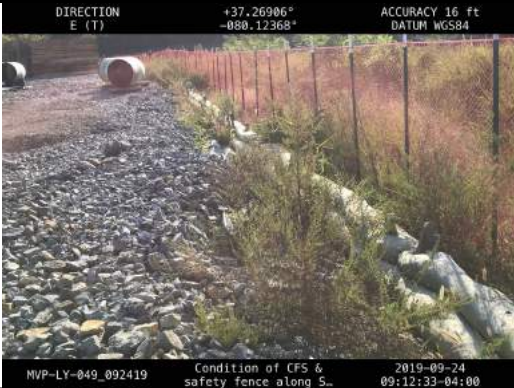
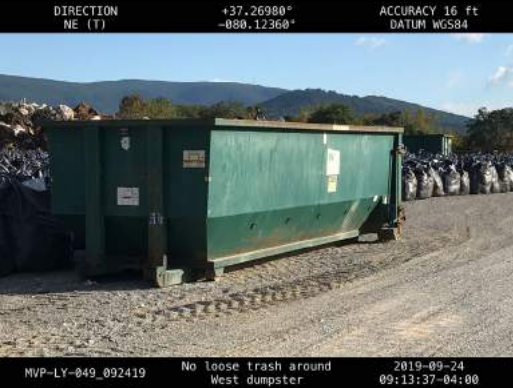
GPS Location	MVP-LY-049 See photo for gps data		GPS Location	MVP-LY-049 See photo for gps data	
Field Station#	+0		Field Station#	+0	
Pic 5 Desc.	Condition of CFS along South boundary. Looking E.		Pic 6 Desc.	No loose trash around West dumpster. Looking NE.

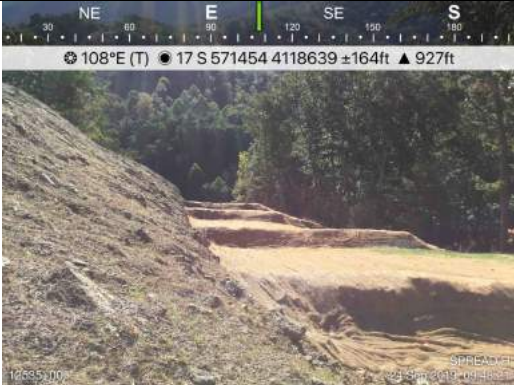
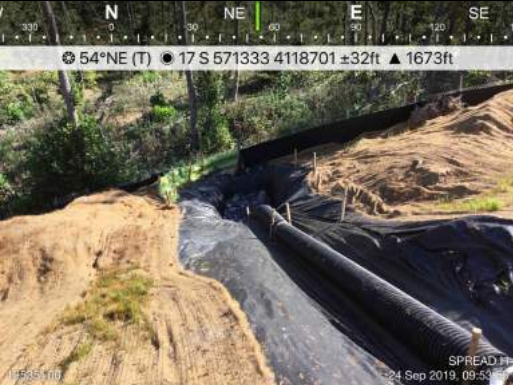
GPS Location	See Photo Above		GPS Location	See Photo Above	
Field Station#	12538+00		Field Station#	12535+00	
Pic 1 Desc.	Temp stabilization on fill slope and waterbars covered with erosion control blanket.		Pic 2 Desc.	Slope drain pipe in good condition

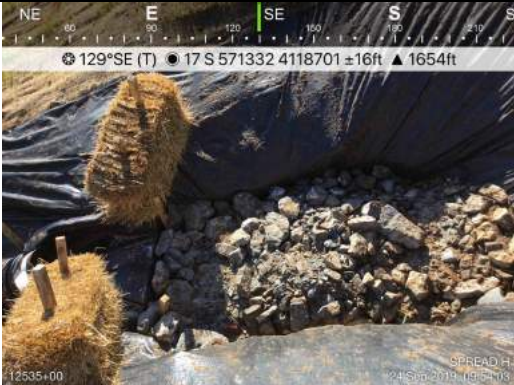
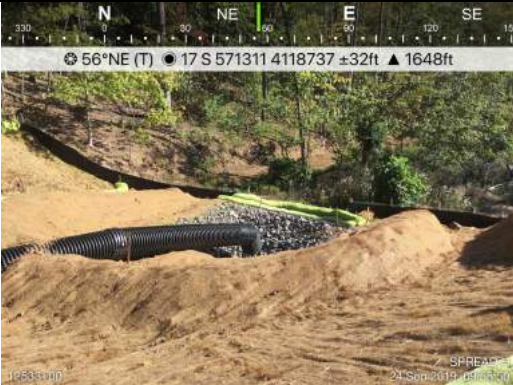
GPS Location	See Photo Above		GPS Location	See Photo Above	
Field Station#	12535+00		Field Station#	12533+00	
Pic 3 Desc.	Stone inlet protection in good condition		Pic 4 Desc.	CWD pipe and berm in good condition. Rock filter outlet in good condition

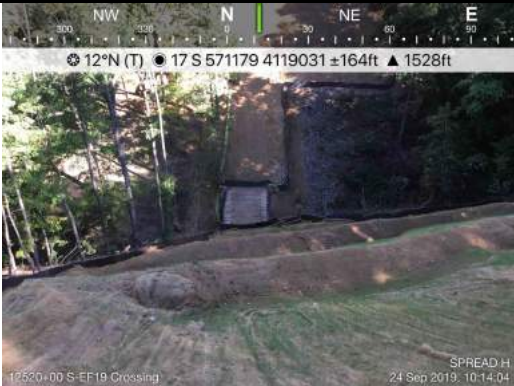
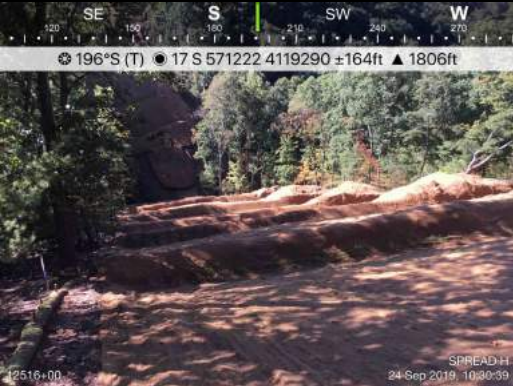
GPS Location	See Photo Above		GPS Location	See Photo Above	
Field Station#	12520+00		Field Station#	12516+00	
Pic 5 Desc.	S-EF19 crossing. Timber Matting in good condition. Waterbars functional and erosion control blanket in good condition		Pic 6 Desc.	Slope with water bars and erosion control blanket

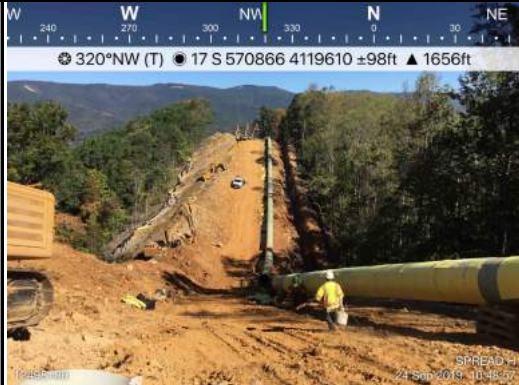
GPS Location	See Photo Above		GPS Location	See Photo Above	
Field Station#	12504+00		Field Station#	12498+00	
Pic 7 Desc.	CWD in good condition and CFS in good condition with geotech and erosion control blanket properly installed		Pic 8 Desc.	Section of pipe still waiting to be lowered in

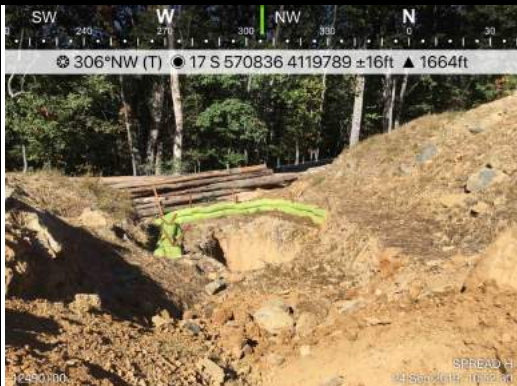
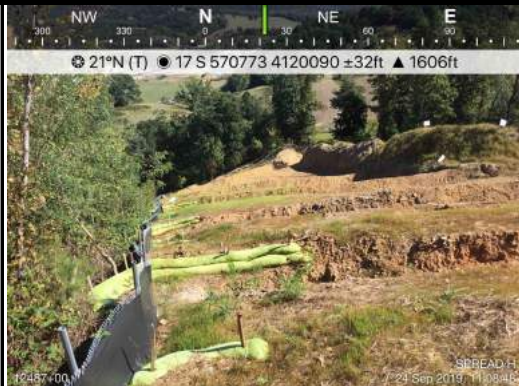
GPS Location	See Photo Above		GPS Location	See Photo Above	
Field Station#	12490+00		Field Station#	12487+00	
Pic 9 Desc.	Water bar end treatment in functional order.		Pic 10 Desc.	Water bars and end treatments on slope with fill slopes temp stabilized and SSF in good condition	
Insert image here			Insert image here		
GPS Location			GPS Location		
Field Station#			Field Station#		
Pic 11 Desc.			Pic 12 Desc.

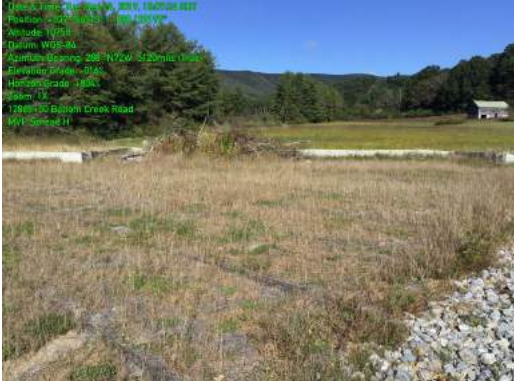
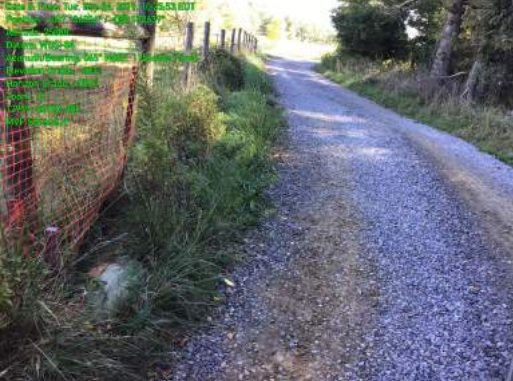
GPS Location	See pic for GPS location		GPS Location	See pic for GPS location	
Field Station#	12865+50		Field Station#	12957+30	
Pic 1 Desc.	No issues or impacts observed near Bottom Creek road.		Pic 2 Desc.	All ECD's and BMP's installed on access road RO-288 remain in good condition.

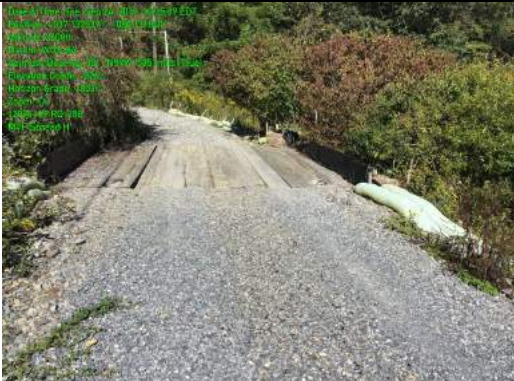
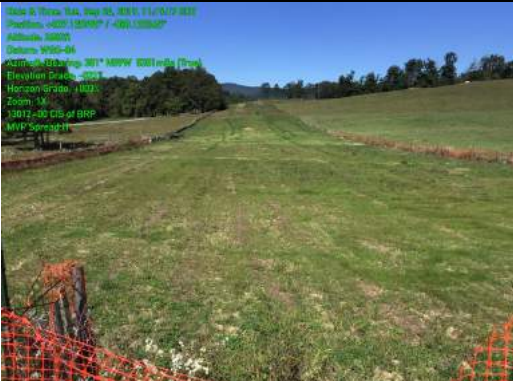
GPS Location	See pic for GPS location		GPS Location	See pic for GPS location	
Field Station#	12974+29		Field Station#	13012+00	
Pic 3 Desc.	No issues or impacts observed along access road RO-288.		Pic 4 Desc.	Good vegetation growth on the CIS of the BRP.

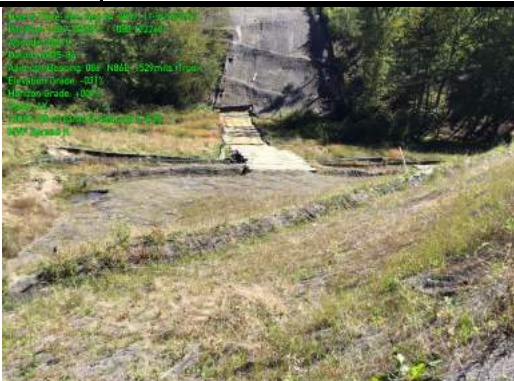
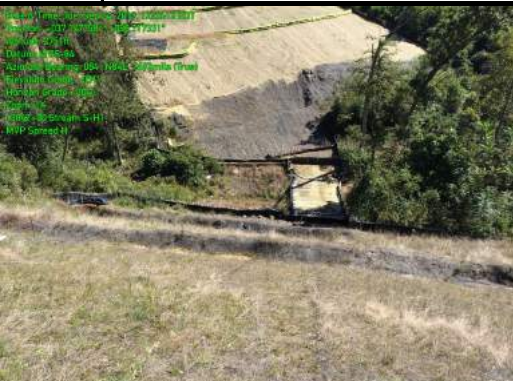
GPS Location	See pic for GPS location		GPS Location	See pic for GPS location	
Field Station#	13022+50		Field Station#	13042+00	
Pic 5 Desc.	No stream impacts or off ROW issues were observed near streams S-G24 and S-G25.		Pic 6 Desc.	No issues or impacts observed near stream S-H1.
