Visual Site Inspection Report

Project Name	H-600 Pipeline Spread H	AFE	124300138	Spread	H-600 Pipeline Spread
Contractor	Precision			Report #	100169
Inspector	Tammy Kruizenga			Date/Time	9/3/2019 10:12 AM
Permit #	TBD	Inspection Type	VA SWPP	Station Begin	12001+00
State	VA	Inspection Area	Partial	Station End	12129+17
County	Montgomery	Ground	Dry	Temperature (°F)	85.00
Municipality	N/A	Weather	Sunny	Rain Gauge (in)	0.00
				Rain Accumulation Time (days)	1.00

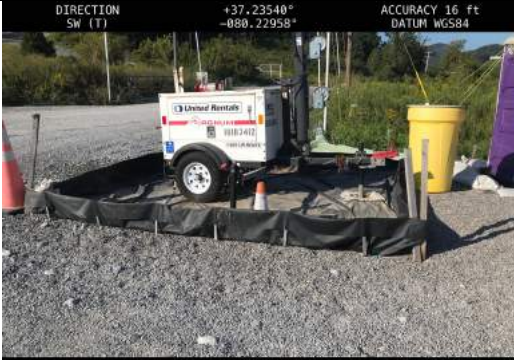
<p>DIRECTION SW (T) +37.23540° -080.22958° ACCURACY 16 ft DATUM WGS84</p> <p>MVP-PY-006_080319 Condition of containment 2019-09-03 09:14:18-04:00</p>

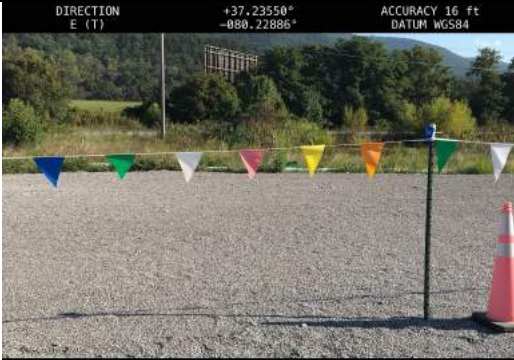
<p>DIRECTION E (T) +37.23550° -080.22886° ACCURACY 16 ft DATUM WGS84</p> <p>MVP-PY-006_080319 Buffer and signage at feature 2019-09-03 09:17:59-04:00</p>

GPS Location	MVP-PY-006 See photo for gps data		GPS Location	MVP-PY-006 See photo for gps data	
Field Station#	+0		Field Station#	+0	
Pic 3 Desc.	Buffer and signage at feature. Looking NE.		Pic 4 Desc.	Off Road Fuel unit no leaky fittings. Looking W.

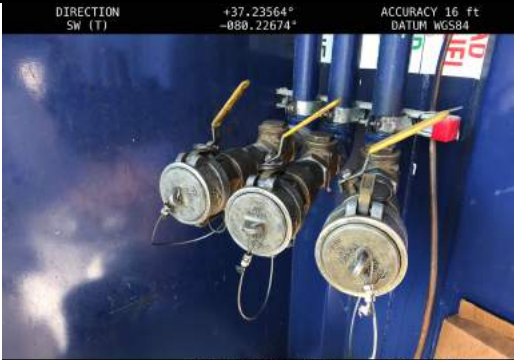
<p>DIRECTION SW (T) +37.23564° -080.22674° ACCURACY 16 ft DATUM WGS84</p> <p>MVP-PY-006_080319 Blue Bulk Fuel tanks no leaky fittings 2019-09-03 09:22:11-04:00</p>

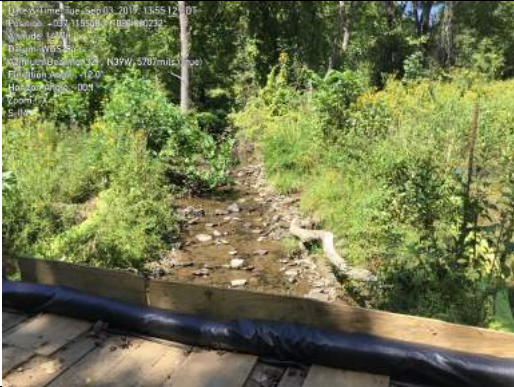
GPS Location	See photo for coordinates.	GPS Location	See photo for coordinates.		
Field Station#	13260+60	Field Station#	13260+60		
Pic 1 Desc.	S-II4, looking upstream of equipment bridge, no turbidity or environmental concerns noted.	Pic 2 Desc.	S-II4, looking downstream of equipment bridge, bridge in good condition, no environmental concerns.

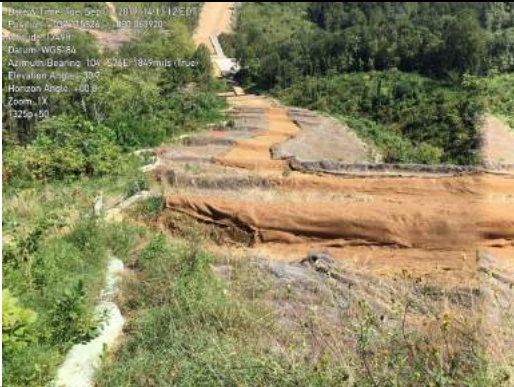
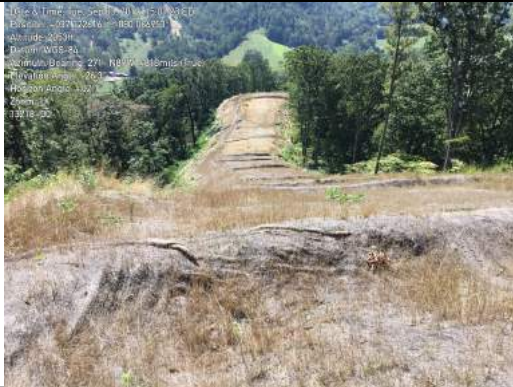
GPS Location	See photo for coordinates.	GPS Location	See photo for coordinates.		
Field Station#	13250+50	Field Station#	13218+50		
Pic 3 Desc.	ROW, waterbars repaired, stabilized with seed and curlex.	Pic 4 Desc.	ROW, waterbars and outlets functioning acceptably, moderate vegetative cover, soil piles stable.

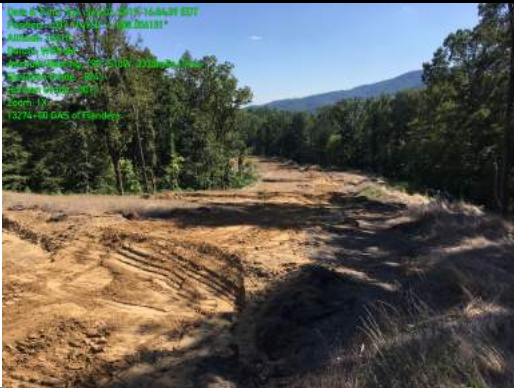
GPS Location	See photo for coordinates.	GPS Location	See photo for coordinates.		
Field Station#	13274+00	Field Station#	13309+09		
Pic 5 Desc.	ROW, travel lane open with waterbars repaired, soil piles stable,	Pic 6 Desc.	S-GH7, looking upstream of equipment bridge, bore activities active, no environmental issues observed.

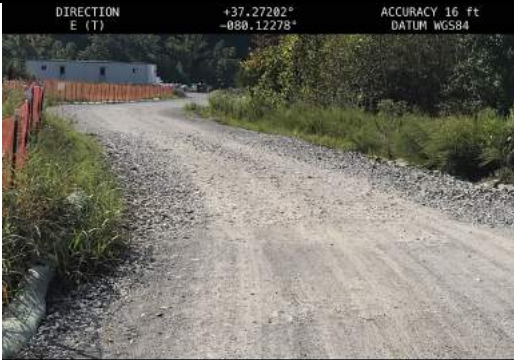
GPS Location	MVP-LY-049 See photo for gps data	GPS Location	MVP-LY-049 See photo for gps data		
Field Station#	+0	Field Station#	+0		
Pic 1 Desc.	Condition of rock entrance on center drive. Looking S.	Pic 2 Desc.	Condition of CFS & safety fence along center drive. Looking S.

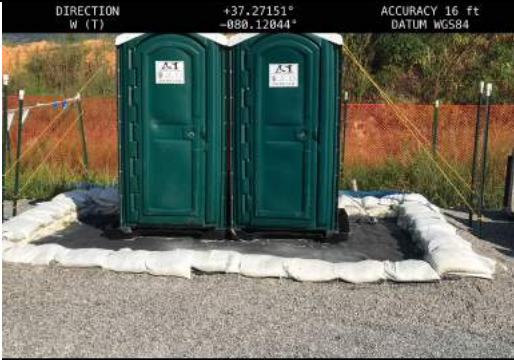
GPS Location	MVP-LY-049 See photo for gps data	GPS Location	MVP-LY-049 See photo for gps data		
Field Station#	+0	Field Station#	+0		
Pic 3 Desc.	Condition of trays and containment under porta toilets north boundary. Looking N.	Pic 4 Desc.	Condition of trays and containment under newly added porta toilets in FAB Area. Looking SE.

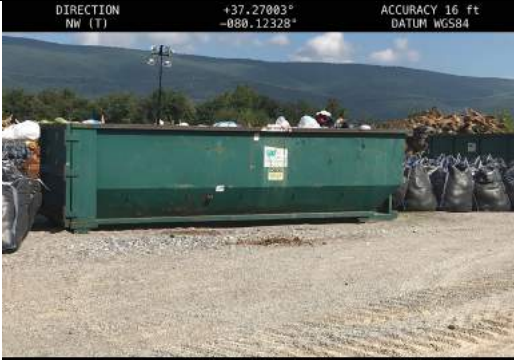
GPS Location	MVP-LY-049 See photo for gps data	GPS Location	MVP-LY-049 See photo for gps data		
Field Station#	+0	Field Station#	+0		
Pic 5 Desc.	No loose trash around West dumpster. Looking NW.	Pic 6 Desc.	Crew loading ROW debris onto dump trucks and dumpster from pile. Looking NW.

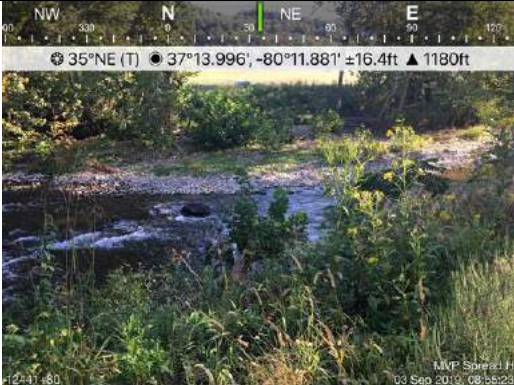
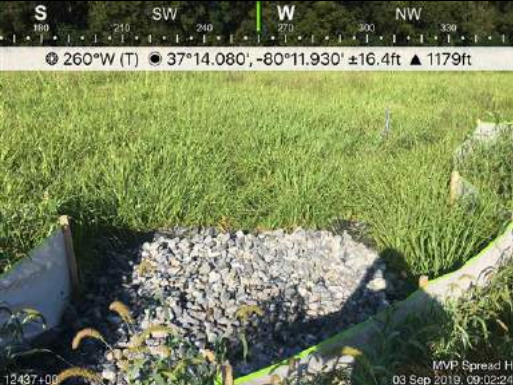
GPS Location	See picture watermark		GPS Location	See picture watermark	
Field Station#	12441+80		Field Station#	12437+00	
Pic 1 Desc.	Resource buffer area at Roanoke River.		Pic 2 Desc.	Clean water diversion outlet in good condition.

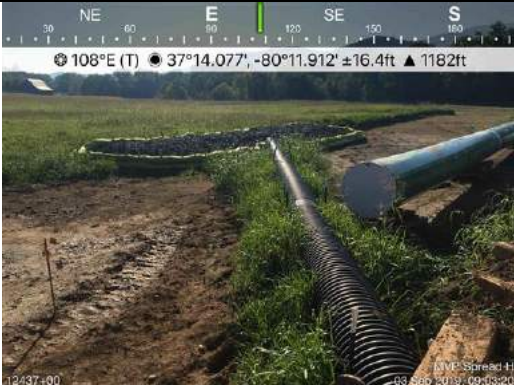
GPS Location	See picture watermark		GPS Location	See picture watermark	
Field Station#	12437+00		Field Station#	12421+60	
Pic 3 Desc.	Clean water diversion pipe and inlet protection good condition		Pic 4 Desc.	Temporary stabilization on CIS of railroad crossing.

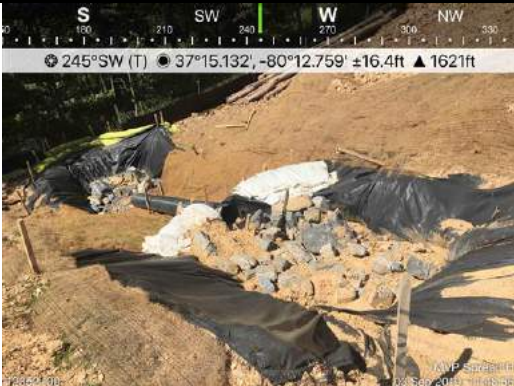
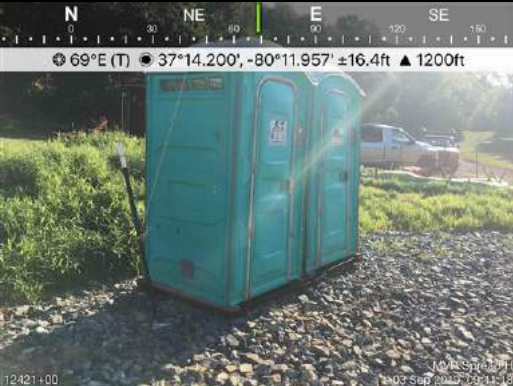
GPS Location	See picture watermark		GPS Location	See picture watermark	
Field Station#	12352+00		Field Station#	12421+00	
Pic 5 Desc.	Slope drain inlet protection with sediment accumulation.		Pic 6 Desc.	Portable toilets within secondary containment.

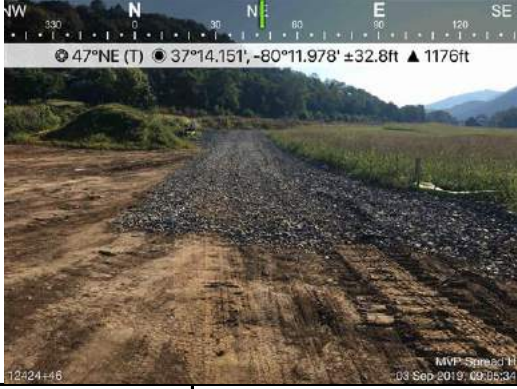
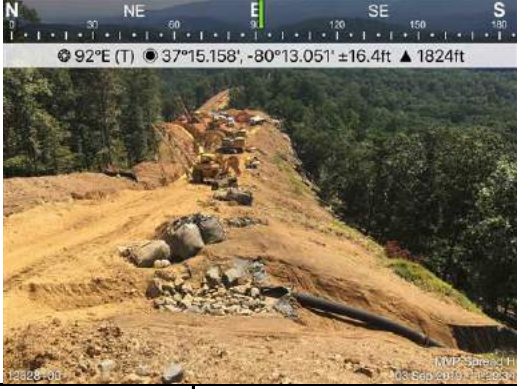
GPS Location	See picture watermark		GPS Location	See picture watermark	
Field Station#	12424+46		Field Station#	12328+00	
Pic 9 Desc.	Rock construction entrance in good condition at CIS Roanoke River ATWS.		Pic 10 Desc.	False-fill slope drains and pipe tie-in work area.

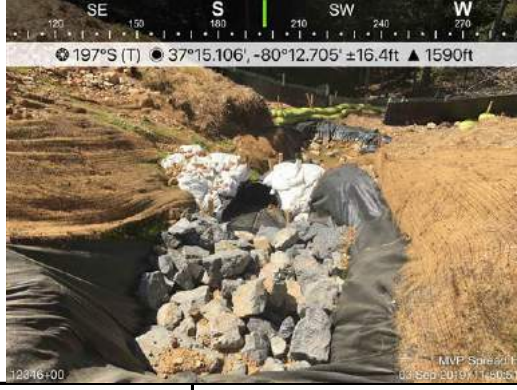
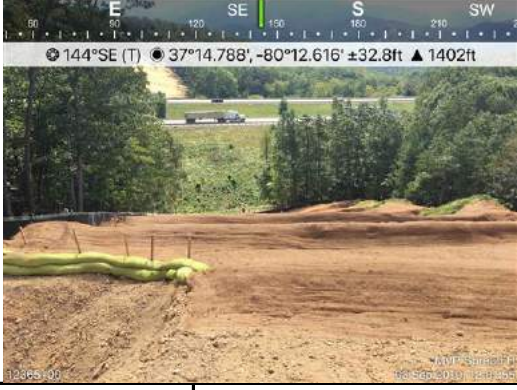
GPS Location	See picture watermark		GPS Location	See picture watermark	
Field Station#	12348+00		Field Station#	12365+00	
Pic 11 Desc.	Clean slope drain inlet protection and outfall plunge pool.		Pic 12 Desc.	CIS I-81 temporary stabilization measures.

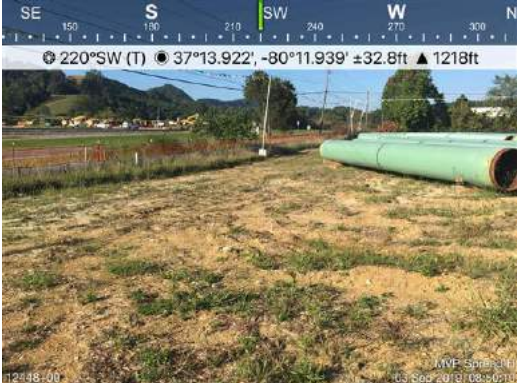
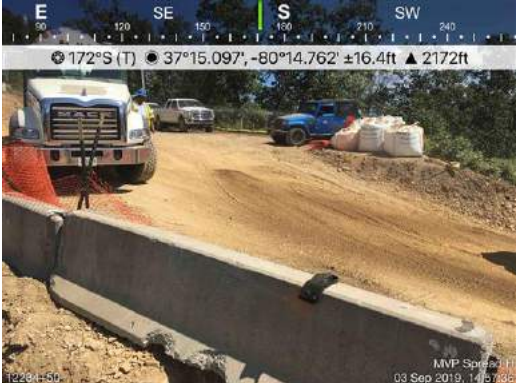
GPS Location	See picture watermark		GPS Location	See picture watermark	
Field Station#	12448+00		Field Station#	12234+50	
Pic 13 Desc.	Rt. 11 bore area in good condition.		Pic 14 Desc.	Dust control implementation at switchback backfill pouring activity.

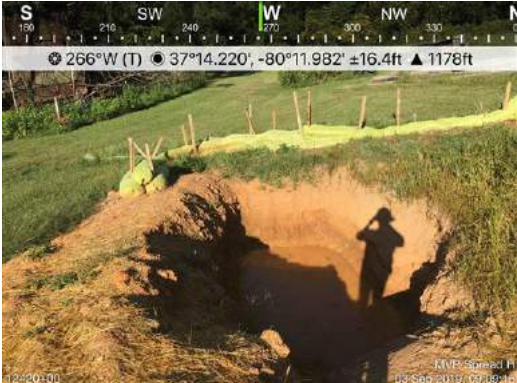
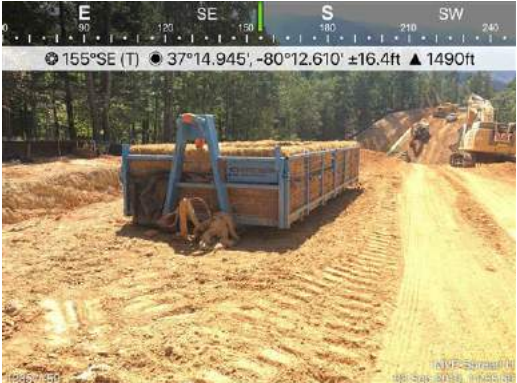
GPS Location	See picture watermark		GPS Location	See picture watermark	
Field Station#	12420+00		Field Station#	12357+50	
Pic 15 Desc.	Waterbar end treatment in good condition and functional.		Pic 16 Desc.	Mobile dewatering operation on-site but not in use.

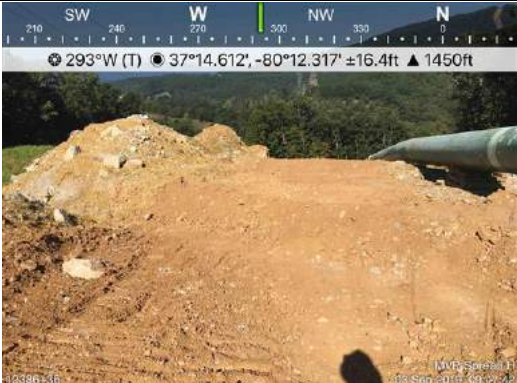
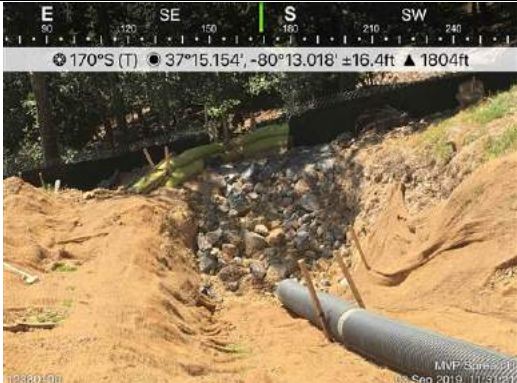
GPS Location	See picture watermark		GPS Location	See picture watermark	
Field Station#	12386+36		Field Station#	12330+00	
Pic 17 Desc.	Travel lane waterbars that were reinstalled at the end of the previous workday.		Pic 18 Desc.	False-fill slope drain outlet plunge pool in good condition.

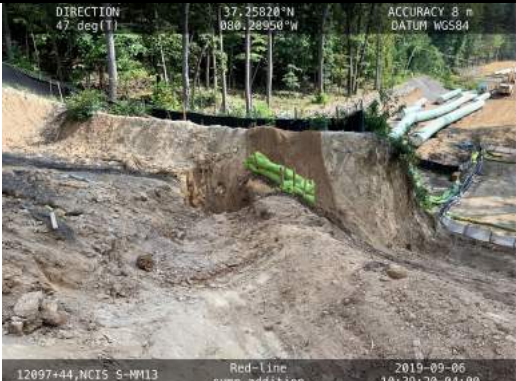
GPS Location	See photo GPS for location		GPS Location	See photo GPS for location	
Field Station#	12097+44		Field Station#	12086+56	
Pic 5 Desc.	Sump added per DEQ red-line recommendation. Located at the CIS, north side, stream buffer of S-MM13.		Pic 6 Desc.	Stream is dry at S-MM14.

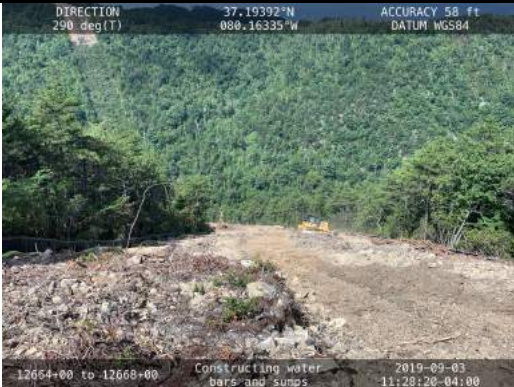
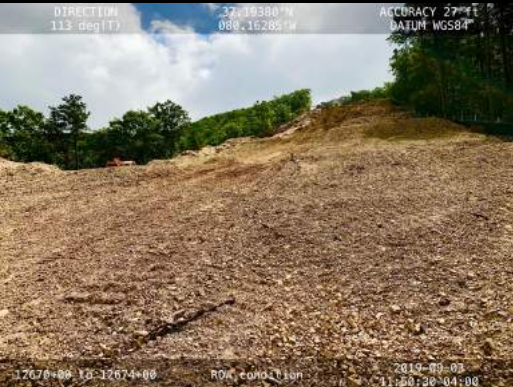
GPS Location	See photo for gps data.		GPS Location	See photo for gps data.	
Field Station#	12668+00		Field Station#	12670+00	
Pic 1 Desc.	Photo shows the ROW condition and the contractor installing water bars and sump outlets between 12664+00 and 12668+00.		Pic 2 Desc.	Photo shows the ROW condition from about 12670+00 to 12674+00.

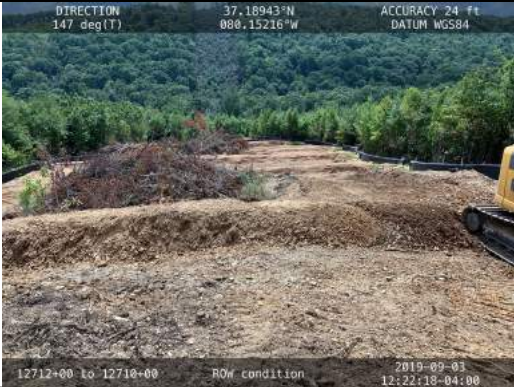
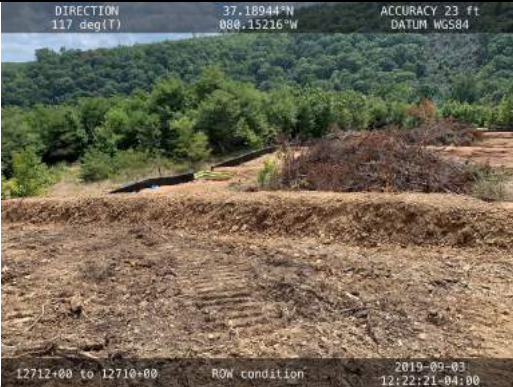
GPS Location	See photo for gps data.		GPS Location	See photo for gps data.	
Field Station#	12710+00		Field Station#	12710+00	
Pic 3 Desc.	Photo shows the ROW condition and the sump outlets installed between 12710+00 and 12712+00.		Pic 4 Desc.	Photo shows the sump outlets installed between 12710+00 and 12711+00.

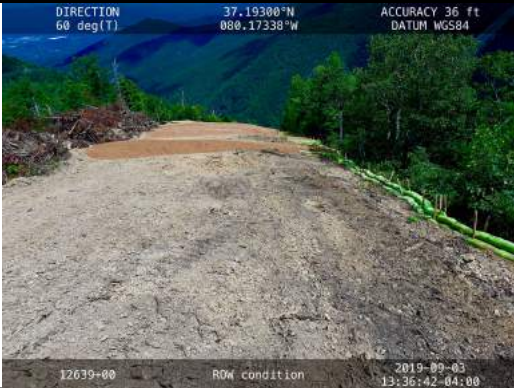
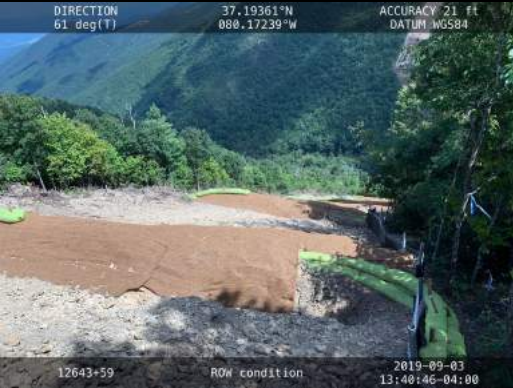
GPS Location	See photo for gps data.		GPS Location	See photo for gps data.	
Field Station#	12639+00		Field Station#	12643+59	
Pic 5 Desc.	Photo shows the ROW condition and sump outlets installed from about 12639+00 to 12640+00.		Pic 6 Desc.	Photo shows the ROW condition and sump outlets installed between 12643+59 and 12645+00.

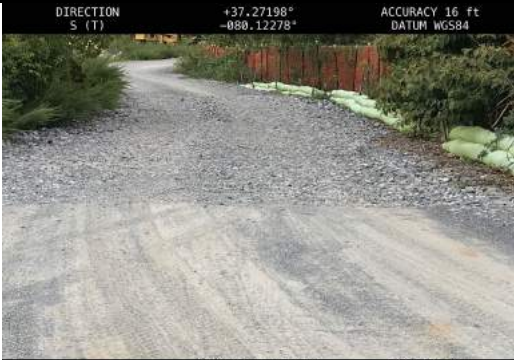
GPS Location	MVP-PY-049 See photo for gps data	GPS Location	MVP-PY-049 See photo for gps data		
Field Station#	+0	Field Station#	+0		
Pic 1 Desc.	Condition of north rock entrance. Looking SW	Pic 2 Desc.	Condition of containment under light plant. Looking NE.

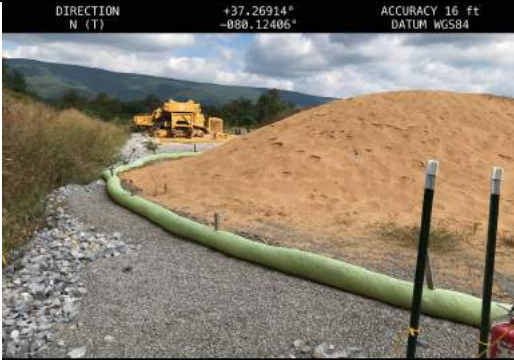
GPS Location	MVP-PY-049 See photo for gps data	GPS Location	MVP-PY-049 See photo for gps data		
Field Station#	+0	Field Station#	+0		
Pic 3 Desc.	Compost filter sock around sand pile. Looking N.	Pic 4 Desc.	No loose trash around the FAB Area dumpsters. Looking S.

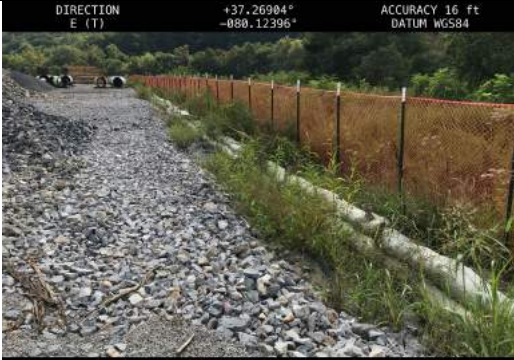
GPS Location	MVP-PY-049 See photo for gps data	GPS Location	MVP-PY-049 See photo for gps data		
Field Station#	+0	Field Station#	+0		
Pic 5 Desc.	Condition of compost filter sock and safety fence along South boundary. Looking E.	Pic 6 Desc.	No loose trash around West dumpster. Looking NE.

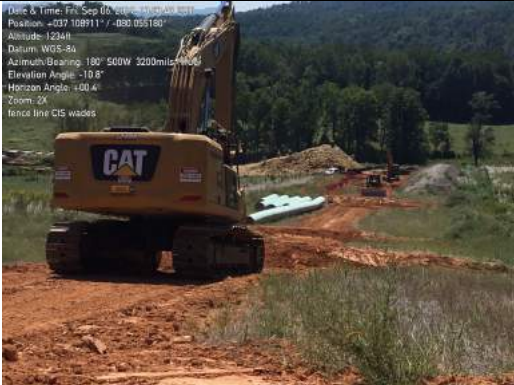
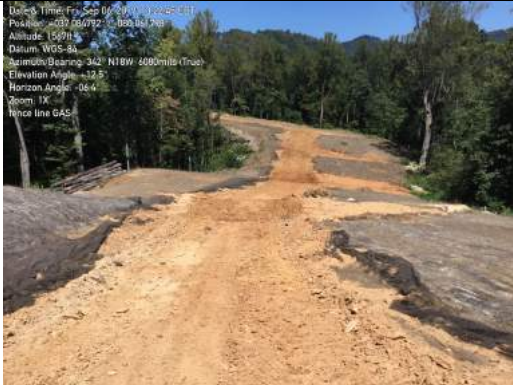
GPS Location	See photo for coordinates.		GPS Location	See photo for coordinates.	
Field Station#	13301+00		Field Station#	13292+00	
Pic 1 Desc.	ROW, waterbar repair in progress, subsoil pile seeded and mulched.		Pic 2 Desc.	ROW, maintenance to waterbar and waterbar outlets in progress.

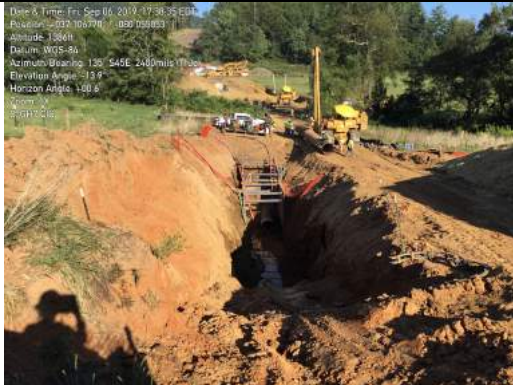
GPS Location	See photo for coordinates.		GPS Location	See photo for coordinates.	
Field Station#	13309+09		Field Station#	13306+00	
Pic 3 Desc.	S-GH7, looking upstream of equipment bridge, no turbidity noted, stream banks appear stable.		Pic 4 Desc.	GAS, open bore pit on the CIS of S-GH7, perimeter ECDs functioning acceptably.

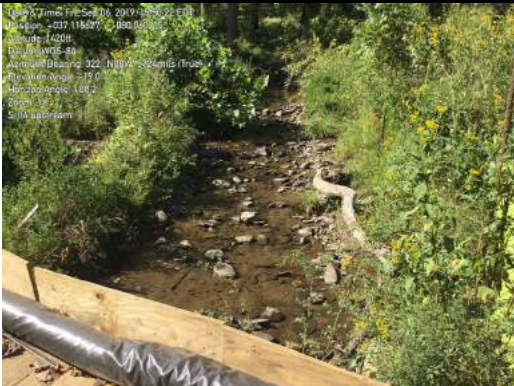
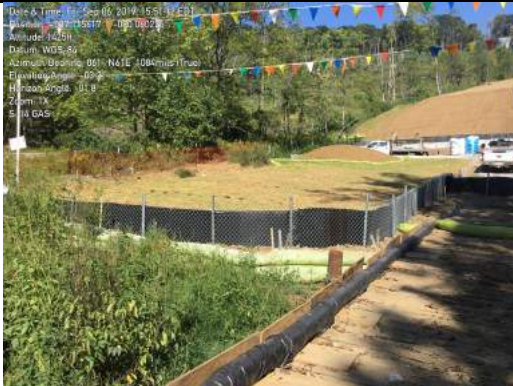
GPS Location	See photo for coordinates.		GPS Location	See photo for coordinates.	
Field Station#	13260+60		Field Station#	13260+70	
Pic 5 Desc.	S-II4, looking upstream of equipment bridge, ECDs functioning acceptably, no turbidity noted.		Pic 6 Desc.	Flanders Road crossing, area stabilized, vegetation noted, clean water diversion berm functioning acceptably.

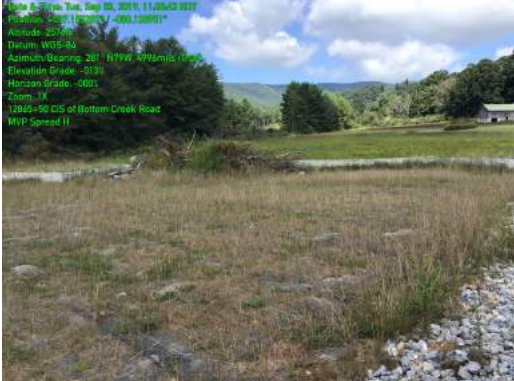
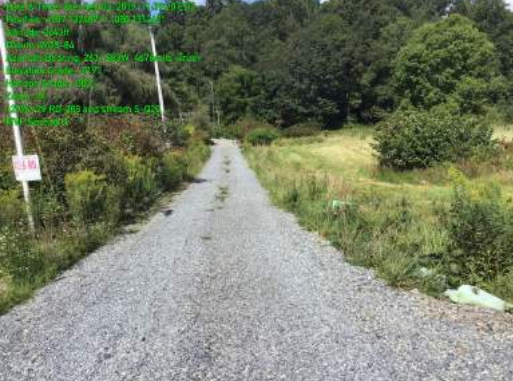
GPS Location	See pic for GPS location		GPS Location	See pic for GPS location	
Field Station#	12865+50		Field Station#	12974+29	
Pic 1 Desc.	No issues or impacts observed at Bottom Creek Road.		Pic 2 Desc.	No issues or impacts observed at access roads RO-287&288.

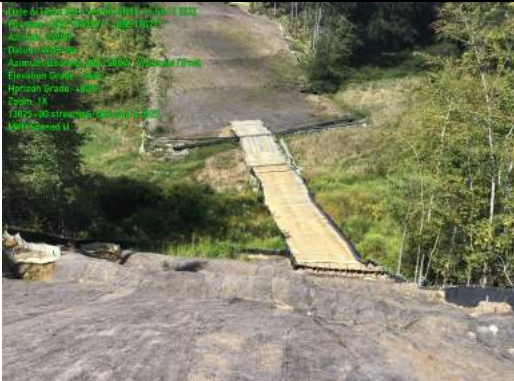
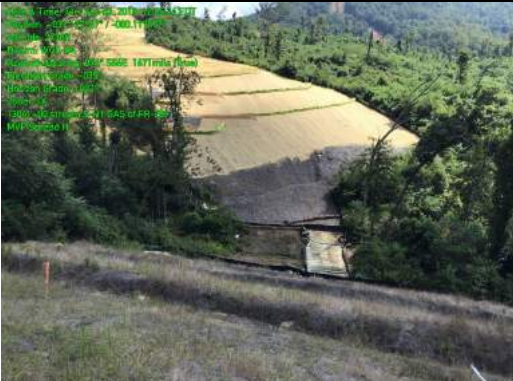
GPS Location	See pic for GPS location		GPS Location	See pic for GPS location	
Field Station#	13025+00		Field Station#	13041+00	
Pic 3 Desc.	No issues or impacts observed near streams S-G24 and S-G25.		Pic 4 Desc.	S-H1 showed no signs of impact and restoration performed on the GAS of the stream.

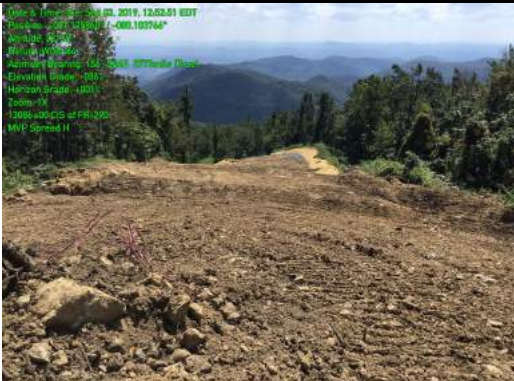
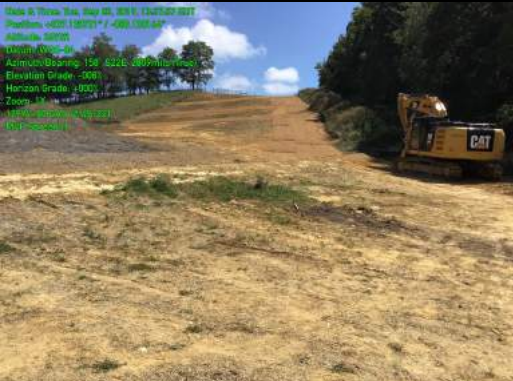
GPS Location	See pic for GPS location		GPS Location	See pic for GPS location	
Field Station#	13086+00		Field Station#	12994+50	
Pic 5 Desc.	No issues or impacts observed on the CIS of FR-291.		Pic 6 Desc.	Waterbars regraded and curlexed.

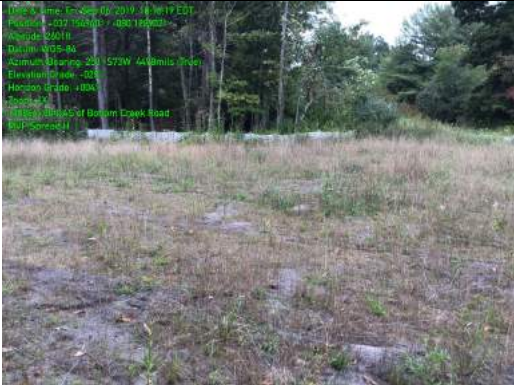
GPS Location	See pic for GPS location		GPS Location	See pic for GPS location	
Field Station#	12866+00		Field Station#	12865+00	
Pic 1 Desc.	GAS of Bottom Creek Road remains in compliance.		Pic 2 Desc.	Stabilization remains adequate at Bottom Creek Road.

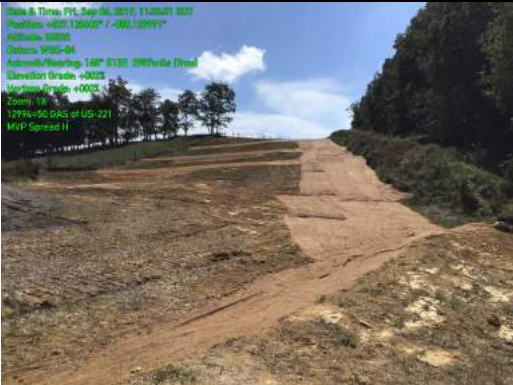
GPS Location	See pic for GPS location		GPS Location	See pic for GPS location	
Field Station#	12974+29		Field Station#	12994+50	
Pic 3 Desc.	No issues or impacts observed near RO-288.		Pic 4 Desc.	Disturbed areas have recently been re-stabilized near GAS of US-221.

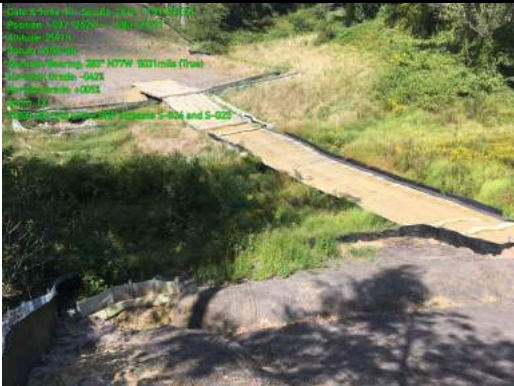
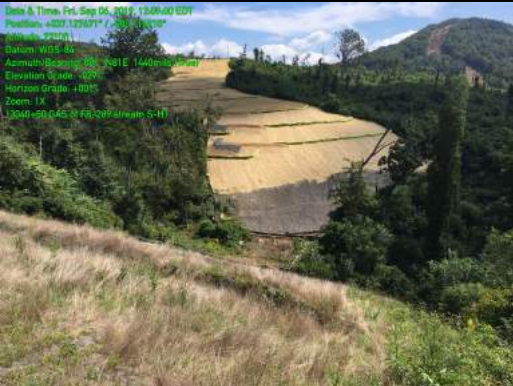
GPS Location	See pic for GPS location		GPS Location	See pic for GPS location	
Field Station#	13025+00		Field Station#	13040+50	
Pic 5 Desc.	No issues or impacts observed on the GAS of the BRP.		Pic 6 Desc.	No issues or impacts observed near S-H1.

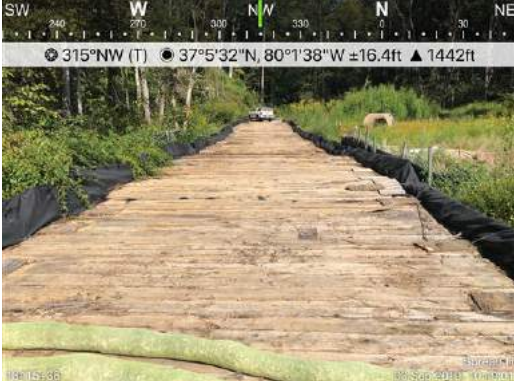
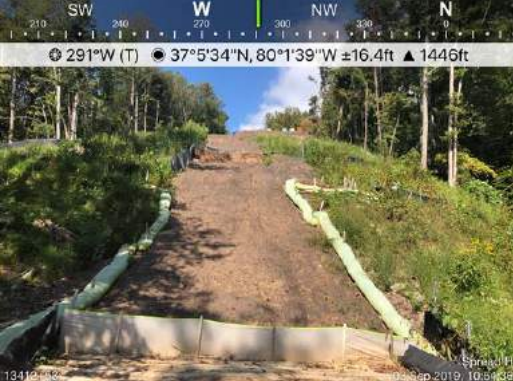
GPS Location	see photo	GPS Location	see photo		
Field Station#	13415+36	Field Station#	13412+53		
Pic 1 Desc.	Equipment bridges in this section are in good condition and functioning.	Pic 2 Desc.	Controls on this slope leading to S-IJ1 are functioning

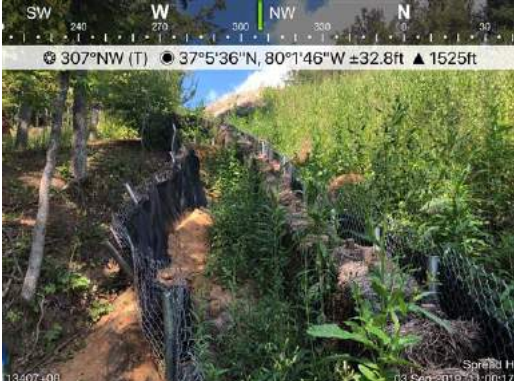
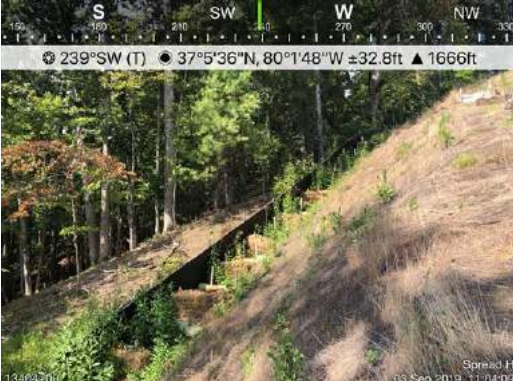
GPS Location	see photo	GPS Location	see photo		
Field Station#	13407+00	Field Station#	13404+00		
Pic 3 Desc.	Checkdams and additional super silt fence in good condition and functioning.	Pic 4 Desc.	Checkdams functioning at this location.

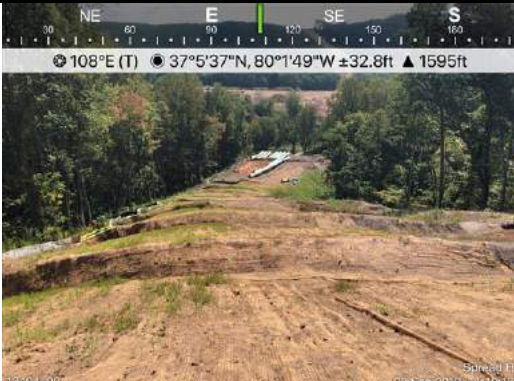
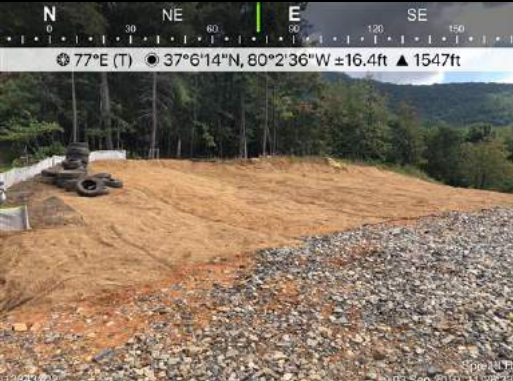
GPS Location	see photo	GPS Location	see photo		
Field Station#	13404+00	Field Station#	13343+22		
Pic 5 Desc.	Waterbars appear to be to spec and functioning.	Pic 6 Desc.	CE and additional stabilization in place in the ATWS on the GAS of Webster Corner.

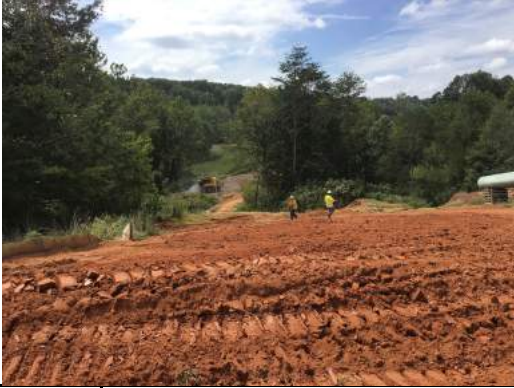
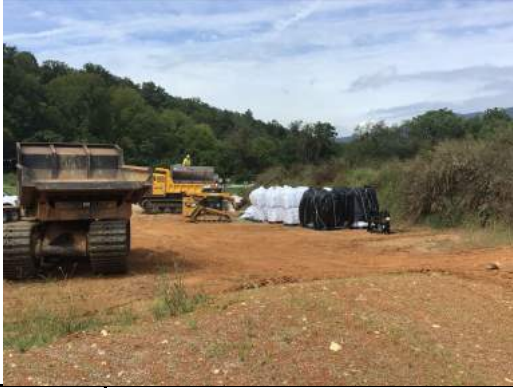
GPS Location	00000	GPS Location	00000		
Field Station#	13663+12	Field Station#	13644+99		
Pic 1 Desc.	Contractor broadcasting seed on hill side		Pic 2 Desc.	Contractor preparing to stabilize recently disturbed areas of row

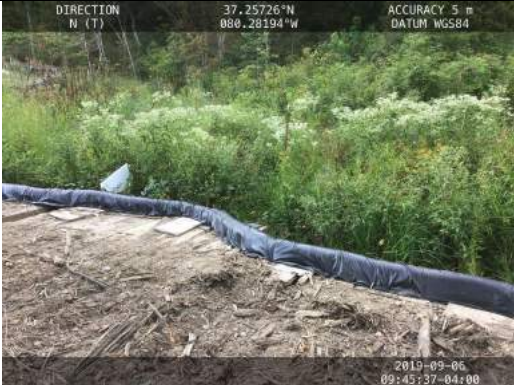
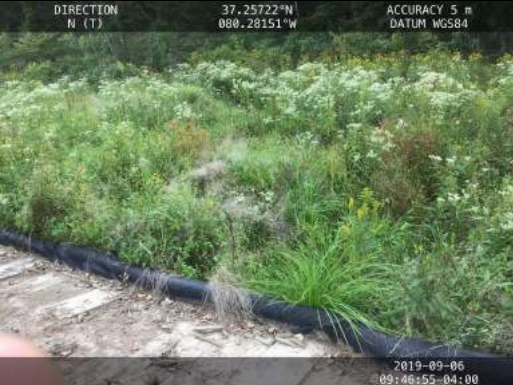
GPS Location	See photo		GPS Location	See photo	
Field Station#	12121+33		Field Station#	12121+83	
Pic 1 Desc.	Stream S-C33, facing north		Pic 2 Desc.	Stream S-C36, facing north

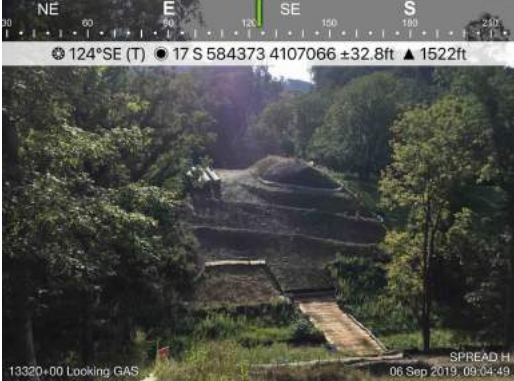
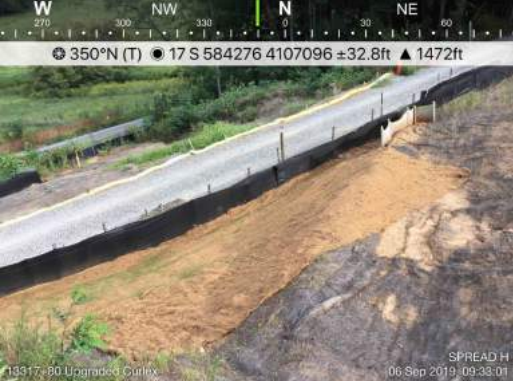
GPS Location	See Photo Above		GPS Location	See Photo Above	
Field Station#	13320+00		Field Station#	13317+80	
Pic 1 Desc.	Overview of ROW with curlex, clean timber mat at S-GH15 crossing and SF/SSF in functional order		Pic 2 Desc.	Upgraded curlex and SSF that was rekeyed in from undermine

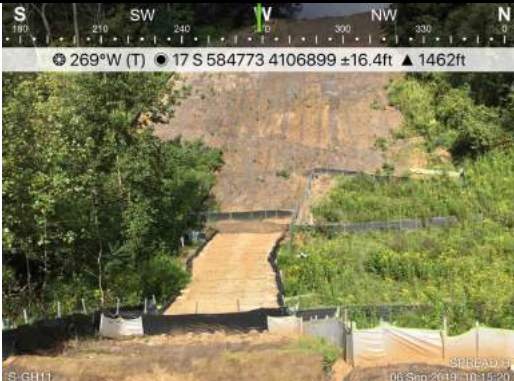
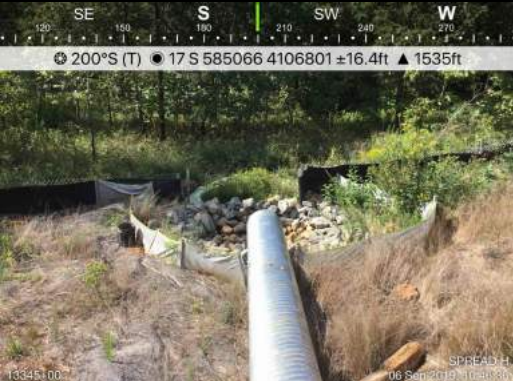
GPS Location	See Photo Above		GPS Location	See Photo Above	
Field Station#	13336+00		Field Station#	13345+00	
Pic 5 Desc.	S-GH11 timber mat crossing in good condition with stabilized slope CIS of stream		Pic 6 Desc.	CWD Pipe in good condition with CWD stone outlet and berm in good condition

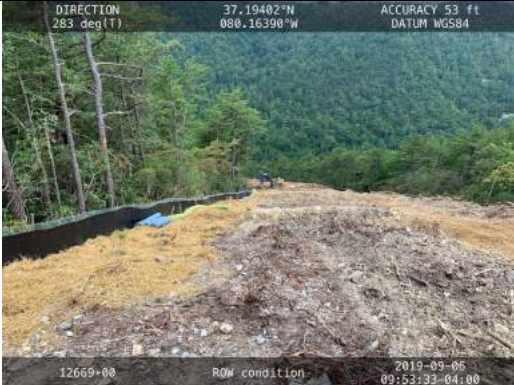
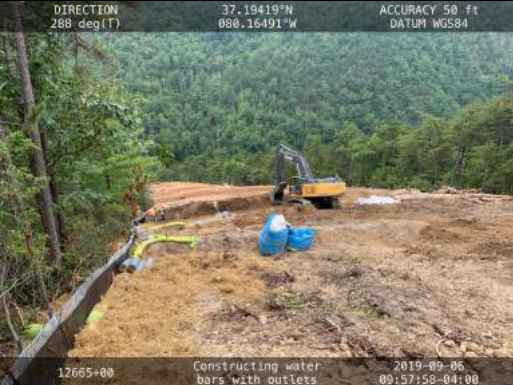
GPS Location	See photo for gps data.		GPS Location	See photo for gps data.	
Field Station#	12669+00		Field Station#	12665+00	
Pic 1 Desc.	Photo shows the ROW condition from about 12669+00 to 12665+00.		Pic 2 Desc.	Photo shows the ROW condition from about 12665+00 to 12663+00.

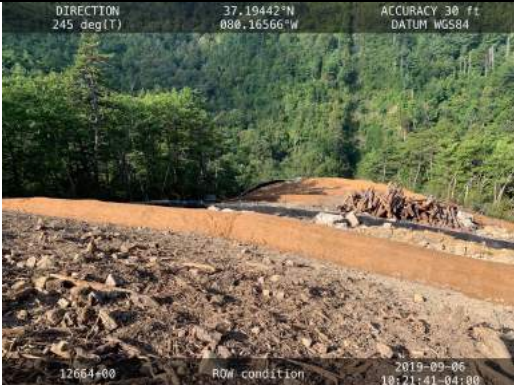
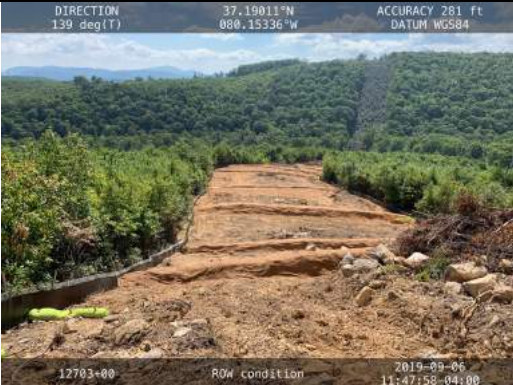
GPS Location	See photo for gps data.		GPS Location	See photo for gps data.	
Field Station#	12664+00		Field Station#	12703+00	
Pic 3 Desc.	Photo shows the ROW condition from about 12664+00 to 12661+00.		Pic 4 Desc.	Photo shows the ROW condition from about 12703+00 to 12708+00.

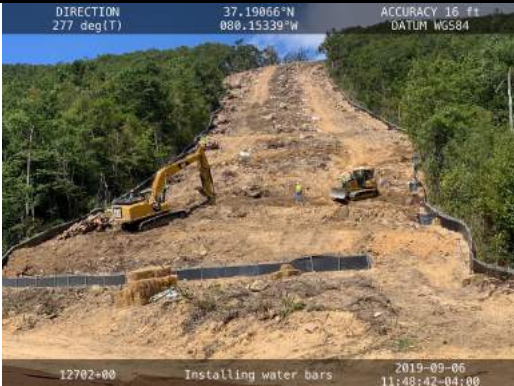
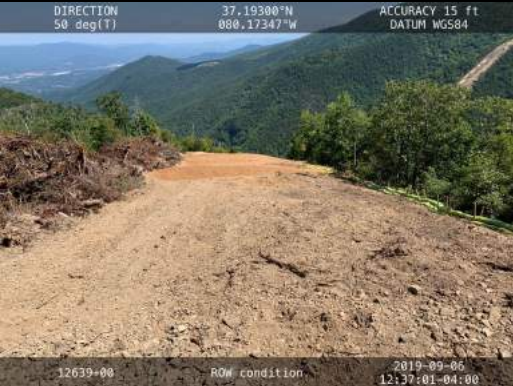
GPS Location	See photo for gps data.		GPS Location	See photo for gps data.	
Field Station#	12702+00		Field Station#	12639+00	
Pic 5 Desc.	Photo shows the ROW condition from about 12702+00 to 12692+00.		Pic 6 Desc.	Photo shows the ROW condition from about 12639+00 to 12641+00.
