Visual Site Inspection Report

Project Name	H-600 Pipeline Spread H	AFE	124300138	Spread	H-600 Pipeline Spread
Contractor	Precision			Report #	100019
Inspector	Tammy Kruizenga			Date/Time	9/30/2019 6:43 AM
Permit #	TBD	Inspection Type	VA SWPP	Station Begin	12001+00
State	VA	Inspection Area	Partial	Station End	12119+17
County	Montgomery	Ground	Dusty	Temperature (°F)	86.00
Municipality	N/A	Weather	Cloudy	Rain Gauge (in)	0.00
				Rain Accumulation Time (days)	1.00

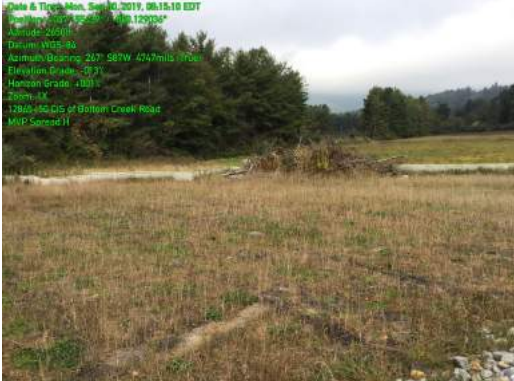
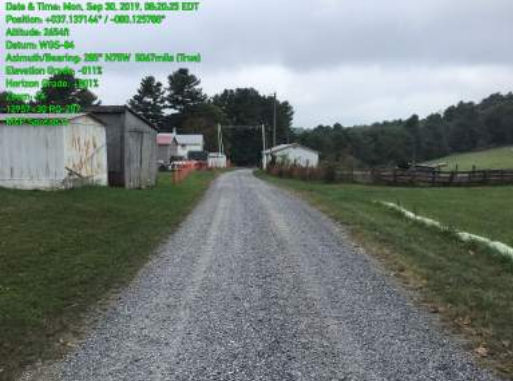
GPS Location	See pic for GPS location		GPS Location	See pic for GPS location	
Field Station#	12865+50		Field Station#	12957+30	
Pic 1 Desc.	Bottom Creek Road remains in good condition with good vegetative stabilization.		Pic 2 Desc.	No issues or impacts observed at access road RO-287.

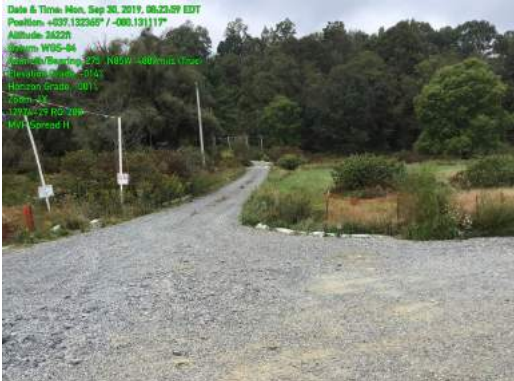
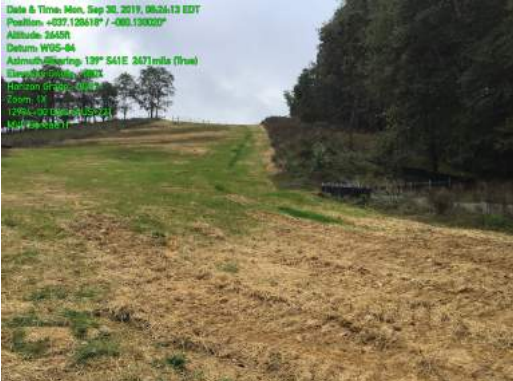
GPS Location	See pic for GPS location		GPS Location	See pic for GPS location	
Field Station#	12974+29		Field Station#	12994+00	
Pic 3 Desc.	No issues or impacts observed at access road RO-288.		Pic 4 Desc.	Vegetative stabilization growth on the GAS of US-221.

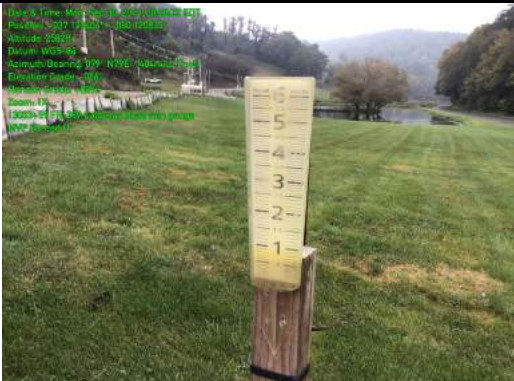
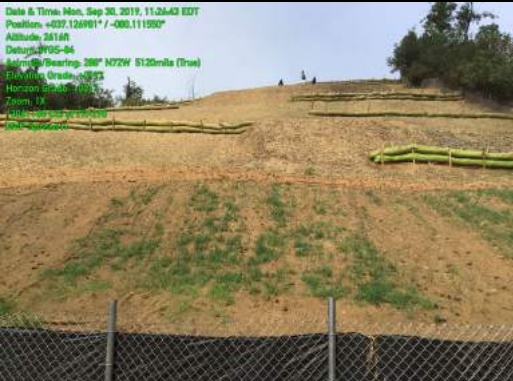
GPS Location	See pic for GPS location		GPS Location	See pic for GPS location	
Field Station#	13033+59		Field Station#	13061+00	
Pic 5 Desc.	0.0" total precipitation		Pic 6 Desc.	CIS of FR-290. Slope has final restoration performed with ProGanics and FlexTera applied for stabilization.

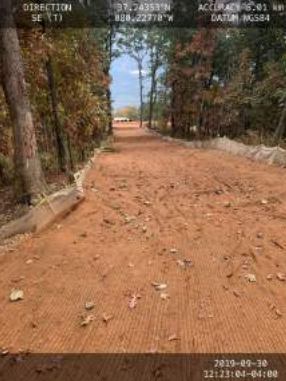
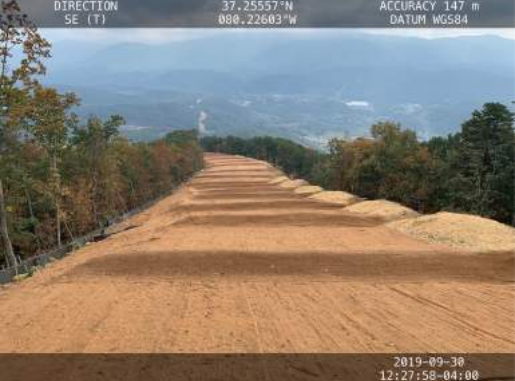
GPS Location	see picture for GPS data		GPS Location	See picture for GPS data	
Field Station#	12298+50		Field Station#	12232+00	
Pic 1 Desc.	Stabilized access road down to the ROW.		Pic 2 Desc.	Stabilized ROW.

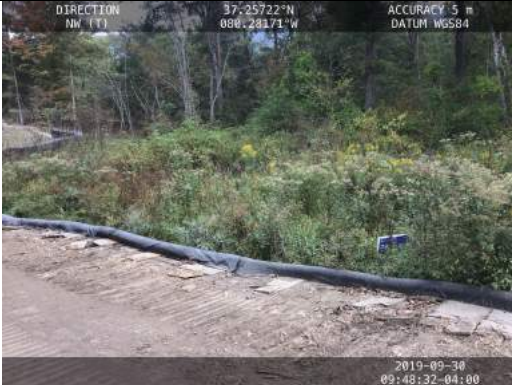
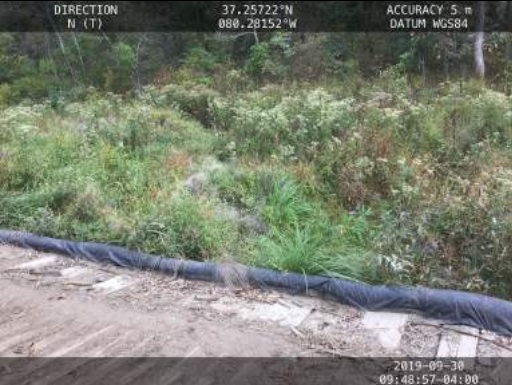
GPS Location	See photo		GPS Location	See photo	
Field Station#	12121+33		Field Station#	12121+83	
Pic 1 Desc.	Stream S-C33, facing northwest, upstream		Pic 2 Desc.	Stream S-C36, facing north, upstream

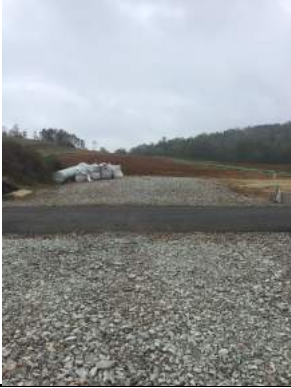
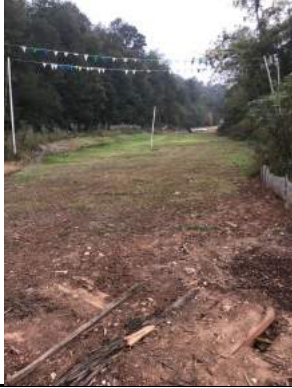
GPS Location	0000	GPS Location	0000		
Field Station#	13644+89	Field Station#	13643+00		
Pic 1 Desc.	RCE in place and functioning	Pic 2 Desc.	Temporary vegetation starting to come up in a area that has been recently disturbed

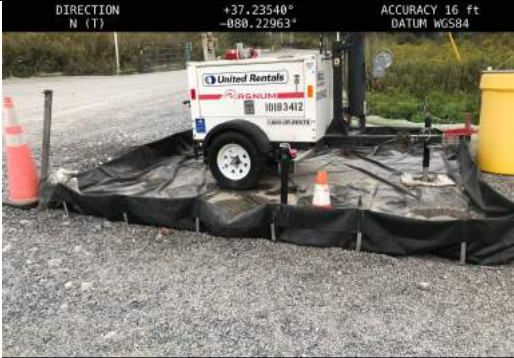
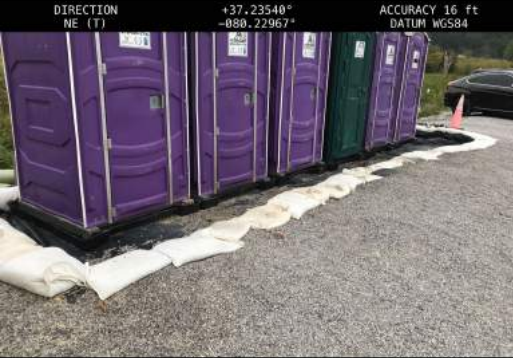
GPS Location	MVP-PY-006 See photo for gps data		GPS Location	MVP-PY-006 See photo for gps data	
Field Station#	+0		Field Station#	+0	
Pic 1 Desc.	Condition of containment under light plant. Looking N.		Pic 2 Desc.	Condition of trays and containment under toilets. Looking NE.

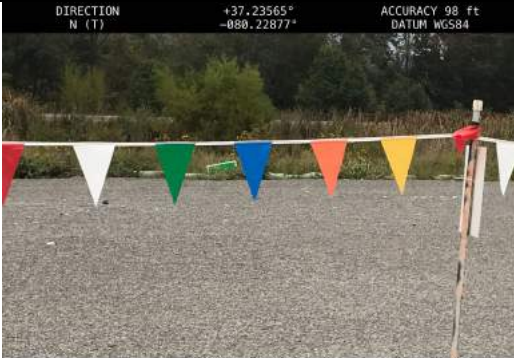
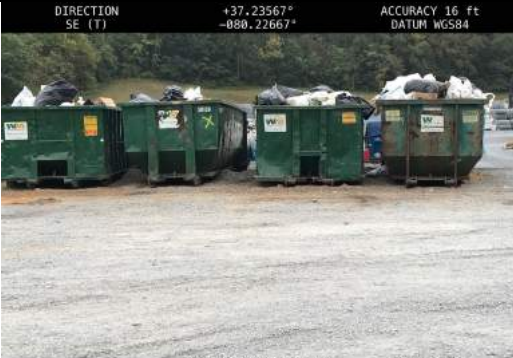
GPS Location	MVP-PY-006 See photo for gps data		GPS Location	MVP-PY-006 See photo for gps data	
Field Station#	+0		Field Station#	+0	
Pic 3 Desc.	Signage and buffer at feature in place and being observed. Looking N.		Pic 4 Desc.	No loose trash around dumpsters. Looking SE.

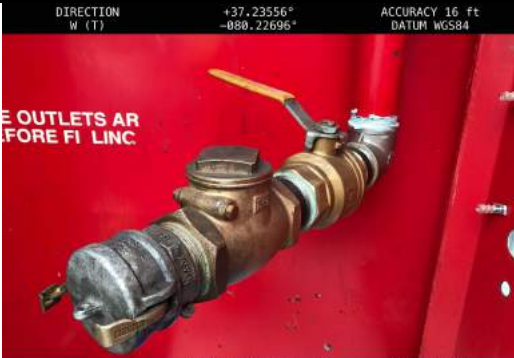
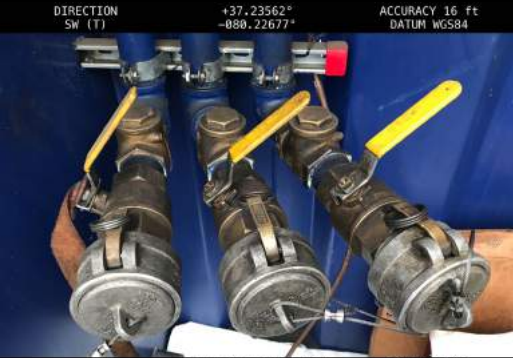
GPS Location	MVP-PY-006 See photo for gps data		GPS Location	MVP-PY-006 See photo for gps data	
Field Station#	+0		Field Station#	+0	
Pic 5 Desc.	Off Road Fuel unit no leaky fittings. Looking W.		Pic 6 Desc.	Blue bulk fuel tanks no leaky fittings. Looking SW.

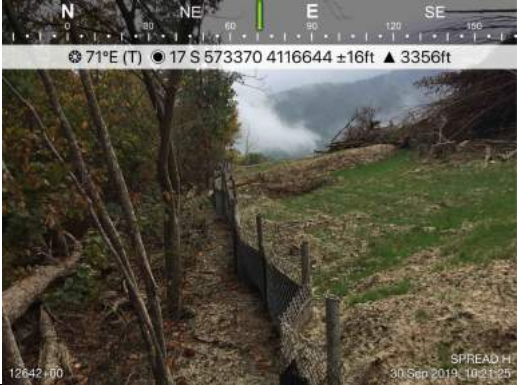
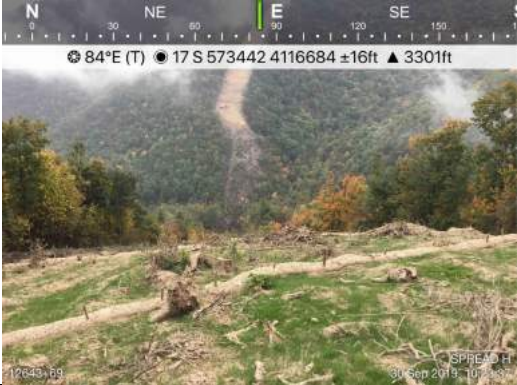
GPS Location	See Photo Above		GPS Location	See Photo Above	
Field Station#	12642+00		Field Station#	12643+69	
Pic 7 Desc.	SSF in good shape and hydraulically applied blanket functional with grass growing already. Water bar on either side of timber stack with sumps and end treatments		Pic 8 Desc.	CFS installed going down slope towards S-IJ50. Hydraulically applied blanket working

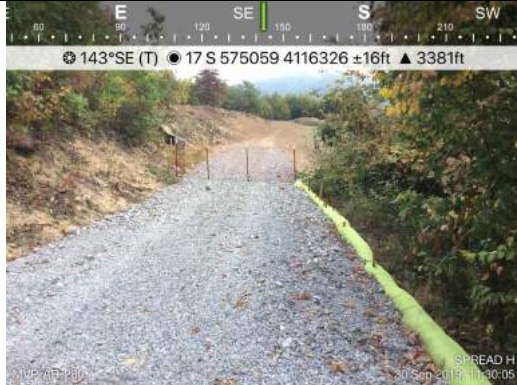
Insert image here	
GPS Location	See Photo Above		GPS Location		
Field Station#	2+80		Field Station#		
Pic 11 Desc.	MVP-AR-280 in good condition with CFS along perimeter		Pic 12 Desc.

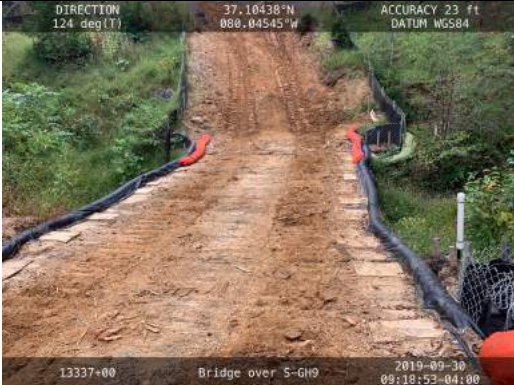
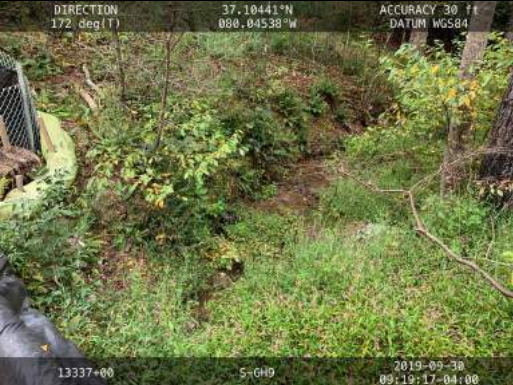
GPS Location	See photo for gps data.		GPS Location	See photo for gps data.	
Field Station#	13337+00		Field Station#	13337+05	
Pic 1 Desc.	Photo shows the bridge over S-GH9.		Pic 2 Desc.	Photo shows stream S-GH9.

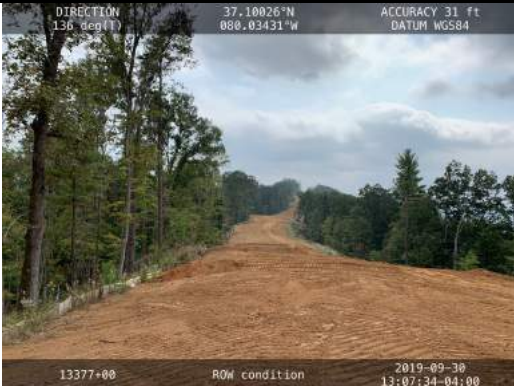
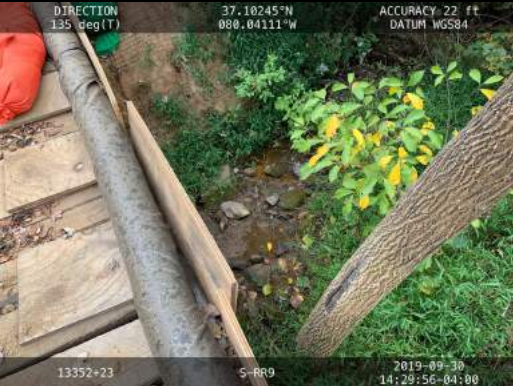
GPS Location	See photo for gps data.		GPS Location	See photo for gps data.	
Field Station#	13377+00		Field Station#	13352+23	
Pic 5 Desc.	Photo shows the ROW condition from about 13337+00 to 13389+00.		Pic 6 Desc.	Photo shows stream S-RR9

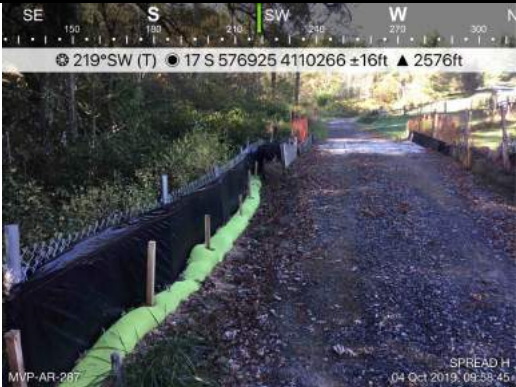
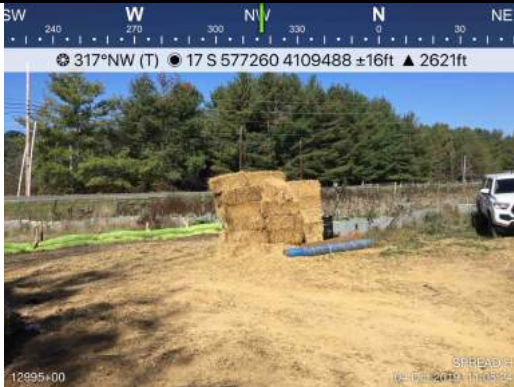
GPS Location	See Photo Above		GPS Location	See Photo Above	
Field Station#	2+87		Field Station#	12995+00	
Pic 1 Desc.	MVP-AR-287 is in good condition and SSF and CFS is in acceptable condition along the perimeter		Pic 2 Desc.	Straw bales on site to apply more mulch if/when needed. SF and CFS in good condition

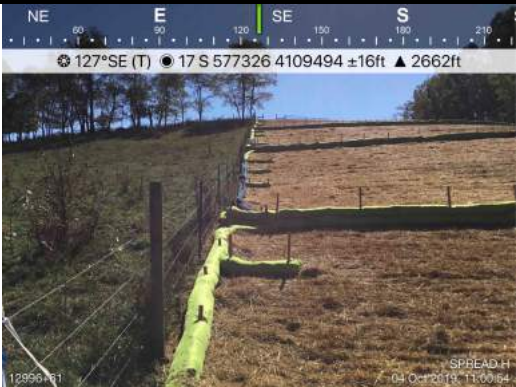
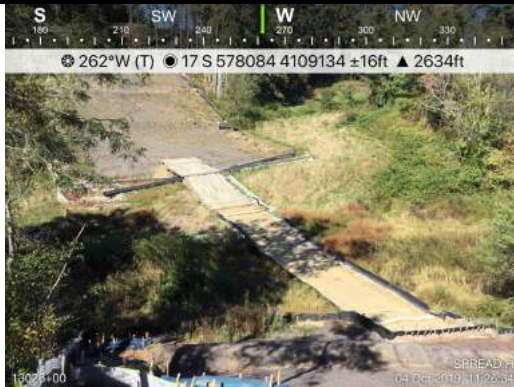
GPS Location	See Photo Above		GPS Location	See Photo Above	
Field Station#	12996+61		Field Station#	13026+00	
Pic 3 Desc.	Temp stabilization sufficiently applied and CFS energy dissipation installed accordingly		Pic 4 Desc.	S-G24 crossing. Timber mat in good condition. SSF and CFS in good condition. Erosion control blanket installed on slope

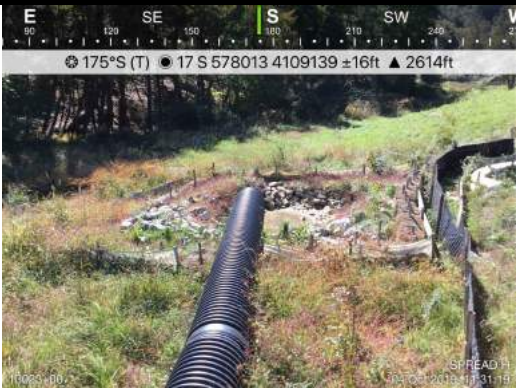
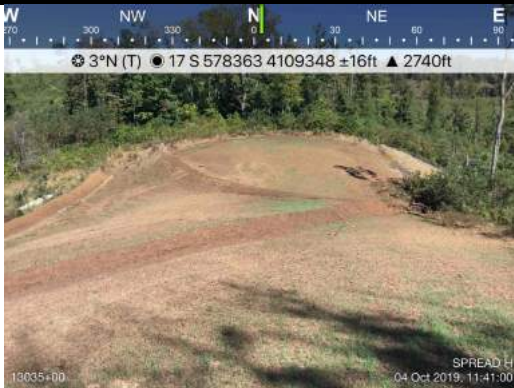
GPS Location	See Photo Above		GPS Location	See Photo Above	
Field Station#	13023+00		Field Station#	13035+00	
Pic 5 Desc.	CWD pipe in good condition and CWD Berm acceptable		Pic 6 Desc.	PI has acceptable water bars and temporary stabilization via hydraulically applied blanket and seed.

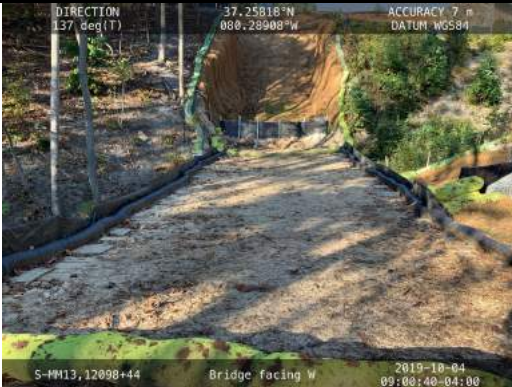
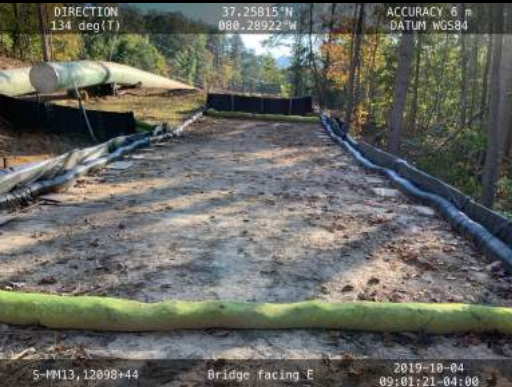
GPS Location	See photo GPS for location		GPS Location	See photo GPS for location	
Field Station#	12098+44		Field Station#	12098+44	
Pic 1 Desc.	S-MM13 bridge and surrounding ECDs are in acceptable condition.		Pic 2 Desc.	S-MM13 bridge and surrounding ECDs are in acceptable condition.

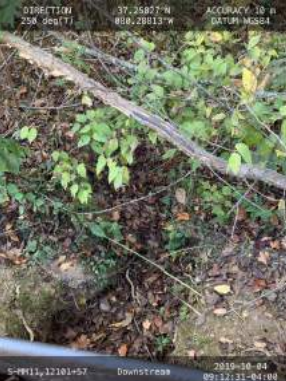
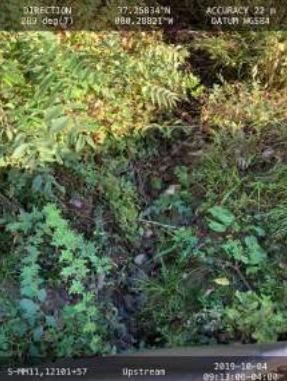
GPS Location	See photo GPS for location		GPS Location	See photo GPS for location	
Field Station#	12101+57		Field Station#	12101+57	
Pic 3 Desc.	S-MM11 is completely dried up as it crosses this ROW area.		Pic 4 Desc.	S-MM11 is completely dried up as it crosses this ROW area.

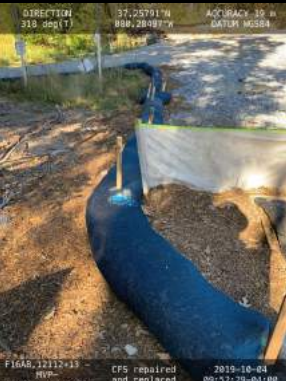
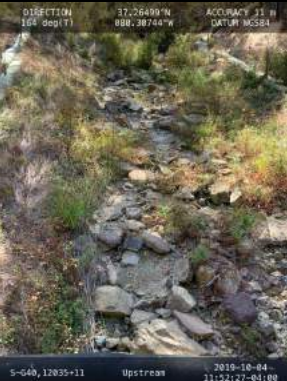
GPS Location	See photo GPS for location		GPS Location	See photo GPS for location	
Field Station#	12109+69		Field Station#	12035+11	
Pic 5 Desc.	CFS repaired and replaced.		Pic 6 Desc.	S-G40 is completely dried up as it crosses this ROW area.

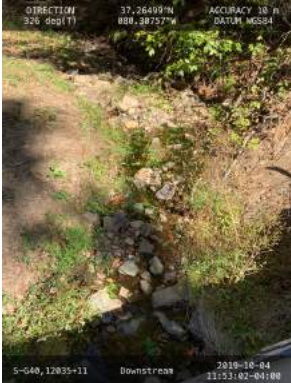
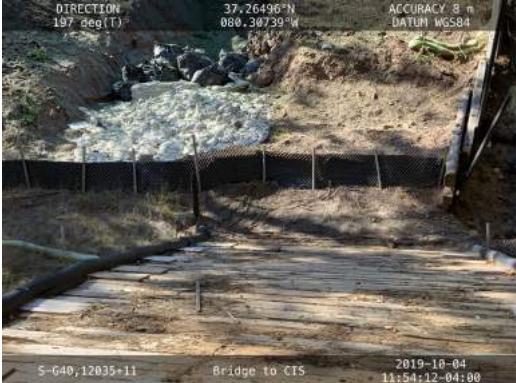
GPS Location	See photo GPS for location		GPS Location	See photo GPS for location	
Field Station#	12035+11		Field Station#	12035+11	
Pic 7 Desc.	S-G40 is completely dried up as it crosses this ROW area.		Pic 8 Desc.	S-G40 bridge and surrounding ECDs are in acceptable condition.

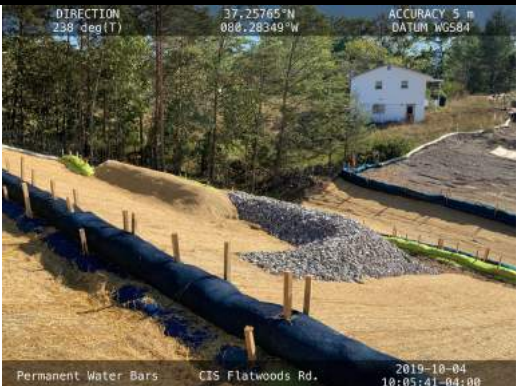
GPS Location	See photo GPS for location		GPS Location	See photo GPS for location	
Field Station#	12115+83		Field Station#	12116+34	
Pic 9 Desc.	Permanent water bars built to spec within the permanent easement.		Pic 10 Desc.	Permanent water bars built to spec within the permanent easement.

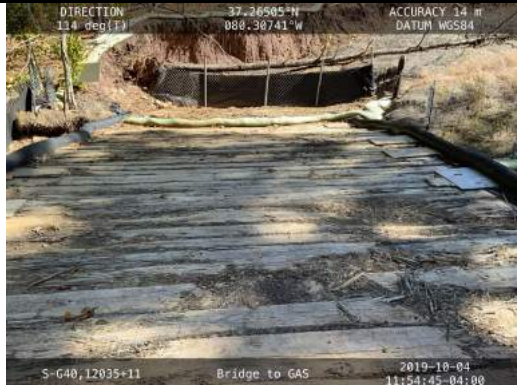
<p style="text-align: center;">Insert image here</p>			
GPS Location	See photo GPS for location		GPS Location		
Field Station#	12035+11		Field Station#		
Pic 11 Desc.	S-G40 bridge and surrounding ECDs are in acceptable condition.		Pic 12 Desc.

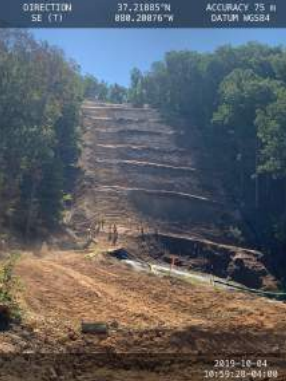
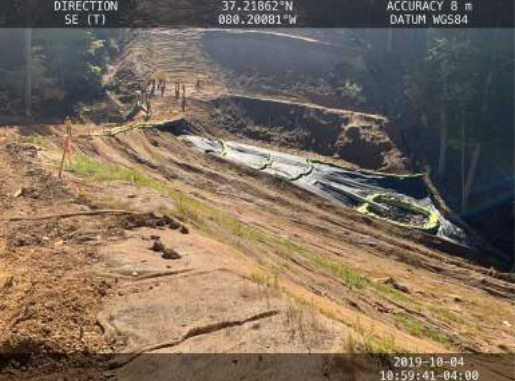
GPS Location	See picture for GPS data		GPS Location	See picture for GPS data	
Field Station#	12504+00		Field Station#	12504+00	
Pic 1 Desc.	Environmental crew installing erosion control blanket to the water bars.		Pic 2 Desc.	Clear water crossing pipe and outlet.

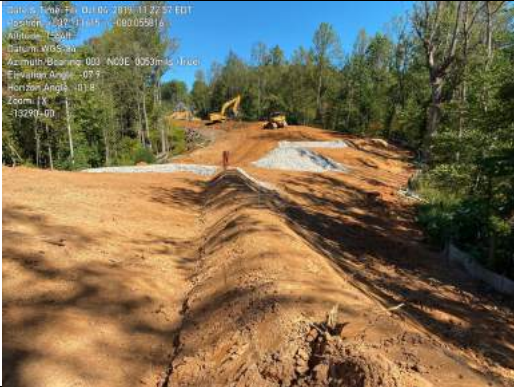
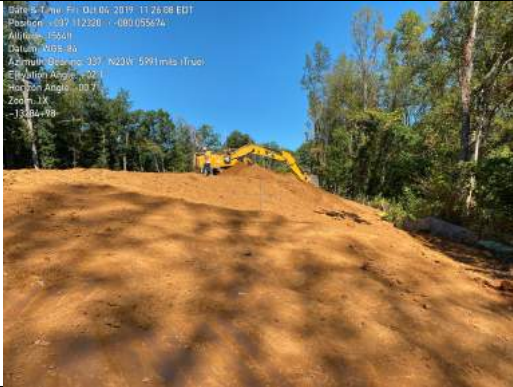
GPS Location	See photo for coordinates.		GPS Location	See photo for coordinates.	
Field Station#	13290+00		Field Station#	13284+98	
Pic 1 Desc.	ROW, permanent waterbars installed.		Pic 2 Desc.	ROW, regrading ROW after survey marked pre-construction elevations.

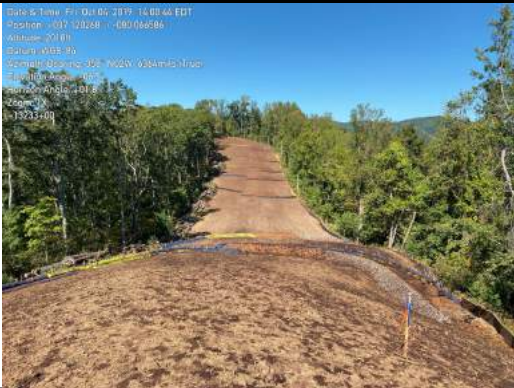
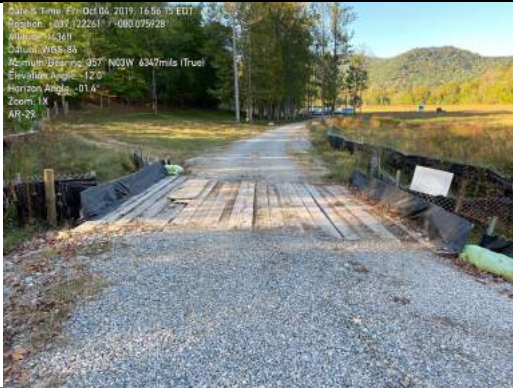
GPS Location	See photo for coordinates.		GPS Location	See photo for coordinates.	
Field Station#	13233+00		Field Station#	13190+00	
Pic 5 Desc.	ROW, areal application of ProGanics in progress.		Pic 6 Desc.	MVP-AR-29, access road in acceptably condition, Arnold staged in ROW for areal seeding.

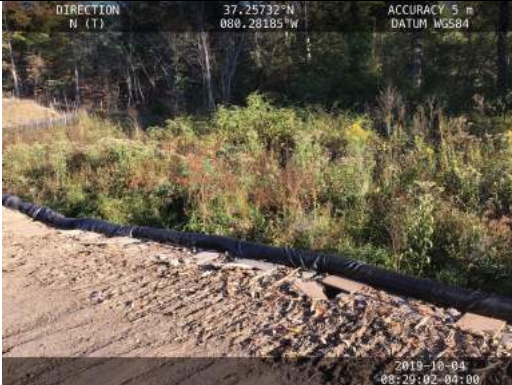
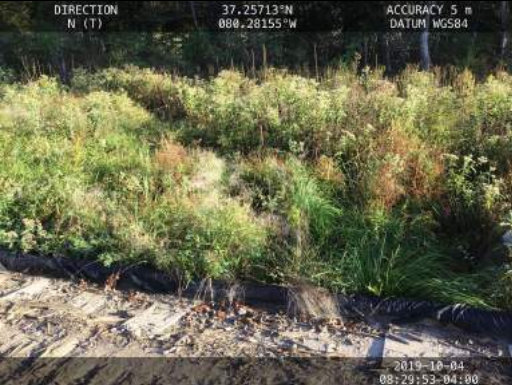
GPS Location	See photo		GPS Location	See photo	
Field Station#	12121+33		Field Station#	12121+83	
Pic 1 Desc.	Stream S-C33, facing north, upstream		Pic 2 Desc.	Stream S-C36, facing north, upstream

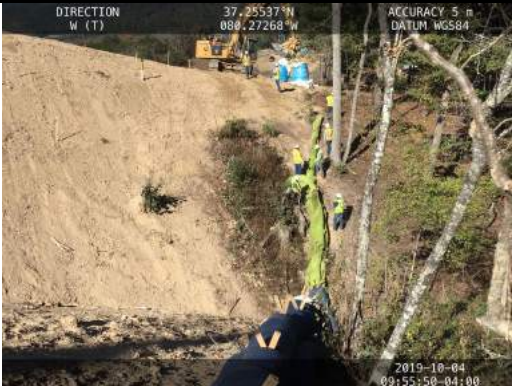
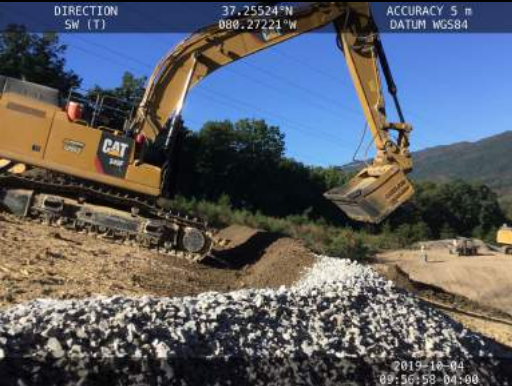
GPS Location	See photo		GPS Location	See photo	
Field Station#	12147+50		Field Station#	12149+50	
Pic 5 Desc.	Laborers replaced perimeter controls that had been pulled for restoration with CFS on going away side of AR 272.		Pic 6 Desc.	An operator used a shaker bucket to spread topsoil on the permanent waterbars on the coming in side of AR 273.

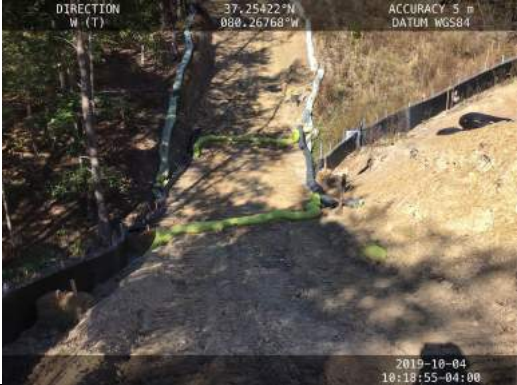
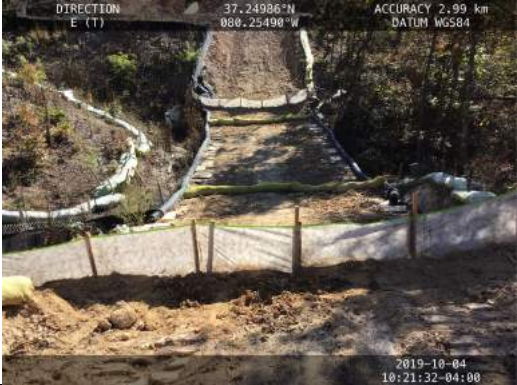
GPS Location	See photo		GPS Location	See photo	
Field Station#	12163+05		Field Station#	12166+47	
Pic 7 Desc.	Stream S-C25, facing west		Pic 8 Desc.	Stream S-C24, facing east

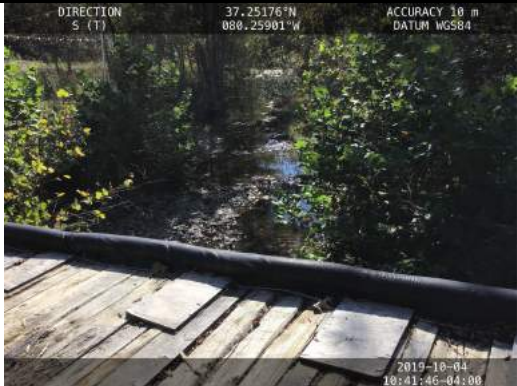
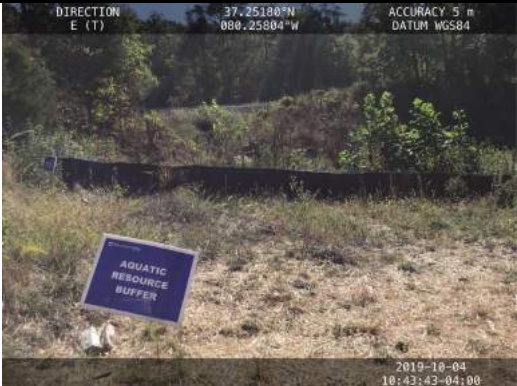
GPS Location	See photo		GPS Location	See photo	
Field Station#	12192+50		Field Station#	12196+00	
Pic 9 Desc.	Stream S-C21, Bradshaw Creek, facing south, downstream		Pic 10 Desc.	Stream S-OO11 and buffer zone, facing east, upstream

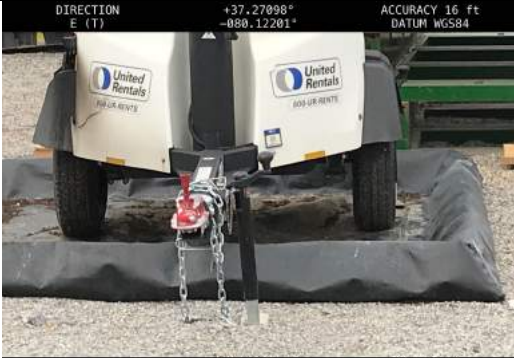
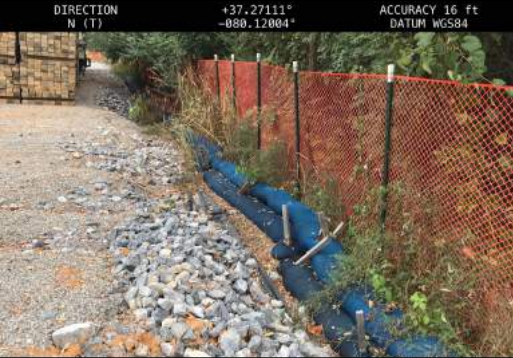
GPS Location	MVP-LY-049 See photo for gps data		GPS Location	MVP-LY-049 See photo for gps data	
Field Station#	+0		Field Station#	+0	
Pic 1 Desc.	Condition of containment under light plant. Looking E.		Pic 2 Desc.	Condition of CFS and safety fence along East boundary. Looking N.

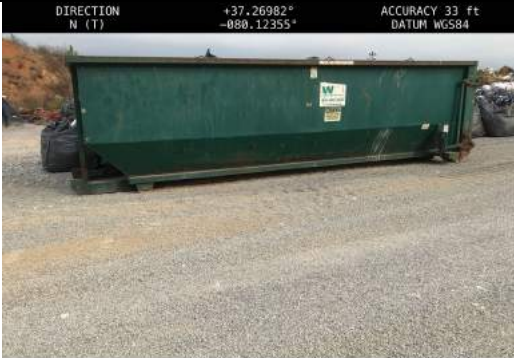
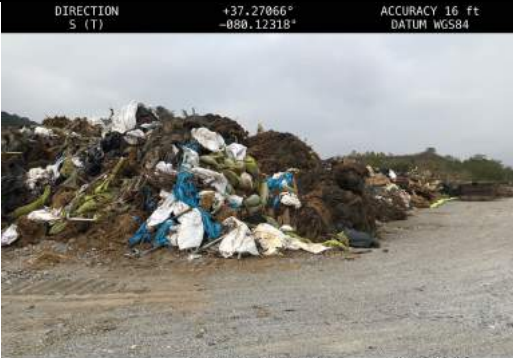
GPS Location	MVP-LY-049 See photo for gps data		GPS Location	MVP-LY-049 See photo for gps data	
Field Station#	+0		Field Station#	+0	
Pic 3 Desc.	No loose trash around West dumpster. Looking N.		Pic 4 Desc.	Status of ROW debris pile. Looking S.

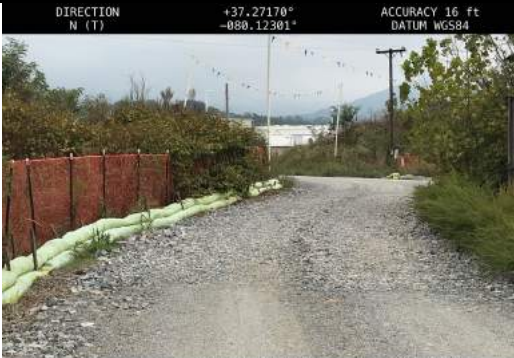
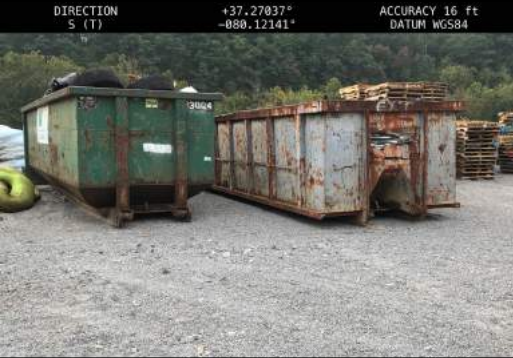
GPS Location	MVP-LY-049 See photo for gps data		GPS Location	MVP-LY-049 See photo for gps data	
Field Station#	+0		Field Station#	+0	
Pic 5 Desc.	Condition of rock entrance on North drive. Looking N.		Pic 6 Desc.	No loose trash around FAB Area dumpsters. Looking S.

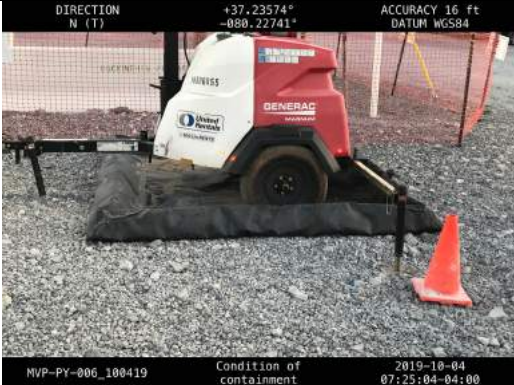
GPS Location	MVP-PY-006 See photo for gps data		GPS Location	MVP-PY-006 See photo for gps data	
Field Station#	+0		Field Station#	+0	
Pic 1 Desc.	Condition of containment under light plant. Looking N.		Pic 2 Desc.	Buffer and signage in place at off LOD feature. Looking NE.

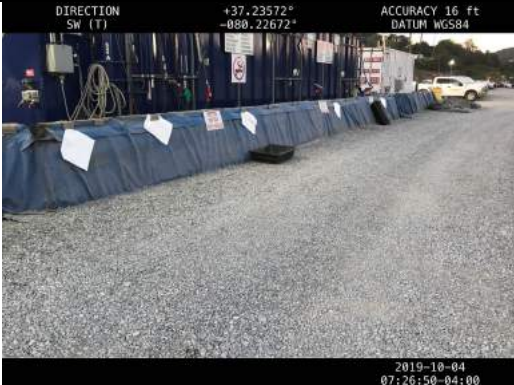
GPS Location	MVP-PY-006 See photo for gps data		GPS Location	MVP-PY-006 See photo for gps data	
Field Station#	+0		Field Station#	+0	
Pic 3 Desc.	No fluid deposits on the North side of the Blue Bulk Fuel tanks. Looking SW.		Pic 4 Desc.	Off Road Fuel unit no leaky fittings. Looking SW.

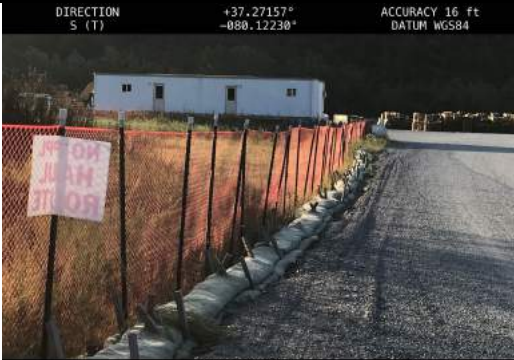
<p>DIRECTION S (T) +37.27157° -080.12230° ACCURACY 16 ft DATUM WGS84</p> <p>MVP-LY-049_100419 Condition of CFS & safety fence along d... 2019-10-04 08:21:36-04:00</p>

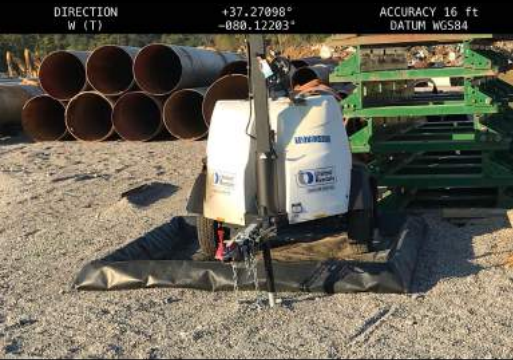
<p>DIRECTION W (T) +37.27098° -080.12203° ACCURACY 16 ft DATUM WGS84</p> <p>MVP-LY-049_100419 Condition of containment 2019-10-04 08:22:01-04:00</p>			
GPS Location	MVP-LY-049 See photo for gps data		GPS Location	MVP-LY-049 See photo for gps data	
Field Station#	+0		Field Station#	+0	
Pic 1 Desc.	Condition of CFS and safety fence along drive. Looking S.		Pic 2 Desc.	Condition of containment under light plant. Looking W.

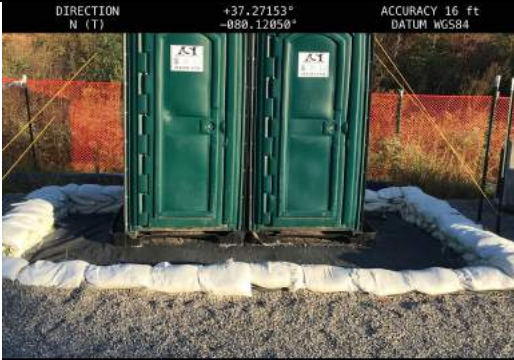
<p>DIRECTION N (T) +37.27153° -080.12050° ACCURACY 16 ft DATUM WGS84</p> <p>MVP-LY-049_100419 Condition of trays and containment 2019-10-04 08:23:02-04:00</p>

GPS Location	MVP-LY-049 See photo for gps data		GPS Location	MVP-LY-049 See photo for gps data	
Field Station#	+0		Field Station#	+0	
Pic 3 Desc.	Condition of trays and containment under toilets. Looking N.		Pic 4 Desc.	No loose trash around West dumpster. Looking N.

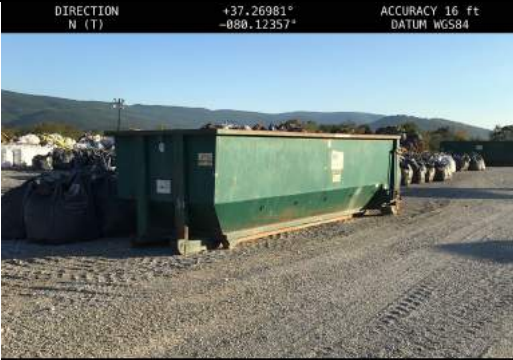
<p>DIRECTION N (T) +37.26981° -080.12357° ACCURACY 16 ft DATUM WGS84</p> <p>MVP-LY-049_100419 No loose trash at West dumpster 2019-10-04 08:26:55-04:00</p>

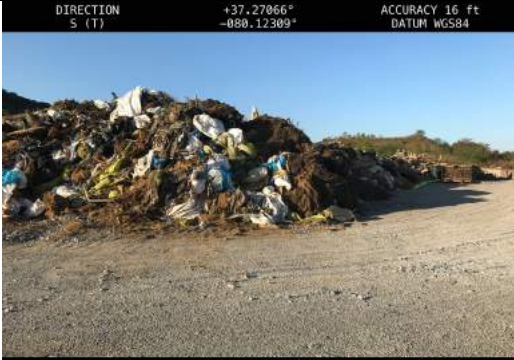
<p>DIRECTION S (T) +37.27066° -080.12309° ACCURACY 16 ft DATUM WGS84</p> <p>MVP-LY-049_100419 Status of ROW debris pile 2019-10-04 08:28:30-04:00</p>

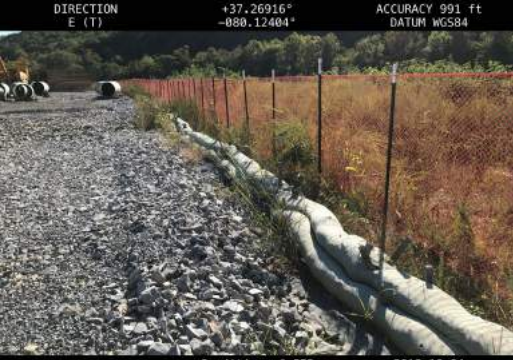
<p>DIRECTION E (T) +37.26916° -080.12404° ACCURACY 991 ft DATUM WGS84</p> <p>MVP-LY-049_100419 Condition of CFS along S boundary 2019-10-04 10:19:15-04:00</p>			
GPS Location	MVP-LY-049 See photo for gps data		GPS Location	MVP-LY-049 See photo for gps data	
Field Station#	+0		Field Station#	+0	
Pic 5 Desc.	Status of ROW debris pile. Looking SW.		Pic 6 Desc.	Condition of CFS and Silt fence along south boundary. Looking E.
