Visual Site Inspection Report

| Project Name H-600 Pipeline Spread I | | AFE 124300139 | Spread H-600 Pipeline Spread I |

| Project Name Transco Interconnect Station | | AFE 124300113 | Spread Transco Interconnect Station |

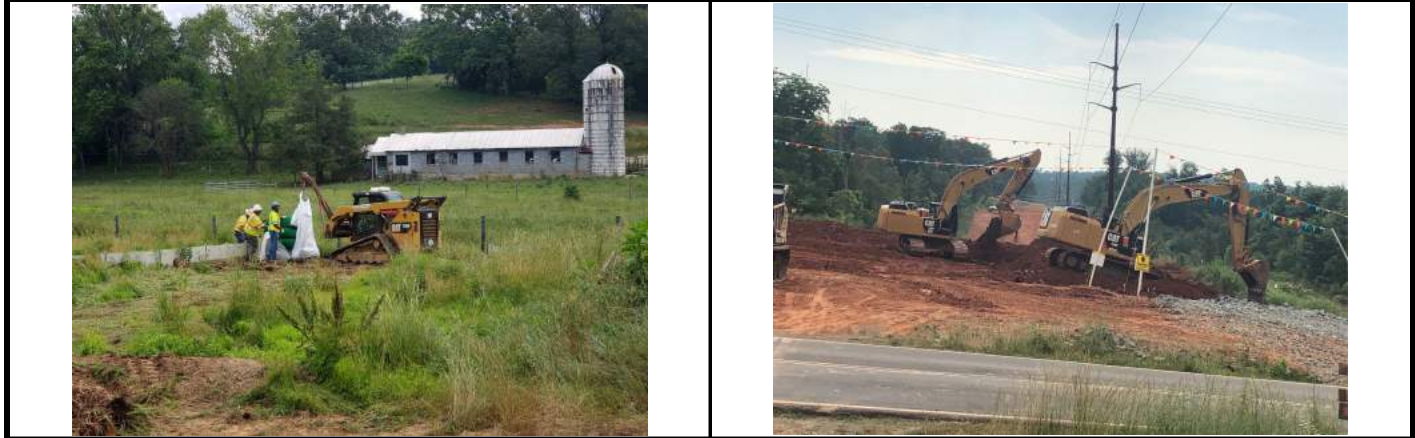
| GPS Location 36.97 | Field Station# 13692+23 | GPS Location 36.97 | Field Station# 14696+00 |

| Description Contractor removing nonfunctional de-water structure and making repairs to ECD's | | Description Restoring subsoil during temporary stabilization process | |

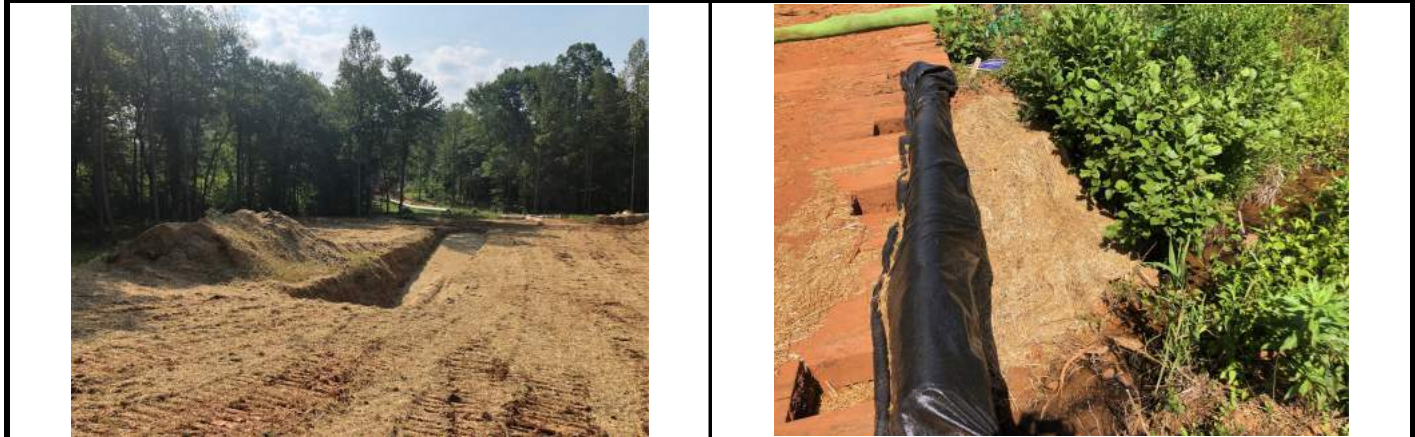
| GPS Location 36.97 | Field Station# 14655+00 | GPS Location 36.97 | Field Station# 14658+00 |

| Description Seed and straw applied during temporary stabilization process | | Description Stream bank of S-E18 restored and stabilized | |

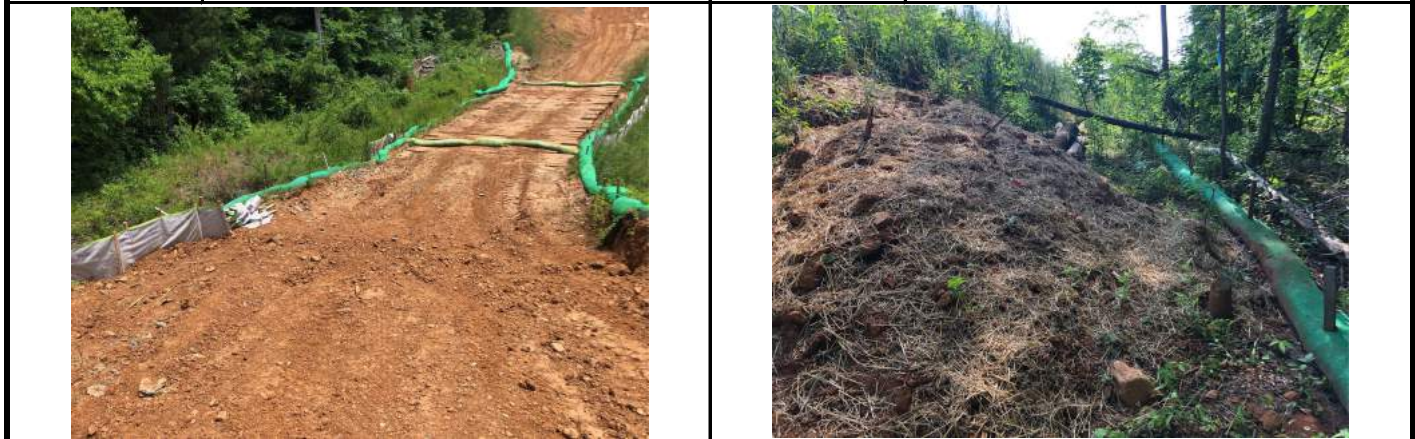
| GPS Location 36.97 | Field Station# 14782+00 | GPS Location 36.97 | Field Station# 14569+00 |

| Description P1 fence that had been repeatedly torn down removed | | Description Stockpile stabilized and CFS perimeter maintained | |

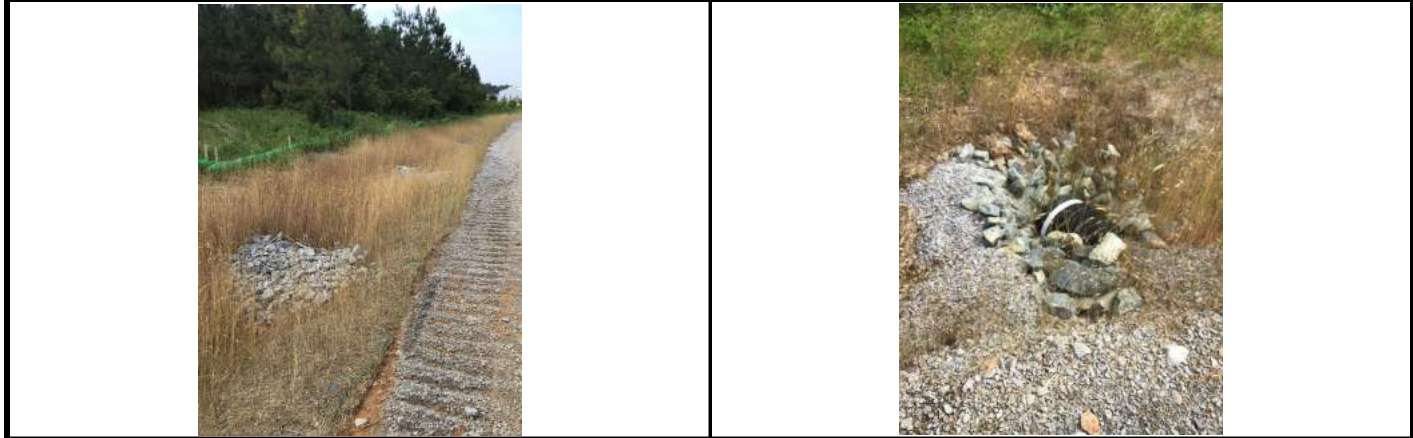
| GPS Location 36.83 | Field Station# 00+00 | GPS Location 36.83 | Field Station# 00+00 |

| Description Observing rock check dams in drainage channel. | Description Observing outlet and outlet protection. |

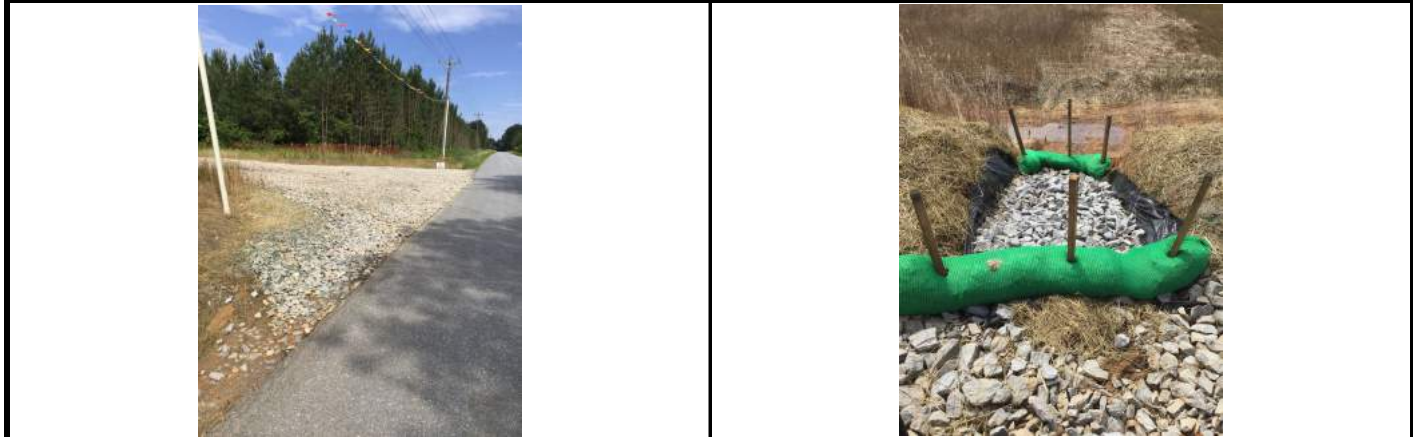
| GPS Location 36.83 | Field Station# 00+00 | GPS Location 36.83 | Field Station# 00+00 |

| Description Observing RCE at Transco. | Description Observing rock drain performing as it should. |

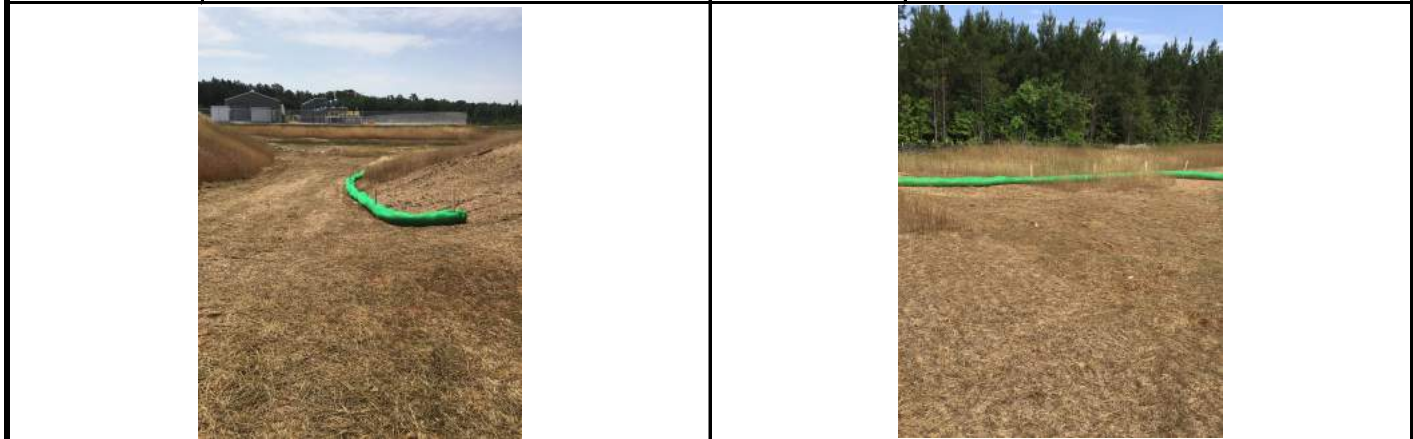
| GPS Location 36.83 | Field Station# 00+00 | GPS Location 36.83 | Field Station# 00+00 |

| Description Observing ECD's performing as they should. | Description Observing ECD's performing as they should. |

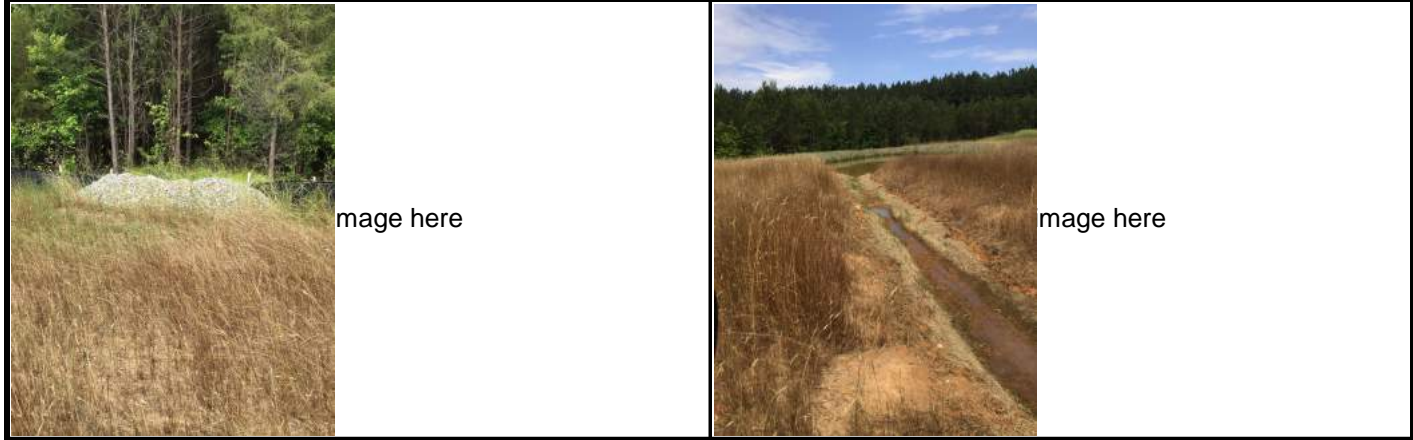
| GPS Location | 36.83 | Field Station# | 00+00 | GPS Location | 36.83 | Field Station# | 00+00 |

| Description | Observing rock check. | Description | Observing stabilized channel. |

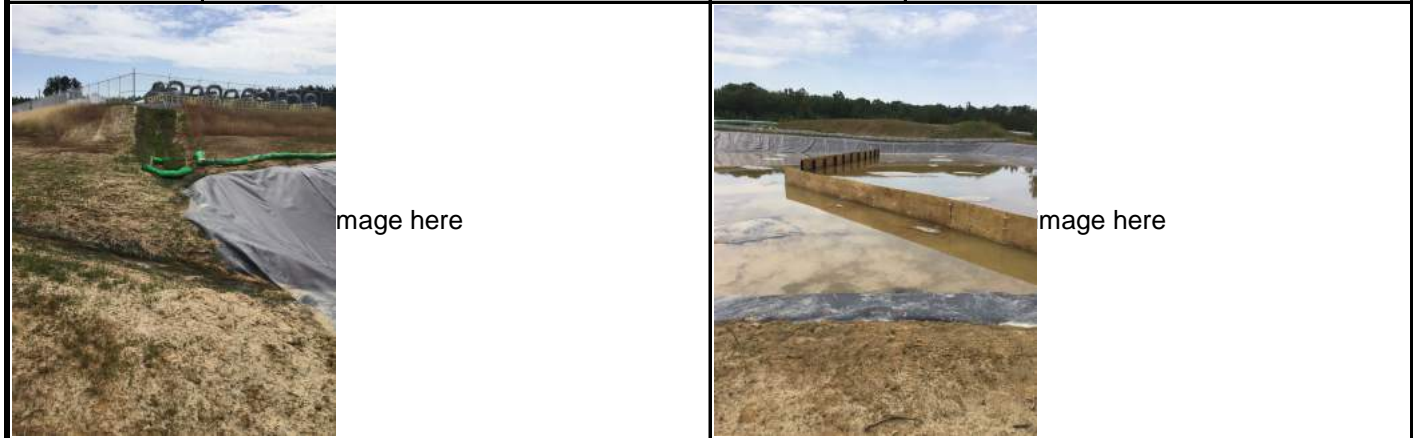
| GPS Location | 36.83 | Field Station# | 00+00 | GPS Location | 36.83 | Field Station# | 00+00 |

| Description | Observing drainage channels. | Description | Observing baffles in the storm water pond. |

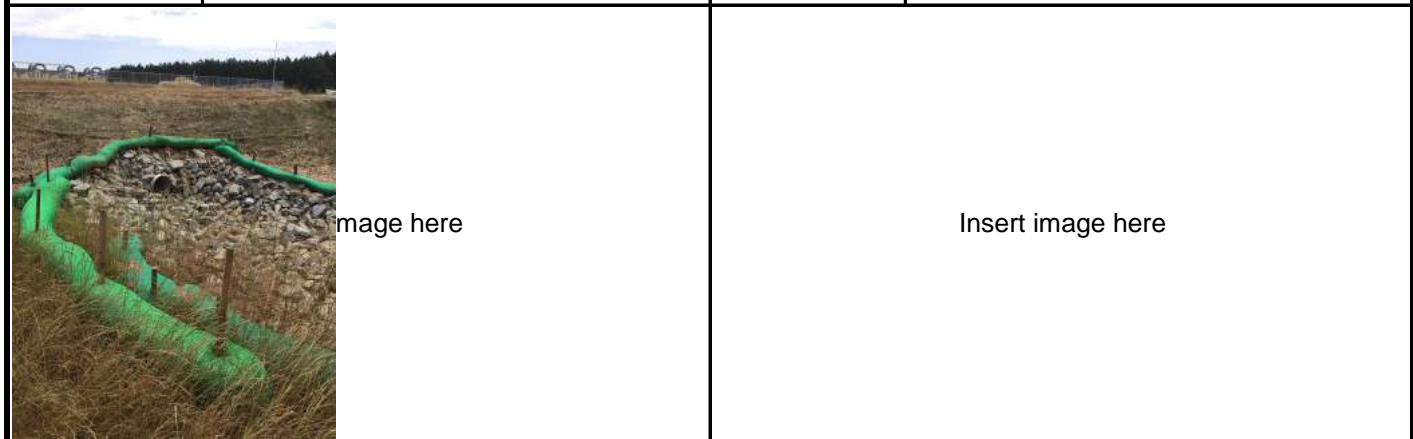
| GPS Location | 36.83 | Field Station# | 00+00 | GPS Location | | Field Station# | |

| Description | Observing storm water pond outlet. | Description | |

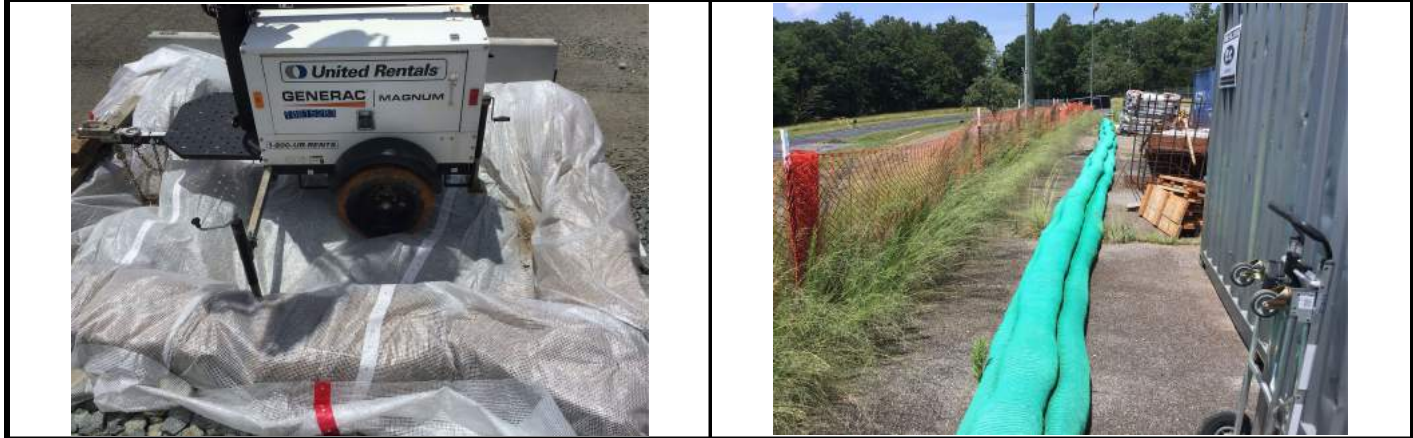
| GPS Location | 36.97 | Field Station# | 0000+00 | GPS Location | 36.97 | Field Station# | 0000+00 |

| Description | Hole in plastic liner for light plant near inspection office, issue addressed. | Description | Perimeter ECD's in good condition on west side of paved yard. |

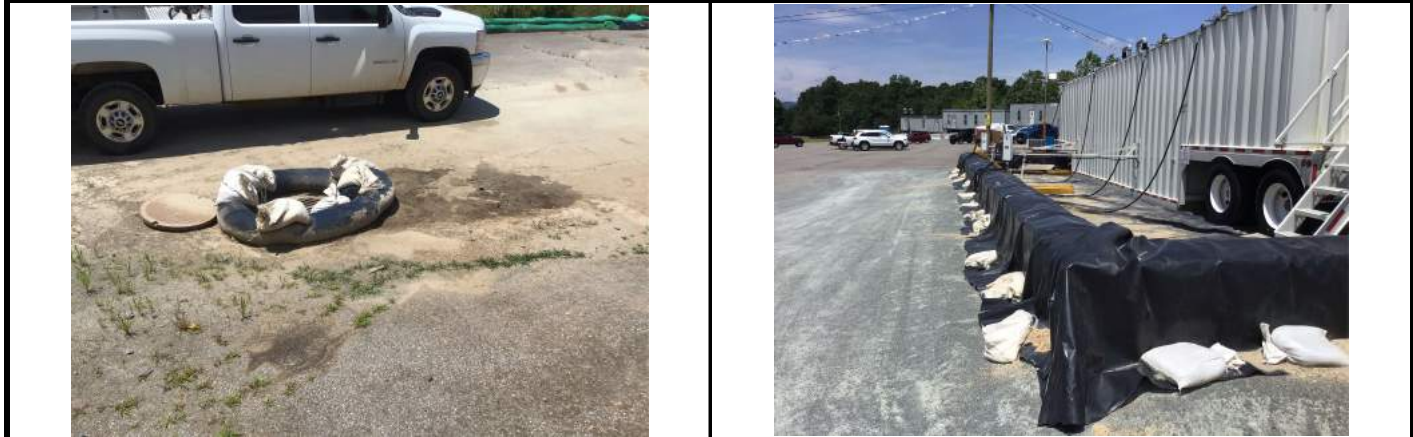
| GPS Location | 36.97 | Field Station# | 0000+00 | GPS Location | 36.97 | Field Station# | 0000+00 |

| Description | Inlet protection for the parking lot drain on south end of paved yard, sediment build up addressed. | Description | Secondary containment structure for fuel cell in compliance. |

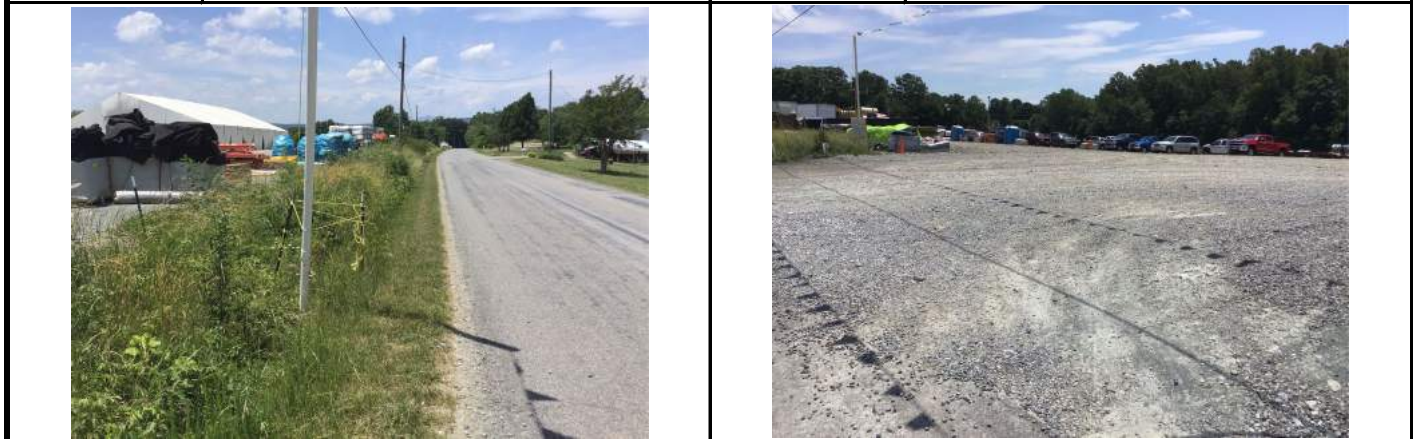
| GPS Location | 36.97 | Field Station# | 0000+00 | GPS Location | 36.97 | Field Station# | 0000+00 |

| Description | Roadside ditch along Triple Creek Rd clean of debris. | Description | RCE at gravel yard in good condition. |
