# Visual Site Inspection Report

<b>Project Name</b> Transco Interconnect Station		<b>AFE</b> 124300113	<b>Spread</b> Transco Interconnect St
<b>Contractor</b> Kanahwa		<b>Report #</b> 4761	
<b>Inspector</b> Justin Burch		<b>Date/Time</b> 10/16/2019 10:06 AM	
<b>Permit #</b> TBD	<b>Inspection Type</b> VA SWPP	<b>Station Begin</b>	00+00
<b>State</b> VA	<b>Inspection Area</b> Full	<b>Station End</b>	00+00
<b>County</b> Pittsylvania	<b>Ground</b> Wet	<b>Temperature (°F)</b>	63.00
<b>Municipality</b> Chatham	<b>Weather</b> Light Rain	<b>Rain Gauge (in)</b>	1.30
<b>Rain Accumulation Time (days)</b>			4.00

<b>Project Name</b> H-600 Pipeline Spread I		<b>AFE</b> 124300139	<b>Spread</b> H-600 Pipeline Spread I
<b>Contractor</b> Precision		<b>Report #</b> 4768	
<b>Inspector</b> Charles Head		<b>Date/Time</b> 10/16/2019 1:57 PM	
<b>Permit #</b> TBD	<b>Inspection Type</b> VA SWPP	<b>Station Begin</b> 13958+31	
<b>State</b> VA	<b>Inspection Area</b> Partial	<b>Station End</b> 14454+22	
<b>County</b> Franklin	<b>Ground</b> Wet	<b>Temperature (°F)</b> 61.00	
<b>Municipality</b> N/A	<b>Weather</b> Light Rain	<b>Rain Gauge (in)</b> 1.20	
<b>Rain Accumulation Time (days)</b>			6.00

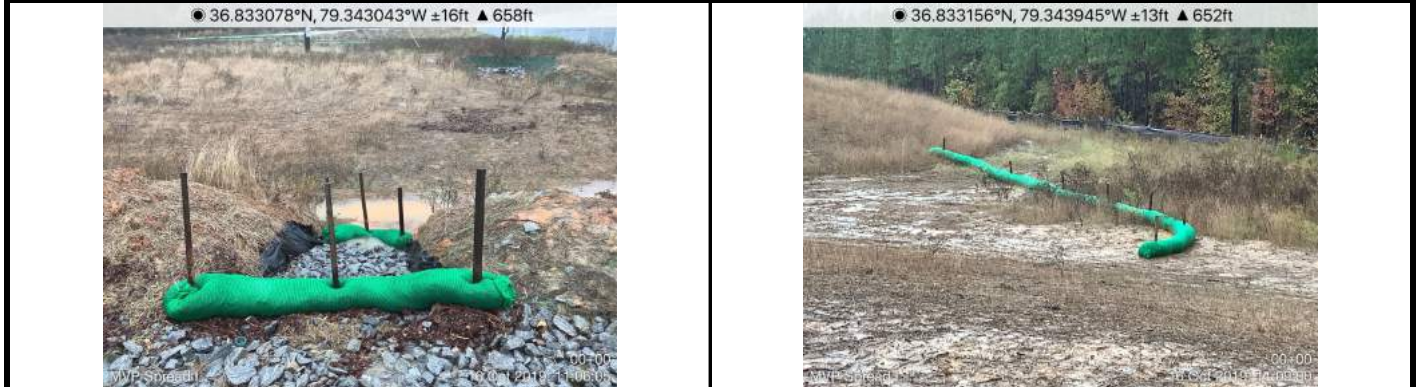
<b>GPS Location</b>	0	<b>GPS Location</b>	0
<b>Field Station#</b>	00+00	<b>Field Station#</b>	00+00
<b>Pic 1 Desc.</b>	Rock lined channel is acceptable	<b>Pic 2 Desc.</b>	CFS is acceptable

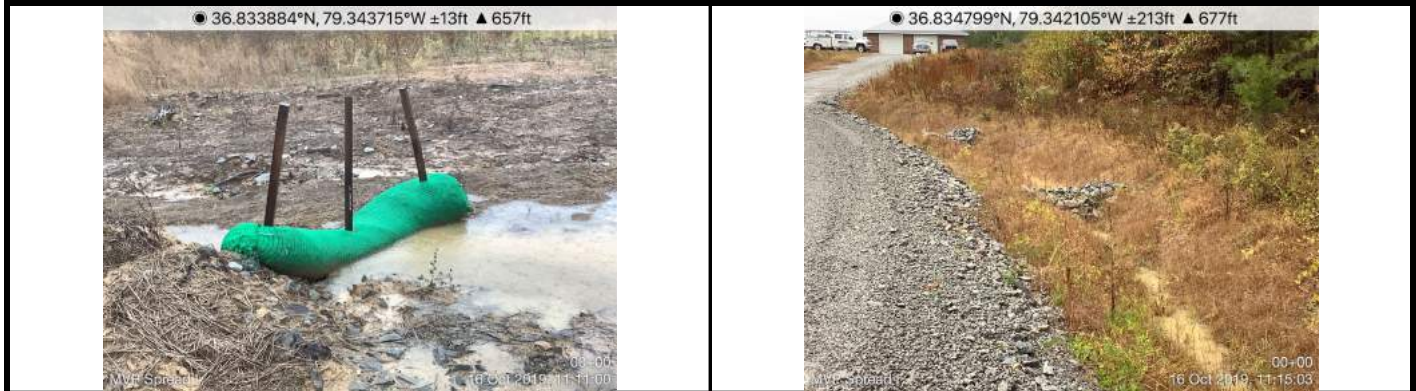
- Inspector performed a SWPPP inspection at the Transco Facility and Laydown yard. This site is in compliance with the exception that a CFS was observed to be undermined, which was submitted for addition to the punch list.
- Two rain events occurred since the last SWPPP inspection. See rain log for details.

<b>GPS Location</b>	0	<b>GPS Location</b>	0
<b>Field Station#</b>	00+00	<b>Field Station#</b>	00+00
<b>Pic 3 Desc.</b>	CFS has been undermined and requires maintenance	<b>Pic 4 Desc.</b>	Rock check dams are acceptable

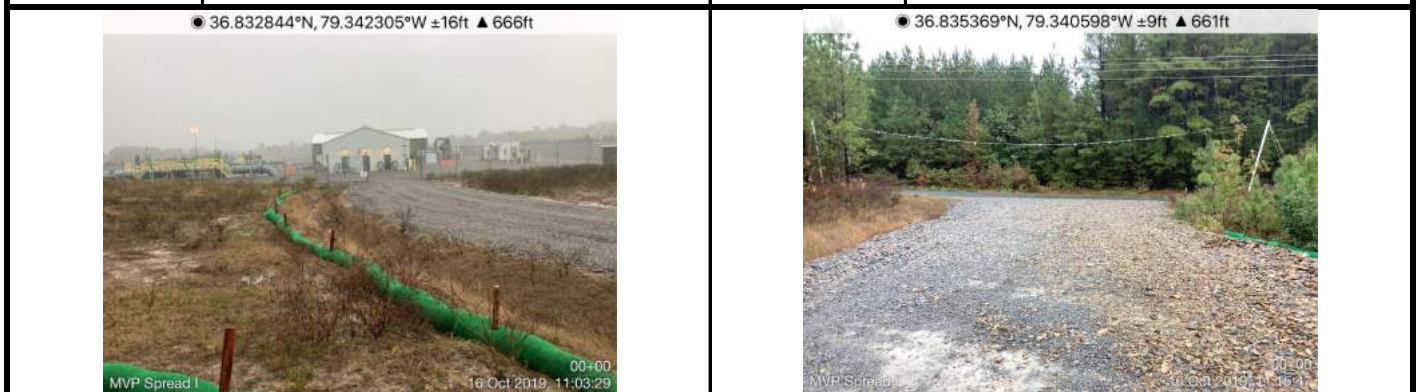
<b>GPS Location</b>	0	<b>GPS Location</b>	0
<b>Field Station#</b>	00+00	<b>Field Station#</b>	00+00
<b>Pic 5 Desc.</b>	CFS is acceptable	<b>Pic 6 Desc.</b>	RCE is acceptable

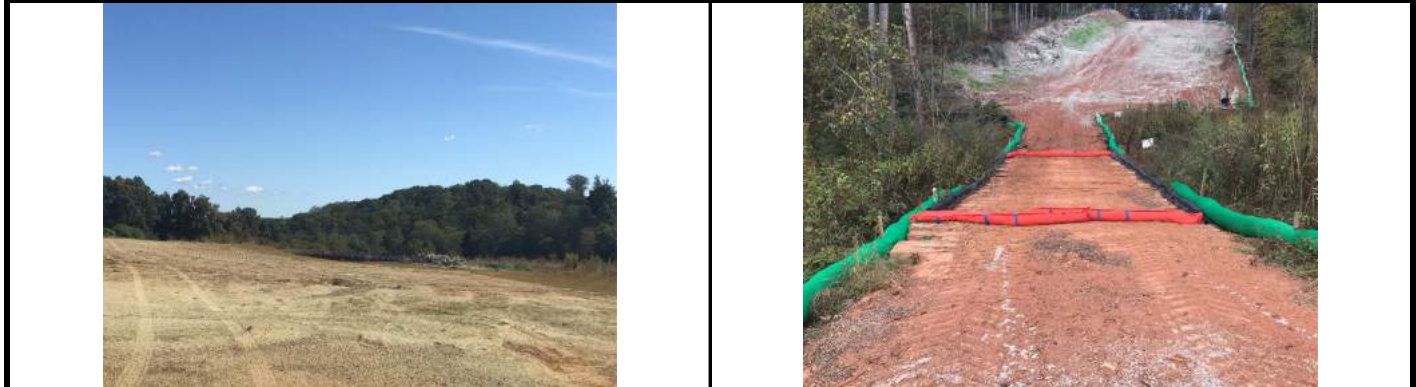
<b>Pic 1 Desc.</b>	Approximately 13960+00. CWD installed and appears to be functioning correctly at time of inspection.	<b>Pic 2 Desc.</b>	Approximately 14157+55. Overview of stream crossing and equipment bridge at stream S-KL51.
--------------------	--	--------------------	--

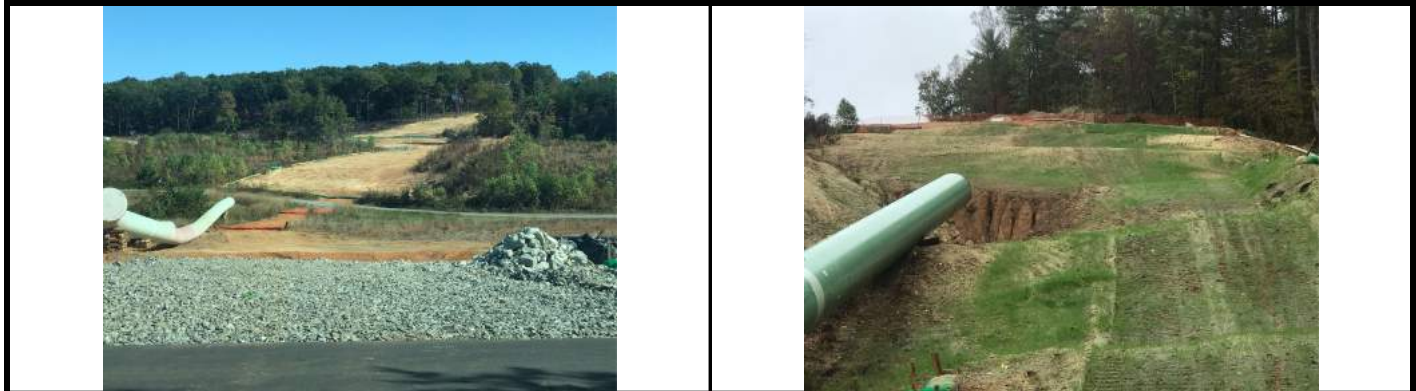
<b>Pic 3 Desc.</b>	Approximately 14312+00. Road crossing and RCE free of mud and debris at time of inspection.	<b>Pic 4 Desc.</b>	Approximately 14000+00. ROW temporarily seeded and stabilized in this area. Temporary vegetation growing.
--------------------	---	--------------------	---

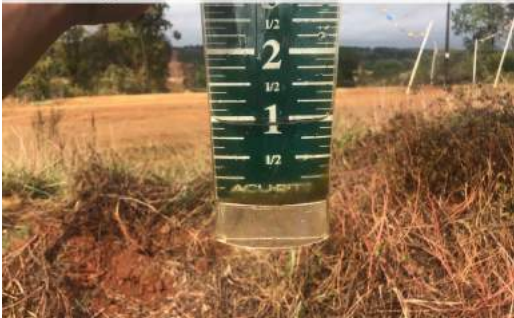
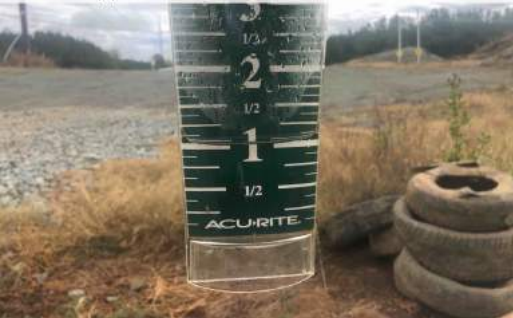
<b>GPS Location</b>	0	<b>GPS Location</b>	0
<b>Field Station#</b>	14524+76	<b>Field Station#</b>	14758+16
<b>Pic 1 Desc.</b>	Rain gauge at Timber Ridge Road 1"	<b>Pic 2 Desc.</b>	Rain gauge at Indian Cave Road 1"
<p style="text-align: center;"><b>South West Elevation</b></p> <p style="text-align: center;">☉ 32°NE (T) LAT: 37.005951 LON: -79.753096 ±16ft ▲ 970ft</p>

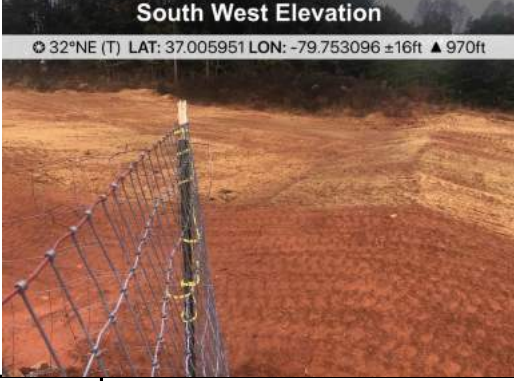
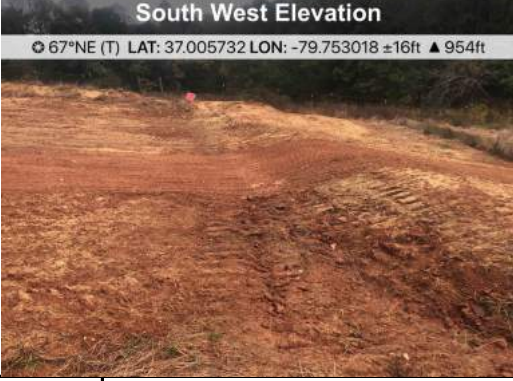
<b>GPS Location</b>	0	<b>GPS Location</b>	0
<b>Field Station#</b>	14540+00	<b>Field Station#</b>	14545+00
<b>Pic 3 Desc.</b>	Water bar functioning as intended	<b>Pic 4 Desc.</b>	Water bar functioning as intended
<p style="text-align: center;"><b>South East Elevation</b></p> <p style="text-align: center;">☉ 333°NW (T) LAT: 36.988297 LON: -79.704263 ±16ft ▲ 937ft</p>

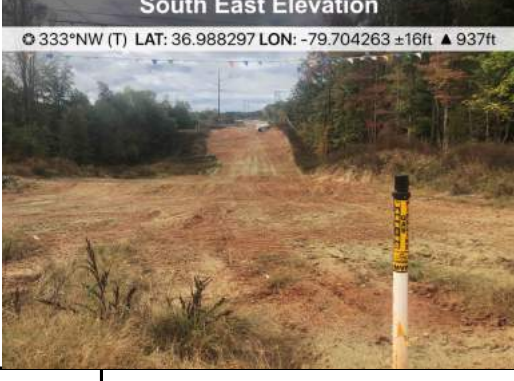
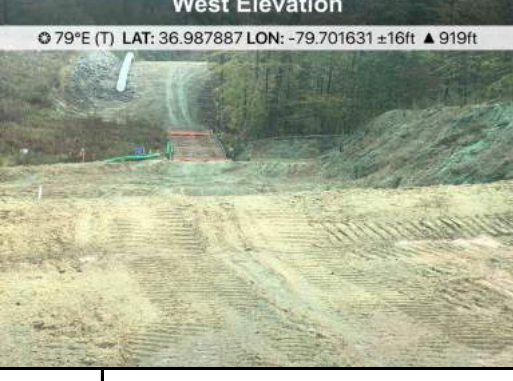
<b>GPS Location</b>	0	<b>GPS Location</b>	0
<b>Field Station#</b>	14711+00	<b>Field Station#</b>	14720+00
<b>Pic 5 Desc.</b>	Temporary stabilization	<b>Pic 6 Desc.</b>	Temporary stabilization

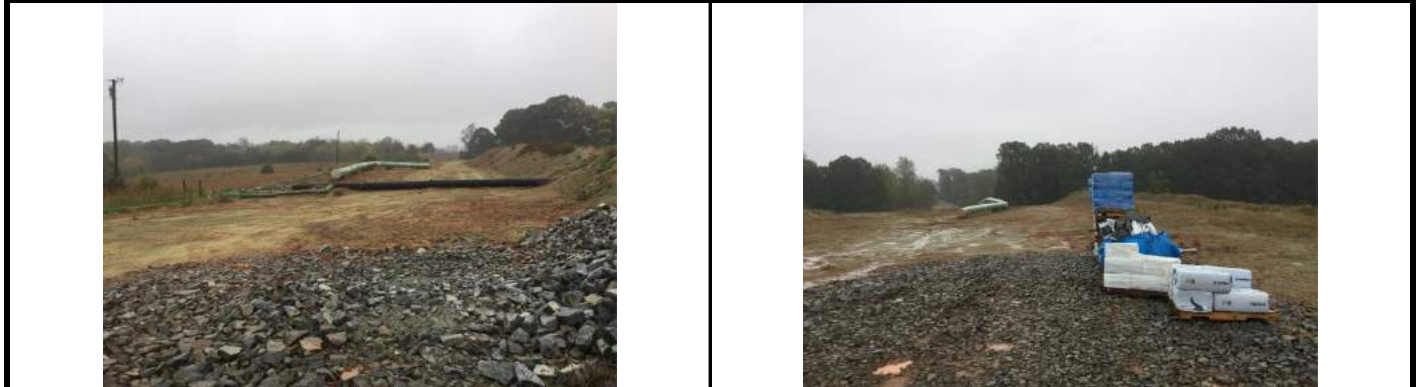
<b>Pic 1 Desc.</b> View of hydroseeded ROW during rain event during inspection	<b>Pic 2 Desc.</b> View of hydroseeded ROW during rain event during inspection
--	--

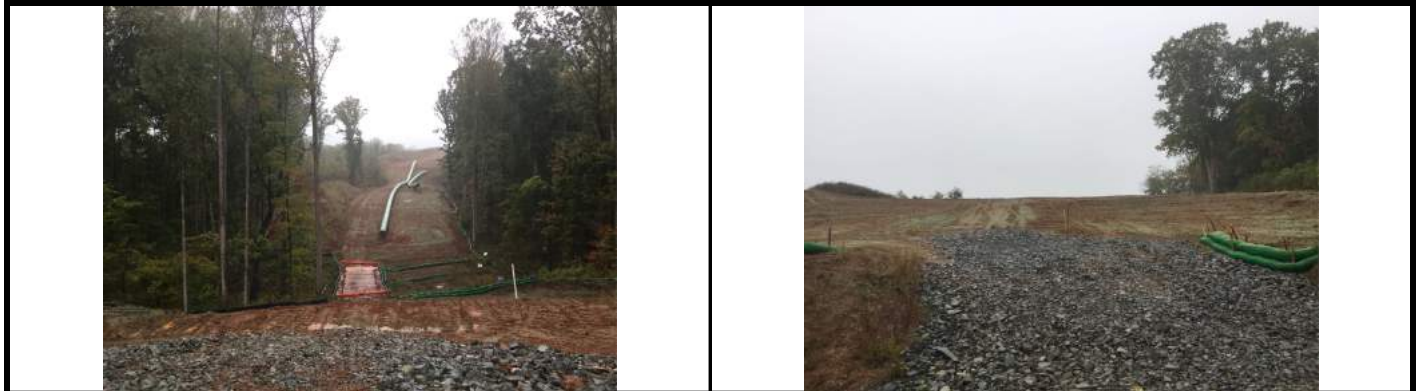
<b>Pic 3 Desc.</b> View of hydroseeded ROW during rain event during inspection	<b>Pic 4 Desc.</b> View of hydroseeded ROW during rain event during inspection
--	--

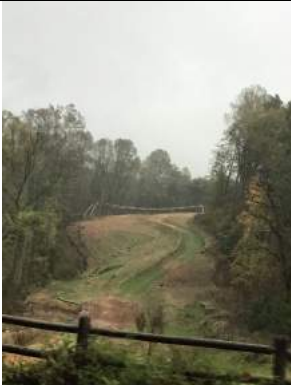
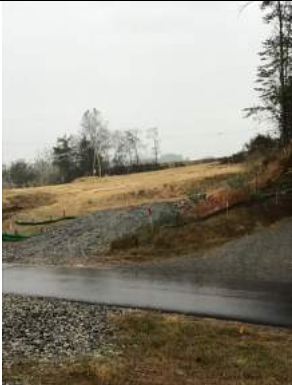
<b>GPS Location</b>	0000	<b>GPS Location</b>	0000		
<b>Field Station#</b>	13814+00	<b>Field Station#</b>	13811+13		
<b>Pic 1 Desc.</b>	Row photo during rain showers	<b>Pic 2 Desc.</b>	RCE cis Brick Church

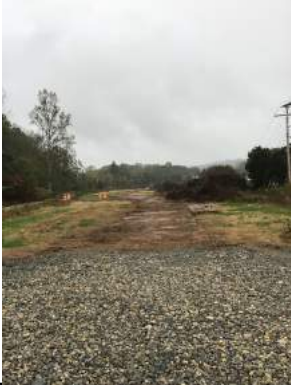
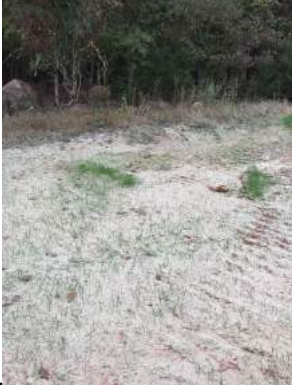
<b>GPS Location</b>	0000	<b>GPS Location</b>	0000		
<b>Field Station#</b>	13690+67	<b>Field Station#</b>	13826+99		
<b>Pic 3 Desc.</b>	Row photo during light rain showers	<b>Pic 4 Desc.</b>	New vegetation coming up		
Insert image here			Insert image here		
<b>GPS Location</b>		<b>GPS Location</b>			
<b>Field Station#</b>		<b>Field Station#</b>			
<b>Pic 5 Desc.</b>		<b>Pic 6 Desc.</b>
