Visual Site Inspection Report

Project Name H-600 Pipeline Spread I		AFE 124300139	Spread H-600 Pipeline Spread I
Contractor Precision		Report # 5034	
Inspector Ben Davenport		Date/Time 10/22/2019 8:38 AM	
Permit # TBD	Inspection Type VA SWPP	Station Begin 14981+55	
State VA	Inspection Area Partial	Station End 15496+70	
County Franklin/Pittsylvania	Ground Muddy	Temperature (°F) 66.00	
Municipality Chatham	Weather Heavy Rain	Rain Gauge (in) 0.00	
			Rain Accumulation Time (days) 0.00

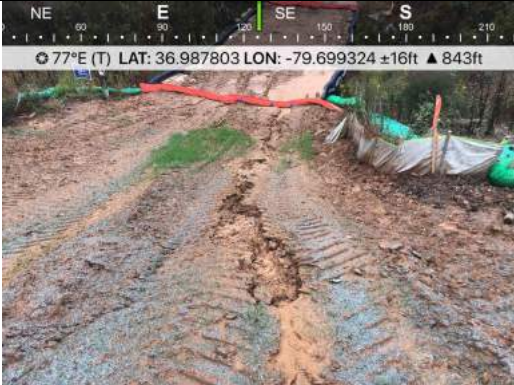
GPS Location	0	GPS Location	0
Field Station#	14728+90	Field Station#	14728+90
Pic 1 Desc.	Hillside washing out causing sediment to settle on the bridge at stream S-A19	Pic 2 Desc.	Sediment on bridge at stream S-19

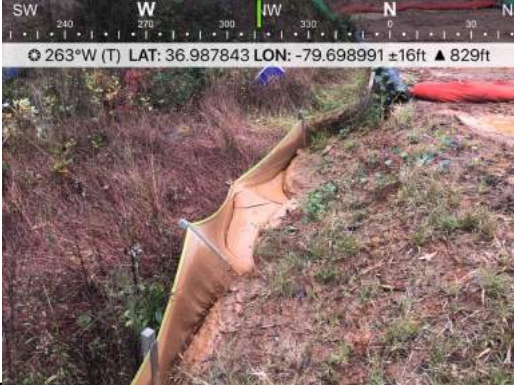
GPS Location	0	GPS Location	0
Field Station#	14729+00	Field Station#	14719+00
Pic 3 Desc.	P1 silt fence full and requires maintenance	Pic 4 Desc.	CFS full and needs cleaned out

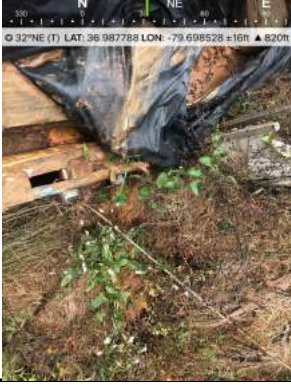
GPS Location	0	GPS Location	0
Field Station#	14729+19	Field Station#	14728+90
Pic 5 Desc.	Geotech needs to be fixed on bridge at stream S-A20	Pic 6 Desc.	Contractor fixing bridges at stream crossings S-A19 and S-A20

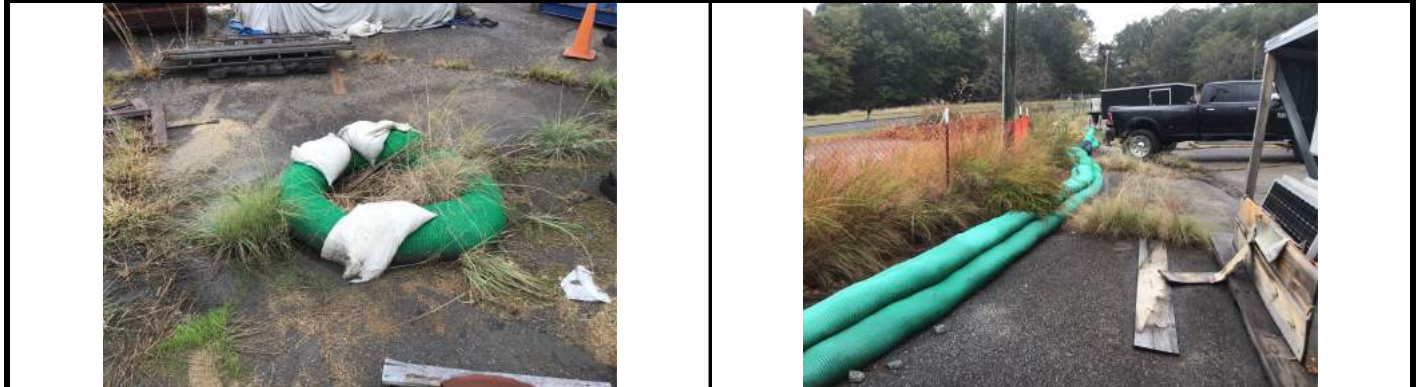
GPS Location	00000000	GPS Location	00000000
Field Station#	0000+00	Field Station#	0000+00
Pic 1 Desc.	Inlet protection for parking lot drains in good condition.	Pic 2 Desc.	Perimeter ECD's in good condition on west side of paved yard.

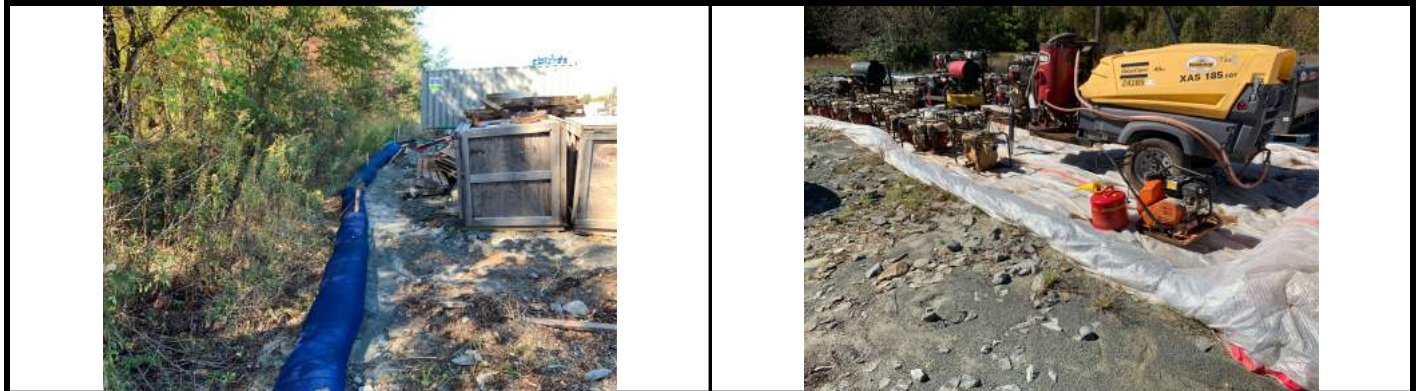
GPS Location	00000000	GPS Location	00000000
Field Station#	0000+00	Field Station#	0000+00
Pic 3 Desc.	Perimeter ECD's on west side of gravel yard in good condition.	Pic 4 Desc.	Secondary containment on north end on gravel yard in good condition.

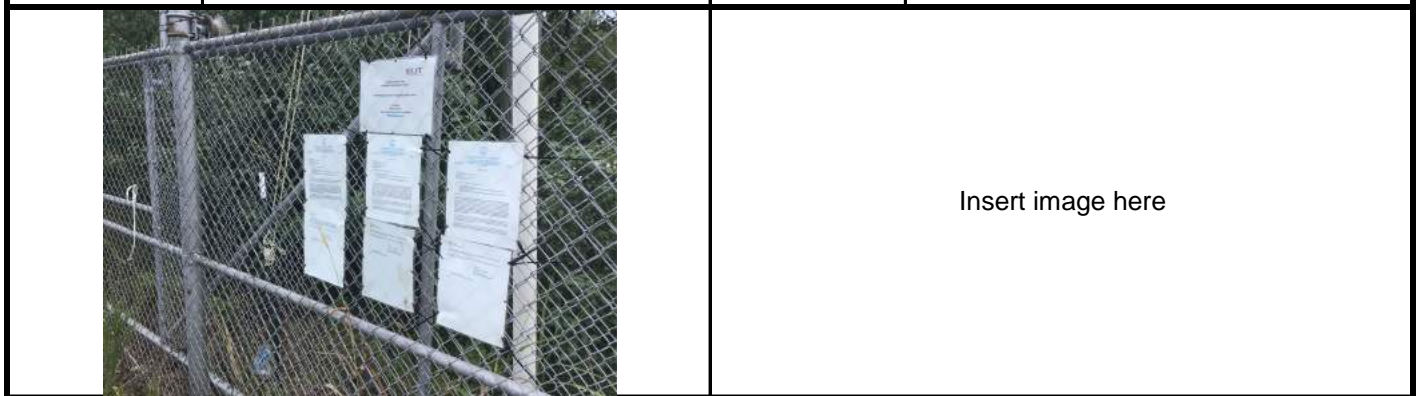
GPS Location	00000000	GPS Location	
Field Station#	0000+00	Field Station#	
Pic 5 Desc.	General Construction permits and contact information posted at main entrance as required	Pic 6 Desc.

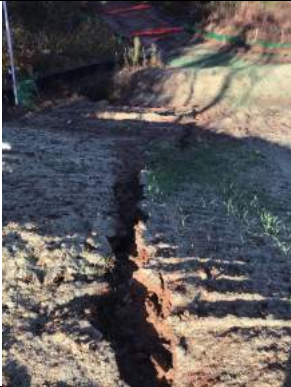
GPS Location	0000	GPS Location	0000		
Field Station#	13807+15	Field Station#	13898+00		
Pic 1 Desc.	Erosion channel and water bar , requires maintenance, added to the punch list		Pic 2 Desc.	Bank of sump pit requires maintenance, added to the punch list

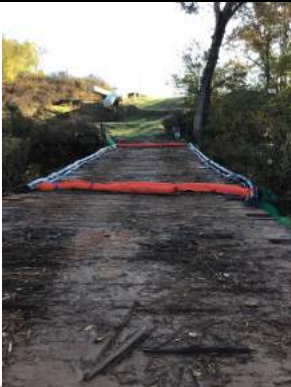
GPS Location	0000	GPS Location	0000		
Field Station#	13790+47	Field Station#	13790+47		
Pic 3 Desc.	Stream crossing showing bridge in place along with functioning ECDs.		Pic 4 Desc.	Upstream photo after recent rain events	
Insert image here			Insert image here		
GPS Location		GPS Location			
Field Station#		Field Station#			
Pic 5 Desc.		Pic 6 Desc.

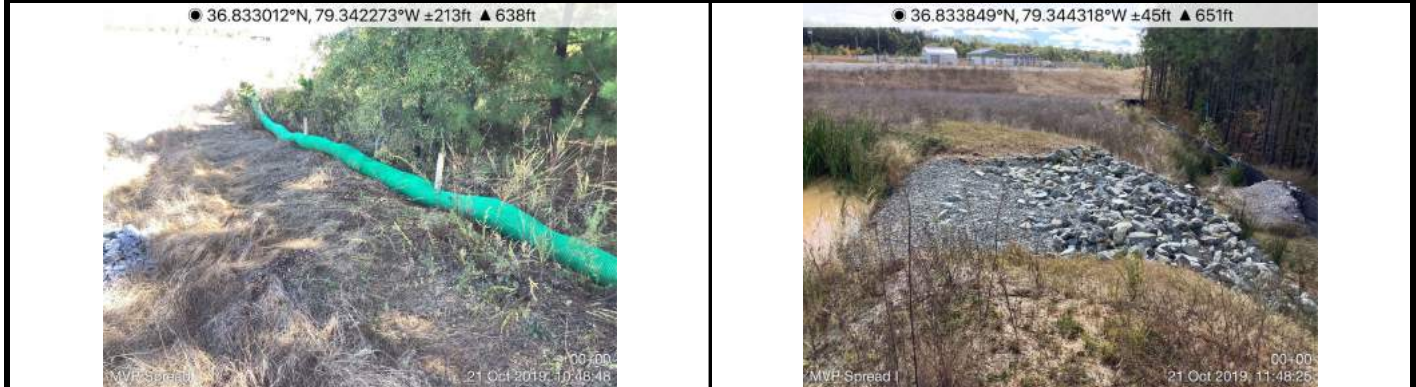
GPS Location	0	GPS Location	0
Field Station#	00+00	Field Station#	00+00
Pic 1 Desc.	CFS is acceptable	Pic 2 Desc.	Rock filter is acceptable

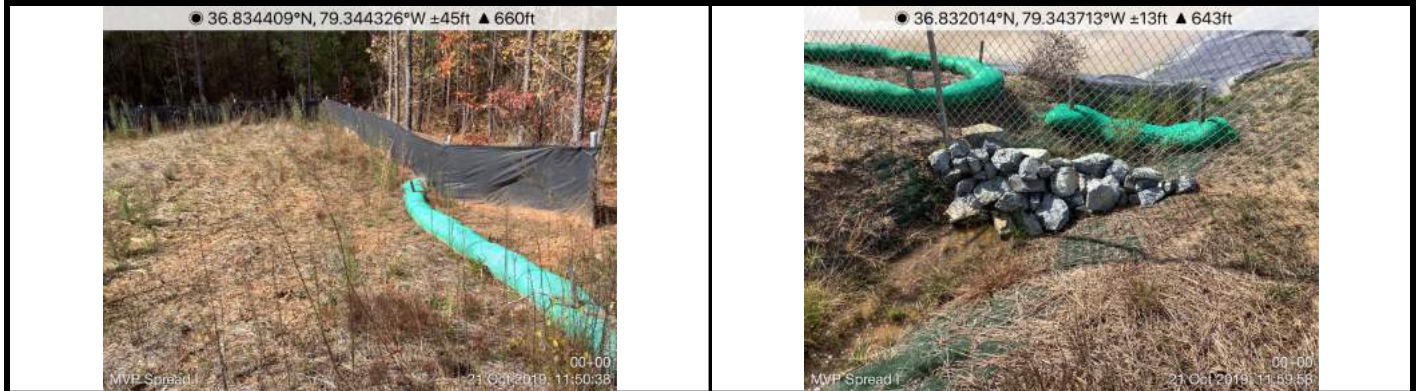
GPS Location	0	GPS Location	0
Field Station#	00+00	Field Station#	00+00
Pic 3 Desc.	Super silt fence is acceptable	Pic 4 Desc.	Rock check dam is acceptable

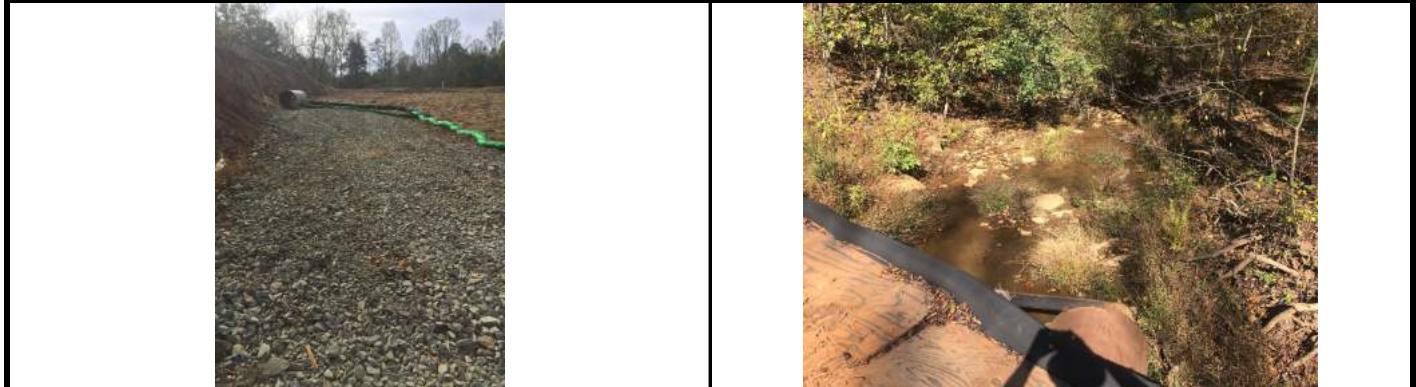
GPS Location 0	GPS Location 0
Field Station# 14210+30	Field Station# 14208+85
Pic 1 Desc. Approximately 14210+30. Contractor spread new rock on RCE.	Pic 2 Desc. Approximately 14208+85. Downstream view of stream S-F8. Water running clean and clear at time of inspection.

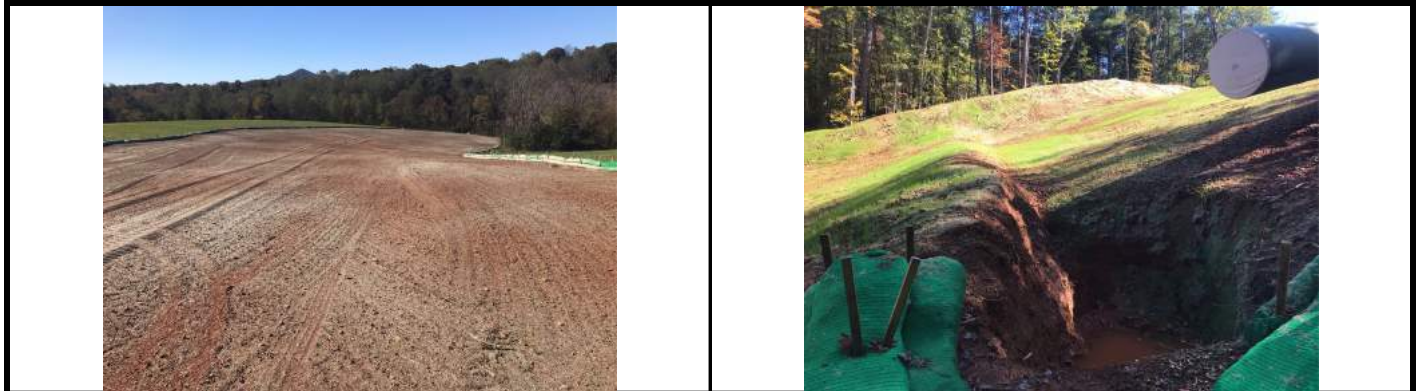
GPS Location 0	GPS Location 0
Field Station# 14165+00	Field Station# 14049+00
Pic 3 Desc. Approximately 14165+00. ROW seeded and stabilized in this area.	Pic 4 Desc. Approximately 14049+00. Water bar, sump and end treatment installed and appears to be functioning correctly at time of inspection. ROW temporarily seeded and stabilized in this
