Visual Site Inspection Report

Project Name	H-600 Pipeline Spread I	AFE	124300139	Spread	H-600 Pipeline Spread I
Contractor	Precision			Report #	5239
Inspector	Ben Davenport			Date/Time	10/28/2019 7:46 AM
Permit #	TBD	Inspection Type	VA SWPP	Station Begin	14981+55
State	VA	Inspection Area	Partial	Station End	15496+70
County	Franklin/Pittsylvania	Ground	Muddy	Temperature (°F)	70.00
Municipality	Chatham	Weather	Sunny	Rain Gauge (in)	1.70
				Rain Accumulation Time (days)	1.00

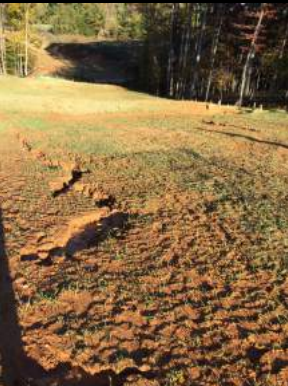
GPS Location	5	GPS Location	6		
Field Station#	15062+00	Field Station#	15094+00		
Pic 5 Desc.	Erosion channels forming and require attention		Pic 6 Desc.	CFS J hooks and end treatments overtopping and require maintenance

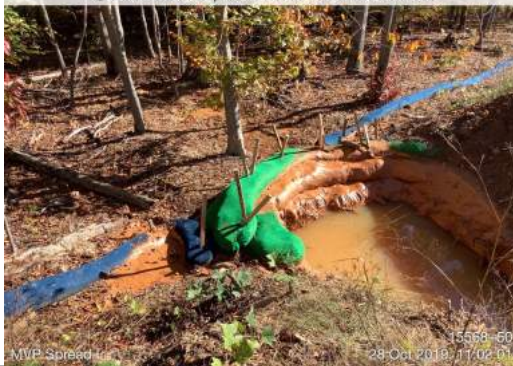
GPS Location	0	GPS Location	0		
Field Station#	15520+85	Field Station#	15550+00		
Pic 1 Desc.	Curb on equipment bridge needs maintenance	Pic 2 Desc.	Water is bypassing filter sock. End treatment requires maintenance.

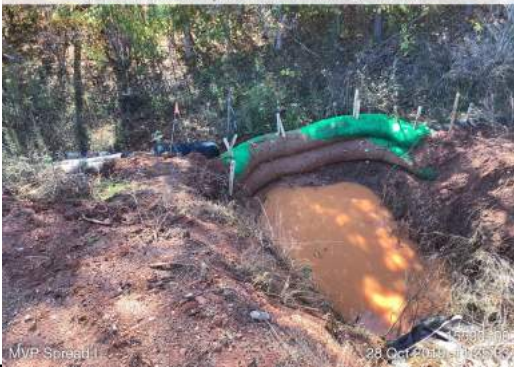
GPS Location	0	GPS Location	0		
Field Station#	15556+83	Field Station#	15568+50		
Pic 3 Desc.	Equipment bridge requires maintenance	Pic 4 Desc.	Sediment left ROW; requires retrieval

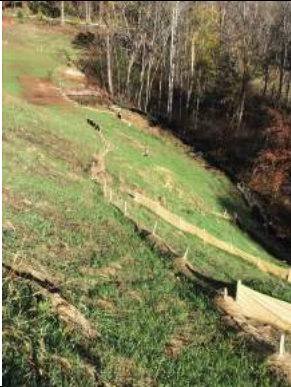
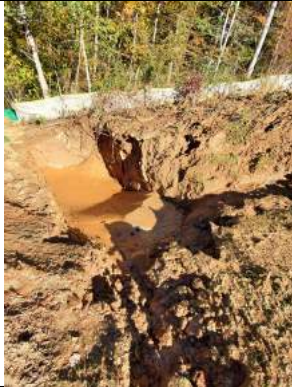
GPS Location	0000	GPS Location	0000		
Field Station#	13820+00	Field Station#	13783+20		
Pic 1 Desc.	Photo showing vegetation and ECDs in place	Pic 2 Desc.	Sump pit full , added to the punch list

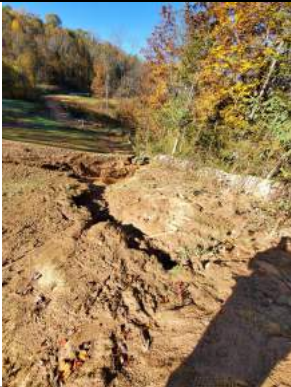
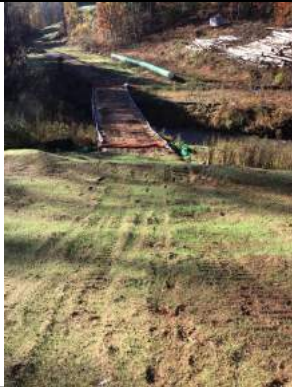
GPS Location	0000	GPS Location	0000		
Field Station#	13783+00	Field Station#	13834+01		
Pic 3 Desc.	Large erosion channel , added to the punch list	Pic 4 Desc.	Vegetation photo		
Insert image here			Insert image here		
GPS Location		GPS Location			
Field Station#		Field Station#			
Pic 5 Desc.		Pic 6 Desc.

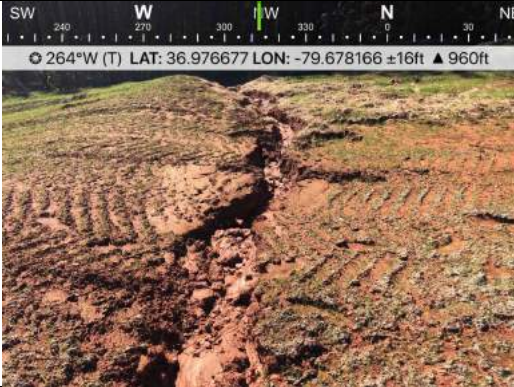
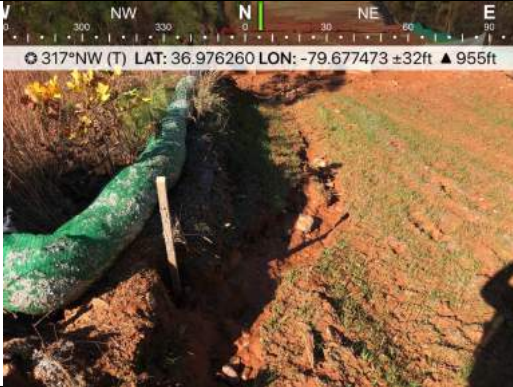
GPS Location	0	GPS Location	0		
Field Station#	14803+00	Field Station#	14805+25		
Pic 1 Desc.	Erosion occurring in water bar flow path		Pic 2 Desc.	Erosion occurring on slope causing sediment to wash onto bridge at steam S-H23

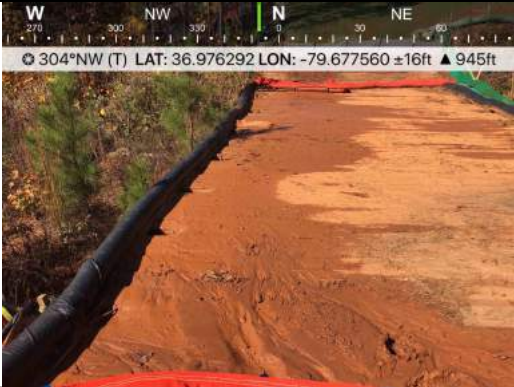
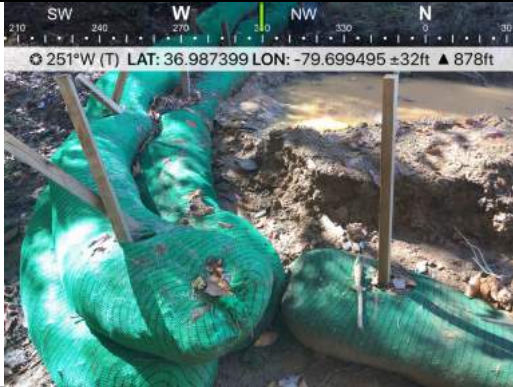
GPS Location	0	GPS Location	0		
Field Station#	14804+99	Field Station#	14726+50		
Pic 3 Desc.	Bridge needs cleaned off at stream S-H23		Pic 4 Desc.	CFS undermined on sump pit

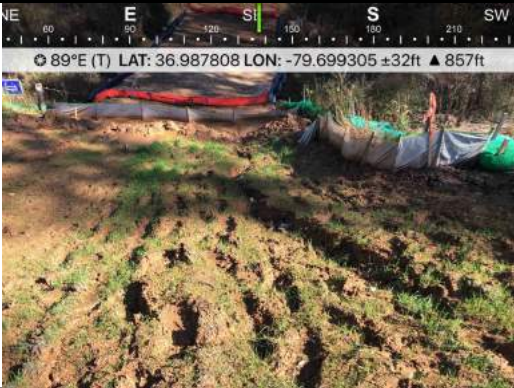
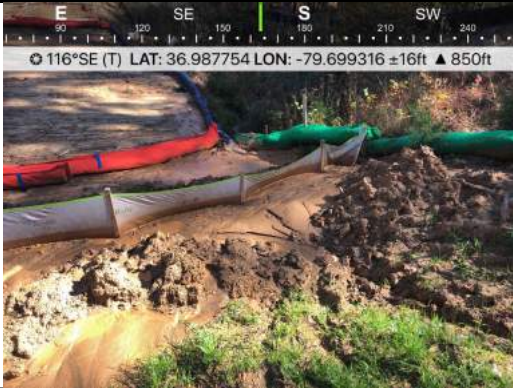
GPS Location	0	GPS Location	0		
Field Station#	14727+00	Field Station#	14727+00		
Pic 5 Desc.	Erosion occurring on slope causing sediment build up on silt fence		Pic 6 Desc.	P1 silt fence needs cleaned out over 50% full

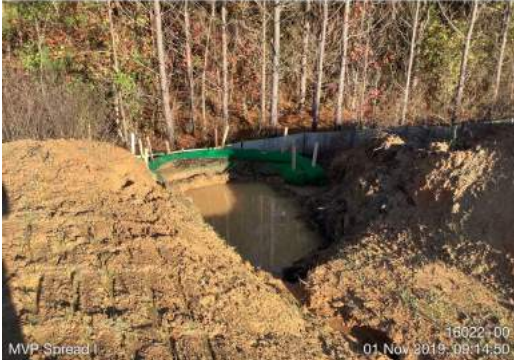
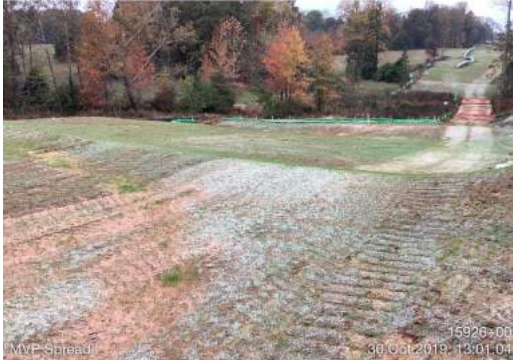
GPS Location	0	GPS Location	0		
Field Station#	16022+00	Field Station#	15926+00		
Pic 1 Desc.	Waterbar end treatment is acceptable		Pic 2 Desc.	Waterbars are acceptable

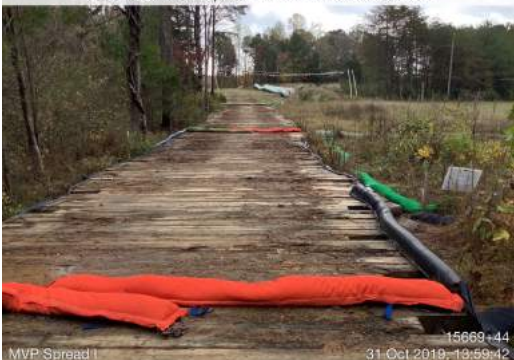
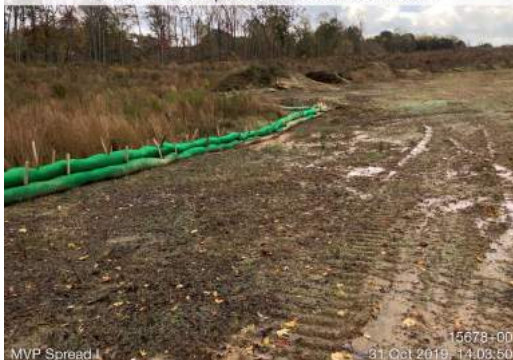
GPS Location	0	GPS Location	0		
Field Station#	15669+44	Field Station#	15678+00		
Pic 3 Desc.	Equipment bridge is acceptable		Pic 4 Desc.	CFS is acceptable

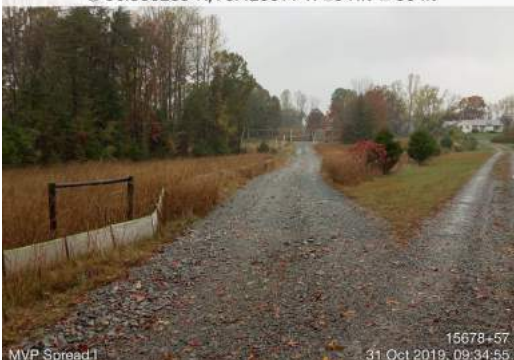
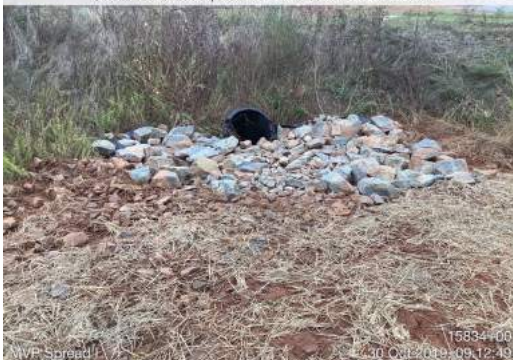
GPS Location	0	GPS Location	0		
Field Station#	15678+57	Field Station#	15834+00		
Pic 5 Desc.	RCE is acceptable		Pic 6 Desc.	Clean water diversion pipe is acceptable

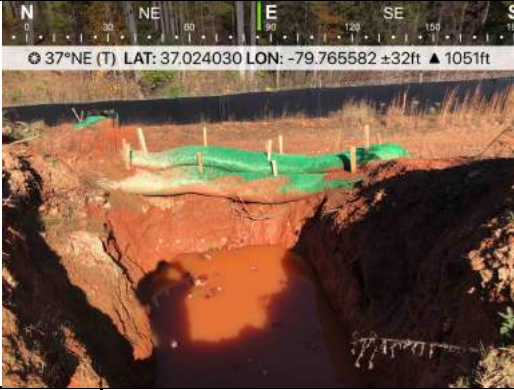
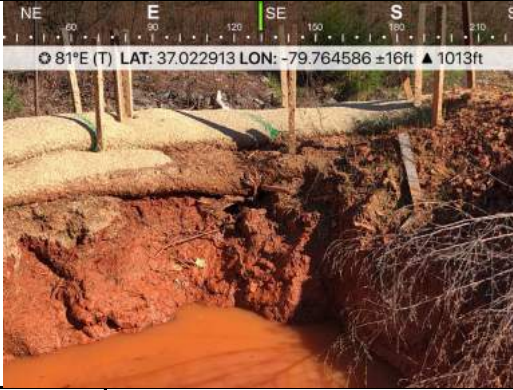
GPS Location	0	GPS Location	0		
Field Station#	14460+00	Field Station#	14469+00		
Pic 1 Desc.	CFS on end treatment undermined	Pic 2 Desc.	CFS on end treatment undermined

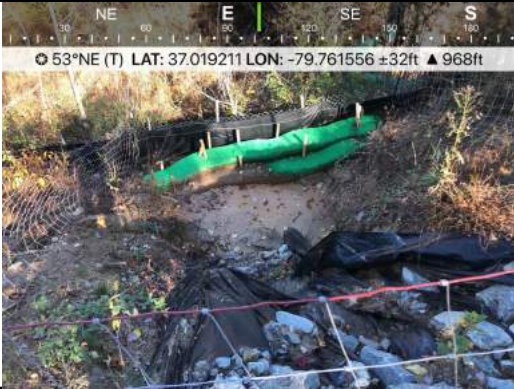
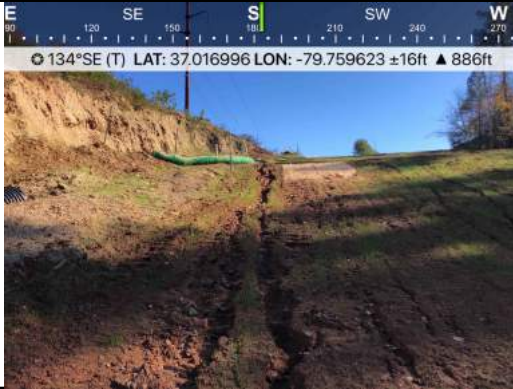
GPS Location	0	GPS Location	0		
Field Station#	14488+50	Field Station#	14500+00		
Pic 3 Desc.	Sump pit needs cleaned out	Pic 4 Desc.	Water bar washed out causing erosion on slope

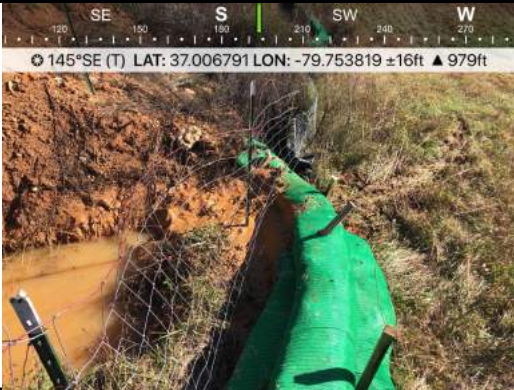
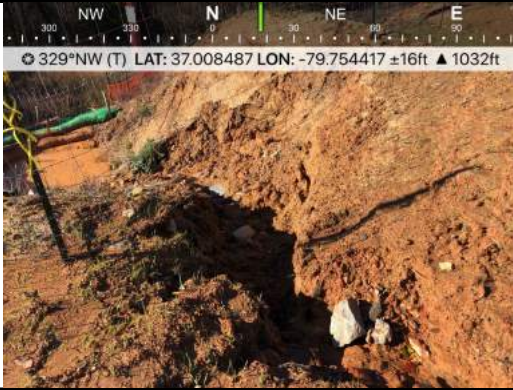
GPS Location	0	GPS Location	0		
Field Station#	14540+00	Field Station#	14534+00		
Pic 5 Desc.	CFS needs cleaned out over 50% full	Pic 6 Desc.	Water bar washing out

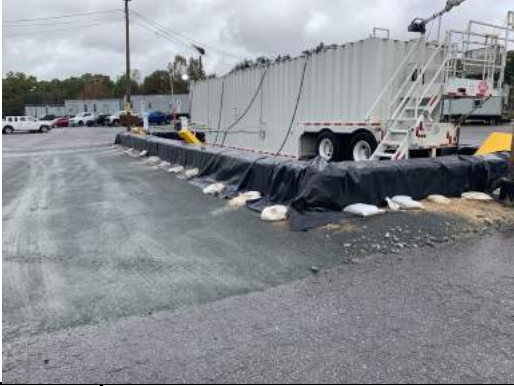
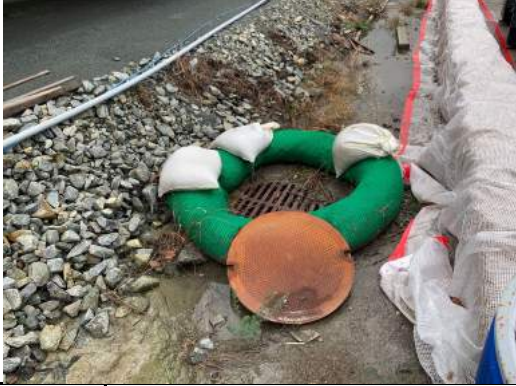
GPS Location	00000000	GPS Location	00000000		
Field Station#	0000+00	Field Station#	0000+00		
Pic 1 Desc.	Secondary containment structure for fuel cell in compliance	Pic 2 Desc.	Inlet protection for parking lot drain near storage building in good condition.

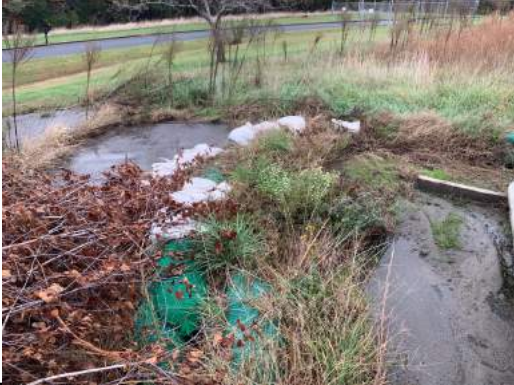
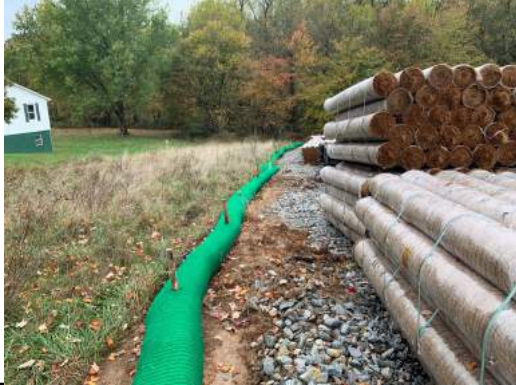
GPS Location	00000000	GPS Location	00000000		
Field Station#	0000+00	Field Station#	0000+00		
Pic 3 Desc.	Triple stack CFS in northwest corner of paved yard needs maintenance (over 50% full)	Pic 4 Desc.	Perimeter ECD's on south end of gravel yard in good condition.		
Insert image here		Insert image here			
GPS Location		GPS Location			
Field Station#		Field Station#			
Pic 5 Desc.		Pic 6 Desc.
