# Visual Site Inspection Report

<b>Project Name</b> H-600 Pipeline Spread I		<b>AFE</b> 124300139	<b>Spread</b> H-600 Pipeline Spread I
<b>Contractor</b> Precision		<b>Report #</b> 4532	
<b>Inspector</b> Justin Burch		<b>Date/Time</b> 10/10/2019 6:17 AM	
<b>Permit #</b> TBD	<b>Inspection Type</b> VA SWPP	<b>Station Begin</b> 15496+70	
<b>State</b> VA	<b>Inspection Area</b> Full	<b>Station End</b> 16027+46	
<b>County</b> Pittsylvania	<b>Ground</b> Dry	<b>Temperature (°F)</b> 74.00	
<b>Municipality</b> Chatham	<b>Weather</b> Sunny	<b>Rain Gauge (in)</b> 0.00	
<b>Rain Accumulation Time (days)</b>			4.00

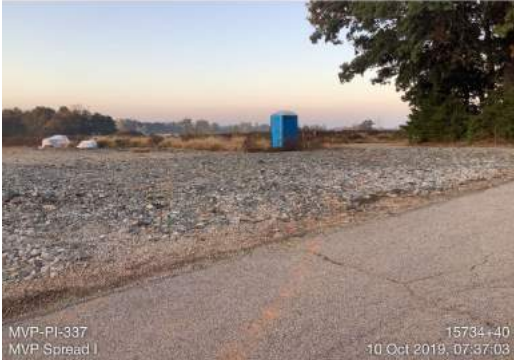
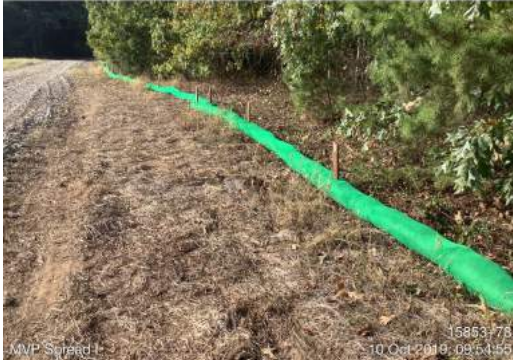
<p>● 36.851346°N, 79.385506°W ±22ft ▲ 779ft</p> <p>MVP Spread I</p> <p>15853+78 10 Oct 2019, 09:54:55</p>	
<b>GPS Location</b>	0	<b>GPS Location</b>	0
<b>Field Station#</b>	15734+40	<b>Field Station#</b>	15853+78
<b>Pic 1 Desc.</b>	RCE at access road MVP-PI-337 is acceptable	<b>Pic 2 Desc.</b>	CFS at access road MVP-PI-340 is acceptable

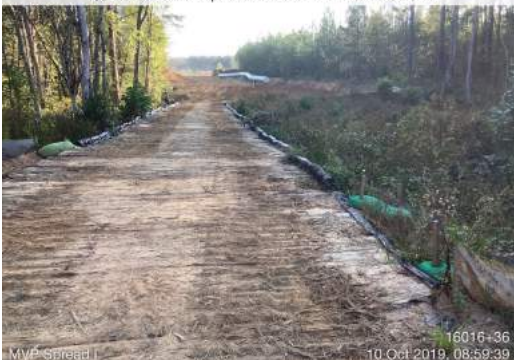
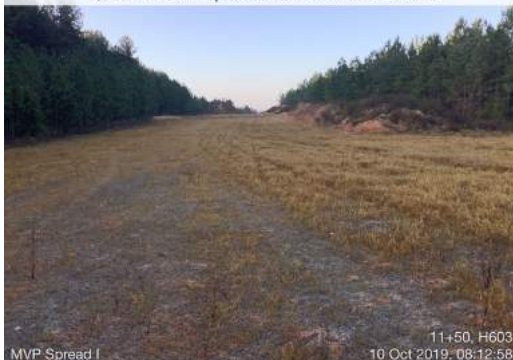
<p>● 36.834808°N, 79.340297°W ±22ft ▲ 659ft</p> <p>MVP Spread I</p> <p>11+50, H603 10 Oct 2019, 08:12:58</p>	
<b>GPS Location</b>	0	<b>GPS Location</b>	0
<b>Field Station#</b>	16016+36	<b>Field Station#</b>	11+50
<b>Pic 3 Desc.</b>	Equipment bridge is acceptable	<b>Pic 4 Desc.</b>	Temporary stabilization is acceptable on Pipeline H603

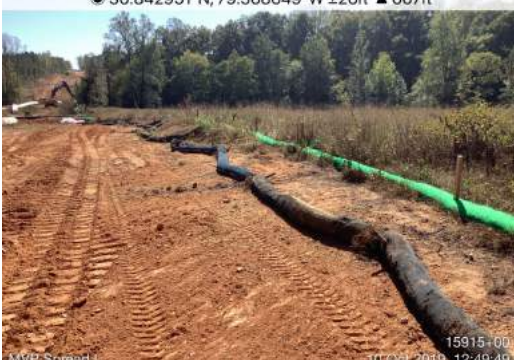
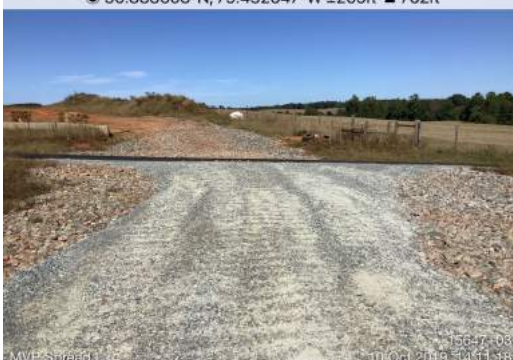
<p>● 36.888608°N, 79.432647°W ±265ft ▲ 762ft</p> <p>MVP Spread I</p> <p>15647+03 10 Oct 2019, 14:11:38</p>	
<b>GPS Location</b>	0	<b>GPS Location</b>	0
<b>Field Station#</b>	15915+00	<b>Field Station#</b>	15647+03
<b>Pic 5 Desc.</b>	CFS is acceptable	<b>Pic 6 Desc.</b>	Rock construction entrance is acceptable

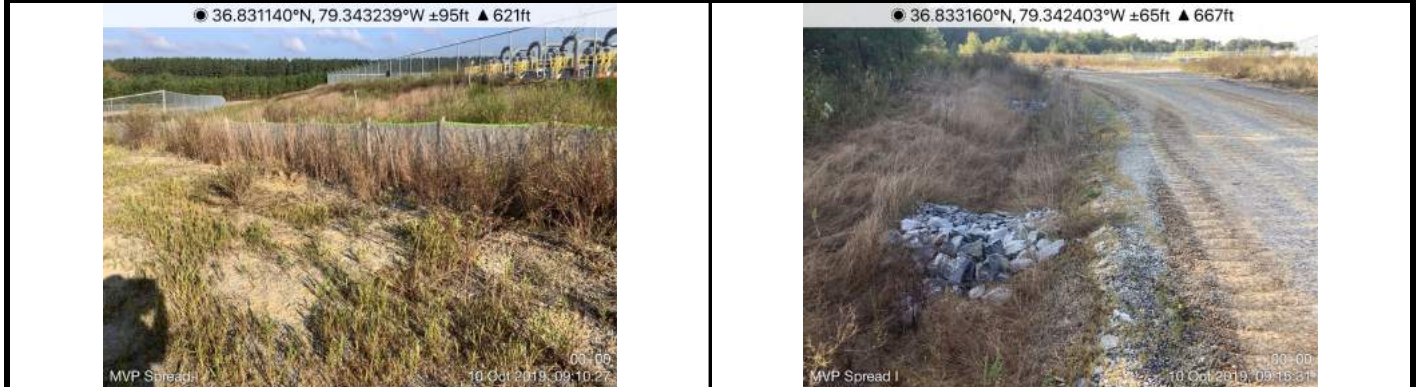
<b>GPS Location</b>	0	<b>GPS Location</b>	0
<b>Field Station#</b>	00+00	<b>Field Station#</b>	00+00
<b>Pic 1 Desc.</b>	P1 silt fence is acceptable	<b>Pic 2 Desc.</b>	Rock check dam is acceptable

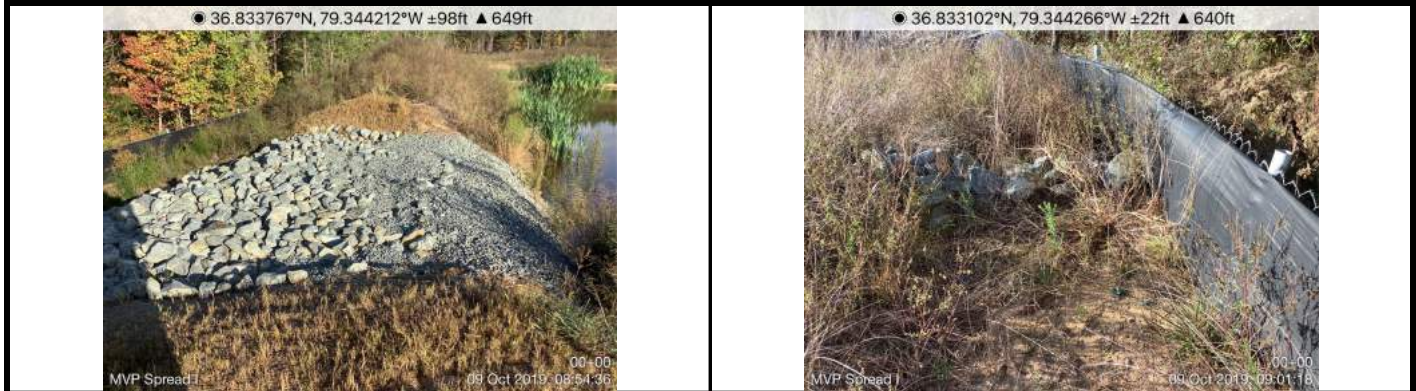
<b>GPS Location</b>	0	<b>GPS Location</b>	0
<b>Field Station#</b>	00+00	<b>Field Station#</b>	00+00
<b>Pic 3 Desc.</b>	Rock filter is acceptable	<b>Pic 4 Desc.</b>	Super silt fence is acceptable

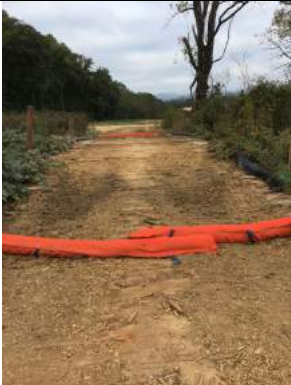
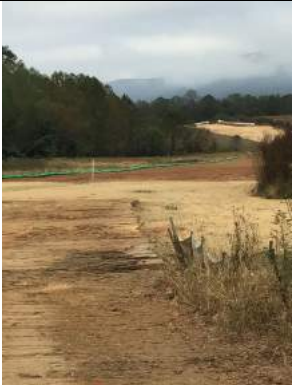
<b>GPS Location</b>	00000	<b>GPS Location</b>	00000		
<b>Field Station#</b>	13678+88	<b>Field Station#</b>	13678+70		
<b>Pic 1 Desc.</b>	Ecds in place at stream crossing	<b>Pic 2 Desc.</b>	Photo showing some vegetation starting to come up in a recently restored area

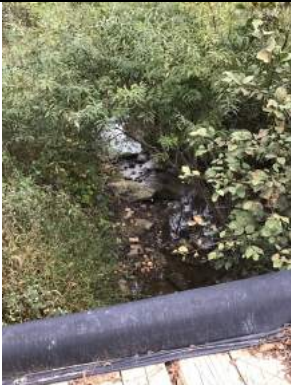
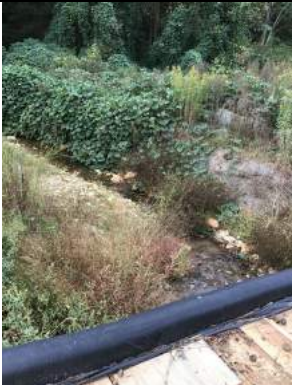
<b>GPS Location</b>	00000	<b>GPS Location</b>	00000		
<b>Field Station#</b>	13678+71	<b>Field Station#</b>	13678+71		
<b>Pic 3 Desc.</b>	Stream crossing facing down stream	<b>Pic 4 Desc.</b>	Stream crossing facing up stream		
Insert image here			Insert image here		
<b>GPS Location</b>		<b>GPS Location</b>			
<b>Field Station#</b>		<b>Field Station#</b>			
<b>Pic 5 Desc.</b>		<b>Pic 6 Desc.</b>

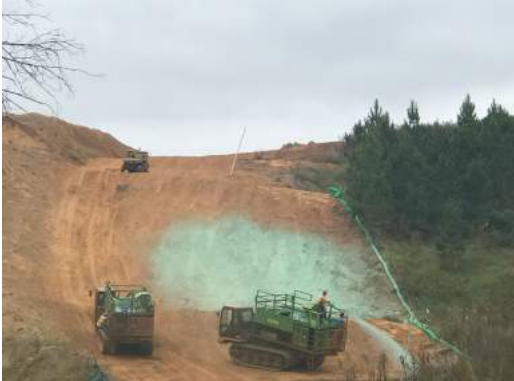
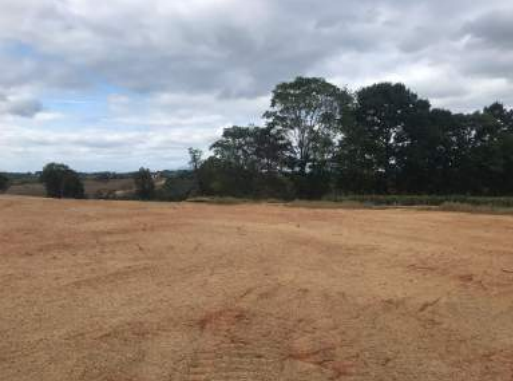
<b>GPS Location</b> 0		<b>GPS Location</b> 0			
<b>Field Station#</b> 13990+00		<b>Field Station#</b> 14410+00			
<b>Pic 1 Desc.</b> Approximately 13990+00. Crews spraying hydro mulch and seed for temporary seeding and stabilization.		<b>Pic 2 Desc.</b> Approximately 14410+00. ROW temporarily seeded and stabilized in this area.

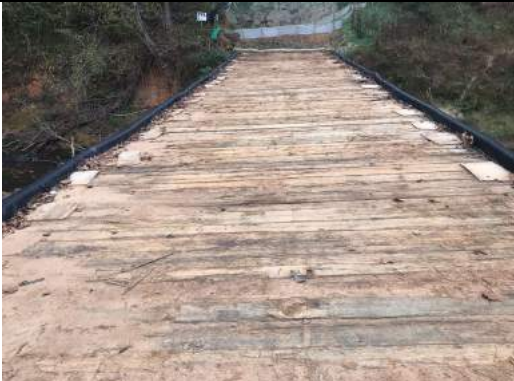
<b>GPS Location</b> 0		<b>GPS Location</b> 0			
<b>Field Station#</b> 14233+35		<b>Field Station#</b> 14275+00			
<b>Pic 3 Desc.</b> Approximately 14233+35. Overview of stream crossing and equipment bridge at stream S-C19.		<b>Pic 4 Desc.</b> Approximately 14275+00. ROW temporarily seeded and stabilized in this area. ECDs installed and appear to be functioning correctly at time of inspection.			
Insert image here		Insert image here			
<b>GPS Location</b>		<b>GPS Location</b>			
<b>Field Station#</b>		<b>Field Station#</b>

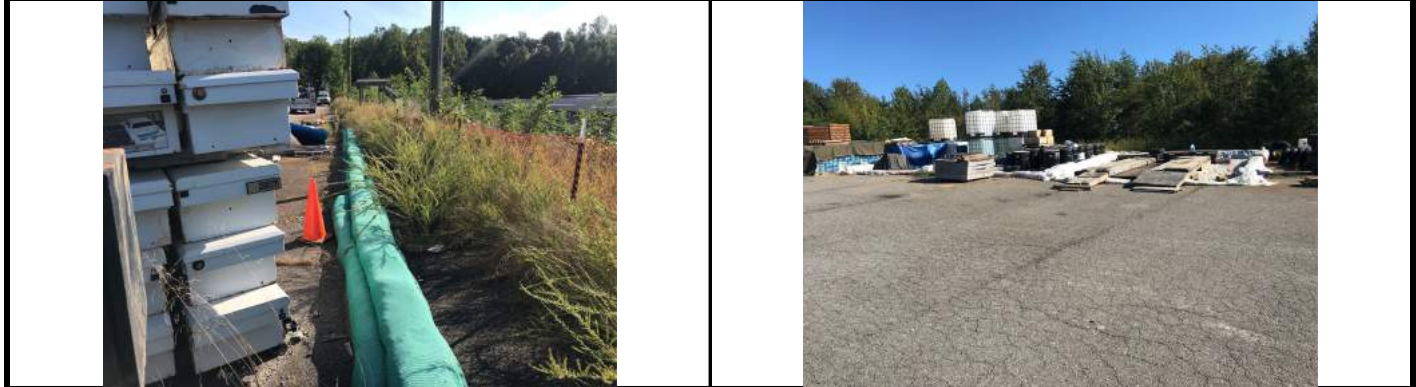
<b>GPS Location</b>	00000000	<b>GPS Location</b>	00000000
<b>Field Station#</b>	0000+00	<b>Field Station#</b>	0000+00
<b>Pic 1 Desc.</b>	Perimeter ECD's in good condition on west side of paved yard.	<b>Pic 2 Desc.</b>	Oil changing station and barrel containment in acceptable condition.

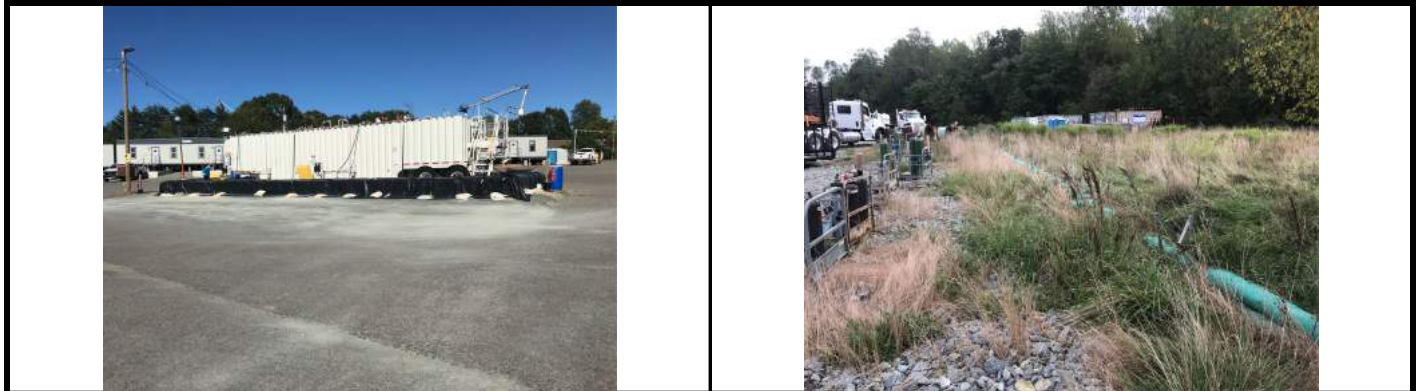
<b>GPS Location</b>	00000000	<b>GPS Location</b>	00000000
<b>Field Station#</b>	0000+00	<b>Field Station#</b>	0000+00
<b>Pic 3 Desc.</b>	Secondary containment structure for fuel cell in compliance.	<b>Pic 4 Desc.</b>	Perimeter ECD's on northern end of gravel yard in good condition.

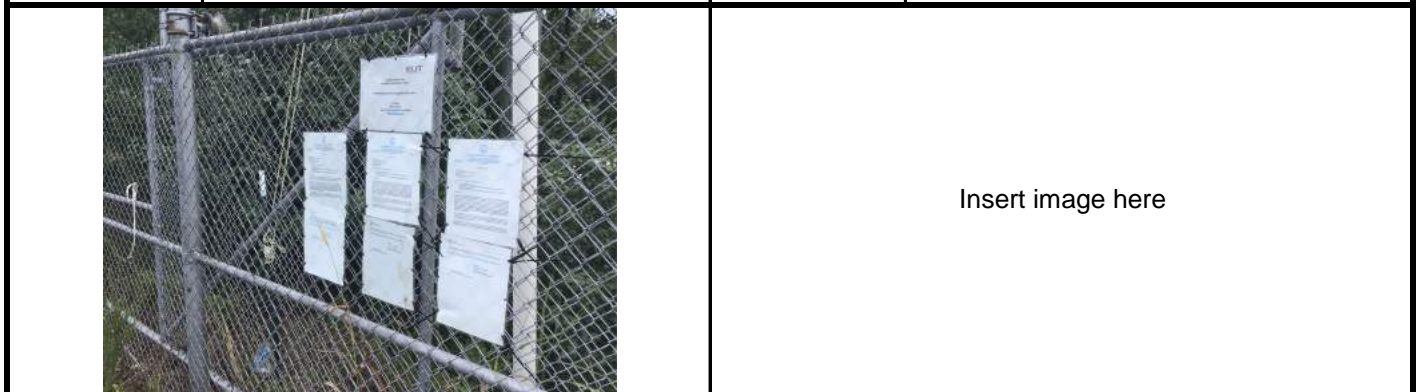
<b>GPS Location</b>	00000000	<b>GPS Location</b>	
<b>Field Station#</b>	0000+00	<b>Field Station#</b>	
<b>Pic 5 Desc.</b>	General construction permits are posted at the main entrance of the paved yard as required.	<b>Pic 6 Desc.</b>
