# Visual Site Inspection Report

<b>Project Name</b>	H-600 Pipeline Spread I	<b>AFE</b>	124300139	<b>Spread</b>	H-600 Pipeline Spread I
<b>Contractor</b>	Precision			<b>Report #</b>	6004
<b>Inspector</b>	Logan Box			<b>Date/Time</b>	11/19/2019 5:38 PM
<b>Permit #</b>	TBD	<b>Inspection Type</b>	VA SWPP	<b>Station Begin</b>	13670+00
<b>State</b>	VA	<b>Inspection Area</b>	Partial	<b>Station End</b>	13853+45
<b>County</b>	Franklin	<b>Ground</b>	Damp	<b>Temperature (°F)</b>	44.00
<b>Municipality</b>	N/A	<b>Weather</b>	Cloudy	<b>Rain Gauge (in)</b>	0.20
				<b>Rain Accumulation Time (days)</b>	1.00

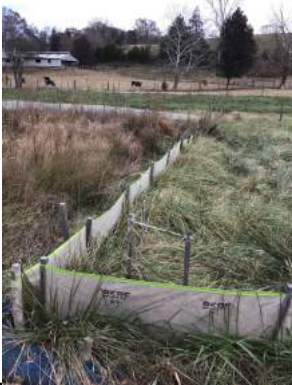
<b>GPS Location</b>	0000	<b>GPS Location</b>	0000		
<b>Field Station#</b>	13811+91	<b>Field Station#</b>	13852+50		
<b>Pic 1 Desc.</b>	Row photo showing vegetation and RCE	<b>Pic 2 Desc.</b>	Ruts repaired and area stabilized, punch list item completed

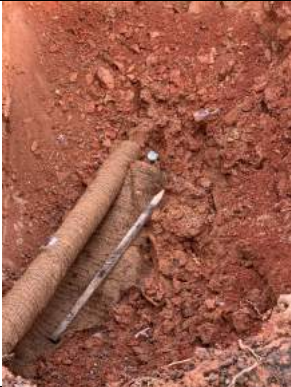
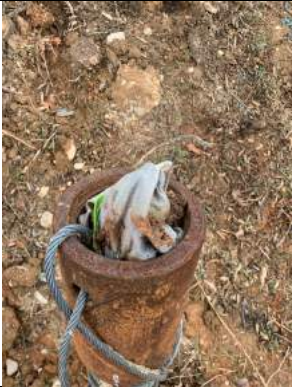
<b>GPS Location</b>	O	<b>GPS Location</b>	O		
<b>Field Station#</b>	15701+50	<b>Field Station#</b>	15700+00		
<b>Pic 1 Desc.</b>	Observing trash that needs to be removed from the sump.	<b>Pic 2 Desc.</b>	Observing trash that needs to be removed from the deadman.

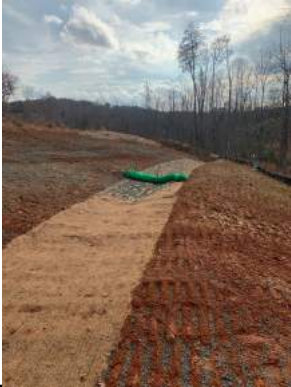
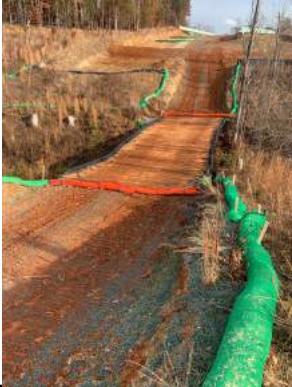
<b>GPS Location</b>	O	<b>GPS Location</b>	O		
<b>Field Station#</b>	15699+00	<b>Field Station#</b>	15700+40		
<b>Pic 3 Desc.</b>	Observing ECD's performing as they should.	<b>Pic 4 Desc.</b>	Observing stream crossing and ECD's performing as they should.		
Insert image here			Insert image here		
<b>GPS Location</b>		<b>GPS Location</b>			
<b>Field Station#</b>		<b>Field Station#</b>			
<b>Pic 5 Desc.</b>		<b>Pic 6 Desc.</b>

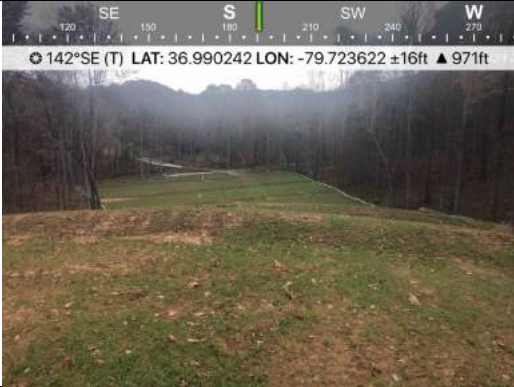
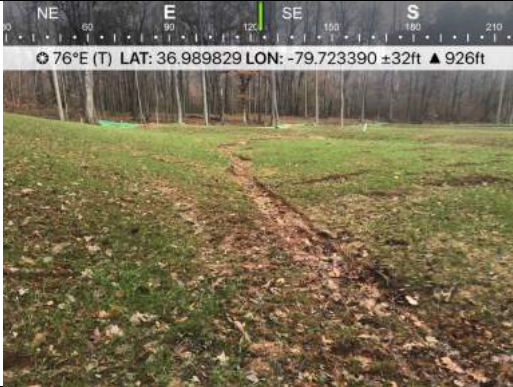
<b>GPS Location</b>	0	<b>GPS Location</b>	0		
<b>Field Station#</b>	14652+00	<b>Field Station#</b>	14655+00		
<b>Pic 1 Desc.</b>	Permanent stabilization on the GAS of Hwy 40	<b>Pic 2 Desc.</b>	Erosion at bottom of slope causing sediment build up in water bar flow path

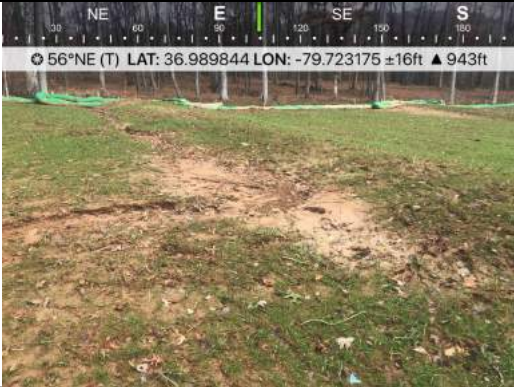
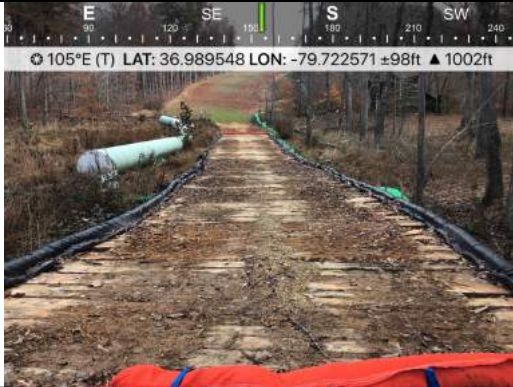
<b>GPS Location</b>	0	<b>GPS Location</b>	0		
<b>Field Station#</b>	14655+00	<b>Field Station#</b>	14656+87		
<b>Pic 3 Desc.</b>	Sediment building up in water bar flow path	<b>Pic 4 Desc.</b>	Equipment bridge clean at stream S-H38

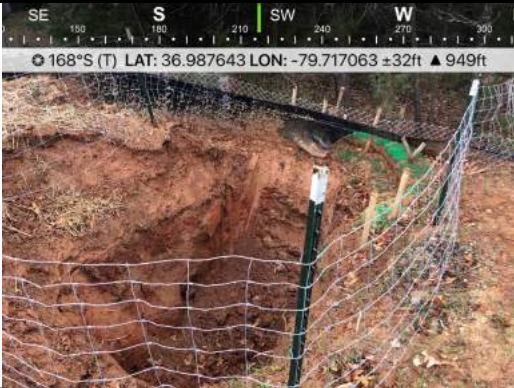
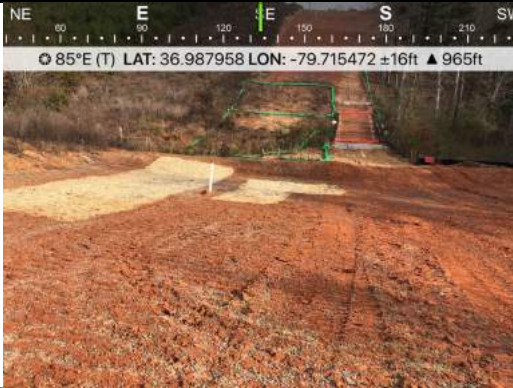
<b>GPS Location</b>	0	<b>GPS Location</b>	0		
<b>Field Station#</b>	14675+00	<b>Field Station#</b>	14680+00		
<b>Pic 5 Desc.</b>	Sump pit to spec	<b>Pic 6 Desc.</b>	Erosion fixed and curlex installed

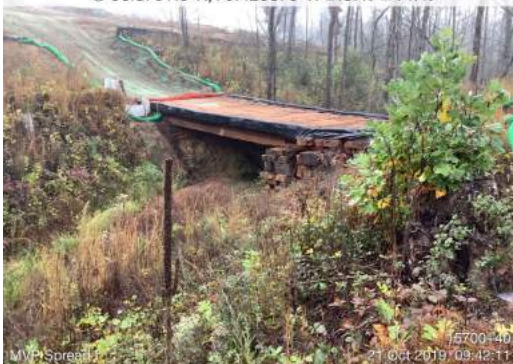
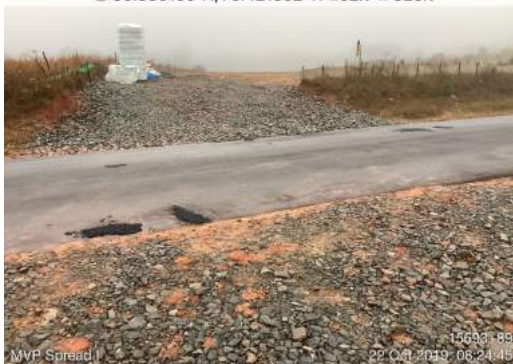
GPS Location	0		GPS Location	0	
Field Station#	15700+40		Field Station#	15693+89	
Pic 1 Desc.	Equipment bridge is acceptable		Pic 2 Desc.	RCE is acceptable at Riddle Road

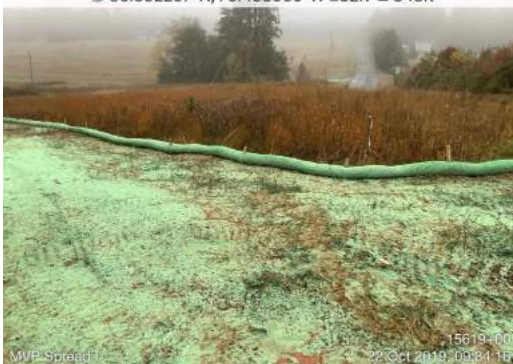
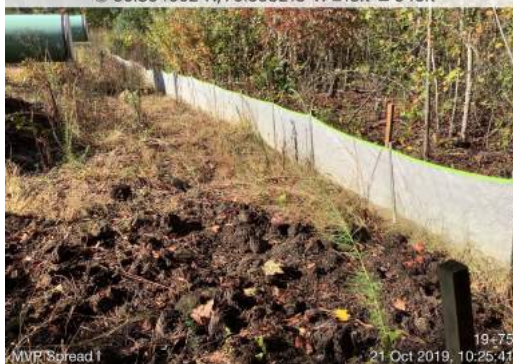
GPS Location	0		GPS Location	0	
Field Station#	15619+00		Field Station#	19+75	
Pic 3 Desc.	CFS is acceptable		Pic 4 Desc.	P1 silt fence is acceptable on Pipeline H603

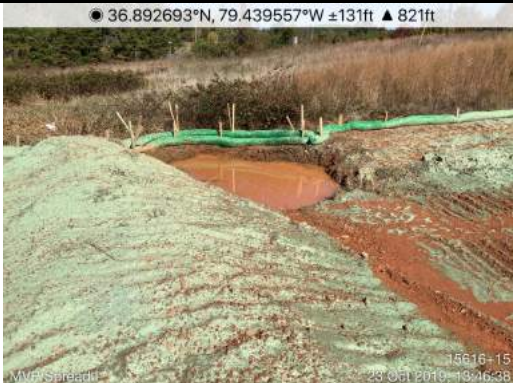
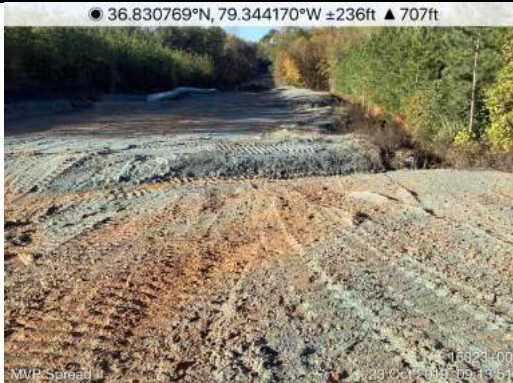
GPS Location	0		GPS Location	0	
Field Station#	15616+15		Field Station#	16023+00	
Pic 5 Desc.	Waterbar end treatment is acceptable		Pic 6 Desc.	Waterbars are acceptable
