Visual Site Inspection Report

Project Name	H-600 Pipeline Spread I	AFE	124300139	Spread	H-600 Pipeline Spread I
Contractor	Precision			Report #	18463
Inspector	Ben Davenport			Date/Time	6/11/2019 7:56 AM
Permit #	TBD	Inspection Type	VA SWPP	Station Begin	14981+55
State	VA	Inspection Area	Partial	Station End	15496+70
County	Franklin/Pittsylvania	Ground	Muddy	Temperature (°F)	76.00
Municipality	Chatham	Weather	Sunny	Rain Gauge (in)	0.25
				Rain Accumulation Time (days)	1.00

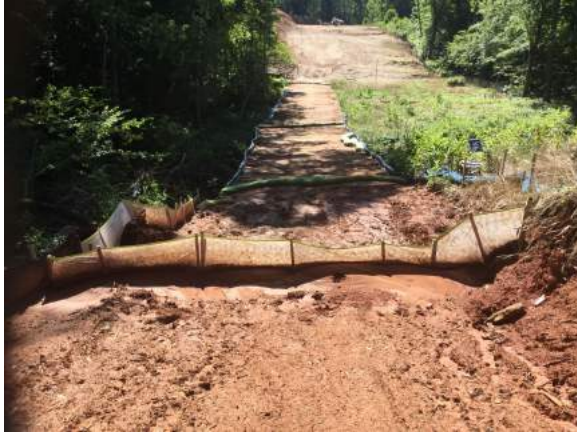
GPS Location		37.00		Field Station#		15426+00		GPS Location		37.00	
Field Station#		15426+00		GPS Location		37.00		Field Station#		15475+00	
Description		P1 fence requires maintenance (more than half full)				Description		CFS requires maintenance (more than half full)

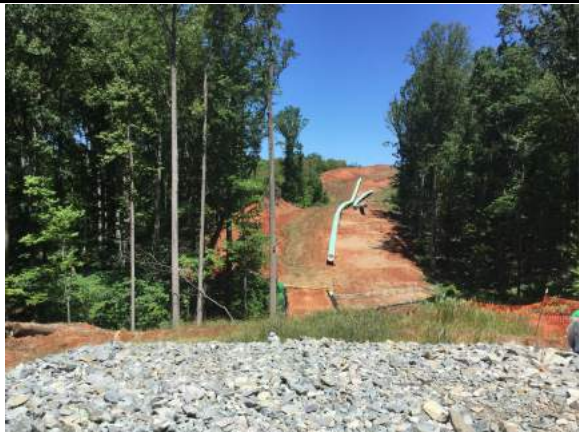
GPS Location		37.00		Field Station#		15490+00		GPS Location		37.00	
Field Station#		15490+00		GPS Location		37.00		Field Station#		15142+66	
Description		Vegetation beginning to grow along ROW with vegetated diversion berm along perimeter				Description		RCE in good condition and vegetation growing along ROW

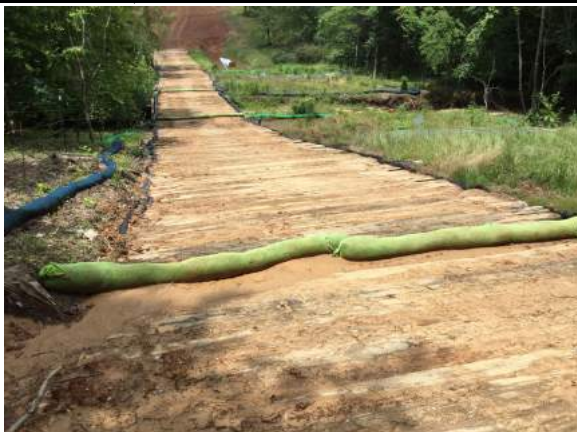
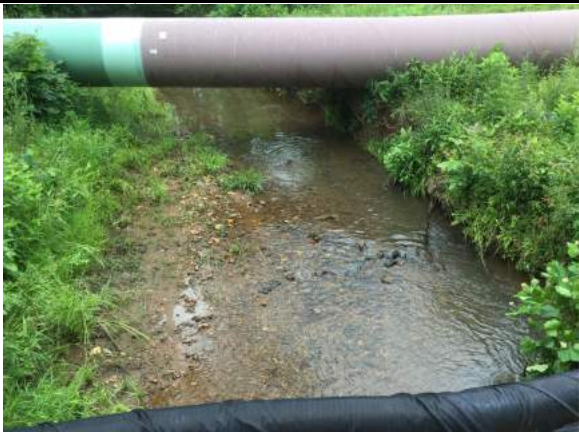
GPS Location		37.00		Field Station#		15046+50		GPS Location		37.00	
Field Station#		15046+50		GPS Location		37.00		Field Station#		15026+09	
Description		Remove sediment from wattles on bridge (more than half full)				Description		Clean water flowing downstream at S-D3

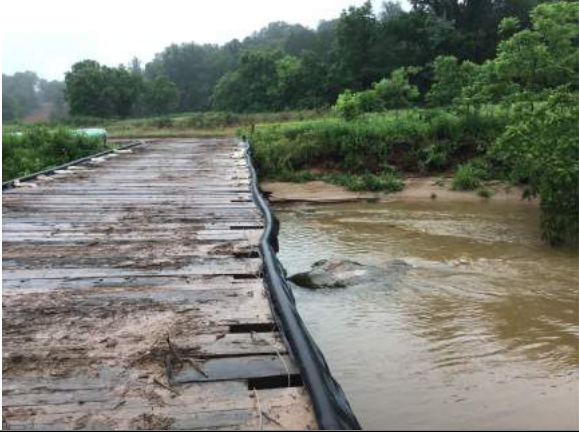
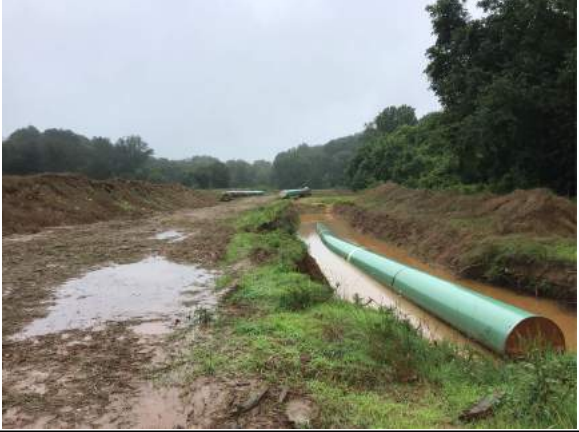
GPS Location	37.08	Field Station#	13875+71	GPS Location	37.08
Field Station#	13863+21	Description	Equipment bridge with environmental controls in place and functioning during rain events		
Description	Photo showing saturated row conditions

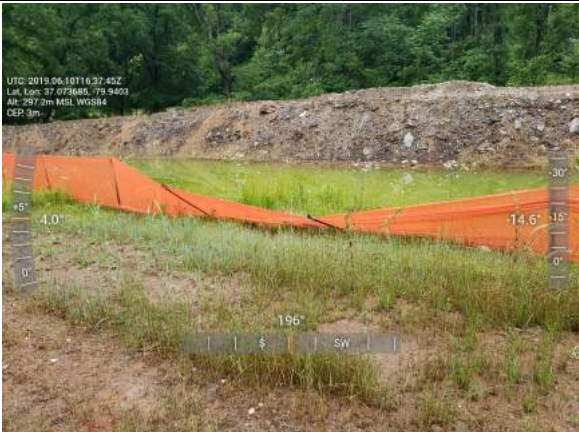
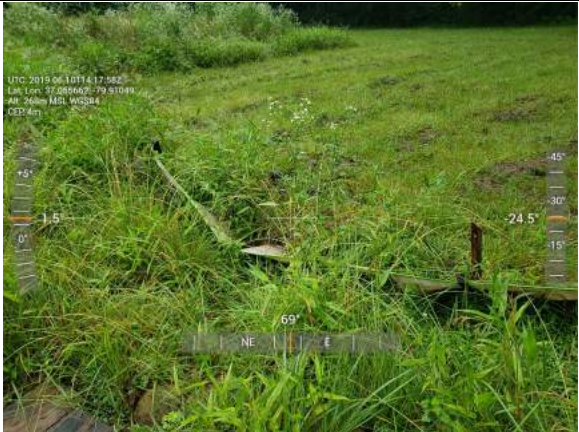
GPS Location	37.08	Field Station#	13755+30	GPS Location	37.08
Field Station#	13888+21	Description	Safety fence around open ditch needing maintenance, added to the punch list		
Description	Silt fence damaged, added to the punch list				
<p>Insert image here</p>			<p>Insert image here</p>		
GPS Location		Field Station#		GPS Location	
Field Station#		Description			
Description

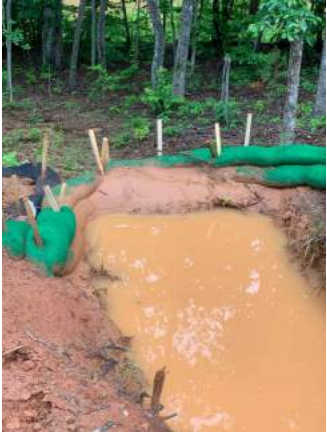
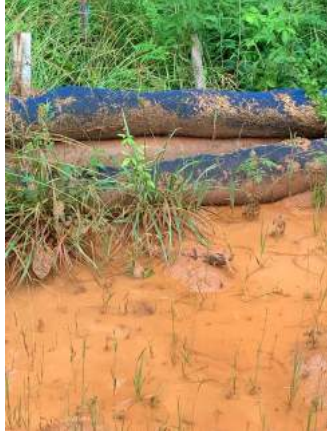
GPS Location	36.88	Field Station#	15884+50	GPS Location	36.88
Field Station#	15890+00	Description	Observing end treatment that requires maintenance.	Description	Observing CFS that requires maintenance.

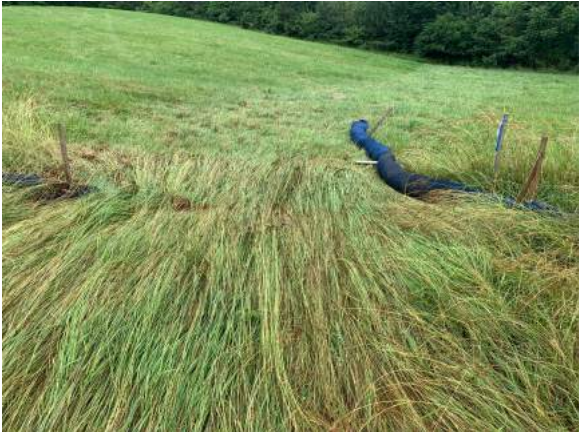
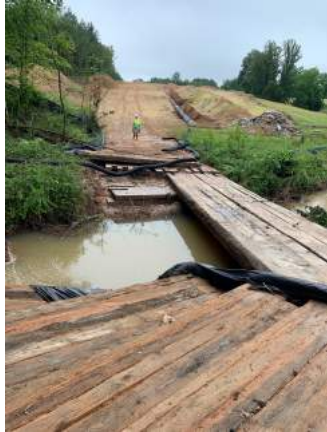
GPS Location	36.88	Field Station#	15896+00	GPS Location	36.88
Field Station#	15923+59	Description	Observing CFS that requires maintenance.	Description	Observing bridge that requires maintenance.
Insert image here			Insert image here		
GPS Location		Field Station#		GPS Location	
Description			Description

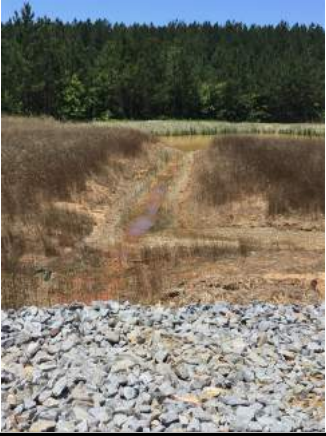
<p>image here</p>		<p>Insert image here</p>	
GPS Location	36.83	Field Station#	00+00	GPS Location	
Description	Observing stabilized channel.		Description		
<p>Insert image here</p>			<p>Insert image here</p>		
GPS Location		Field Station#		GPS Location	
Description			Description		
<p>Insert image here</p>			<p>Insert image here</p>		
GPS Location		Field Station#		GPS Location	
Description			Description		
<p>Insert image here</p>			<p>Insert image here</p>		
GPS Location		Field Station#		GPS Location	
Description			Description

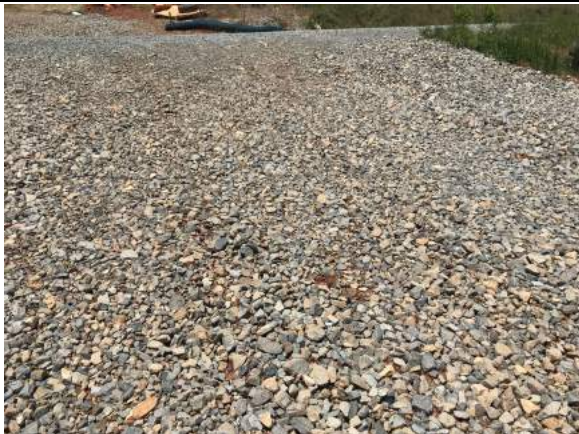
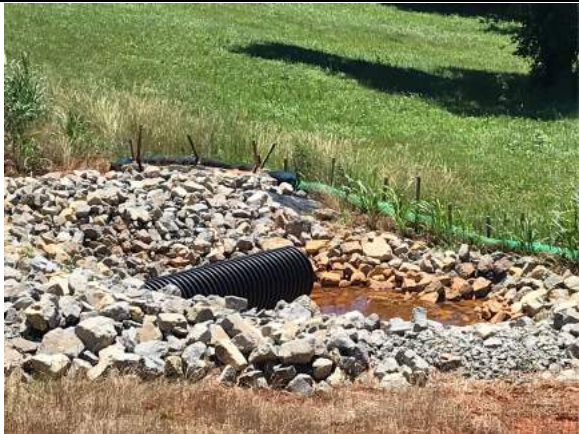
GPS Location		37.06		Field Station#		14131+50		GPS Location		37.06		Field Station#		14132+75	
Description		Approximately 14131+50. RCE in compliance at time of inspection.						Description		Approximately 14132+75. CWD piping and plunge pool installed and appear to be functioning correctly at time of inspection.

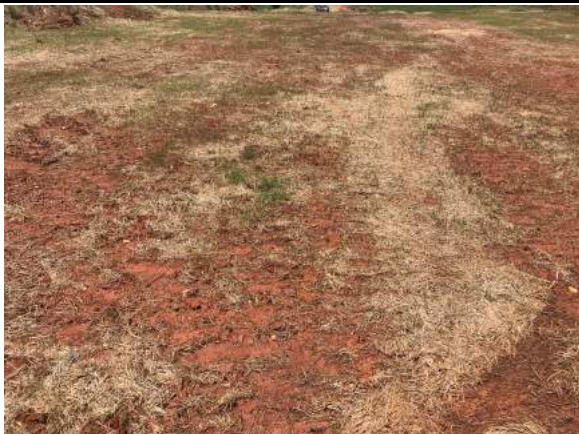
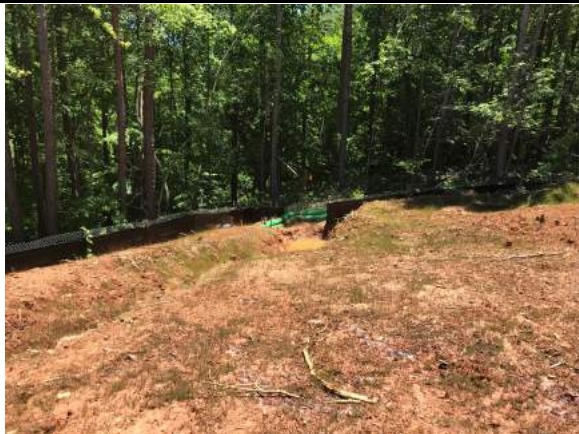
GPS Location		37.06		Field Station#		14135+00		GPS Location		37.06		Field Station#		14140+00	
Description		Approximately 14135+00. ROW temporarily seeded and stabilized in this area.						Description		Approximately 14140+00. Water bar, sump, and CFS end treatment installed and appear to be functioning correctly at time of inspection.

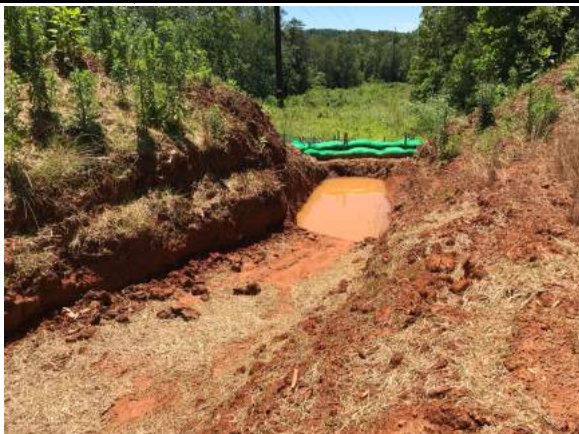
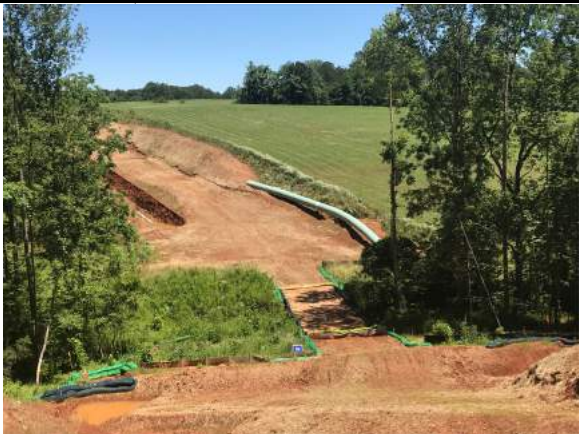
GPS Location		37.05		Field Station#		14143+00		GPS Location		37.05		Field Station#		14159+00

Description		Approximately 14143+00. Water bar, sump, CFS end treatment installed and appear to be functioning correctly at time of inspection.						Description		Approximately 14155+00-14160+00. Over of ROW. ROW temporarily seeded and stabilized. LOD and resource boundary ECDs appear to be installed and functioning correctly

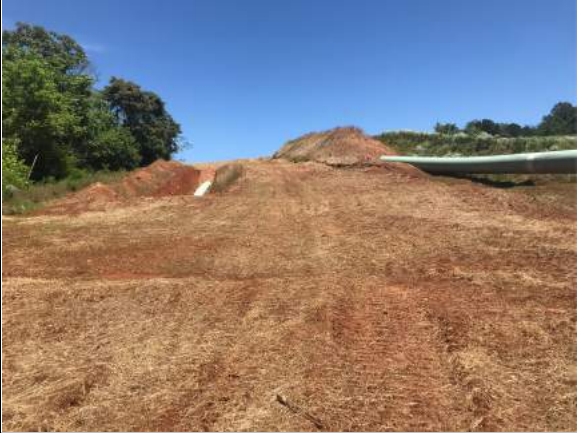
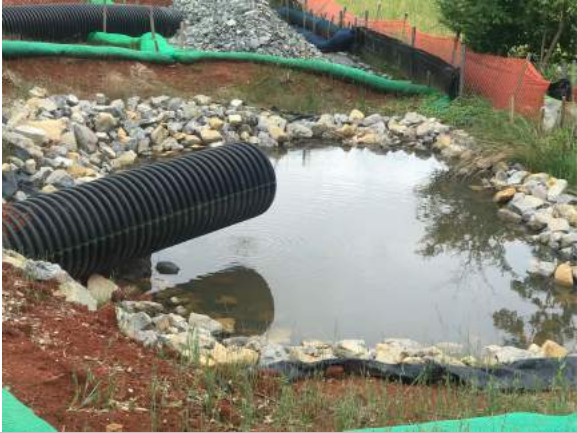
GPS Location 37.05		Field Station# 14166+00		GPS Location 37.05	
Field Station# 14236+25		Description		Approximately 14161+00. ROW and spoil temporarily seeded and stabilized in this area.

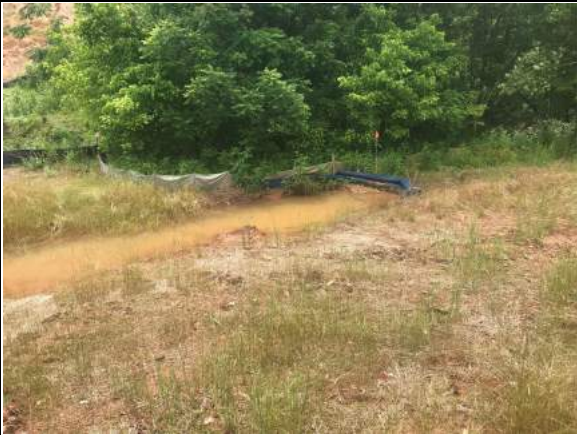
<p style="text-align: center;">Insert image here</p>		
GPS Location 37.05		Field Station# 14233+90		GPS Location	
Field Station#		Description		Approximately 14236+25. CWD piping and plunge pool appear to be installed and functioning correctly at time of inspection.	
<p style="text-align: center;">Insert image here</p>			<p style="text-align: center;">Insert image here</p>		
GPS Location		Field Station#		GPS Location	
Field Station#		Description		Description

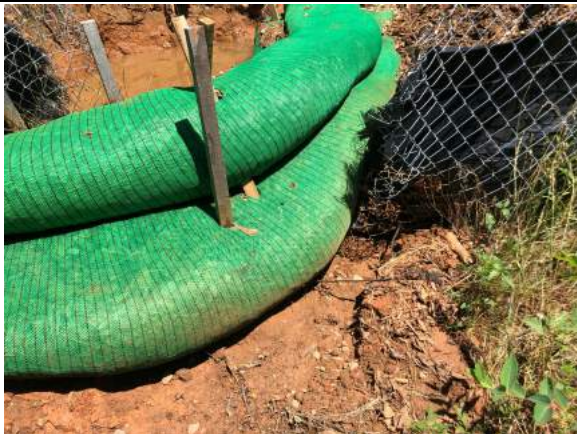
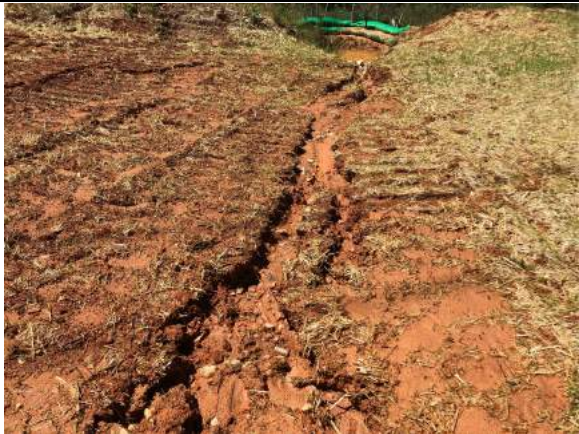
GPS Location		37.00		Field Station#		14708+00		GPS Location		37.00		Field Station#		14705+00	
Description		Super silt fence undermined						Description		Erasing washing towards sump

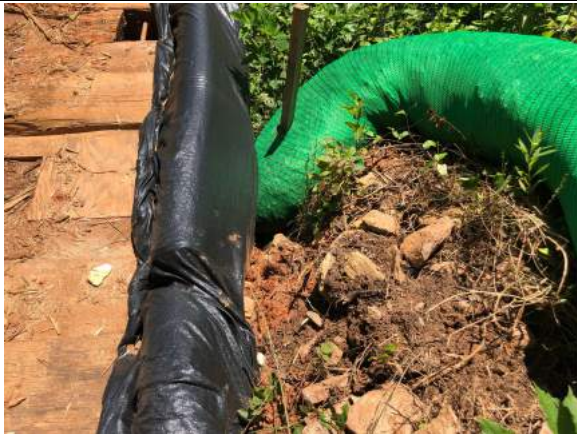
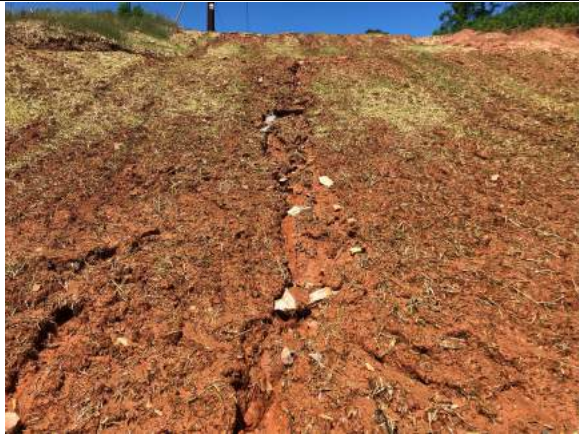
GPS Location		37.00		Field Station#		14700+70		GPS Location		37.00		Field Station#		14600+00	
Description		CFS undermined						Description		Hillside washing out

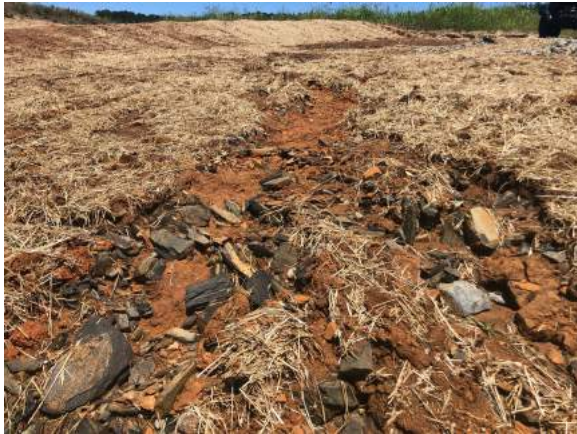
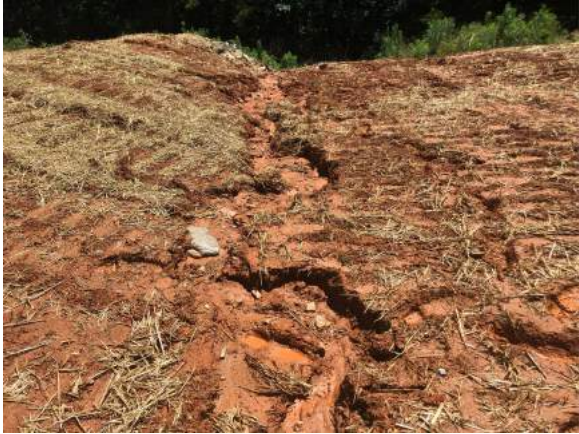
GPS Location		37.00		Field Station#		14757+00		GPS Location		37.00		Field Station#		14749+00	
Description		Hillside washing out						Description		Erosion washing towards sump
