Visual Site Inspection Report

Project Name	H-600 Pipeline Spread I	AFE	124300139	Spread	H-600 Pipeline Spread I
Contractor	Precision			Report #	19021
Inspector	Charles Head			Date/Time	6/21/2019 9:26 AM
Permit #	TBD	Inspection Type	VA SWPP	Station Begin	13958+31
State	VA	Inspection Area	Partial	Station End	14454+22
County	Franklin	Ground	Damp	Temperature (°F)	75.00
Municipality	N/A	Weather	Sunny	Rain Gauge (in)	2.00
				Rain Accumulation Time (days)	4.00

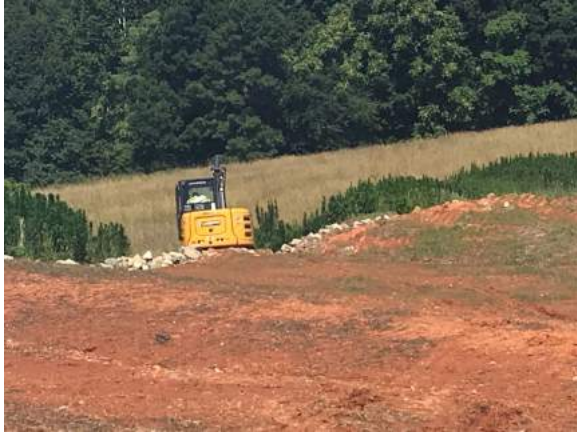
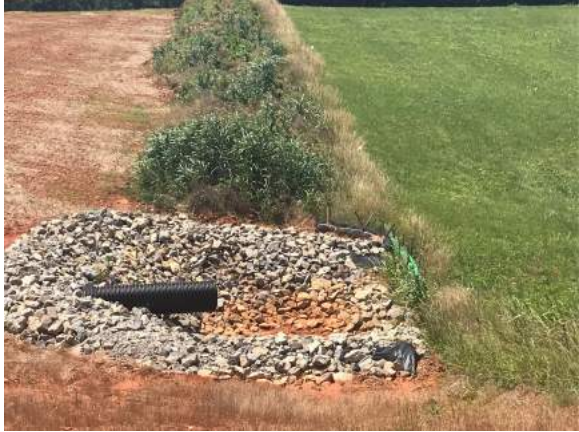
GPS Location		37.02		Field Station#		14452+00		GPS Location		37.01		Field Station#		14132+30	
Description		Approximately 14452+00. Contractor working on maintenance issues.						Description		Approximately 14132+30. CWD piping and plunge pool appear to be installed and functioning correctly at time of inspection.

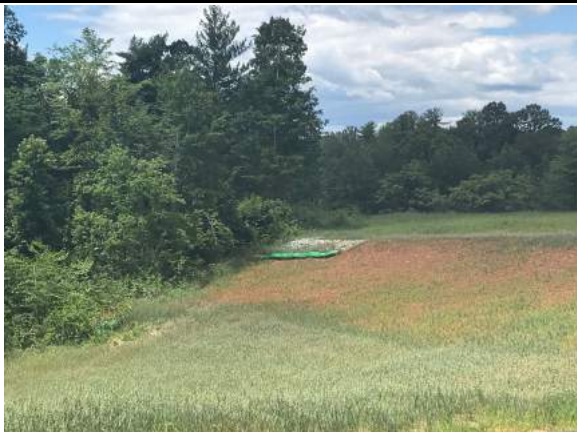
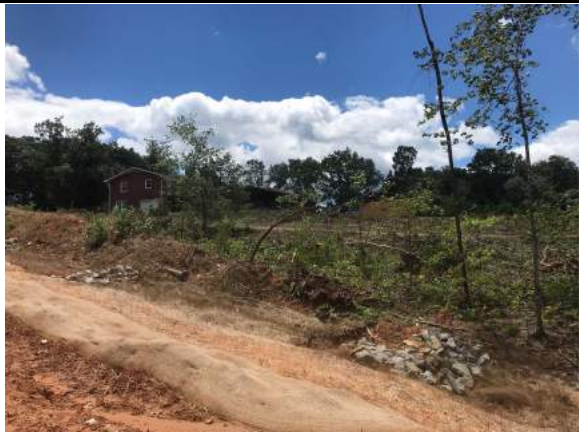
GPS Location		37.06		Field Station#		14017+75		GPS Location		37.06		Field Station#		14059+00	
Description		Approximately 14017+75. ROW temporarily seeded and stabilized in this area.						Description		Approximately 14057+00-14062+00. Third party logging activities adjacent to ROW.

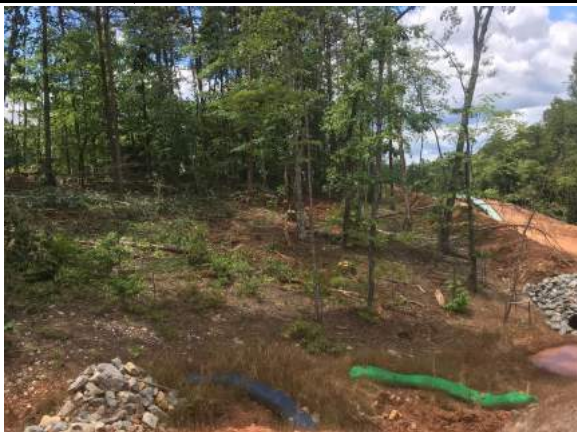
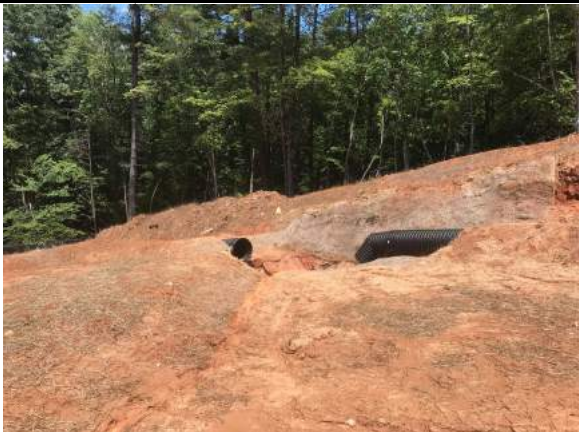
GPS Location		37.06		Field Station#		14057+00		GPS Location		37.06		Field Station#		14057+50	
Description		Approximately 14057+00-14062+00. Third party logging activities adjacent to ROW.						Description		Approximately 14057+50. Water bar, sump, and storm water drainage pipe.

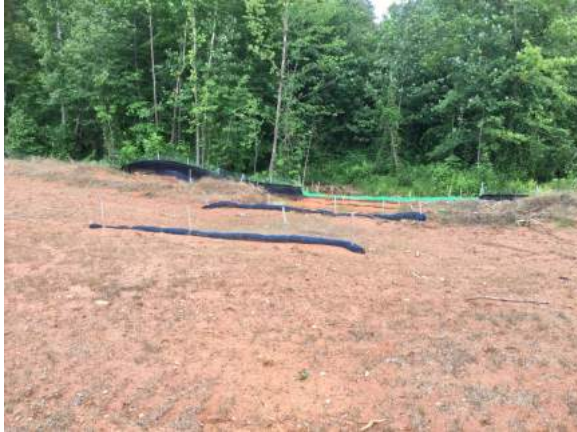
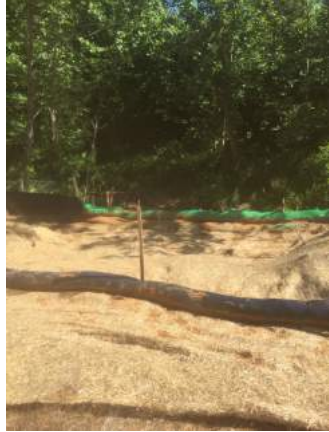
GPS Location		36.96		Field Station#		15454+00		GPS Location		36.96	
Field Station#		15454+00		Description		CFS check dams require maintenance (more than half full)		Description		CFS check dams repaired and erosion control blanket laid down to help control erosion

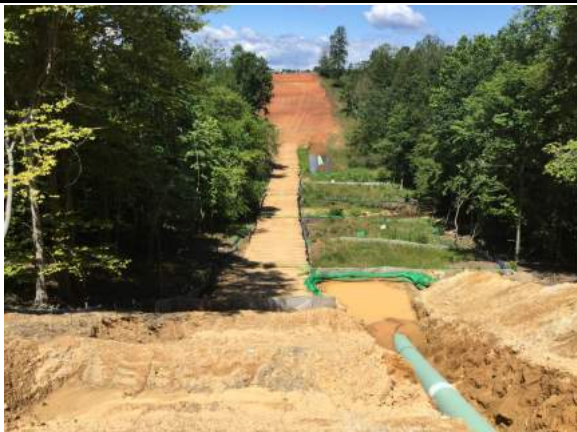
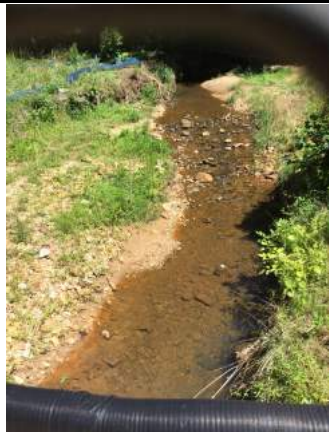
GPS Location		36.96		Field Station#		15046+00		GPS Location		36.96	
Field Station#		15046+00		Description		View of stabilized ROW with functioning ECD's and perimeter controls near S-D2		Description		Upstream view of S-D2 clean water at ROW crossing

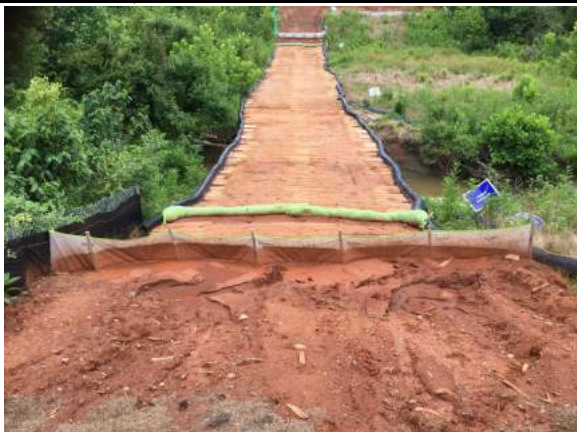
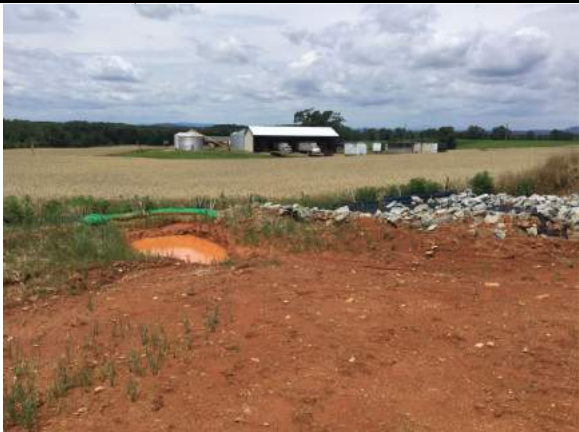
GPS Location		36.96		Field Station#		15346+50		GPS Location		36.96	
Field Station#		15346+50		Description		P1 requires maintenance (more than half full)		Description		Sump pit and ECD performing intended functions

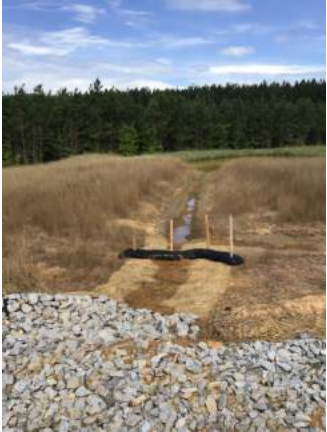
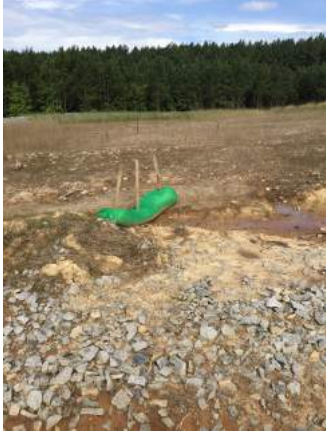
GPS Location	36.83	Field Station#	00+00	GPS Location	36.83
Description	Observing stabilized channel.		Description	Observing CFS performing as it should.

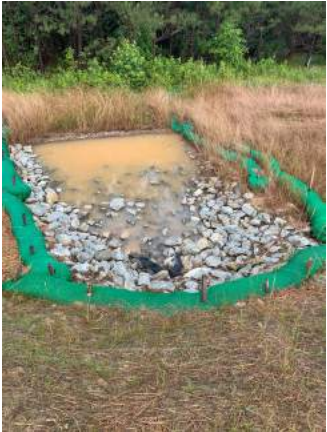
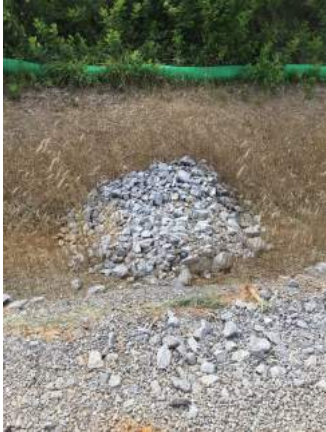
GPS Location	36.83	Field Station#	00+00	GPS Location	36.83
Description	Observing outlet and outlet protection.		Description	Observing rock check dam.

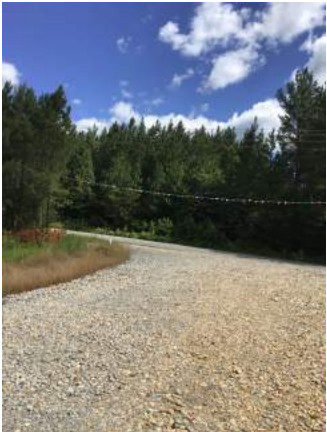
Insert image here			
GPS Location	36.83	Field Station#	00+00	GPS Location	
Description	Observing RCE at Transco.		Description

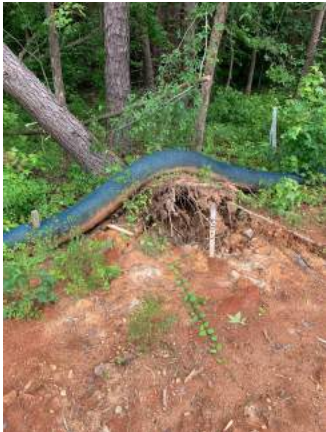
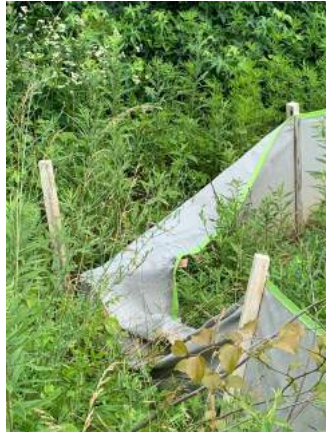
GPS Location	36.83	Field Station#	16010+65	GPS Location	36.88	Field Station#	17+70
Description	Observing CFS that requires maintenance.			Description	Observing P-1 that requires maintenance.

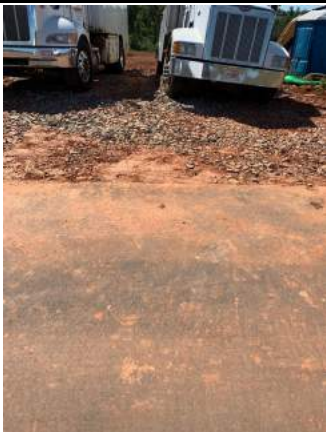
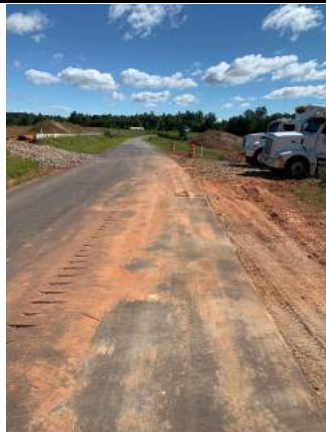
GPS Location	36.88	Field Station#	15693+99	GPS Location	36.88	Field Station#	15693+99
Description	Observing RCE that requires maintenance.			Description	Observing road crossing that requires maintenance.

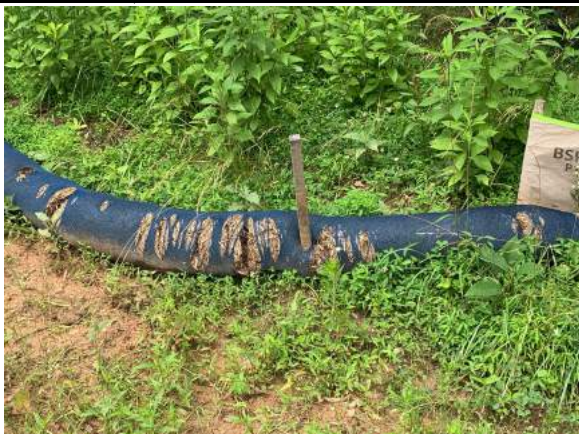
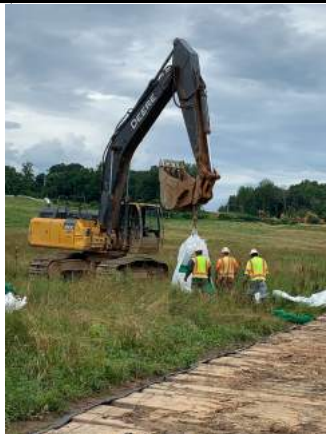
GPS Location	36.88	Field Station#	15963+00	GPS Location	36.88	Field Station#	15952+30
Description	Observing CFS that requires maintenance.			Description	Observing the Contractor installing new ECD's.

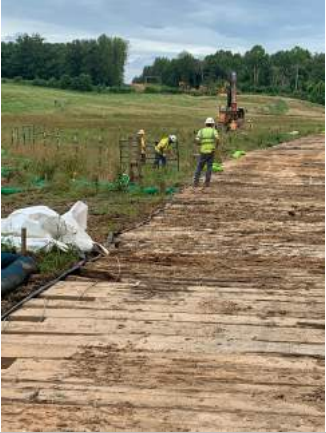
<p>image here</p>		<p>Insert image here</p>	
GPS Location	36.88	Field Station#	15958+37	GPS Location	
Description	Observing the Contractor repairing fence.		Description		
<p>Insert image here</p>			<p>Insert image here</p>		
GPS Location		Field Station#		GPS Location	
Description			Description		
<p>Insert image here</p>			<p>Insert image here</p>		
GPS Location		Field Station#		GPS Location	
Description			Description		
<p>Insert image here</p>			<p>Insert image here</p>		
GPS Location		Field Station#		GPS Location	
Description			Description

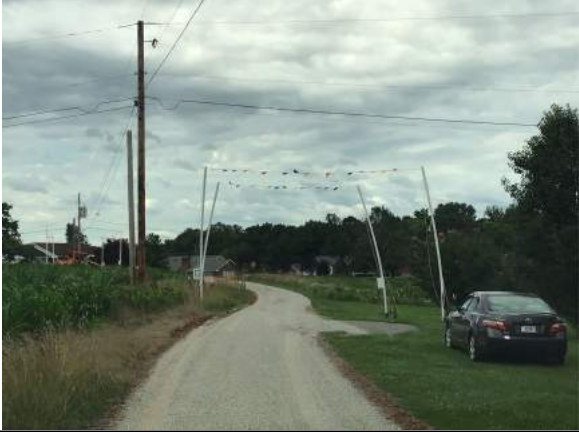
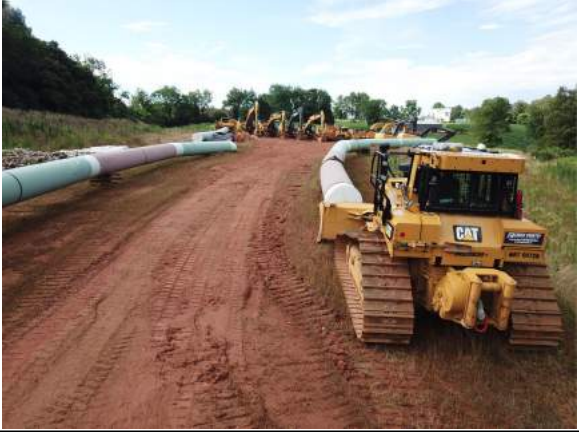
GPS Location	37.02	Field Station#	13784+35	GPS Location	37.02	Field Station#	13784+90
Description	Brick Church access rd as the contractor added rock to repair after tracking equipment to the row.			Description	Equipment staged on row

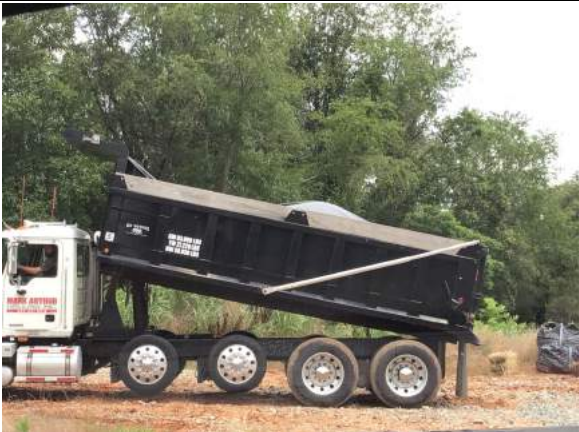
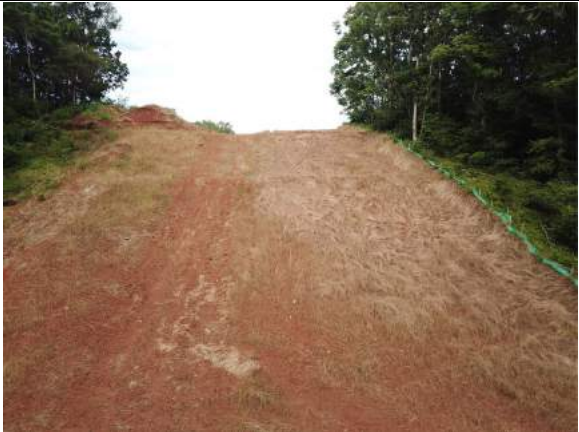
GPS Location	37.02	Field Station#	13784+35	GPS Location	37.02	Field Station#	13785+50
Description	Contractor adding gravel to access rd for maintenance			Description	Vegetation on hill side. Ecds in place on row edge.		
Insert image here				Insert image here			
GPS Location		Field Station#		GPS Location		Field Station#	
Description				Description

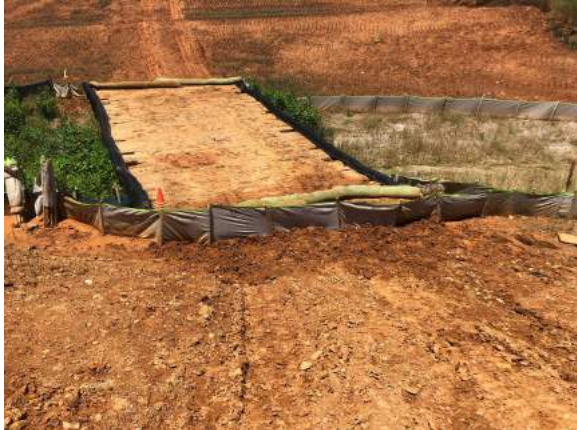
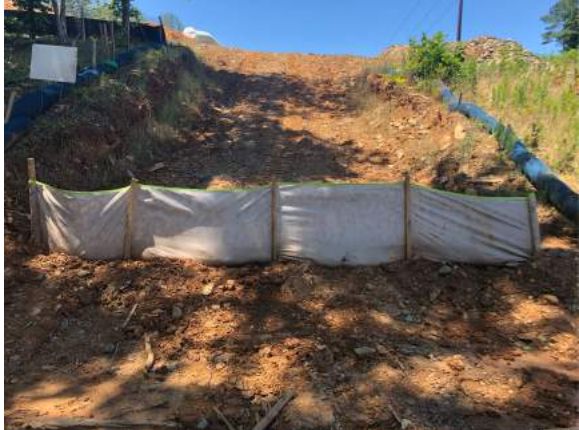
GPS Location		36.97		Field Station#		14916+30		GPS Location		36.97		Field Station#		14907+30	
Description		P1 silt fence replaced						Description		P1 silt fence replaced

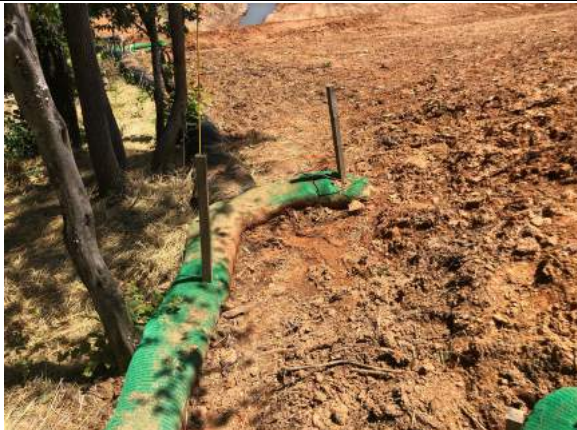
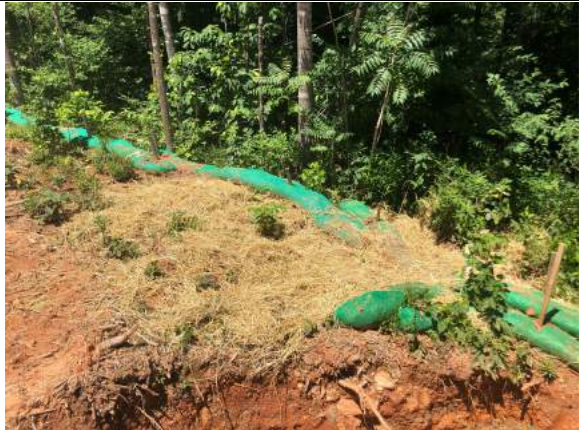
GPS Location		36.97		Field Station#		14903+00		GPS Location		36.97		Field Station#		14900+00	
Description		CFS cleaned out						Description		CFS cleaned out

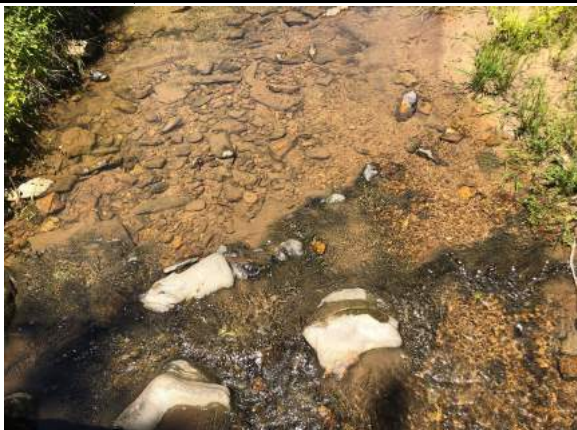
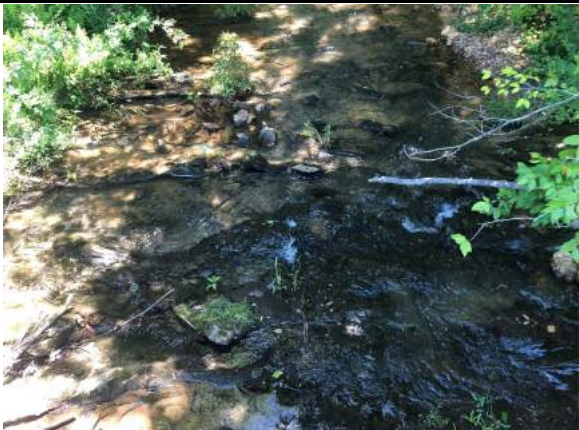
GPS Location		36.97		Field Station#		14907+52		GPS Location		36.97		Field Station#		14907+52	
Description		Upstream side of stream S-DD3 clean						Description		Downstream side of stream S-DD3 clean

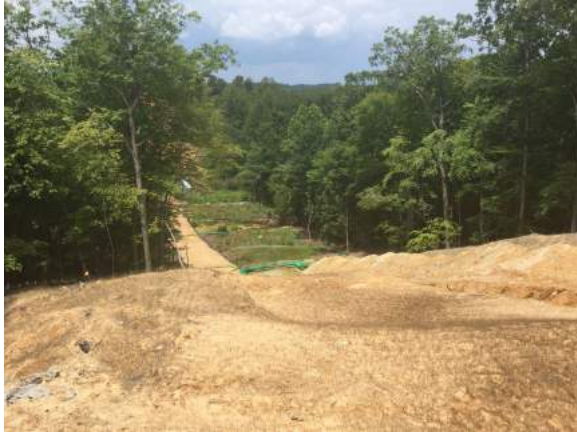
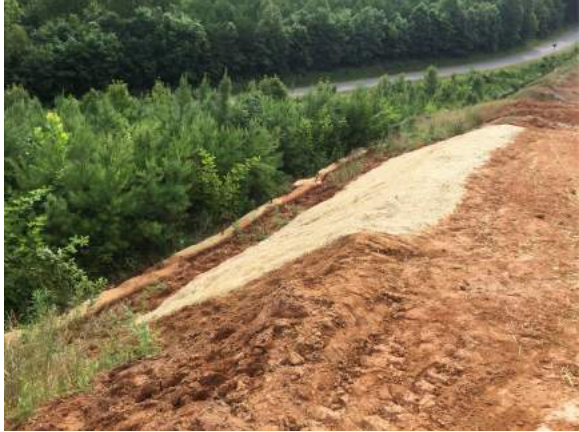
GPS Location		37.00		Field Station#		15047+00		GPS Location		37.00	
Field Station#		15360+00		Description				View of temporary vegetation growing and perimeter controls/ECD's performing intended function			
GPS Location		37.00		Field Station#		15360+00		Description			
Field Station#		15360+00		Description				Curlex Installed on bank and sediment removed

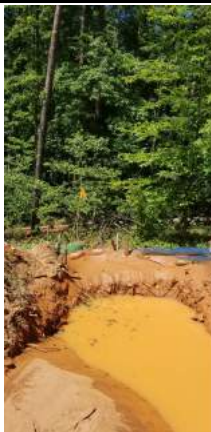
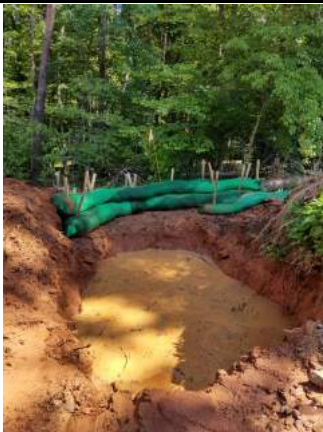
GPS Location		37.00		Field Station#		15394+50		GPS Location		37.00	
Field Station#		15394+50		Description				Triple stack overtopping and needs replaced, sump needs dug to specifications			
GPS Location		37.00		Field Station#		15394+50		Description			
Field Station#		15394+50		Description				Triple stack was replaced with 18" CFS, sump was re-dug to specifications

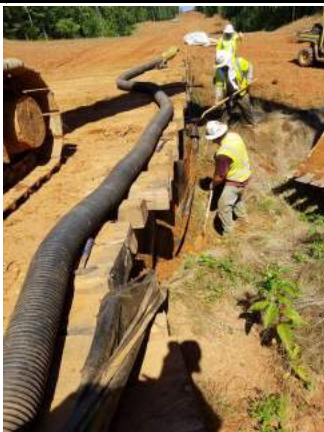
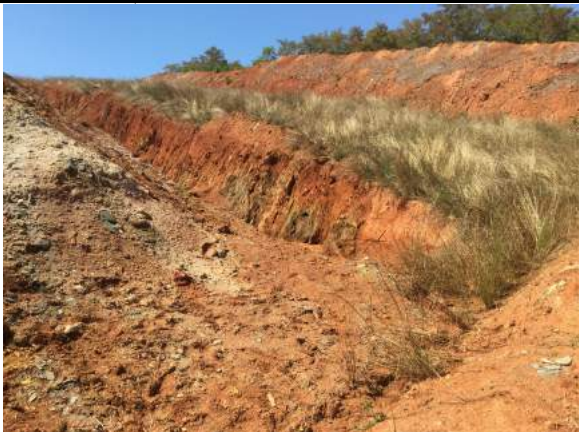
GPS Location		37.00		Field Station#		15393+50		GPS Location		37.00

Field Station#		15127+00		Description				Environmental crew replacing geotextile fabric at bridge crossing			
GPS Location		37.00		Field Station#		15127+00		Description			
Field Station#		15127+00		Description				CFS needs installed at end of open trench

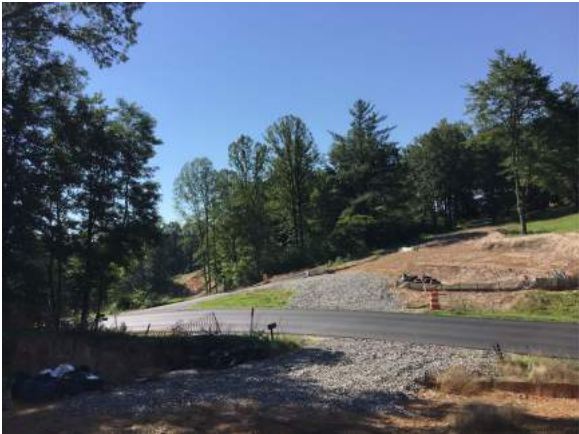
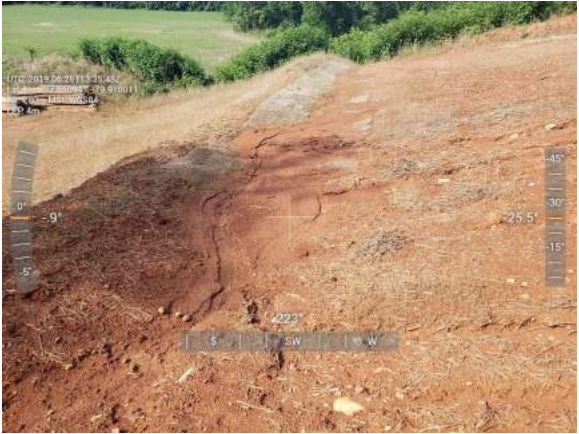
GPS Location	37.08	Field Station#	13811+33	GPS Location	37.08
Field Station#	13811+33	GPS Location	37.08	Field Station#	13910+00
Description	RCEs at Brick Church rd			Description	Water Bar requiring maintenance

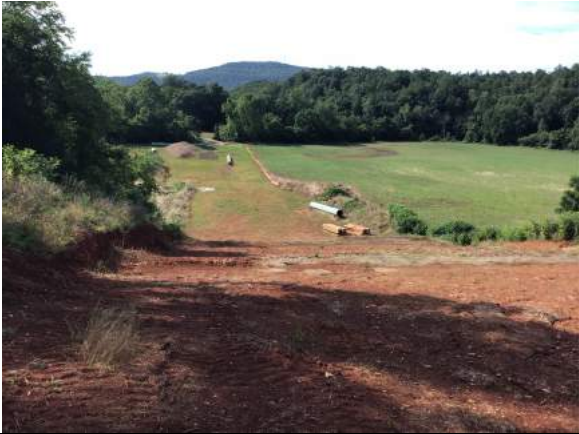
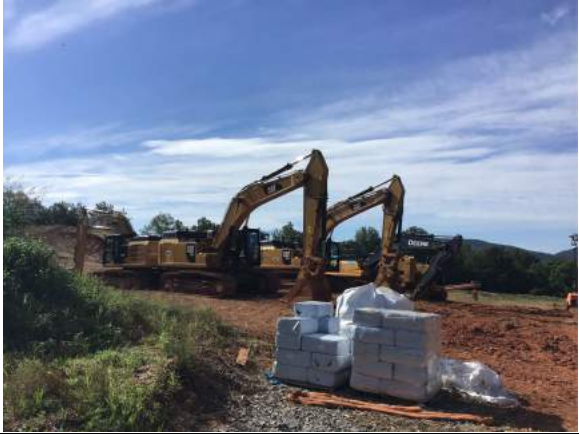
GPS Location	37.08	Field Station#	13910+00	GPS Location	37.08
Field Station#	13910+00	GPS Location	37.08	Field Station#	13892+33
Description	Photo showing vegetation and water bars in place and functioning.			Description	Equipment parked at Iron Ridge rd
Insert image here			Insert image here		
GPS Location		Field Station#		GPS Location	
Field Station#		GPS Location		Field Station#	
Description				Description

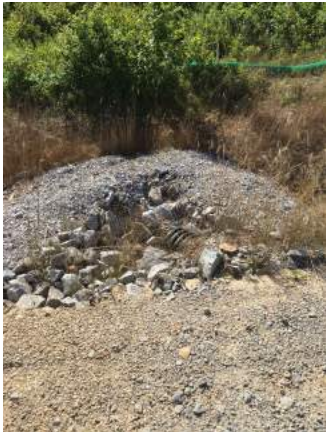
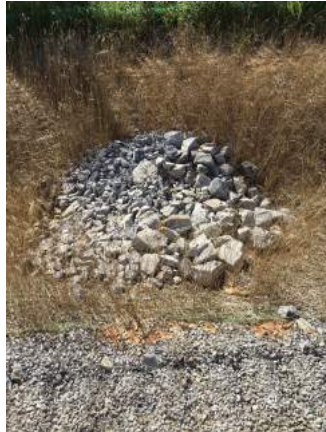
GPS Location	36.83	Field Station#	00+00	GPS Location	36.83	Field Station#	00+00
Description	Observing outlet and outlet protection.			Description	Observing rock check dam.

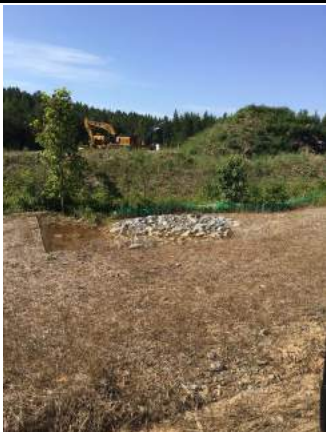
GPS Location	36.83	Field Station#	00+00	GPS Location	36.83	Field Station#	00+00
Description	Observing outlet and outlet protection.			Description	Observing drainage channel performing as it should.

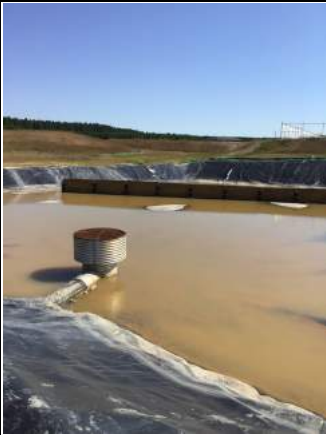
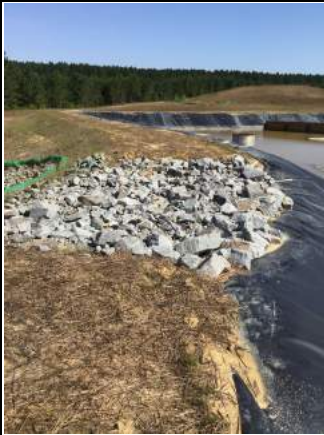
GPS Location 36.83		Field Station# 00+00		GPS Location 36.83	
Description		Observing storm water pond.		Description	
<div style="text-align: center;">Insert image here</div>		<div style="text-align: center;">Insert image here</div>			
GPS Location		Field Station#		GPS Location	
Description				Description

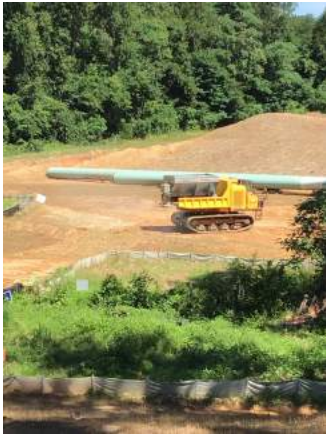
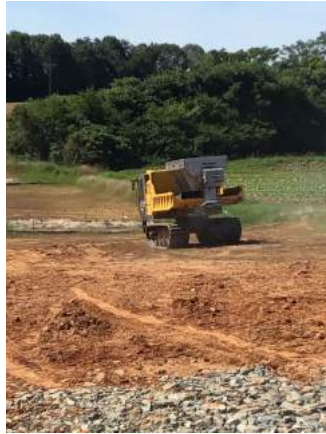
GPS Location	36.83	Field Station#	15762+14	GPS Location	36.83	Field Station#	15776+00
Description	Observing the Contractor installing earth guard on the ROW			Description	Observing the Contractor installing earth guard on the ROW.

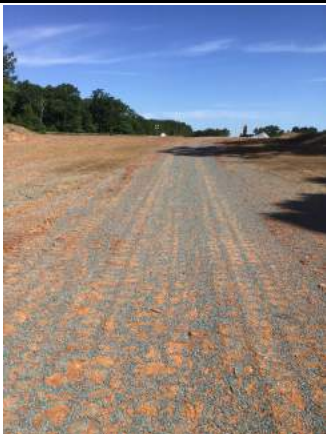
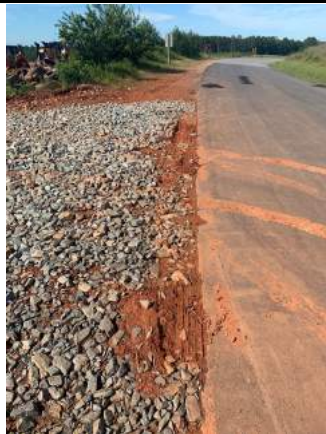
GPS Location	36.83	Field Station#	15830+00	GPS Location	36.83	Field Station#	15693+99
Description	Observing stabilized ROW.			Description	Observing RCE that requires maintenance.

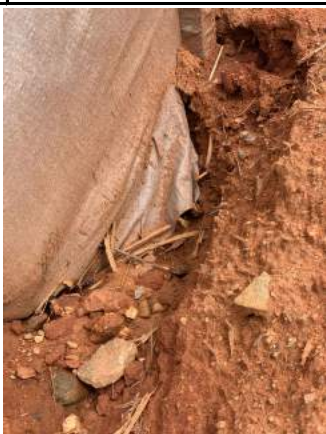
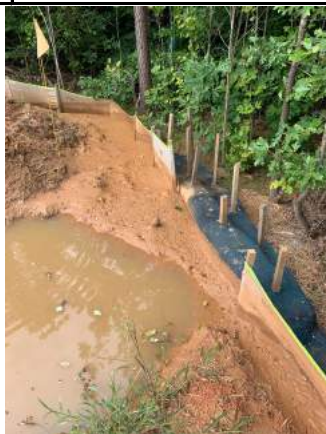
GPS Location	36.83	Field Station#	15556+20	GPS Location	36.83	Field Station#	15508+55
Description	Observing P-1 that requires maintenance.			Description	Observing ECD's that require maintenance.

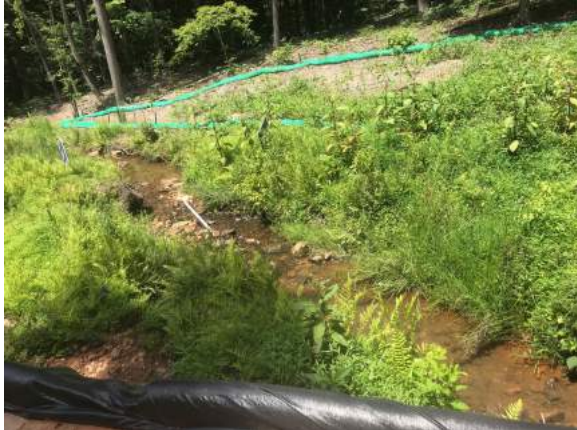
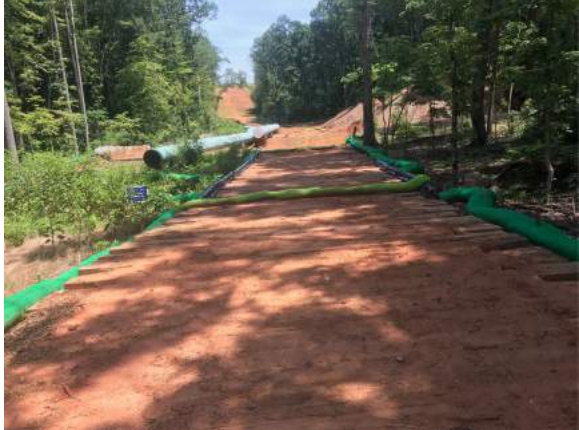
GPS Location		37.05		Field Station#		14438+33		GPS Location		36.98		Field Station#		14434+01	
Description		Downstream view of stream S-GH44. Approximately 14438+33. Water flowing clean and clear of sediment at time of inspection.						Description		Approximately 14434+01. Overview of stream crossing and equipment bridge at stream S-GH40.

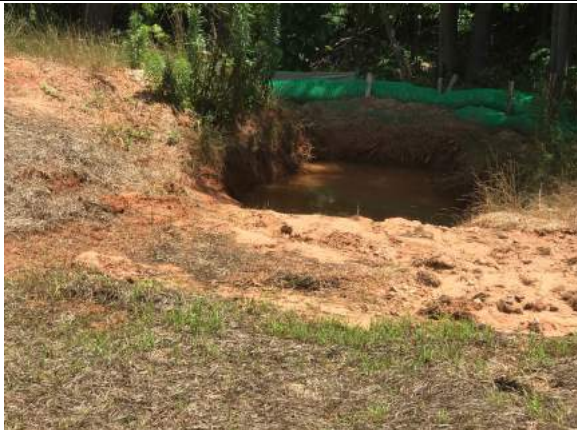
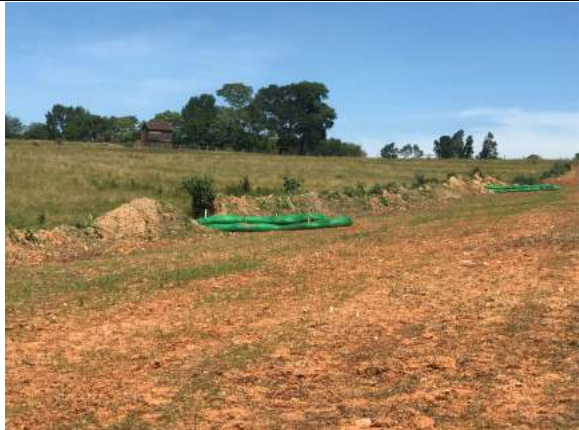
GPS Location		36.98		Field Station#		14414+00		GPS Location		36.84		Field Station#		14375+00	
Description		Approximately 14414+00. Water bar, sump, and end treatment. All appear to be installed and functioning correctly at time of inspection.						Description		Approximately 14375+00. ROW temporarily seeded and stabilized in this area. CFS checks at sumps appear to be installed and functioning correctly at time of inspection.

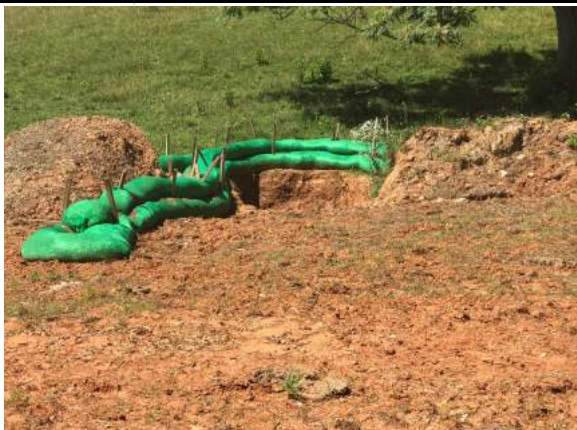
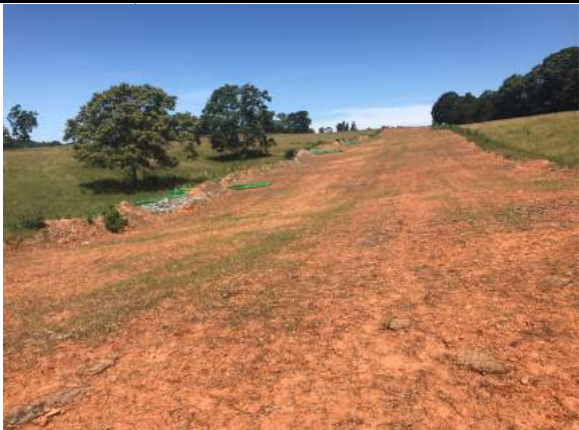
GPS Location		36.84		Field Station#		24380+00		GPS Location		36.84		Field Station#		14384+00	
Description		Approximately 14380+00. CFS check, sump, and end treatment installed and appear to be functioning correctly at time of inspection.						Description		Approximately 14384+00. ROW temporarily seeded and stabilized in this area.

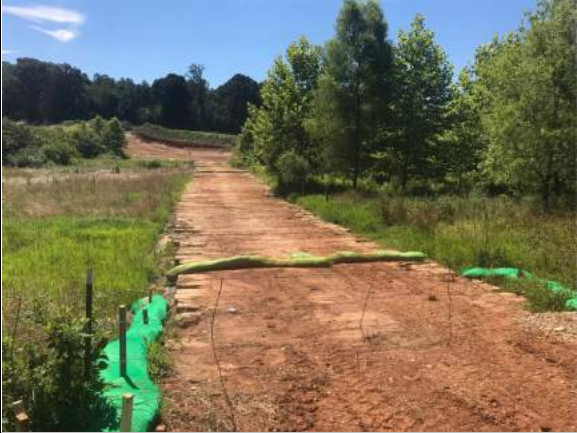
<p>Insert image here</p>			
GPS Location	36.84	Field Station#	14390+00	GPS Location	
Description	Approximately 14390+00. Mat travel lane and bridge across wetland W-DD1 and stream crossing S-A41.		Description		
<p>Insert image here</p>			<p>Insert image here</p>		
GPS Location		Field Station#		GPS Location	
Description			Description		
<p>Insert image here</p>			<p>Insert image here</p>		
GPS Location		Field Station#		GPS Location	
Description			Description		
<p>Insert image here</p>			<p>Insert image here</p>		
GPS Location		Field Station#		GPS Location	
Description			Description

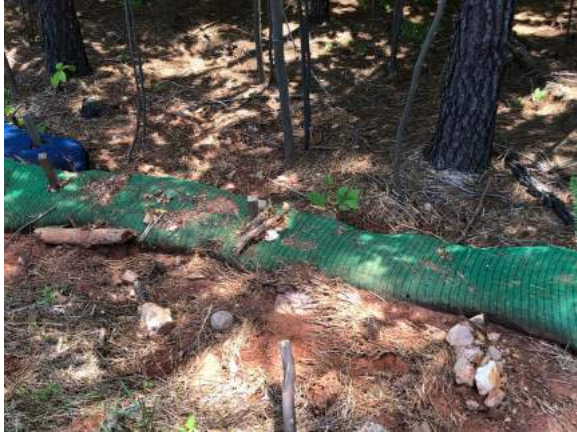
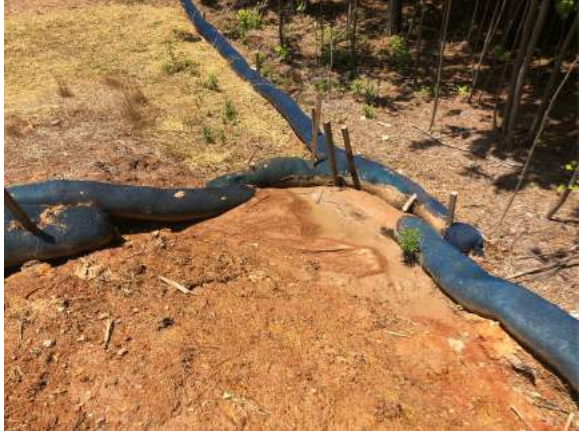
GPS Location		37.00		Field Station#		14966+00		GPS Location		37.00		Field Station#		14967+00									
Description		CFS needs cleaned out to prevent sediment from overflowing off of ROW										Description		CFS undermined at top and CFS needs cleaned out at bottom

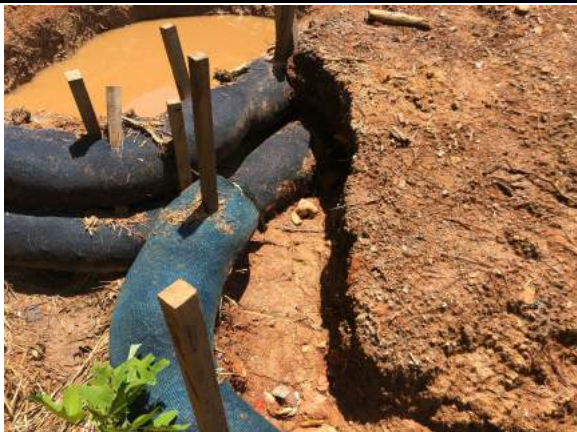
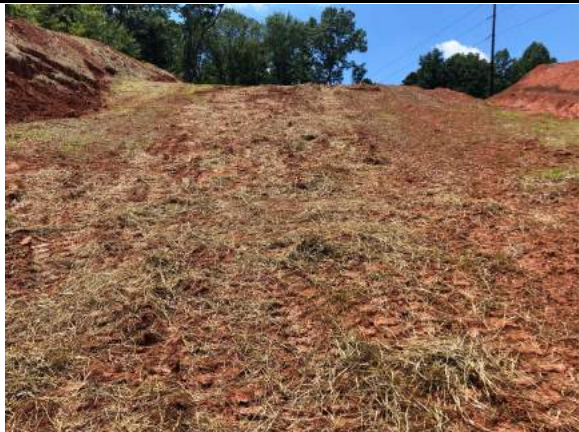
GPS Location		37.00		Field Station#		14968+00		GPS Location		37.00		Field Station#		14672+00									
Description		CFS on end treatment is undermined										Description		Contractor repaired rill erosion on hillside

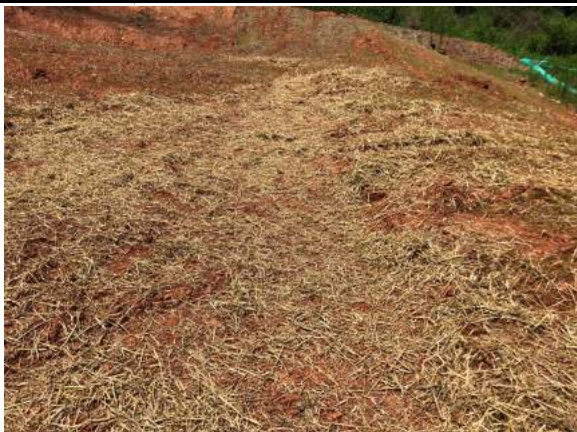
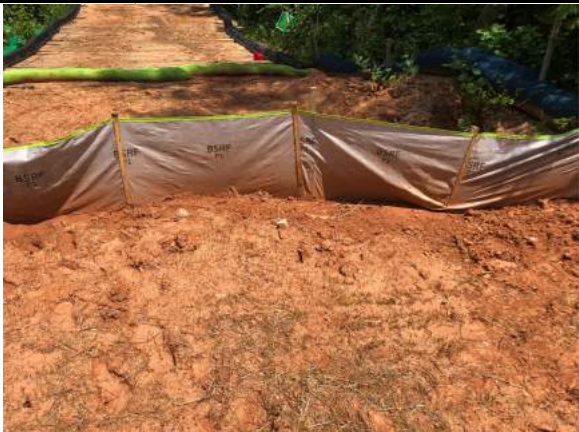
GPS Location		37.00		Field Station#		14672+40		GPS Location		37.00		Field Station#		14680+20									
Description		Contractor cleaned out water bar flow path										Description		Contractor fixed P1 silt fence that was undermined
