Visual Site Inspection Report

Project Name	H-600 Pipeline Spread I	AFE	124300139	Spread	H-600 Pipeline Spread I
Contractor	Precision			Report #	19627
Inspector	Logan Box			Date/Time	7/3/2019 4:27 PM
Permit #	TBD	Inspection Type	VA SWPP	Station Begin	13670+00
State	VA	Inspection Area	Partial	Station End	13958+31
County	Franklin	Ground	Damp	Temperature (°F)	88.00
Municipality	N/A	Weather	Sunny	Rain Gauge (in)	0.00
				Rain Accumulation Time (days)	0.00

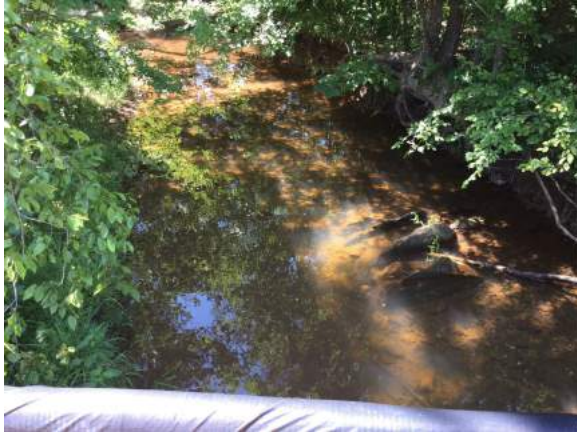
GPS Location		36.98		Field Station#		15026+04		GPS Location		36.98		Field Station#		15490+00	
Description		Downstream view of clean water running at S-D3										Description		View of stabilized ROW and crew loading material

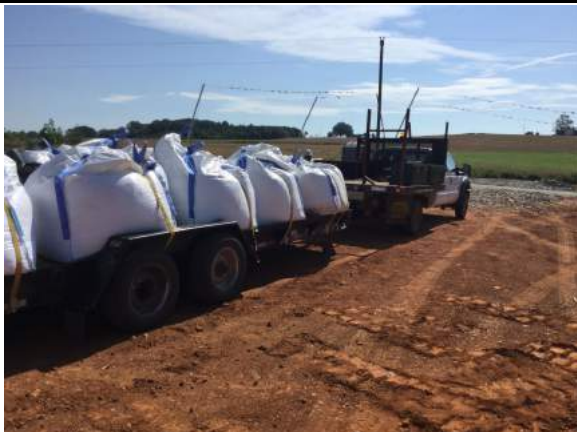
GPS Location		36.98		Field Station#		15480+06		GPS Location		36.90		Field Station#		15250+00	
Description		Crew loading material and hauling to another site										Description		Cleanup crew restoring ROW to pre-construction condition

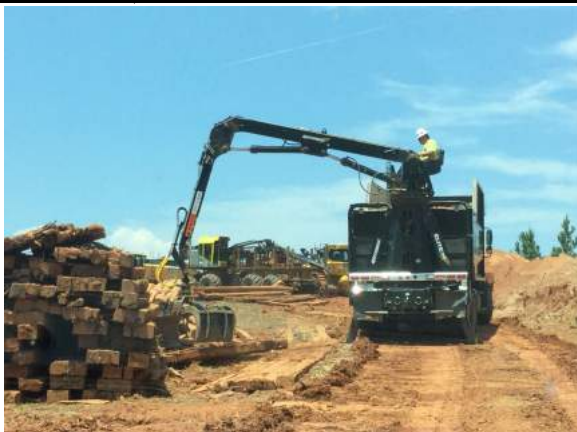
GPS Location		36.90		Field Station#		15229+50		GPS Location		36.90		Field Station#		15220+00	
Description		Crew loading timber mats and removing them from site										Description		View of ROW in final restoration with grass growing and permanent ECD's

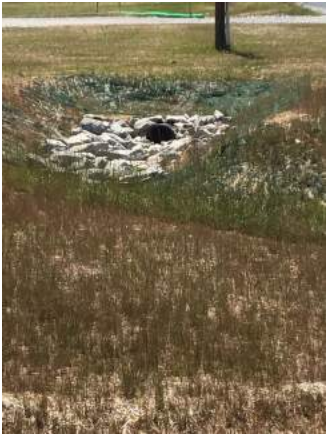
GPS Location	36.82	Field Station#	00+00		GPS Location	36.82	Field Station#	00+00
Description	Observing outlet and outlet protection.				Description	Observing rock drain.

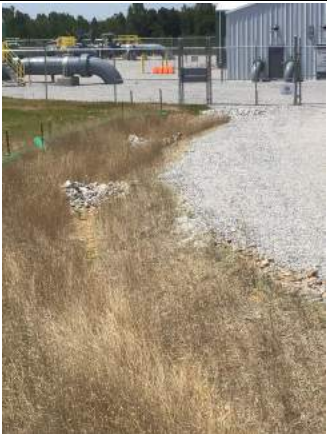
GPS Location	36.82	Field Station#	00+00		GPS Location	36.82	Field Station#	00+00
Description	Observing rock check dam.				Description	Observing vegetation.		
Insert image here					Insert image here			
GPS Location		Field Station#			GPS Location		Field Station#	
Description					Description

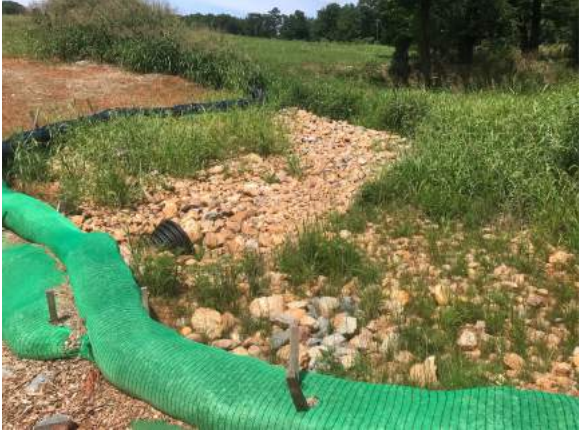
GPS Location	37.04	Field Station#	14132+50	GPS Location	37.04
Field Station#	14121+50	Description	Approximately 13132+50. CWD inlet. CWD appears to be installed and functioning correctly at time of inspection.

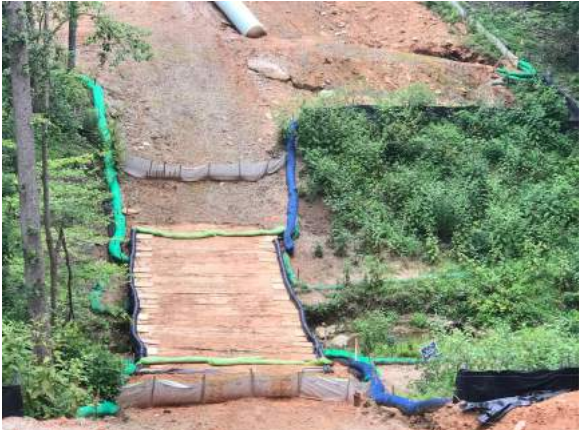
GPS Location	37.04	Field Station#	14105+26	GPS Location	37.04
Field Station#	14057+00	Description	Approximately 14105+26. Overview of stream crossing and equipment bridge at stream S-KL41. Resource buffer ECDs installed and appear to be functioning correctly at time of		
<p style="text-align: center;">Insert image here</p>			<p style="text-align: center;">Insert image here</p>		
GPS Location		Field Station#		GPS Location	
Description			Description

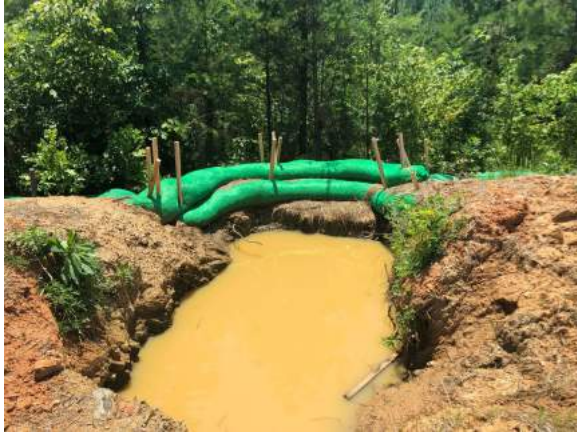
GPS Location	37.00	Field Station#	14660+00	GPS Location	37.00	Field Station#	1468+36
Description	Sump pit functioning properly			Description	Equipment bridge clean at stream S-H36

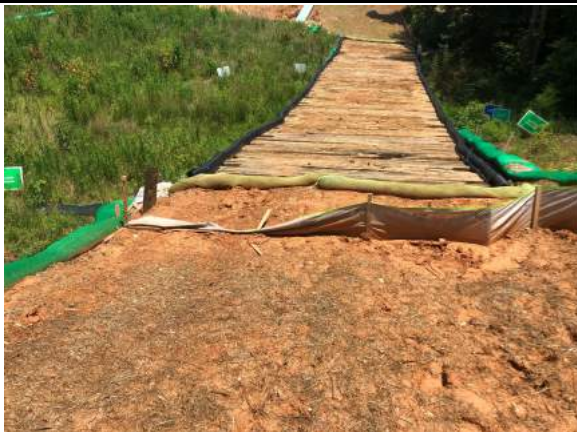
GPS Location	37.00	Field Station#	14716+15	GPS Location	37.00	Field Station#	14718+00
Description	P1 silt fence down and needs fixed at wetland W-H11			Description	Sump pit and end treatment functioning properly
