Visual Site Inspection Report

Project Name	H-600 Pipeline Spread I	AFE	124300139	Spread	H-600 Pipeline Spread I
Contractor	Precision			Report #	1379
Inspector	Ben Davenport			Date/Time	8/26/2019 8:28 AM
Permit #	TBD	Inspection Type	VA SWPP	Station Begin	14981+55
State	VA	Inspection Area	Partial	Station End	15496+70
County	Franklin/Pittsylvania	Ground	Dry	Temperature (°F)	76.00
Municipality	Chatham	Weather	Sunny	Rain Gauge (in)	0.00
				Rain Accumulation Time (days)	0.00

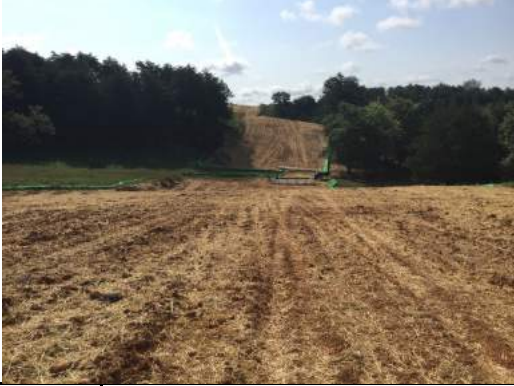
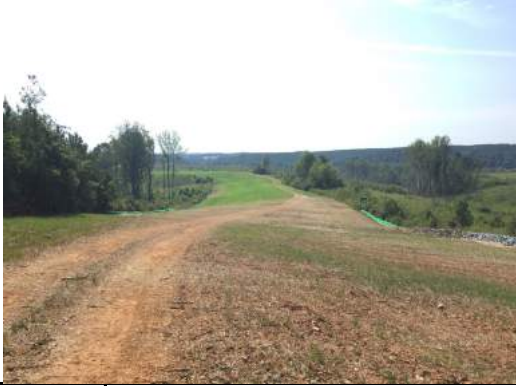
GPS Location	1	GPS Location	2		
Field Station#	15325+00	Field Station#	15232+00		
Pic 1 Desc.	Contractor restoring subsoil to pre-construction condition and then stabilized ROW		Pic 2 Desc.	Updated view of permanent vegetation growing along ROW

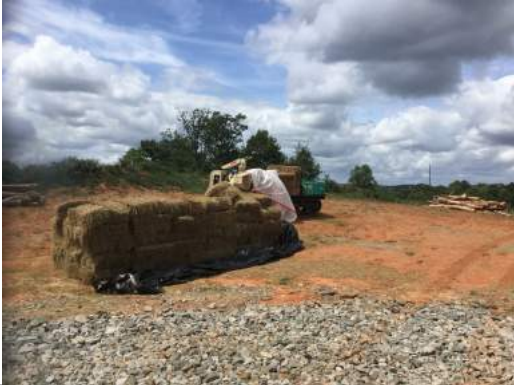
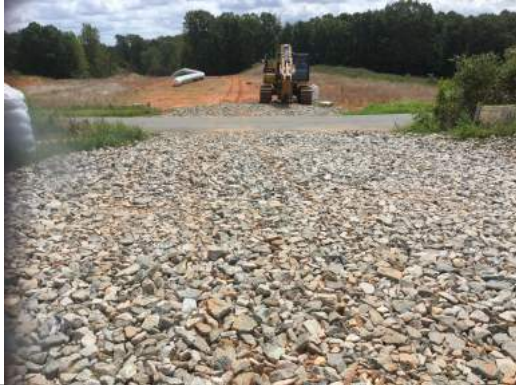
GPS Location	3	GPS Location	4		
Field Station#	15063+00	Field Station#	15063+85		
Pic 3 Desc.	Material and equipment staged CIS Armstrong Rd		Pic 4 Desc.	View of RCE approaches at Armstrong Rd

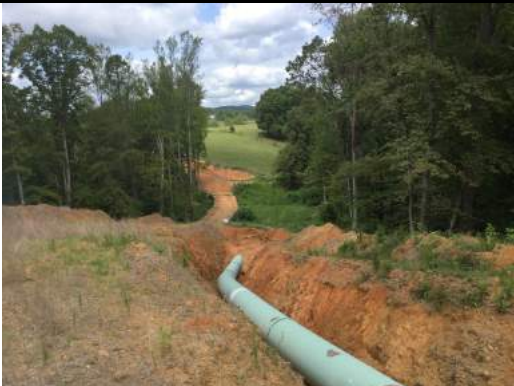
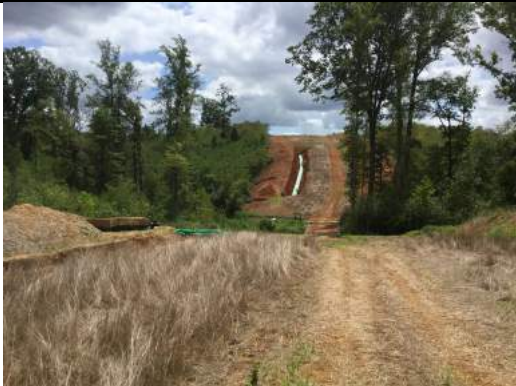
GPS Location	5	GPS Location	6		
Field Station#	15108+00	Field Station#	15125+00		
Pic 5 Desc.	View of open trench and stabilized ROW		Pic 6 Desc.	View of open trench and stabilized ROW

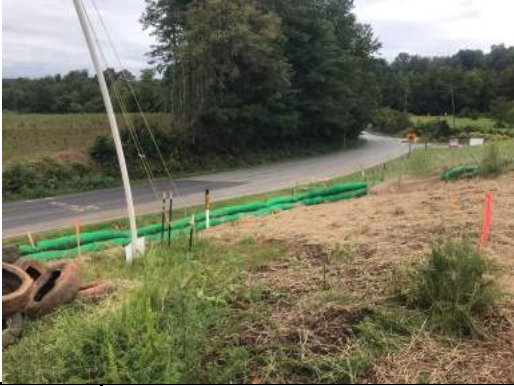
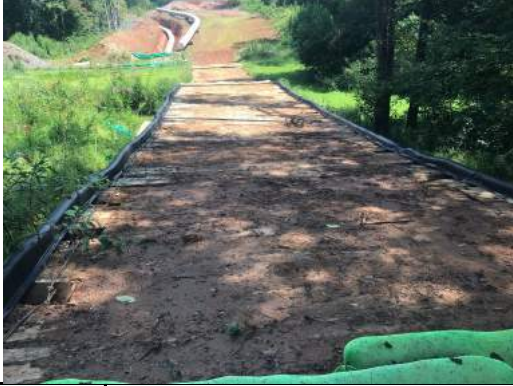
GPS Location	0	GPS Location	0		
Field Station#	14018+75	Field Station#	14035+28		
Pic 1 Desc.	Approximately 14018+75. LOD boundary ECDs replaced.	Pic 2 Desc.	Approximately 14035+28. Overview of stream crossing and equipment bridge at stream S-KL39.

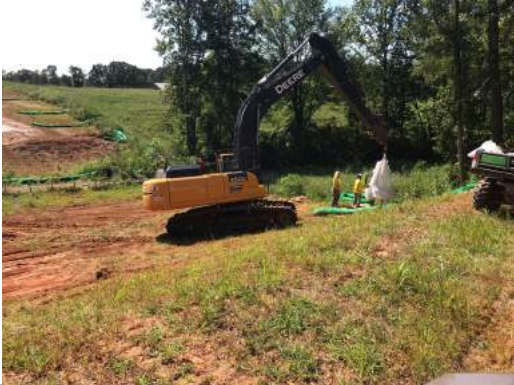
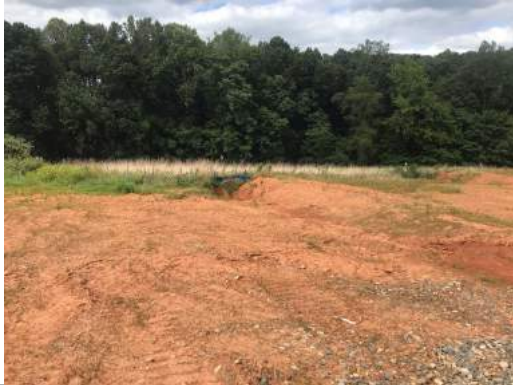
GPS Location	0	GPS Location	0		
Field Station#	14125+00	Field Station#	14172+25		
Pic 3 Desc.	Approximately 14125+00. Crews replacing LOD ECDs with CFS triple stack.	Pic 4 Desc.	Approximately 14172+25. Water bar, sump, and end treatment installed and appear to be functioning correctly at time of inspection.		
Insert image here		Insert image here			
GPS Location		GPS Location			
Field Station#		Field Station#			
Pic 5 Desc.		Pic 6 Desc.

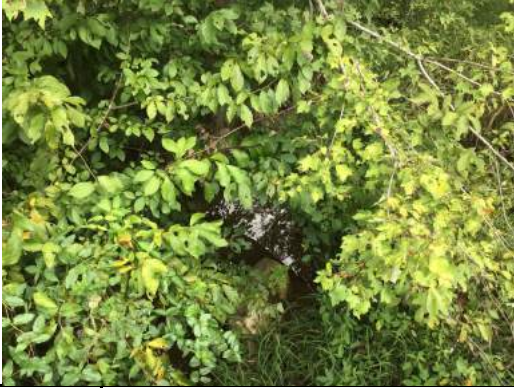
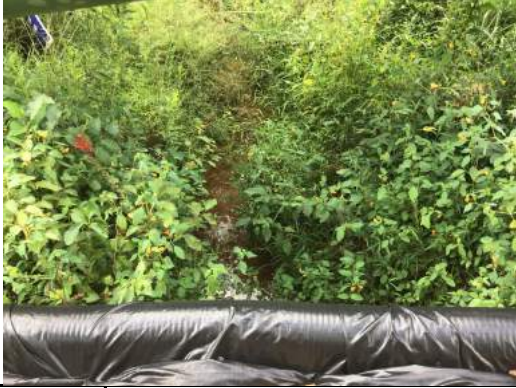
GPS Location	00000	GPS Location	00000		
Field Station#	13949+70	Field Station#	13949+70		
Pic 1 Desc.	Stream/wetland photo facing downstream		Pic 2 Desc.	Stream/wetland photo facing up stream

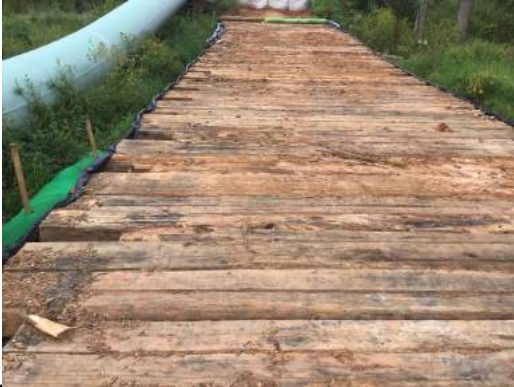
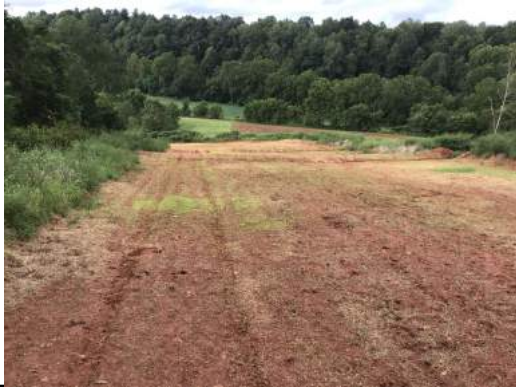
GPS Location	00000	GPS Location	00000		
Field Station#	13949+24	Field Station#	13910+00		
Pic 3 Desc.	Equipment crossing , ECDs in place and functioning		Pic 4 Desc.	Temporary vegetation starting to grow in a recently stabilized area	
Insert image here			Insert image here		
GPS Location		GPS Location			
Field Station#		Field Station#			
Pic 5 Desc.			Pic 6 Desc.

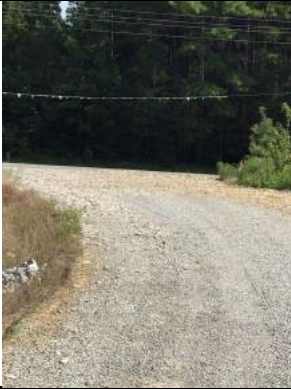
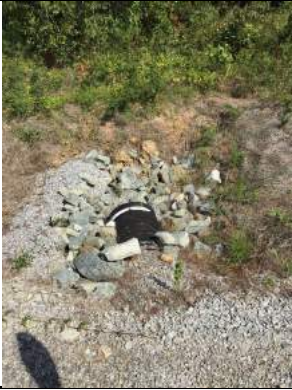
GPS Location	0		GPS Location	0	
Field Station#	00+00		Field Station#	00+00	
Pic 1 Desc.	Observing RCE at Transco.		Pic 2 Desc.	Observing outlet and outlet protection.

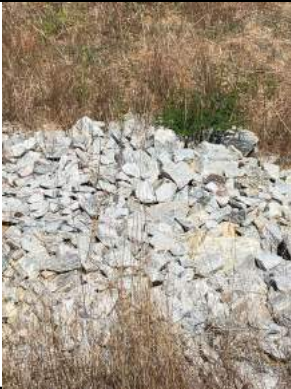
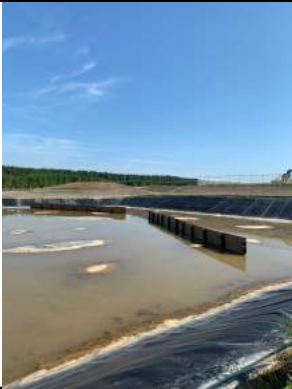
GPS Location	0		GPS Location	0	
Field Station#	00+00		Field Station#	00+00	
Pic 3 Desc.	Observing rock check dam.		Pic 4 Desc.	Observing storm water pond.	
Insert image here			Insert image here		
GPS Location			GPS Location		
Field Station#			Field Station#		
Pic 5 Desc.			Pic 6 Desc.

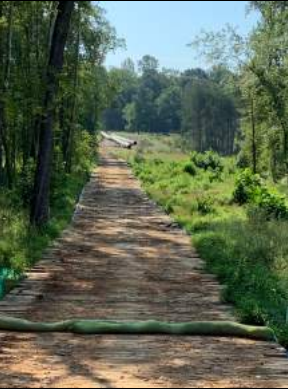
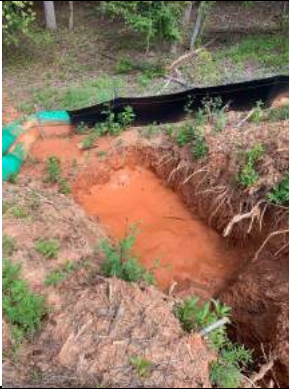
GPS Location	0	GPS Location	0		
Field Station#	15665+50	Field Station#	15720+00		
Pic 1 Desc.	Observing wetland crossing.	Pic 2 Desc.	Observing sump and end treatment.

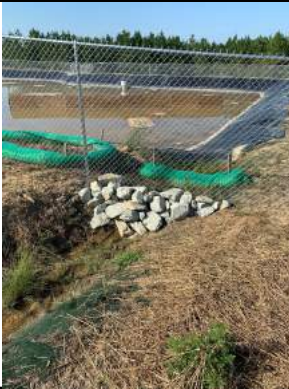
GPS Location	0	GPS Location	0		
Field Station#	15837+00	Field Station#	00+00		
Pic 3 Desc.	Observing ECD's performing as they should.	Pic 4 Desc.	Observing ECD's performing as they should		
Insert image here			Insert image here		
GPS Location		GPS Location			
Field Station#		Field Station#			
Pic 5 Desc.		Pic 6 Desc.

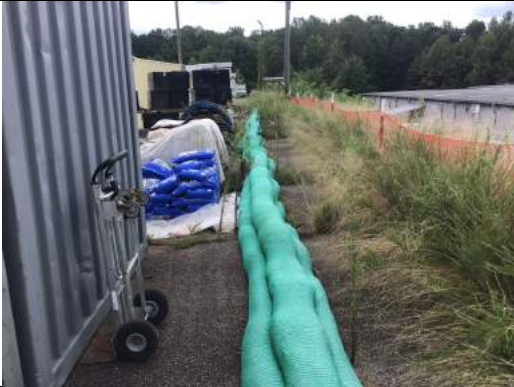
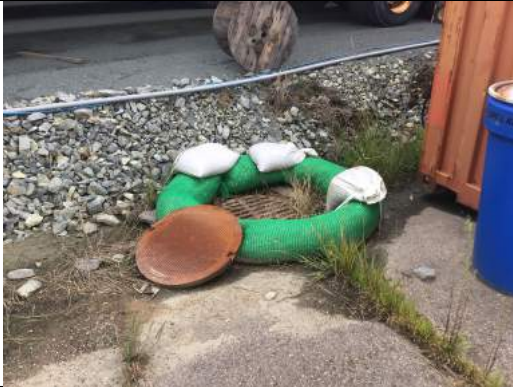
GPS Location	0000	GPS Location	0000		
Field Station#	0000+00	Field Station#	0000+00		
Pic 1 Desc.	Perimeter ECD's on west side of paved yard in good condition.	Pic 2 Desc.	Inlet protection for parking lot drain near storage building in compliance.

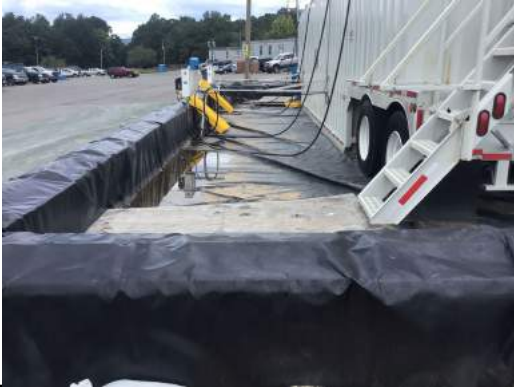
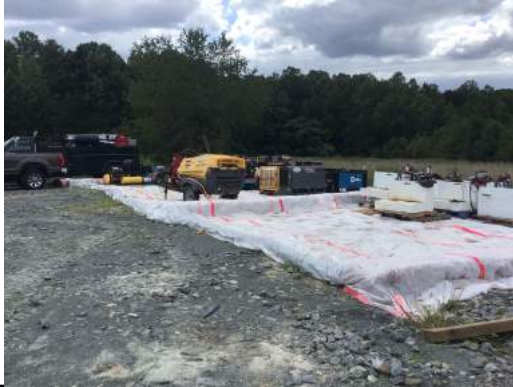
GPS Location	00000	GPS Location	0000		
Field Station#	0000+00	Field Station#	0000+00		
Pic 3 Desc.	Secondary containment structure for fuel cell in compliance.	Pic 4 Desc.	Secondary containment structure in compliance on north end of gravel yard.

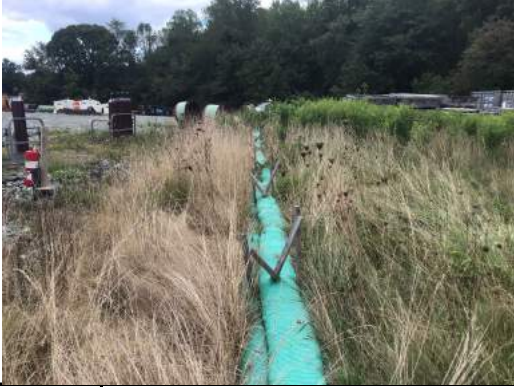
Insert image here			
GPS Location	0000	GPS Location			
Field Station#	0000+00	Field Station#			
Pic 5 Desc.	Perimeter ECD's in good condition on north end of gravel yard.	Pic 6 Desc.

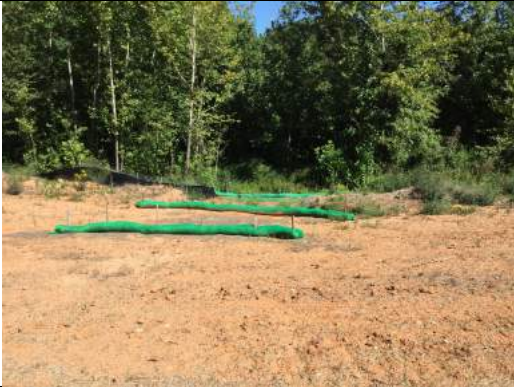
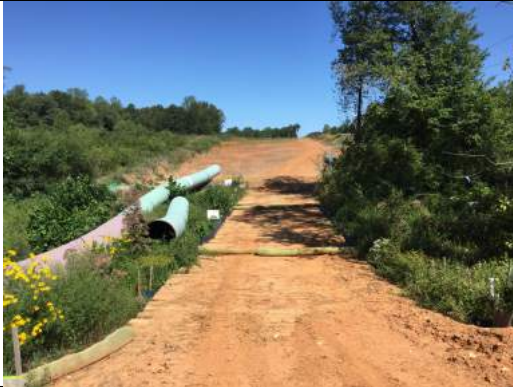
GPS Location	1	GPS Location	2		
Field Station#	15456+00	Field Station#	15447+73		
Pic 1 Desc.	CFS check dams in place and functioning as intended	Pic 2 Desc.	View of equipment crossing at S-CC16 with ECD's and perimeter controls in place

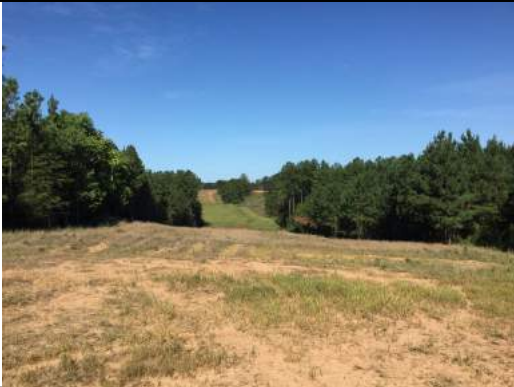
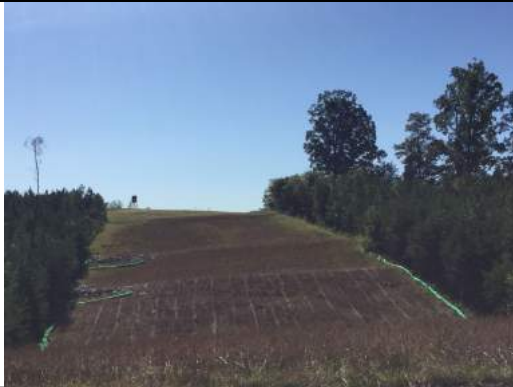
GPS Location	3	GPS Location	4		
Field Station#	15209+00	Field Station#	15222+00		
Pic 3 Desc.	Permanent vegetation growing along ROW and functioning perimeter controls in place	Pic 4 Desc.	Permanent vegetation growing along ROW and functioning perimeter controls and ECD's in place

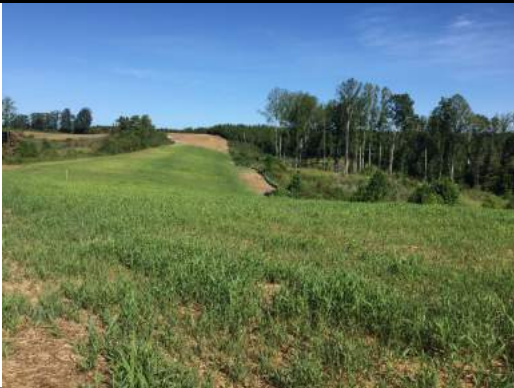
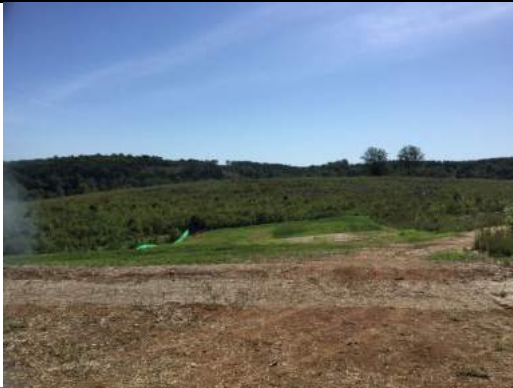
GPS Location	5	GPS Location	6		
Field Station#	15243+00	Field Station#	15258+00		
Pic 5 Desc.	Permanent vegetation growing along ROW and functioning perimeter controls in place	Pic 6 Desc.	Permanent vegetation growing along ROW and functioning perimeter controls in place

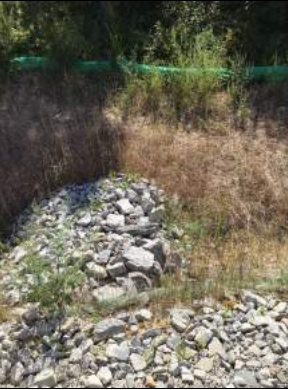
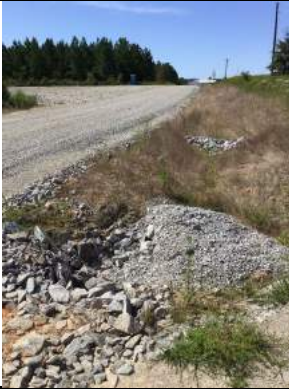
GPS Location	0	GPS Location	0		
Field Station#	00+00	Field Station#	00+00		
Pic 1 Desc.	Observing rock check dam.	Pic 2 Desc.	Observing outlet and outlet protection.

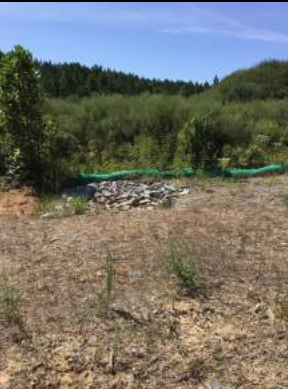
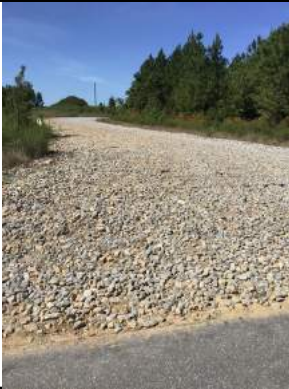
GPS Location	0	GPS Location	0		
Field Station#	00+00	Field Station#	00+00		
Pic 3 Desc.	Observing ECD's performing as they should.	Pic 4 Desc.	Observing RCE at Transco.		
Insert image here			Insert image here		
GPS Location		GPS Location			
Field Station#		Field Station#			
Pic 5 Desc.		Pic 6 Desc.

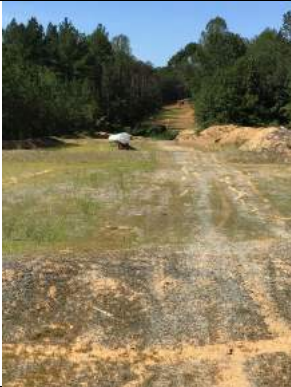
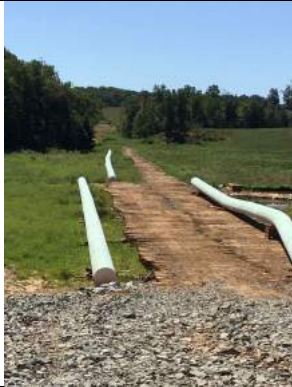
GPS Location	0	GPS Location	0		
Field Station#	16020+00	Field Station#	15952+70		
Pic 1 Desc.	Observing the row	Pic 2 Desc.	Observing wetland crossing.

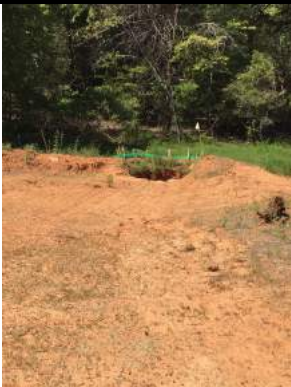
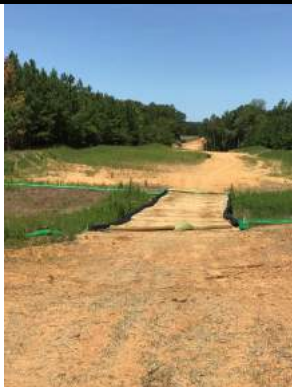
GPS Location	0	GPS Location	0		
Field Station#	15810+00	Field Station#	15812+00		
Pic 3 Desc.	Observing sump and end treatment.	Pic 4 Desc.	Observing equipment crossing.		
Insert image here			Insert image here		
GPS Location		GPS Location			
Field Station#		Field Station#			
Pic 5 Desc.		Pic 6 Desc.

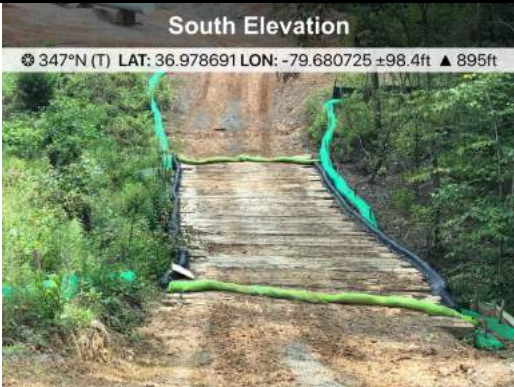
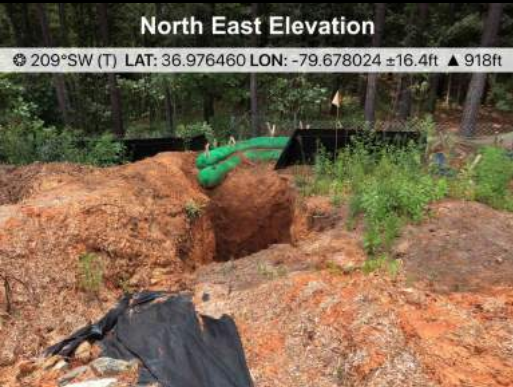
GPS Location	0	GPS Location	0		
Field Station#	14881+54	Field Station#	14902+00		
Pic 1 Desc.	Equipment bridge clean at stream S-CD8	Pic 2 Desc.	Sump pit functioning as intended		
South East Elevation <small>311°NW (T) LAT: 37.021942 LON: -79.763794 ±16.4ft ▲ 993ft</small>

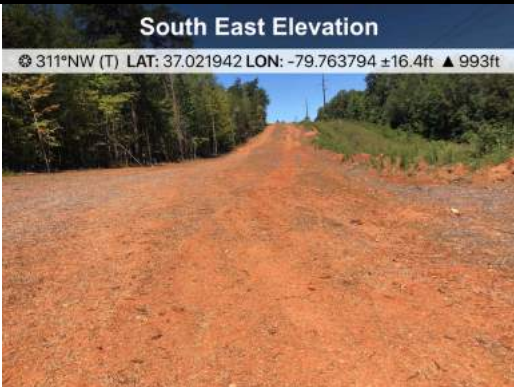
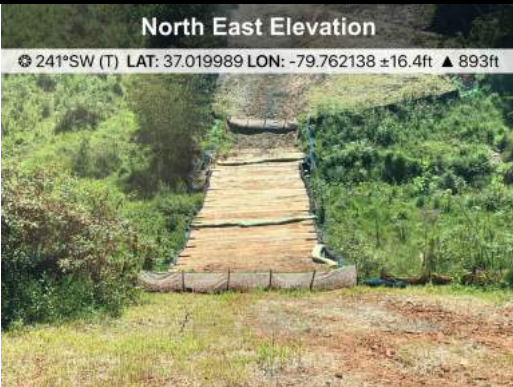
GPS Location	0	GPS Location	0		
Field Station#	14480+00	Field Station#	14486+56		
Pic 3 Desc.	Temporary stabilization	Pic 4 Desc.	Equipment bridge clean at stream S-G22		
West Elevation <small>76°E (T) LAT: 36.971180 LON: -79.659019 ±16.4ft ▲ 938ft</small>

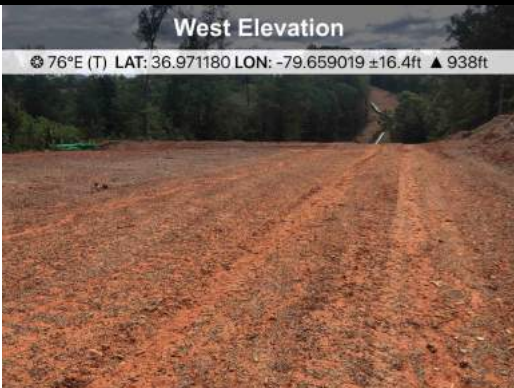
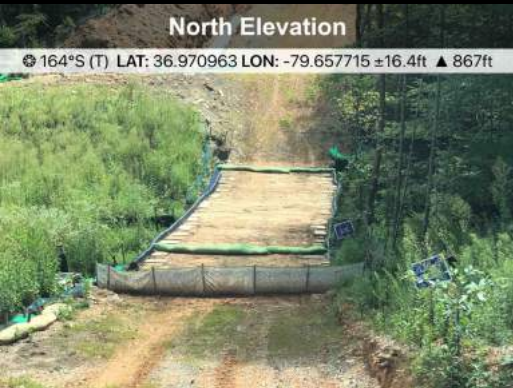
GPS Location	0	GPS Location	0		
Field Station#	14865+00	Field Station#	14870+43		
Pic 5 Desc.	Temporary stabilization	Pic 6 Desc.	Equipment bridge clean at stream S-SS8

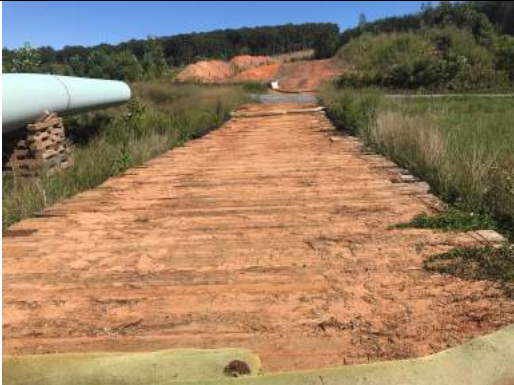
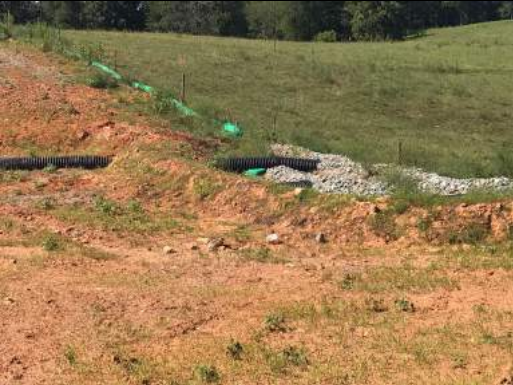
GPS Location	0	GPS Location	0		
Field Station#	14314+79	Field Station#	14275+00		
Pic 1 Desc.	Approximately 14314+79. Overview of stream crossing and equipment bridge at stream S-GG4.		Pic 2 Desc.	Approximately 14275+00. CWD piping and level spreaders.

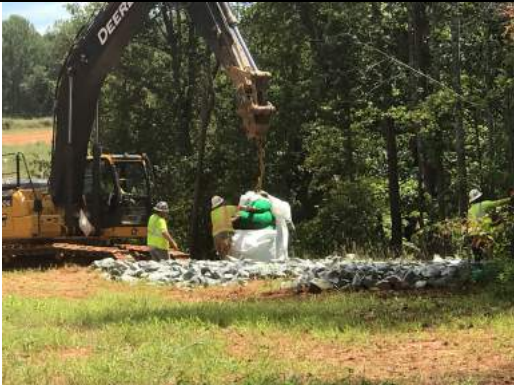
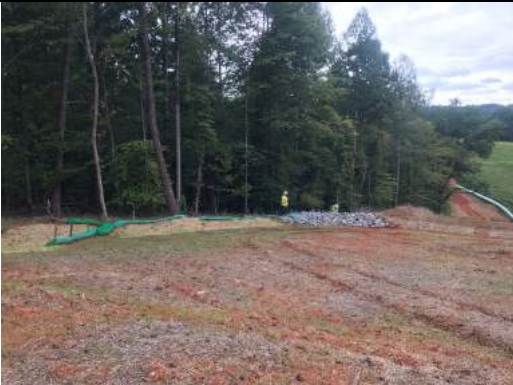
GPS Location	0	GPS Location	0		
Field Station#	14123+00	Field Station#	14153+00		
Pic 3 Desc.	Approximately 14123+00. Crews installing CFS triple stack.		Pic 4 Desc.	Approximately 14153+00. Crews cleaning sediment buildup from rip rap end treatment.	
Insert image here			Insert image here		
GPS Location		GPS Location			
Field Station#		Field Station#			
Pic 5 Desc.		Pic 6 Desc.

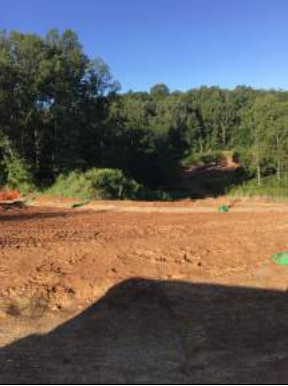
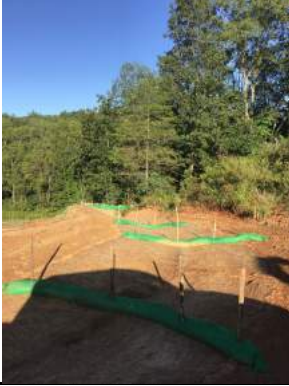
GPS Location	0000		GPS Location	0000	
Field Station#	13784+55		Field Station#	13784+55	
Pic 1 Desc.	ECDs in place on recently repaired area of row.		Pic 2 Desc.	ECDs in place on new breaker added

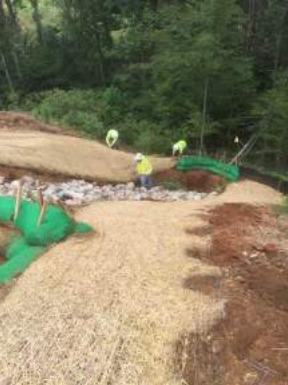
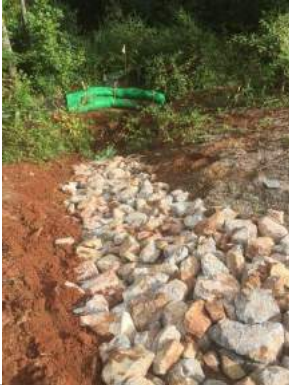
GPS Location	0000		GPS Location	00000	
Field Station#	13773+60		Field Station#	13773+60	
Pic 3 Desc.	Environmental crew installing erosion blanket		Pic 4 Desc.	Newly installed rip rap channel leading to sump pit	
Insert image here			Insert image here		
GPS Location			GPS Location		
Field Station#			Field Station#		
Pic 5 Desc.			Pic 6 Desc.
