Visual Site Inspection Report

Project Name	H-600 Pipeline Spread I	AFE	124300139	Spread	H-600 Pipeline Spread I
Contractor	Precision			Report #	100253
Inspector	Logan Box			Date/Time	9/18/2019 10:34 AM
Permit #	TBD	Inspection Type	VA SWPP	Station Begin	13670+00
State	VA	Inspection Area	Partial	Station End	13958+31
County	Franklin	Ground	Dry	Temperature (°F)	73.00
Municipality	N/A	Weather	Cloudy	Rain Gauge (in)	0.00
				Rain Accumulation Time (days)	0.00

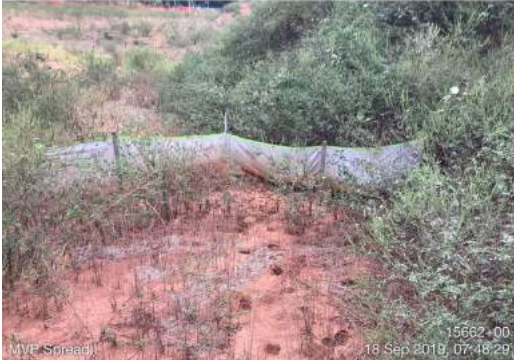
GPS Location	0	GPS Location	0		
Field Station#	15662+00	Field Station#	15659+50		
Pic 1 Desc.	P1 silt fence is acceptable	Pic 2 Desc.	Waterbar end treatment is acceptable

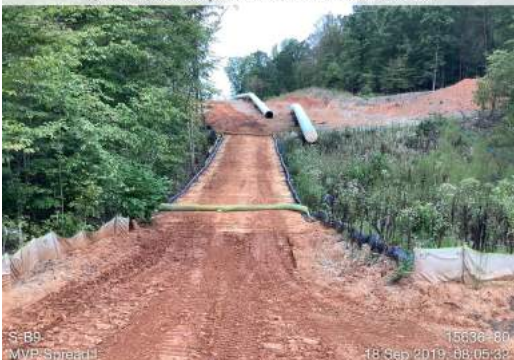
GPS Location	0	GPS Location	0		
Field Station#	15636+80	Field Station#	12+00		
Pic 3 Desc.	Equipment bridge is acceptable	Pic 4 Desc.	Waterbar is acceptable on Pipeline Branch H603

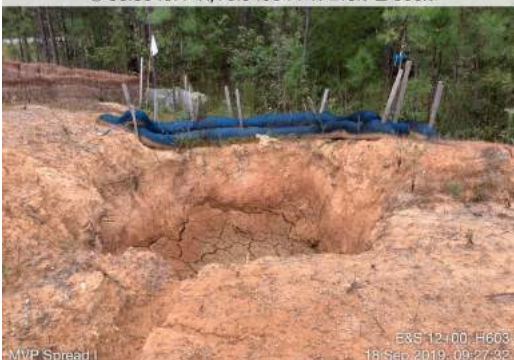
GPS Location	0	GPS Location	0		
Field Station#	12+00	Field Station#	5+53		
Pic 5 Desc.	Waterbar end treatment is acceptable on Branch Pipeline H603	Pic 6 Desc.	Equipment bridge is acceptable on Branch Pipeline H602

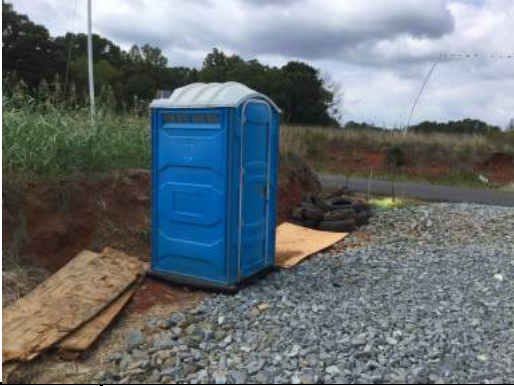
GPS Location	1	GPS Location	2		
Field Station#	15113+25	Field Station#	15223+00		
Pic 1 Desc.	Portajohns reinstalled at road crossings and placed in containment/drip pans		Pic 2 Desc.	View of permanent vegetation growing along ROW with ECD's performing intended function

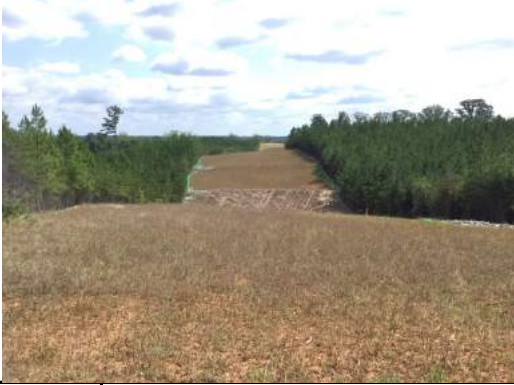
GPS Location	3	GPS Location	4		
Field Station#	15212+00	Field Station#	15200+00		
Pic 3 Desc.	View of permanent vegetation growing along ROW with ECD's performing intended function		Pic 4 Desc.	View of permanent vegetation growing along ROW with ECD's performing intended function

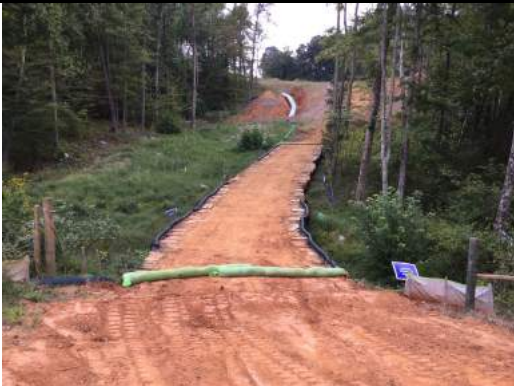
GPS Location	5	GPS Location	6		
Field Station#	15103+90	Field Station#	15168+59		
Pic 5 Desc.	Bridge crossing at S-G8/S-Q15 with ECD's in place; open trench visible		Pic 6 Desc.	Bridge crossing at S-C7 with ECD's in place; open trench visible

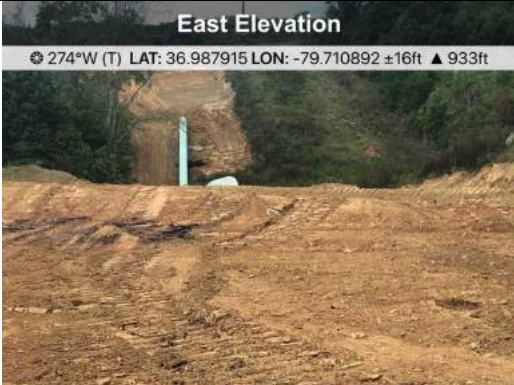
<p>East Elevation ⊙ 275°W (T) LAT: 36.987940 LON: -79.711477 ±32ft ▲ 917ft</p>			
GPS Location	0	GPS Location	0		
Field Station#	14690+00	Field Station#	14689+36		
Pic 1 Desc.	Water bars put back to spec once open trench was backfilled		Pic 2 Desc.	Equipment bridge clean at stream S-34

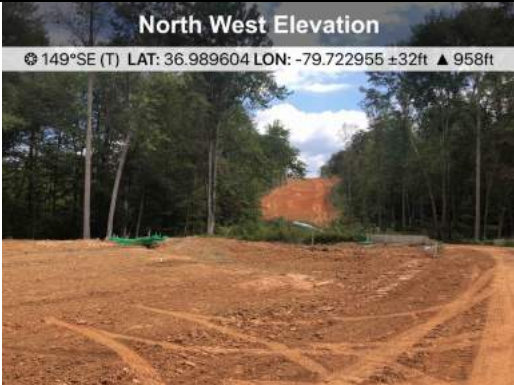
<p>North West Elevation ⊙ 126°SE (T) LAT: 36.989411 LON: -79.722567 ±32ft ▲ 963ft</p>			
GPS Location	0	GPS Location	0		
Field Station#	14655+00	Field Station#	14656+87		
Pic 3 Desc.	Water bars put back to spec once open trench was backfilled		Pic 4 Desc.	Equipment bridge clean at stream S-H38

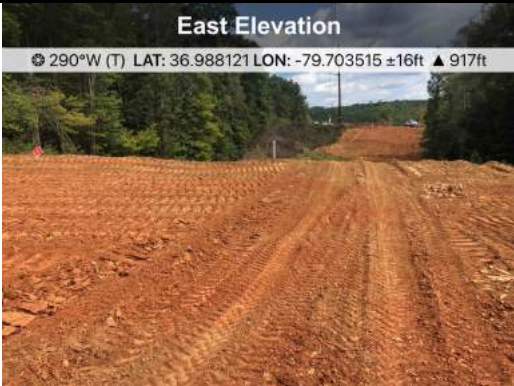
GPS Location	0	GPS Location	0		
Field Station#	14716+00	Field Station#	14716+96		
Pic 5 Desc.	Water bars put back to spec once open trench was backfilled		Pic 6 Desc.	Equipment bridge clean at wetland W-H11
