Visual Site Inspection Report

Project Name	H-600 Pipeline Spread G	AFE	124300137	Spread	H-600 Pipeline Spread G
Contractor	Precision			Report #	7503
Inspector	Garrett Barclay			Date/Time	1/20/2020 7:21 AM
Permit #	TBD	Inspection Type	VA SWPP	Station Begin	+28
State	VA	Inspection Area	Partial	Station End	+28
County	Giles	Ground	Damp	Temperature (°F)	10.00
Municipality	N/A	Weather	Below Freezing Temp	Rain Gauge (in)	0.00
				Rain Accumulation Time (days)	1.00

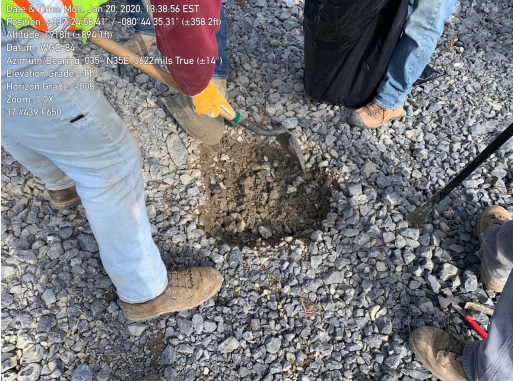
GPS Location	See picture above for GPS coordinates		GPS Location	See picture above for GPS coordinates	
Field Station#	+29		Field Station#	+28	
Pic 3 Desc.	ECD's and row conditions		Pic 4 Desc.	Crews removing contaminated material

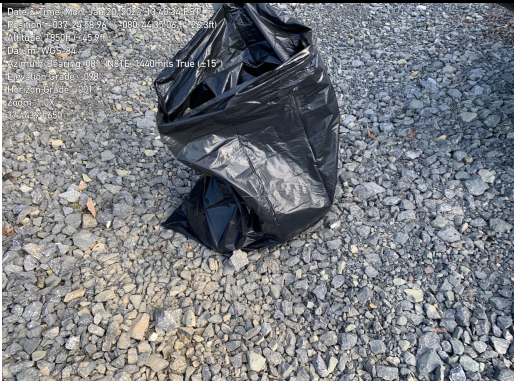
Pic 5 Desc.	Contaminated material placed in trash bags		Pic 6 Desc.	Secondary containment placed under vehicle

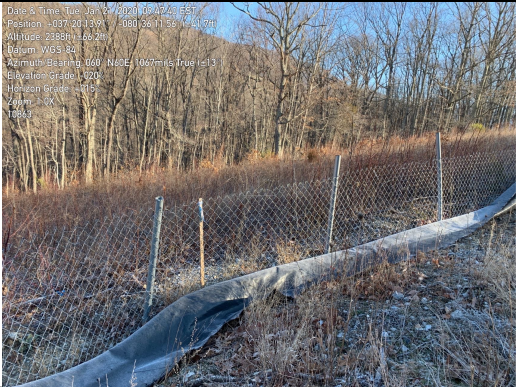
GPS Location	See picture above for GPS coordinates		GPS Location	See picture above for GPS coordinates	
Field Station#	10863+00		Field Station#	10883+00	
Pic 3 Desc.	SSF detached from wire backing		Pic 4 Desc.	Recommended curlex on banks of RCE

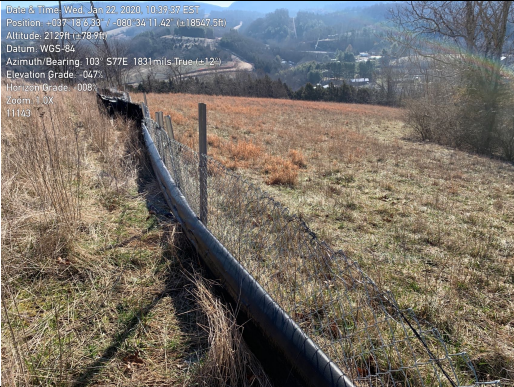
<p>Date & Time: Wed Jan 22, 2020, 10:38:39 EST Position: -037 18 51.831, -080 34 11.42, +103.8N Altitude: 2129ft (+69.9ft) Datum: WGS 84 Azimuth/Bearing: 103° S77E 1831mils True (+13°) Elevation Grade: -047° Horizon Grade: -008° Zoom: 1.0X 11133</p>		GPS Location	See picture above for GPS coordinates
Field Station#	2+49	Field Station#	11143+00	GPS Location	See picture above for GPS coordinates
Pic 1 Desc.	Damaged P1 @ AR 249	Pic 2 Desc.	SSF fabric detached from wire backing	Field Station#	11143+00

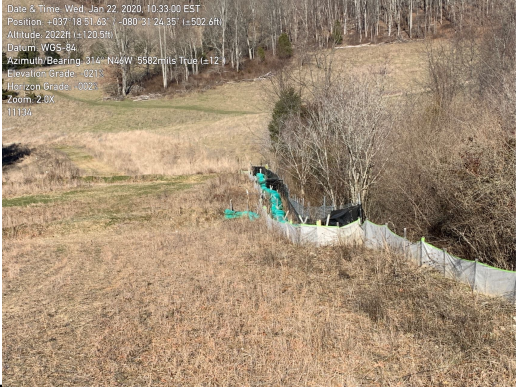
Field Station#	11134+00	Field Station#	11134+00	GPS Location	See picture above for GPS coordinates
Pic 3 Desc.	SSF fabric detached from wire backing	Pic 4 Desc.	Damaged P1	Field Station#	11134+00

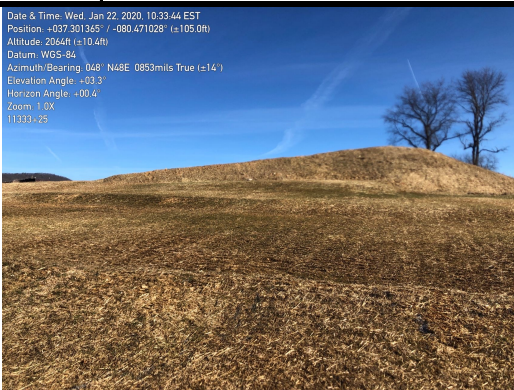
<p><small>Date & Time: Wed, Jan 22, 2020, 10:45:58 EST Position: +037.203447° / -080.473977° (+10.0m) Altitude: 1875ft (+10.0m) Datum: WGS-84 Azimuth/Bearing: 051° N51E 0907mils True (±22°) Elevation Angle: -26.1° Horizon Angle: +00.4° Zoom: 1.0X 11352+35</small></p>  			
GPS Location	5	GPS Location	6		
Field Station#	11333+25	Field Station#	11352+35		
Pic 5 Desc.	Vegetation or stabilization sufficient.	Pic 6 Desc.	Landowner cattle crossing becoming denuded.
